Section 319

NONPOINT SOURCE PROGRAM SUCCESS STORY

Better Management of Unpaved Roads and Cattle Grazing Reduces Sediment Loads

EPA 841-F-11-001M
February 2011

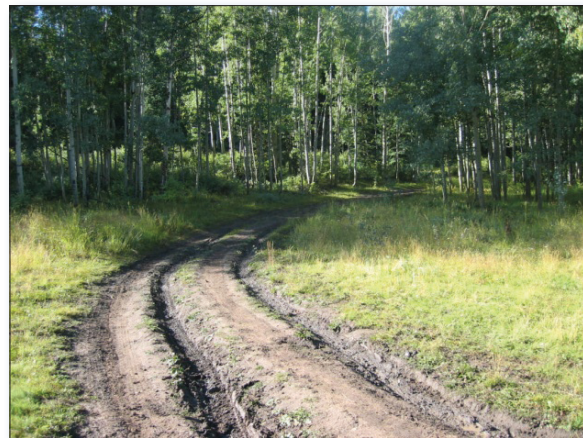
Figure 1. Before restoration efforts, unmaintained forest roads like this one contributed sediment to the creek.

After the TMDL was approved, the USFS implemented watershed restoration projects and changed land management practices to address sediment sources. Unmaintained native surface roads used for off-road vehicle use were a primary source of sediment. Because motorized vehicle use previously had been unrestricted, the road density in the watershed included many unauthorized, user-created and unmaintained recreational use roads. The Bureau of Land Management (BLM) and USFS implemented travel management plans for the surrounding area, specifying which roads would be added, maintained or closed. Each travel management plan outlined travel designations, specifying what types of vehicles would be permitted on each

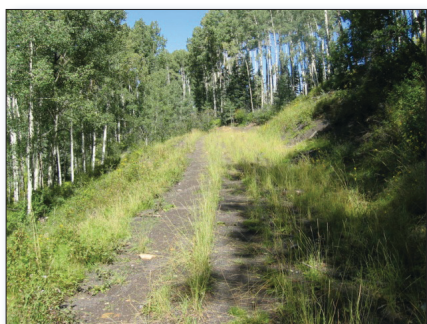
Figure 2. Many unpaved roads, such as this one, were closed to vehicular traffic and reseeded.

designated route and in what season. Travel management decisions set restrictions limiting the use of motorized vehicles (including off-road and four-wheel-drive vehicles) to designated routes on roads maintained or added under the travel management plans. Implementation of the travel management plans also included permanently closing and reclaiming many roads (Figure 2).
