## *Rapid Seafloor Reconnaissance and Assessment of Southeast Florida Ocean Dredged Material Disposal Sites Utilizing Sediment Profile Imaging*

### *May 2006 Post-Disposal SPI Mapping at the Miami ODMDS*

**POST-DISPOSAL SPI MAPPING AT THE MIAMI ODMDS**

**MAY 2006**

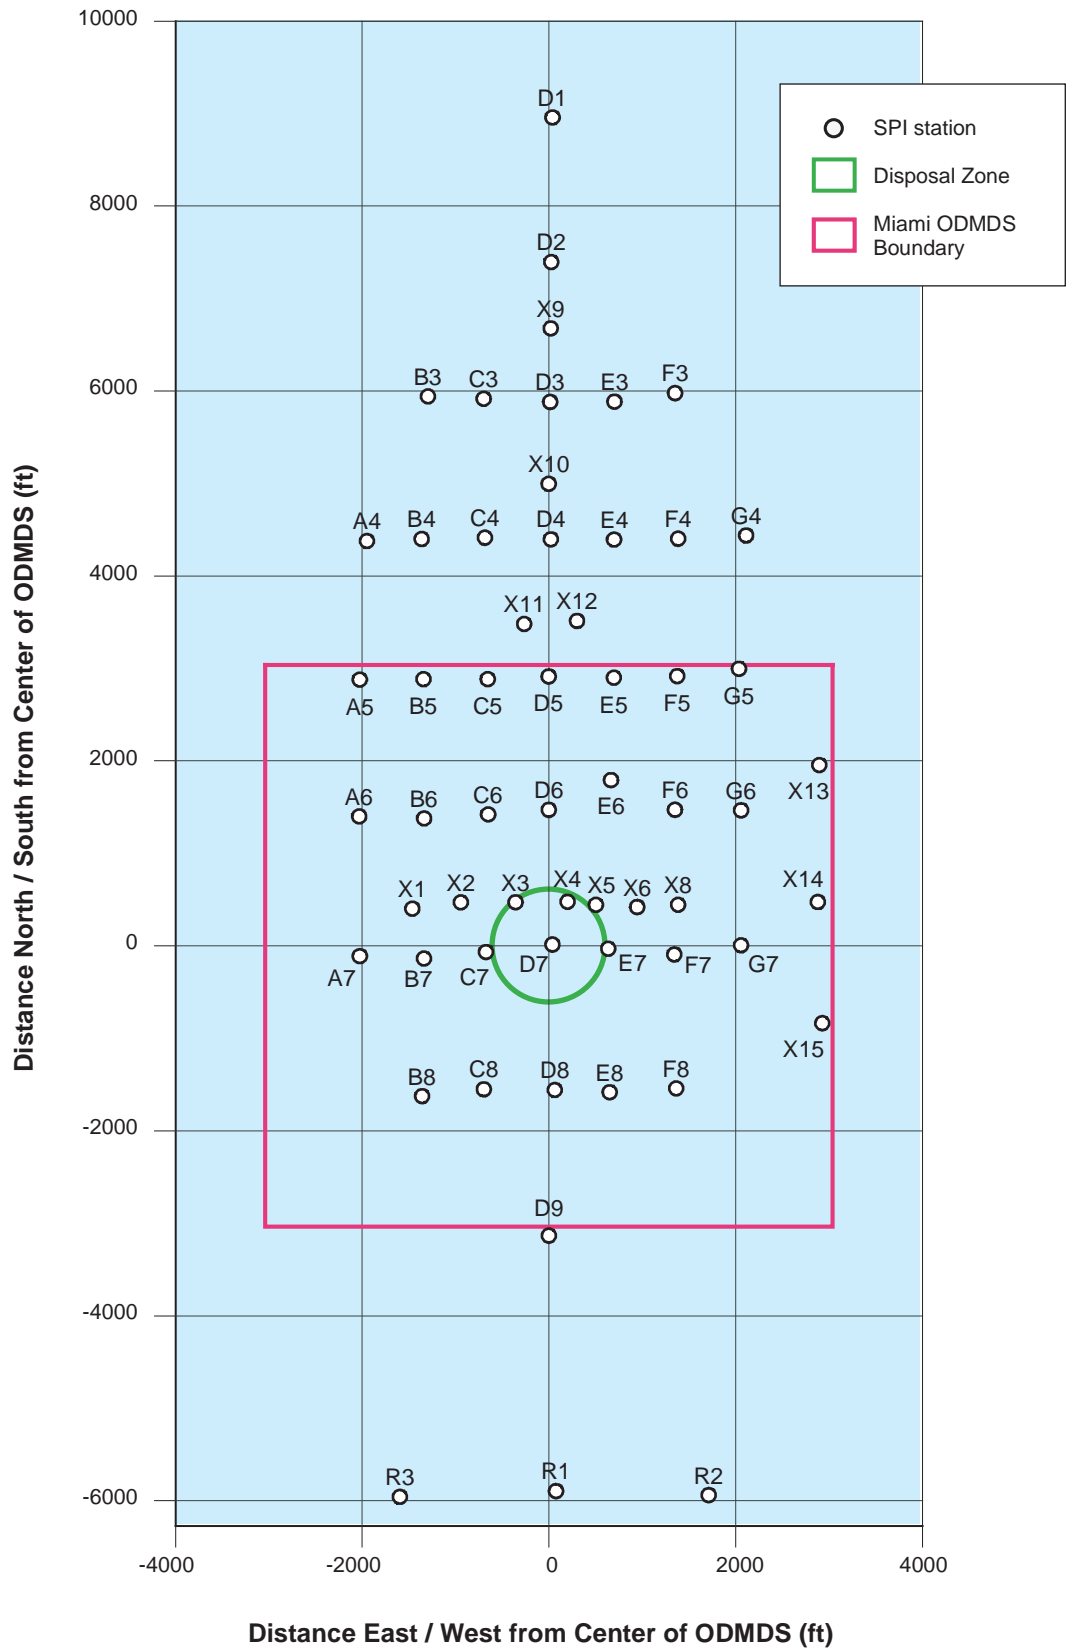
Figure 2-1: SPI sampling locations for the May 2006 survey at the Miami ODMDS.

The sampling involved the collection of sediment-profile images at a total of 58 stations, which can be broken down as follows (see Figure 2-1):

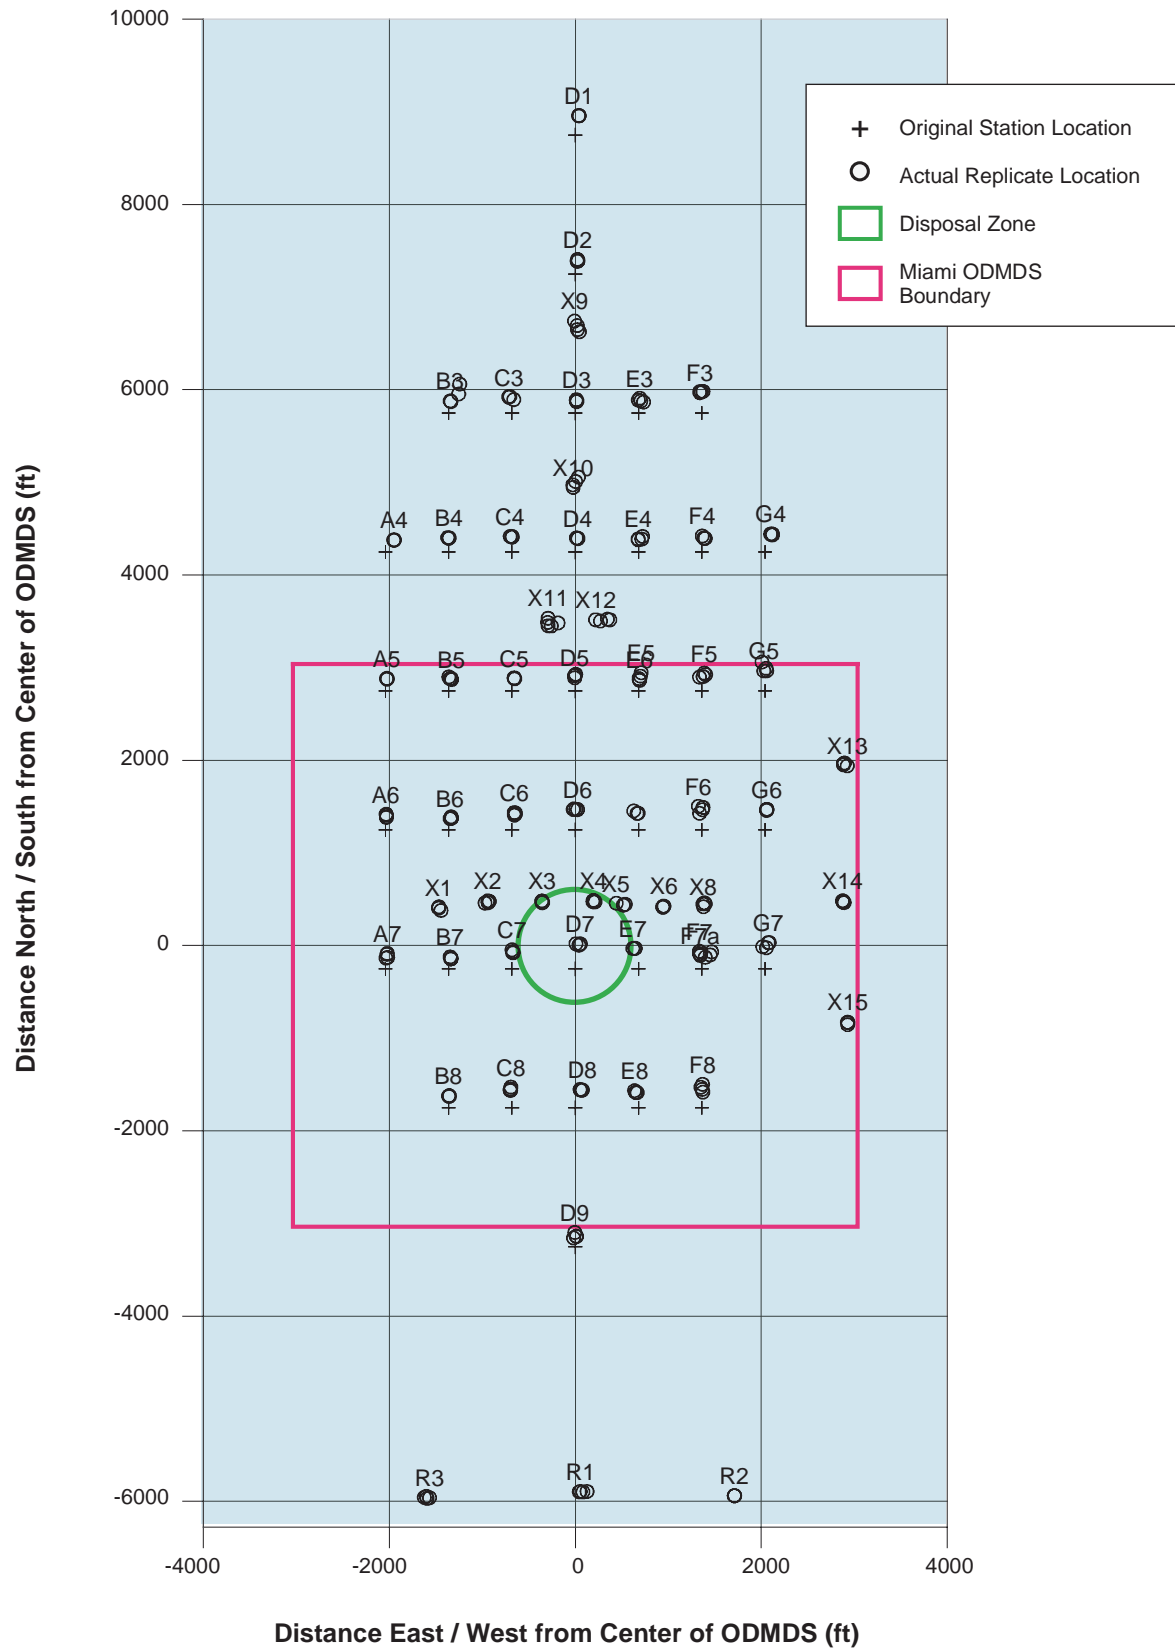
Figure 2-2: Map showing the target sampling location versus the actual location of each replicate camera drop for the May 2006 SPI survey at the Miami ODMDS.

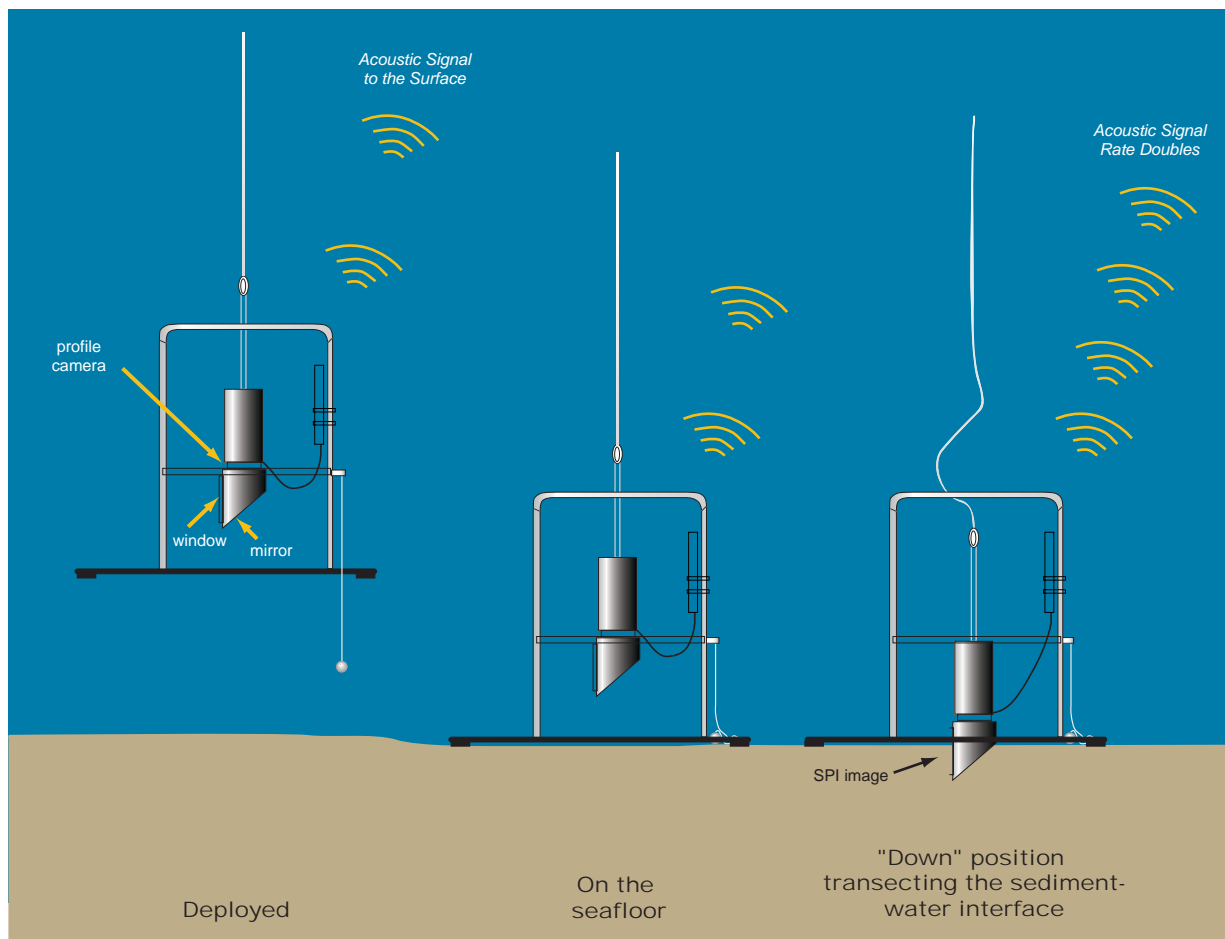
Figure 2-3: Operation of the sediment-profile camera during deployment. The central cradle of the camera is held in the "up" position by tension on the winch wire as it is being lowered to the seafloor (left); once the frame base hits the bottom (center), the prism is then free to penetrate the bottom (right) and take the photograph.

The prism has a strobe mounted inside, near the back of the wedge, to provide illumination for the image. Because the prism is filled with distilled water, the camera always has an optically clear path. The complete assembly, consisting of the watertight camera housing attached to the top of the water-filled prism, is mounted on a moveable carriage within a stainless steel frame. Onboard a survey vessel, this frame is attached to the winch wire and lowered slowly to the seafloor. Tension on the wire keeps the prism in its “up” position. When the frame comes to rest on the seafloor, the winch wire slackens (Figure 2-3) and the camera prism descends into the sediment at a slow, controlled rate that reduces disturbance at the sediment-water interface. As the prism descends and begins to penetrate into the sediment, it trips a trigger that activates a 15-second time-delay circuit. This time delay allows the prism to penetrate fully into the sediment before the image is taken. After the 15-second delay, the internal strobe discharges and the camera’s shutter releases. In this manner, the camera takes a picture of the sediment-water interface and the upper portion of the sediment column that is in direct contact with the prism’s Plexiglas<sup>®</sup> faceplate (i.e., a sediment cross-section or “profile” image). The resulting images give the viewer the same perspective as if looking through the side of an aquarium that is half-filled with sediment.

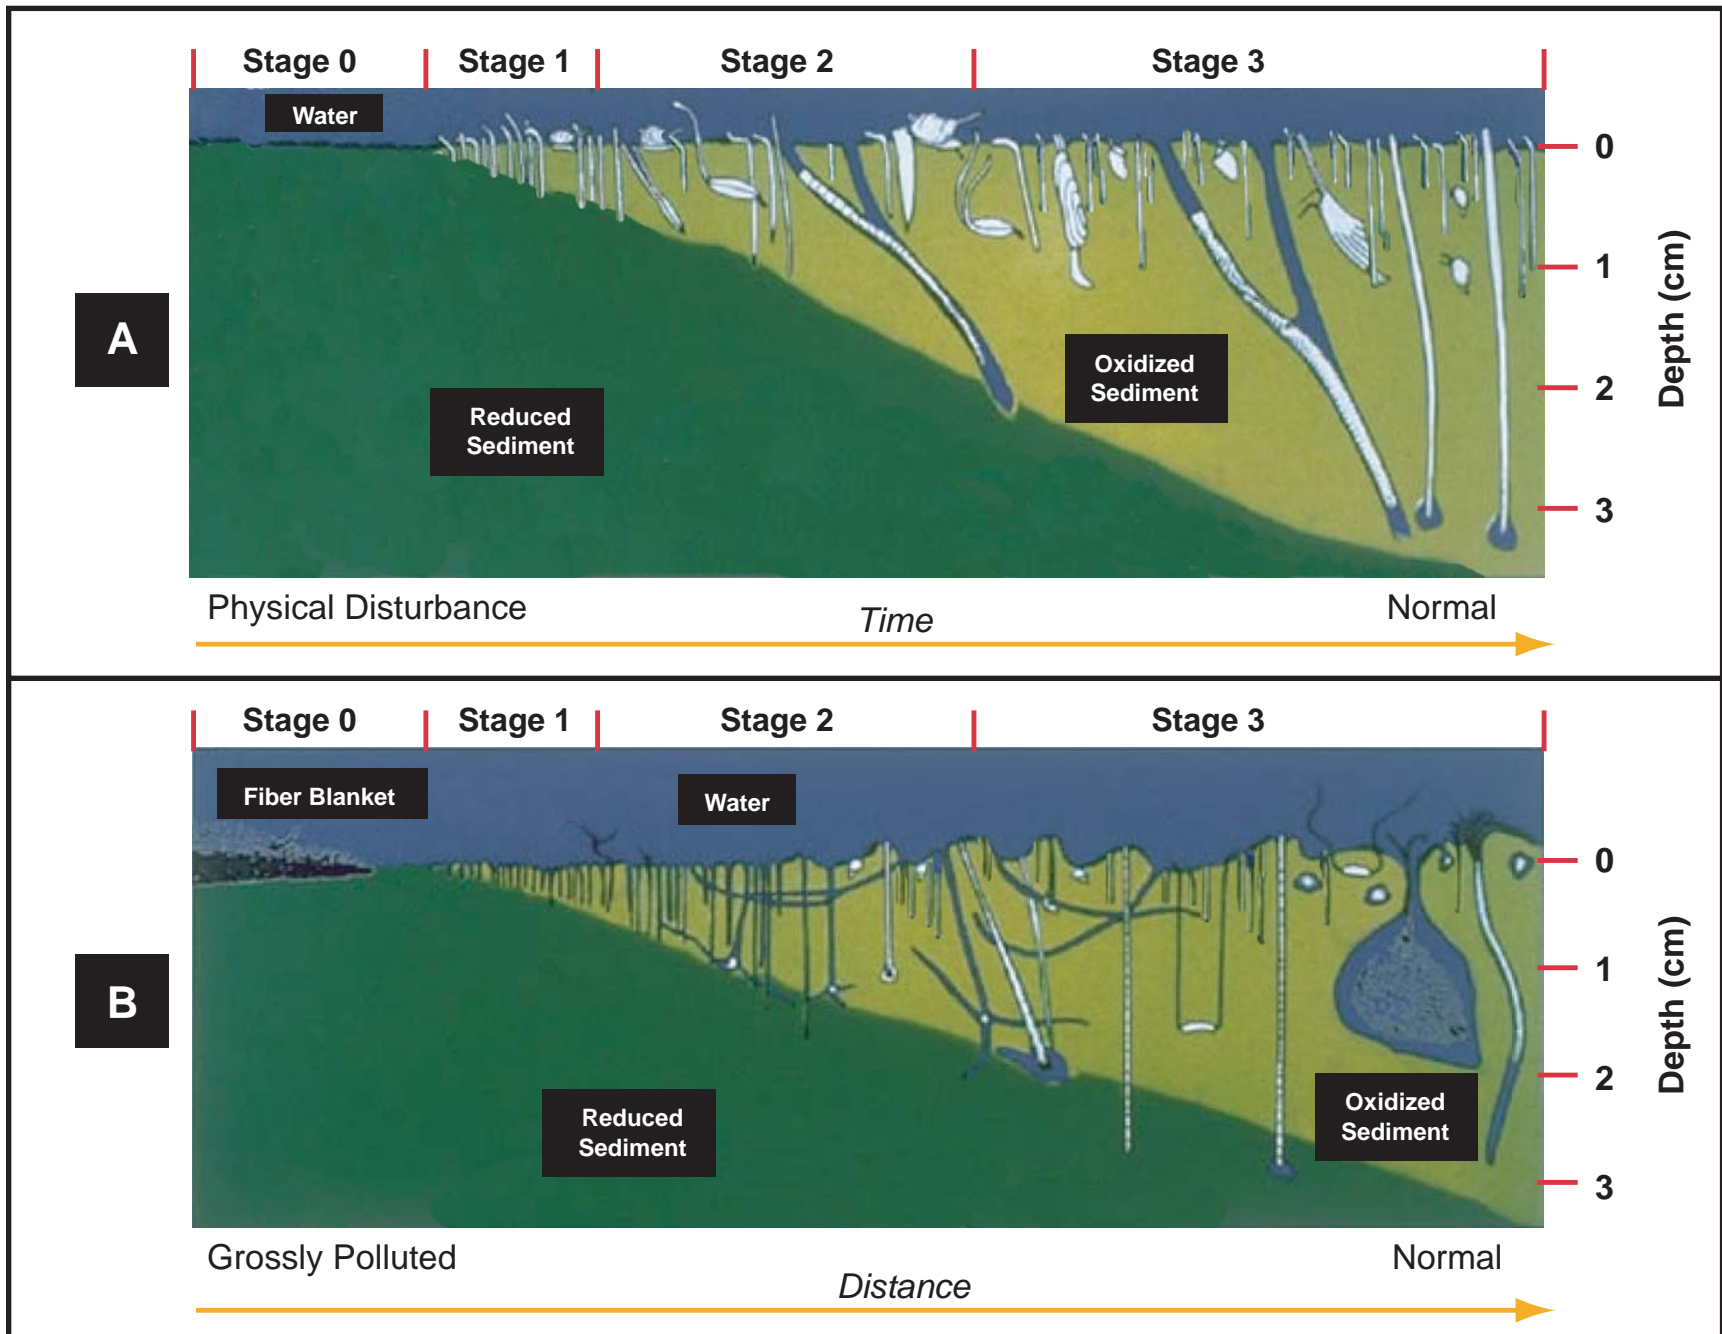
Figure 2-4: Soft-bottom benthic community response to physical disturbance (top panel) or organic enrichment (bottom panel). From Rhoads and Germano, 1982.

Although the successional models depicted in Figure 2-4 are not an ideal fit for an environment like the one at the Miami ODMDS, they nevertheless provided an established conceptual framework within which to evaluate the degree of infaunal activity observed in each image. A successional stage therefore was assigned to each image based on the observation of one or more of the features depicted in the models of

Although the recolonization pattern observed at the Miami ODMDS in the May 2006 SPI survey generally conformed with the conceptual model depicted in Figure 2-4, a key difference relates to organism density. Following disposal of organic-rich dredged material in many nearshore environments, dense mats of Stage 1 tubes are typically observed at the sediment surface within days to weeks. The surface- and near-surface-dwelling Stage 1 and 2 communities observed at the Miami stations within the disposal footprint appeared to have much lower tube densities. Surface tube densities on the surrounding ambient seafloor also appeared to be low. This is attributed to the much lower organic carbon content of both the ambient sediments and the disposed dredged material at the Miami ODMDS.

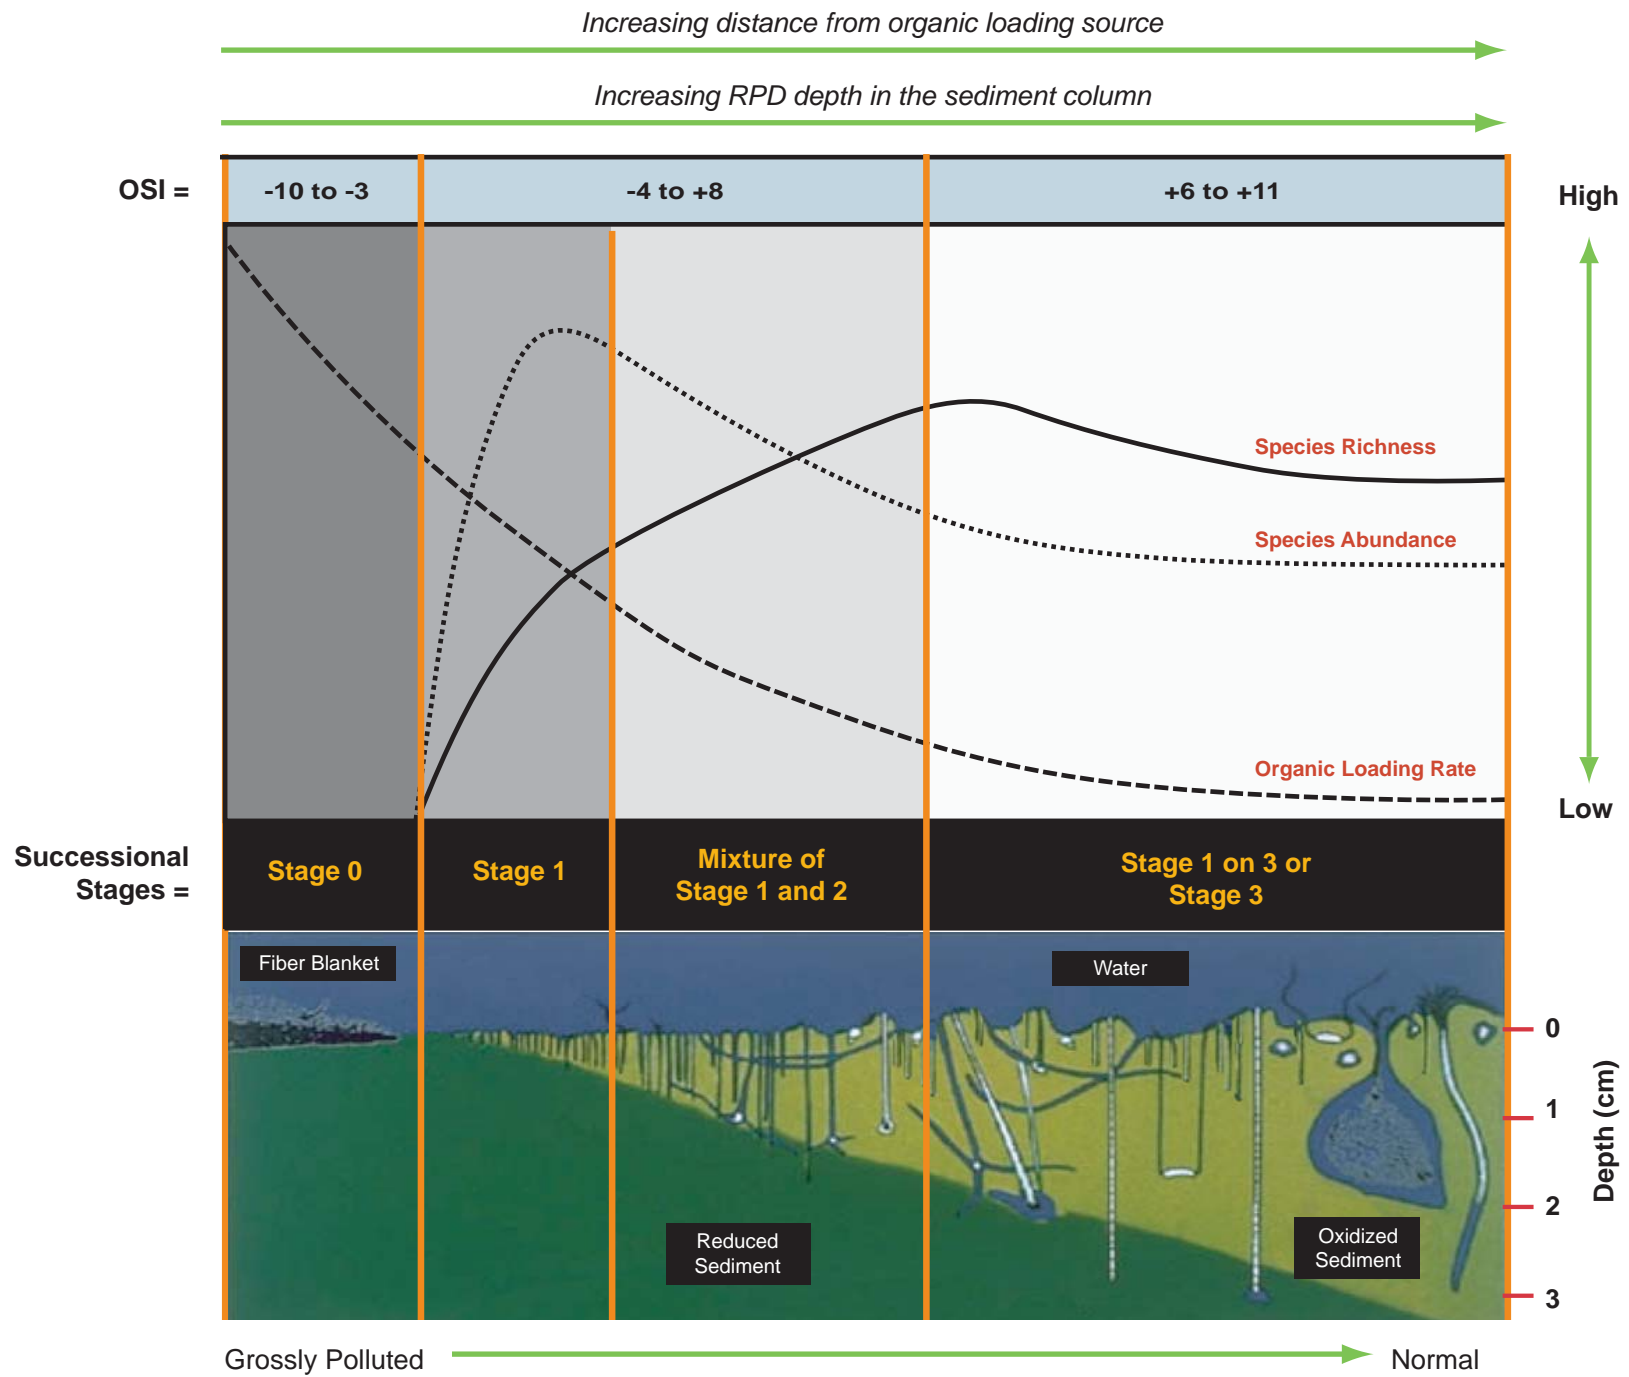
Figure 2-5: Model illustrating the relationships among key SPI parameters and traditional measures of species richness and abundance along an organic enrichment gradient.

Physical measurements made with the SPI system from profile images provide background information about gradients in physical disturbance (caused by dredging, disposal, oil platform cuttings/drilling muds discharge, trawling, or storm resuspension and transport) in the form of maps of sediment grain size, boundary roughness, sediment textural fabrics, and structures. The concentration of organic matter and the sediment oxygen demand (SOD) can be inferred from the optical reflectance of the sediment column and the apparent RPD depth. Organic matter is an important indicator of the relative value of the sediment as a carbon source for both bacteria and infaunal deposit feeders. SOD is an important measure of ecological health; oxygen can be depleted quickly in sediment by the accumulation of organic matter and by bacterial respiration, both of which place an oxygen demand on the porewater and compete with animals for a potentially limited oxygen resource (Figure 2-5; see also Kennish 1986).

The distribution of successional stages in the context of the mapped disturbance gradients is one of the most sensitive indicators of the ecological condition of the seafloor (Rhoads and Germano 1986; Figure 2-5). The presence of Stage 3 equilibrium taxa (mapped from subsurface feeding voids as observed in profile images) can be a good indication of high benthic habitat stability and relative lack of disturbance from natural or anthropogenic factors. A Stage 3 assemblage indicates that the sediment surrounding these organisms has not been disturbed severely in the recent past and that the inventory of bioavailable contaminants is relatively small. These inferences are based on past work, primarily in temperate latitudes, showing that Stage 3 species are relatively intolerant to sediment disturbance, organic enrichment, and sediment contamination. Stage 3 species expend metabolic energy on sediment bioturbation (both particle advection and porewater irrigation) to control sediment properties, including porewater profiles of sulfate, nitrate, and RPD depth in the sedimentary matrix near their burrows or tubes (Aller and Stupakoff 1996; Rice and Rhoads 1989). Bioturbation results in an enhanced rate of decomposition of polymerized organic matter by stimulating microbial decomposition (“microbial gardening”). Stage 3 benthic assemblages are very stable and are also called climax or equilibrium seres.

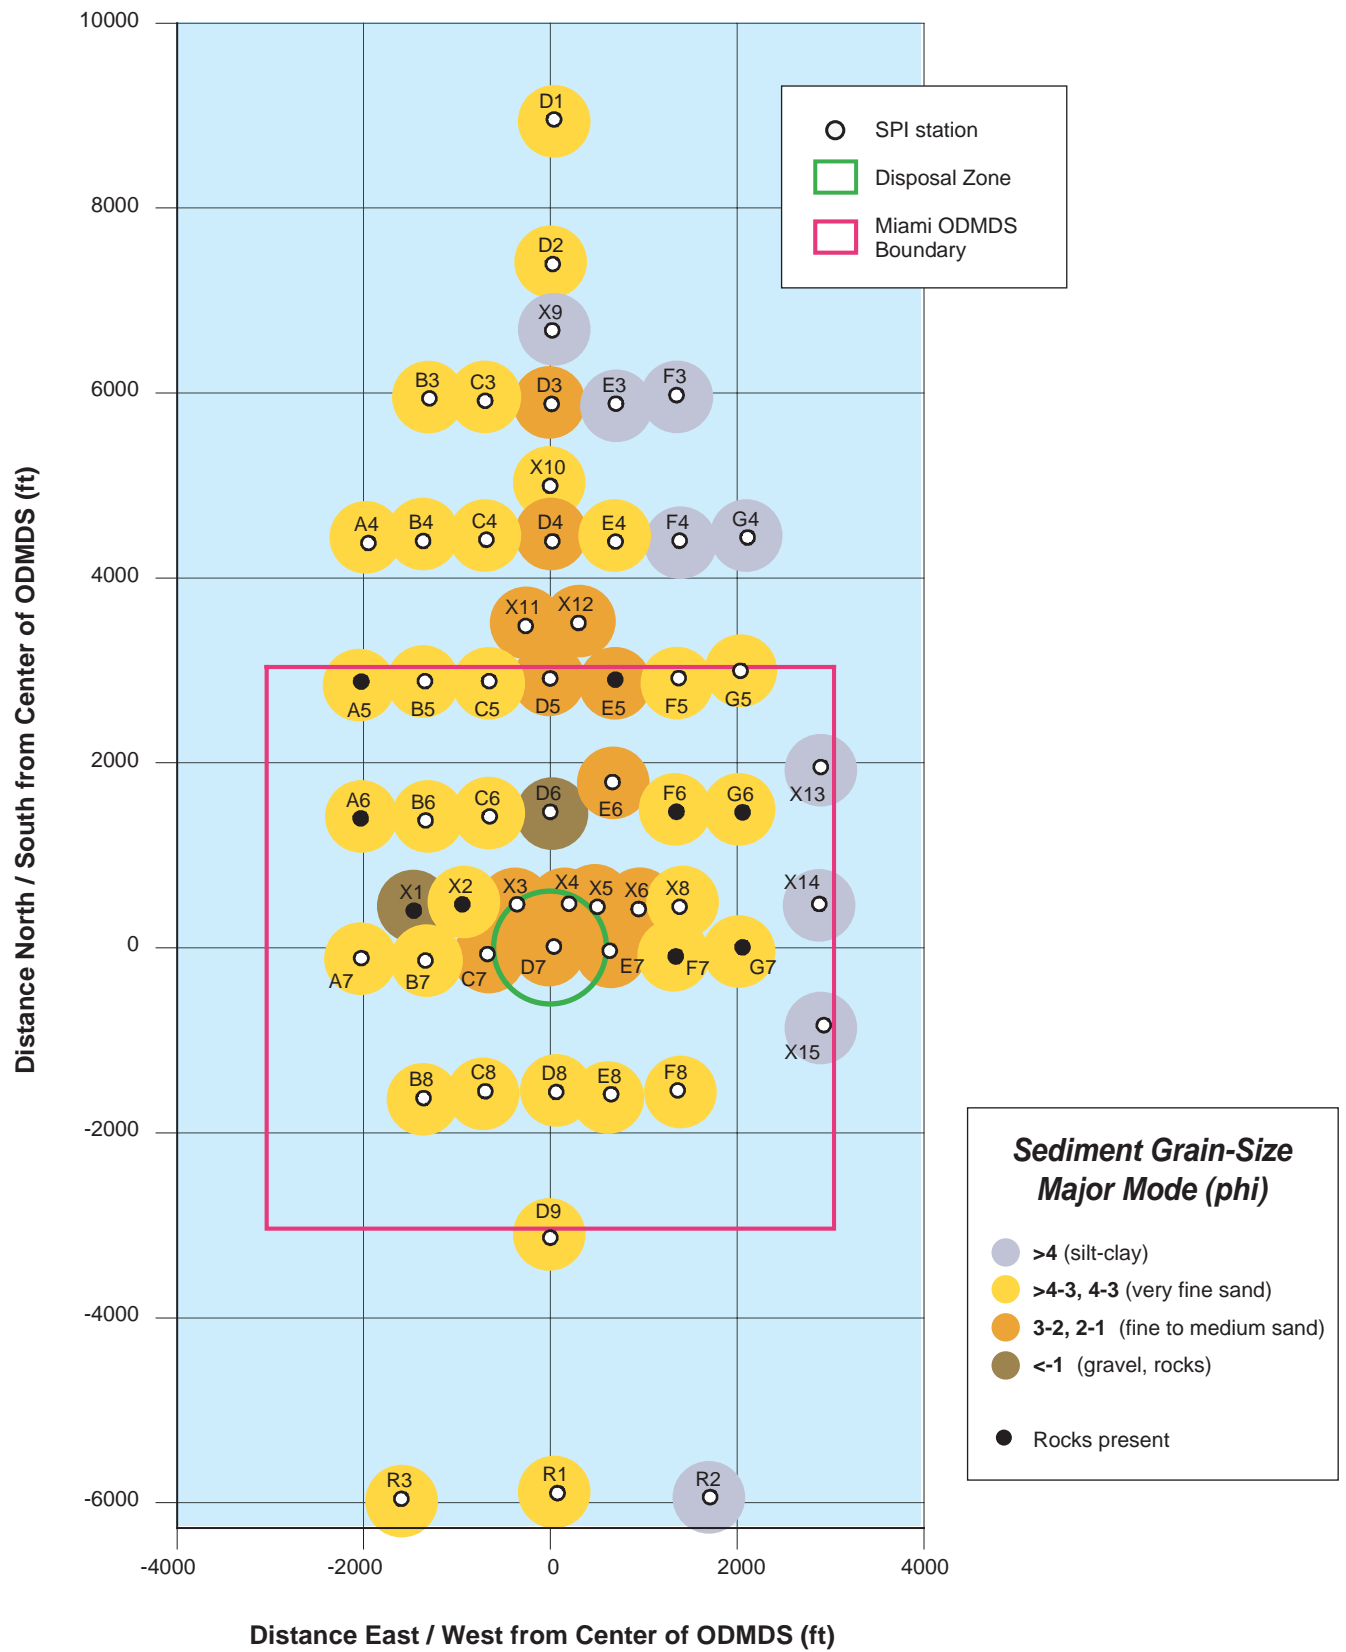
Similar to most of the disposal site stations, reference stations R1 and R3 were characterized by silty, very fine sand, while soft silt was found at reference station R2 (Figures 3-1 and 3-2; Table 3-2).

Figure 3-1: Grain size major mode (in phi units) at the Miami ODMDS SPI stations.

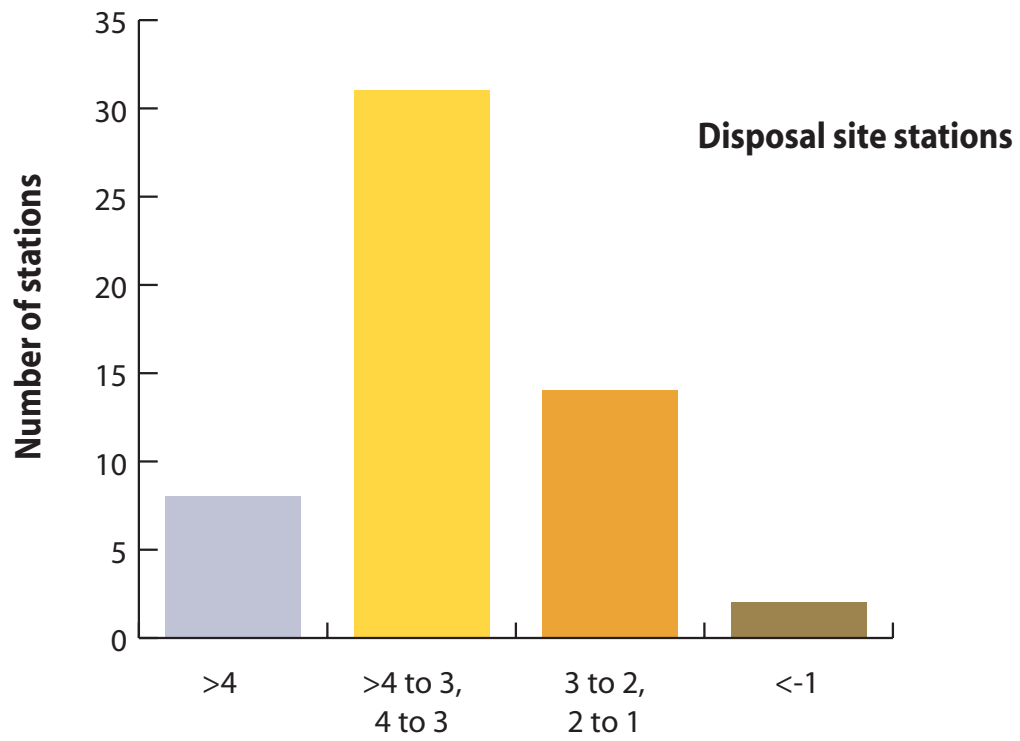
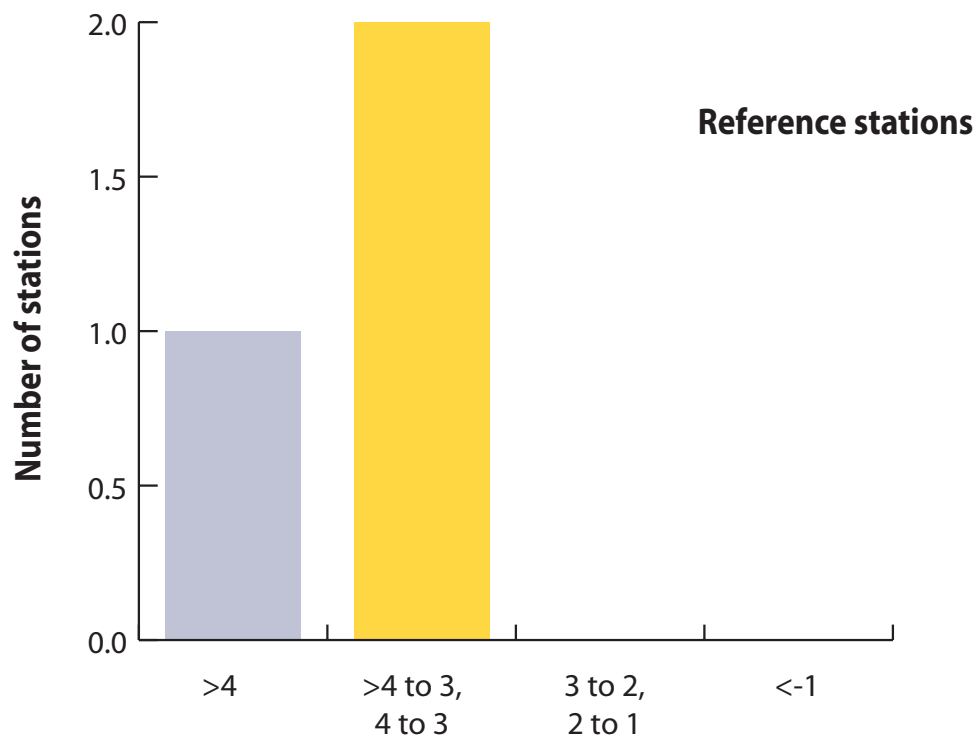
Figure 3-2: Frequency distribution of grain size major modes (in phi units) at the disposal site stations (top) and reference stations (bottom).

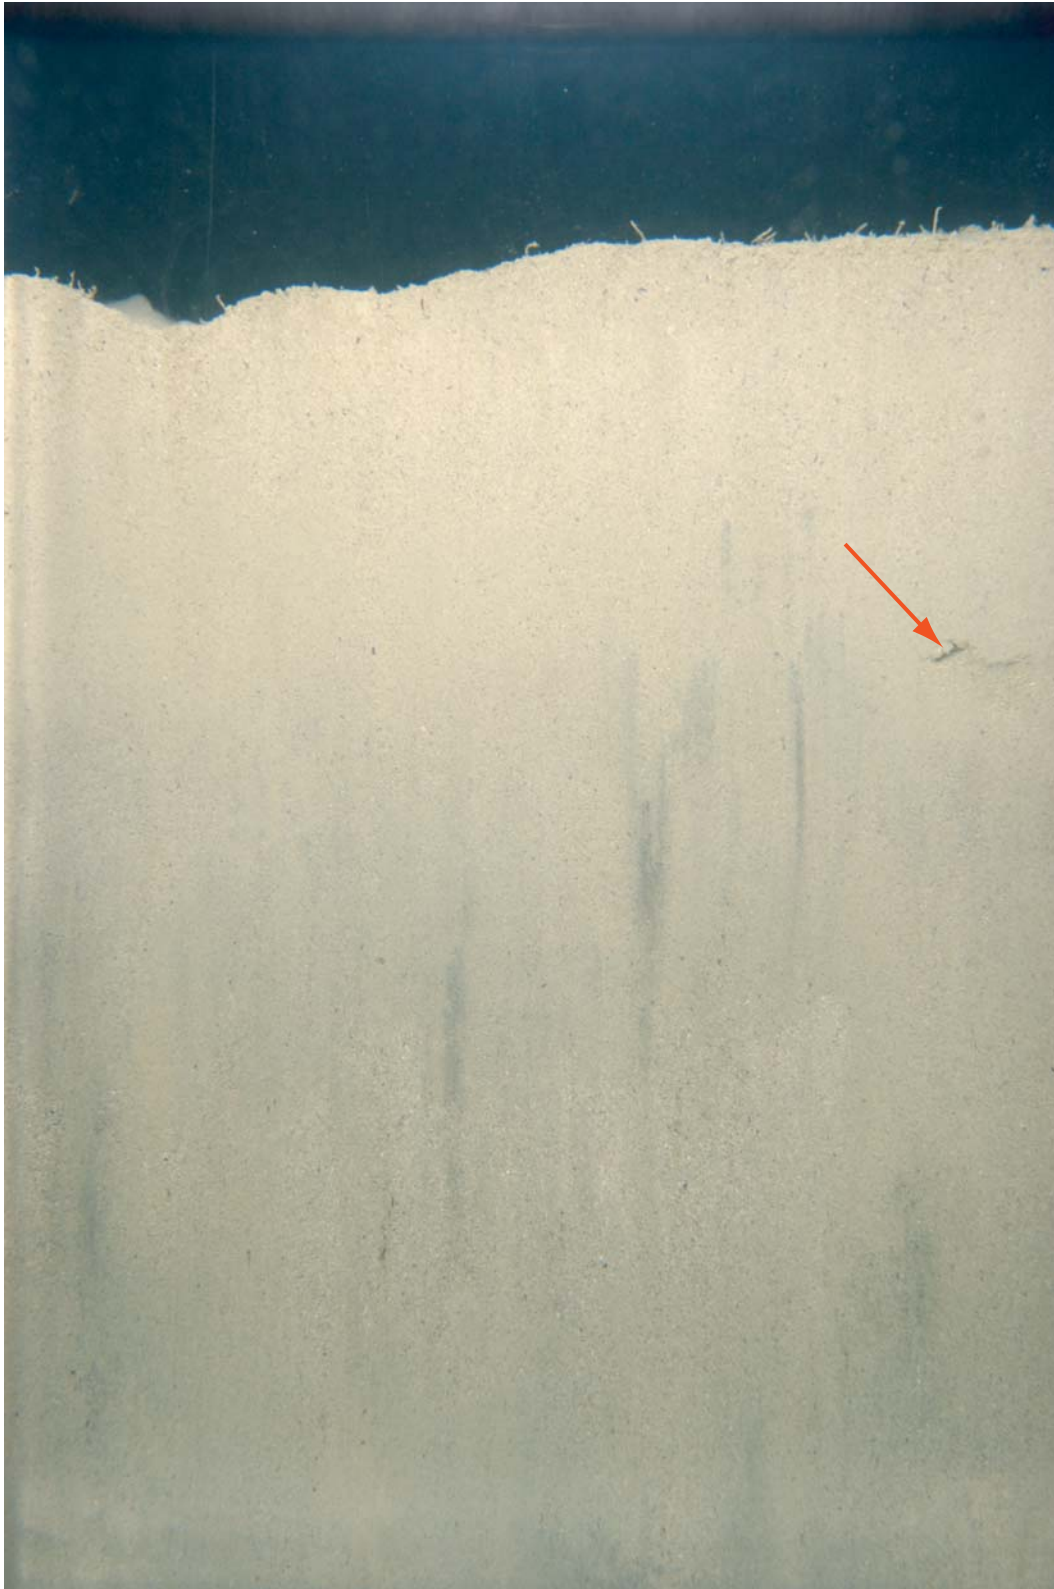
Figure 3-3: SPI image from Station B3 showing typical ambient sediment outside the disposal site consisting of relatively soft, silty, very fine sand (grain size major mode of 4 to 3 phi). Small tubes occur at the sediment surface, and a feeding void is visible at depth (arrow), resulting in a "Stage 1 on 3" successional designation for this image. Scale: actual image width is 14.4 cm.

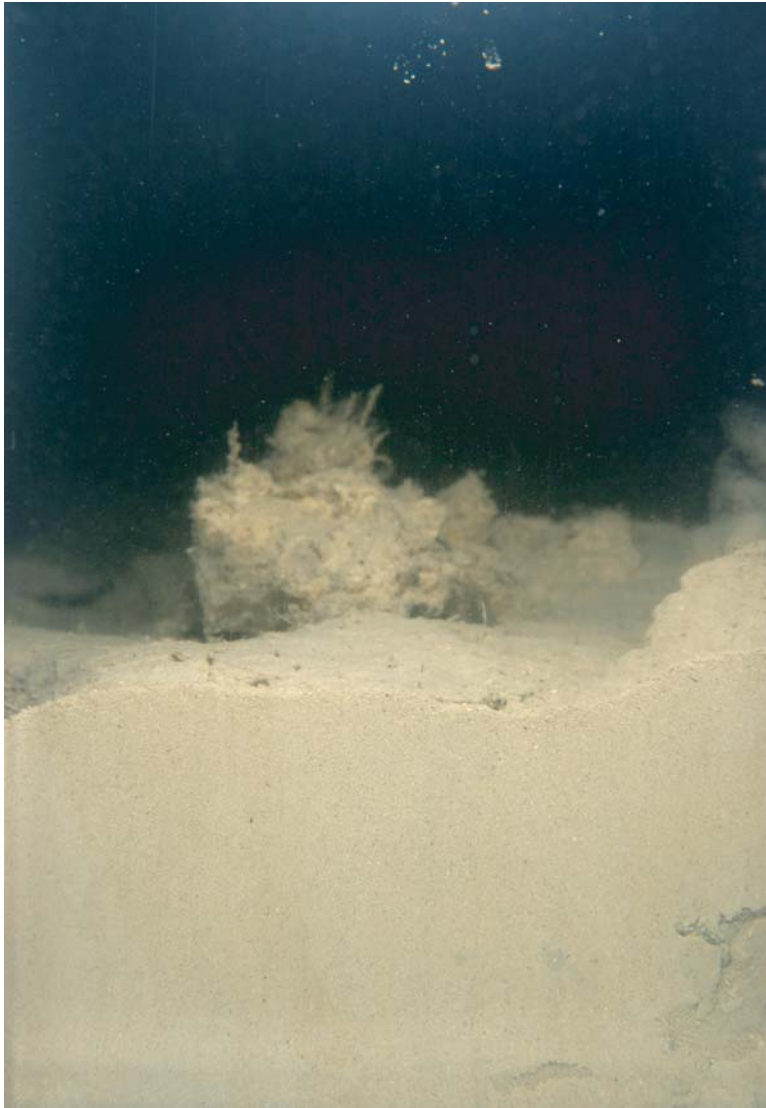
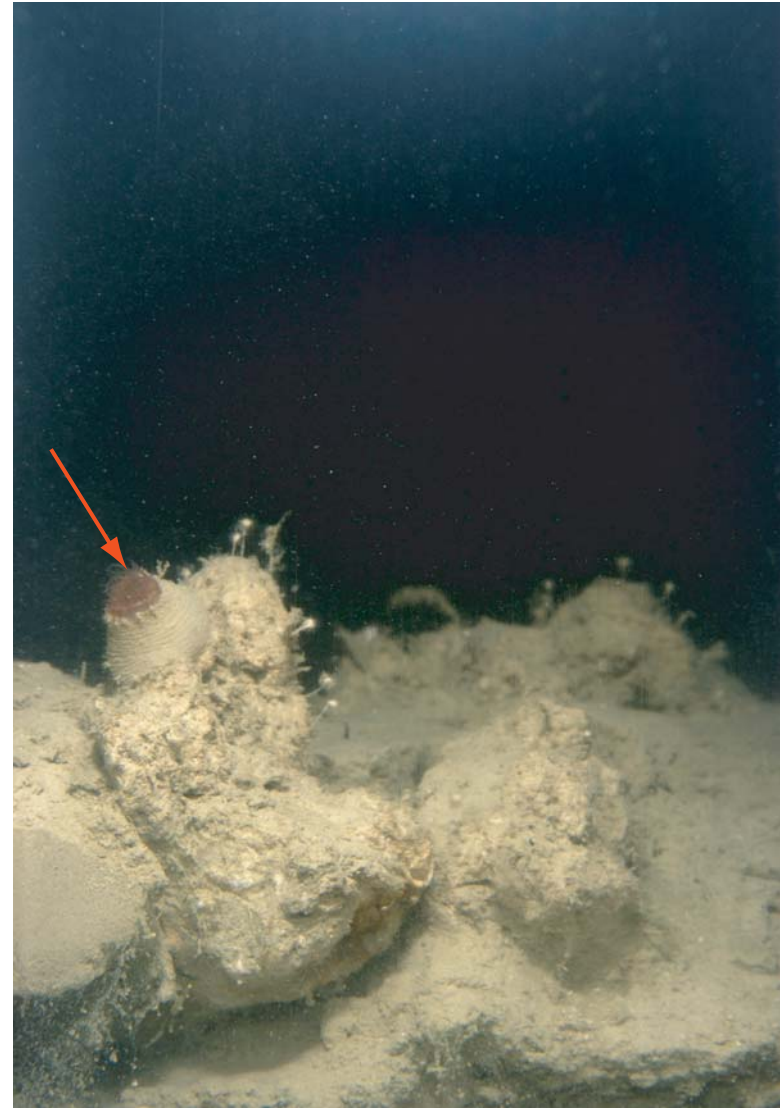
In addition to the recent dredged material, rocks also were observed on top of the sand at stations A5, A6, X1 and X2 on the western side of the disposal site and at stations F5, F6, F7, G6 and G7 on the eastern side (mapped with solid black symbols in Figure 3-1). The rocks at these stations were heavily encrusted with epifauna, such as anemones and hydrozoans (Figure 3-4). Given the extent of the biological growth, it is assumed that these rocks had been in place on the seafloor for some time. It is possible that these rocks occur in patchy "rubble" areas resulting from past dredged material disposal activities, prior to the Phase II Deepening Project. If sand was clearly visible beneath the rocks in a given image, that image was assigned a grain size major mode of sand (3 to 2 or 2 to 1 phi). If only the rocks were visible, the image was assigned a grain size major of gravel (<-1 phi) (Figures 3-1 and 3-4).

Figure 3-4: SPI images from stations F5 (left) and G6 (right) showing small rocks present at the sediment surface. A grain size major mode of  $>4$  to 3 phi was assigned to the left image due to the silty, very fine sand underlying the rocks, while only the rocks themselves are visible in the right image (grain size major mode of  $<-1$ ). In both images, the rocks are heavily encrusted with epifauna (the arrow points to a retracted anemone growing on the rock in the right image). Scale: actual image width is 14.4 cm.

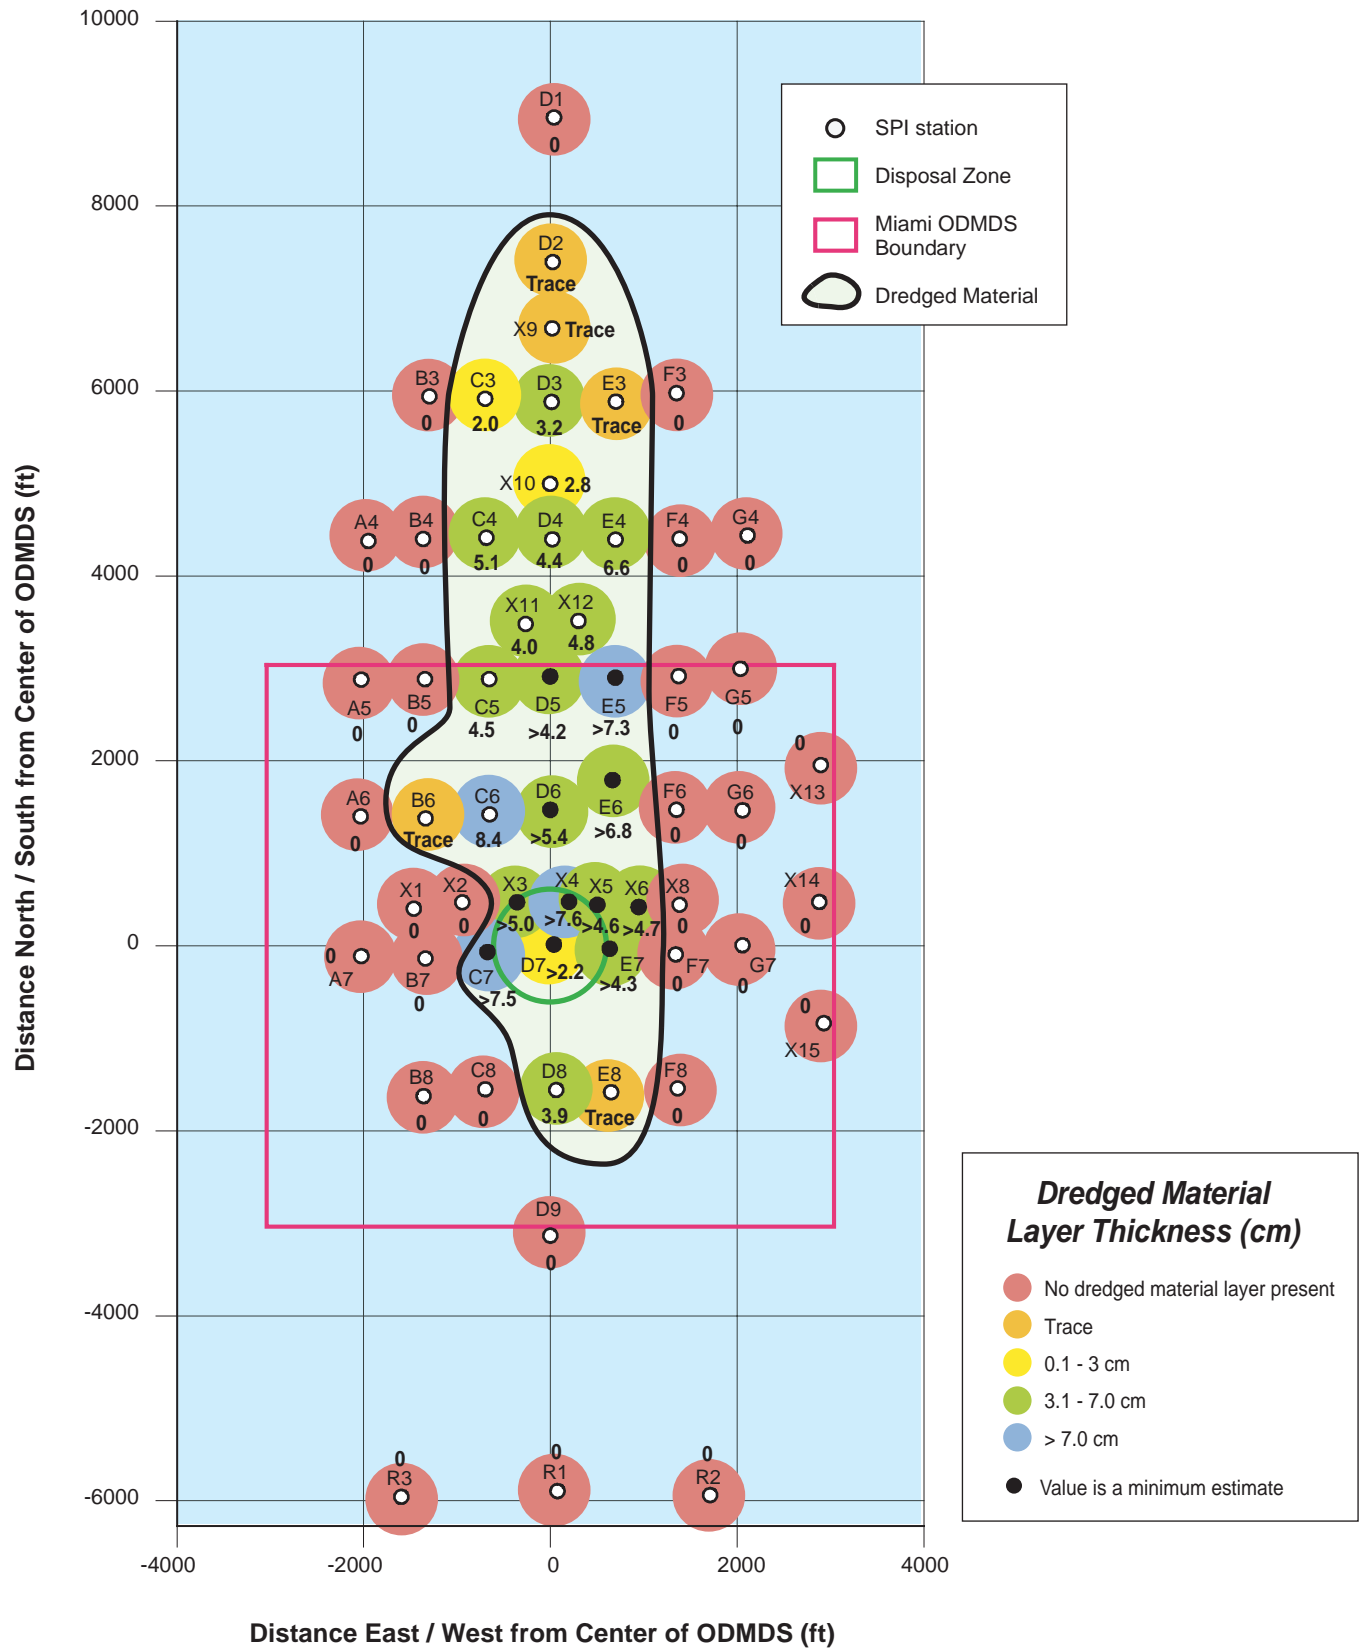
Dredged material was observed in the images at 27 of the 55 stations located within and to the north of the disposal site; there was no dredged material observed at any of the three reference stations (Tables 3-1 and 3-2). The overall footprint of the dredged material deposit formed an ellipse that was elongated in the north-south direction (Figure 3-5). Within this ellipse, the average thickness of the surface dredged material layer ranged from 8.4 cm at station C6 to trace amounts at several perimeter stations (Table 3-1 and Figure 3-5).

To the north of the disposal zone, outside the disposal site boundary, discrete layers of dredged material were observed overlying the ambient (i.e., pre-disposal) sediment surface (Figure 3-5). The dredged material comprising these relatively thin, discrete surface layers consisted of fine to very fine sand, while the underlying ambient sediment appeared to have a somewhat finer, more silty texture (Figure 3-8). In general, the dredged material became both finer-grained and occurred in gradually thinner layers moving northward away from the circular disposal zone. Overall, the dredged material in the images (e.g., Figures 3-6 through 3-8) was clearly distinguishable from the ambient surface sediments (e.g., Figure 3-3).

Figure 3-5: Average thickness of the dredged material layer at each of the Miami ODMDS SPI stations.

3. Given the strong northward drift of the dredged material following its release at the Miami ODMDS, it is recommended that the disposal zone be located to the south of its present location. This should help to ensure that more of the resulting seafloor is located within the ODMDS boundaries. However, even moving the disposal point to the southern end of the currently designated site perimeter will not result in dredged material remaining within the site boundary given the conditions at this particular location.
