## *Rapid Seafloor Reconnaissance and Assessment of Southeast Florida Ocean Dredged Material Disposal Sites Utilizing Sediment Profile Imaging*

### *May 2006 Post-Disposal SPI Mapping at the Miami ODMDS*

**POST-DISPOSAL SPI MAPPING AT THE MIAMI ODMDS**

**MAY 2006**

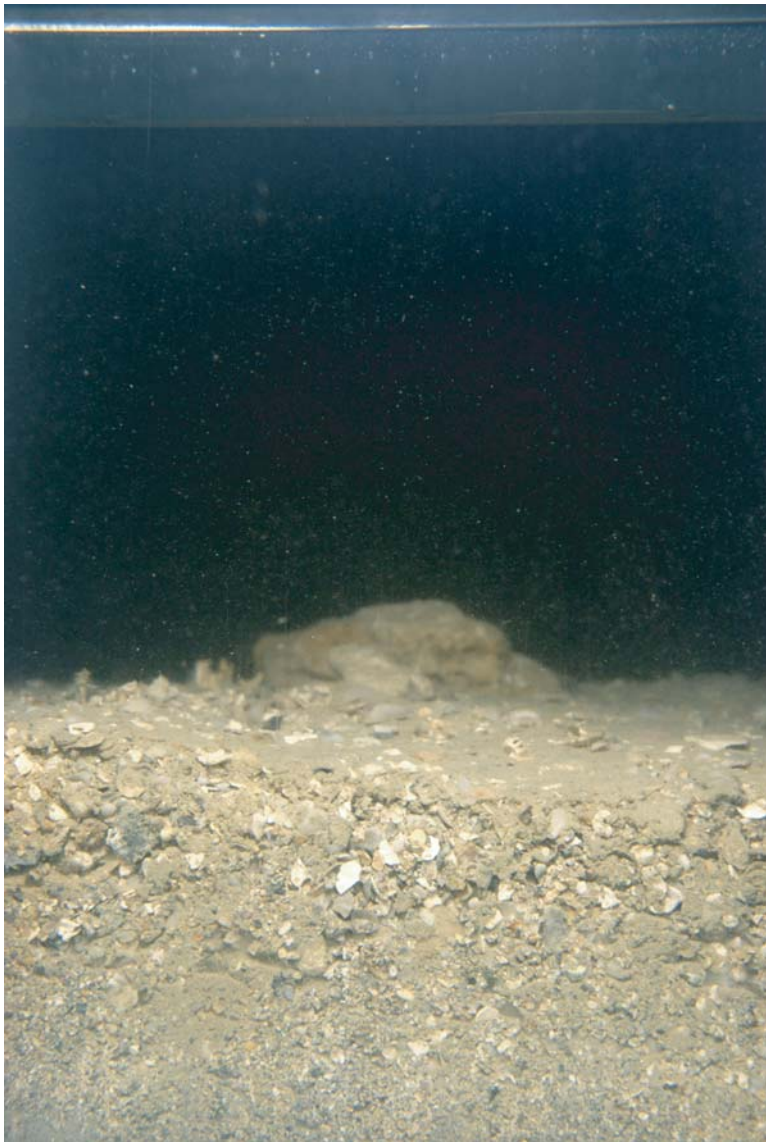
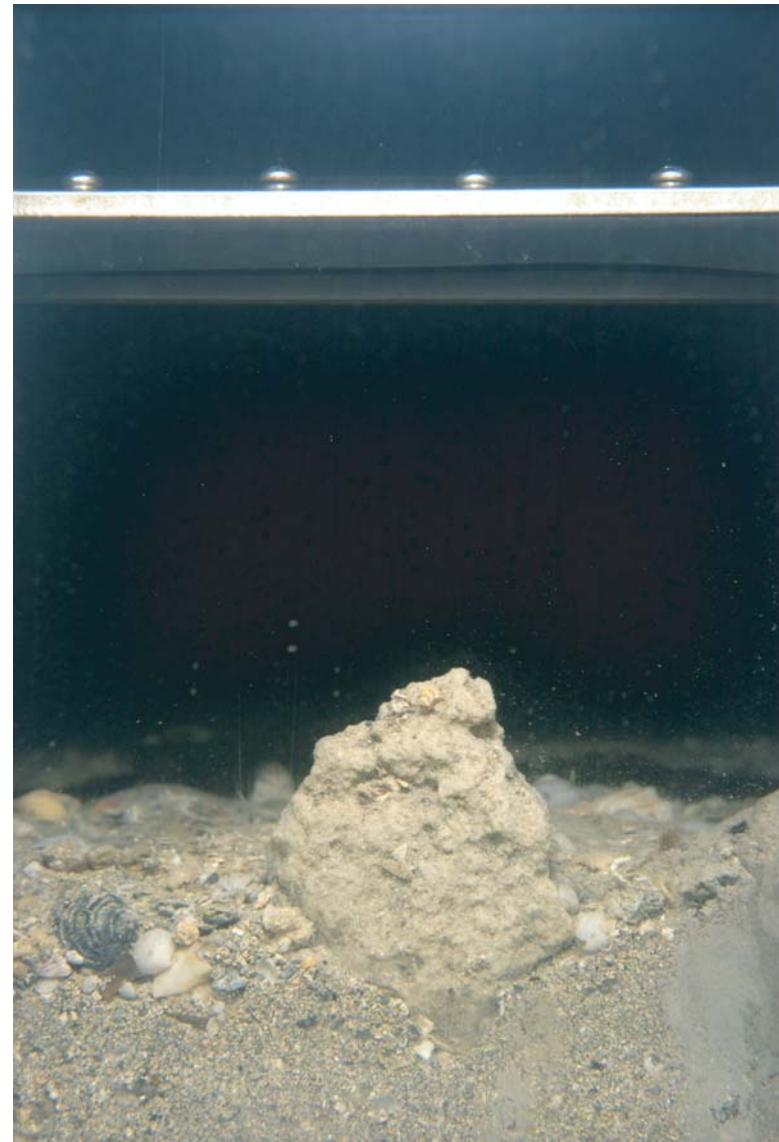
There were differences among stations in the color and texture of the dredged material. The coarsest dredged material, ranging from coarse sand to various sizes of gravel, occurred at the stations within and near the circular disposal zone (Figure 3-6). At most of these stations, the dredged material extended from the sediment surface to below the camera's imaging depth, resulting in the mapped thickness values being displayed with a "greater than" sign in Figure 3-5. The replicate images from Station E7 serve to illustrate some of the variability observed in the texture of the dredged material (Figure 3-7).

Figure 3-6: SPI images from stations D6 (left) and D7 (right) showing recent dredged material consisting of very coarse sand and gravel. In both images, the dredged material layer extends from the sediment surface to below the camera's imaging depth (i.e., thickness value mapped with a "greater than" sign in Figure 3-5). Scale: actual image width is 14.4 cm.

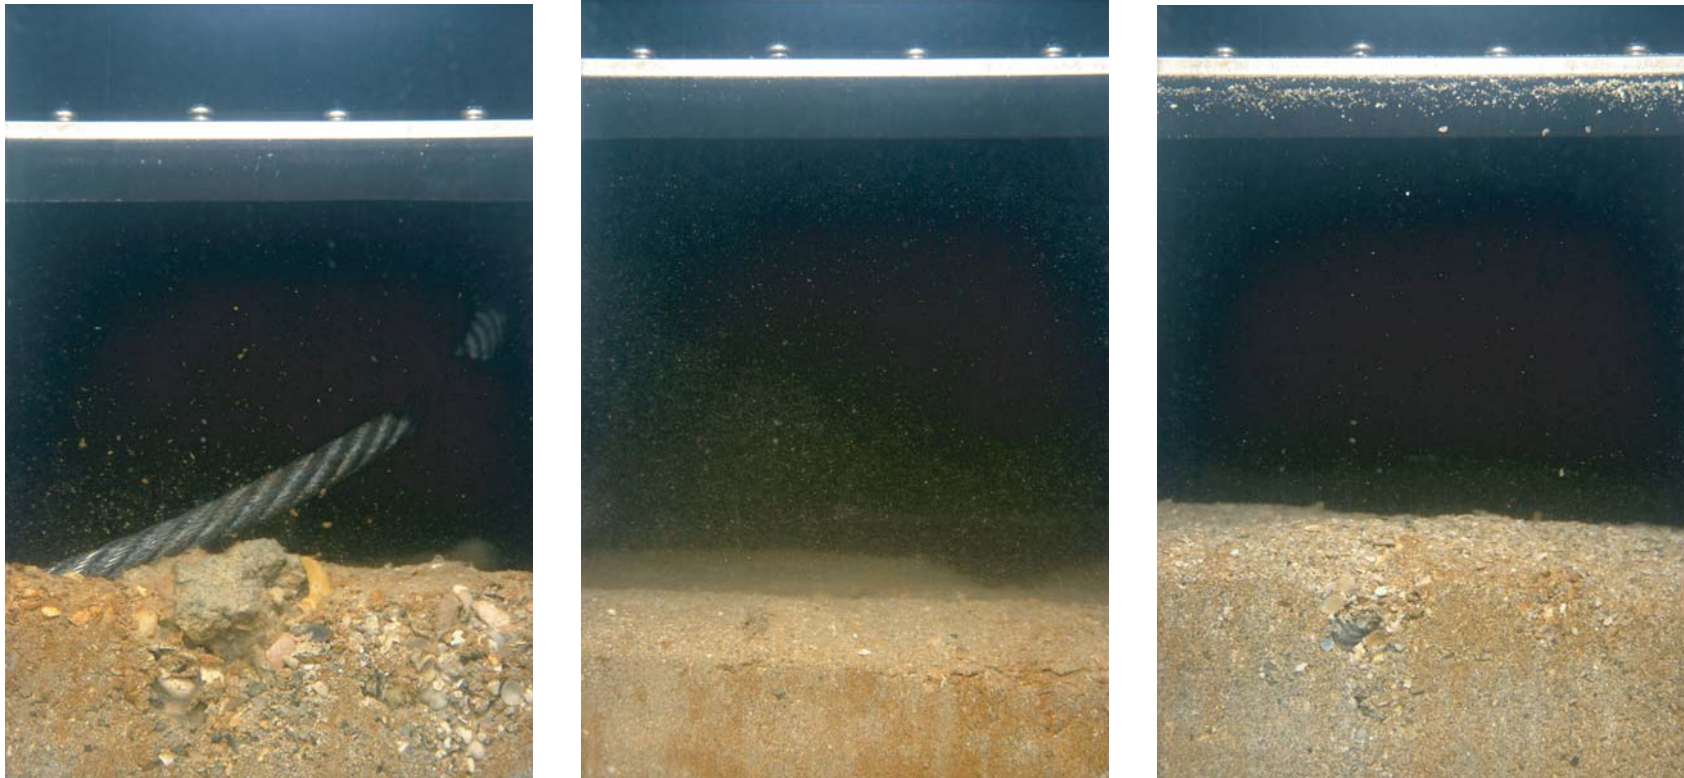
Figure 3-7: Three replicate SPI images from station E7 illustrating within-station variability in the texture of the dredged material, ranging from very coarse sand with gravel and shell fragments (left) to fine sand (middle) to medium sand (right). Note the reddish/rust coloration in all three images. Scale: actual image width is 14.4 cm.

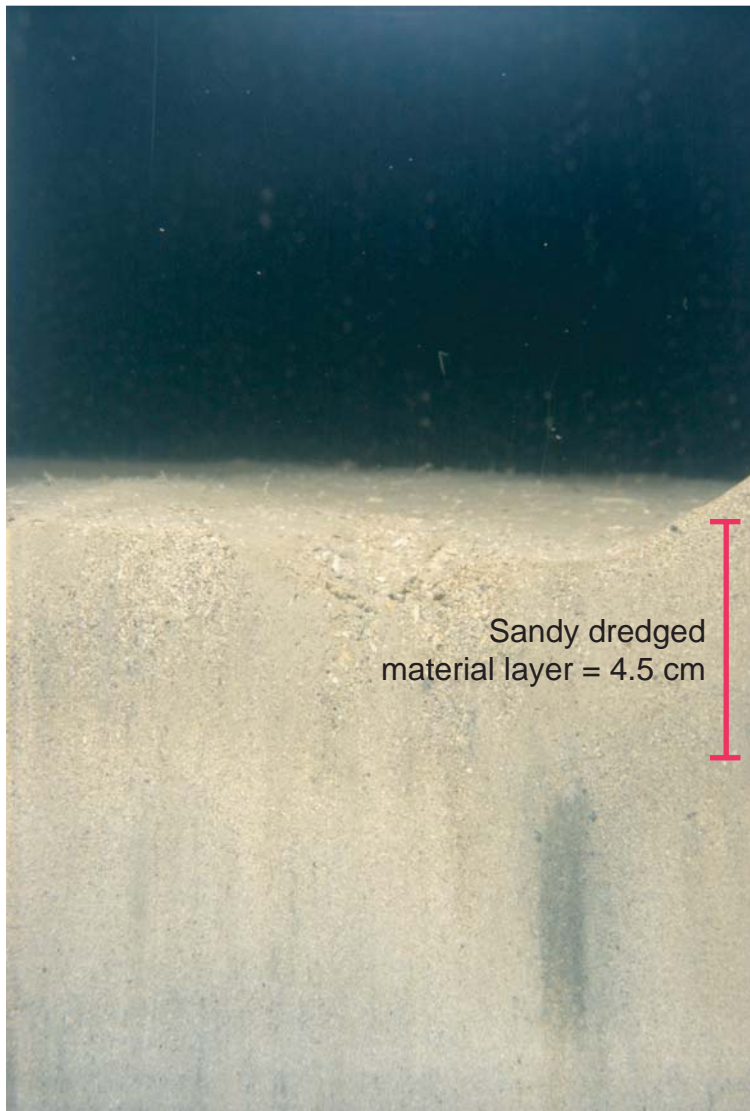
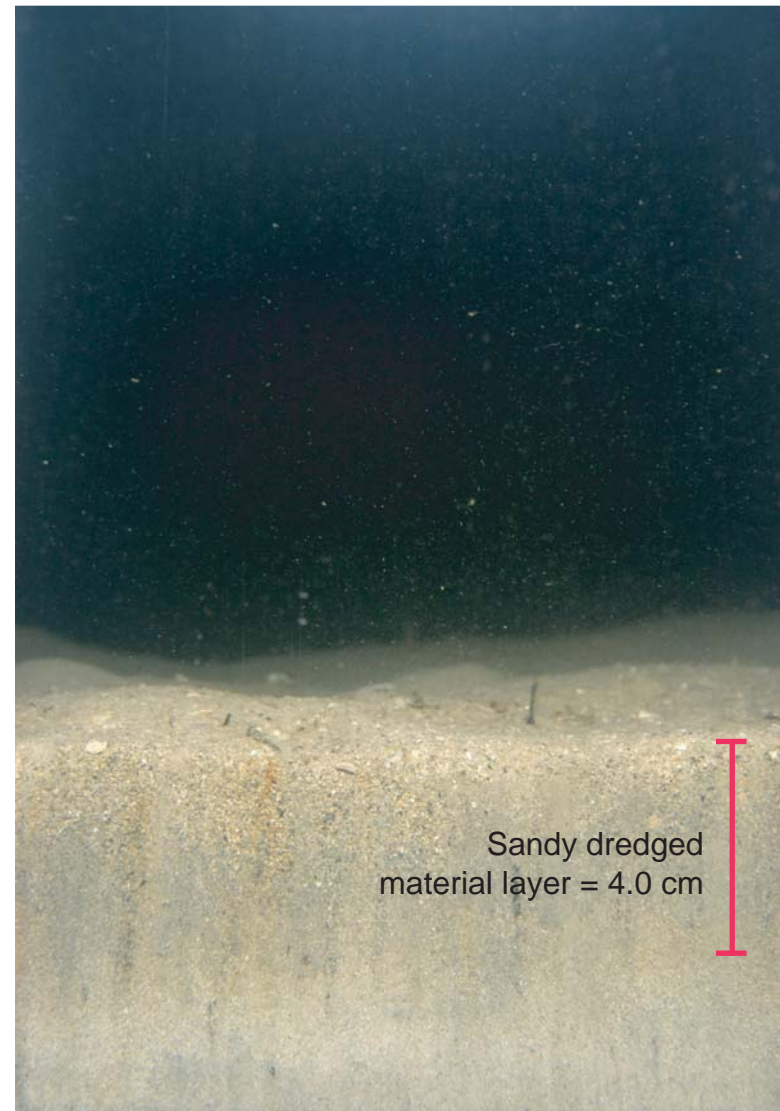
Figure 3-8: SPI images from stations D4 (left) and X11 (right) showing discrete surface layers of dredged material consisting of fine to medium sand overlying ambient sediment at depth. The measured thickness of the surface dredged material layer is 4.5 cm in the left image and 4.0 cm in the right image. Scale: actual image width is 14.4 cm.

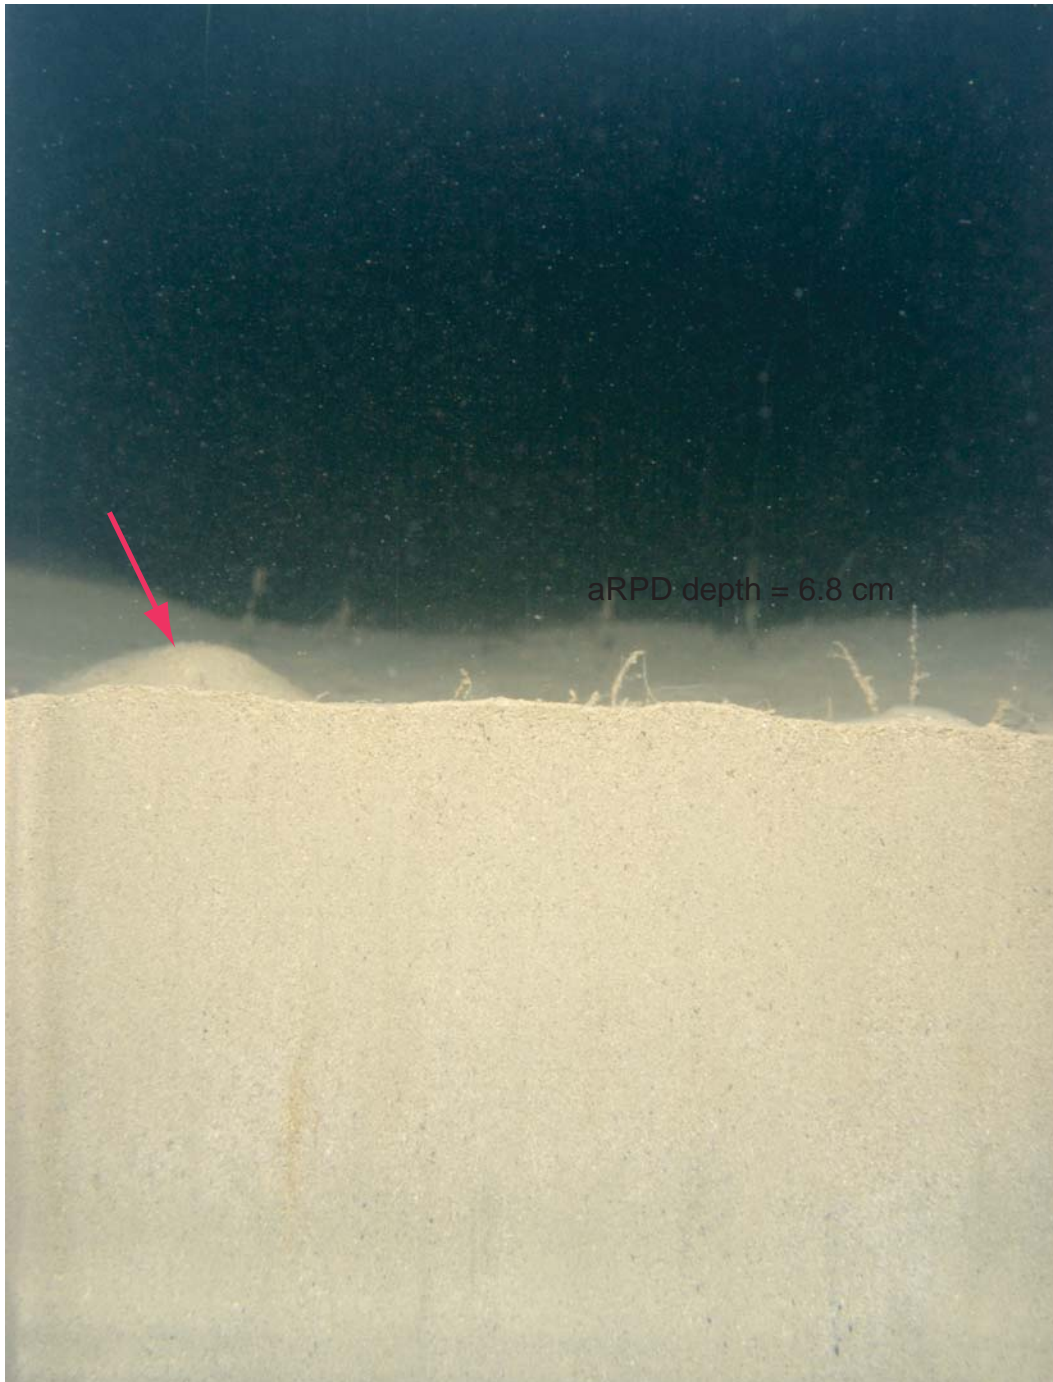
Figure 3-9: In this SPI image from station F8, the small-scale vertical relief across the field-of-view (i.e., "boundary roughness") is due both to sediment accumulation around the upright tubes and to the biogenic mound at left (arrow). This is an example of biogenic boundary roughness. Scale: actual image width is 14.4 cm.

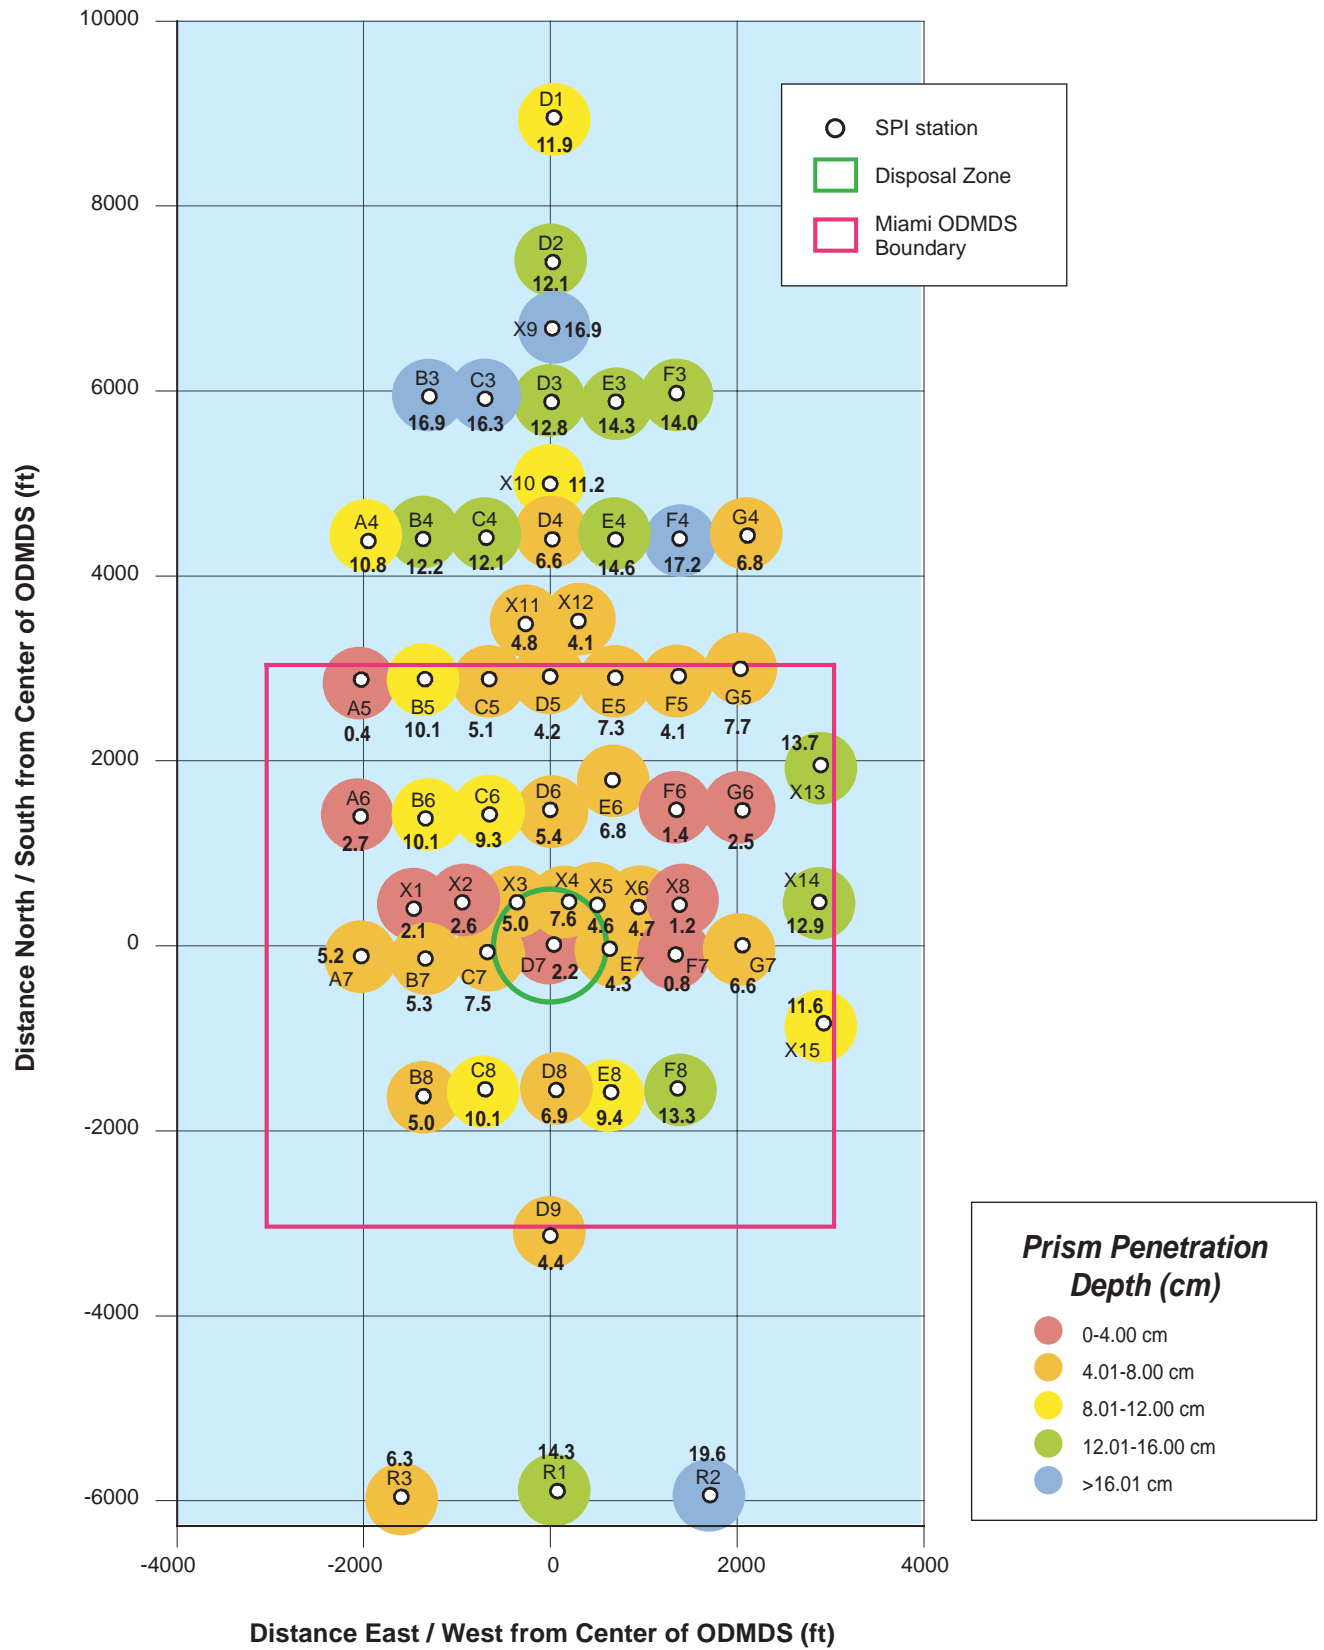
Stations X13 through X15 located along the eastern boundary of the disposal site, as well as nearby station F8 and reference stations R1 and R2, also had relatively deep penetration values (Figure 3-10). These values reflect the moderately soft, unconsolidated, silty sediments found at these stations. The sediment at station R1 was particularly soft, resulting in over-penetration of the camera prism in 3 of the 4 replicate images. Compared to the other two reference stations, the sediment at station R3 was sandier and therefore firmer, resulting in a lower prism penetration value (Table 3-2 and Figure 3-10).

Figure 3-10: Average prism penetration depths (cm) at the Miami ODMDS SPI stations.

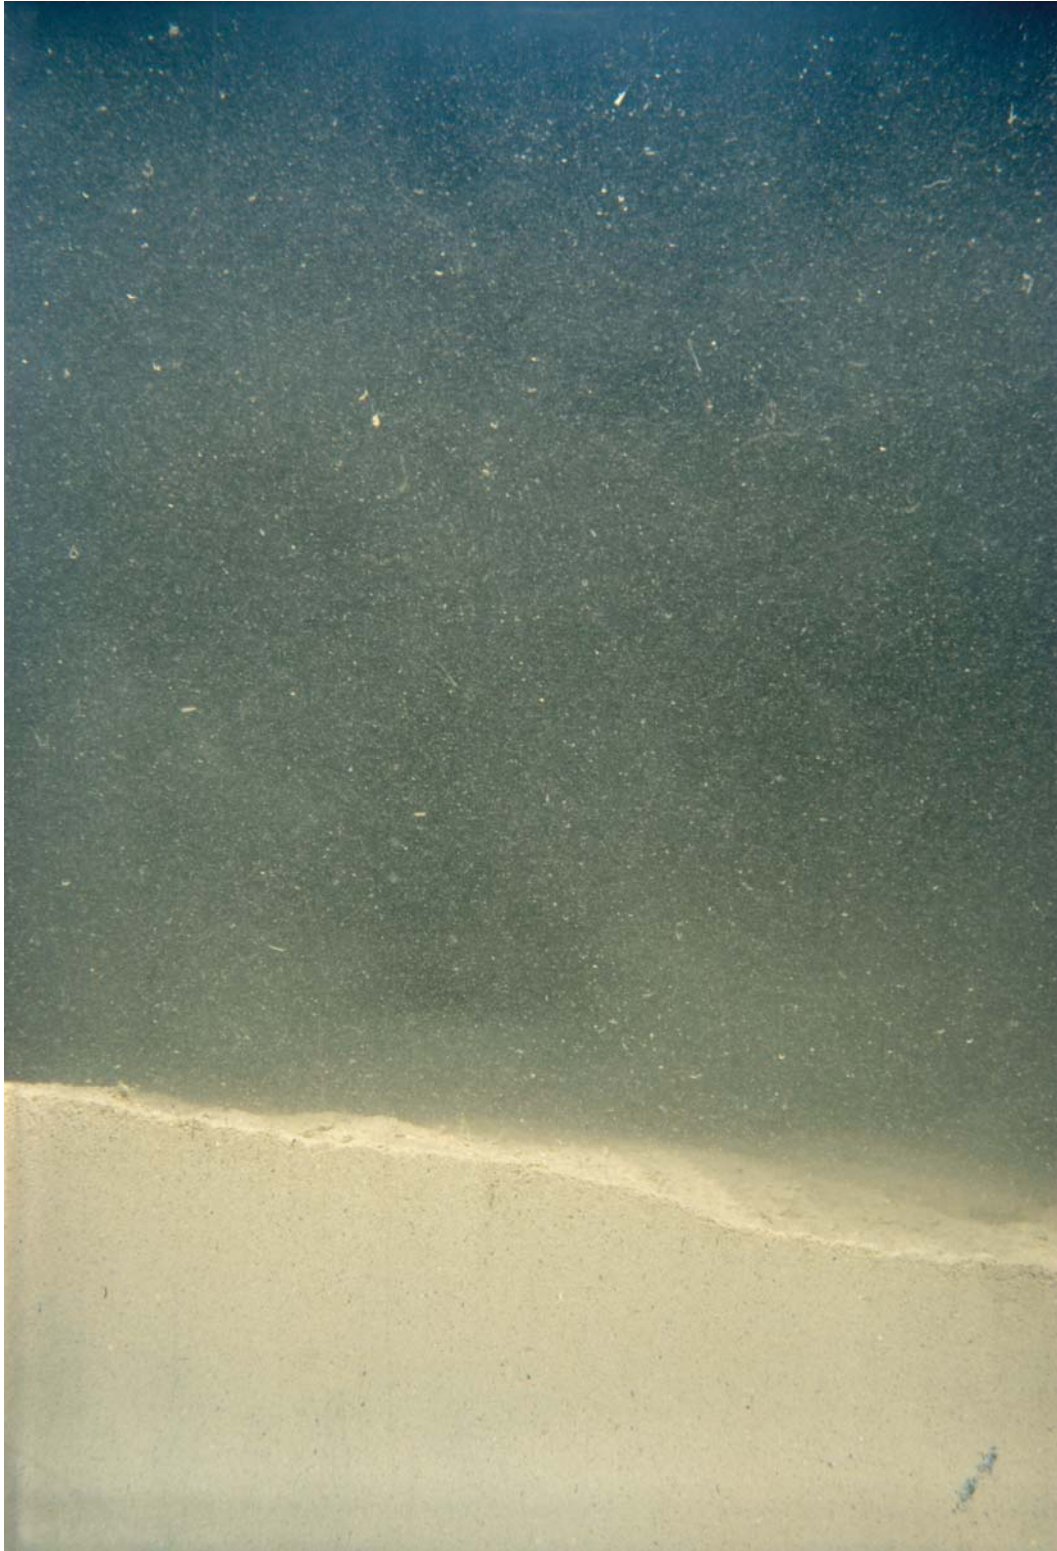
Figure 3-11: SPI image from station A7 showing uniformly light-colored, very silty fine sand. The aRPD depth for this image is considered to be greater than the penetration depth and is expressed as  $>5.1$  cm (i.e., the average vertical distance from the sediment surface to the bottom of the image). Scale: actual image width is 14.4 cm.

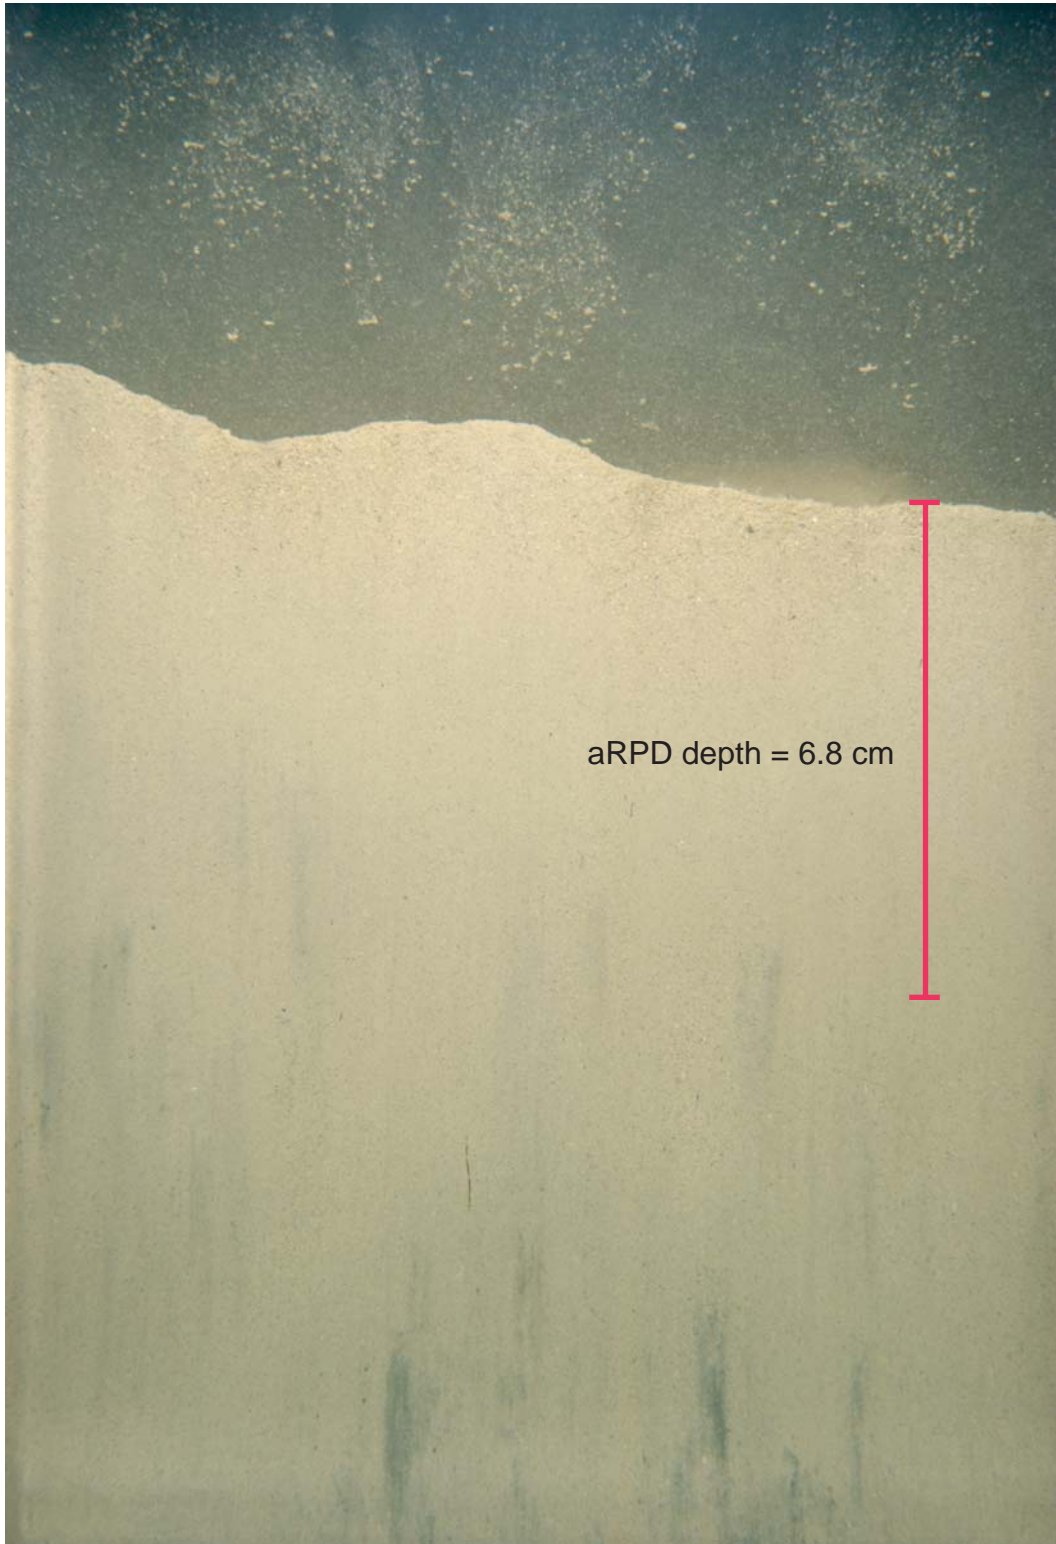
Surface sediments at many stations across the surveyed area had uniformly high optical reflectance, with a notable absence of any strong vertical color contrasts that typically denote the transition from a positive to negative redox state with depth in the sediment column (Figure 3-11). At some stations, particularly those with more fine-grained sediment (i.e., higher apparent silt-clay content), there were some patches of darker sediment at depth that probably indicated the transition to more reducing conditions. However, these patches of darker, more reduced sediment typically occurred beneath a relatively thick layer of light-colored (i.e., oxidized) sediment (Figure 3-12).

Figure 3-12: SPI image from station F4 showing mostly light-colored silt-clay sediment with intermittent patches of darker sediment at depth. The surface layer of light-colored sediment is fairly thick; the measured aRPD depth for this image is 6.8 cm. Scale: actual image width is 14.4 cm.

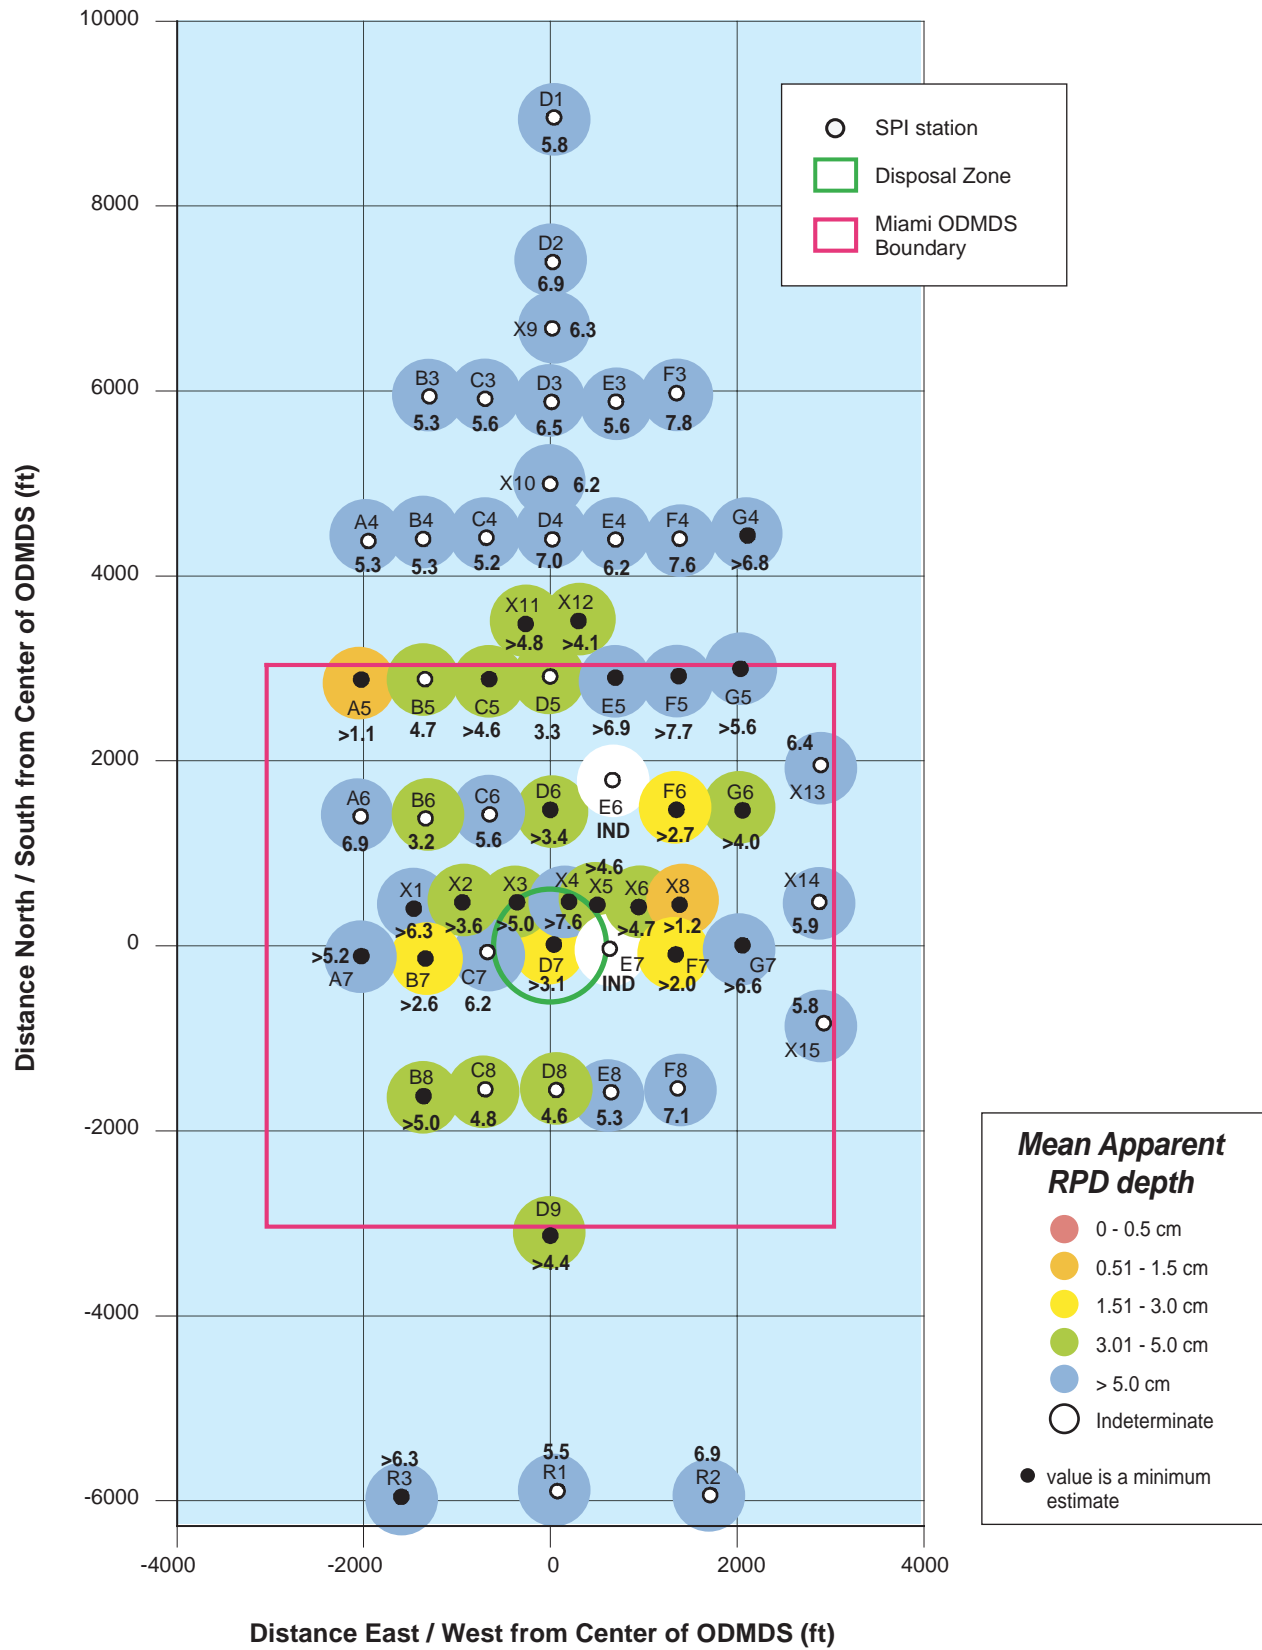
Figure 3-13: Average aRPD depths (cm) at the Miami ODMDS SPI stations.

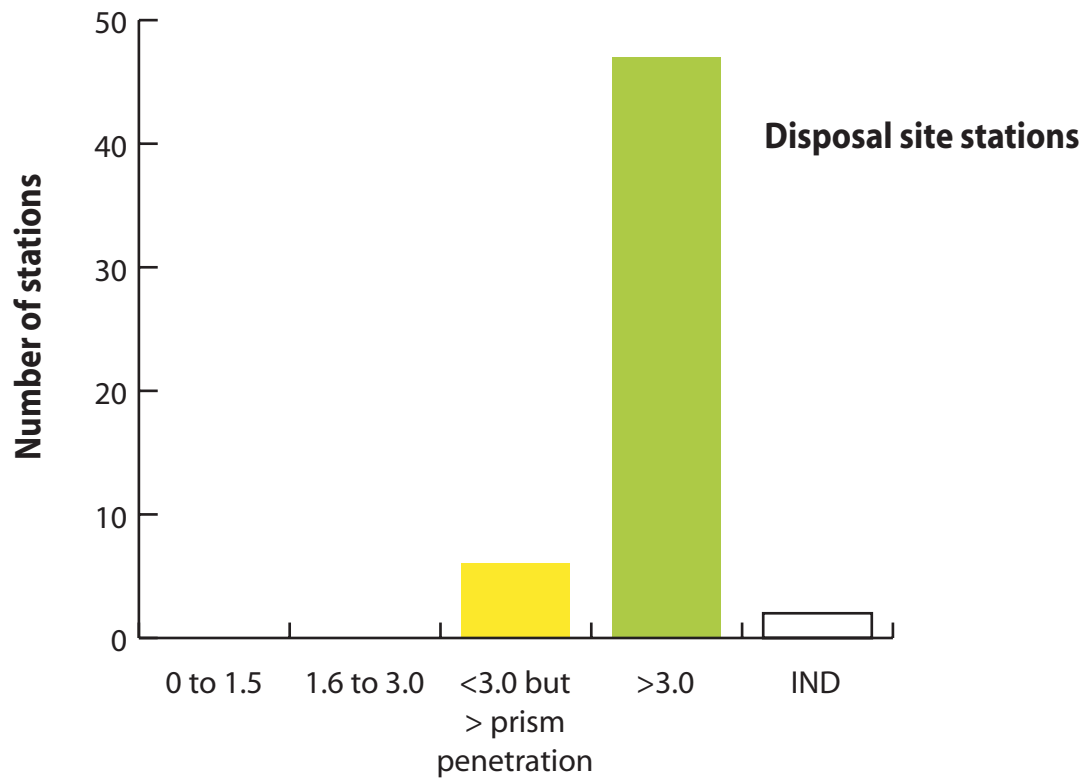
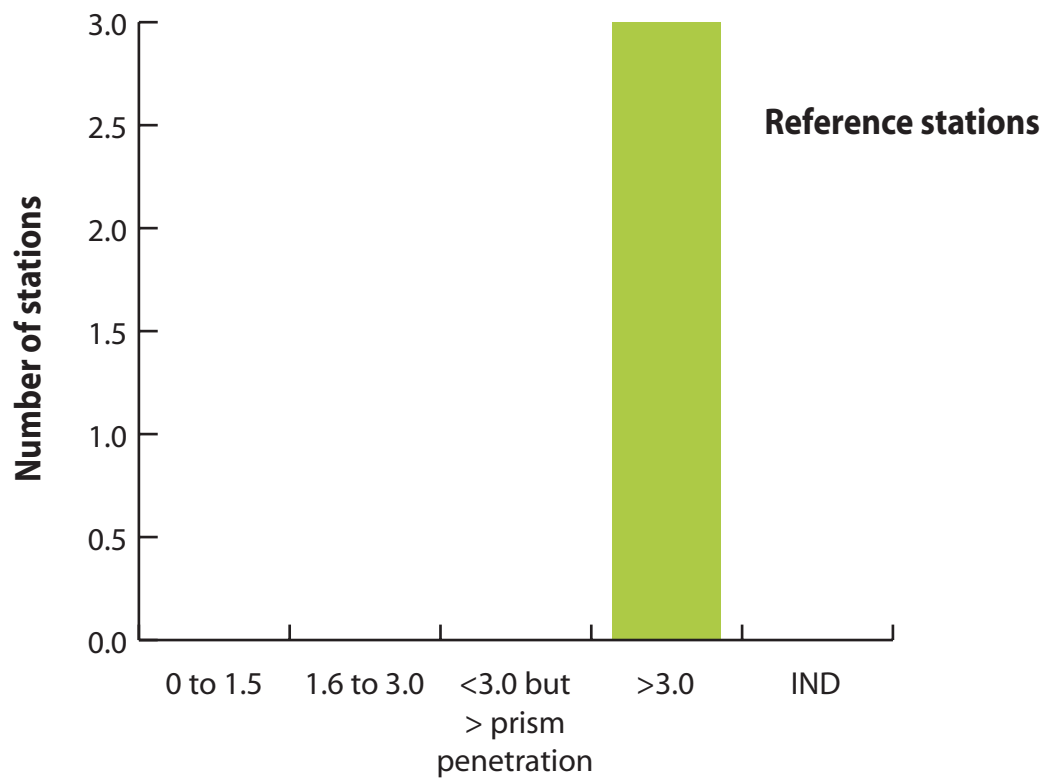
Figure 3-14: Frequency distribution of average RPD depths at the disposal site stations (top) and reference stations (bottom).

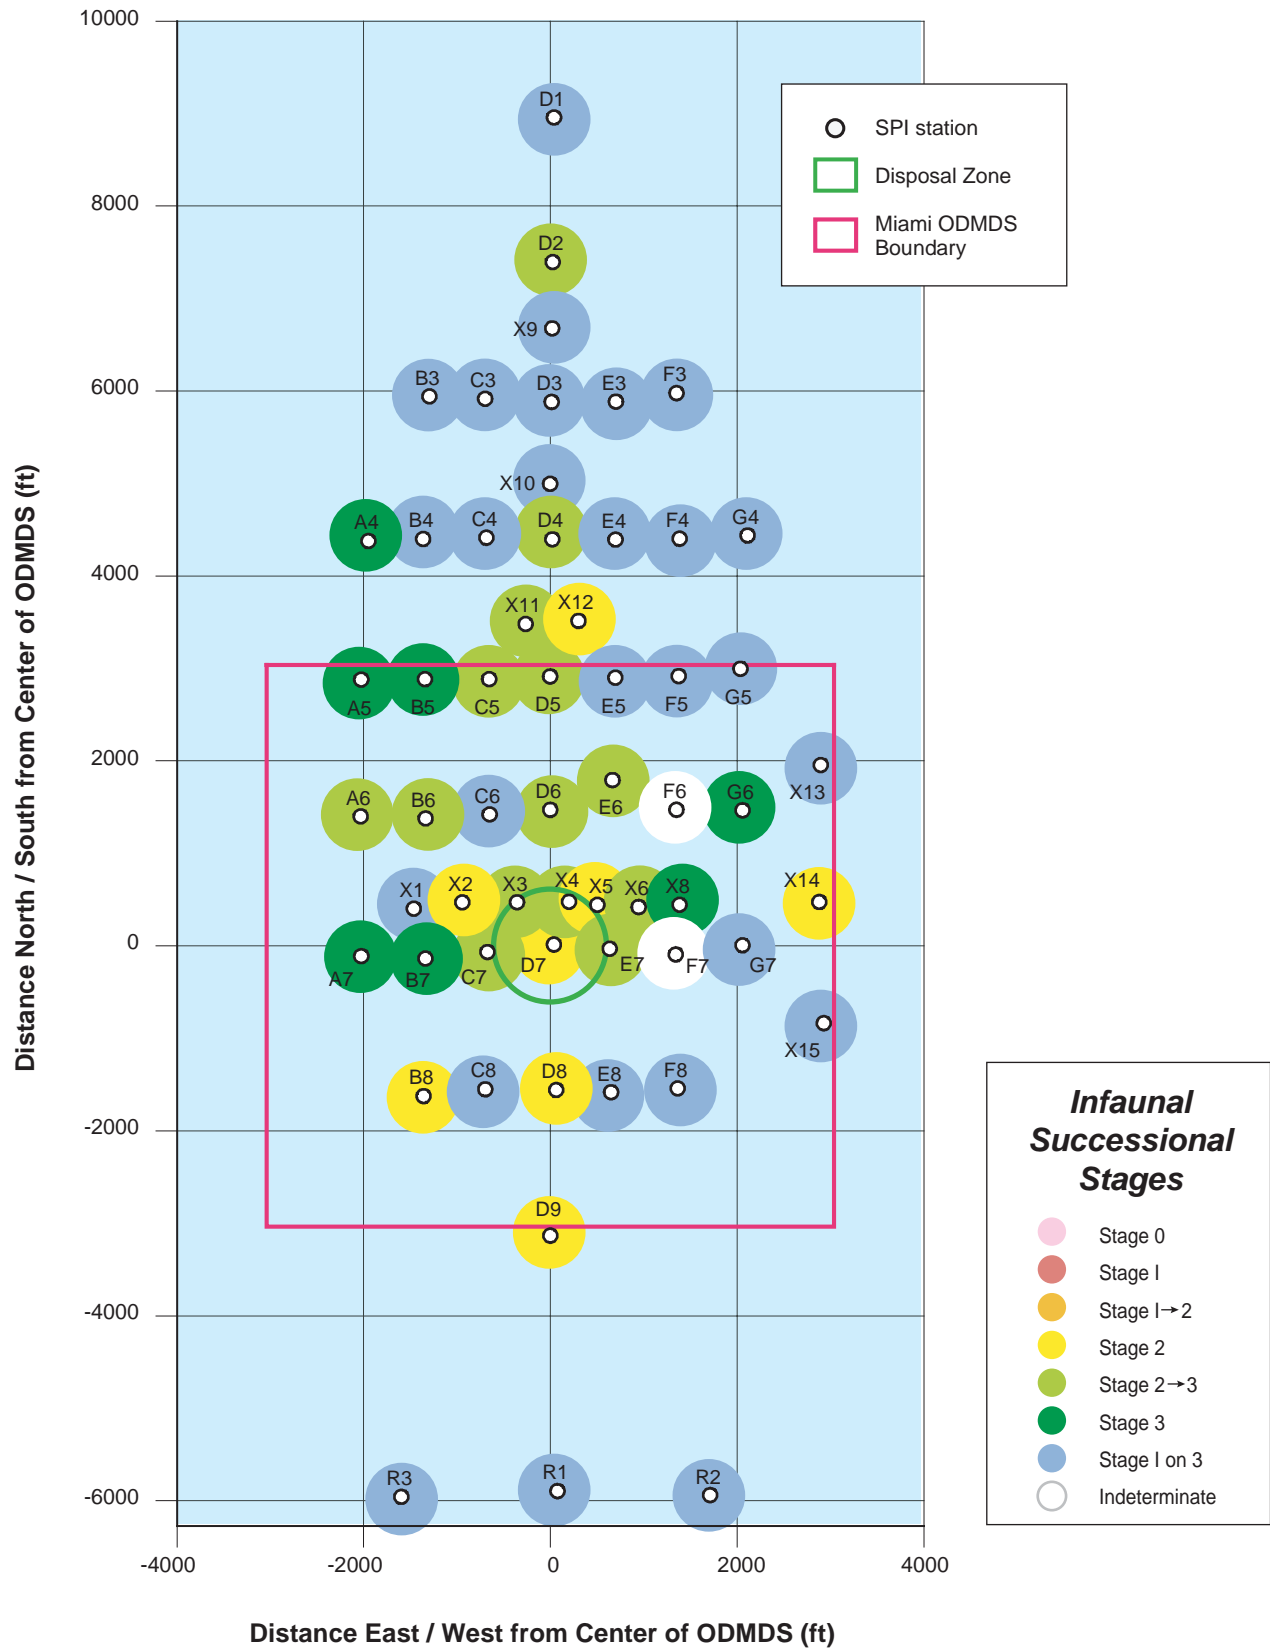
Figure 3-15: Map showing the highest infaunal successional stage observed among the replicate SPI images analyzed at each station in the May 2006 survey.

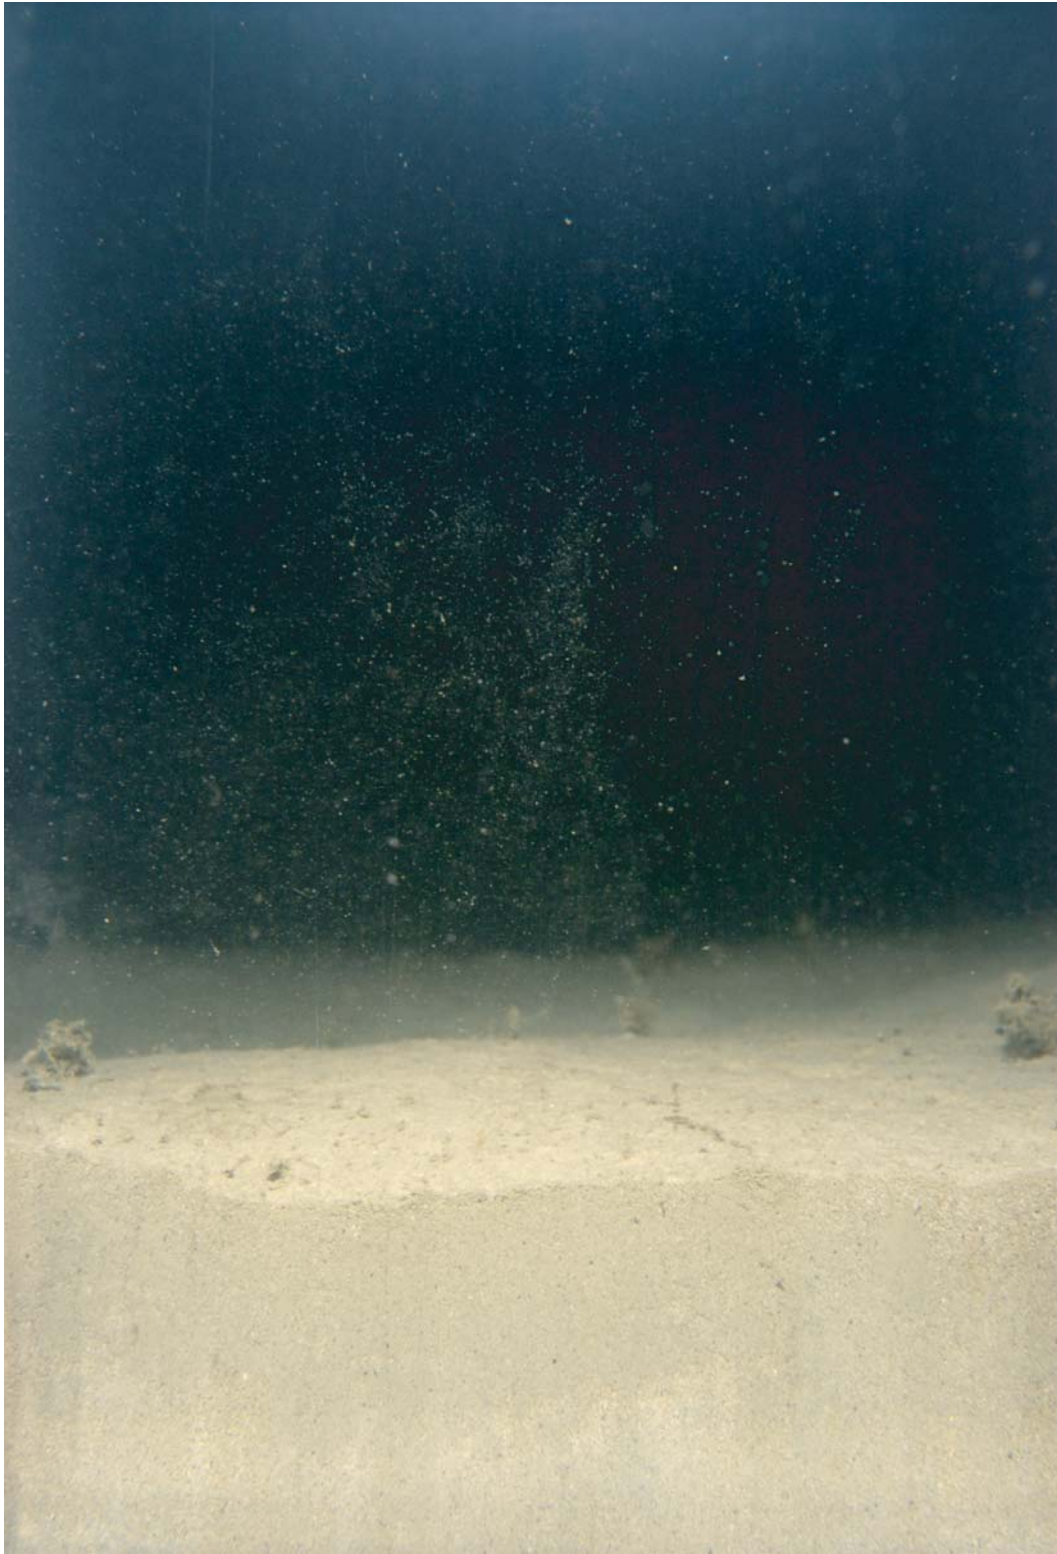
Figure 3-16: SPI image from station D9 illustrating Stage 2, where the visible evidence of biological activity consisted of several different types/sizes of tubes occurring at the sediment surface. Scale: actual image width is 14.4 cm.

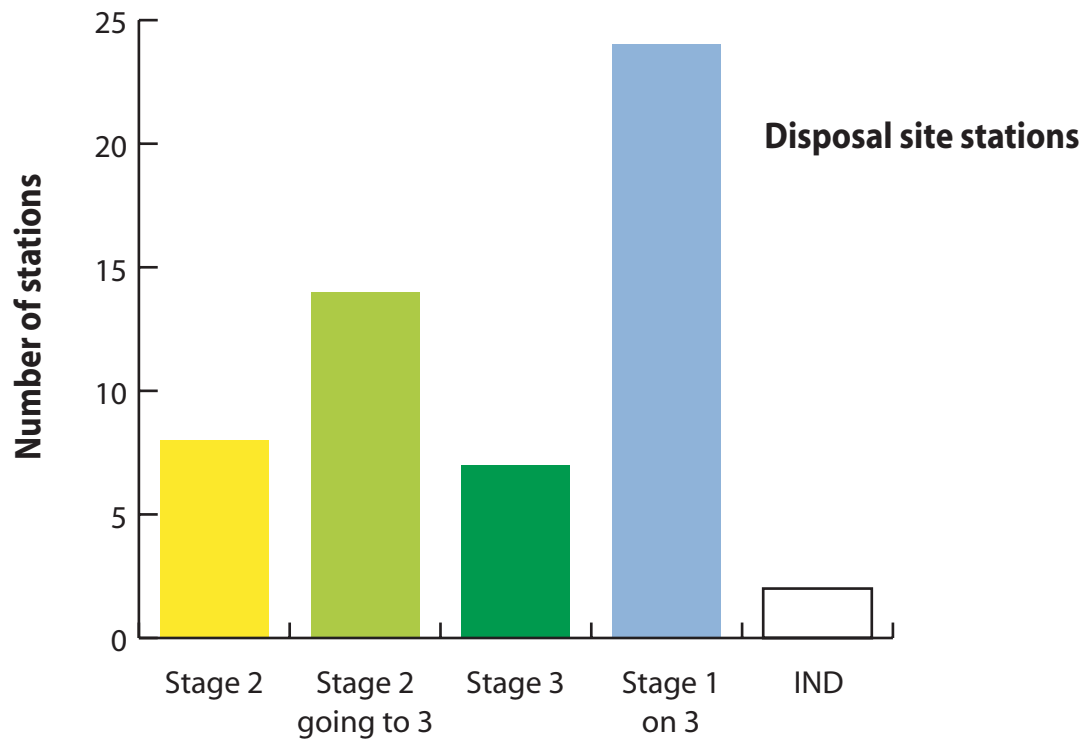
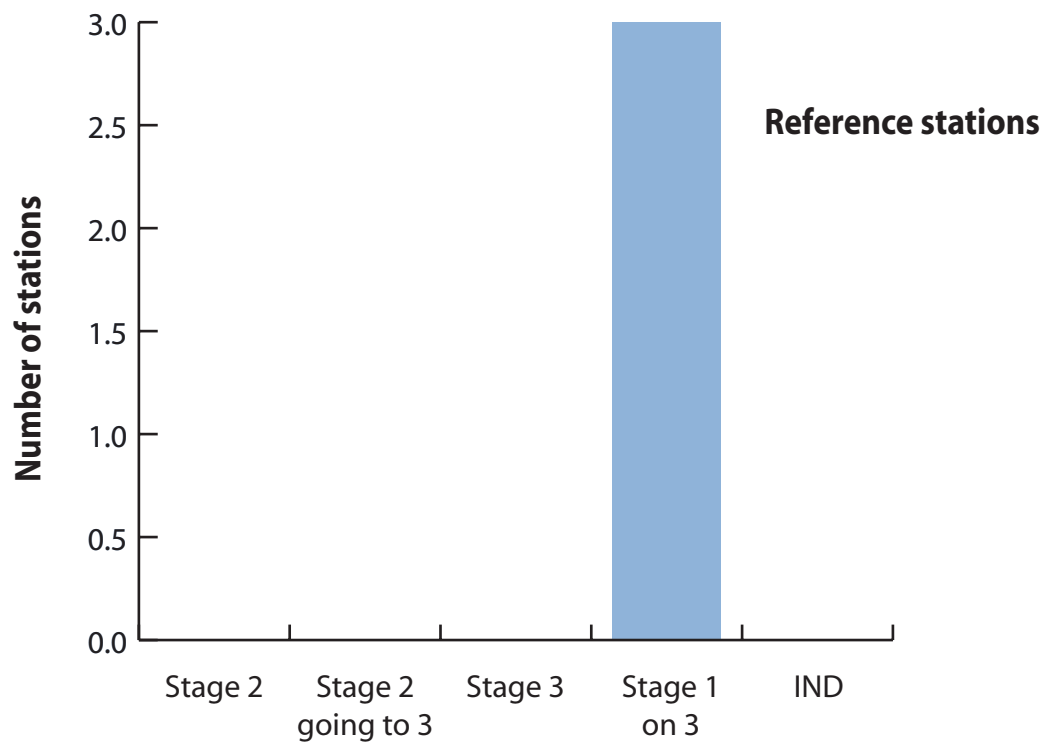
Figure 3-17: Frequency distribution of the highest infaunal successional stage observed at each of the disposal site stations (top) and reference stations (bottom).
