## *Rapid Seafloor Reconnaissance and Assessment of Southeast Florida Ocean Dredged Material Disposal Sites Utilizing Sediment Profile Imaging*

### *May 2006 Post-Disposal SPI Mapping at the Miami ODMDS*

**POST-DISPOSAL SPI MAPPING AT THE MIAMI ODMDS**

**MAY 2006**

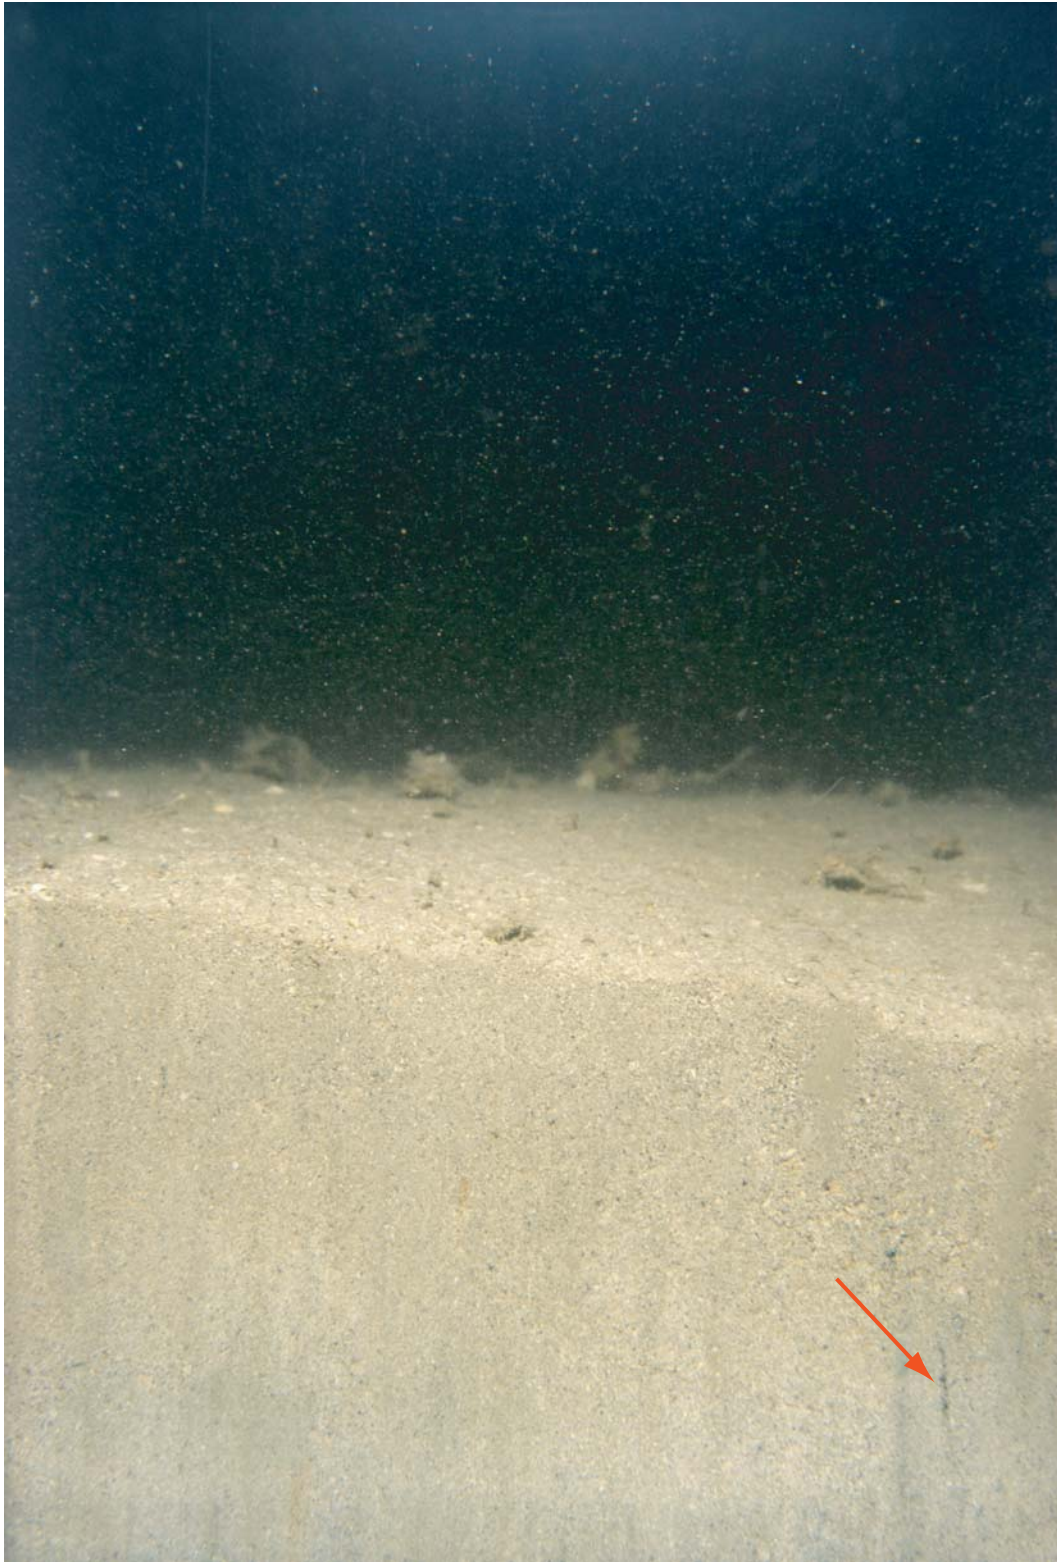
Figure 3-18: SPI image from station C7 illustrating Stage 2 advancing to Stage 3, based on the presence of moderate numbers of different types of tubes at the sediment surface and a small polychaete visible at depth on the lower right (arrow). Scale: actual image width is 14.4 cm.

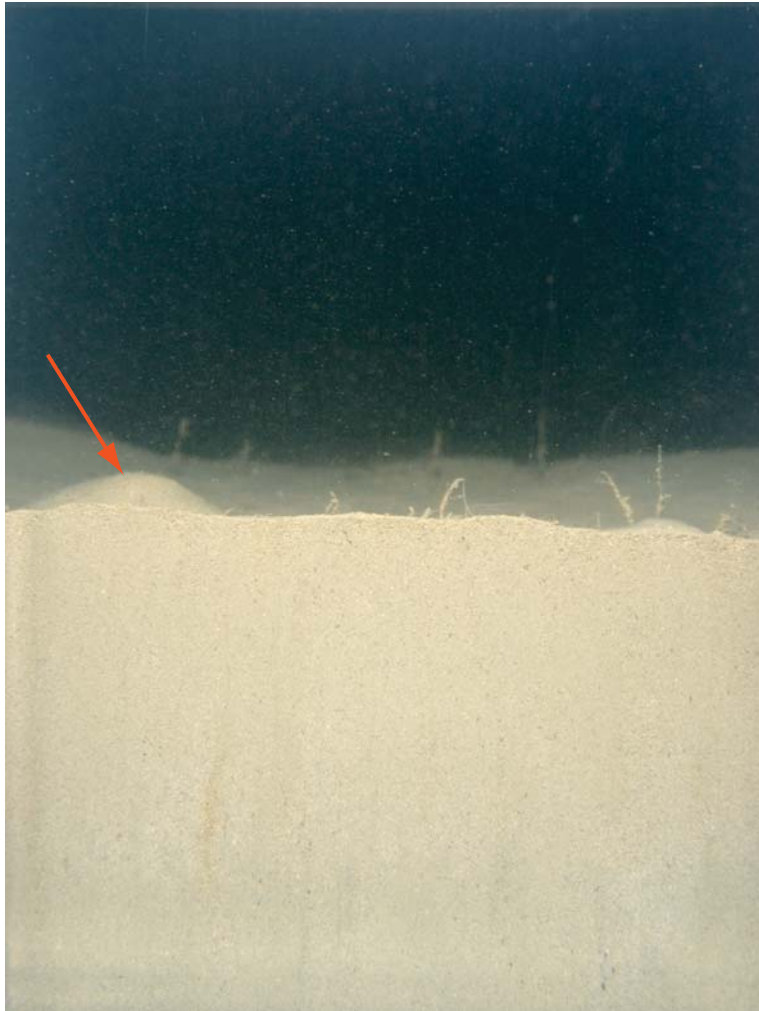
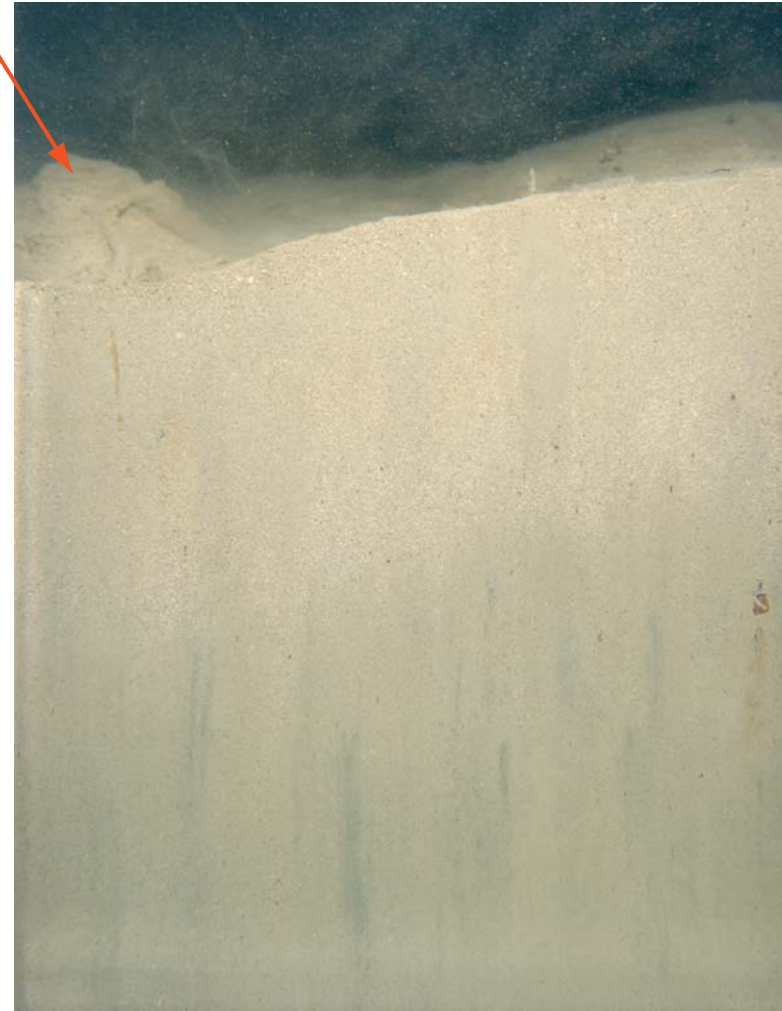
Figure 3-19: SPI images from station F8 (left) and E4 (right) illustrating Stage 1 on 3, based on the observation of low to moderate numbers of small surface tubes, as well as biogenic mounds (arrows) denoting significant bioturbation activity (excavation of subsurface sediment) by deeper-dwelling Stage 3 organisms. Scale: actual image width is 14.4 cm.

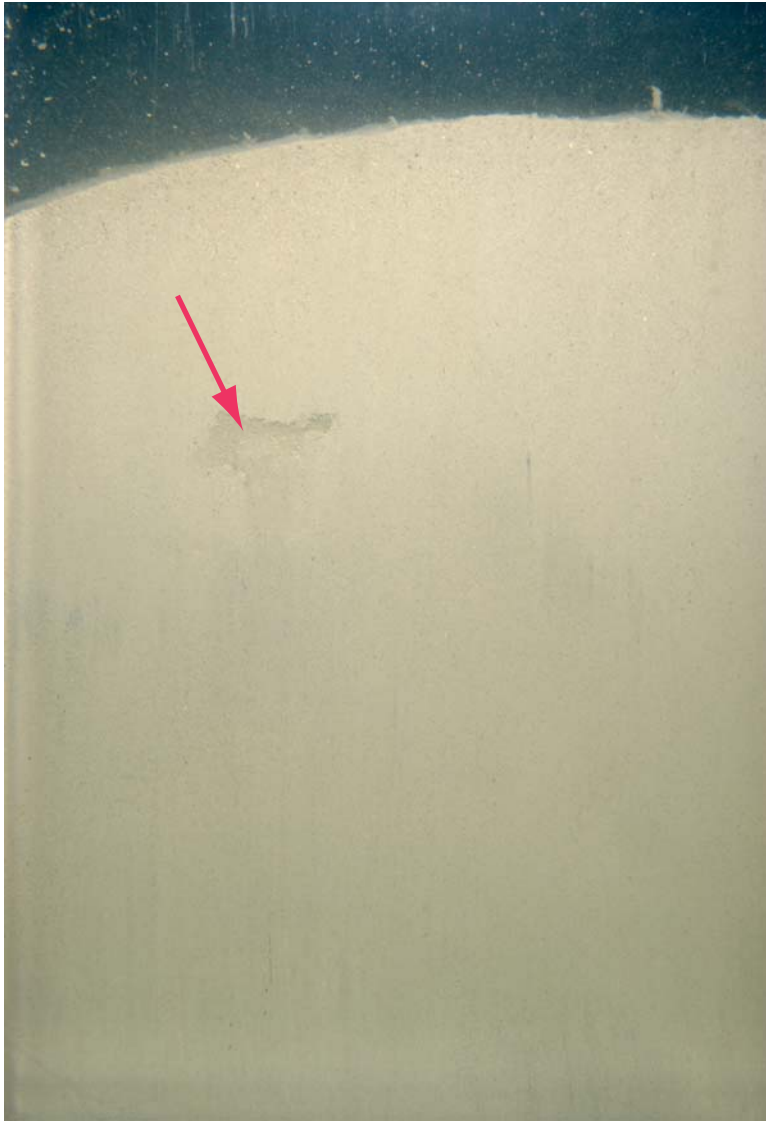
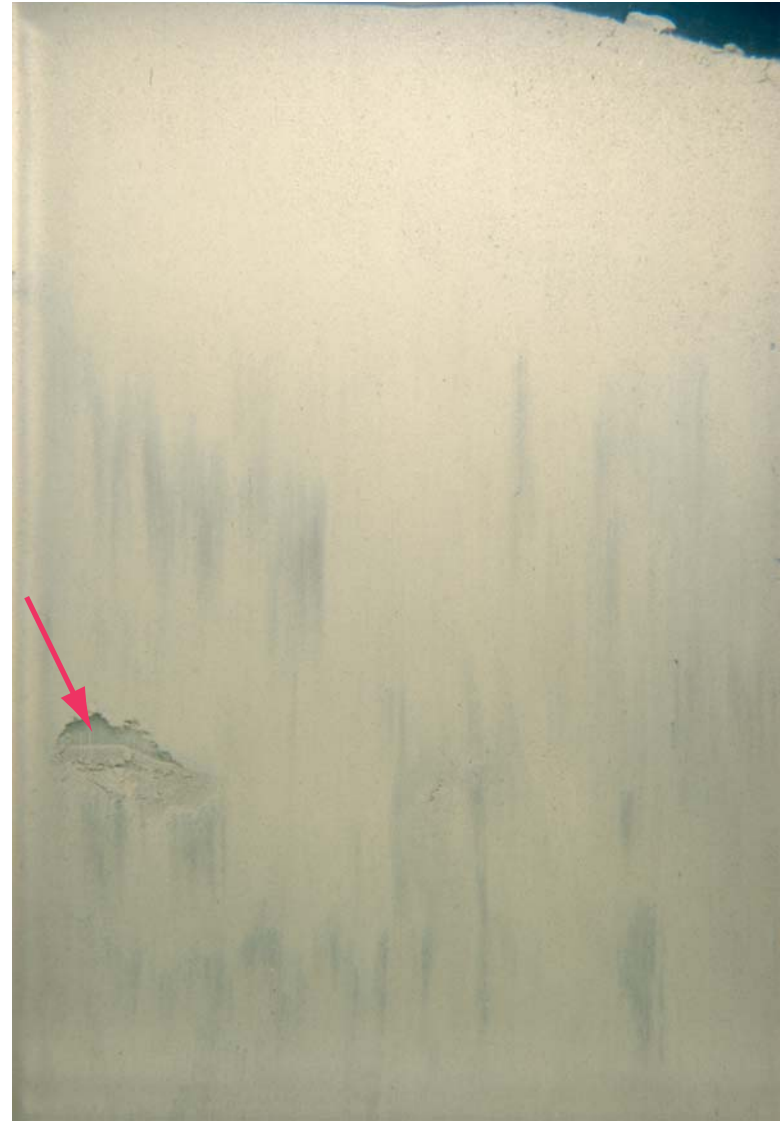
Figure 3-20: SPI images from station F4 (left) and R2 (right) showing Stage 1 surface tubes and active feeding voids at depth (arrows), providing evidence that Stage 3 subsurface deposit-feeders are present in these relatively soft, fine-grained sediments (Stage 1 on 3). Only part of the sediment surface is visible in the right image; the remainder occurs above the viewing window due to over-penetration of the camera prism in soft sediment. Scale: actual image width is 14.4 cm.

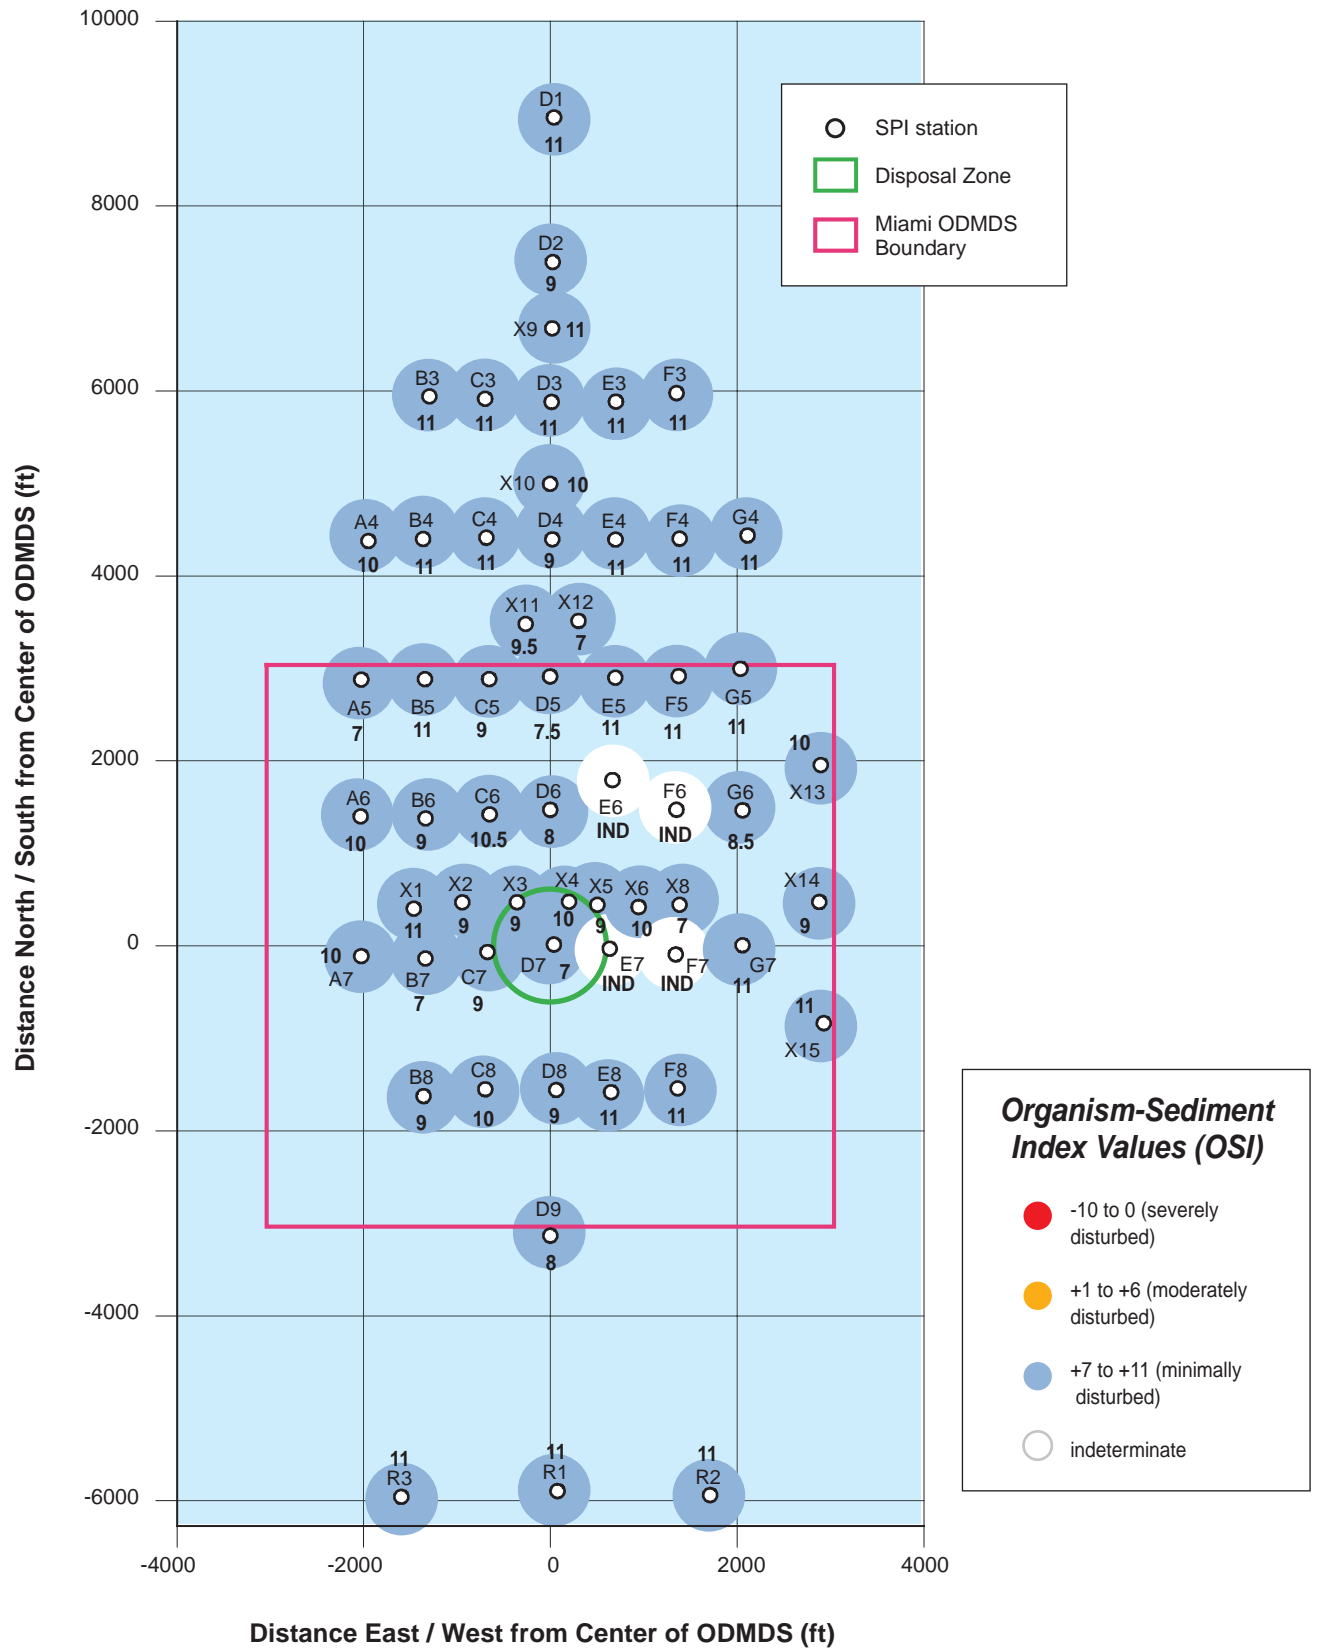
Figure 3-21: Median OSI values at the Miami ODMDS SPI stations.

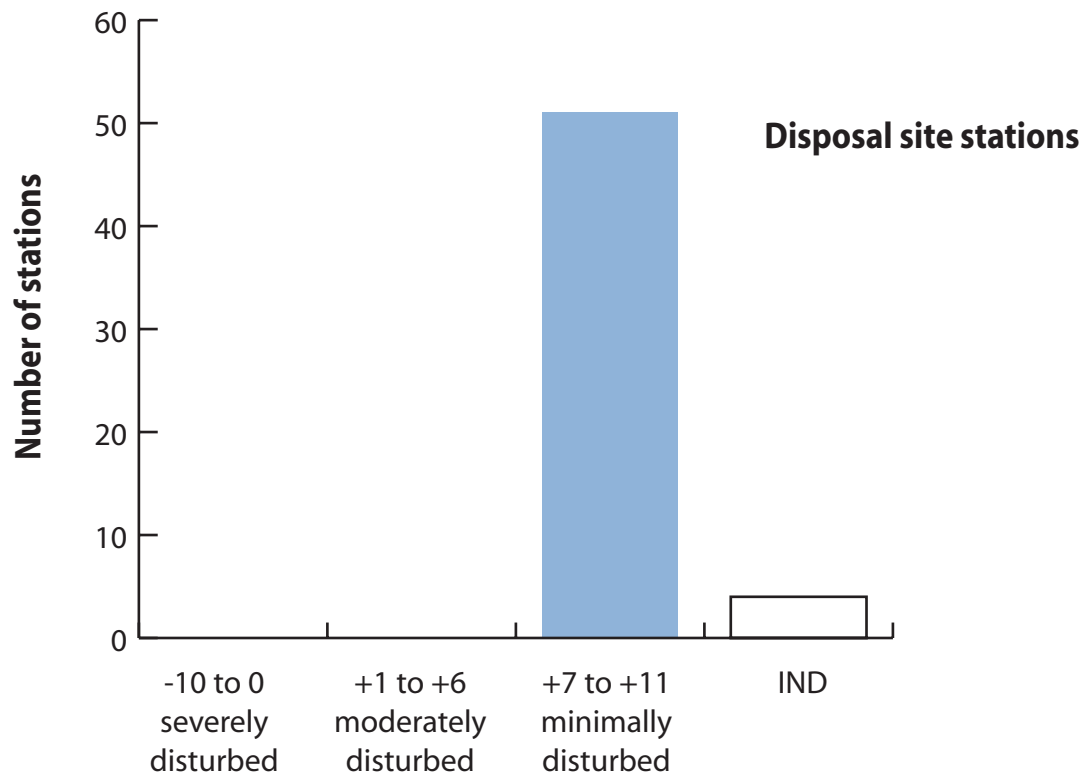
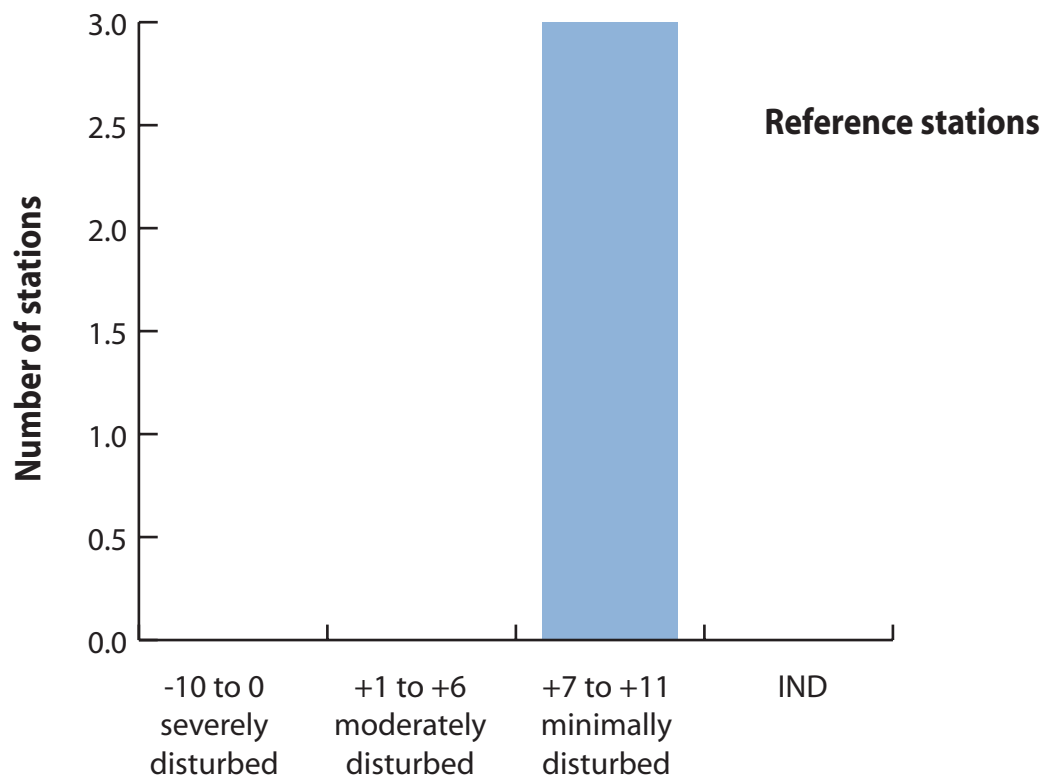
Figure 3-22: Frequency distribution of median OSI values at the disposal site stations (top) and reference stations (bottom).

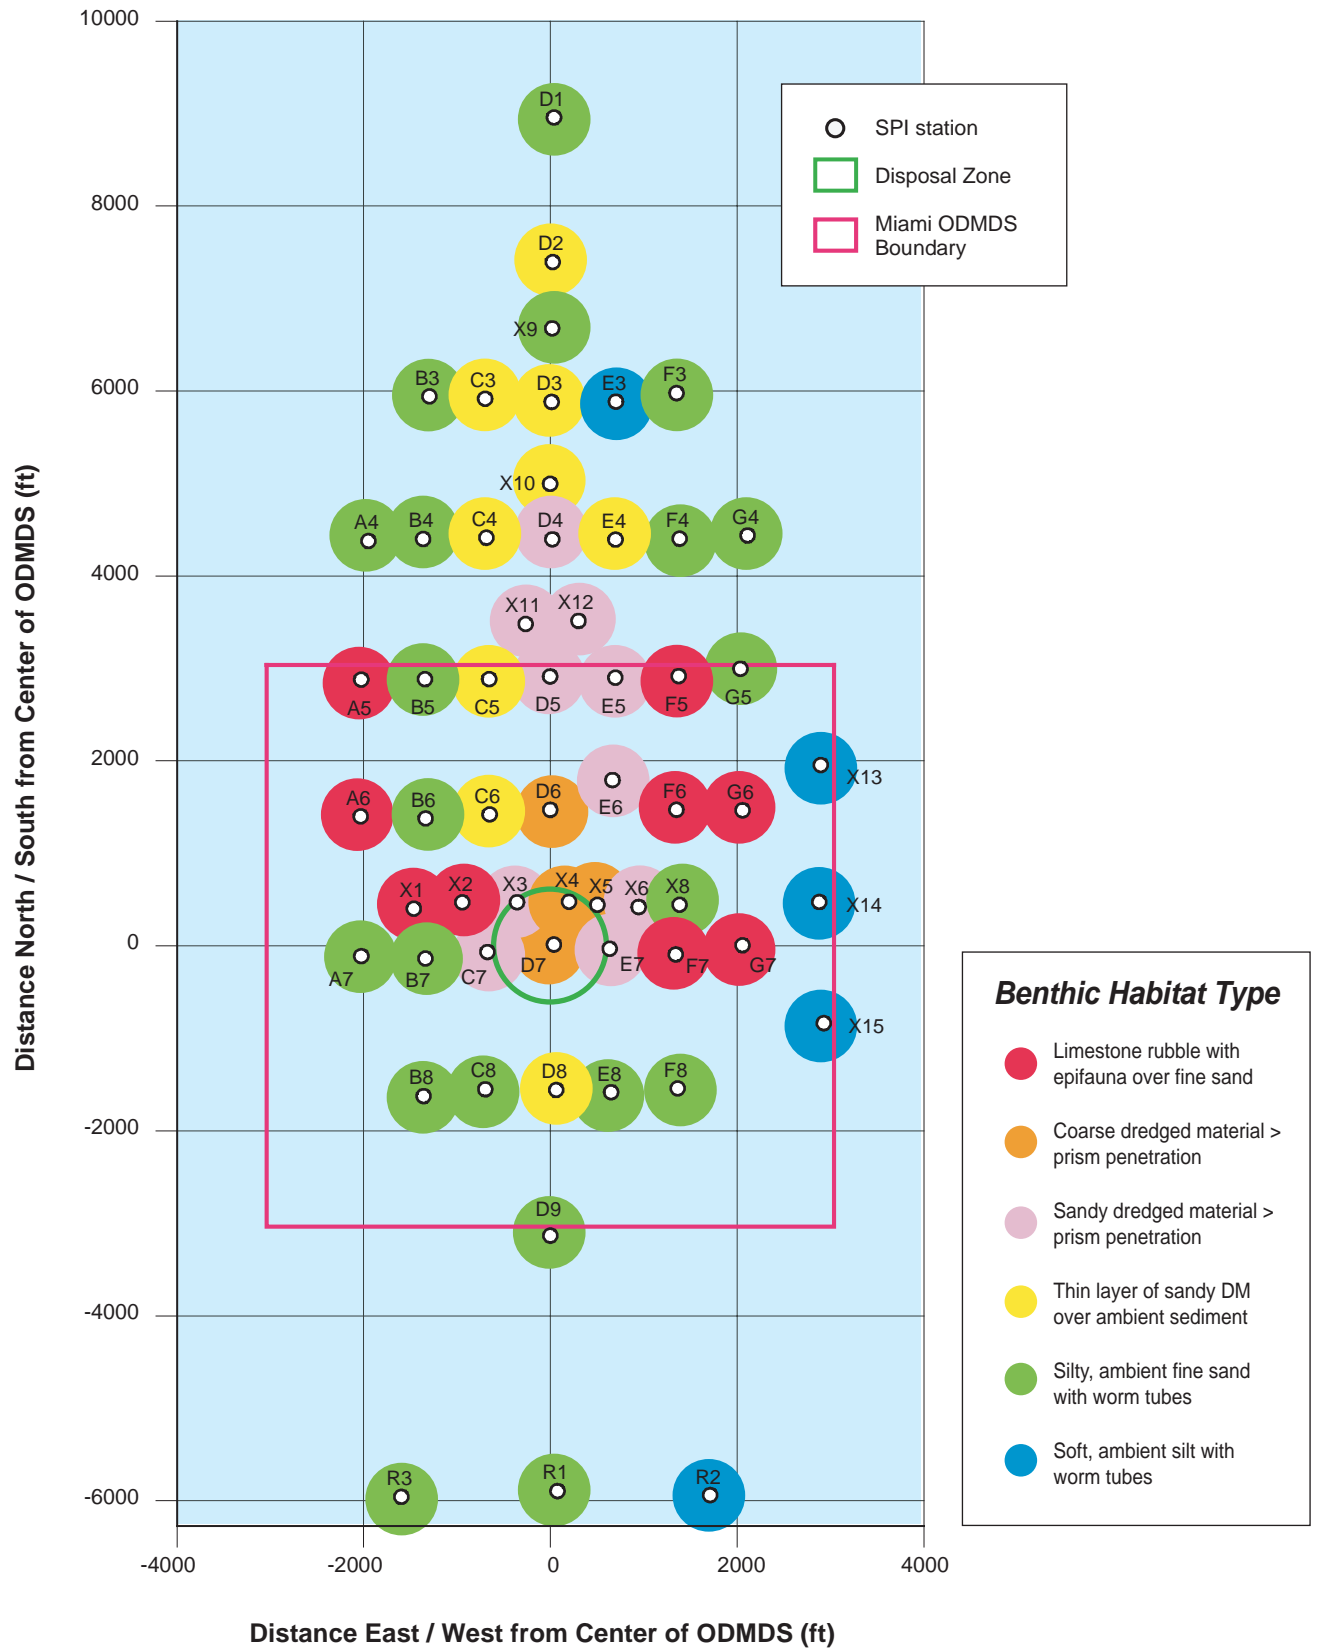
Figure 3-23: Map of benthic habitat types at the Miami ODMDS SPI stations.

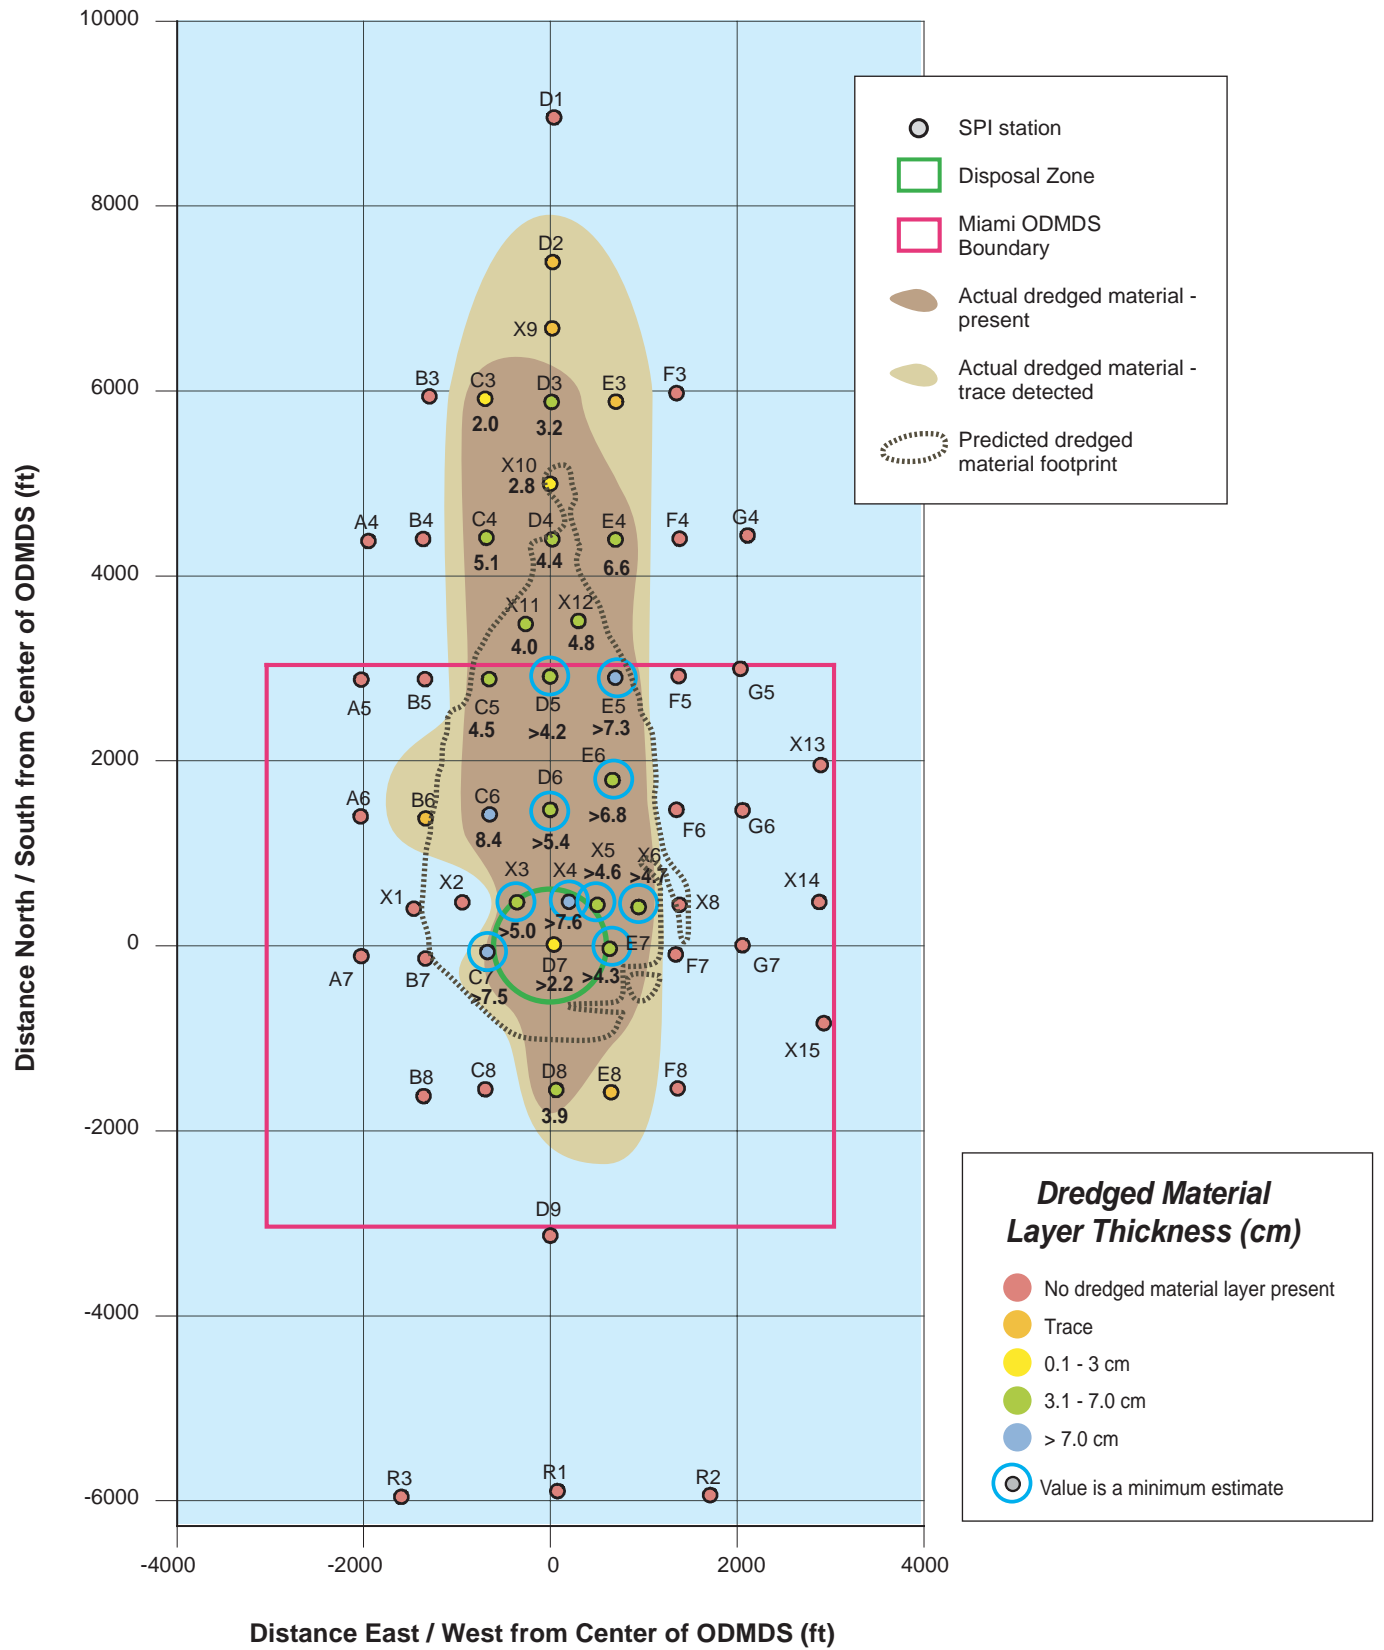
Figure 4-1: Actual distribution of dredged material based on analysis of sediment profile images as compared with modeled results for the Miami Harbor ODMS.

3. Given the strong northward drift of the dredged material following its release at the Miami ODMDS, it is recommended that the disposal zone be located to the south of its present location. This should help to ensure that more of the resulting seafloor is located within the ODMDS boundaries. However, even moving the disposal point to the southern end of the currently designated site perimeter will not result in dredged material remaining within the site boundary given the conditions at this particular location.
