The Hopi Tribe Water Resources Program

By Shirley Piqosa
Nonpoint Source Coordinator

Hopi Springs Sediment Reduction Project

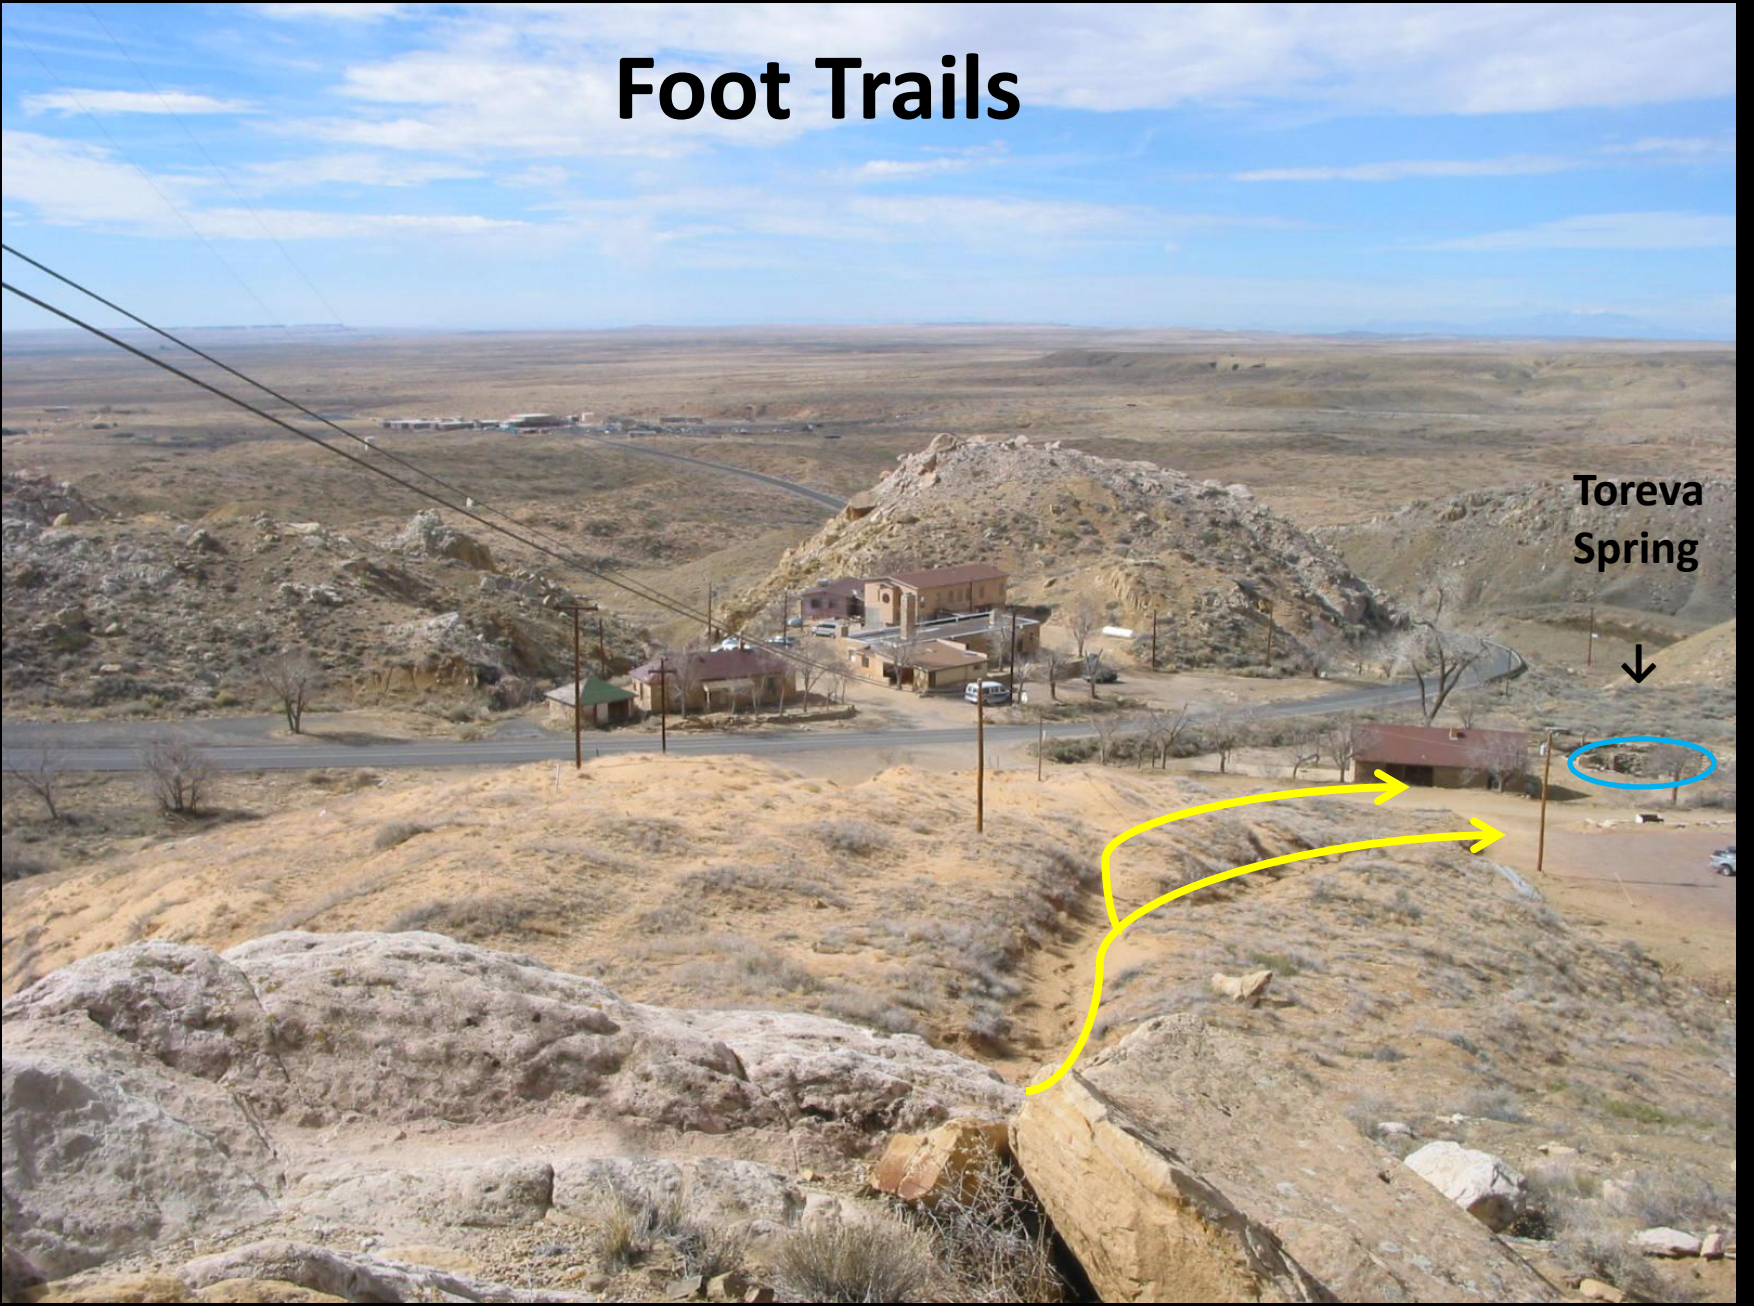
Foot Trails

Foot trails result as water channels during periods of high storm water flow and deposits into Toreva

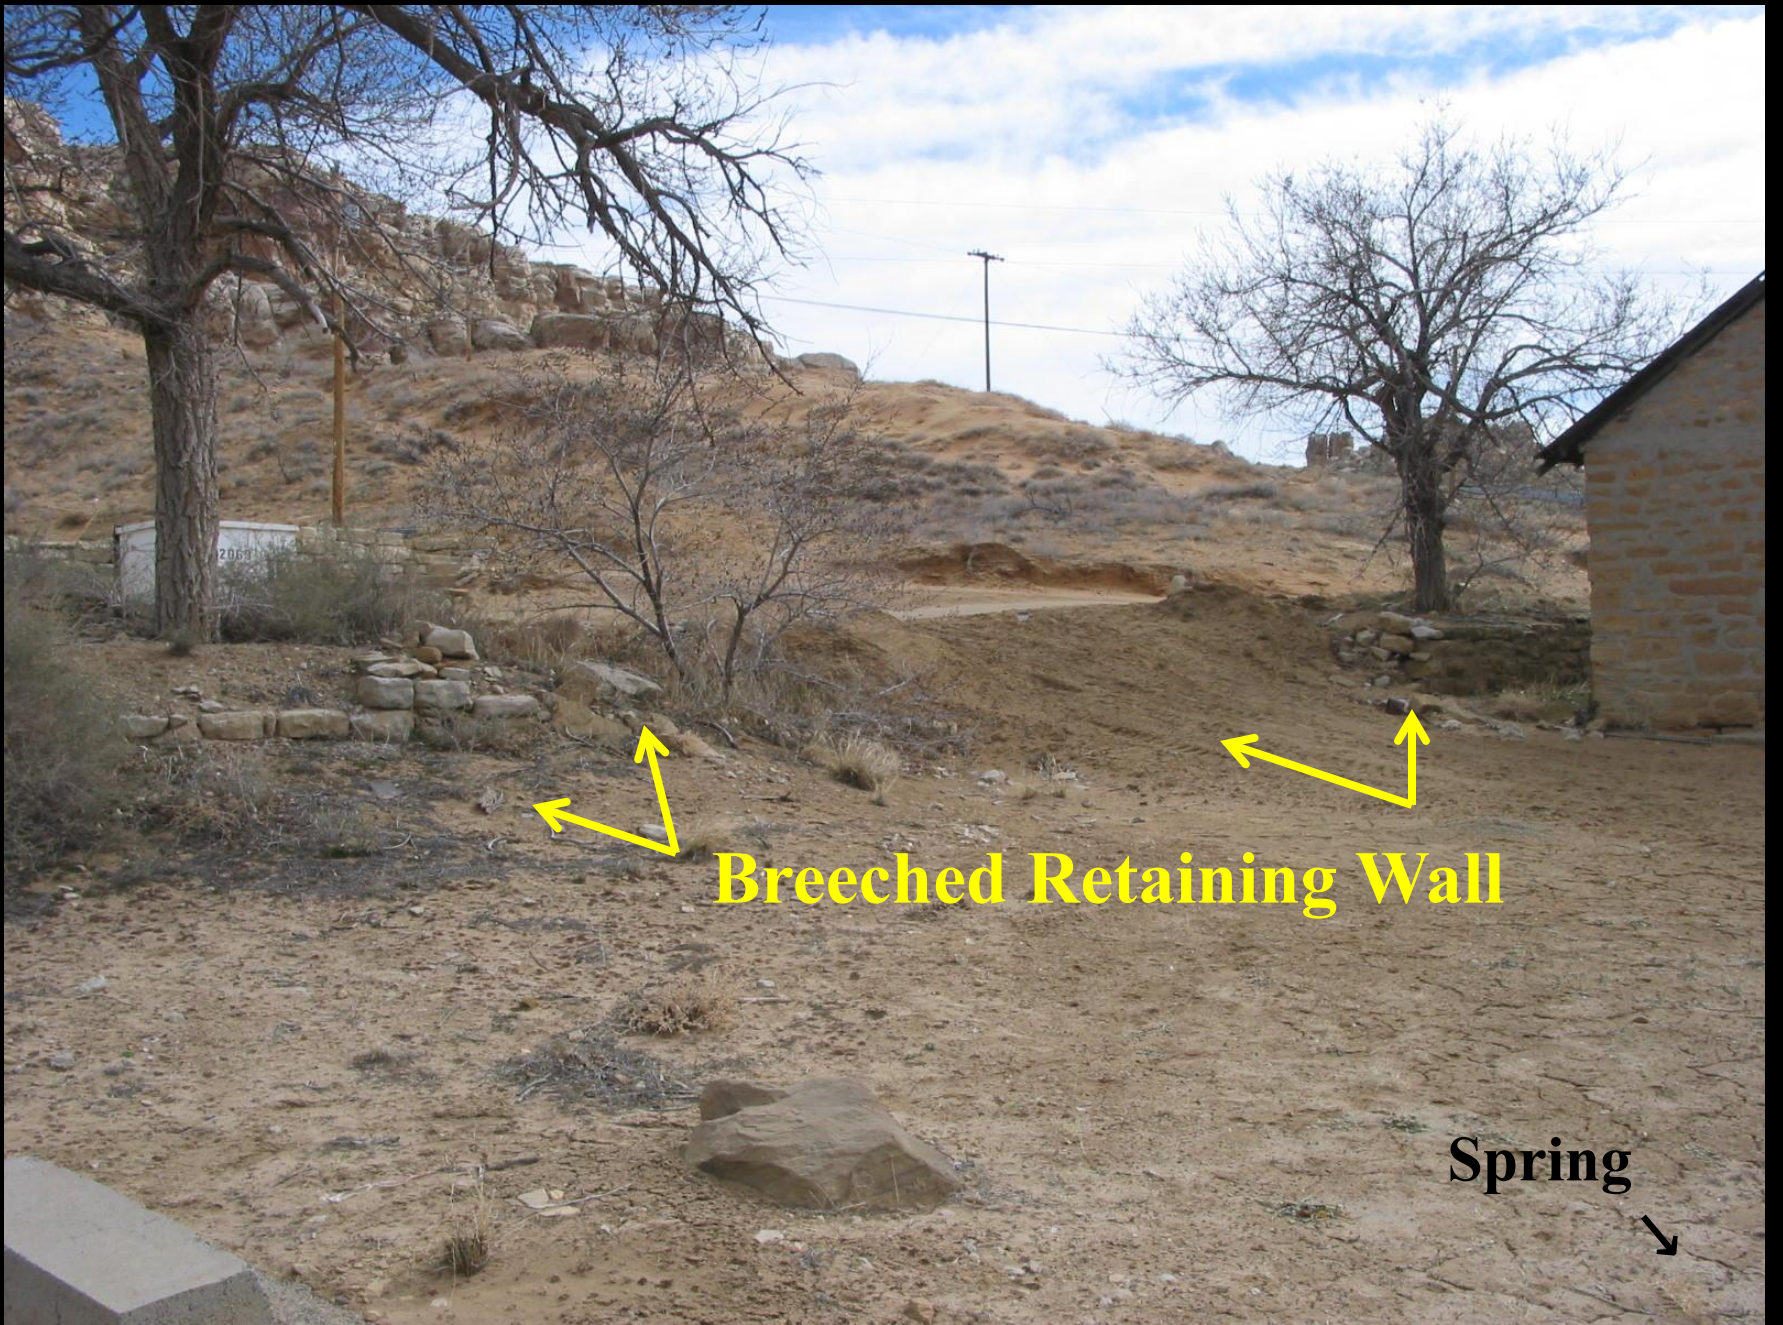
Breeched Retaining Wall

- Nearby foot trails created water channels during wet seasons
- No adequate drainage for storm water to pass Toreva
- The stone retaining wall upstream from the spring had been breeched, allowing runoff to travel directly towards it
- Sediment was beginning to deposit outside the spring wall and also in the spring
- A sewer line grade created another drainage channel towards Toreva
- Parking lots from neighboring buildings drained directly towards it
- Undersized culverts were overwhelmed during high runoff events, allowing excess water to drain into the spring
- Existing sediment retention basin was full

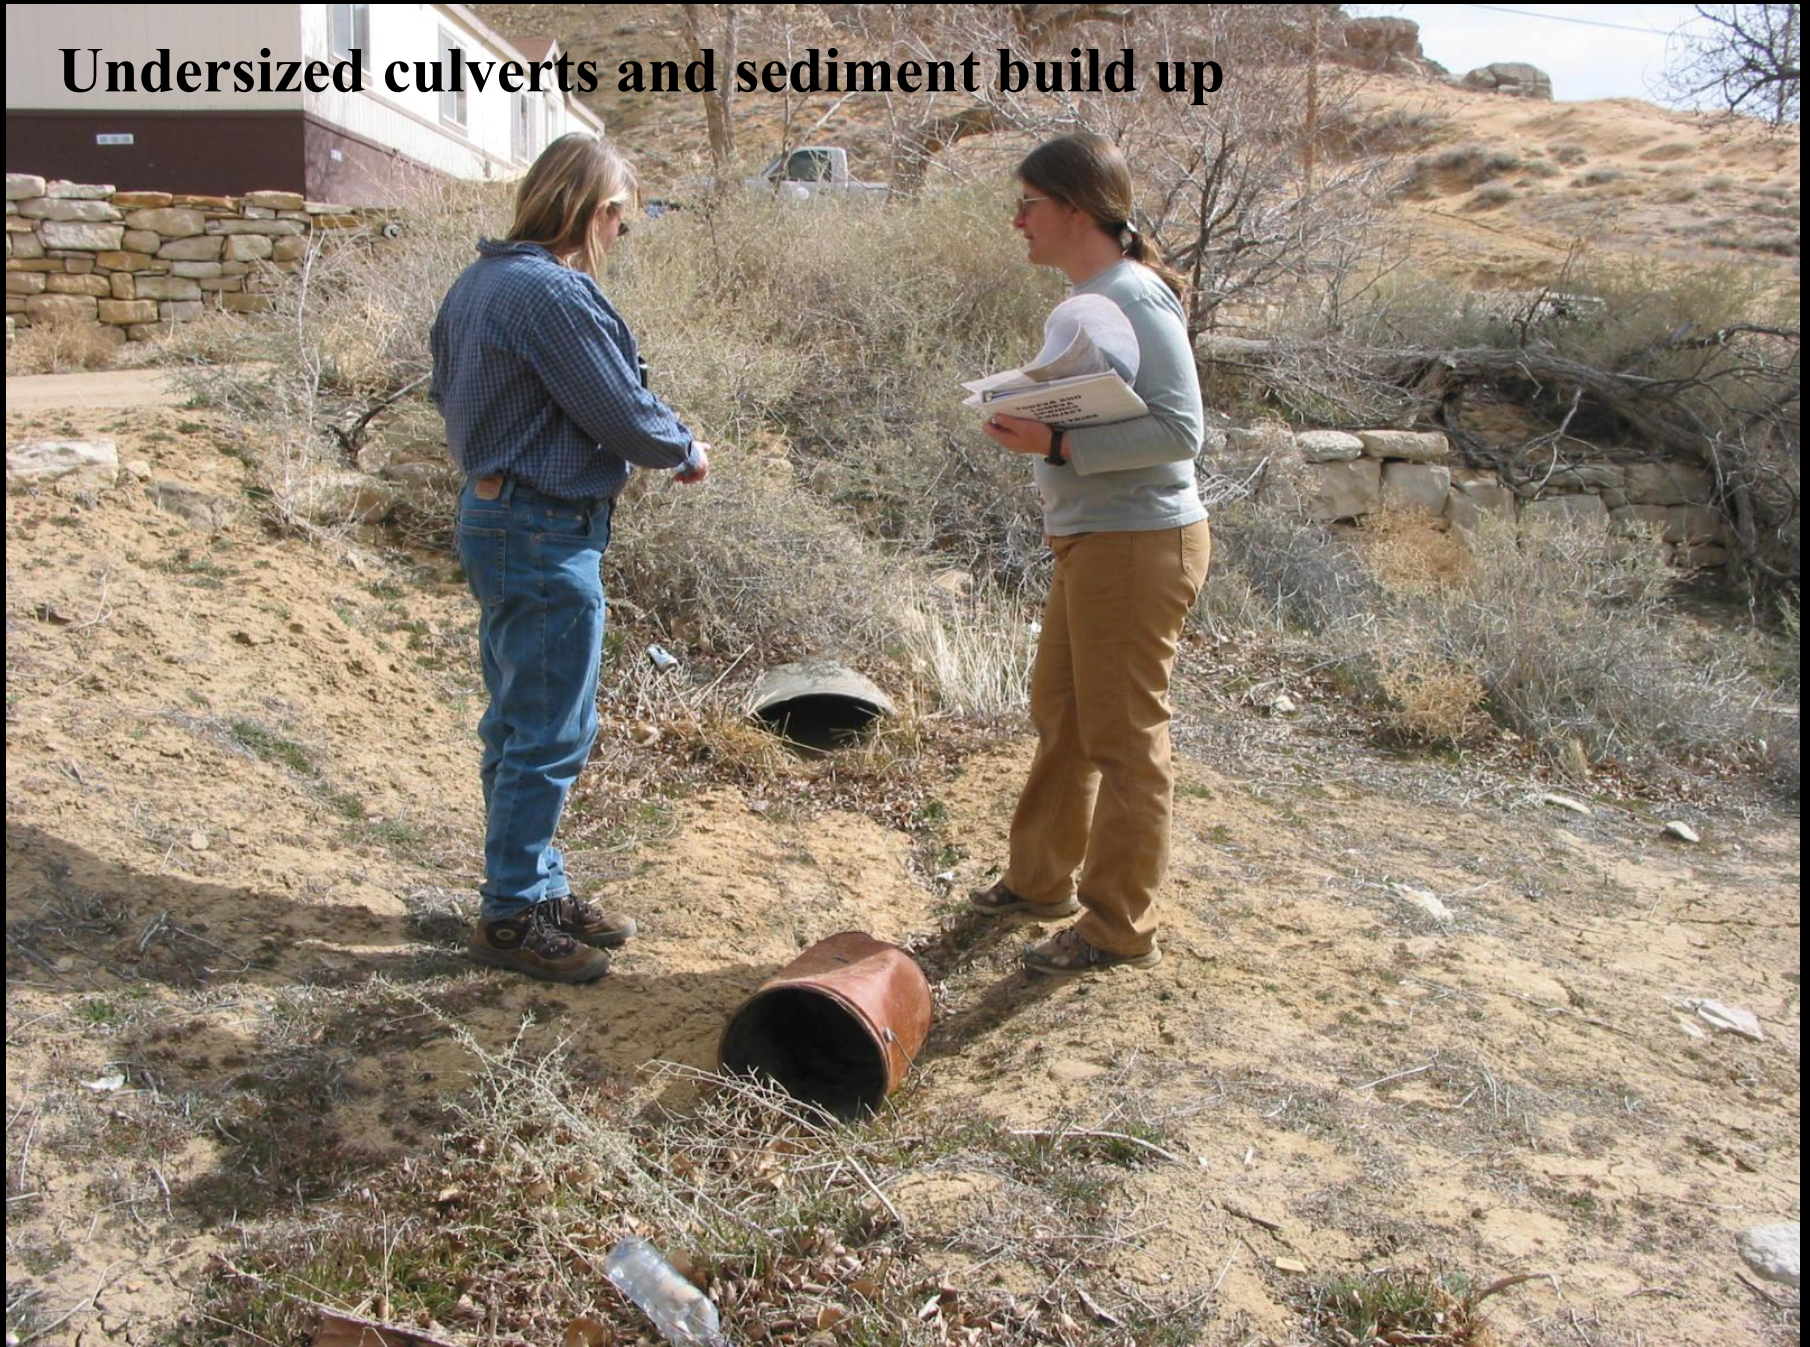
Undersized culverts and sediment build up

**Undersized culverts and
sediment build up**

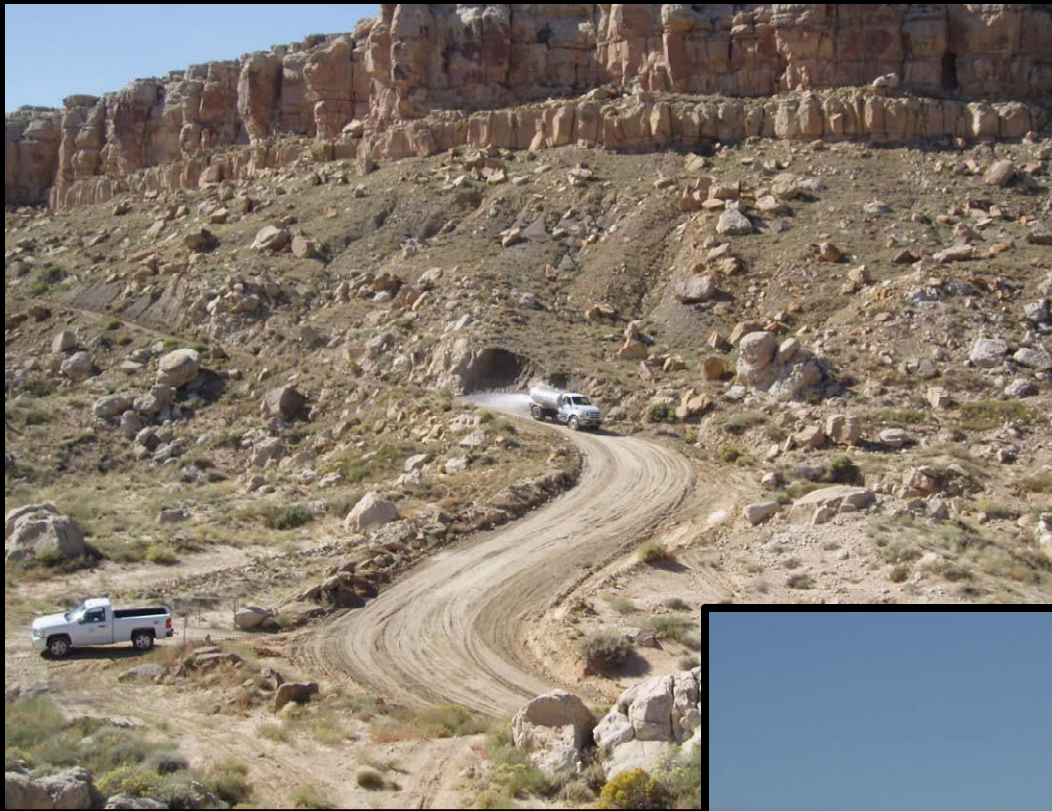
Prep work on Sunlight Mission Road which is approximately 2 miles

Aggregate application to Sunlight Mission Road was important to help reduce water capacity and velocity towards Lomeva.

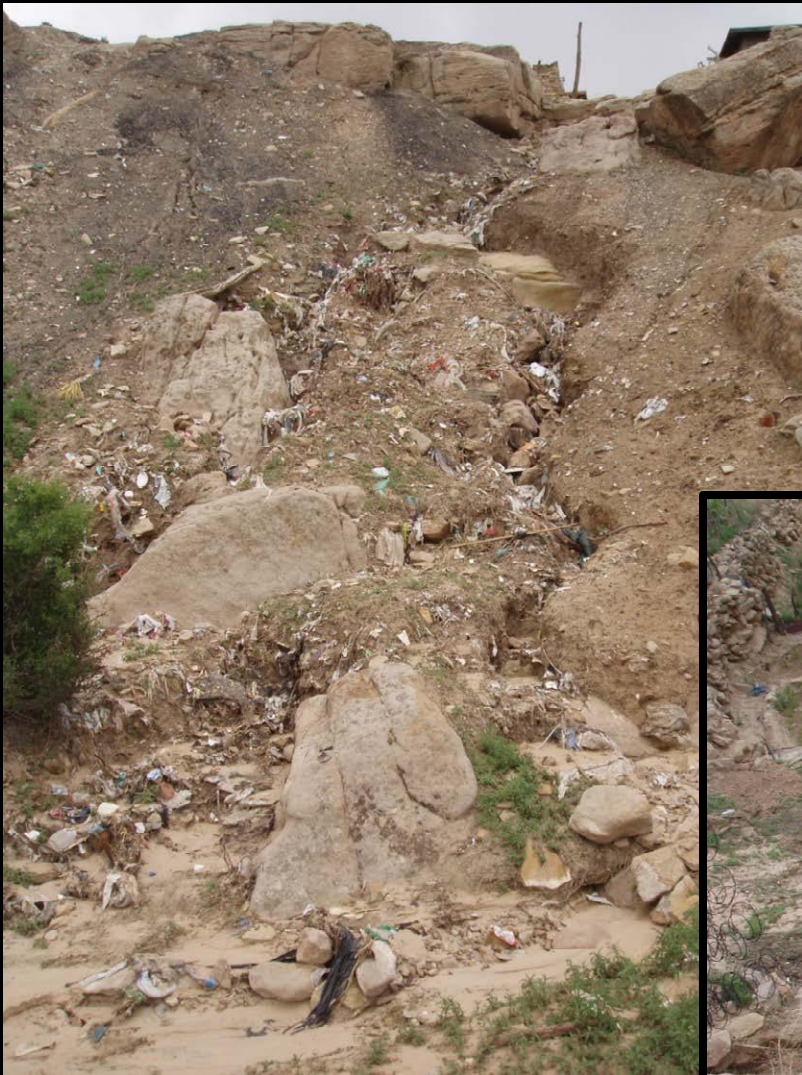
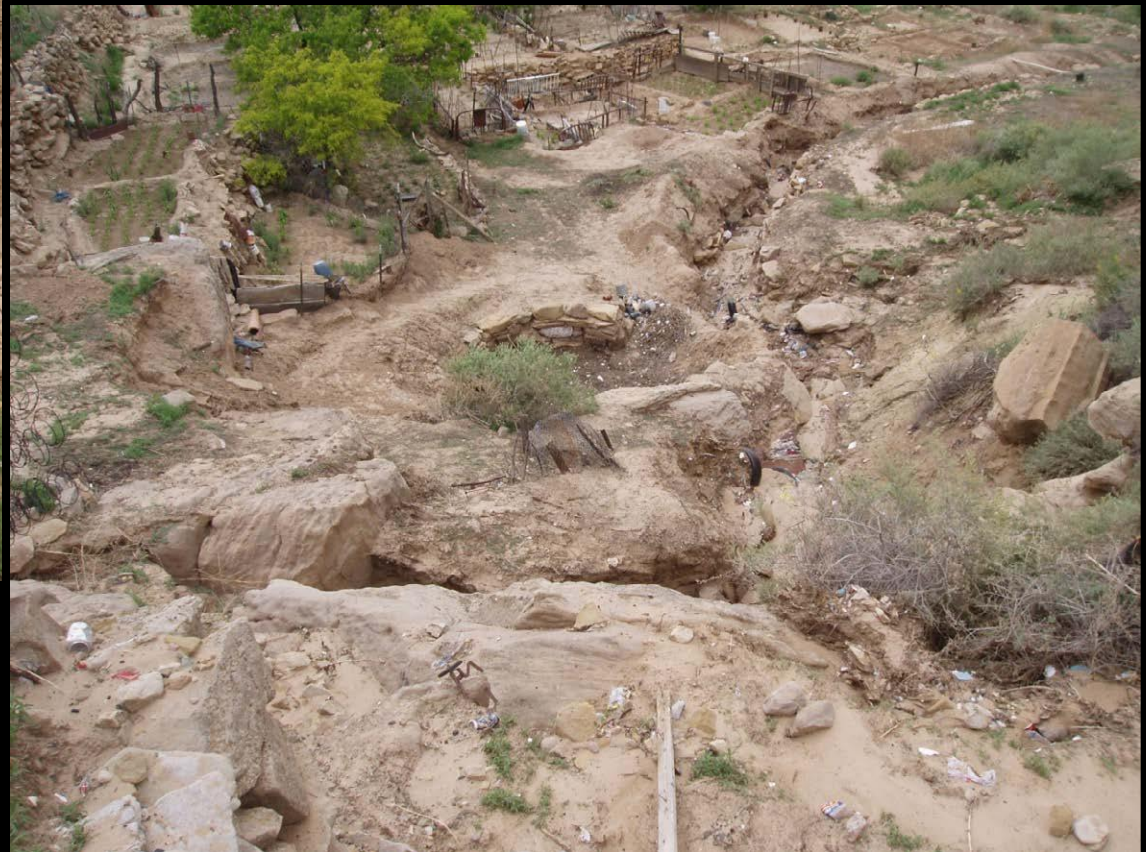
Gullies

- High nitrate concentrations in spring waters, in part, emanating from pit privy outhouses and unconsolidated waste up gradient from the springs
- Gully erosion on slopes above springs
- Poor water drainage
- Dune sand adjacent to the upper spring caused sedimentation build up

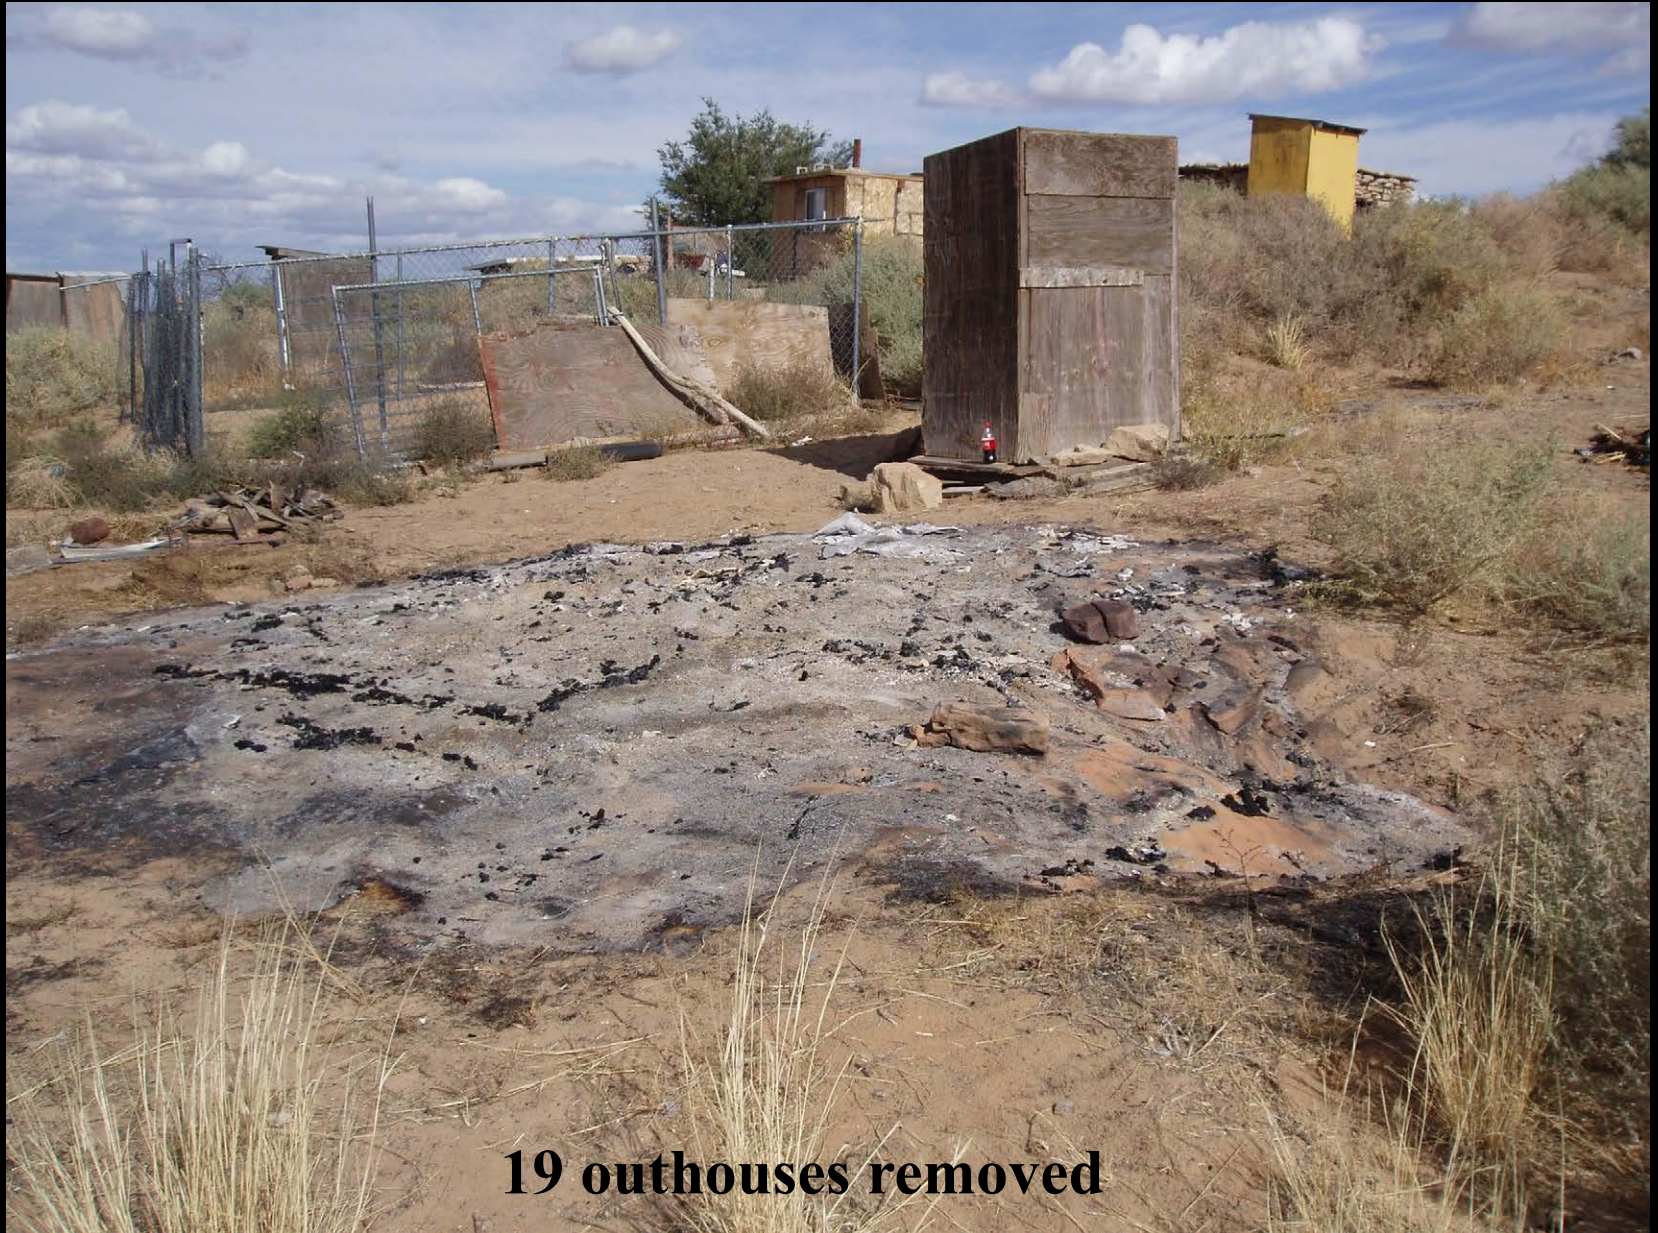
Addressing unconsolidated waste issues

19 outhouses removed

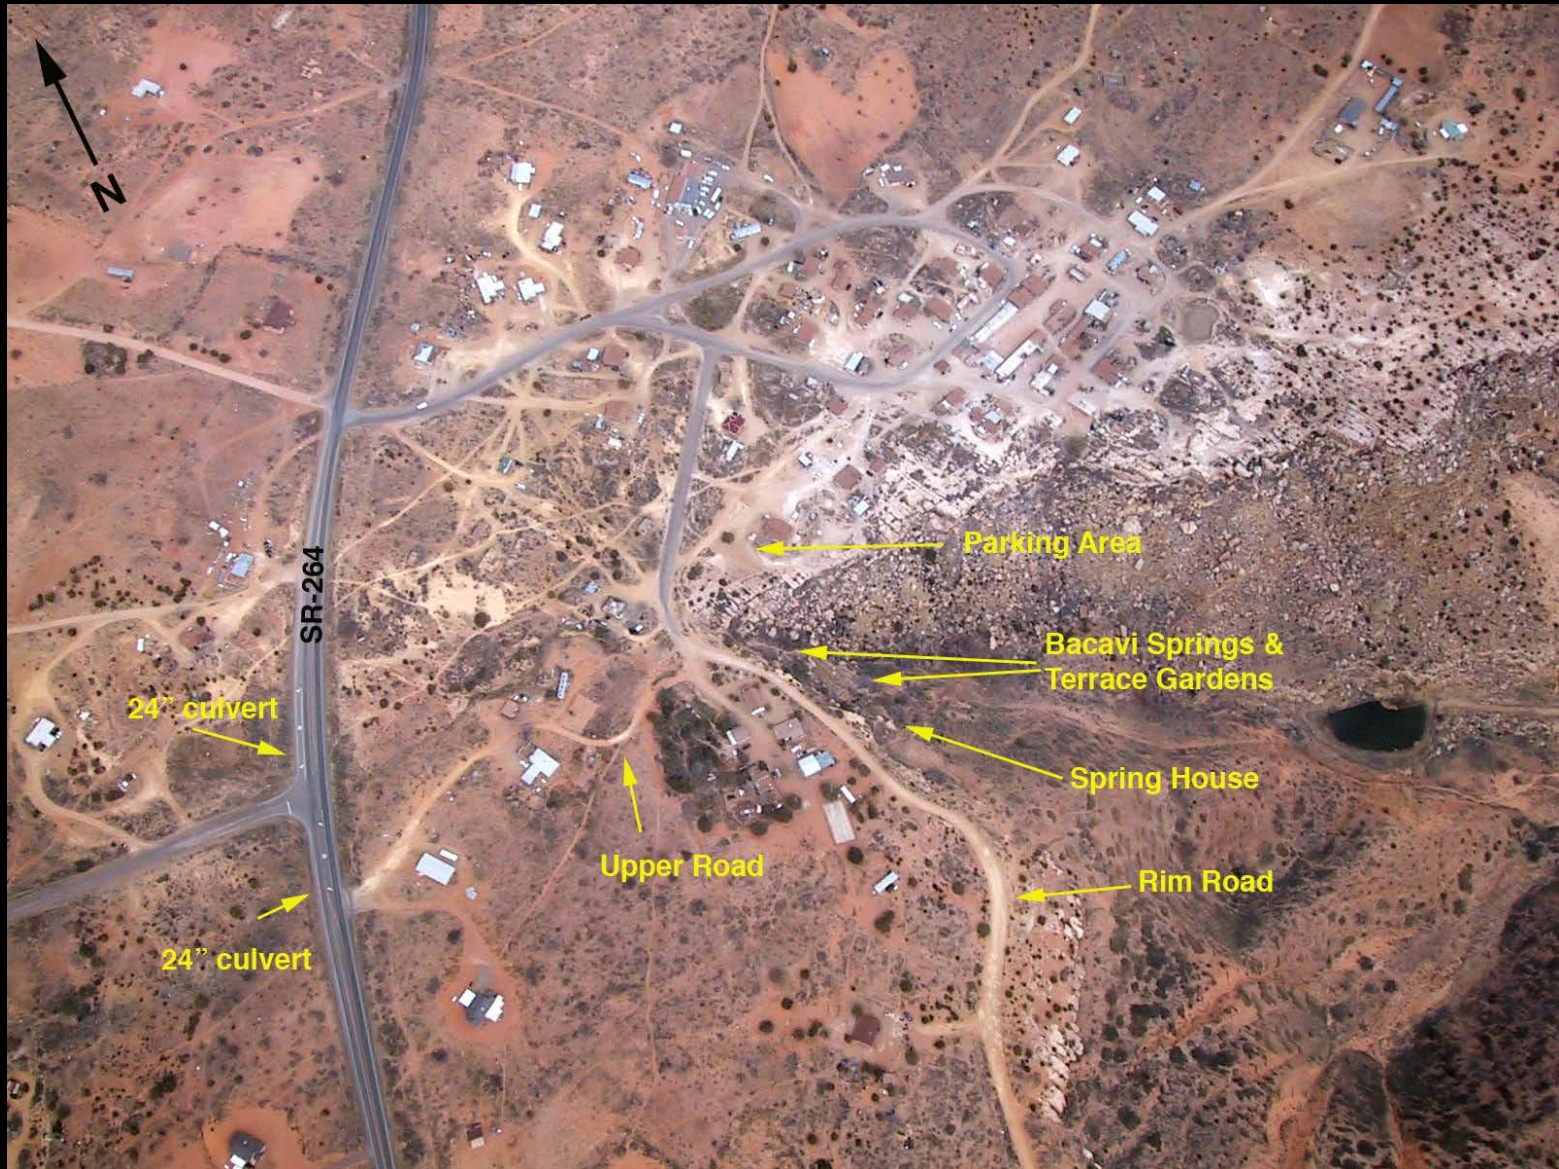
Multiple sources of runoff and sediment

- Runoff from the canyon rim carried sediment to spring pool
- Terrace garden walls were destabilized due to storm water runoff
- A large head cut near abandoned the Well House caused excess sediment to fill spring pools in lower portion of slope
- A rim road contributes to high runoff towards the spring and gardens

The area above the spring has multiple roads and trails which direct runoff towards head of canyon. The roads are highly compacted and incised below the general grade. They capture and speed up runoff.

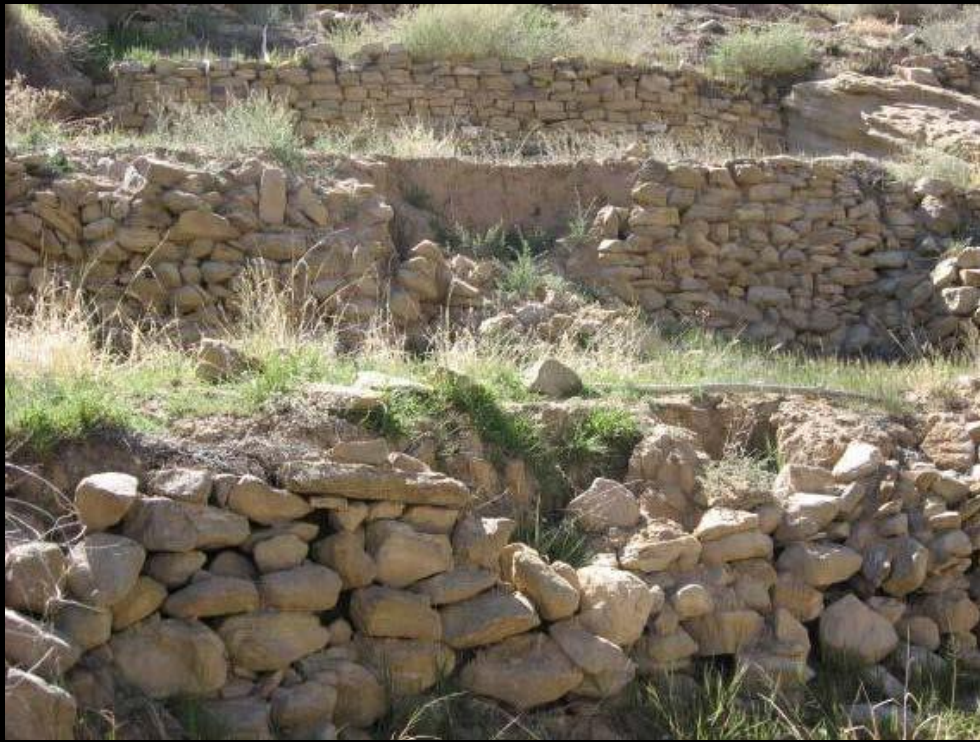
High runoff caused destabilization
of terrace garden walls
