Section 319

NONPOINT SOURCE PROGRAM SUCCESS STORY

Using Agricultural Best Management Practices Restores Creek

EPA 841-F-09-001X
September 2009

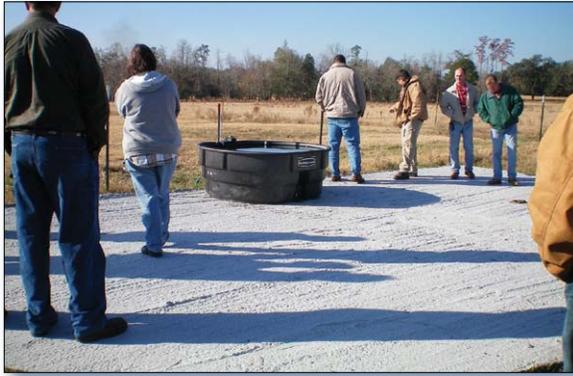
Figure 2. This farmer combined heavy use area protection with an alternate watering source.

CWA section 319 funds paid for several BMPs along Reedy Creek, including installing two foundations to support cattle and soil in heavy-use areas (places where cattle gather for watering and feeding) to prevent erosion (Figure 2), adding two grade-stabilization structures to prevent stream bank failure, seeding pastures and planting riparian zones to protect critical areas at three locations (Figure 3), installing pipelines and other alternative water structures such as wells and ponds at two sites to keep livestock out of streams, and building one poultry litter stackhouse. Those water quality control measures also provide livestock health benefits and improve area aesthetics. Local agriculture agency partners advised landowners on the

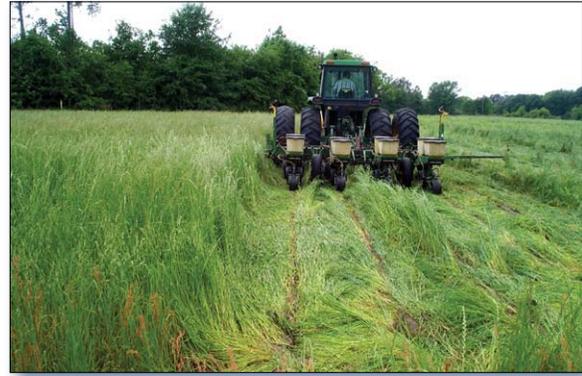
Figure 3. This farmer is planting a pasture as a cover crop on a critical watershed area.
