NONPOINT SOURCE PROGRAM SUCCESS STORY

Repairing Septic Systems Reduces Bacteria in Stamp Creek

EPA 841-F-14-001YY
September 2014

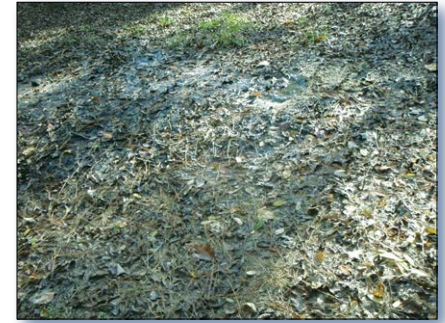
Figure 2. Before the restoration project, bacteria-laden effluent from a failing septic system was surfacing and draining off of this yard in the Stamp Creek watershed.

with two Stamp Creek watershed homeowners to repair their failing residential septic systems in 2009 (Figure 2). The homeowners participated voluntarily and provided partial funding for the repairs.

Stamp Creek has directly benefited from \$5,600 in CWA section 319 funding for septic system repairs. Homeowners provided the remaining 40 percent of repair costs for a total of \$9,300 directed towards septic repair. Key partners in this effort include the Upper Etowah River Alliance, Limestone Valley RC&D, Bartow County Environmental Health Department, and Cherokee County Environmental Health Department. Agents of these generous partners provided technical expertise and labor. Other partners involved in the larger Etowah River watershed project include landowners, The Nature Conservancy, the Wildlife Fund, and the City of Canton. Landowners in the Etowah River watershed contributed in-kind labor hours and some matching funds to the overall project.
