NONPOINT SOURCE PROGRAM SUCCESS STORY

U.S. Forest Service Improves Water Quality In Meadow Creek

EPA 841-F-15-001G
January 2015

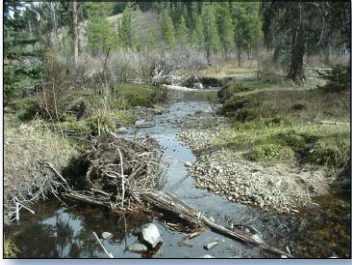
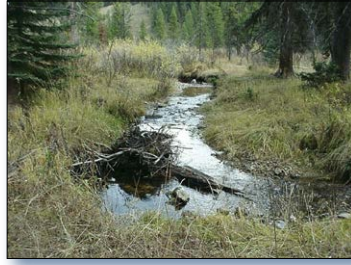
Figure 2. Livestock grazing in the riparian area caused damage in Meadow Creek (as seen on left, 2003). Partners installed fences to exclude livestock. Within two growing seasons, streambank vegetation had recovered (as seen on right, 2005).

USFS has conducted a significant number of improvement projects in the Meadow Creek watershed since the late 1990s to reduce streamside impacts of grazing cattle and improve water quality. These efforts included adding an initial half-mile of riparian fencing along Meadow Creek in 1996; fencing along Bugle Creek in 2000; 1,700 more feet of fencing in 2004; and 500 feet of fencing near Balsam Creek in 2005, with additions in 2007, and several slash fences created from cutting and felling large trees to prevent livestock access to sensitive Meadow Creek riparian areas (Figure 2). In addition, during the 2004 restoration a stream crossing in this area was hardened with logs, gravel and rock to reduce sedimentation from livestock access.

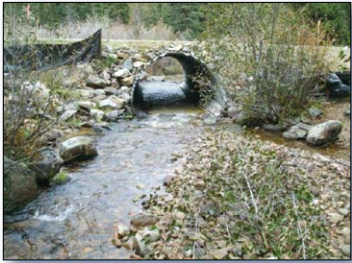
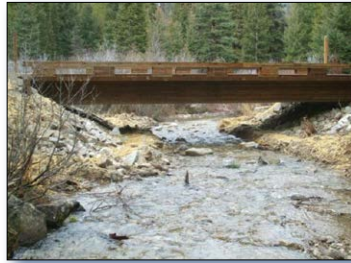
Figure 3. Partners replaced a forest road culvert (left) with a new bridge (right) over Meadow Creek. The bridge allows unimpeded fish passage and reduces road-related sediment loads.

miles where the stream closely paralleled Meadow Creek, (2) modifying the outslope and crown of the road to diffuse runoff, and reseeding roadside disturbed areas to stabilize soils. Two culverts on Meadow Creek were also replaced with bridges (Figure 3) and an undersized culvert on Bugle Creek was replaced with a culvert sized to accommodate a 100-year flood. Lastly, several small crossings on Meadow Creek and headwater tributaries were hardened. Much of this work by the USFS was supported by the development of a 2008 restoration plan by MDEQ. This plan helped guide USFS restoration work in subsequent years.
