# NONPOINT SOURCE PROGRAM SUCCESS STORY

## Adding Protection Measures Restores Sitting Bull Creek

EPA 841-F-14-001KKK  
November 2014

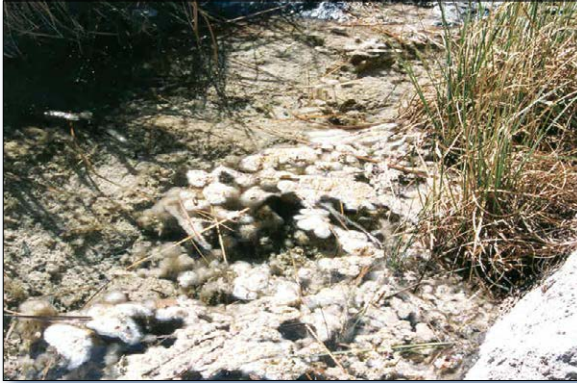
Figure 2. Nuisance algal blooms were common in pools below Sitting Bull Falls in the mid-1990s.

Nuisance algal blooms were common in pools below Sitting Bull Falls in the mid-1990s (Figure 2). Using best professional judgment, NMED determined that the creek did not support its designated uses of warmwater fishery and secondary recreation contact. As a result, in 1998 NMED added a 1.8-mile segment of Sitting Bull Creek (segment NM-9000.A-007: from Last Chance Canyon to Sitting Bull Springs) to the CWA section 303(d) list of impaired waters for sedimentation, bacteria and total phosphorus.

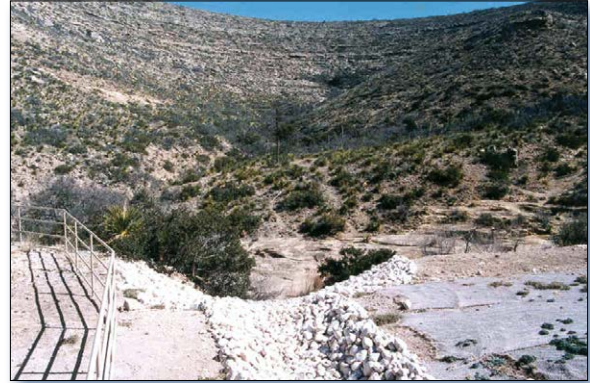
Figure 3. Restoration project efforts included adding fencing and armoring drainage ditches.

To restore water quality in Sitting Bull Creek, the NMED SWQB coordinated with USFS staff from the Lincoln National Forest to include water quality protection measures in their plans to renovate the Sitting Bull Falls Recreation Area. From fall 1996 to summer 1998, partners used CWA section 319 funds to address sediment pollution by installing a sediment retention basin and hard armoring the eroding drainage channels leading from the

road and parking lot (Figure 3). They installed pipe fencing around the picnic areas to discourage access to the unauthorized trails and to protect the riparian area from erosion. In addition, the partners installed a new water supply well and upgraded the restroom facilities; these improvements have resolved the sanitation issue and reduced bacterial loading. Volunteer site hosts are stationed in RVs onsite to monitor the day-use area to ensure success. This project was a good example of interagency cooperation on resource management, as both agencies came together on their planning efforts to upgrade the recreation area and improve water quality.
