2015 Ohio River HAB Event

Greg Youngstrom
Environmental Scientist
ORSANCO

Erich Emery
Water Quality Specialist / Biologist
U.S. Army Corps of Engineers

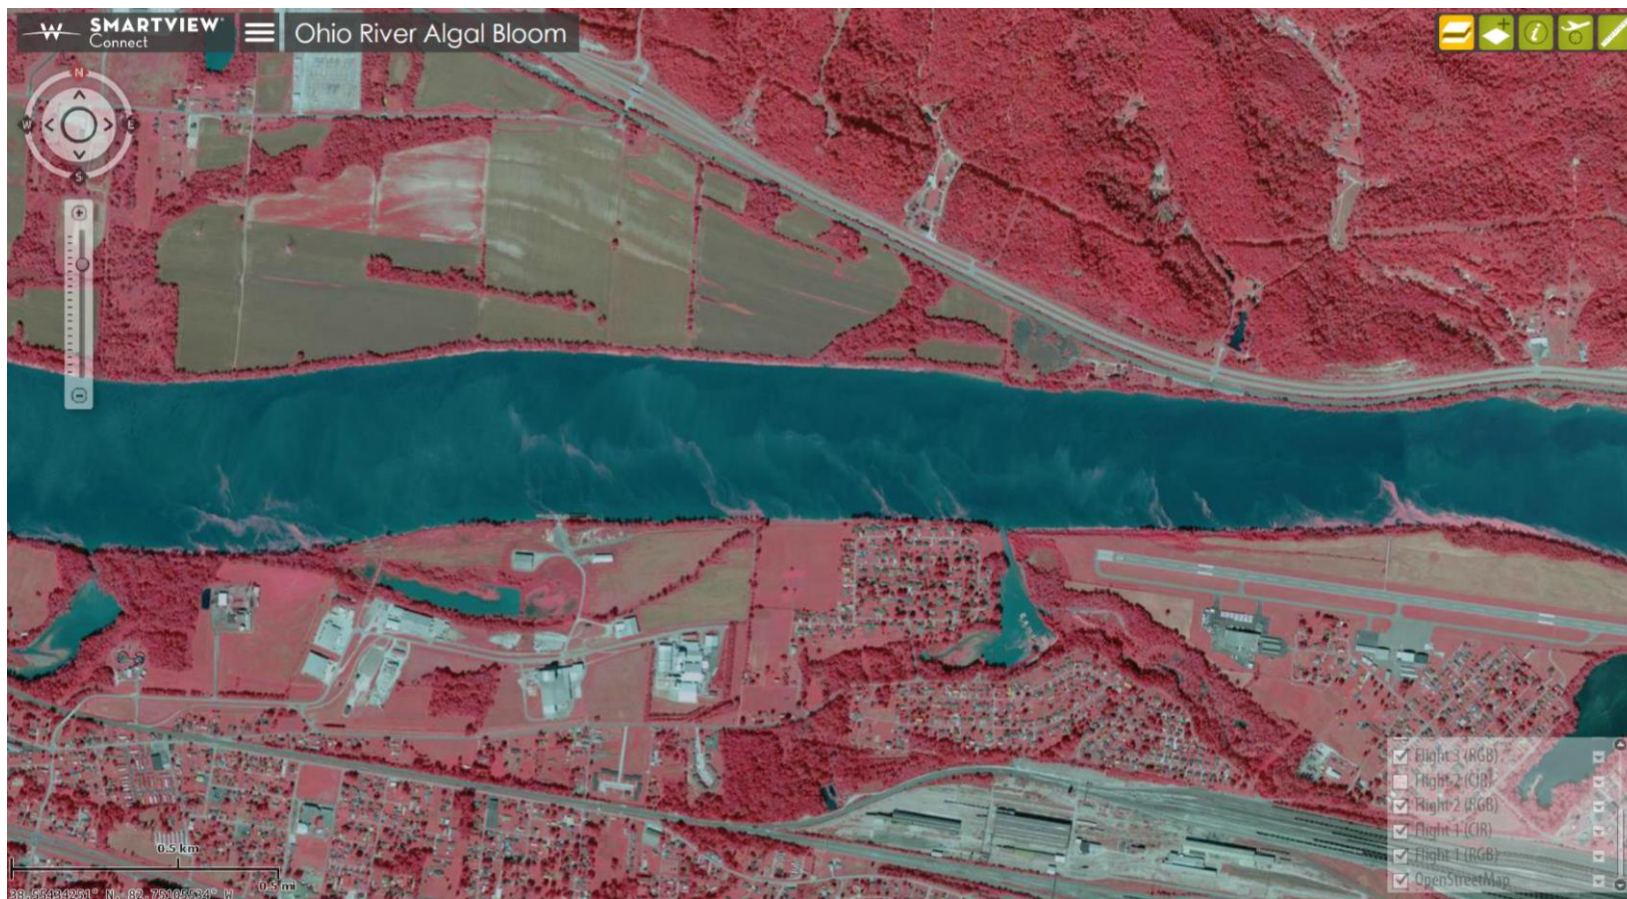
Shoreline Productivity

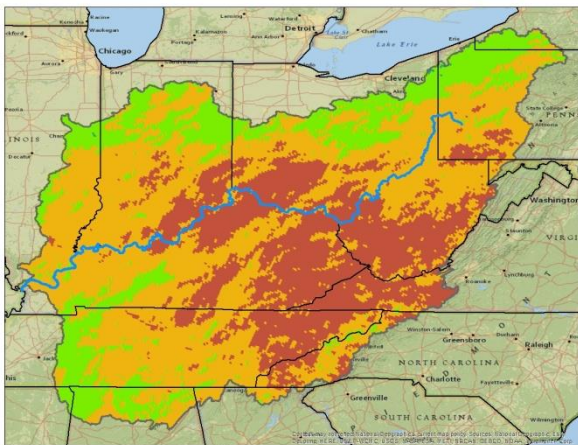
May

Summer 2015 Monthly Precipitation Relative to Normal
