# NONPOINT SOURCE SUCCESS STORY

## Restoring Stream Channel and Riparian Areas Improves Aquatic Habitat in Upper Big Darby Creek

### Waterbody Improved

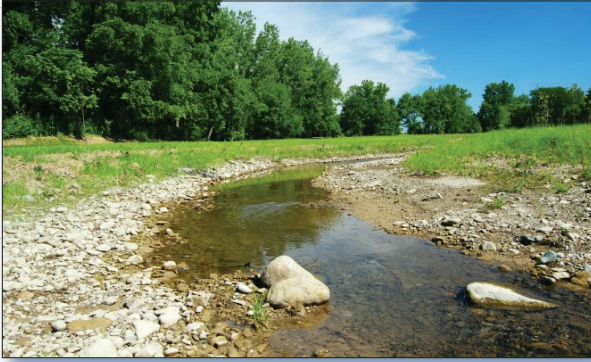
Figure 2. In 2011, partners completed a restoration project along this section of Big Darby Creek, establishing a new floodplain along a formerly channelized, entrenched section.

In response to the impaired conditions of the headwaters of the Big Darby Creek watershed, The Nature Conservancy, in partnership with Ohio EPA via the CWA section 319(h) grants program and the Water Resources Restoration Sponsorship Program (WRRSP), completed restoration and re-naturalization of more than a mile of the headwaters of Big Darby Creek. The Nature Conservancy was the prime partner in the project. Restoration work by TNC began in 2007 and was completed in 2011. Specific restoration actions implemented by The Nature Conservancy included:

- 5.7 acres of riparian wetland restorations.
- 7,086 linear feet of stream restoration with reconnection to channel floodplain and additional hydrologic features (riffle/pool sequences, rootwads, etc) installed.
- 24 acres of riparian area plantings (grasses and 34,094 trees and shrubs).
- Gravel grade control in three tributaries, including directing discharge to a wetland.
- Public education and outreach project.

As a result of the above restoration efforts, conditions have improved in the headwaters of Big Darby Creek. Riparian vegetation has recovered and flourished along the restored sections of the creek (Figures 2 and 3).

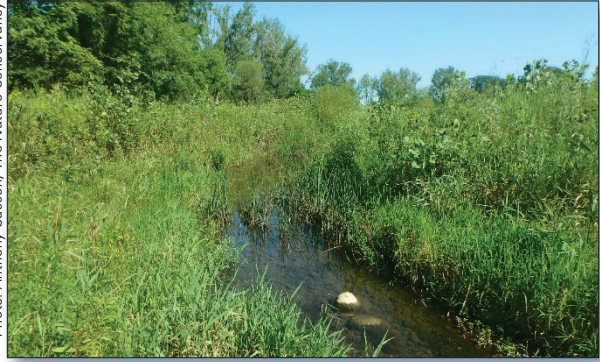
Figure 3. By 2015, grasses and other riparian vegetation had become re-established on the floodplain of Big Darby Creek, providing enhanced wildlife and aquatic habitat.

Post-restoration QHEI scores ranged from just below 60 up to 70 (QHEI > 60 is correlated to support of exceptional warmwater habitat). IBI and ICI indices in 2014 were all greater than 50 (out of a max of 60), indicating exceptional warmwater habitat. Based on these data, Ohio plans to delist the Headwaters of Big Darby Creek AU (19.2 square miles) for hydromodification and habitat alteration in the 2016 integrated report.
