NONPOINT SOURCE PROGRAM SUCCESS STORY

Wyoming

Changing Road Design and Implementing Grazing BMPs Reduce Sediment

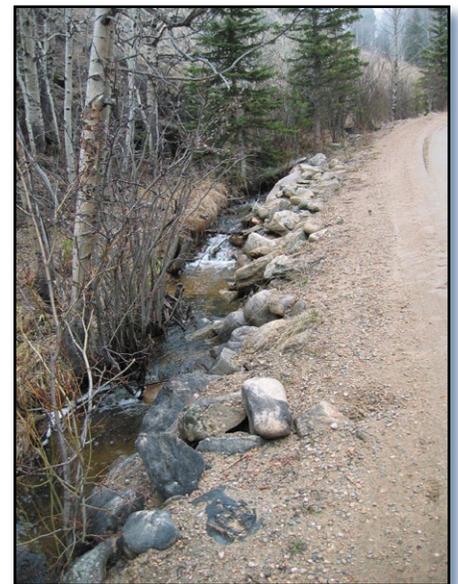
Figure 1. Hunter Creek before the project.

Hunter Creek is a small (approximately 1.9 miles long) tributary to Clear Creek, in the Powder River Basin of the Bighorn Mountains of Wyoming. For the purpose of surface water monitoring, WDEQ divides Hunter Creek into upper and lower sections. WDEQ placed the lower section of Hunter Creek on the state's 1998 Clean Water Act (CWA) section 303(d) list because of heavy siltation, which threatened aquatic life by eliminating important streambed habitats. WDEQ identified that the likely sediment sources included the close proximity of an adjacent road and intensive upstream cattle grazing.

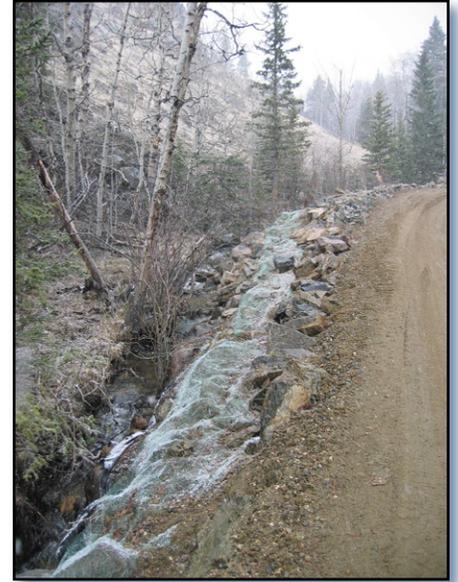
Figure 2. Photo of the project site taken immediately after WDEQ and USFS realigned the road and established a wider buffer area. A white mesh placed on the new riparian area will help hold the soil until vegetation can become established.

To address the two primary pollutant sources—sediment from the adjacent road and intensive upstream cattle grazing—WDEQ and the USFS initiated a management plan. To reduce sediment inputs from the road, the partners removed mineral outcrops from along the road's edges, thus allowing the road to be shifted several feet away from the stream (see Figures 1 and 2). Then, they established a riparian buffer zone in the newly created space using both mineral particles and vegetation to separate the stream from the road (Figure 2). Finally, they constructed a new road section that channeled water away from the stream and into a newly dug ditch that terminated in a sediment basin (Figure 3).

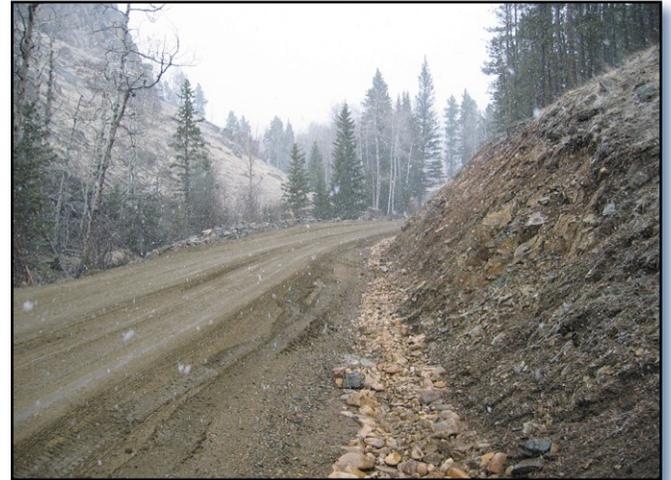
Figure 3. A newly-constructed ditch along the road conveys water away from stream and into a sediment basin.
