UNITED STATES  
ENVIRONMENTAL PROTECTION AGENCY  
REGION III

STATEMENT OF BASIS

**FORMER KEYSTONE COLOR WORKS  
YORK, PENNSYLVANIA**

**June 2014**

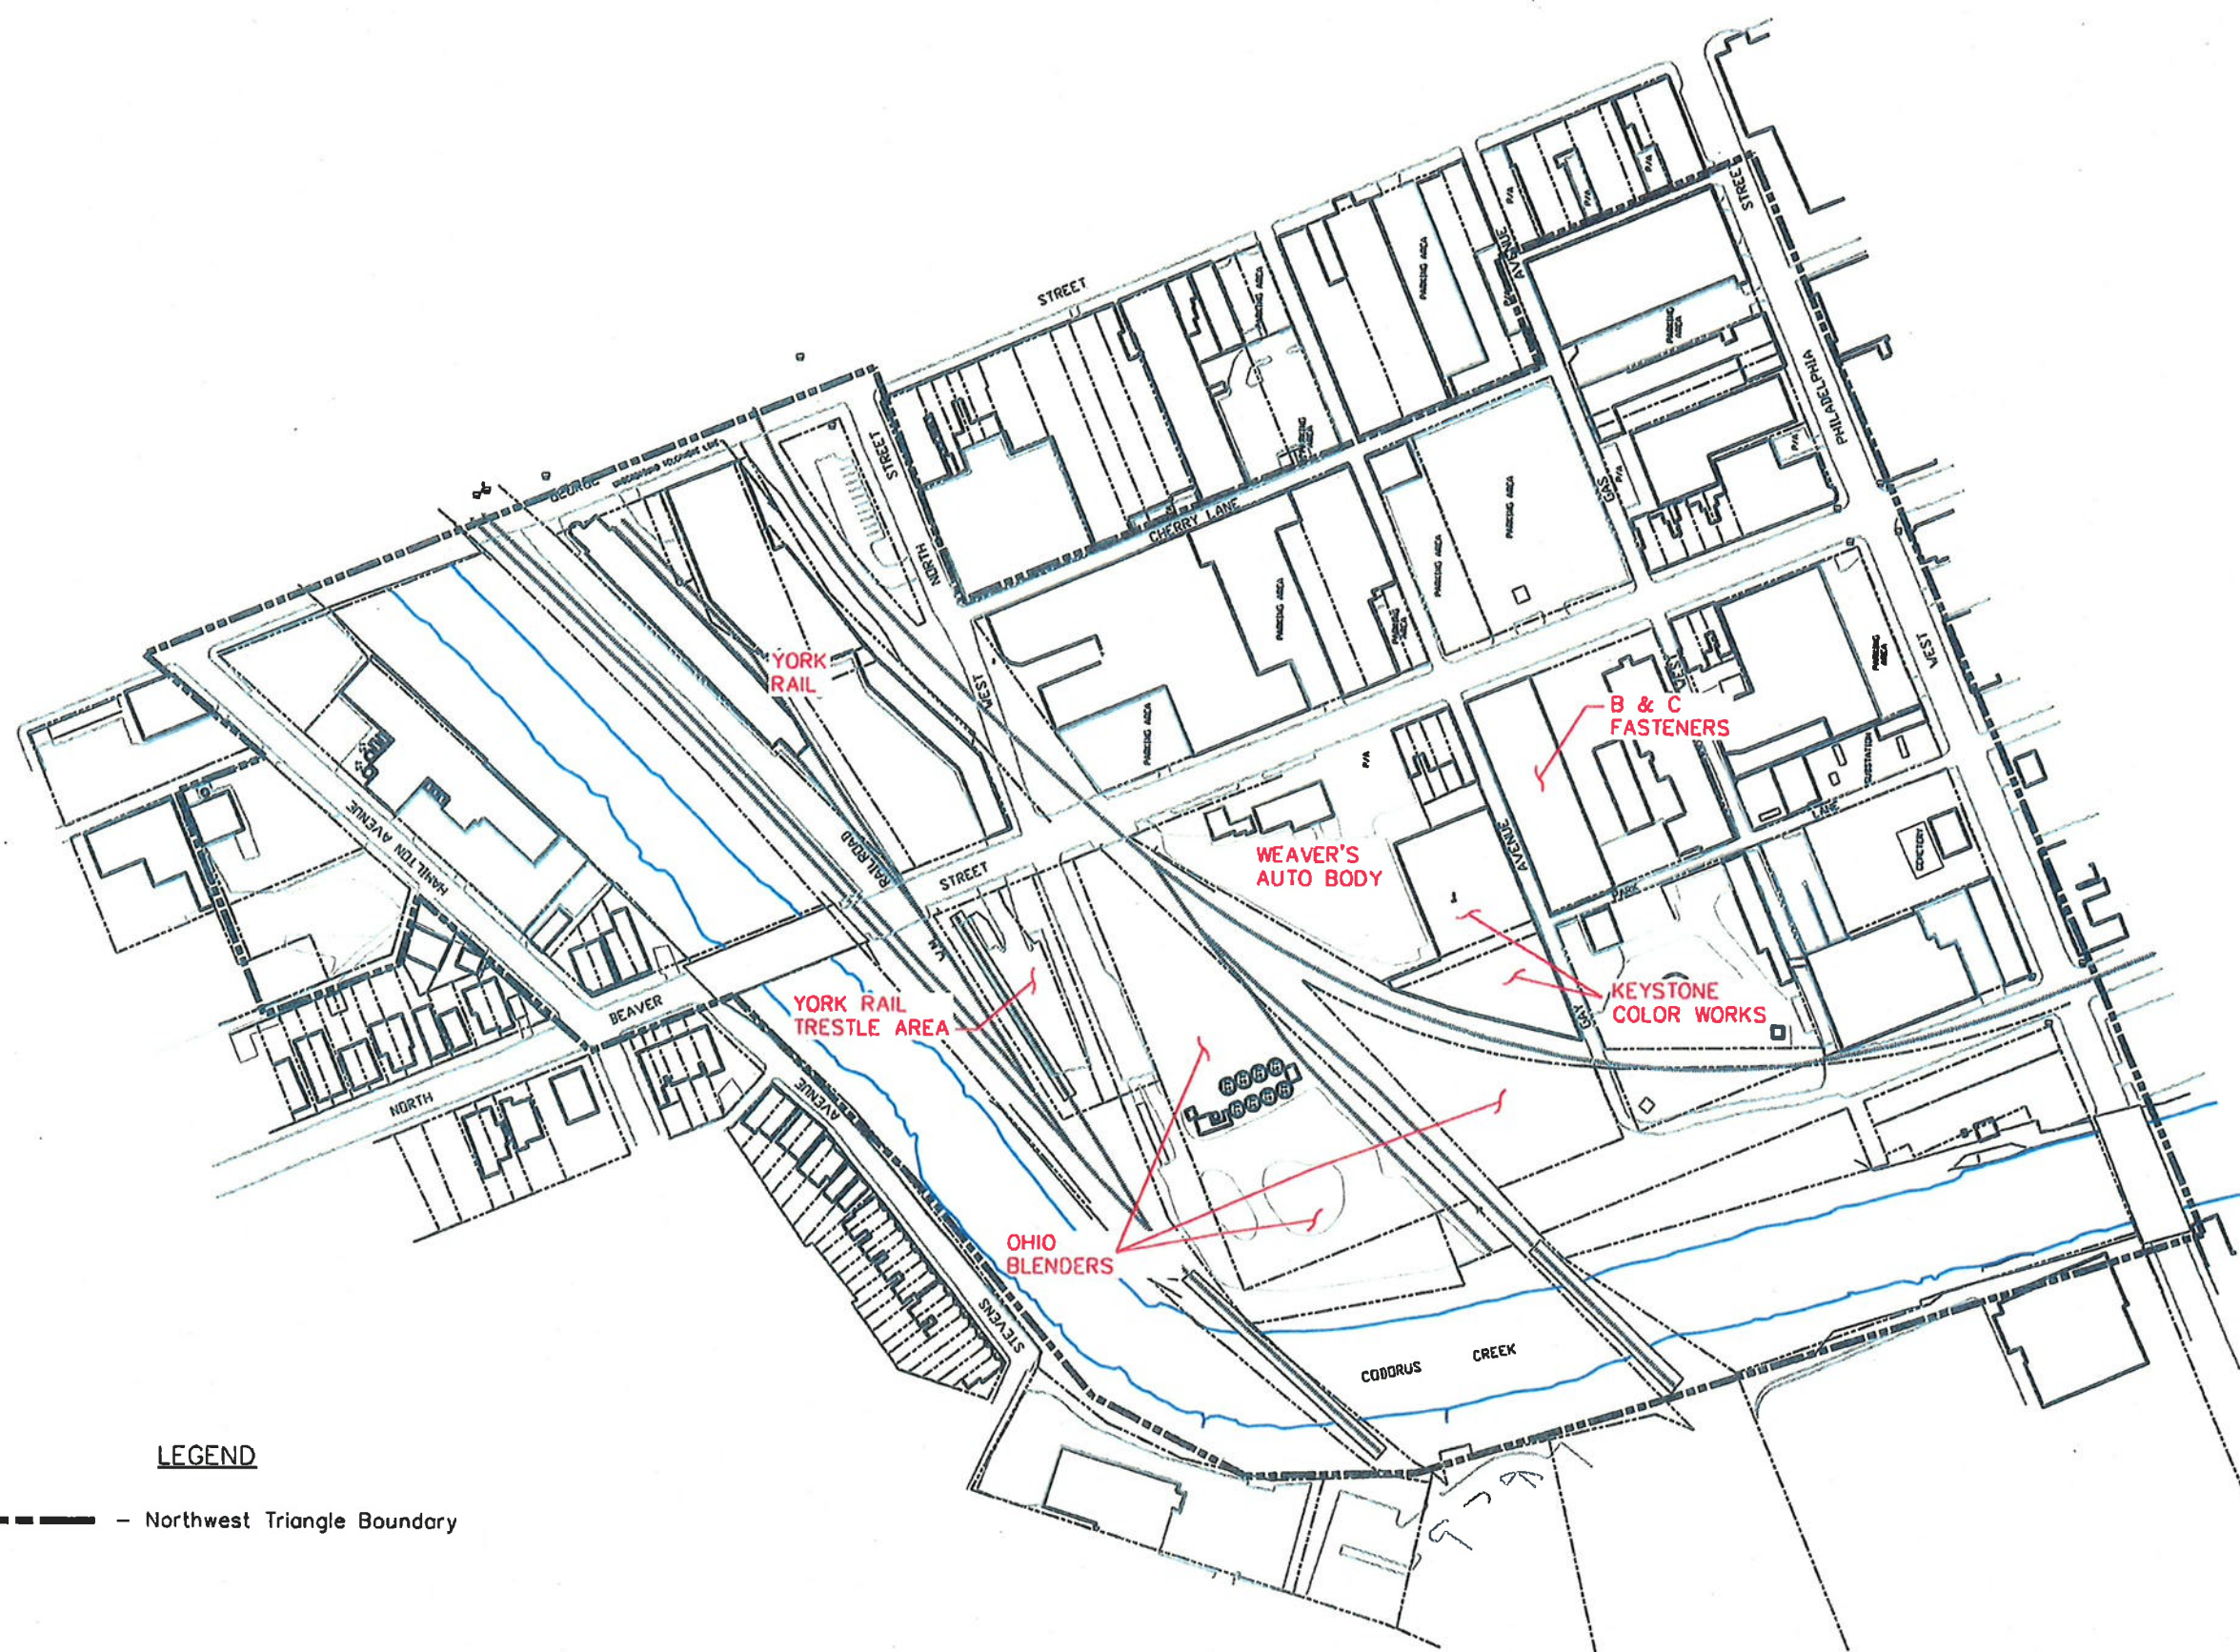
**Figure 1**

**Site Location Map**

**Site Layout**  
Northwest Triangle Initiative  
City of York  
York County, PA

The City of York Redevelopment Authority (RDA), a non-profit organization, is remediating, rehabilitating, and/or redeveloping these impacted and underutilized properties as part of the City of York's revitalization activities. For additional information regarding the NWT Initiative, please refer to the March 2014 Act 2 RIR/FR which has been included in the AR for KCW. A Site Location Map and a Local Area Map depicting surrounding properties are attached to this SB as **Figures 1 and 2**, respectively.

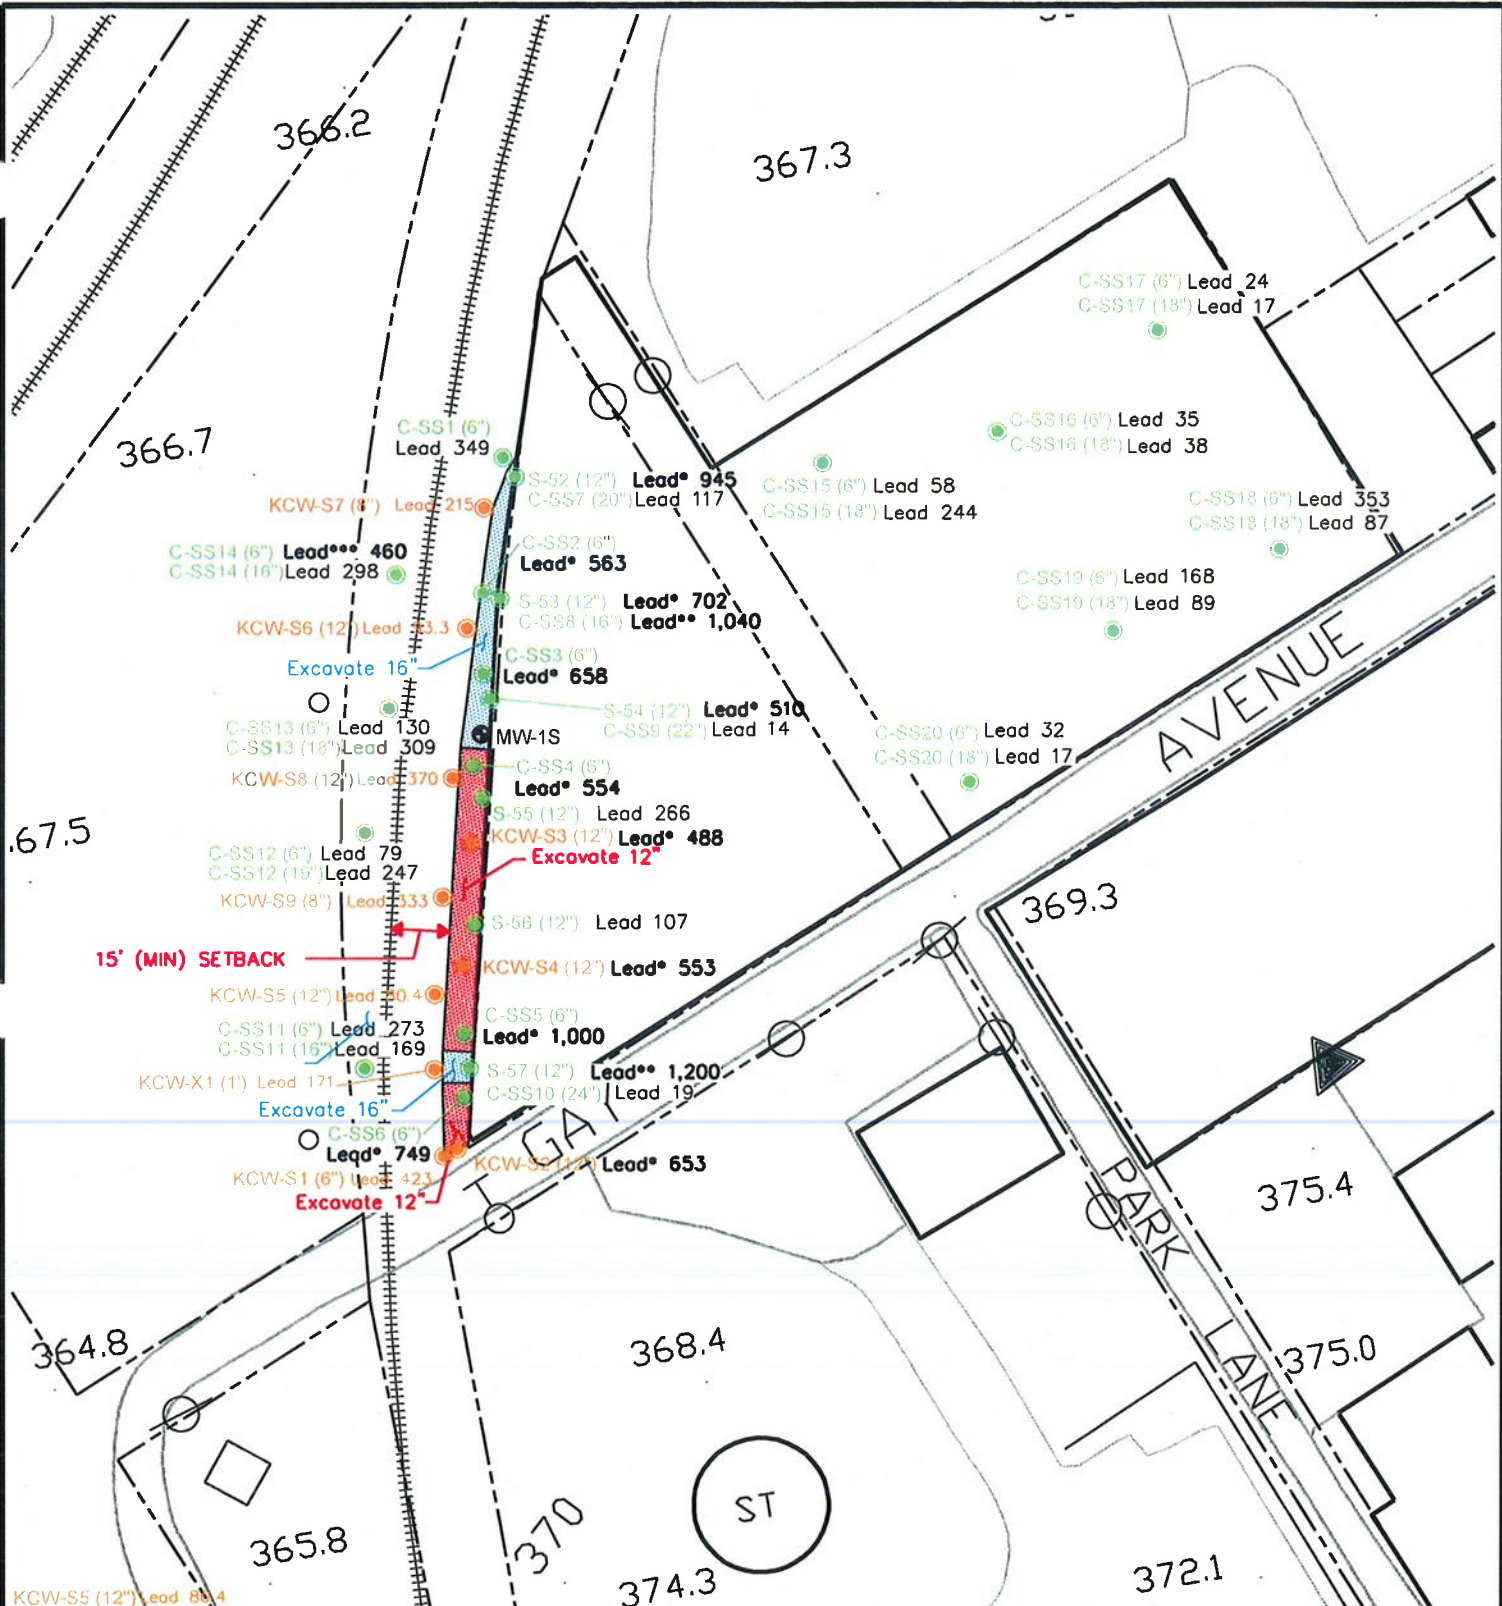
**Soil Sampling Summary for Keystone Color Works**

- Excavate 12"
- Excavate 16"
- MW-1S - Monitoring Well
- C-SS1 (6") - Sample Location
- Lead 107 - Result in Milligrams per Kilogram (mg/Kg)
- Lead\* - Result exceeds Residential Direct Contact and Soil to Groundwater Standard
- Lead\*\* - Result exceeds Non-Residential Direct Contact and Soil to Groundwater Standard
- Lead\*\*\* - Result exceeds Soil to Groundwater Standard

As generally depicted on **Figure 3** (attached), the Facility consists of the existing, triangular shaped KCW industrial building (KCW Building) and associated parking lot to the east, with a small tract of gravel-covered soil along the western edge of the building. Railroad tracks and an associated right-of-way, owned by York Rail, mark the Facility's western property boundary.

Contaminated soil was excavated from along the western side of the KCW Building to a depth of up to approximately two feet in the areas delineated during the investigations. Ten additional samples were collected in March 2009 and analyzed for lead during the soil remediation activities to complete the lateral and horizontal delineation of Site-related lead contamination. The results of this soil sampling are summarized in **Table 2 (Attachment A)** and the sample locations and the delineated boundary of lead contamination are shown on **Figure 3**.

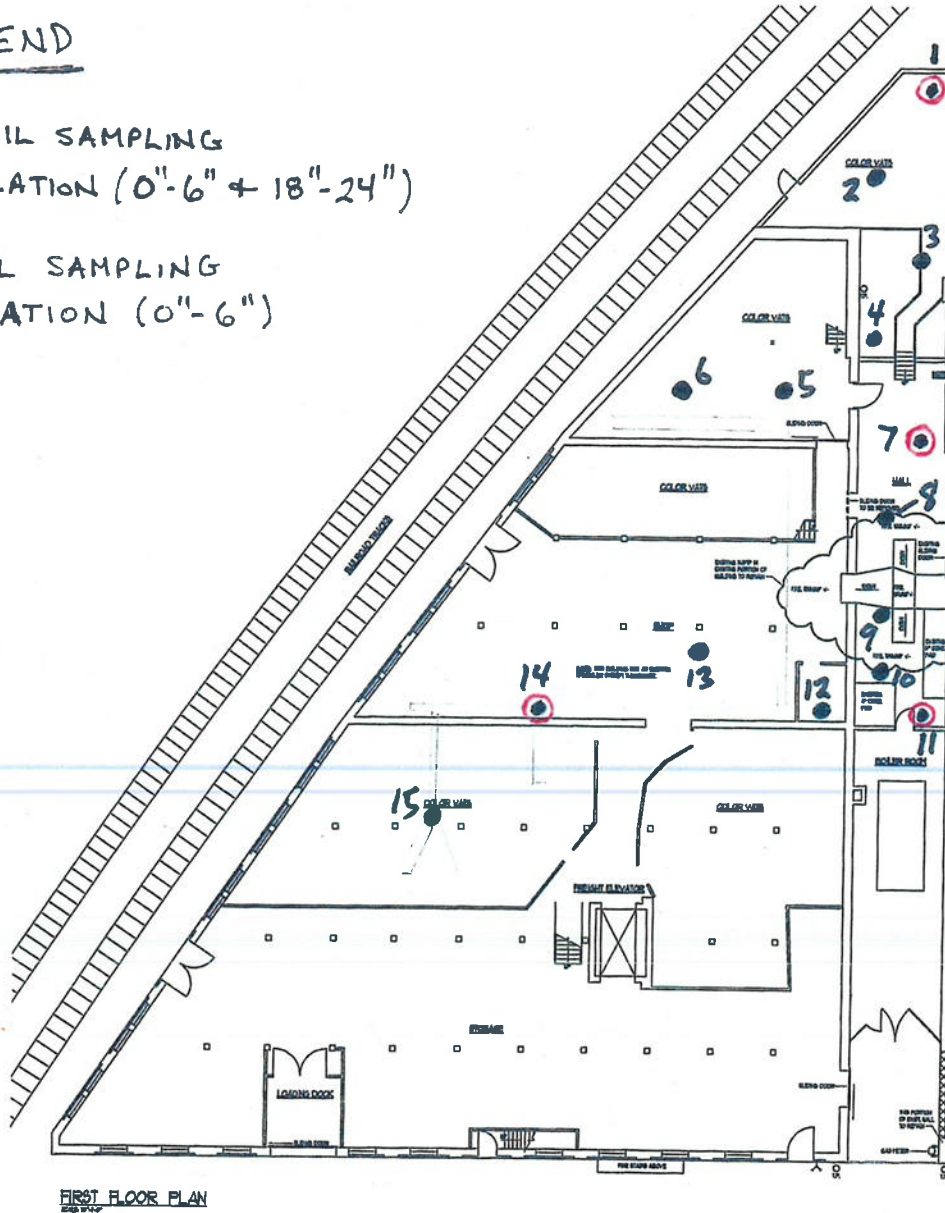
FIGURE 1

= SOIL SAMPLING LOCATION (0"-6" + 18"-24")

= SOIL SAMPLING LOCATION (0"-6")

KEYSTONE COLOR WORKS BUILDING  
SUBSLAB SAMPLING (5/18/2012)

Supplemental soil sampling activities per the request of EPA were conducted in May 2012 to evaluate the soil beneath the KCW Building concrete slab. The sampling involved the completion of cores through the concrete floor slab at 15 locations, and the collection of five subslab soil equal-part composite samples and two subslab grab samples that were analyzed for RCRA-8 metals and hexavalent chromium. Sampling of soils located below the concrete floor slab of the KCW Building on Tract #1 (as shown on **Figure 1** included under Appendix L of the March 2014 Act 2 RIR/FR which is attached to this SB as **Attachment B**) indicated concentrations of arsenic above the Act 2 residential direct contact MSC (12 mg/kg) in three of the composite samples (KCWA; KCWC; and KCWE) and one of the grab samples (KCW7). Concentrations of lead were detected above the Act 2 residential direct contact MSC (500 mg/kg) in two of the composite samples (KCWB and KCWE) and above the non-residential direct contact MSCs (1,000 mg/kg) in one composite sample (KCWA) and one grab sample (KCW7). The results of the May 2012 subslab soil sampling are summarized in **Table 1** under Appendix L of the March 2014 Act 2 RIR/FR, which is included with this SB as **Attachment C**.

Equal-part composite soil samples were derived from the grab sample locations as follows: KCWA from 1, 2, 3 & 4; KCWB from 5, 6, 7 & 8; KCWC from 9, 10, 11 & 12; KCWD from 13, 14 & 15; and KCWE from 1, 7, 11 & 14. See Figure 1 for sample locations.

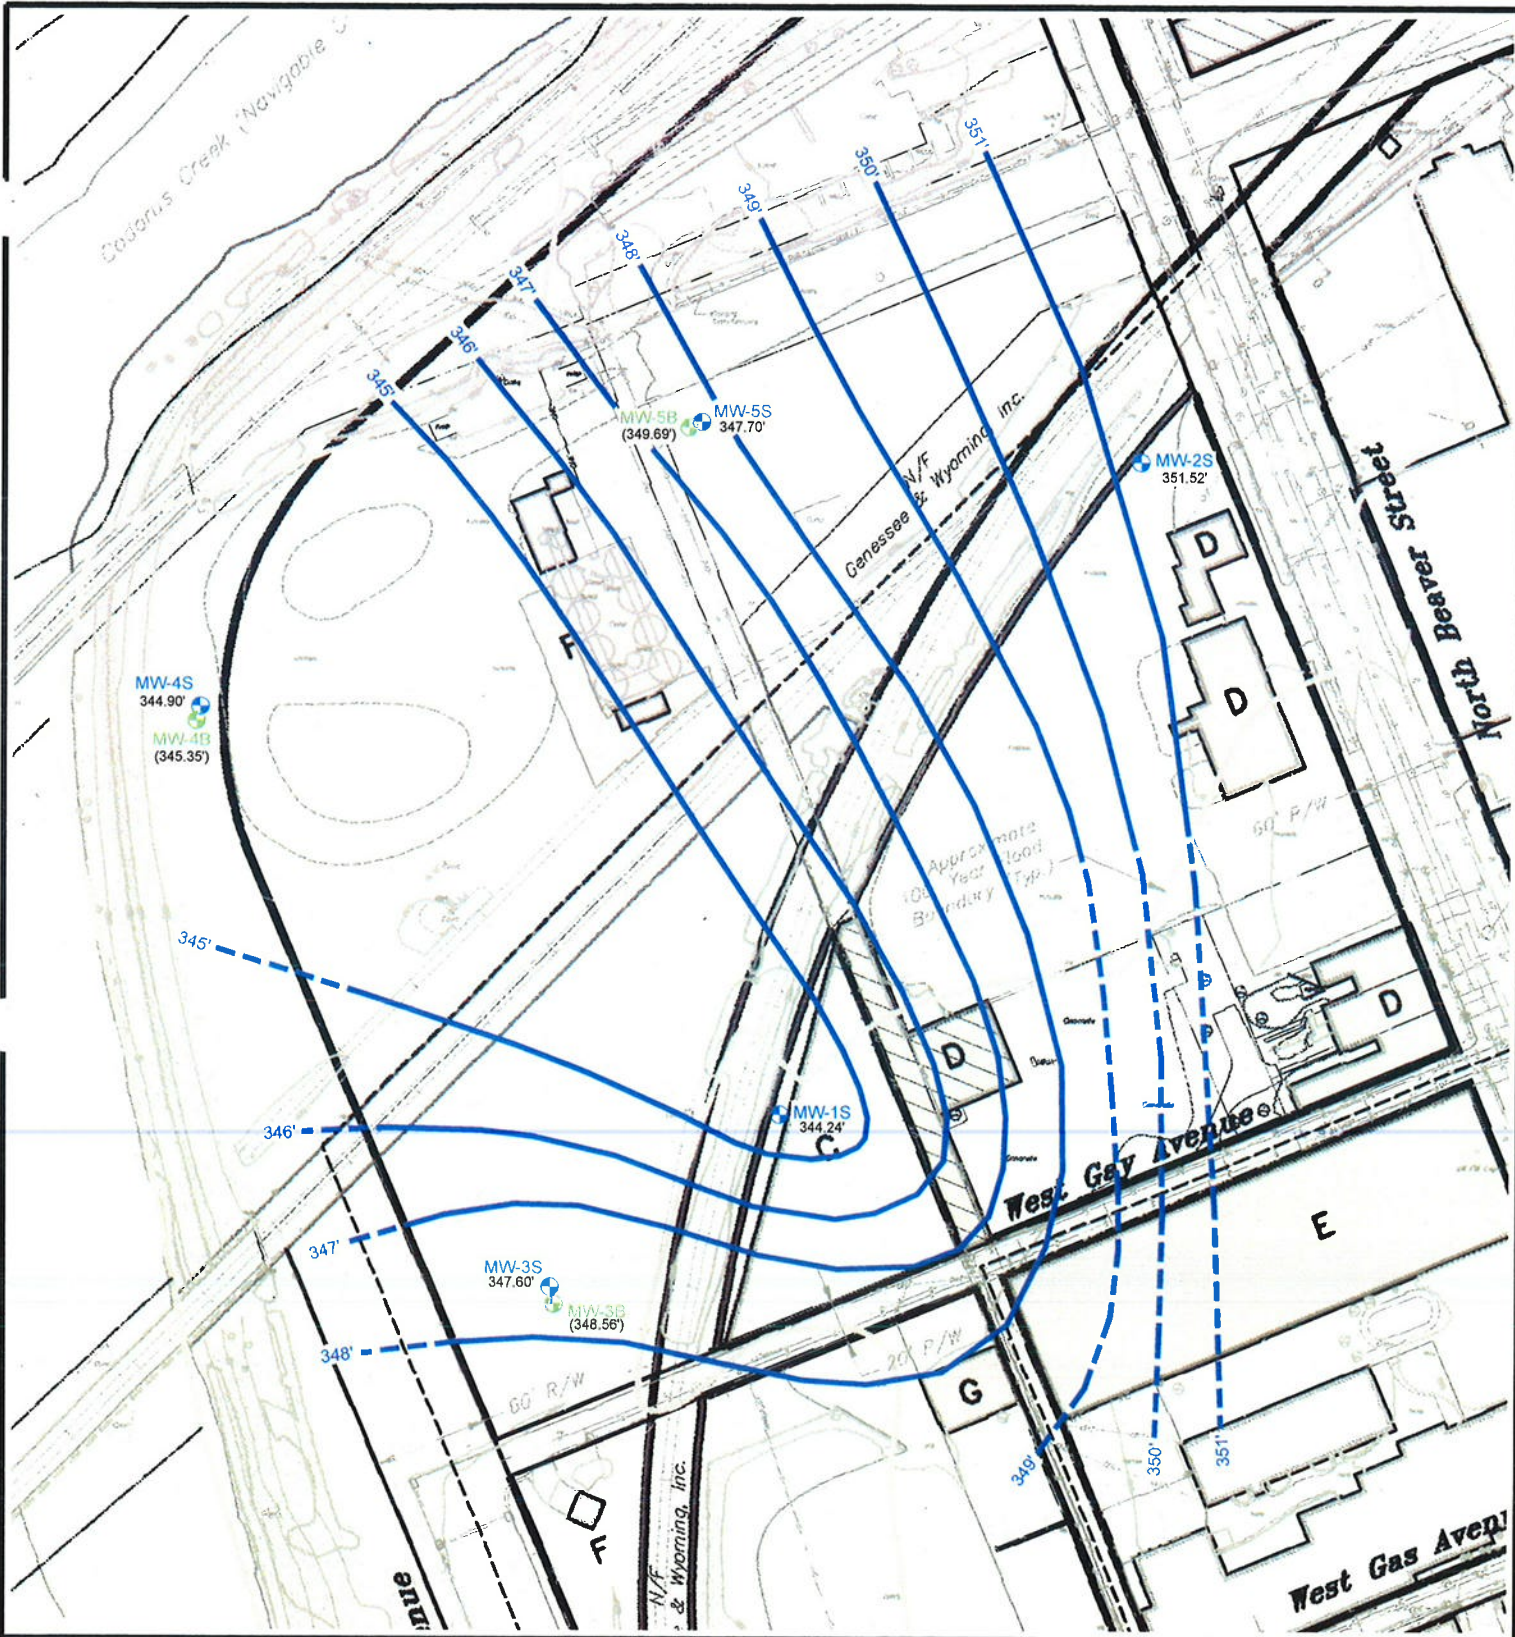
Figure  
**10**

- MW-3S - Shallow Monitoring Well
- MW-3B - Bedrock Monitoring Well
- 347.60' - Relative Groundwater Elevation
- (348.56) - Bedrock Groundwater Elevation Not Used For Mapping
- Groundwater Elevation Contour

**Groundwater Elevations  
June 29, 2009**

Between January 2008 and June 2009, the RDA installed a total of eight monitoring wells (shallow and deep) across the NWT properties to characterize groundwater flow directions and groundwater quality across the area. Groundwater contour maps were developed from the depth-to-groundwater data to estimate groundwater flow directions and gradients. Based on the groundwater contours, the groundwater flow direction in the area is generally toward the northwest corner of the Ohio Blenders property, towards monitoring wells MW-4S and MW-4B. The monitoring well locations and groundwater contours are shown on **Figures 10 through 12** of the March 2014 Act 2 RIR/FR and are included with this SB as **Attachment D**.

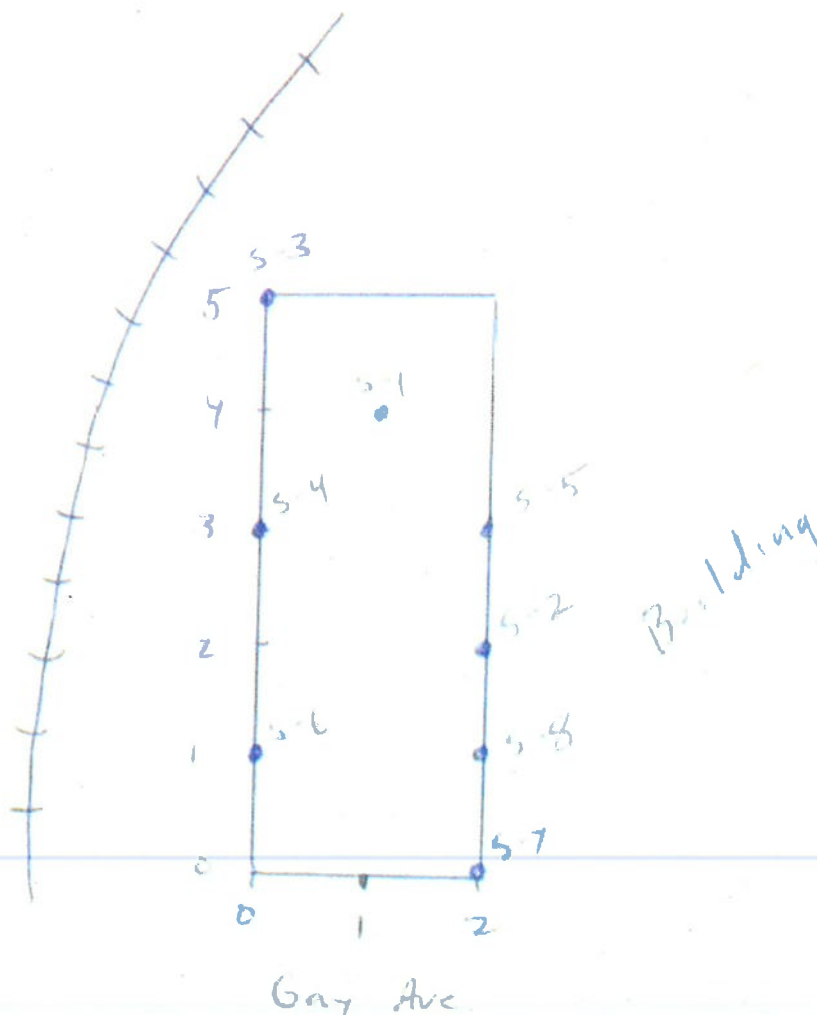
**Random Sample Location Map**

Following soil excavation, additional soil sampling for lead was conducted to confirm the effectiveness of the soil removal. Sample locations are generally shown on **Figure 2** of Appendix H, and the results are summarized on **Table 8** of the March 2014 Act 2 Remedial Investigation Report and Final Report and have been included with this SB as **Attachment F**.
