**Re: Letter of Transmittal: UECA Covenant Submittal  
Univar USA, Inc.  
EPA ID#: VAD003111416**

#### 5 UECA ENVIRONMENTAL COVENANT

**EXHIBIT 1**

**EXHIBIT 2**

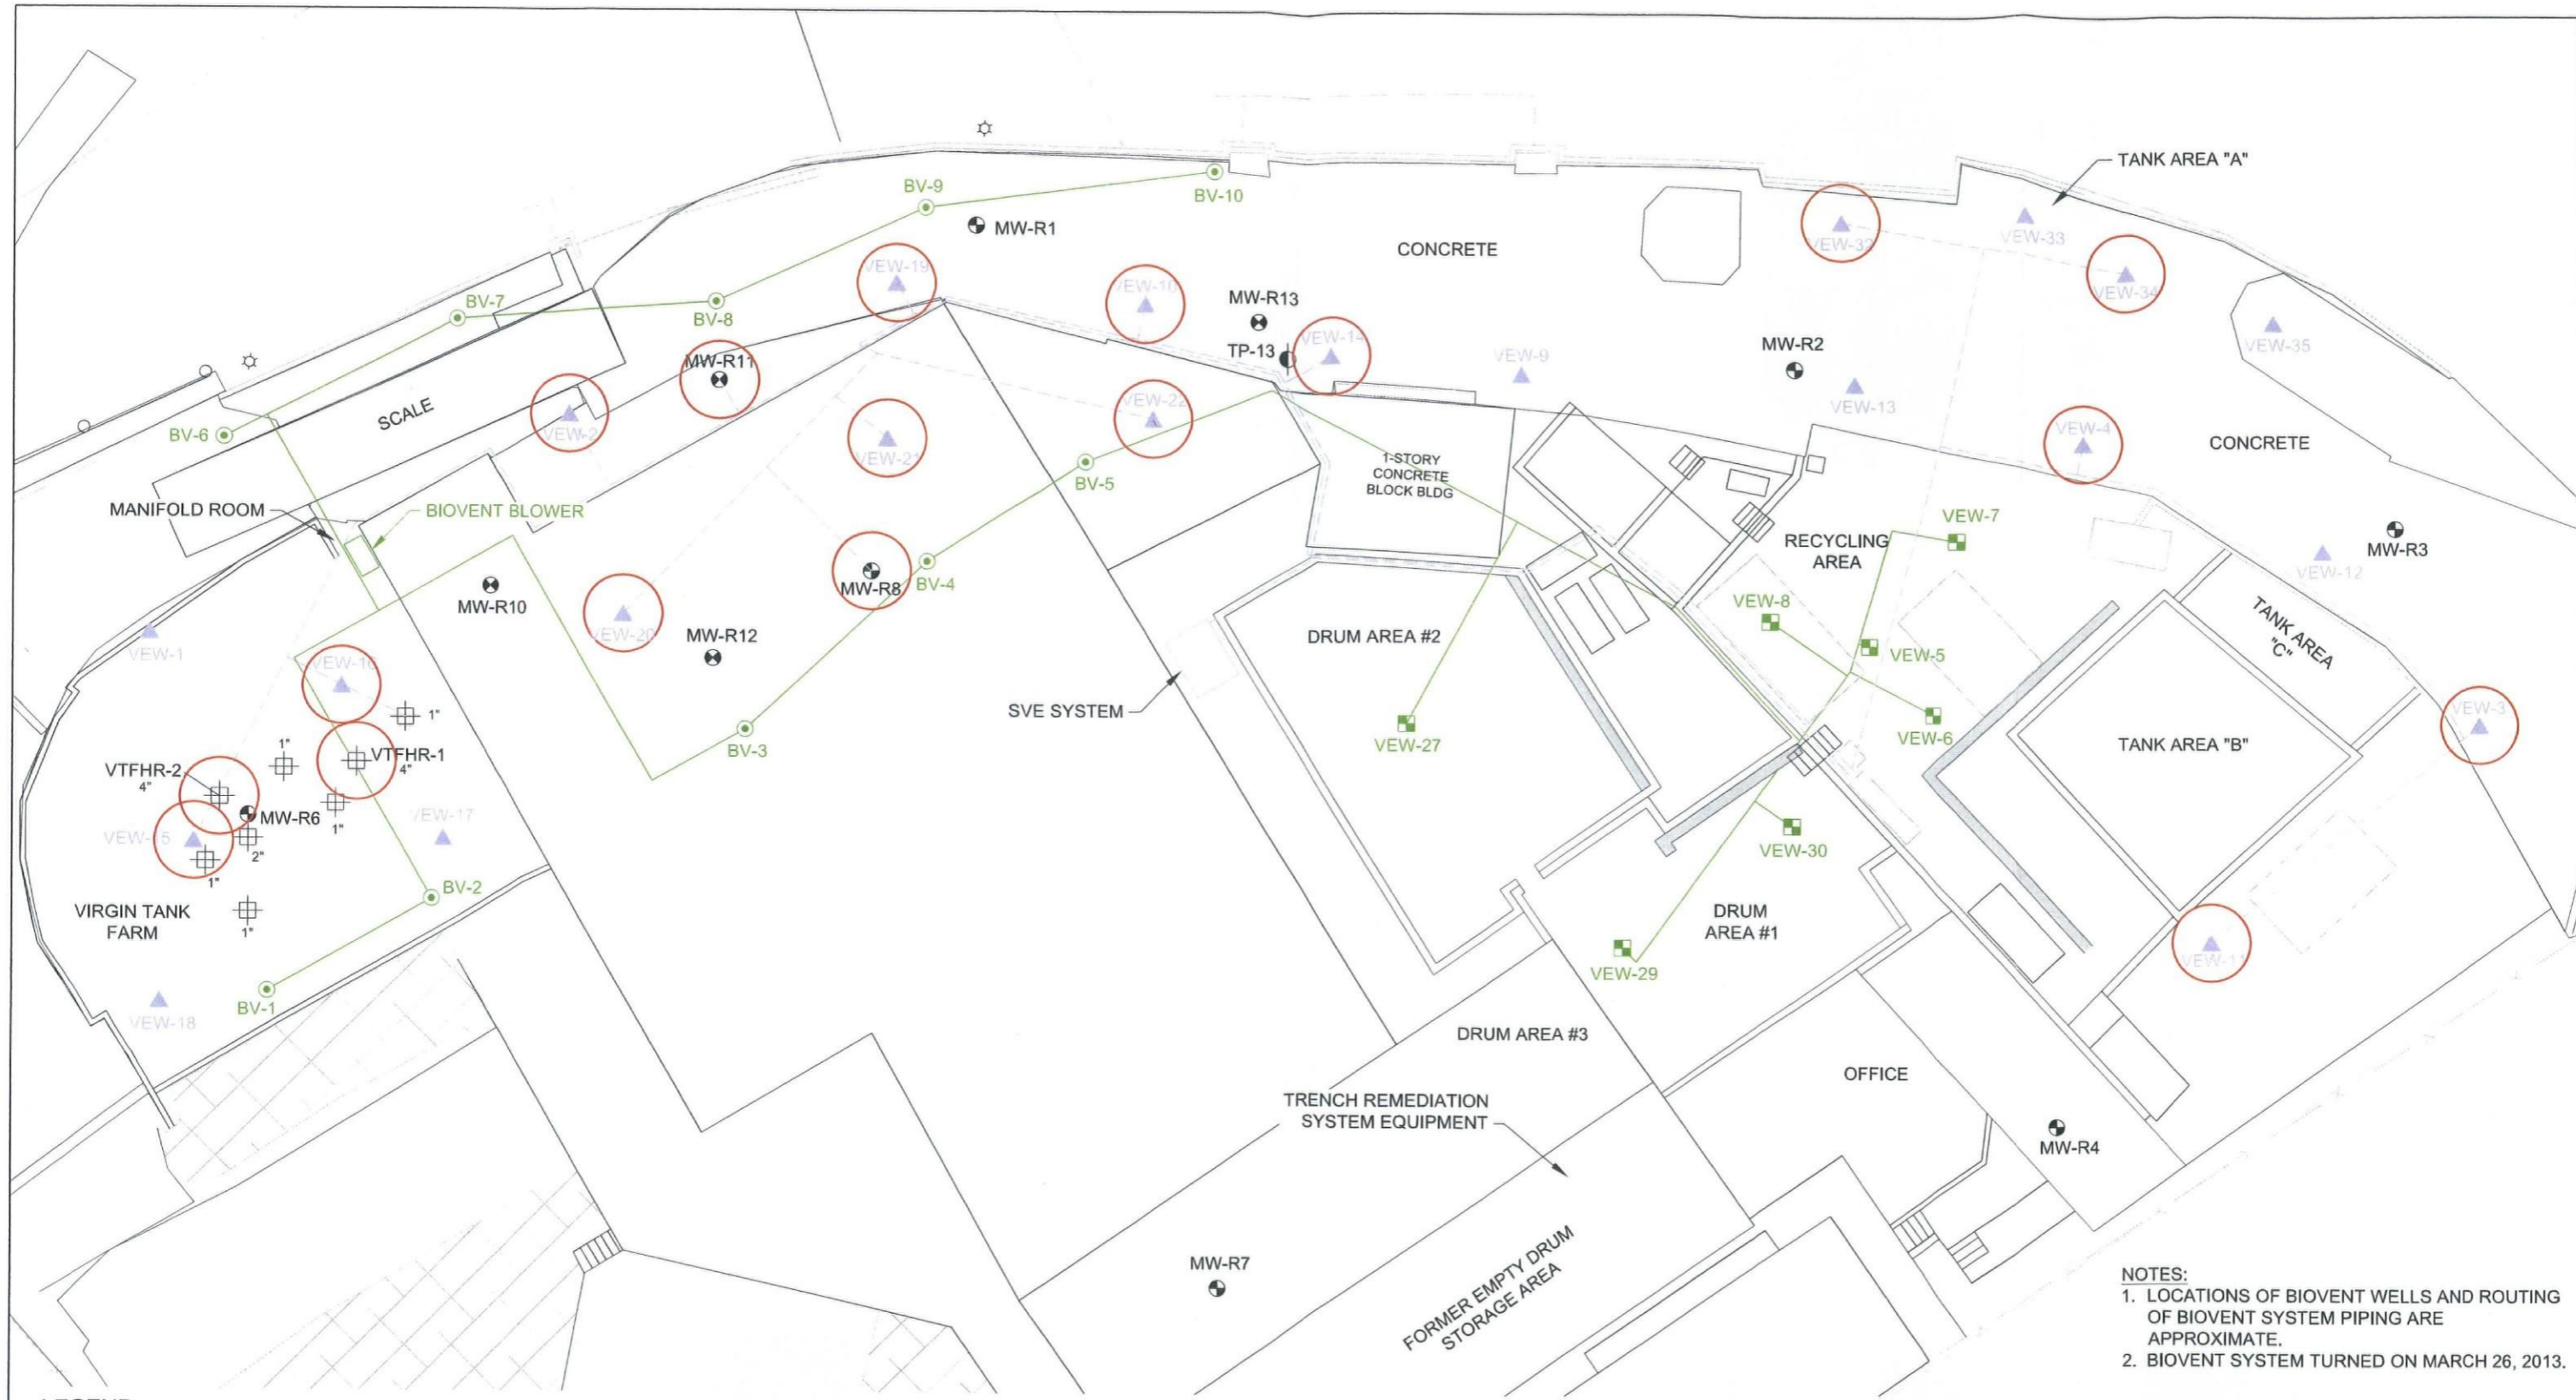
DRAWN	J.TANAKA	CHECKED	J.TANAKA	APPROVED	R.SENN	DATE	5-20-13
FILENAME	P:\DRAWINGS\W03397(MARTINSVILLE)\STATEMENT OF BASIS\SVE BIOVENT LNAPL SYSTEM PLAN.DWG					FIGURE	3

**NOTES:**  
 1. LOCATIONS OF BIOVENT WELLS AND ROUTING OF BIOVENT SYSTEM PIPING ARE APPROXIMATE.  
 2. BIOVENT SYSTEM TURNED ON MARCH 26, 2013.

**SOIL VAPOR EXTRACTION, BIOVENT, AND LNAPL RECOVERY SYSTEM PLAN**
