REDUCE VOC EXPOSURE Off-Loading Rack at Bulk Plant

Saudi Aramco

April 28, 2015

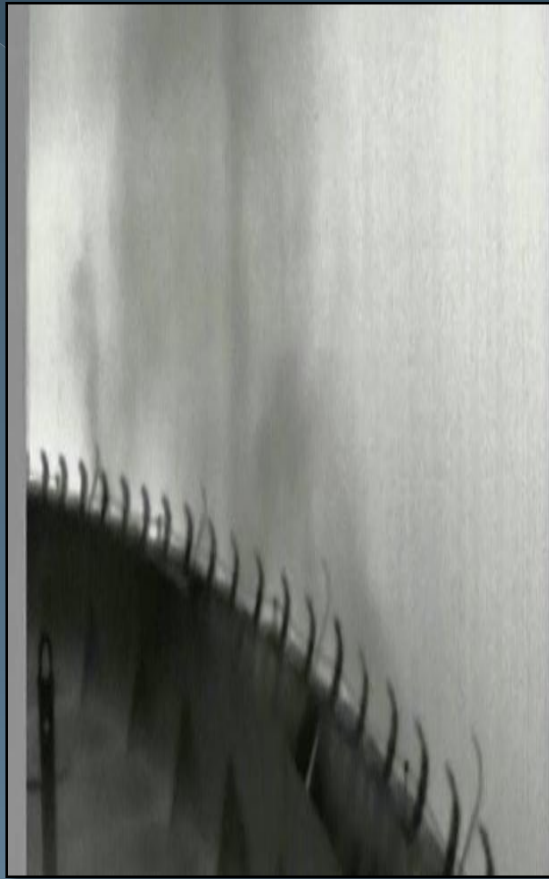
IR Image / Floating Roof Tank

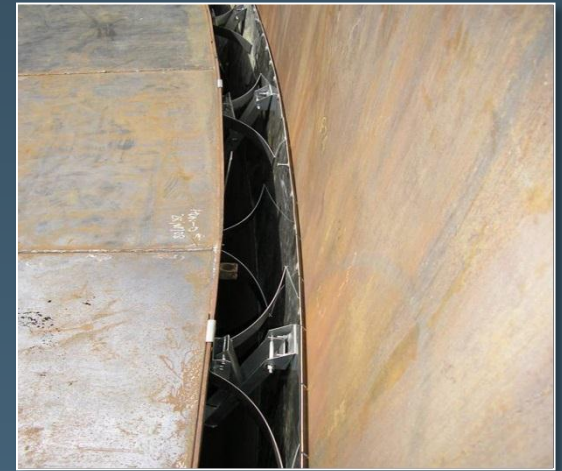
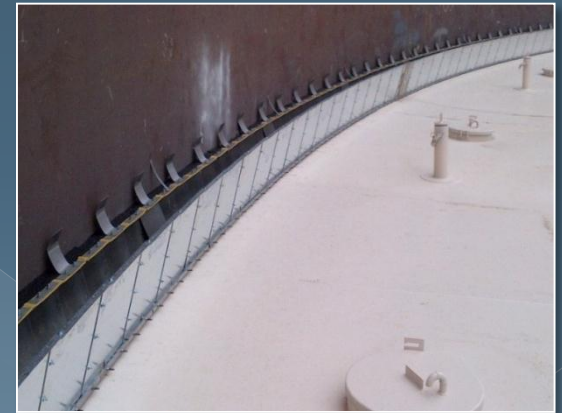
Primary & Secondary Seal

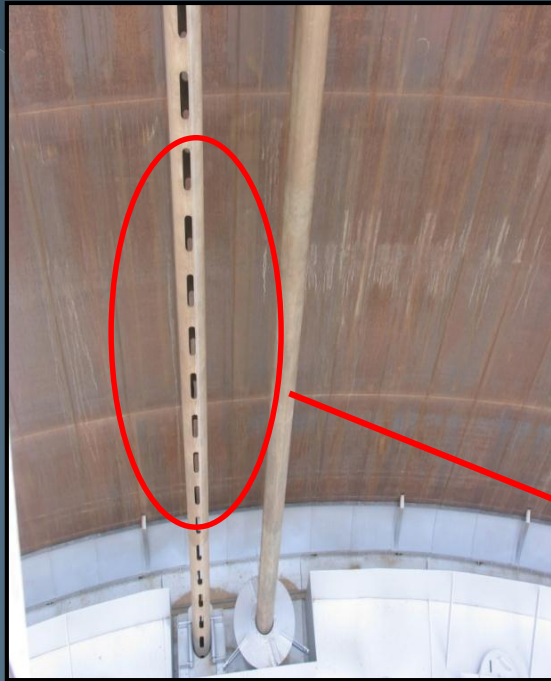
Guide Pole Slots

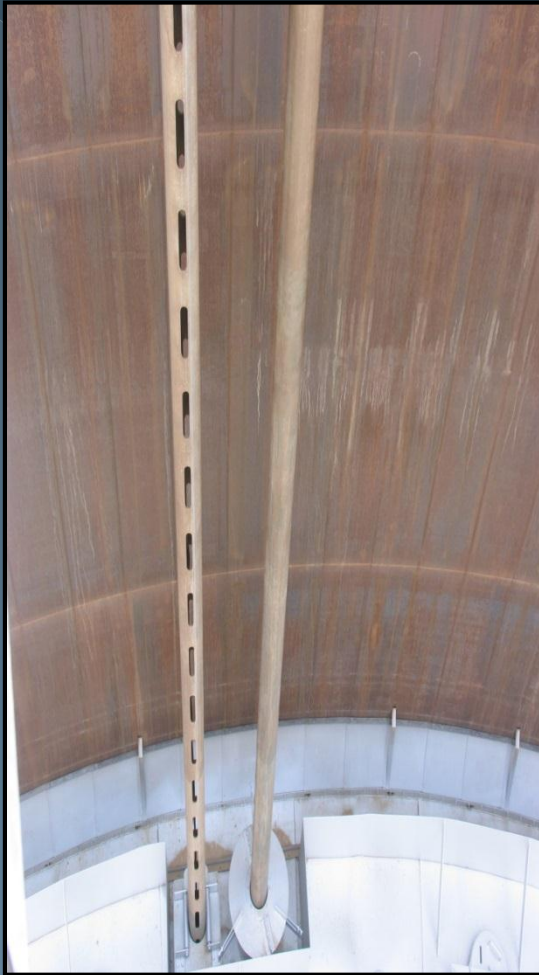
Slotted Guide Pole

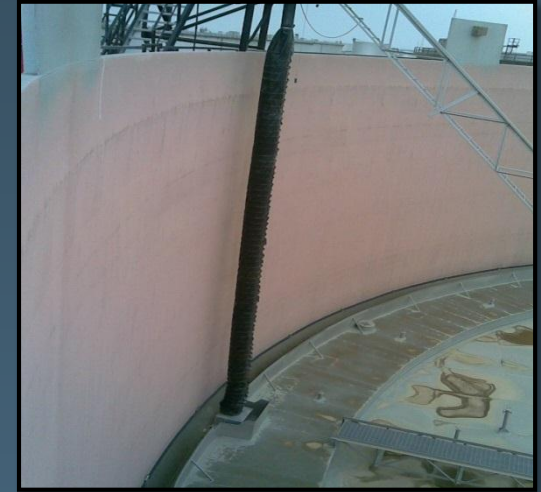
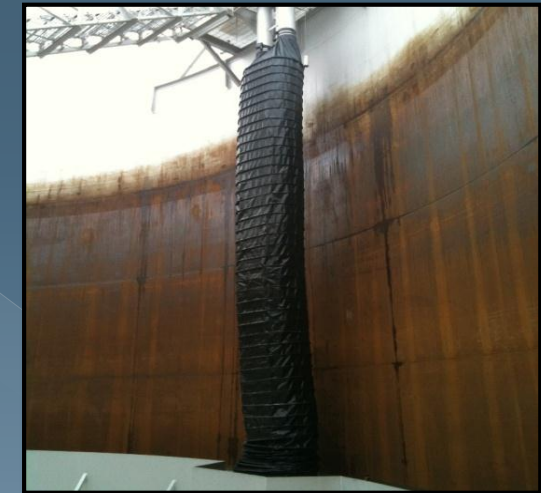
Guide Pole Fittings

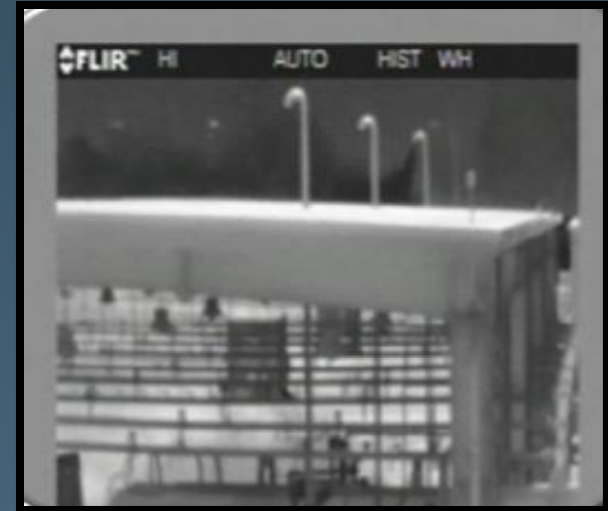
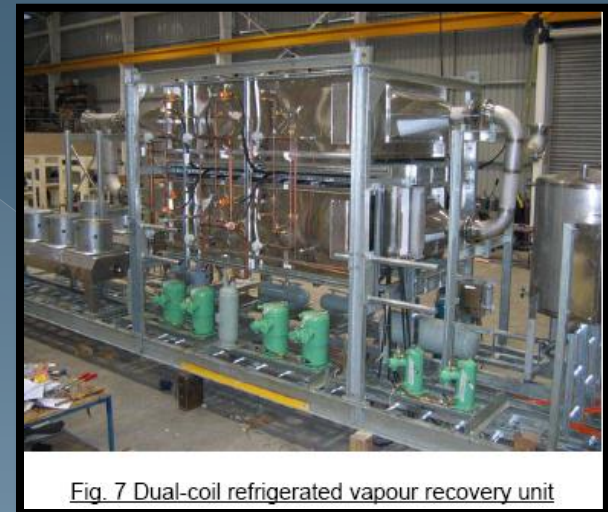
Fig. 7 Dual-coil refrigerated vapour recovery unit

- The vents release the VOC's from the truck to the atmosphere
- Utilize Vapor Recovery System
- Recovers about 96% of the VOC emissions

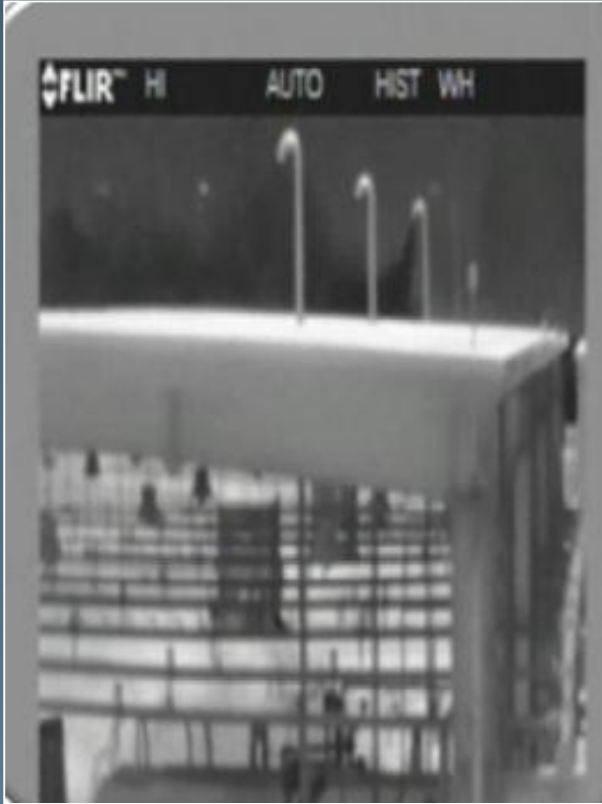
IR Image / Loading Operation Vents

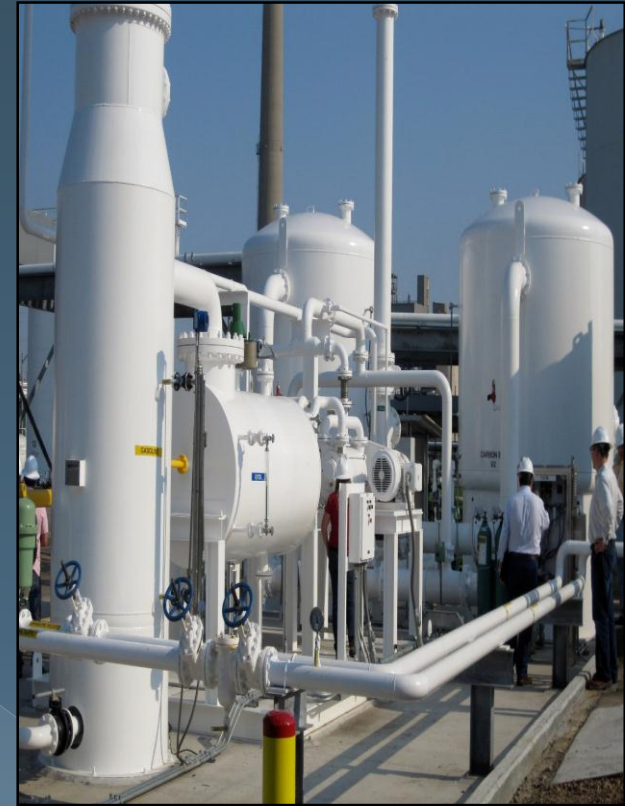
Vapor Recovery Unit

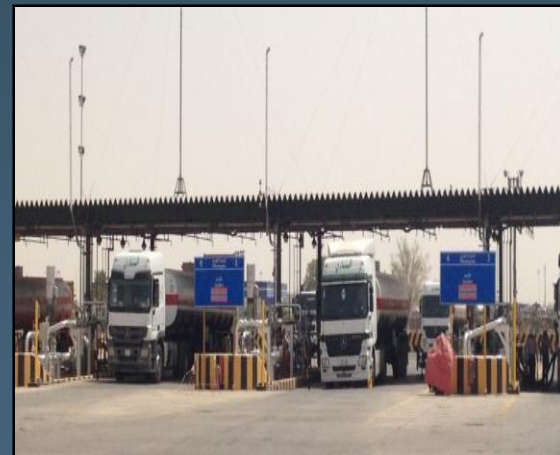
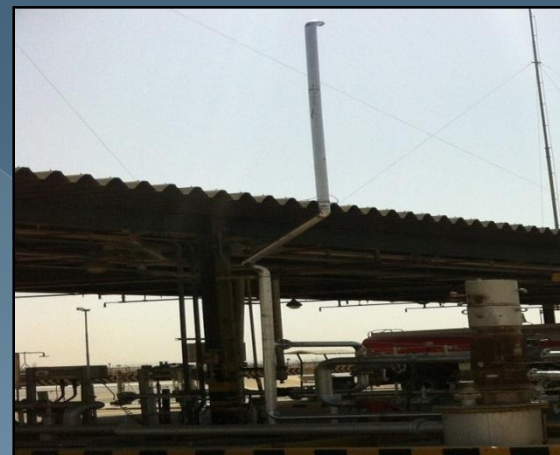
- Truck unload the product by gravity to unloading sumps
- 120 Gasoline & 35 MTBE trucks / Day
- 5 Off-loading bays, each bay has 2 bottom offloading couplers
- Vent lines release the air from the sump directly to the atmosphere

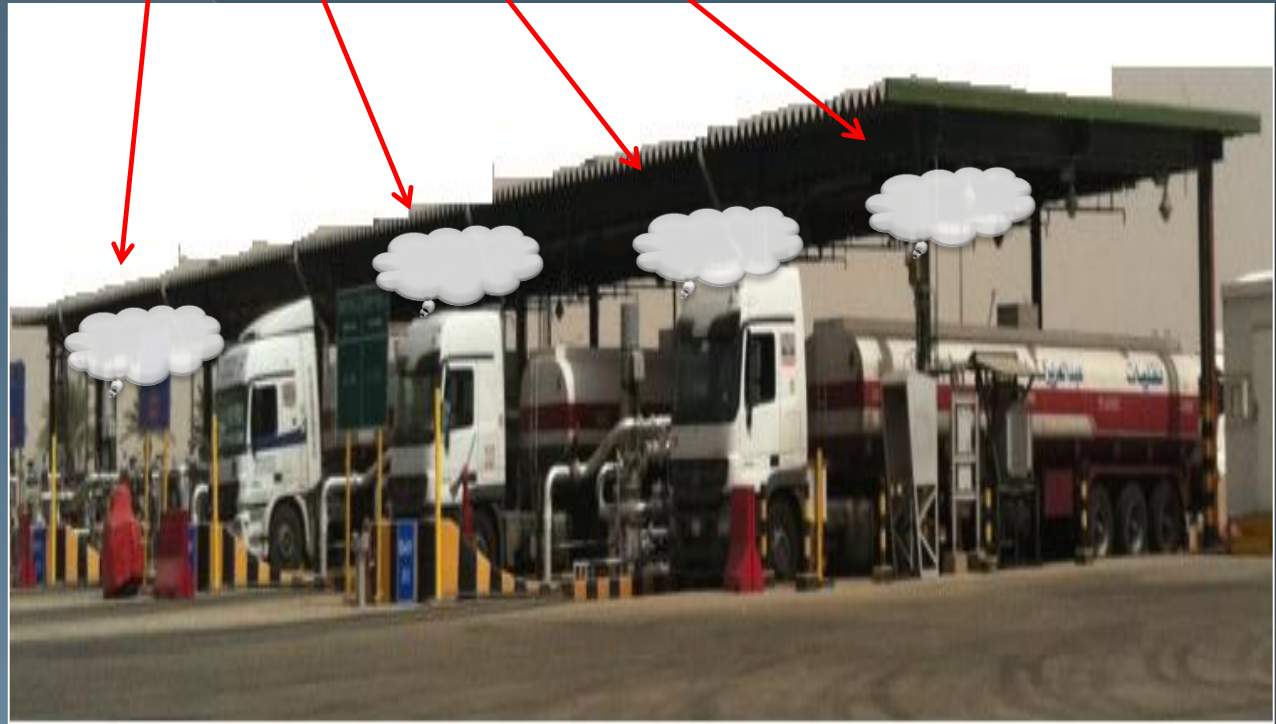
Field operators were exposed to high concentration of VOC emissions

1. Open sample jar holes caused VOC emission

✓ Improved sample jar operation to work similar as tight sampler

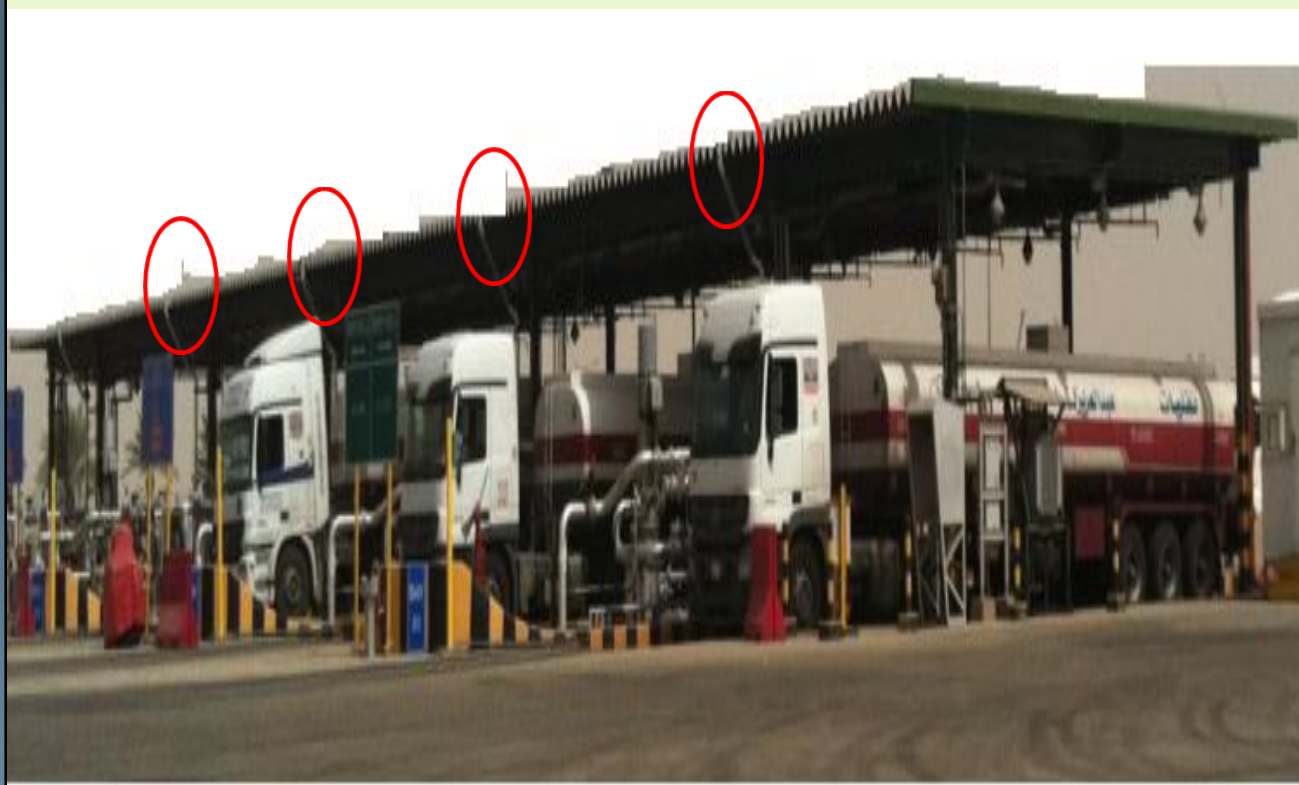
2. Short vapor lines caused low VOC dispersion

- ✓ Extended the vents height by four meters above the unloading roof

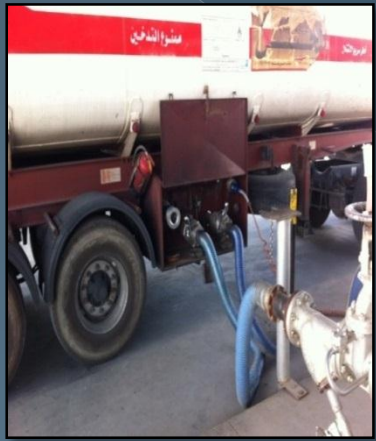
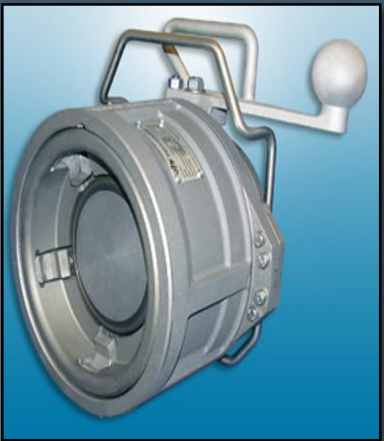
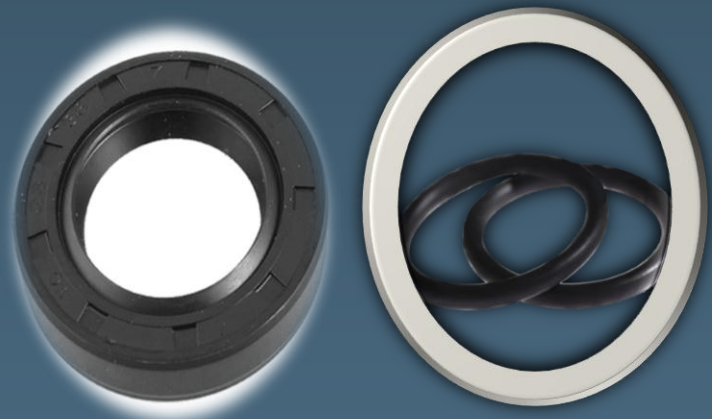
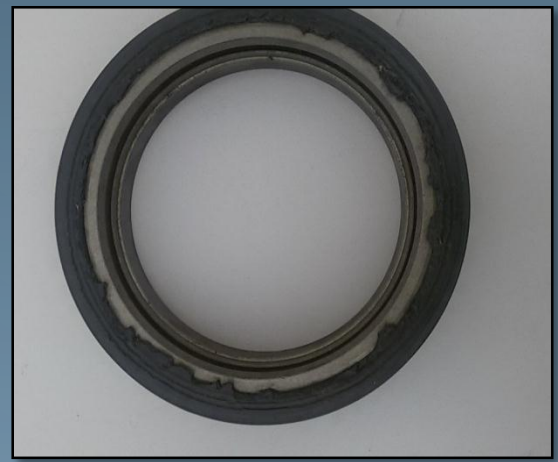
3. MTBE couplers frequent failures caused drips & leaks

Total 4 Couplers Failures / Month	Coupler Average Failures
24 Times	5 Days

- ✓ Improved the MTBE coupler sealing durability by replacing Teflon & Viton types with Fluorocarbon type

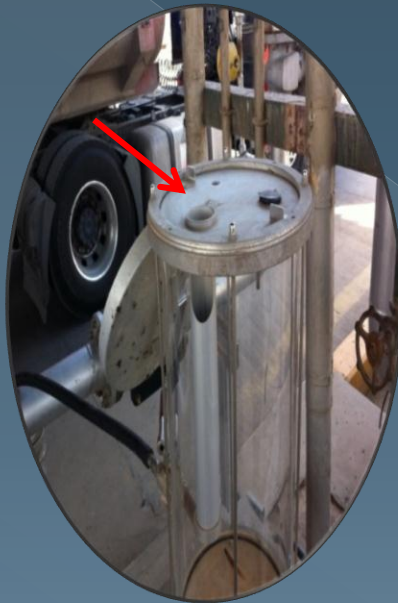
1. Sample Jar Holes

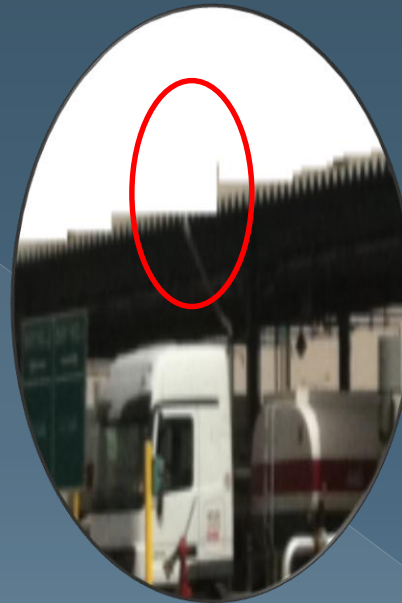
2. Rack Vent Heights

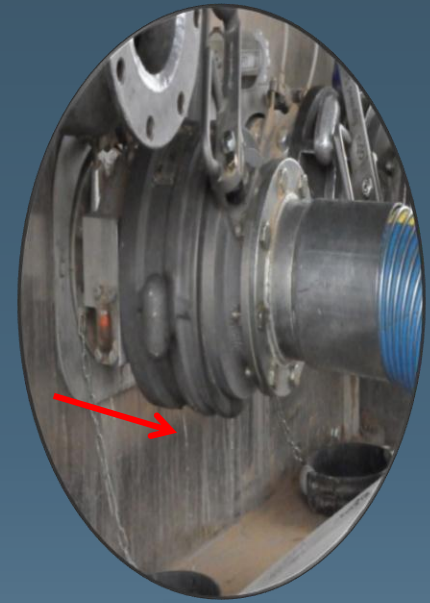
3. Coupler Sealing
