Re: Trip Report for Jantzen Beach Air Testing
Technical Direction Document 15-09-0003

TRIP REPORT

**Jantzen Beach Air Testing
Portland, Oregon
TDD: 15-09-0003**

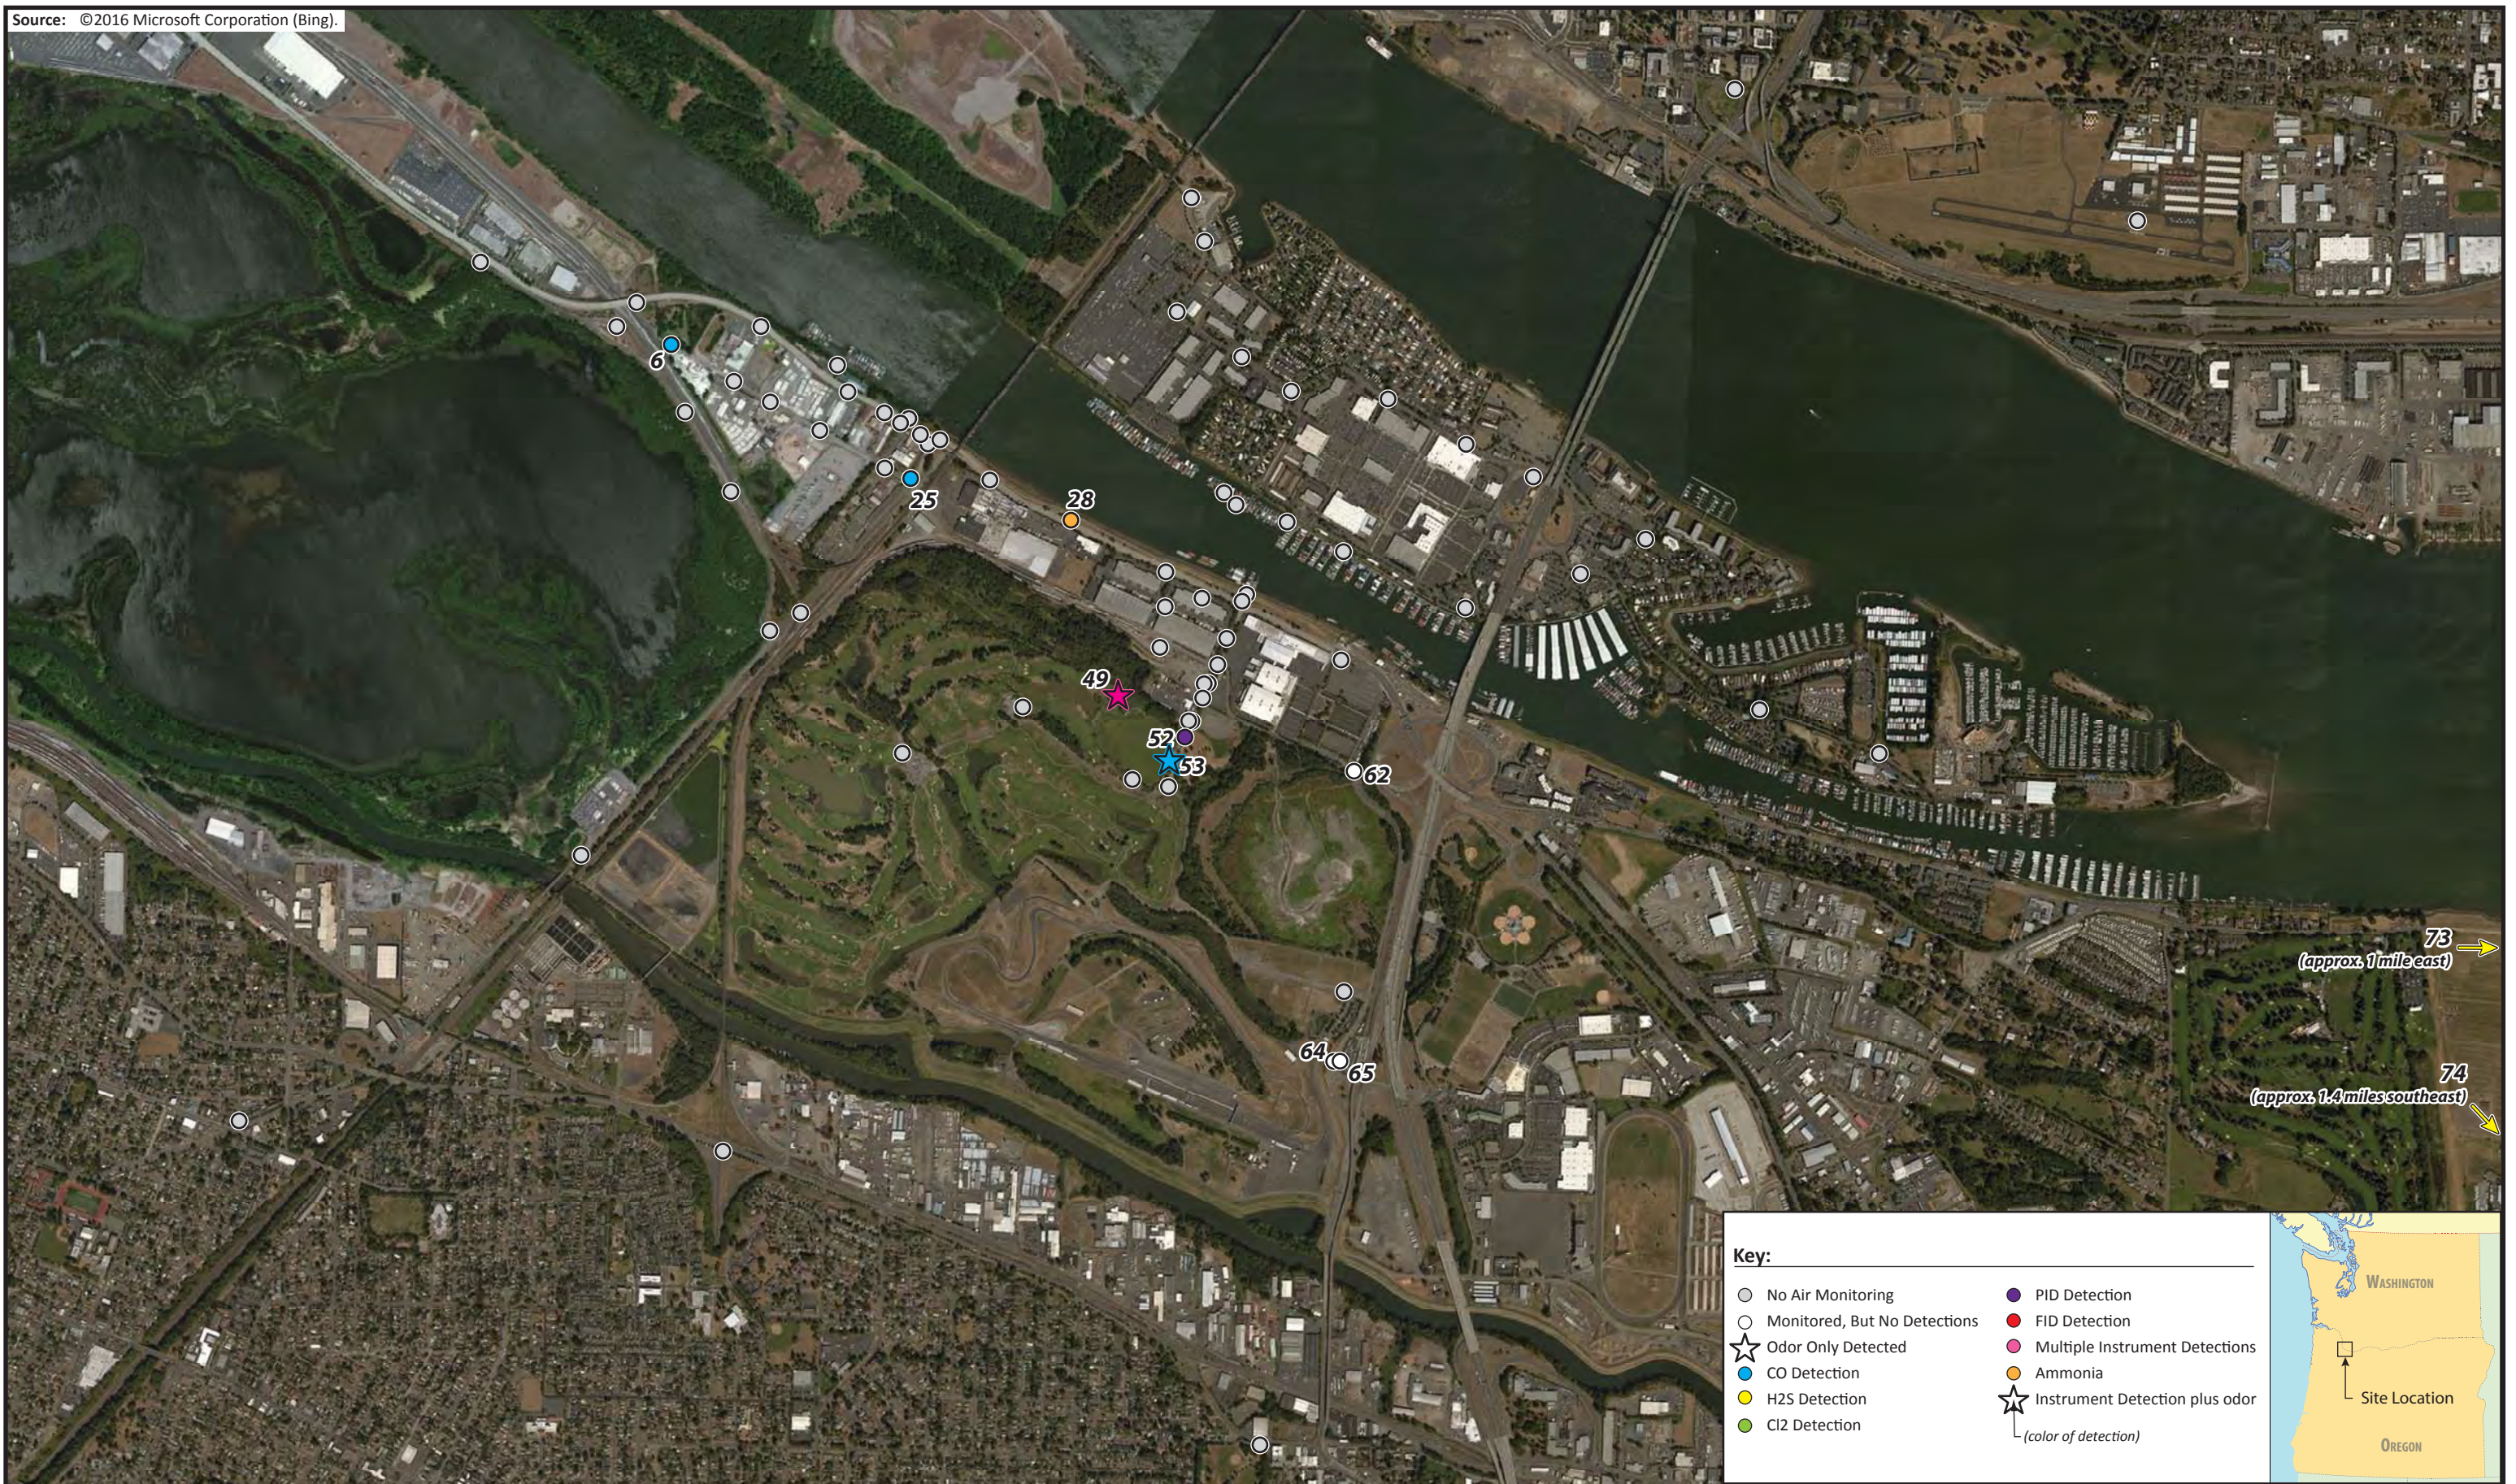
Figure 4
AIR MONITORING EVENT
INITIAL RECON – SEPTEMBER 11, 2015

- No Air Monitoring
- Monitored, But No Detections
- ☆ Odor Only Detected
- CO Detection
- H2S Detection
- Cl2 Detection
- PID Detection
- FID Detection
- Multiple Instrument Detections
- Ammonia
- ☆ Instrument Detection plus odor
(color of detection)

On September 11, 2015, one START responder mobilized to the Site to conduct initial air testing (Figure 4). START was directed to monitor with gas/vapor detection instruments in the vicinity of APES on Force Ave in North Portland for fugitive emissions that were suspected to be a cause of odor complaints in communities located to the north (predominantly on Hayden Island). START monitored the air along Force Avenue, at the HLGC, around the Metro Expo Center, and around the Vanport Max Light Rail Station. Ammonia (NH₃), CO, and combustible gas/vapor (lower explosive limit, or LEL) were detected near the facility (Table 1, Figure 4). Inexplicable odors were noted, qualitatively consistent with caustic chemicals, glycols, and petroleum hydrocarbons.

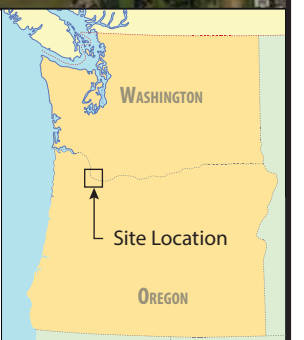
Figure 5
AIR MONITORING EVENT
NIGHT RECON – SEPTEMBER 15, 2015

- No Air Monitoring
- Monitored, But No Detections
- ★ Odor Only Detected
- CO Detection
- H2S Detection
- Cl2 Detection
- PID Detection
- FID Detection
- Multiple Instrument Detections
- Ammonia
- ★ Instrument Detection plus odor
(color of detection)

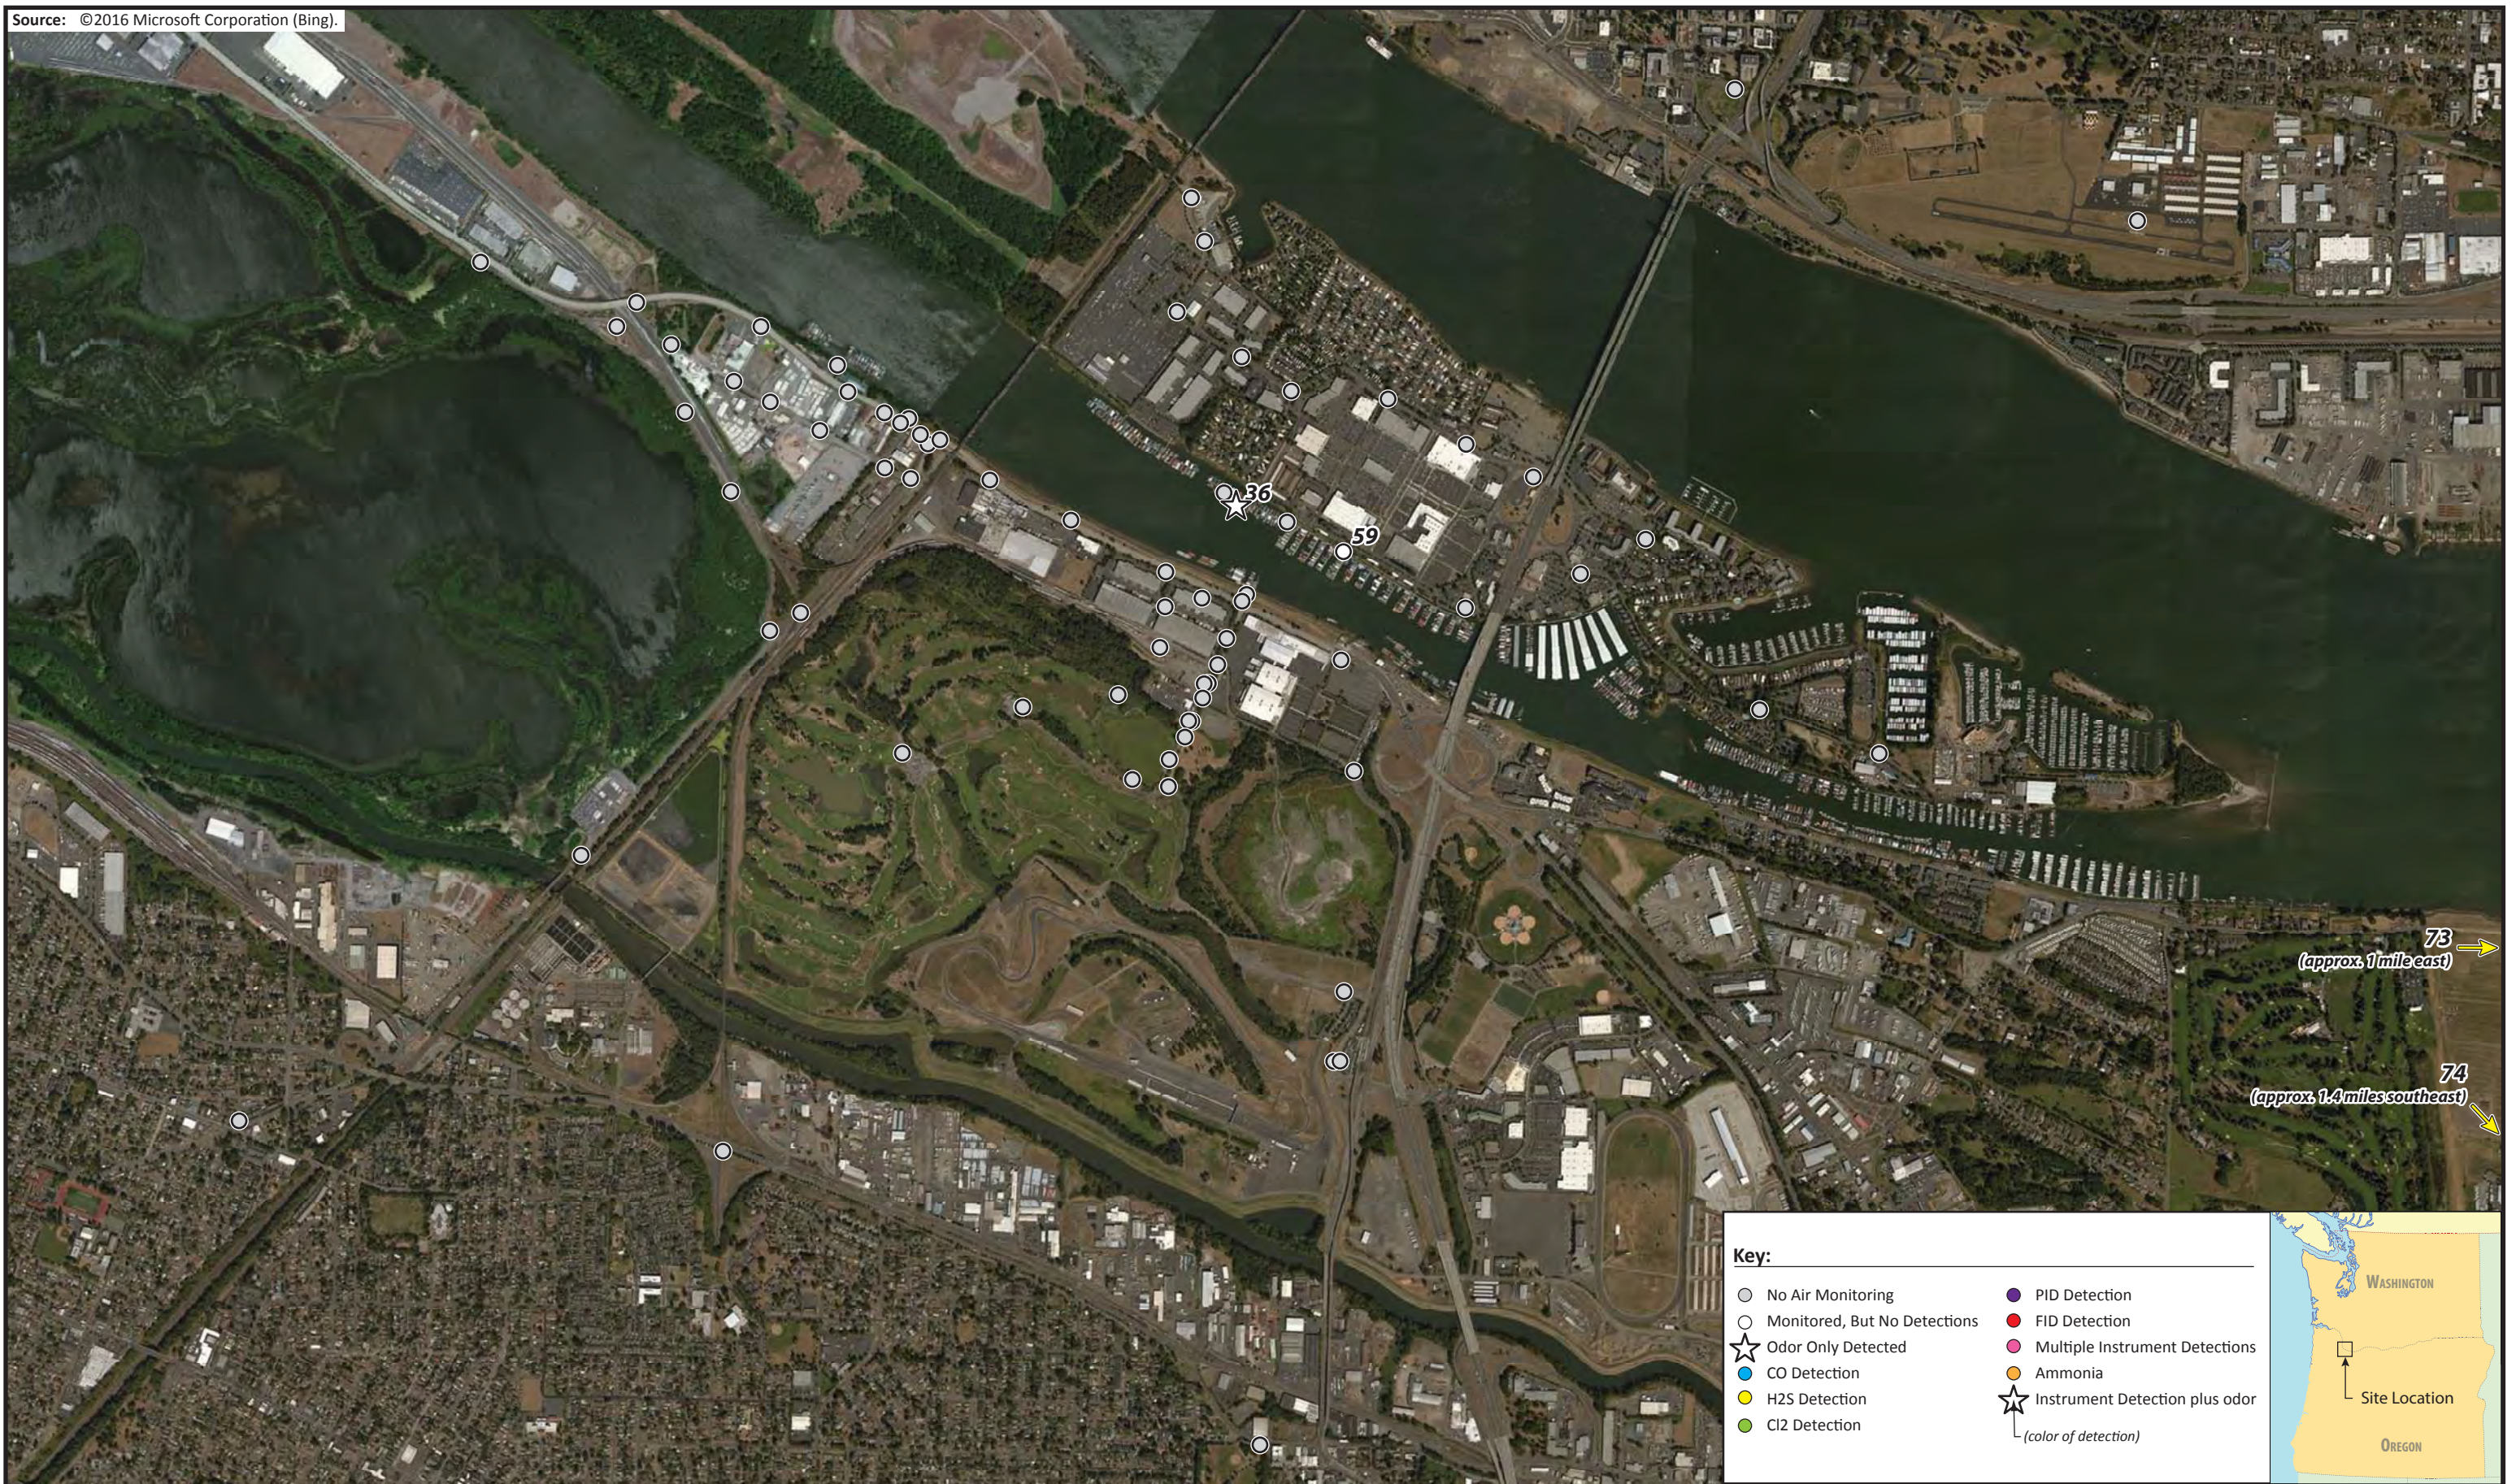
Figure 7
AIR MONITORING JBMI MAINTENANCE VISIT
NOVEMBER 17, 2015

On November 17, 2015, START observed Viper telemetry that indicated elevated PID-10.6 and CO detections from JB02 (Chart 3) at about 06:48 a.m. START contacted the HLGC superintendent, who stated that mower engines had been started at about that time. START notified EPA of the elevated detections and the apparent cause. Later in the day, START visited JB01 (at JBMI) to check on the system and made organoleptic odor observations while making the Site visit, and the odors were consistent with propane, natural gas, methyl mercaptan, and burnt-oil (Table 1, Figure 7).

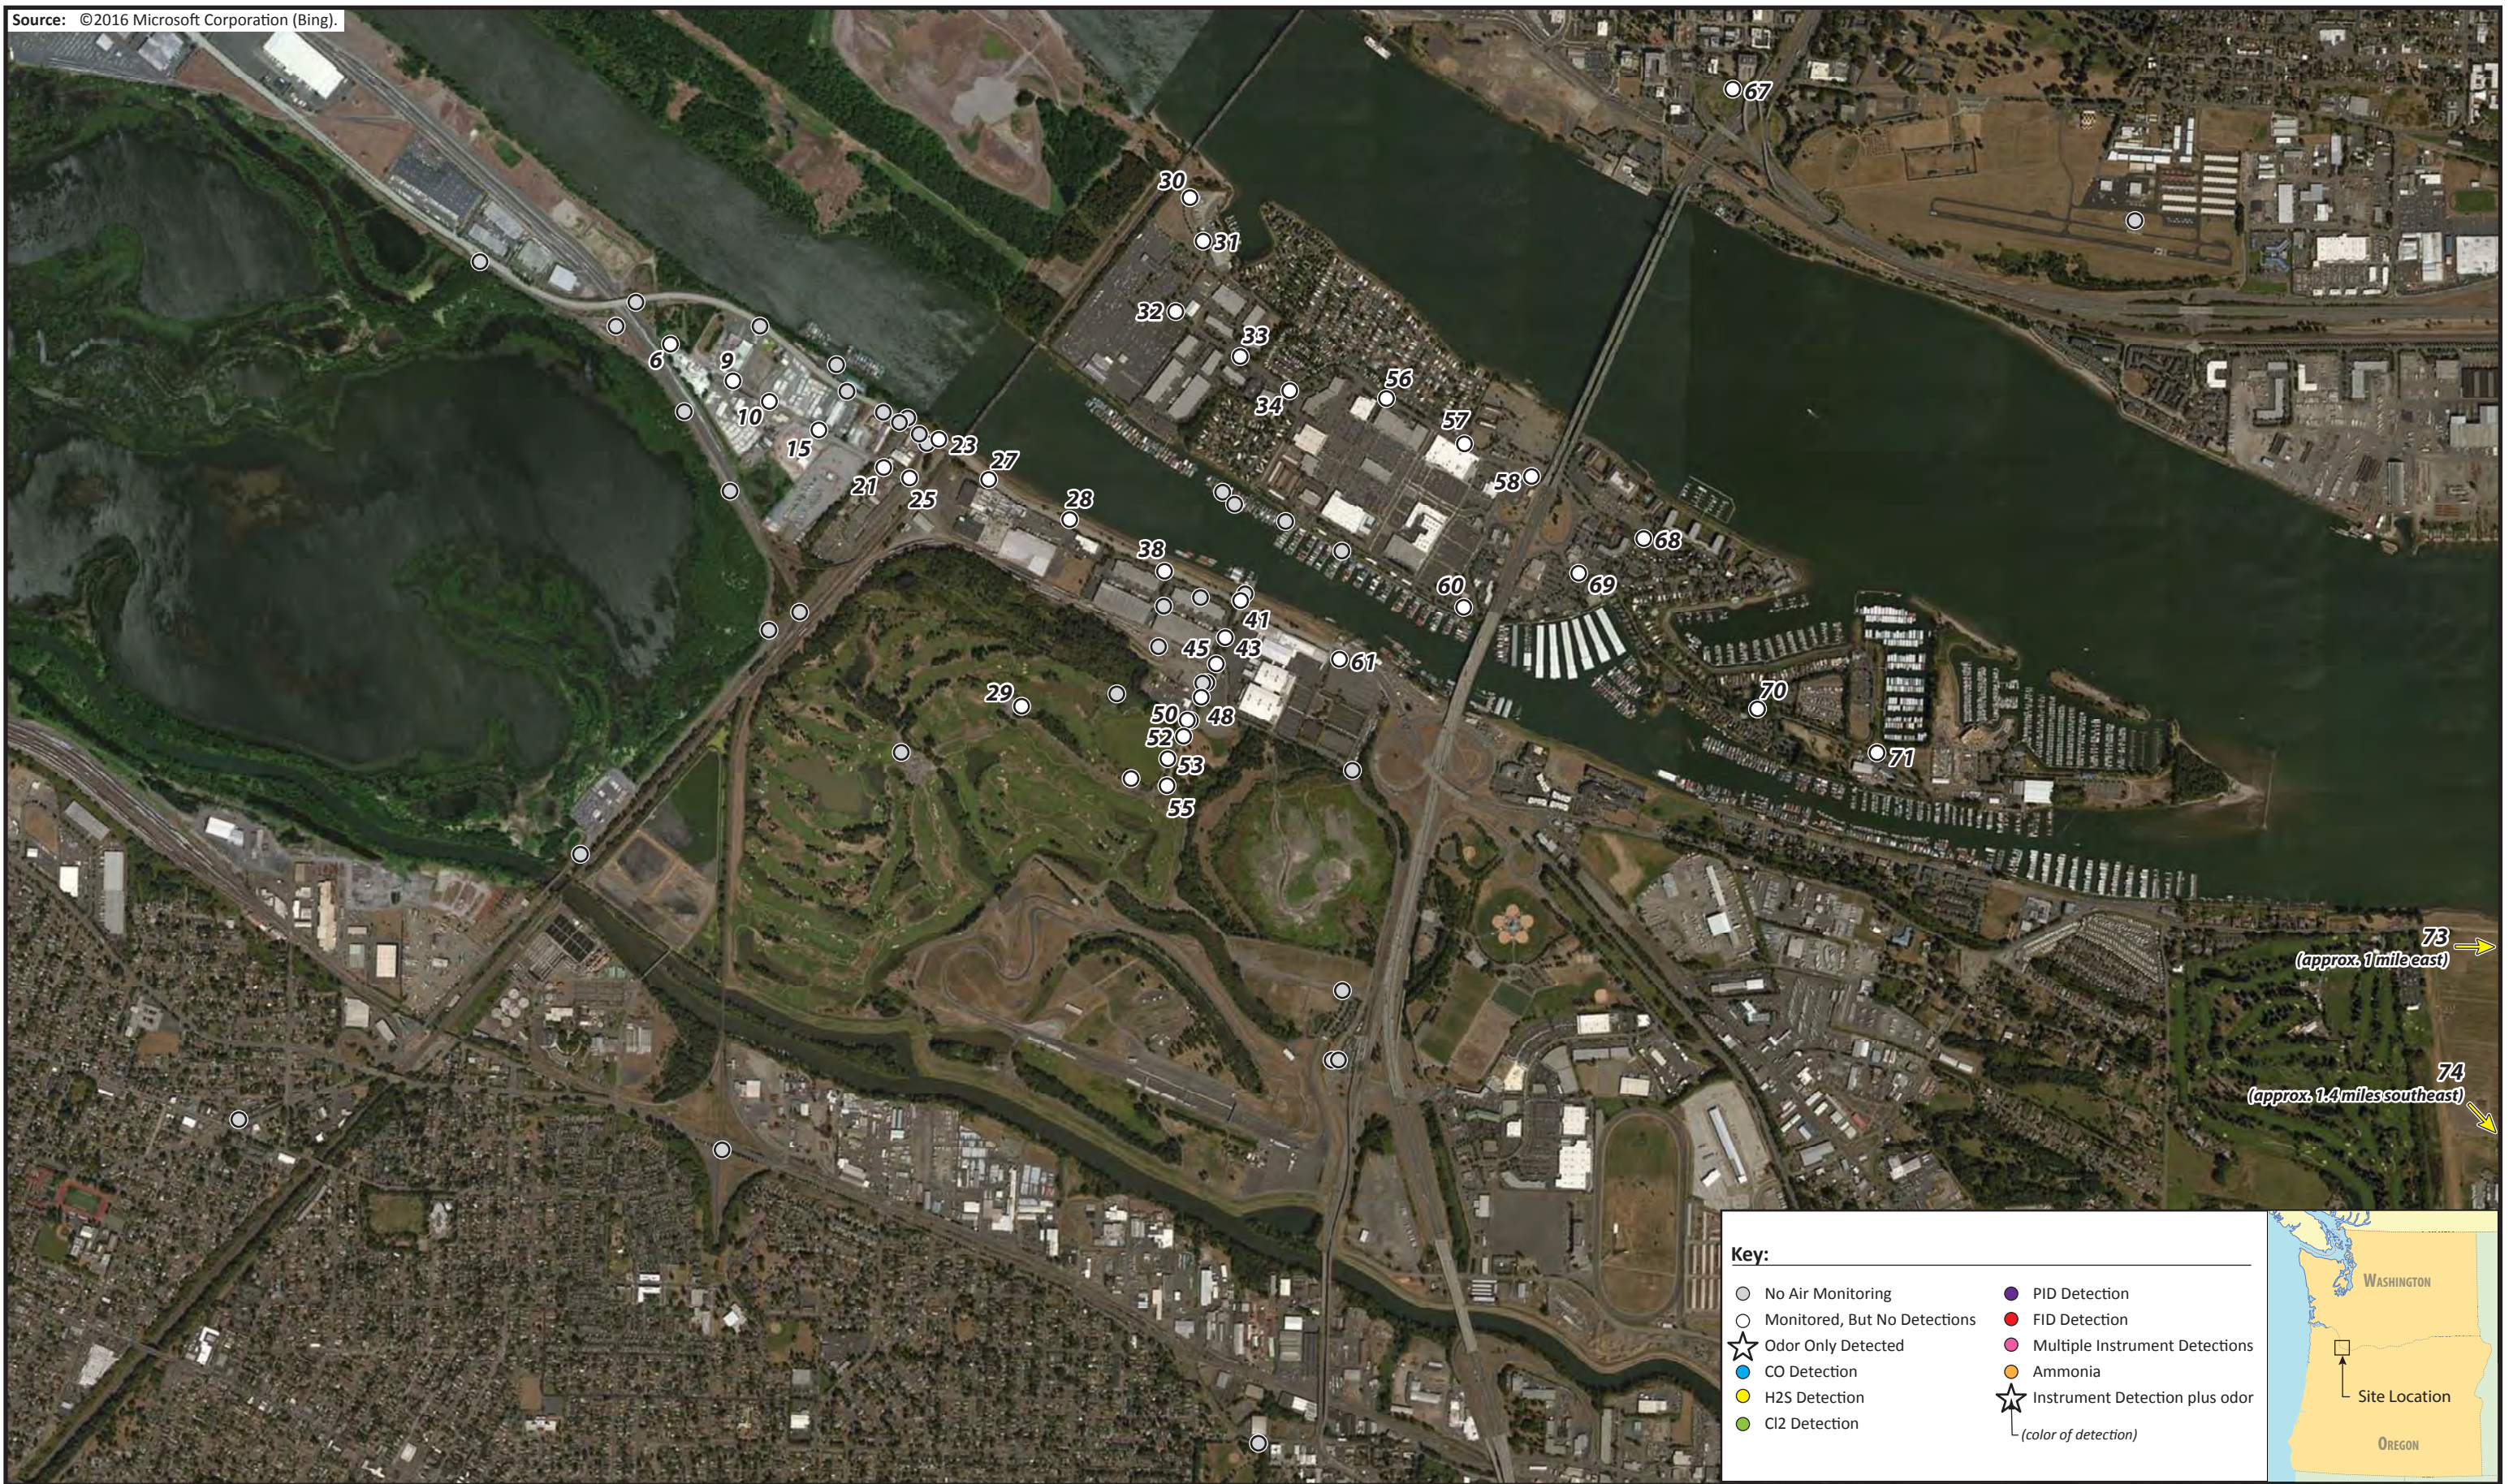
Figure 9
AIR MONITORING MOBILE EVENT
NOVEMBER 27, 2015

On November 27, 2015, START received an automated Viper email notification alarm from ERT at about 09:00 am indicating PID-10.6 detections at JB01 (JBMI) greater than 100 parts per billion (ppb; Chart 5). START contacted the residents; no apparent explanation for the detections was determined, and the residents did not detect any unusual odors. START visited the Site and conducted air testing on Hayden Island, Marine Drive, Suttle Road, and Force Avenue using a mobile UltraRAE 3000 PID-11.7 instrument, but observed no elevated detections and no odors (Table 1, Figure 9). START notified EPA of the testing results.

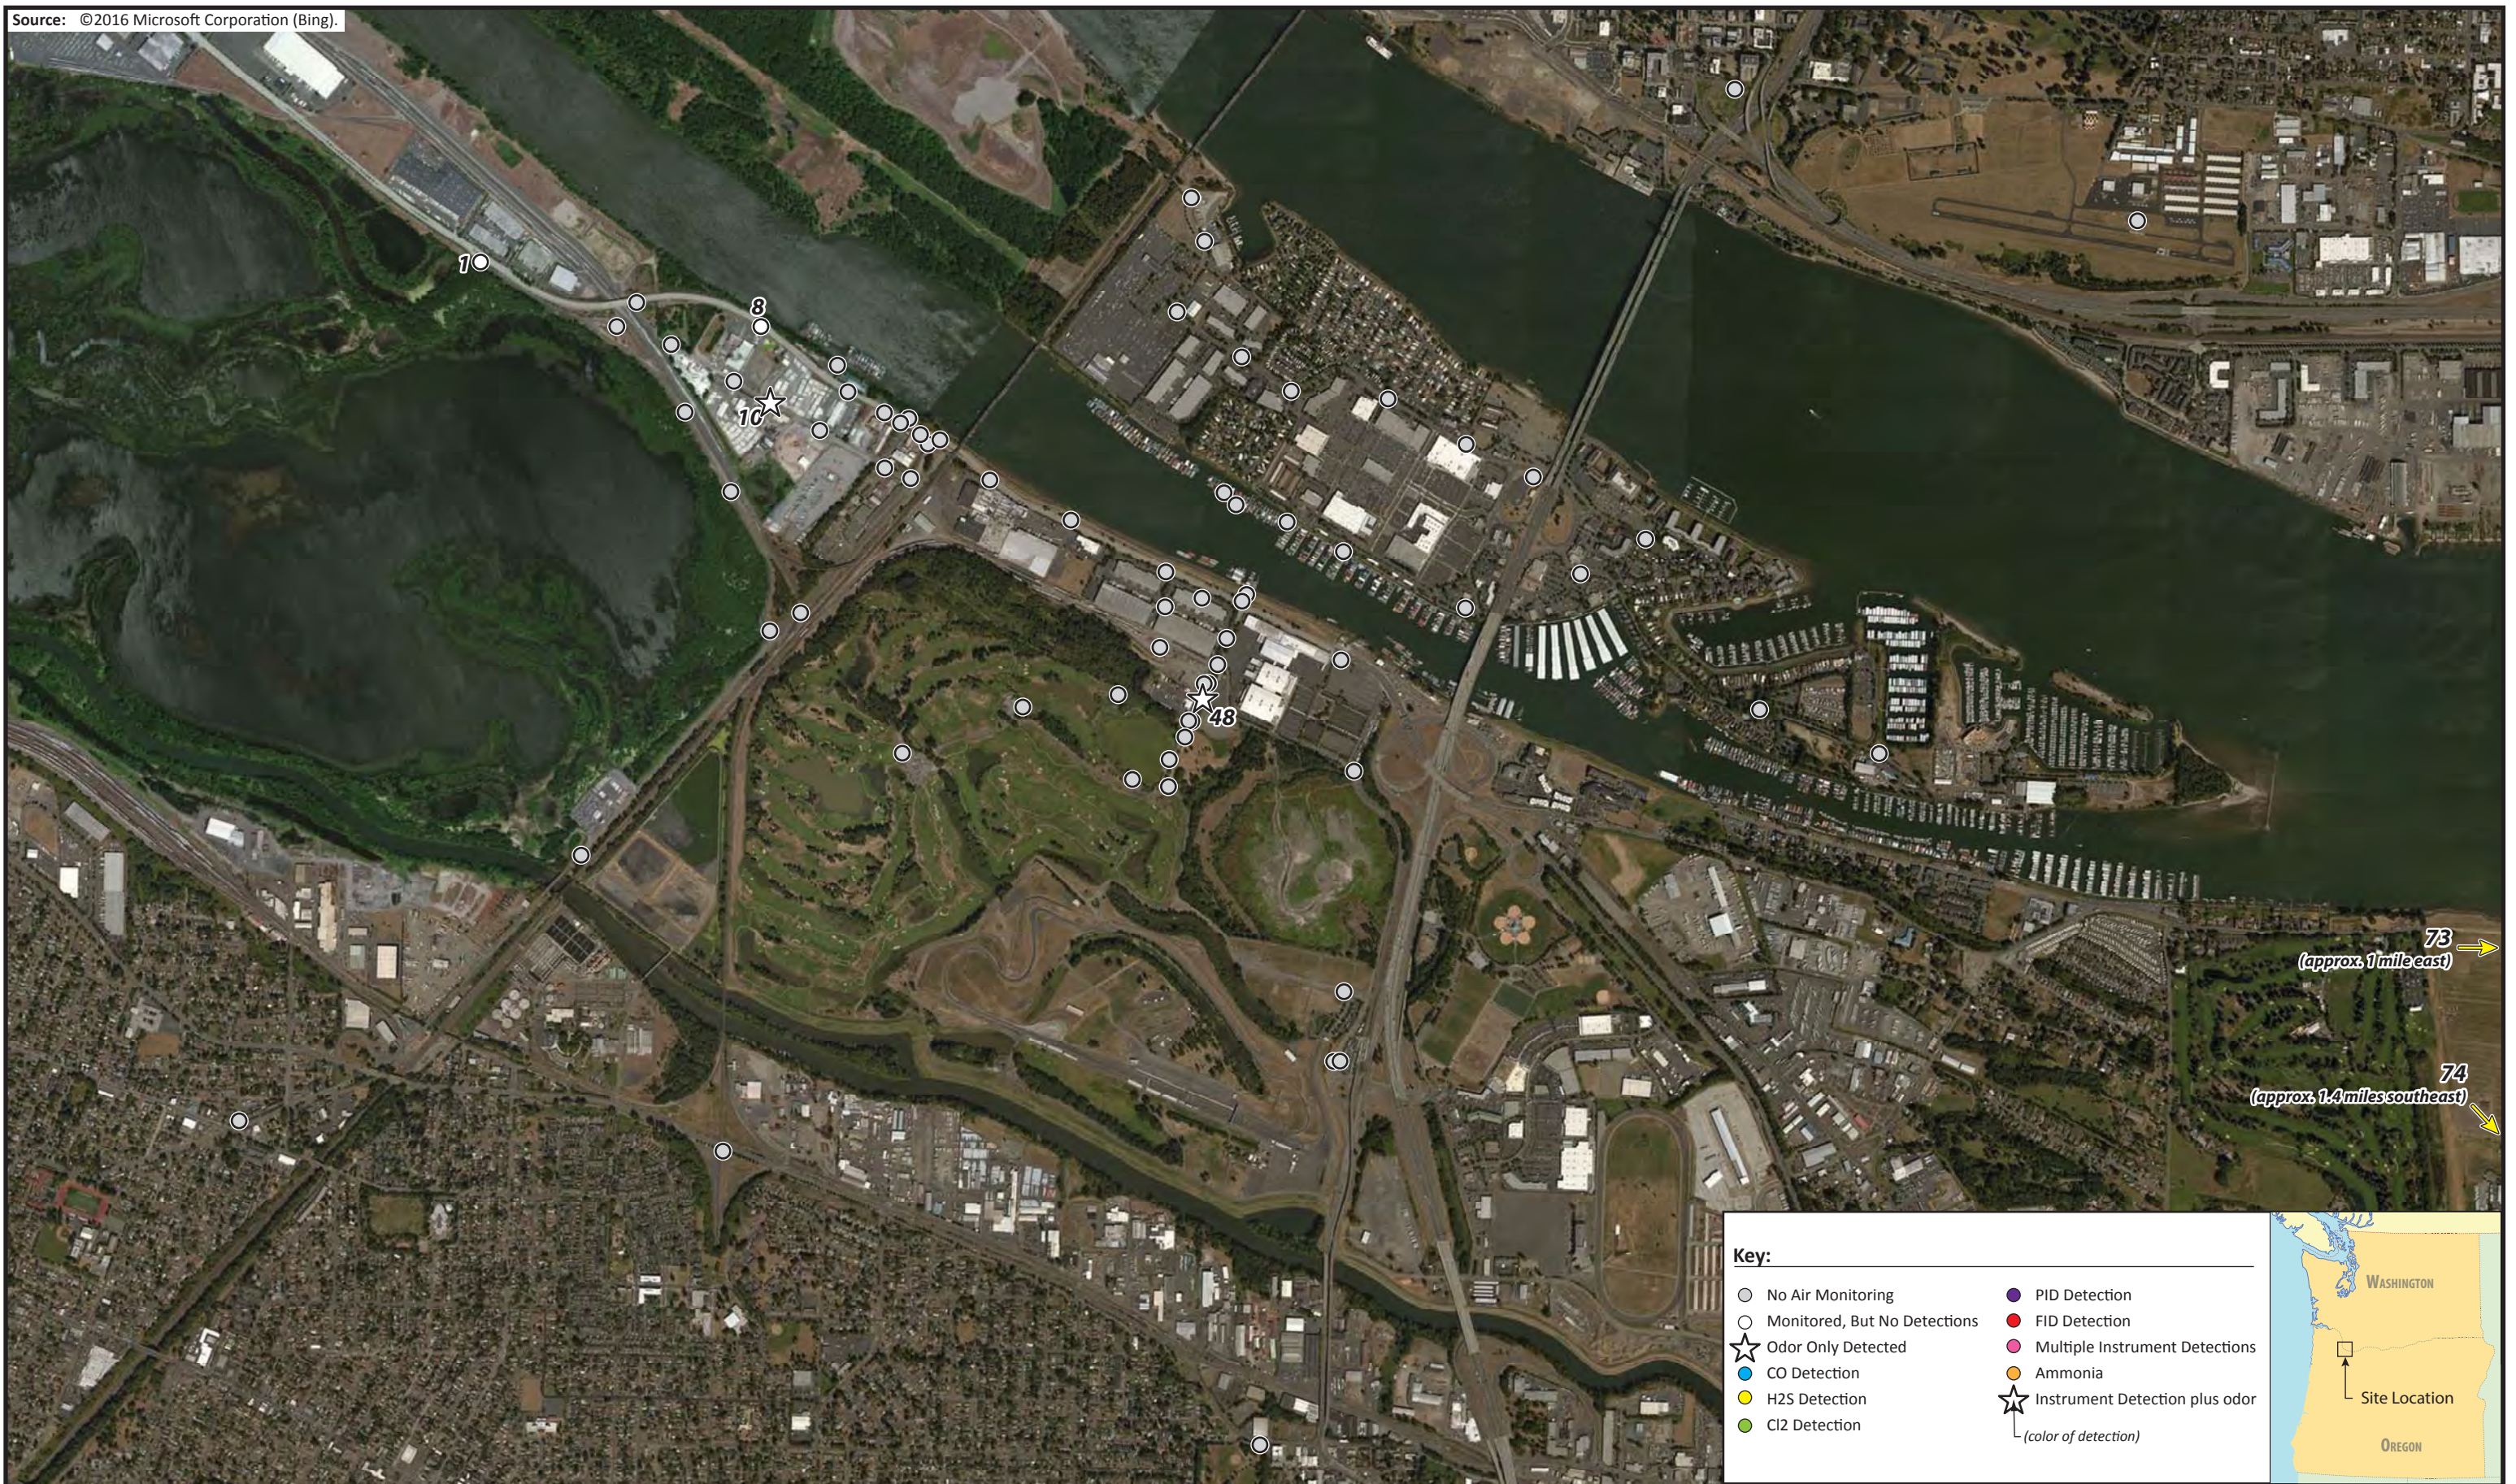
Figure 16
AIR MONITORING MOBILE EVENT
DECEMBER 18, 2015

- No Air Monitoring
- Monitored, But No Detections
- ☆ Odor Only Detected
- CO Detection
- H2S Detection
- Cl2 Detection
- PID Detection
- FID Detection
- Multiple Instrument Detections
- Ammonia
- ☆ Instrument Detection plus odor
(color of detection)

On December 18, 2015, START completed mobile testing at the Site along Force Avenue, Marine Drive, Suttle Road, and the Smith and Bybee Wetlands access road. Nothing was detected with the instruments, but odors were noted (Table 1, Figure 16). Observations were reported to EPA.

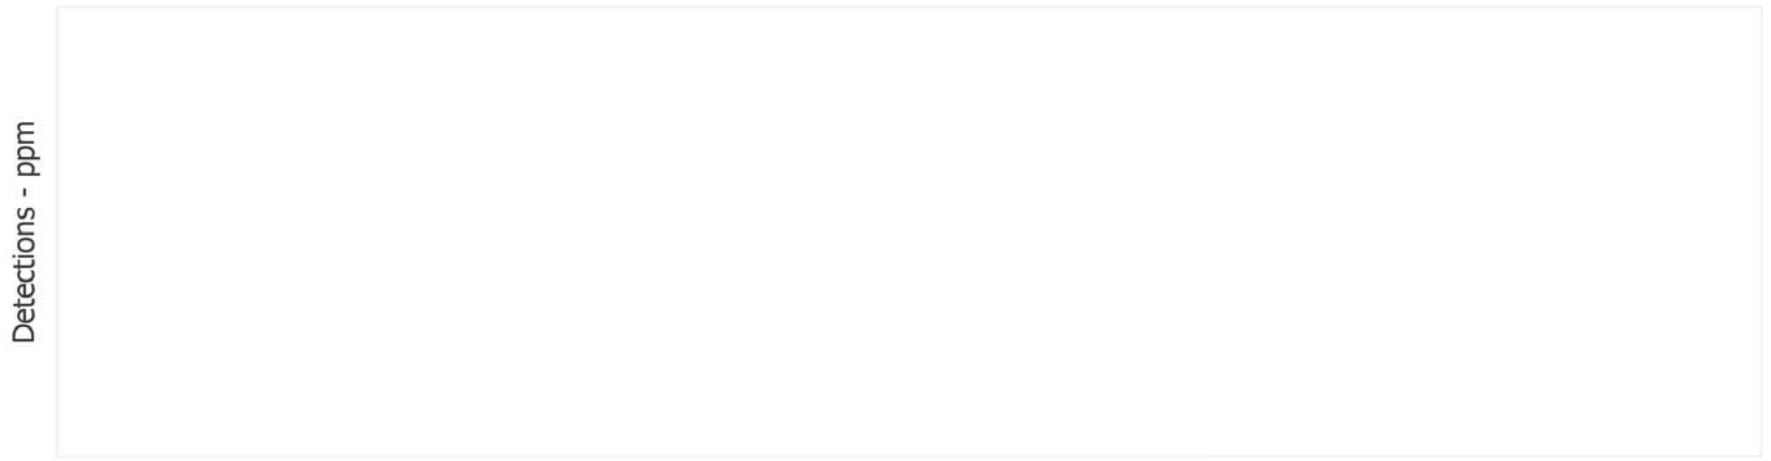
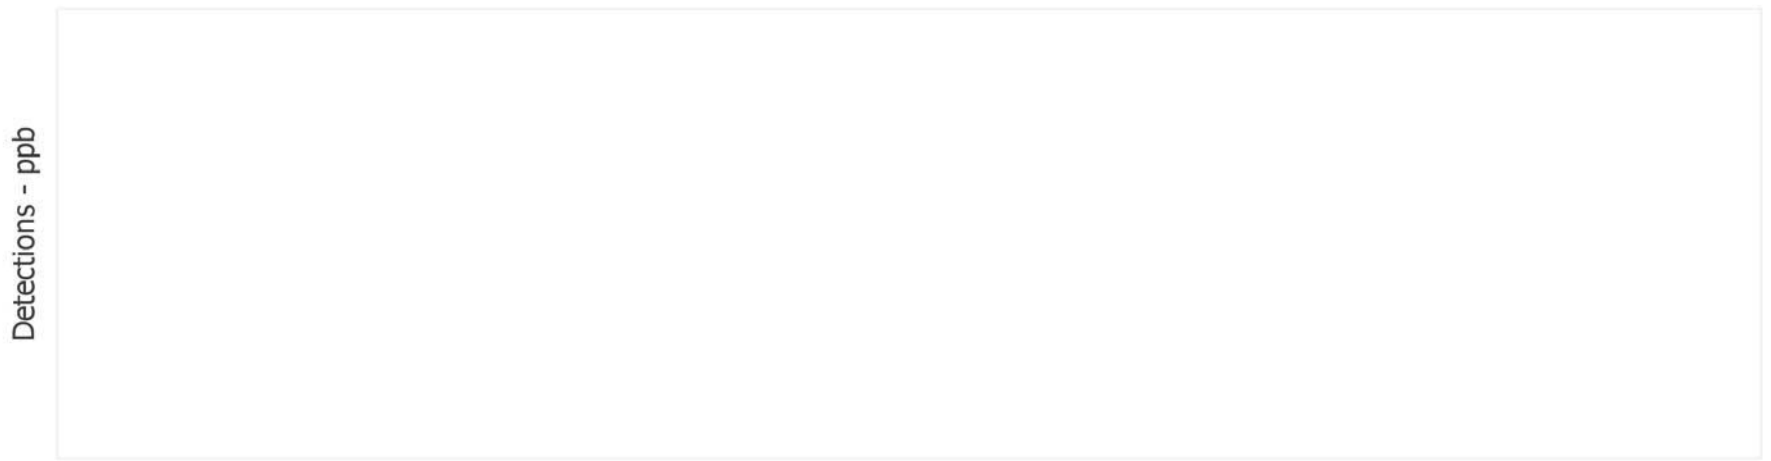
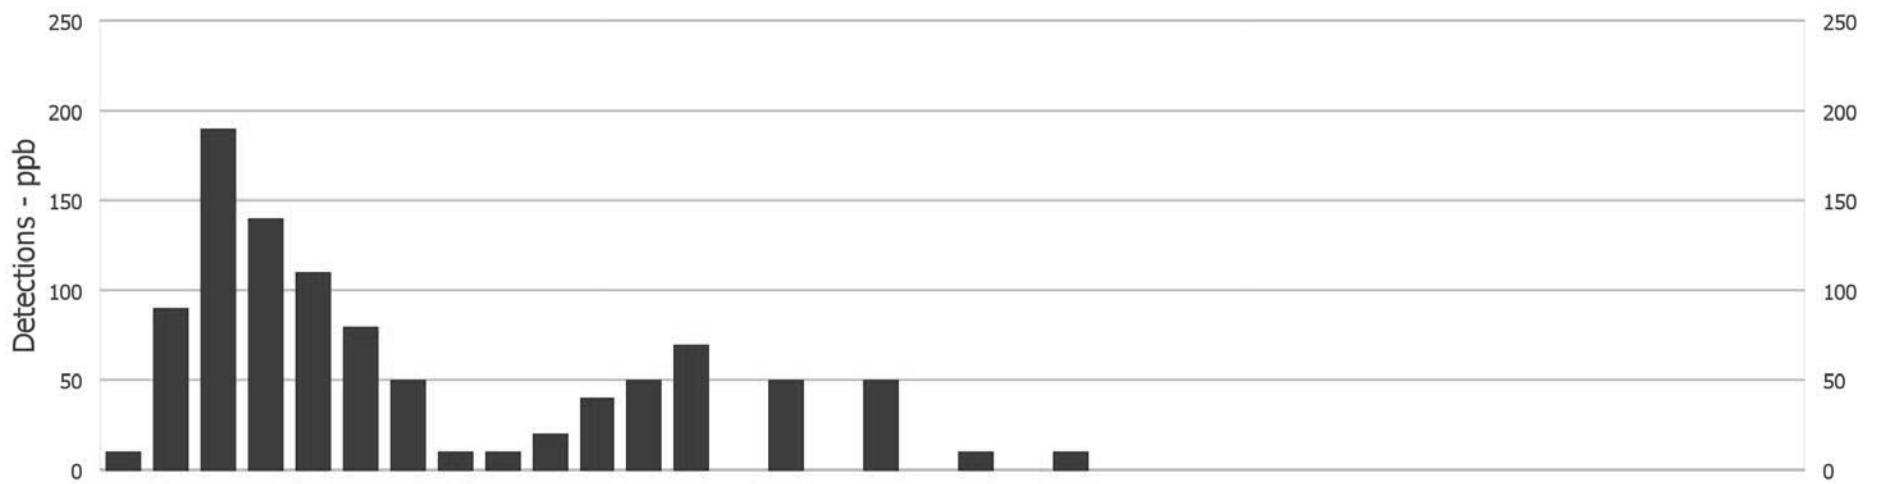
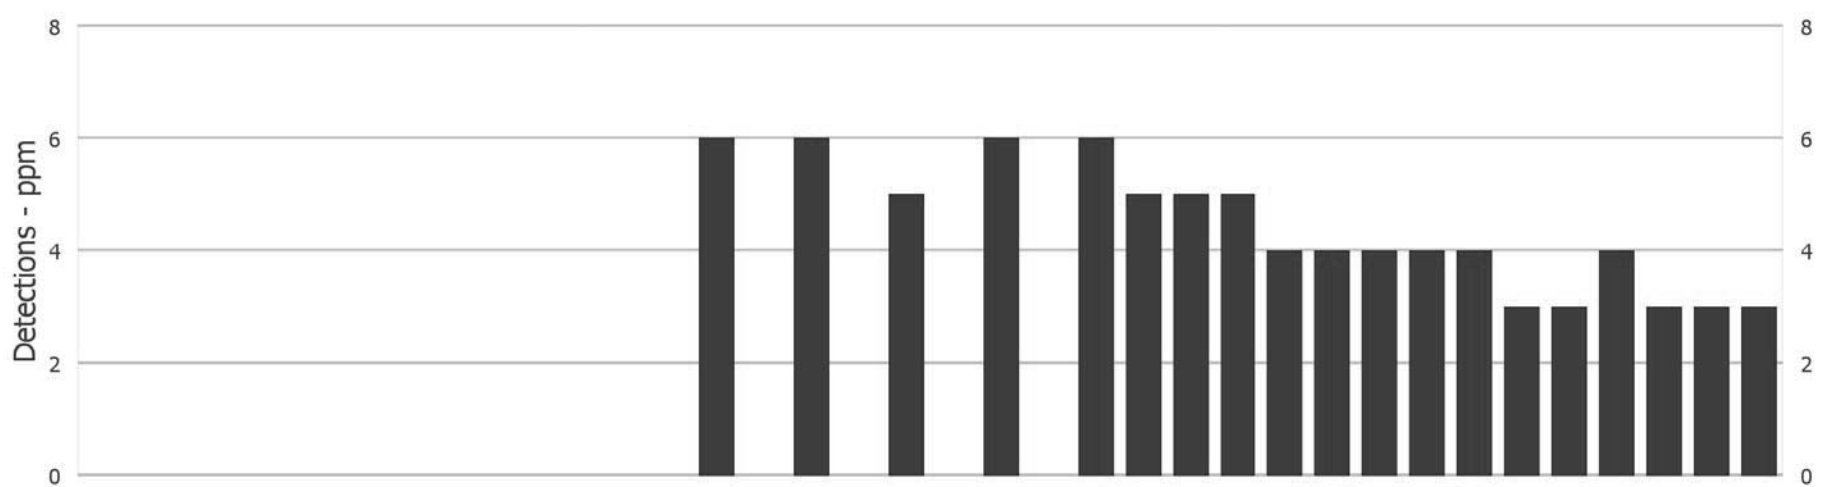
Jantzen Beach Air Release Site - Selected Viper Network Data Chart 3

EventKey 2015/11/17 06:48:27...06:50:00 Heron Lakes Engine Event

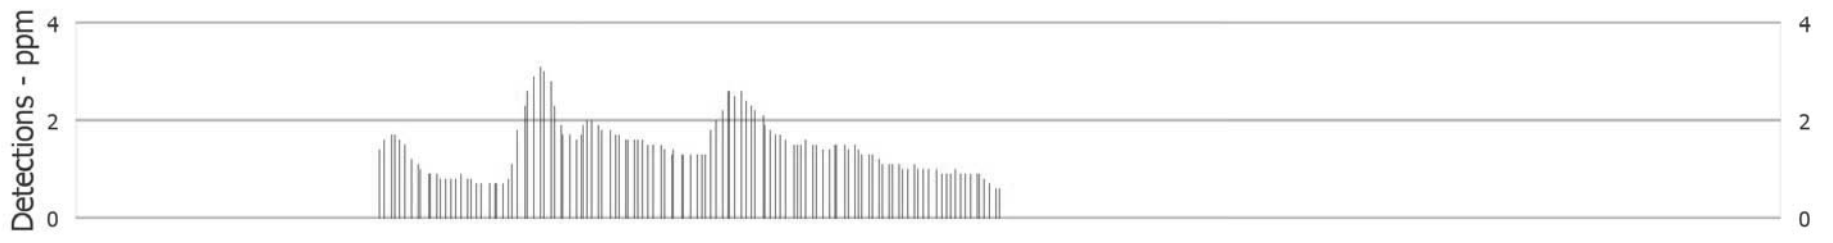
H2S Electrochemical Detections

Monitoring Event (from Table 5.1): 2015/11/24 14:06:48...14:19:23 JBMI Engine Event

Chart 4	11/24/2015 (2:06p.m. to 2:19p.m.)	JBMI (JB01)	Viper Detections: <ul style="list-style-type: none"> H₂S (3.1ppm) CO (360ppm) PID-10.6 (9,000ppb) 	<ul style="list-style-type: none"> MultiRAE Pro SB7020 (PID-10.6, CO, H₂S, LEL, O₂, Gamma) Linc 103 Gateway EPAERT80 Snapper, 6L vacuum container 	Homeowner reported that boat engine (in proximity to monitors) had been started.	Reported to EPA
Chart 5	11/27/2015 (8:51a.m. to 8:56a.m.)	JBMI (JB01)	Viper Detections: <ul style="list-style-type: none"> PID-10.6 (275ppb) 	<ul style="list-style-type: none"> MultiRAE Pro SB7020 (PID-10.6, CO, H₂S, LEL, O₂, Gamma) Linc 103 Gateway EPAERT80 Snapper, 6L vacuum container 	No correlated events were discovered. Residents reported no odor during detection event.	Reported to EPA
Figure 9	11/27/2015 (2:48p.m. to 4:51p.m.)	Force Ave, Hayden Is, Marine Dr., Suttle Rd.	Mobile monitoring: <ul style="list-style-type: none"> No elevated detections 	<ul style="list-style-type: none"> UltraRAE 3000 SB7017 (PID-11.7) 	None	Reported to EPA

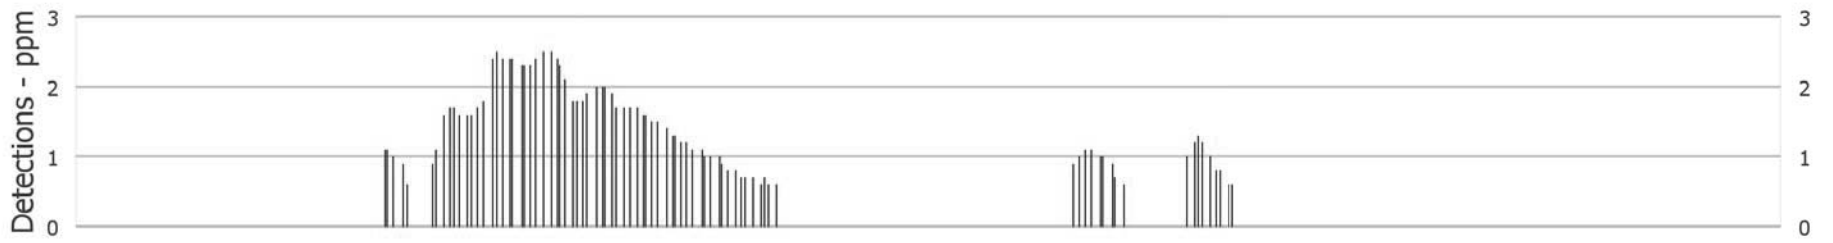
H2S Electrochemical Detections

Monitoring Event (from Table 5.1): 2015/12/01 13:04:33...13:14:35 JBMI Engine Event

Chart 6	12/1/2015 (1:04p.m. to 1:14p.m.)	JBMI (JB01)	Viper detections: <ul style="list-style-type: none"> PID-10.6 (37,400ppb) CO (340ppm) H₂S (2.5ppm) 	<ul style="list-style-type: none"> MultiRAE Pro SB7020 (PID-10.6, CO, H₂S, LEL, O₂, Gamma) Linc 103 Gateway EPAERT80 Snapper, 6L vacuum container 	Homeowner reported that boat engine (in proximity to monitors) had been started.	Reported to EPA
Chart 7	12/1/2015 (4:04p.m. to 6:52p.m.)	JBMI (JB01)	Viper Detections: <ul style="list-style-type: none"> PID-11.7 (28ppb) 	<ul style="list-style-type: none"> MultiRAE Pro SB7020 (PID-10.6, CO, H₂S, LEL, O₂, Gamma) Linc 103 UltraRAE 3000 SB7017 Linc 108 Gateway EPAERT80 Snapper, 6L vacuum container 	No correlated events were discovered.	Reported to EPA
Figure 10	12/2/2015 (1:44p.m. to 2:09p.m.)	Force Ave, HLGC (JB02), Marine Dr, Suttle Rd	Mobile monitoring: <ul style="list-style-type: none"> Odor (burnt-oil) 	<ul style="list-style-type: none"> UltraRAE SB6189 (PID-11.7) 	No correlated events were discovered.	Reported to EPA

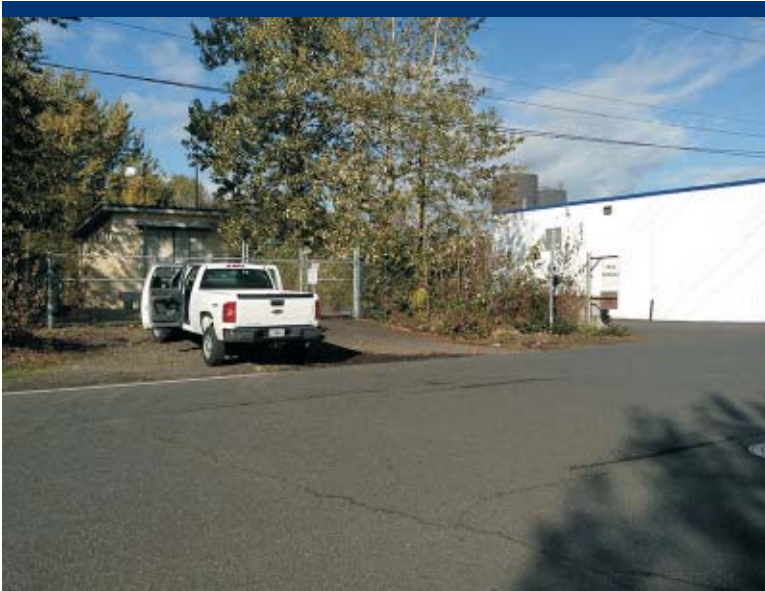
Photo 1 EPA and START assess the viability of locating a fixed Viper air monitoring station at the City of Portland Force Avenue sewer pump station.

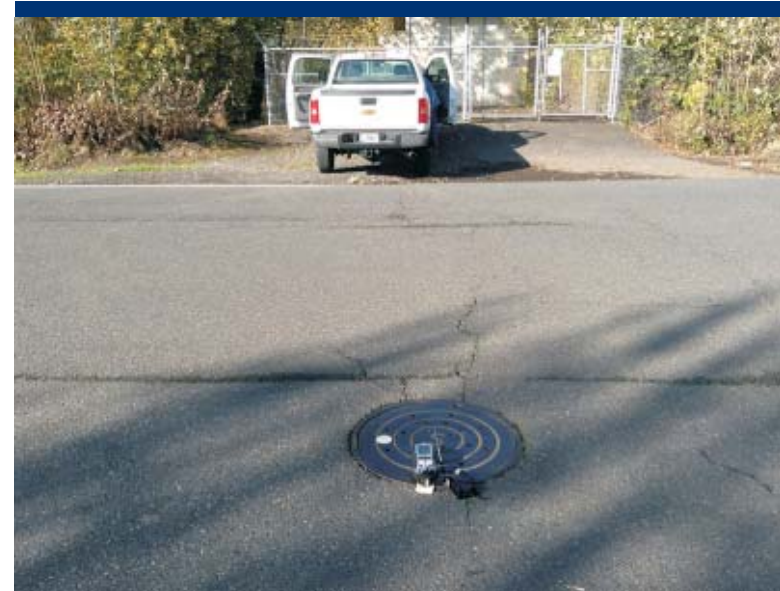
Photo 2 Monitoring for sewer gas emissions from a city of Portland sewer lid located along Force Avenue.

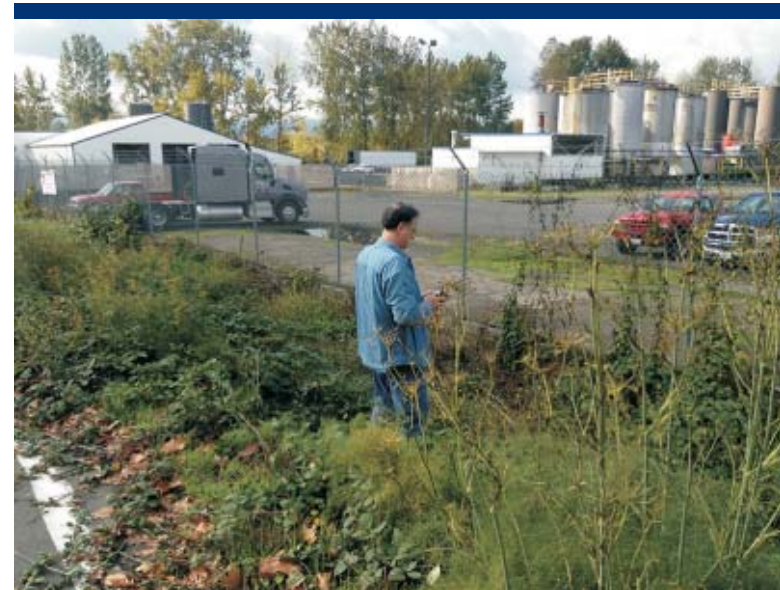
Photo 3 Monitoring effluent vapors from an open pipe on the west shoulder of Force Ave. The City of Portland later determined that it was related to the sewer and had been damaged.

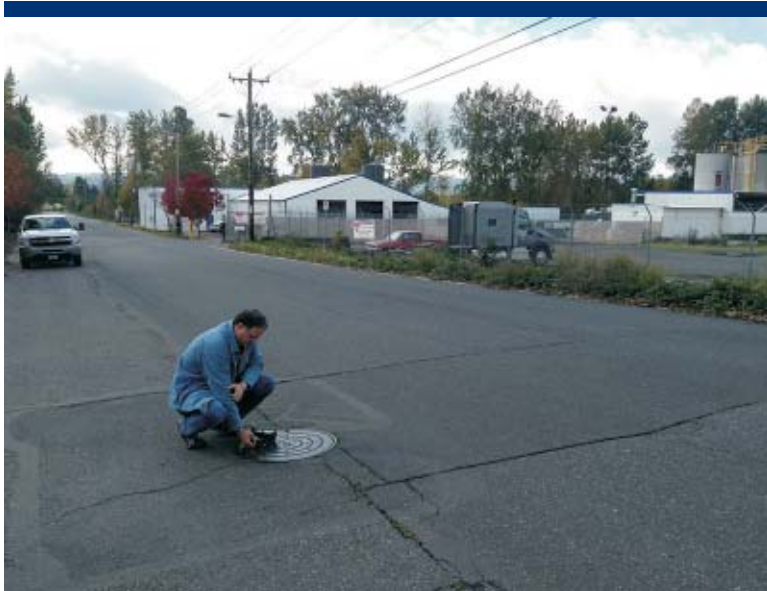
Photo 4 Monitoring effluent vapors from an open pipe on the west shoulder of Force Ave. The City of Portland later determined that it was related to the sewer and had been damaged.
