Re: Trip Report for Jantzen Beach Air Testing
Technical Direction Document 15-09-0003

TRIP REPORT

**Jantzen Beach Air Testing
Portland, Oregon
TDD: 15-09-0003**

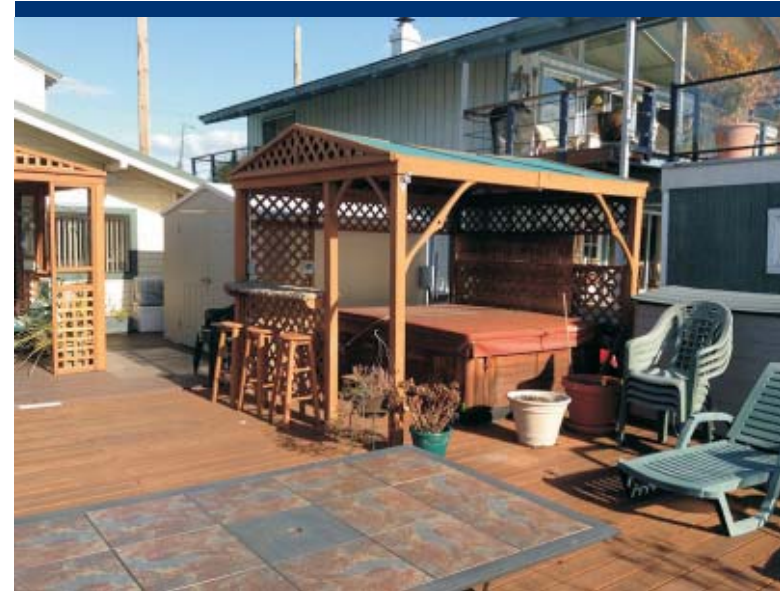
Photo 6 Location that START and EPA were permitted to use at Jantzen Beach Moorage Inc. for installation of a Viper fixed monitoring station.

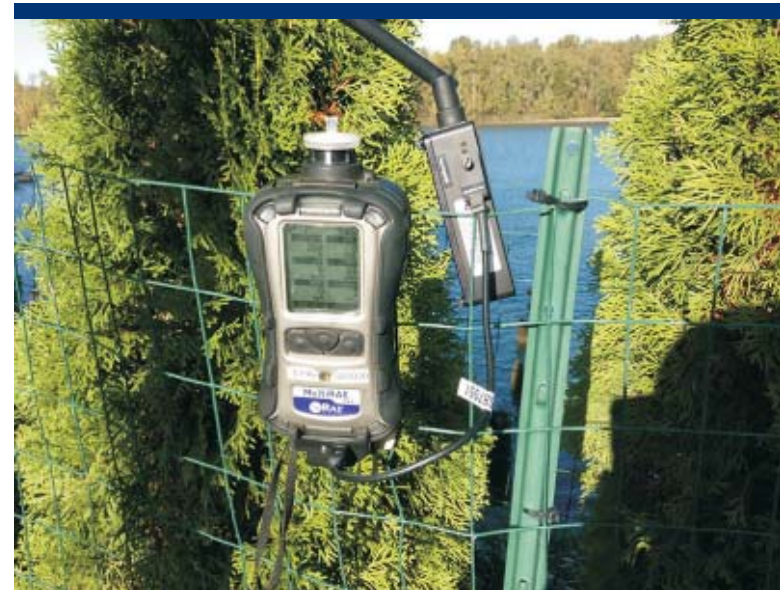
Photo 8 Mobile monitoring near Class Harbor floating home community.

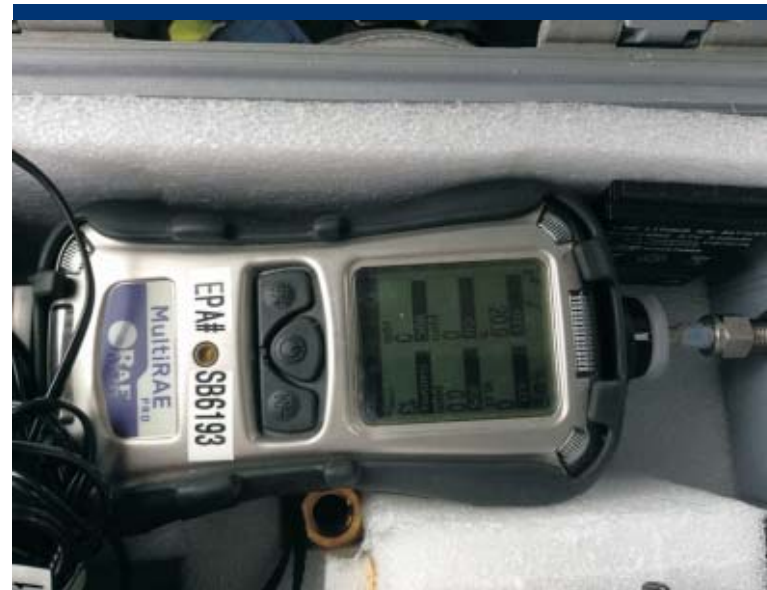
Photo 10 Instrument used for mobile vapor monitoring on Force Avenue during a moment when a sweet-solvent or glycol odor was detected.

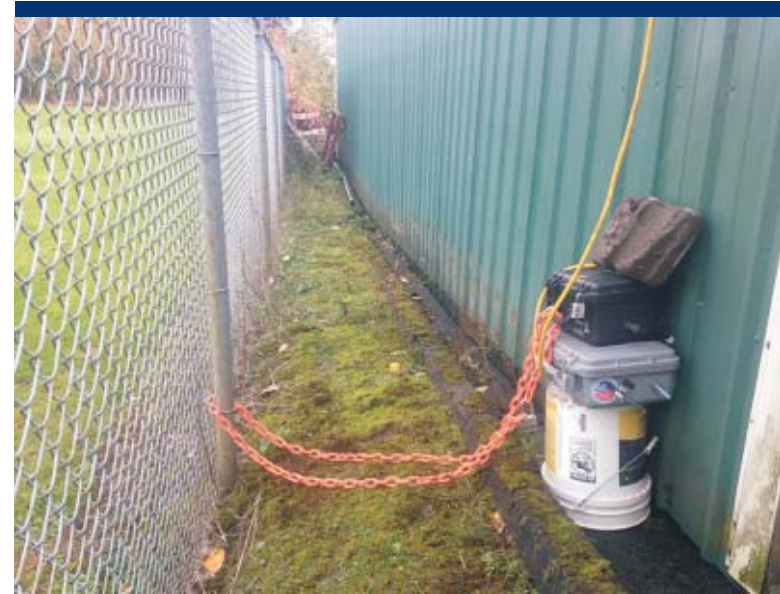
Photo 14 Initial viper deployment at HLGC maintenance facility.

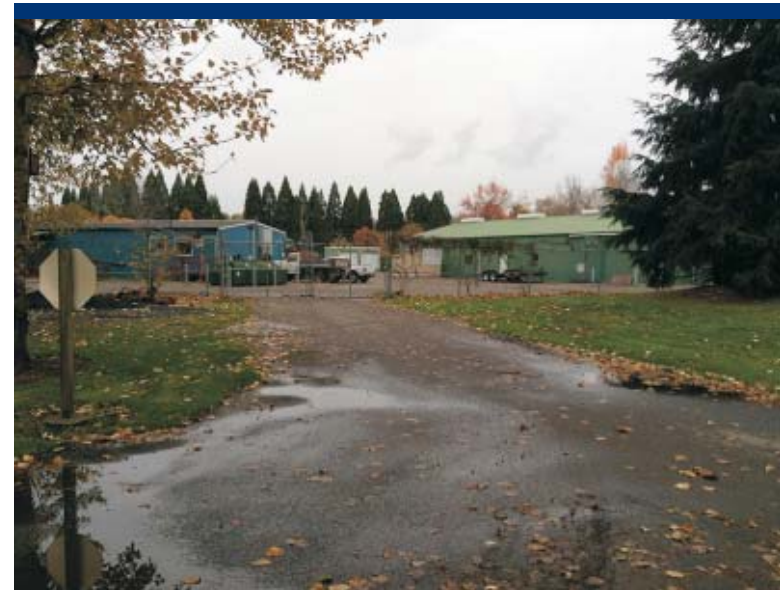
Photo 15 Mobile monitoring on North Hayden Island Drive. Natural gas or mercaptan type odors were noted near here.

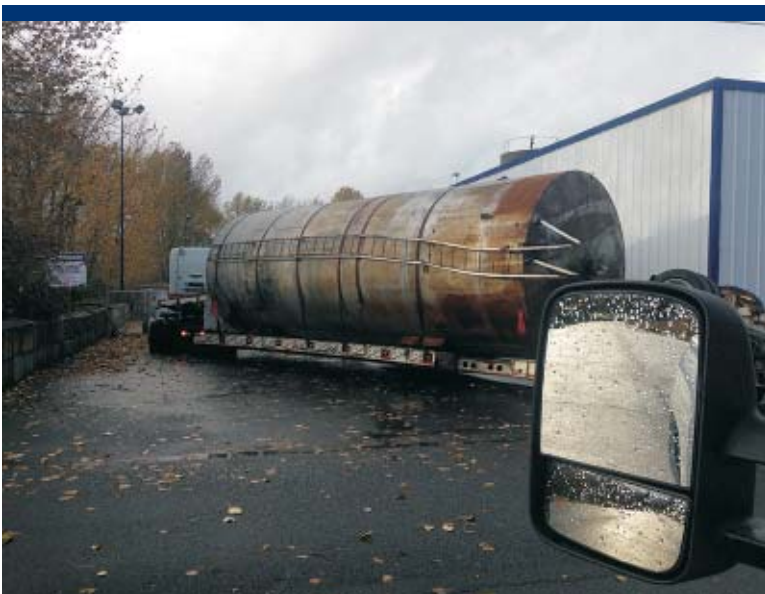
Photo 19 New AST arriving at APES.

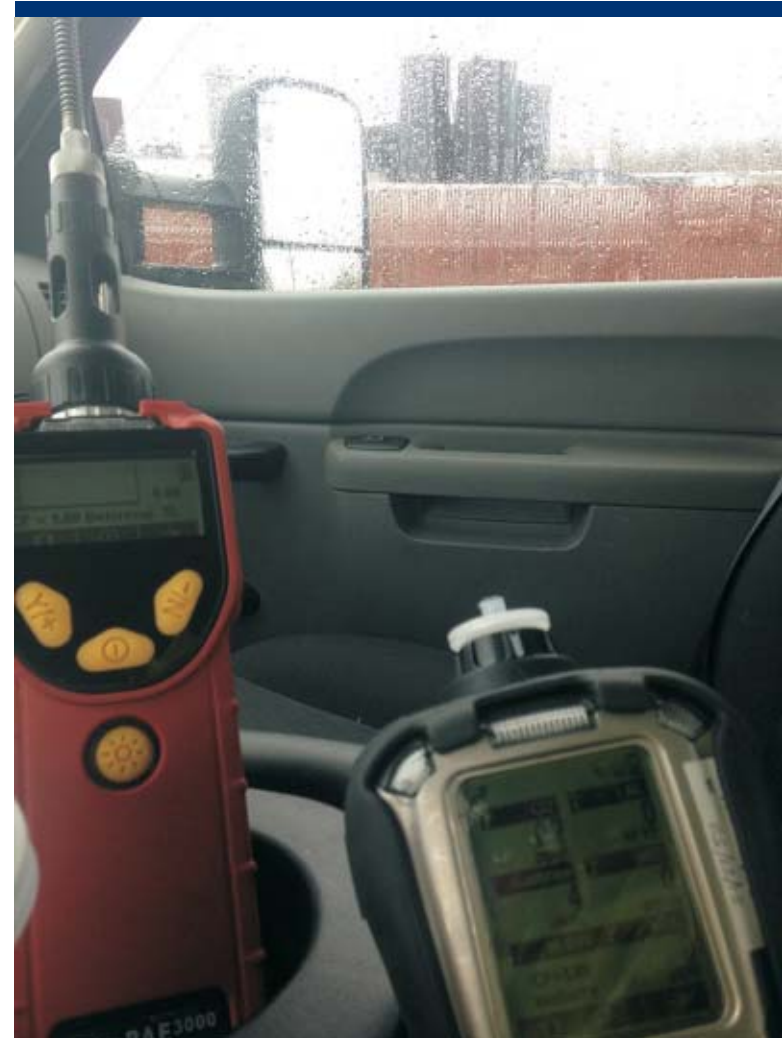
Photo 18 Mobile air monitoring on Force Ave.

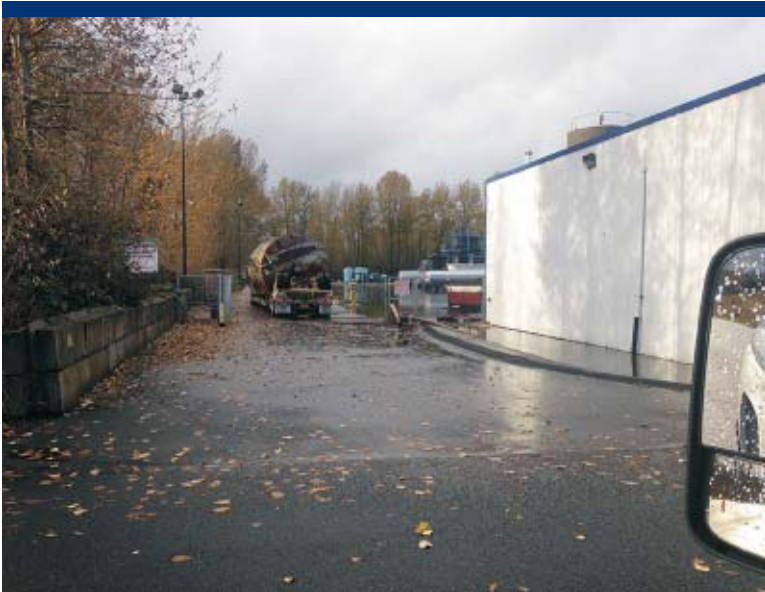
Photo 20 APES lot inundated with stormwater.

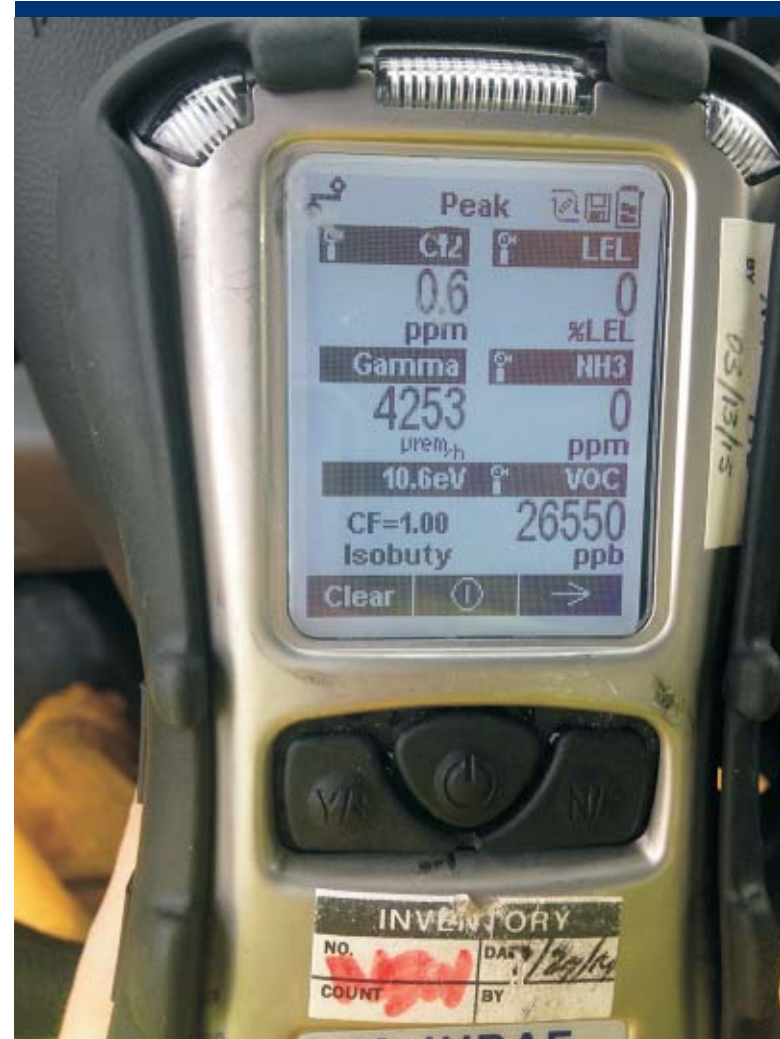
Photo 21 Peak gamma detection believed to be sensor error. Peak VOC due to bump test.

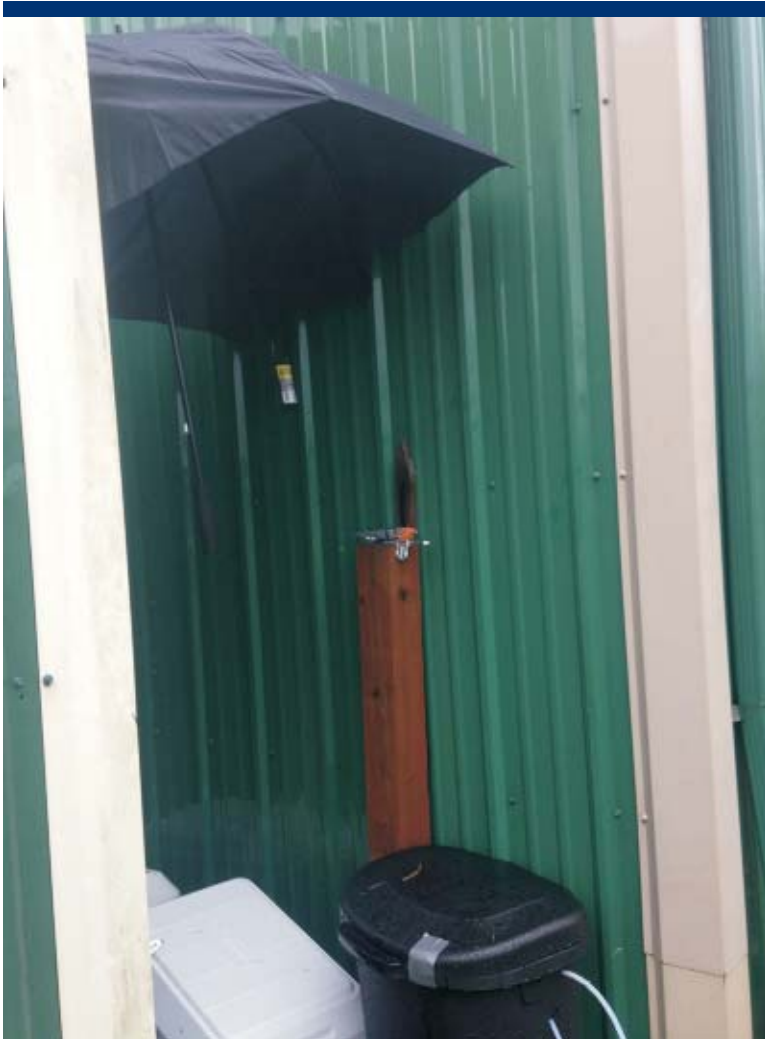
Photo 23 Umbrella used to protect Viper station while it is opened for maintenance.
Direction: Southwest *Date:* 12/11/15 *Time:* 12:54

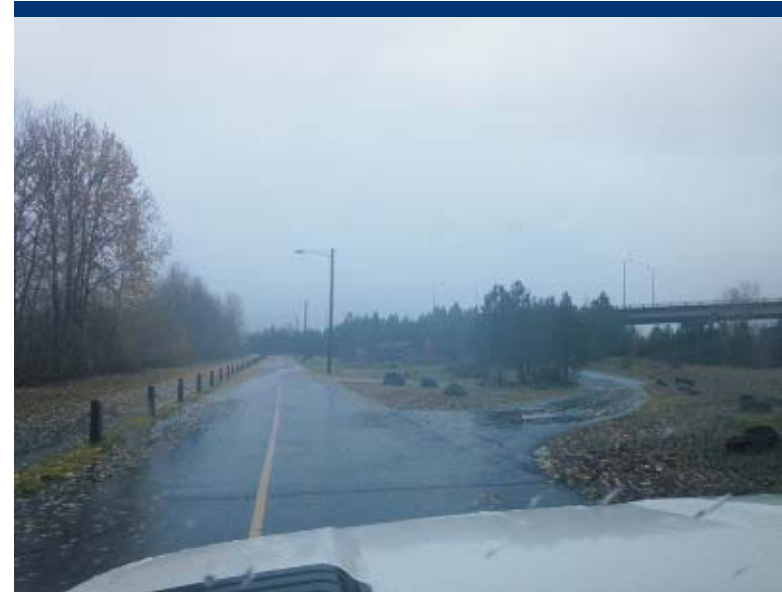
Photo 24 Mobile air monitoring west of Suttle Rd at Smith and Bybee Wetland Natural Area on a public access road.
Direction: Northwest *Date:* 12/11/15 *Time:* 15:08

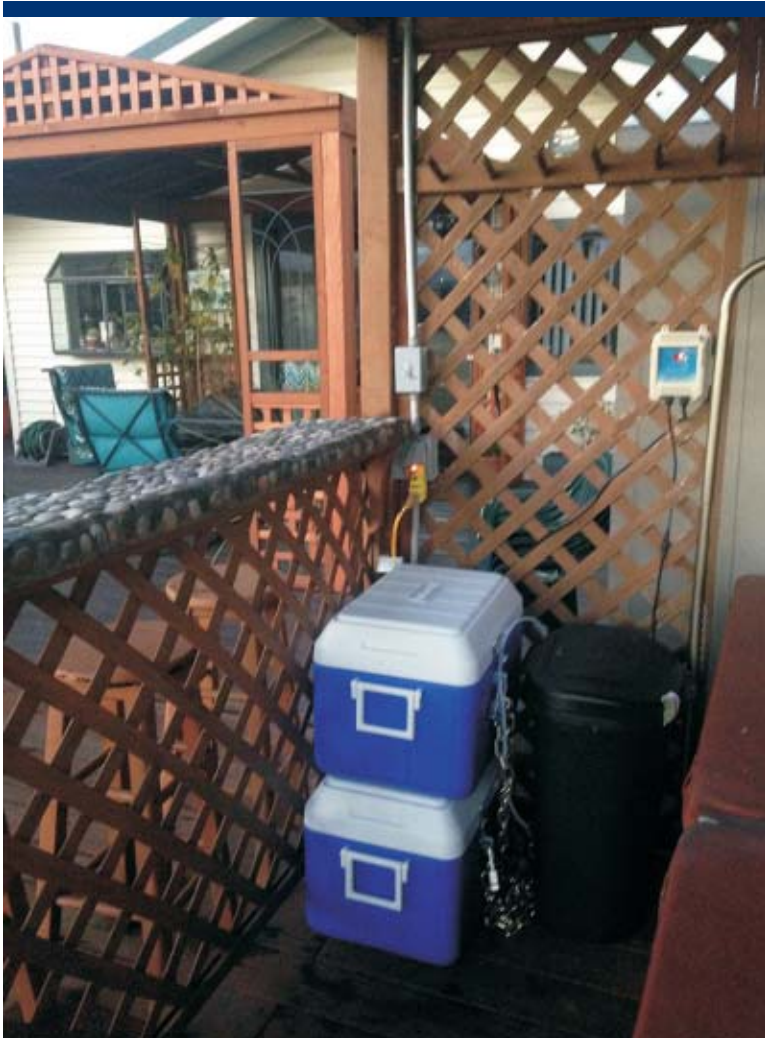
Photo 25 View of Viper Station JB01 at the Jantzen Beach Moorage Inc floating home community.

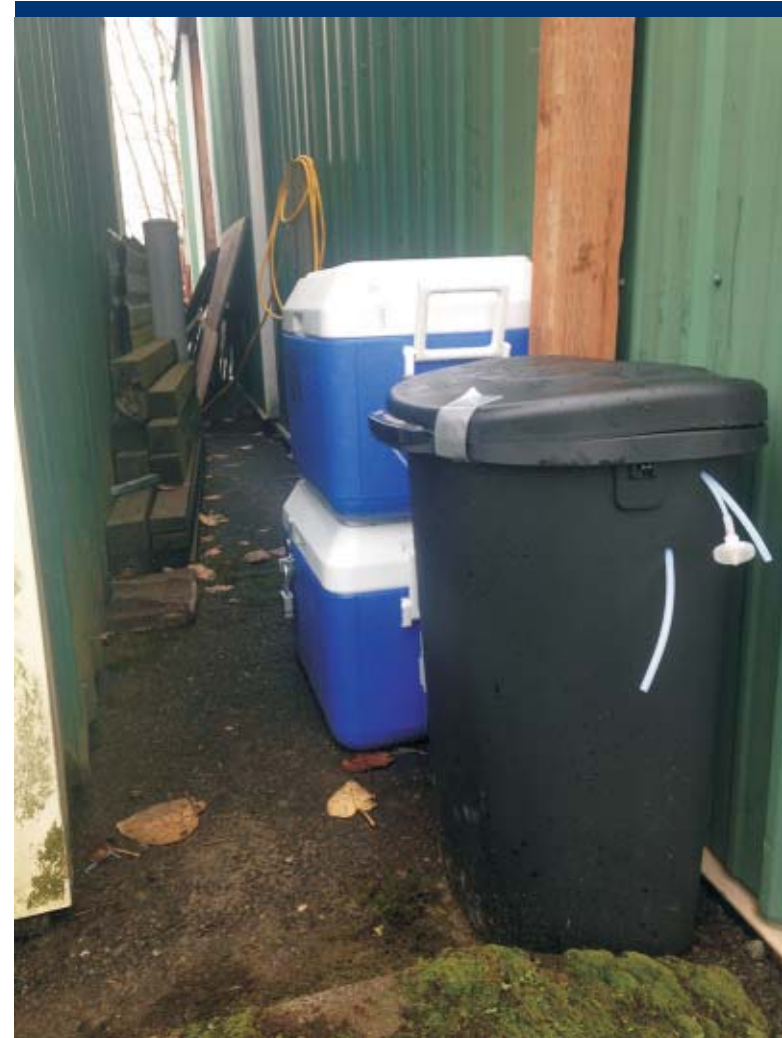
Photo 26 Heron Lakes Golf Course (HLGC) Viper Station JB02.

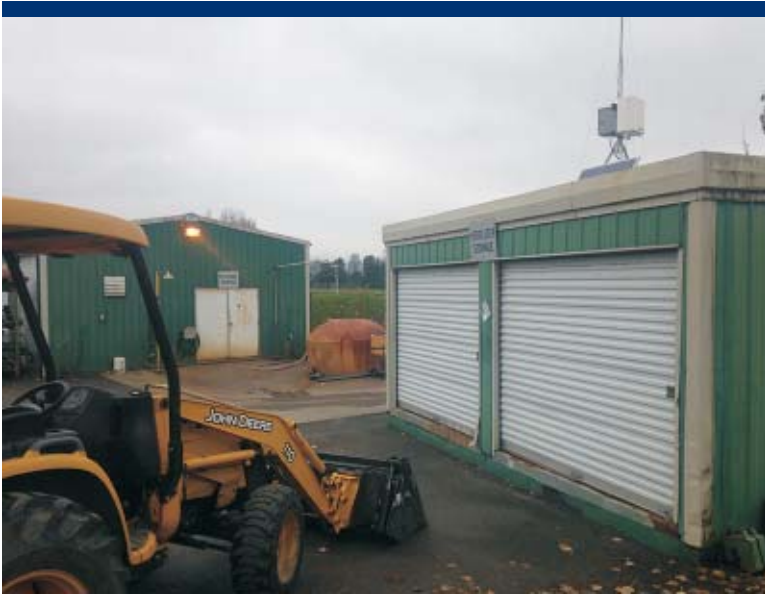
Photo 27 Oregon DEQ weather station has been installed on top of storage building at Heron Lakes Golf Course near Viper Station JB02.

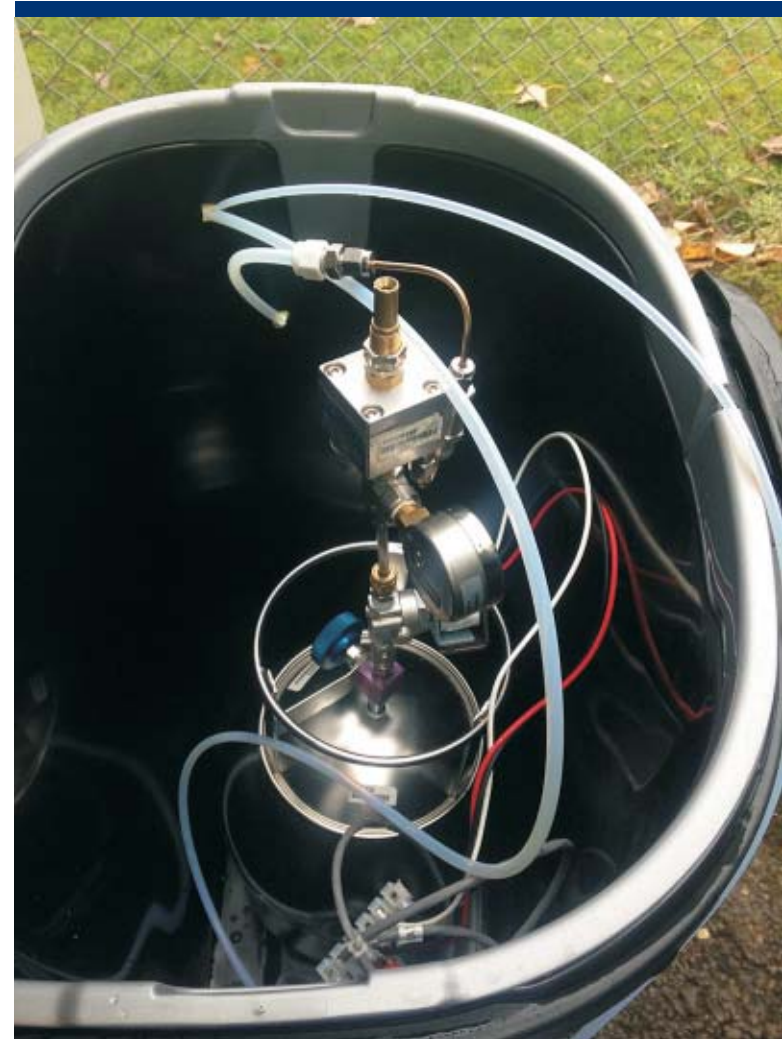
Photo 28 Vacuum canister (connected to Snapper control box) deployed at Heron Lakes Golf course at Viper station JB02.

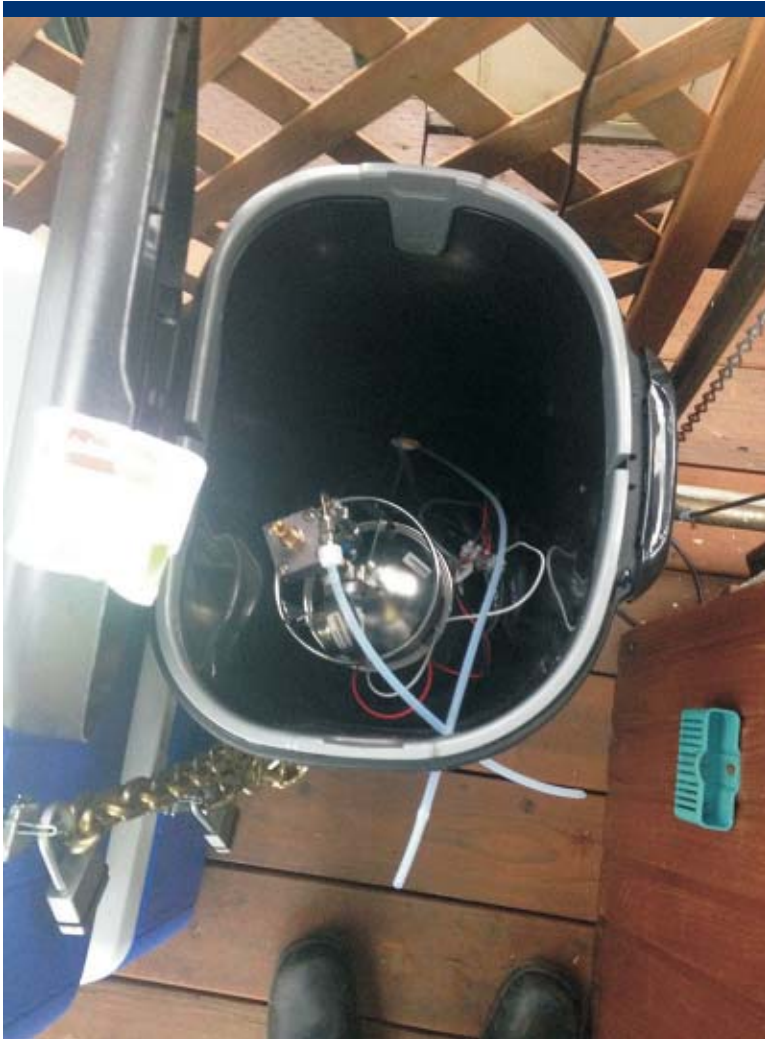
Photo 29 Vacuum canister (connected to Snapper control box)
deployed at Jantzen Beach Moorage Inc at Viper station JB01.
Direction: Down Date: 12/15/15 Time: 15:45
