Long-Term Stewardship Assessment Report

US Army Fort A.P. Hill

Date: July 12, 2016

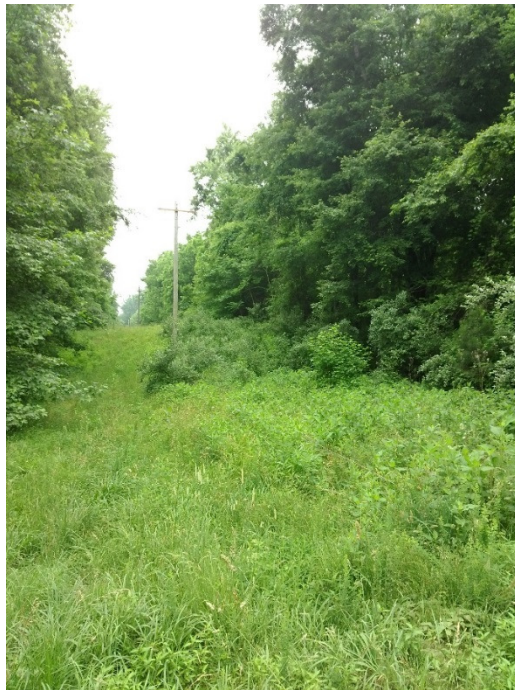
Picture 1: Acors Corner Landfill

EPA visited the following units: AOC-2, SWMU-12, -13, -14, -16 and -17. SWMUs-12 to -14, and -17 (former LFs) appeared to be flush with the ground in areas now heavily forested, and therefore were covered with trees and shrubs. There were signs posted on fences or trees around the former LFs, prohibiting access.

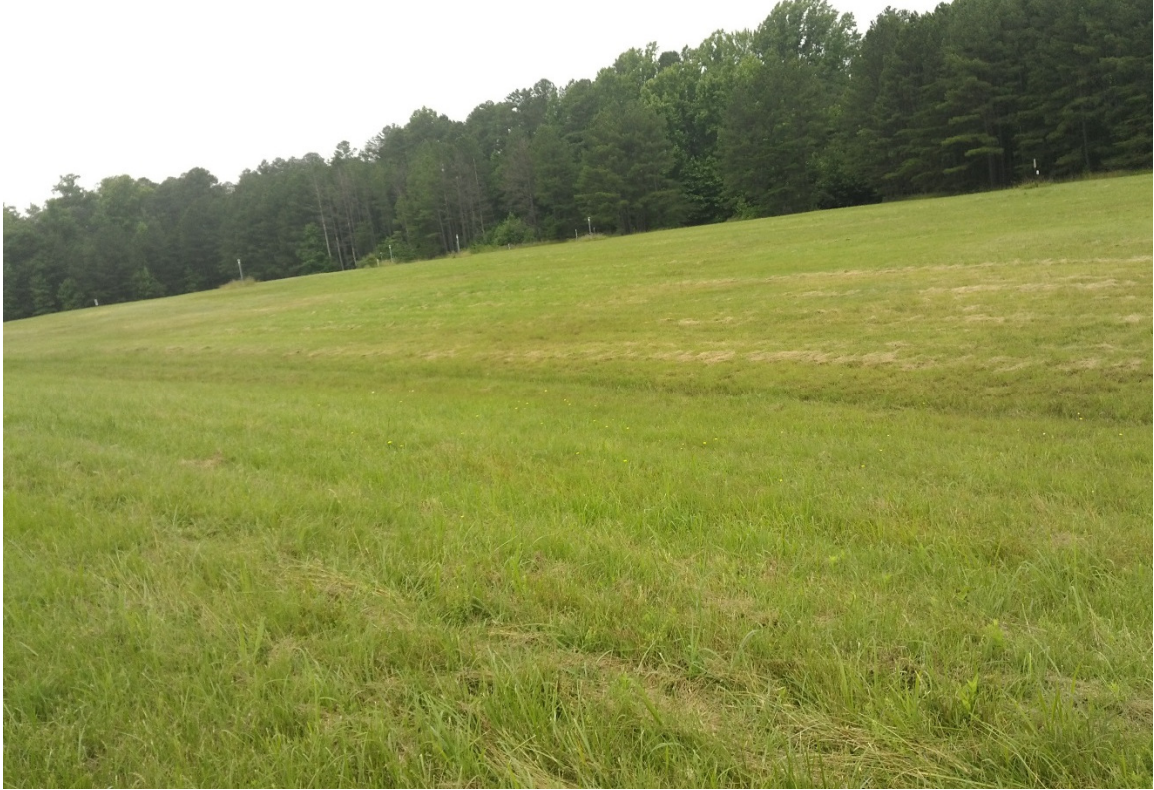
Picture 3: Wilcox Landfill - Vegetative Cap

Wilcox Sanitary Landfill (closed) – SWMU 16: The former landfill (LF) is an 8 acre mound within a 25 acre site, formerly used for non-hazardous solid waste disposal from 1981–1992. Two of the LF's trenches are covered with a synthetic cap, while six trenches are covered with a soil cap. At the time of the site visit, grass covering the landfill was properly maintained and drainage swales were clear. There is a gate and lock at the entrance to SWMU 16 for security purposes. LF Methane monitoring is no longer required by VDEQ because methane has not been detected. The LF shows no deficiencies.

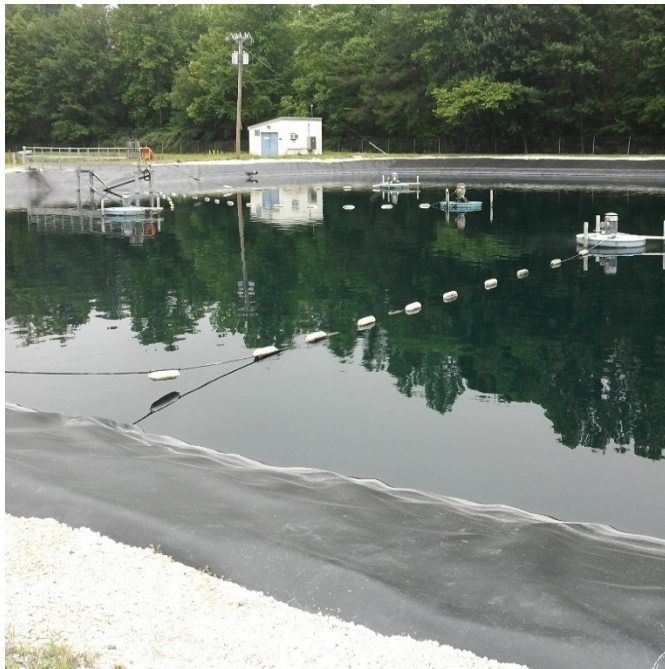
Picture 7: Wilcox WWTP

Wastewater Treatment Plants (WWTPs): Wilcox (AOC-2) and Cooke Camp (AOC-4): Both WWTPs are owned and operated by American Water Inc. and have VPDES Permits. The selected remedy is MNA for AOC-2 (Wilcox Waste Water Treatment Plant) and AOC-4 (Cooke Camp Wastewater Treatment Plant and Spray Irrigation). In the latest GW monitoring reports for both AOCs, all metals meet EPA clean-up goals except EPA cannot determine if lead and cadmium have meet the goals. The laboratory method detection levels for the two metals are higher than EPA's clean-up standards (5.0 µg/L and 15 µg/L, respectively), therefore EPA is recommending additional monitoring (see Conclusions and Recommendations below).

1. Continue annual LF cap integrity inspections at LFs 11 to 14, -15 to -20;
2. Monitor GW at AOC-2 and AOC-4 for lead and cadmium at lower detection levels for 2 to 3 rounds of sampling (at least 6 months apart) and submit the results to EPA. If results show the two metals meet EPA's clean-up goals (at or below Drinking Water Maximum Contaminant Levels (MCLs), EPA can eliminate AOC-2, AOC-3 and AOC-4 from the EC/IC restrictions because groundwater goals will be attained for these AOCs.
3. FAPH requested that GW monitoring wells installed around LFs 11-15, 17-20 could be properly abandoned since contaminants of concern were not identified in these wells. EPA agreed that they can be abandoned according to Virginia regulations.
