REVISED DRAFT  
RCRA FACILITY ASSESSMENT  
REPORT

Evoqua Water Technologies, LLC.  
2523 Mutahar Street  
Parker, Arizona  
AZD 982 441 263

U.S. ENVIRONMENTAL PROTECTION AGENCY  
Region 9  
75 Hawthorne  
San Francisco, CA

Date of Revised Draft	September 2016
US EPA Region 9	
Site No.	AZD 982 441 263
Document Control No.	REPA3-0903-017
Contract No.	68-W-02-022
Draft RFA Prepared by	Booz Allen Hamilton
Revised Draft RFA Prepared By	USEPA Project Manager
Telephone No. (415) 972-3348	“Mike” Mahfouz Zabaneh

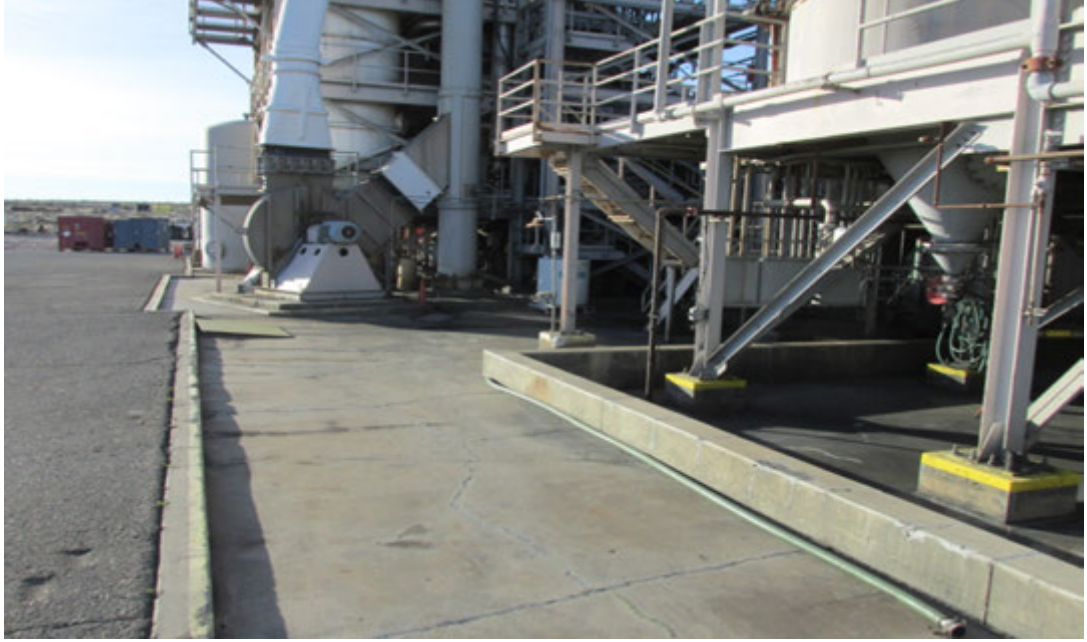
<b>SWMU No.</b>	<b>SWMU Type/Designation</b>	<b>Picture of Unit</b>
1	Bermed concrete in process area (this includes the secondary containment for slurry storage tanks) –  LOCATION: East of Warehouse

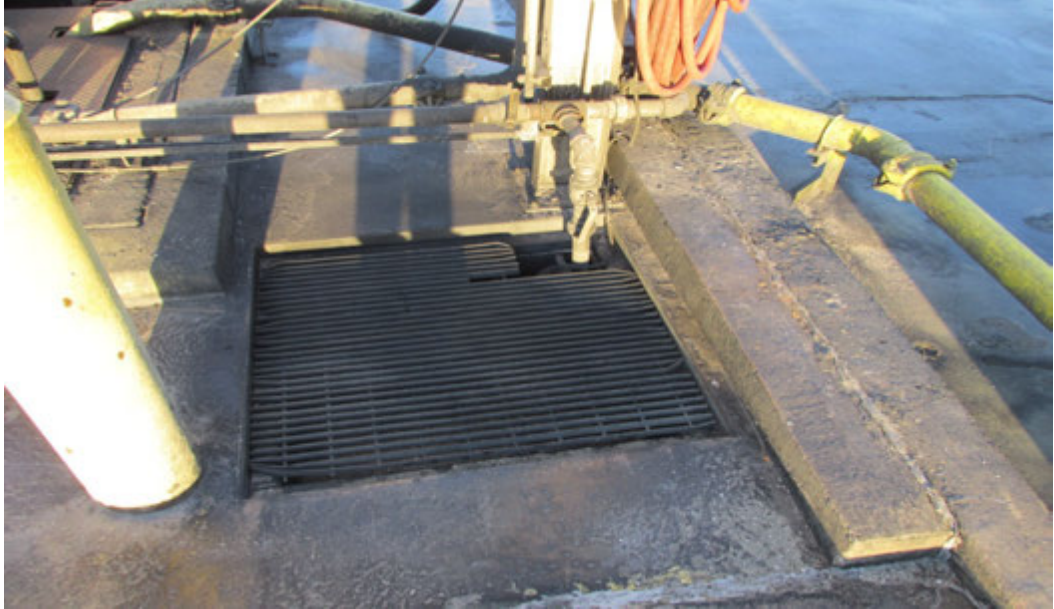
2	Sump by Hopper H-1  LOCATION: South of H-1

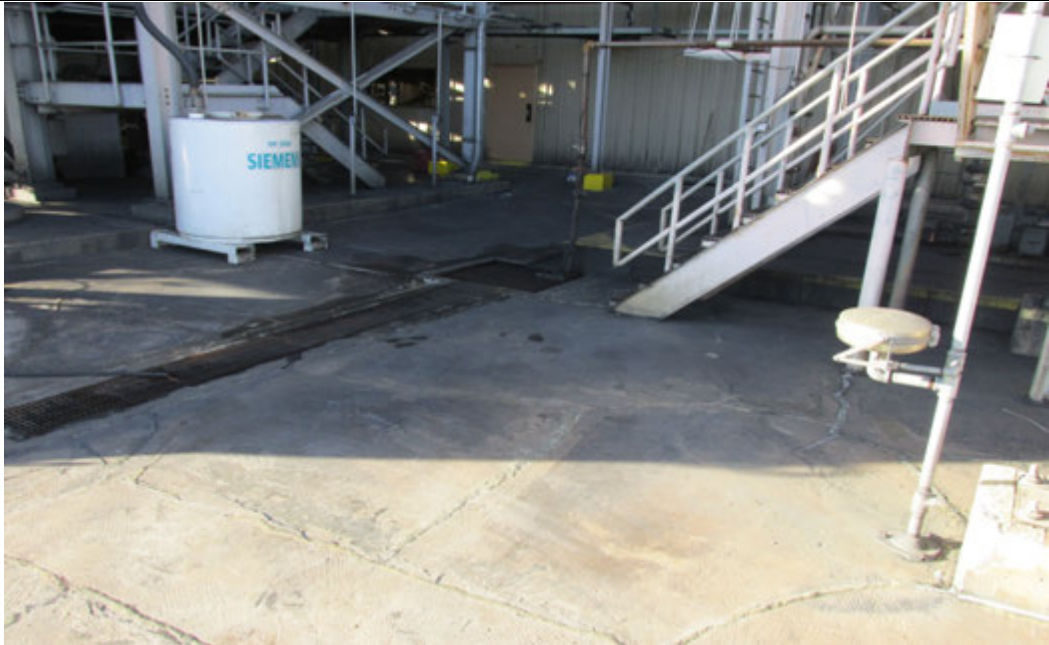
SWMU No.	SWMU Type/Designation	Picture of Unit
3	<p>Sump by storage tank, T-9</p> <p>LOCATION: East of warehouse in between T-9 and RF-2</p>

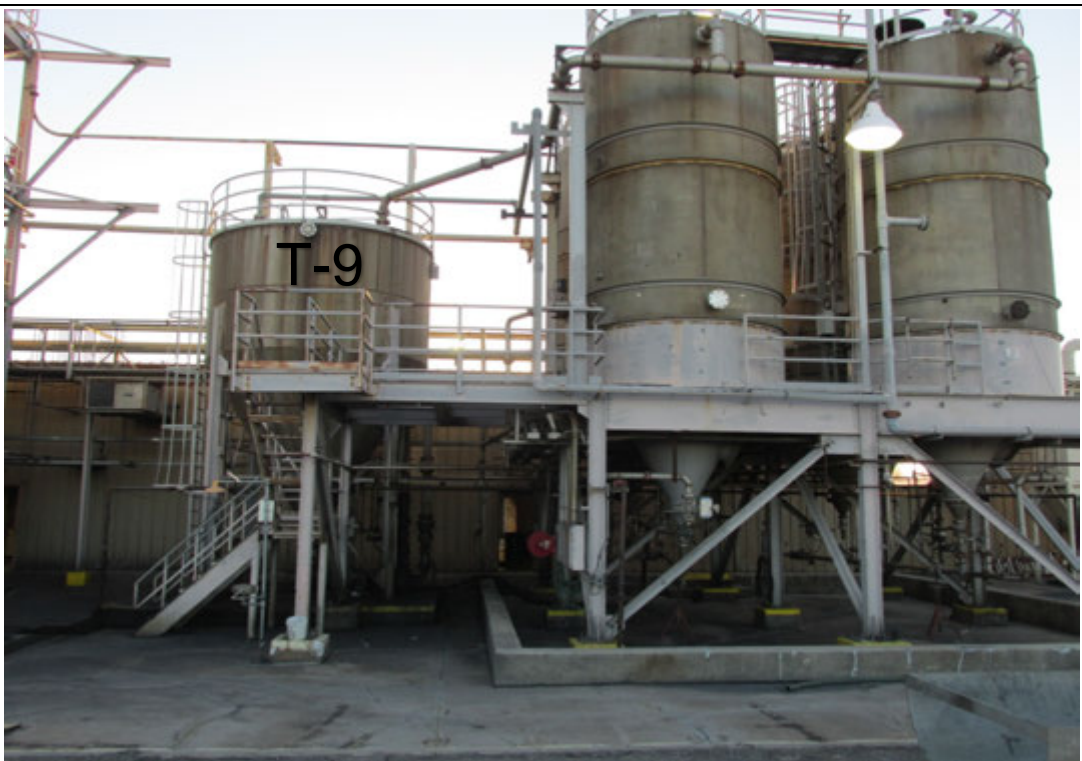
4	<p>Recycled motive water storage tank, T-9</p> <p>LOCATION: East of warehouse on containment</p>

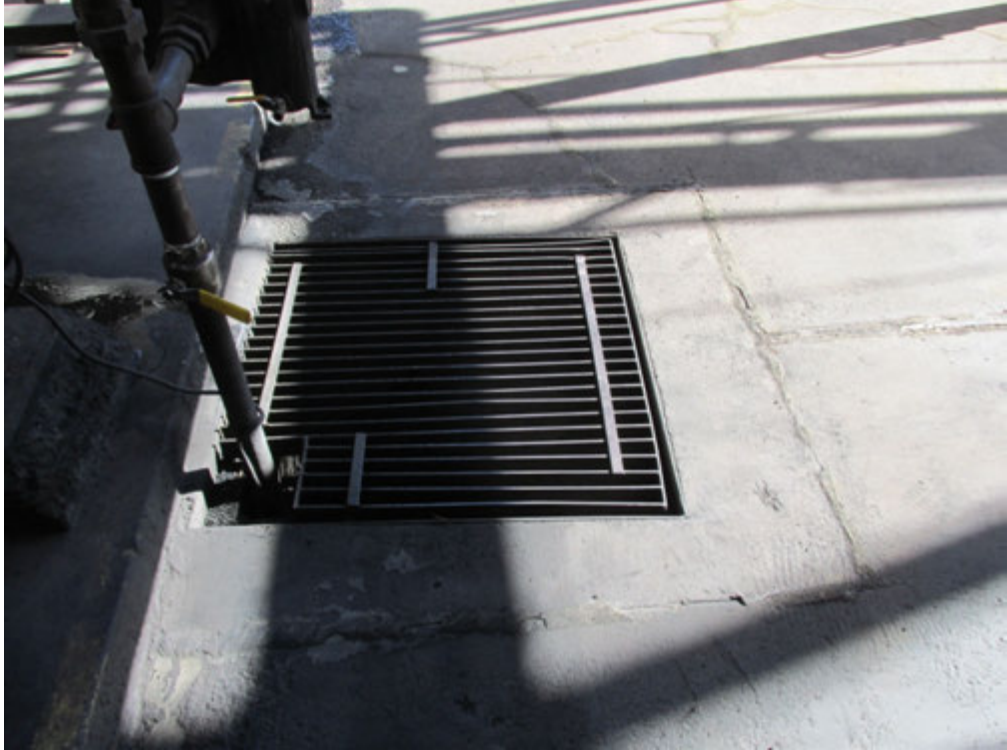
SWMU No.	SWMU Type/Designation	Picture of Unit
7	<p>Sump by cooling screw under Venturi scrubber tank            LOCATION: East of warehouse beside RF-2</p> <p>NOTES: Used for washdown and rainwater drainage</p>

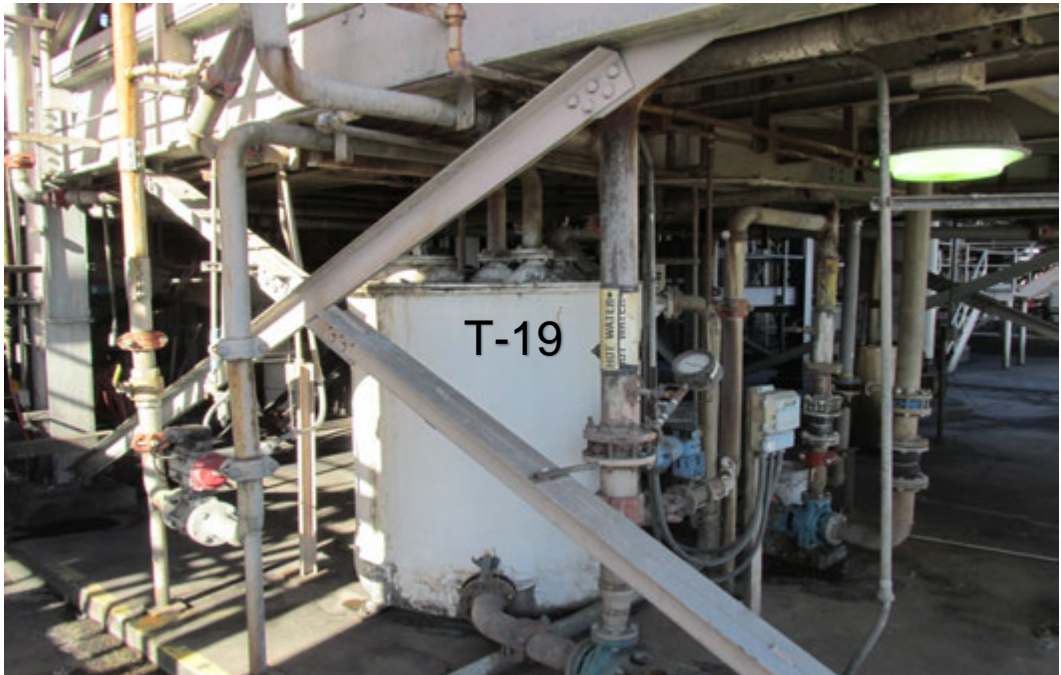
8	<p>RF-2 scrubber water equalization tank, T-19</p> <p>LOCATION: Under RF-2 Structure</p>

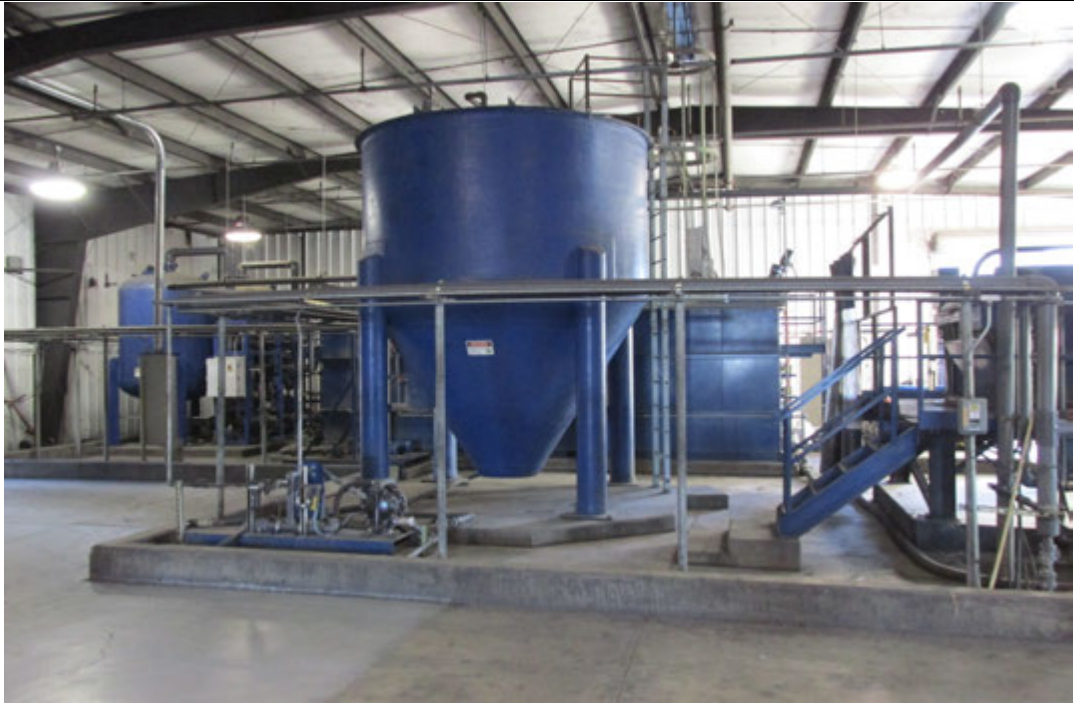
SWMU No.	SWMU Type/Designation	Picture of Unit
12	WWTP  LOCATION: Inside warehouse

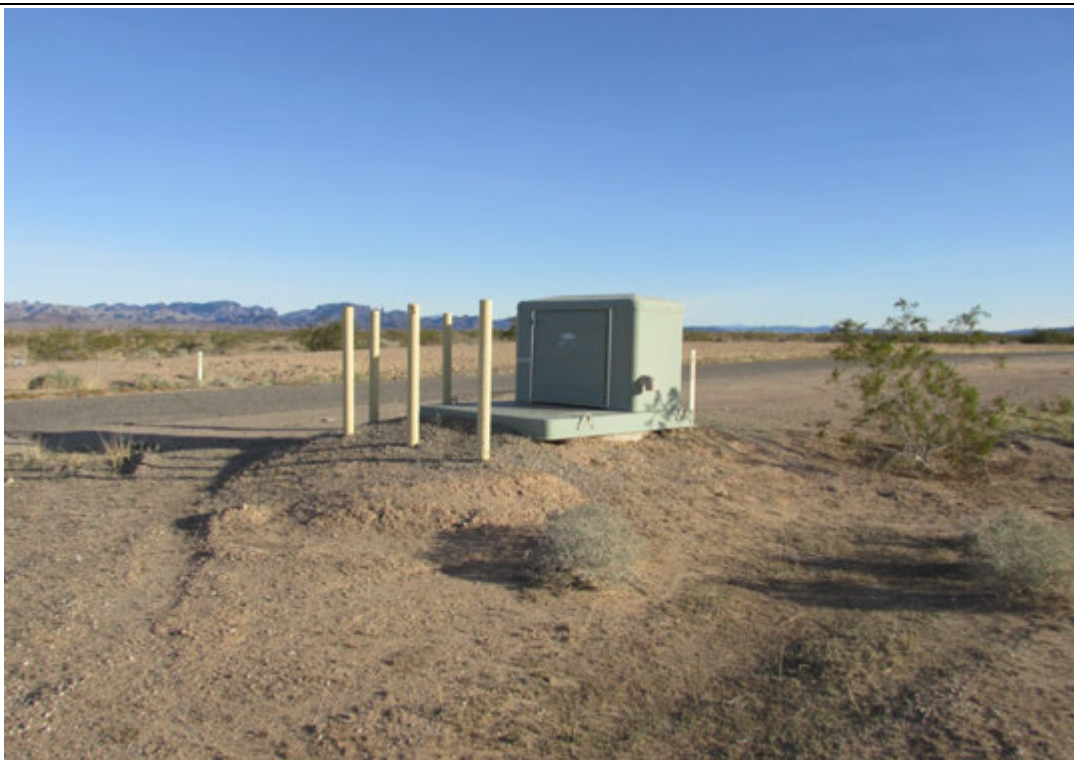
13	Wastewater lift station and piping system (old)  LOCATION: At the end of access road to plant. Old piping from Tank T-11 to the Lift Station

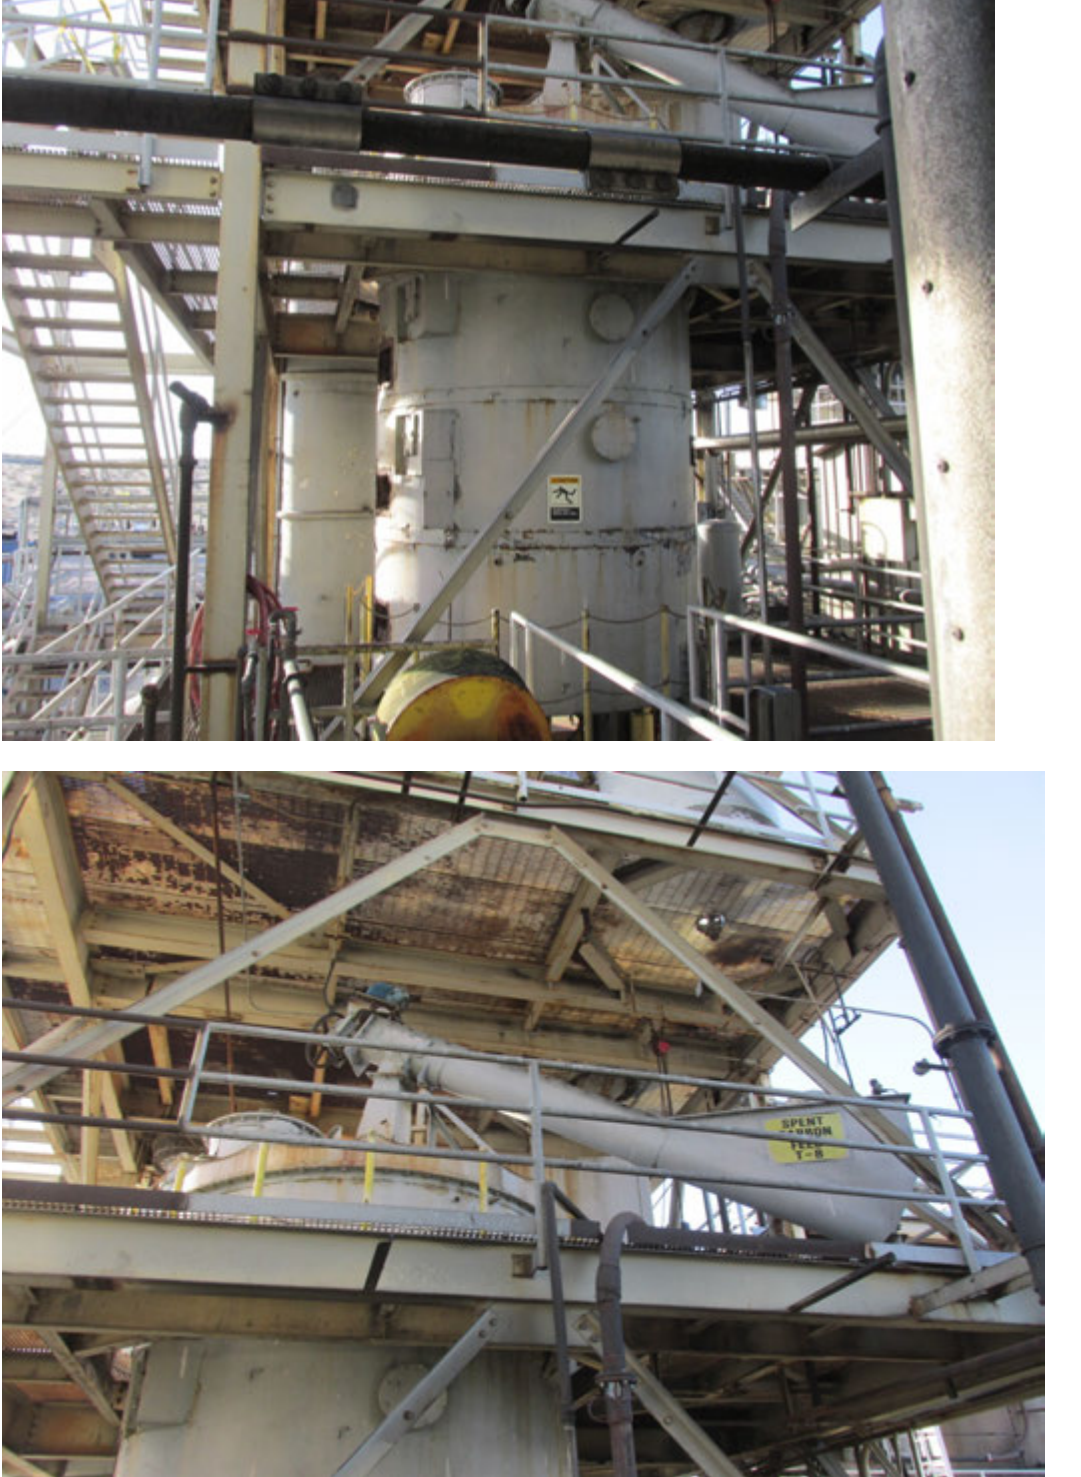
HWMU No.	HWMU Type/Designation	Pictures
1	<p data-bbox="170 430 430 577">Spent carbon reactivation furnace - RF-1 and Associated Equipment (Dewater screw)</p> <p data-bbox="170 609 430 672">LOCATION: South of RF-2</p>          <p data-bbox="170 1249 438 1344">Dewatering Screw for RF-1 (A component of HWMU 1)</p>

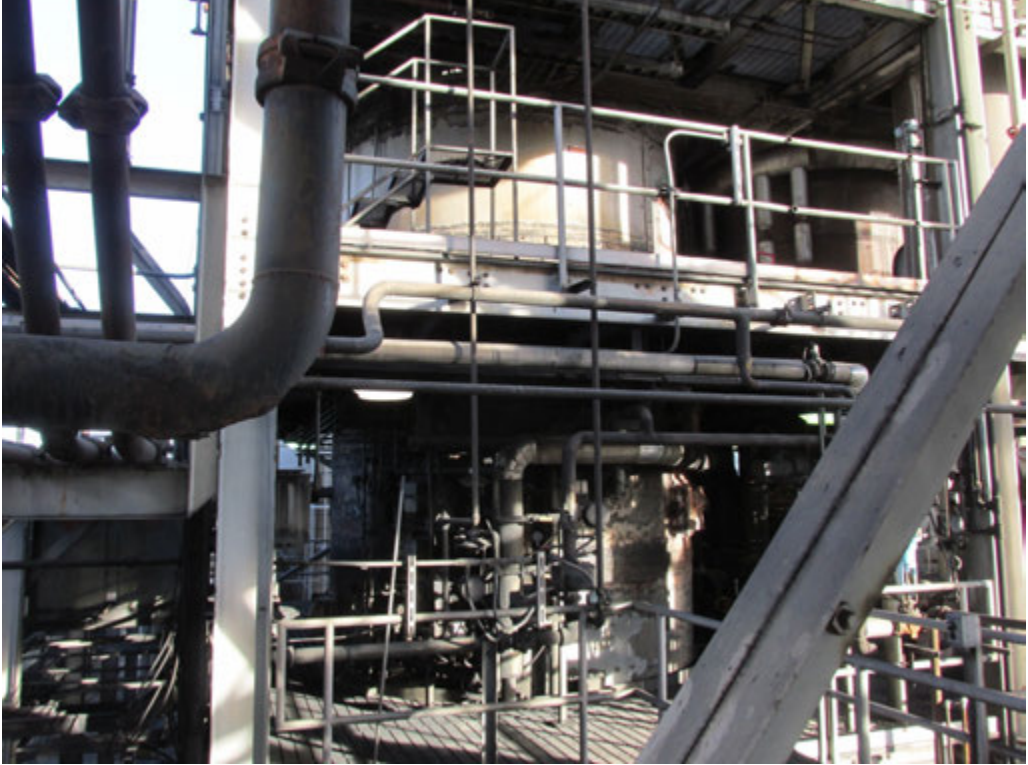
HWMU No.	HWMU Type/Designation	Pictures
2	<p data-bbox="172 428 456 575">Spent carbon reactivation furnace RF-2 and Associated Equipment (Dewater Screw, Weigh Belt)</p> <p data-bbox="172 611 407 663">LOCATION: East of warehouse</p>

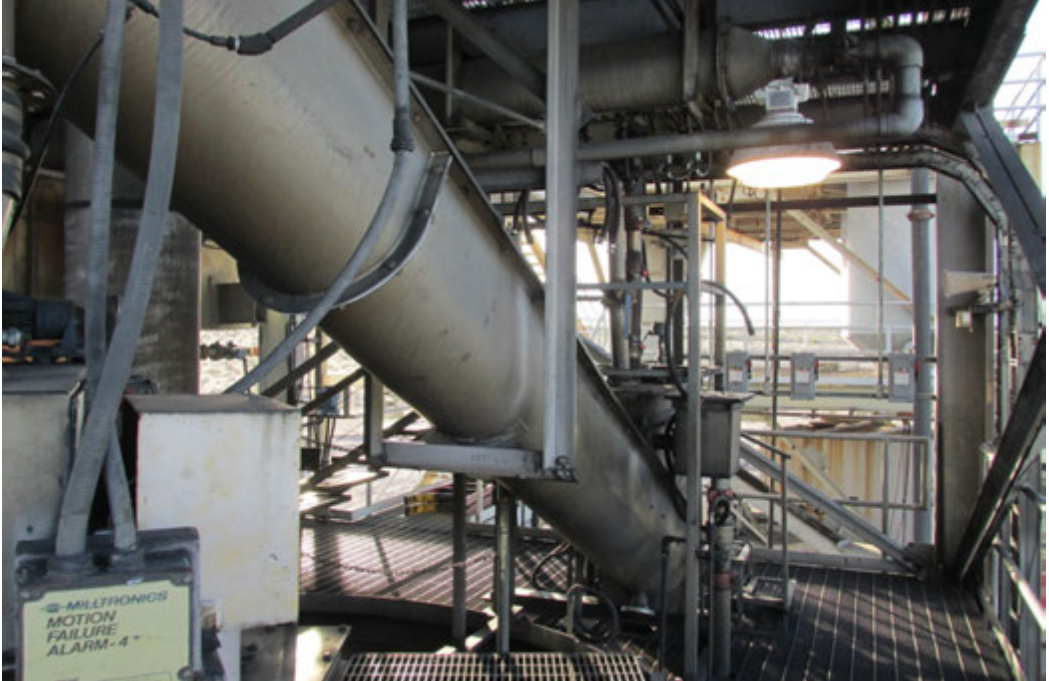
HWMU No.	HWMU Type/Designation	Pictures
	Dewatering Screw (A component of HWMU 2)

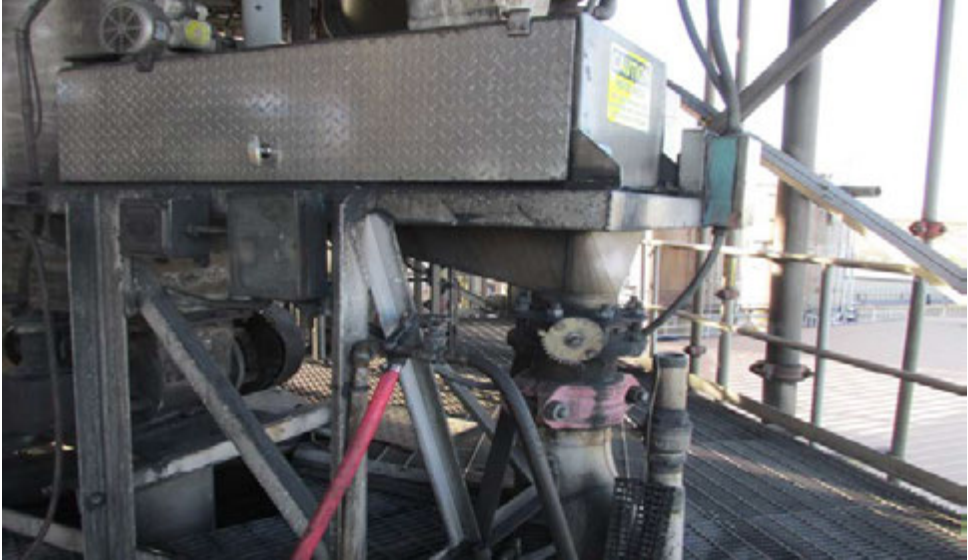
Weigh Belt (A component of HWMU 2)

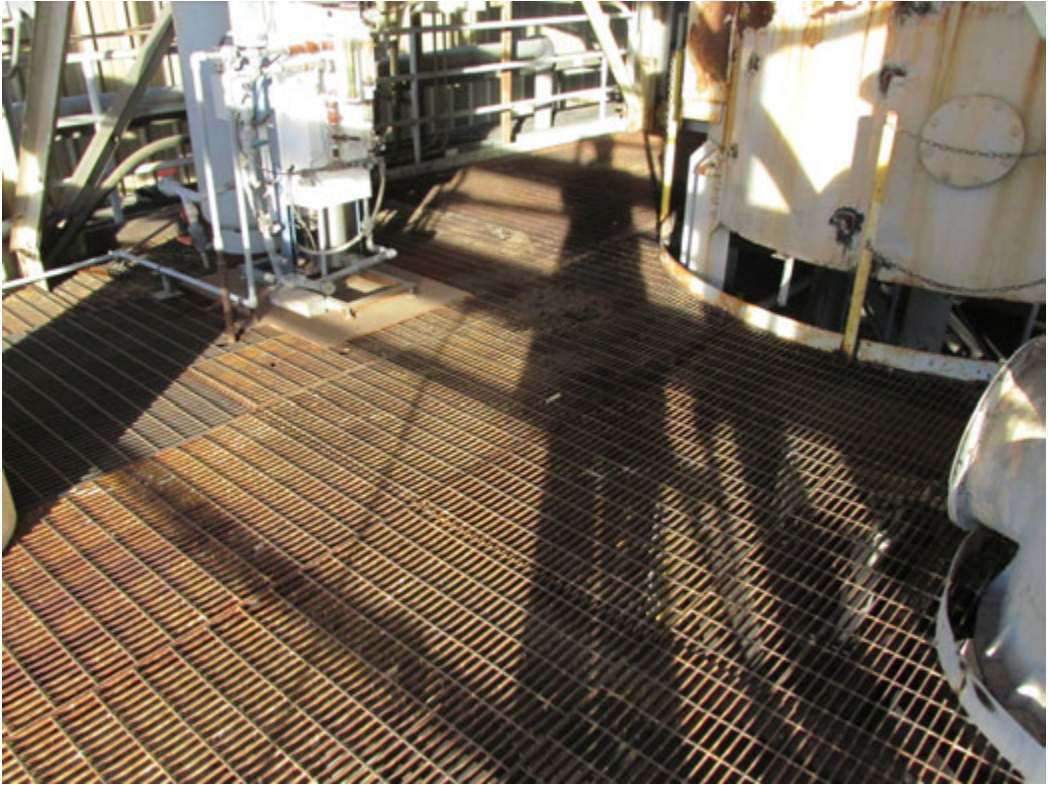
HWMU No.	HWMU Type/Designation	Pictures
3	3 RF-1 Air pollution control equipment	  A photograph showing an industrial facility with large white cylindrical tanks and a complex network of pipes and structural steel. The scene is outdoors, with a clear sky and some distant hills visible in the background. The equipment appears to be part of an air pollution control system.
	Venturi scrubber (A component of HWMU 3)

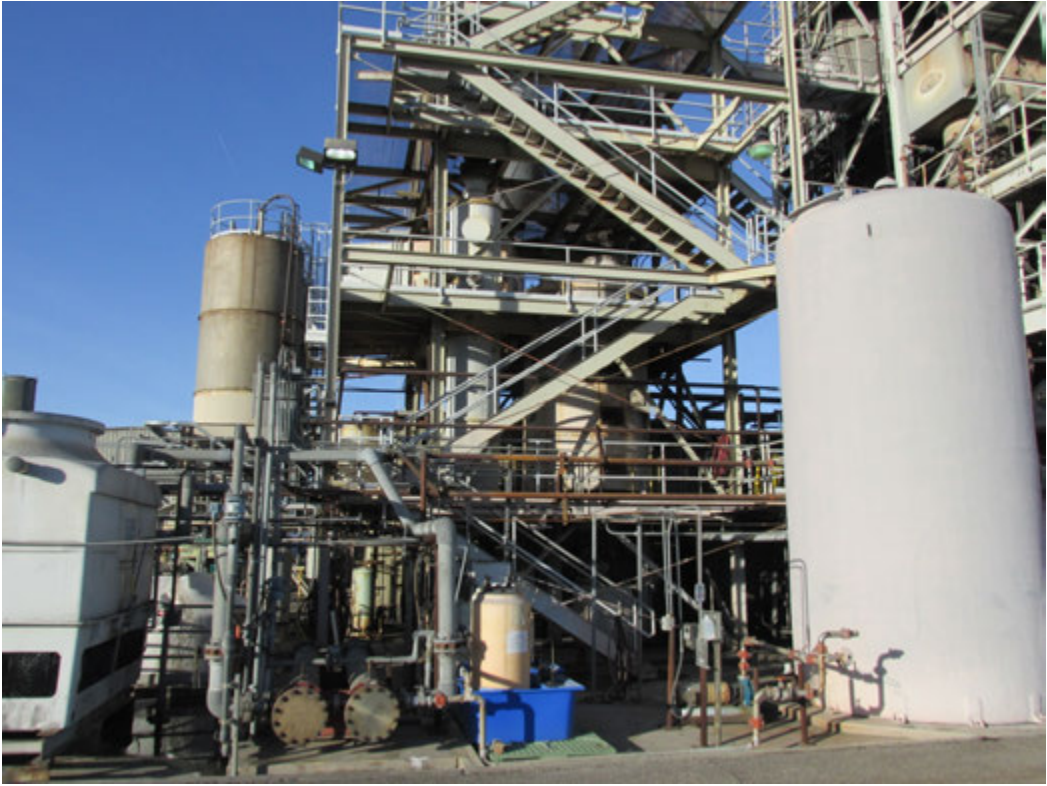
HWMU No.	HWMU Type/Designation	Pictures
	Packed bed scrubber

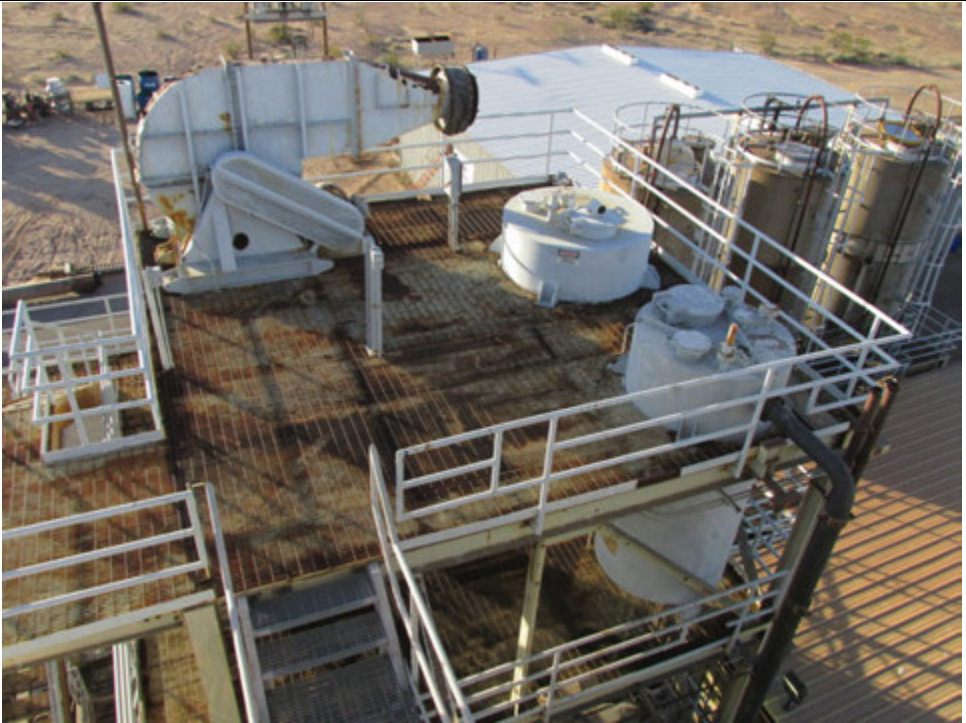
HWMU No.	HWMU Type/Designation	Pictures
	Emissions stack (was removed. This is a picture of where it was.)

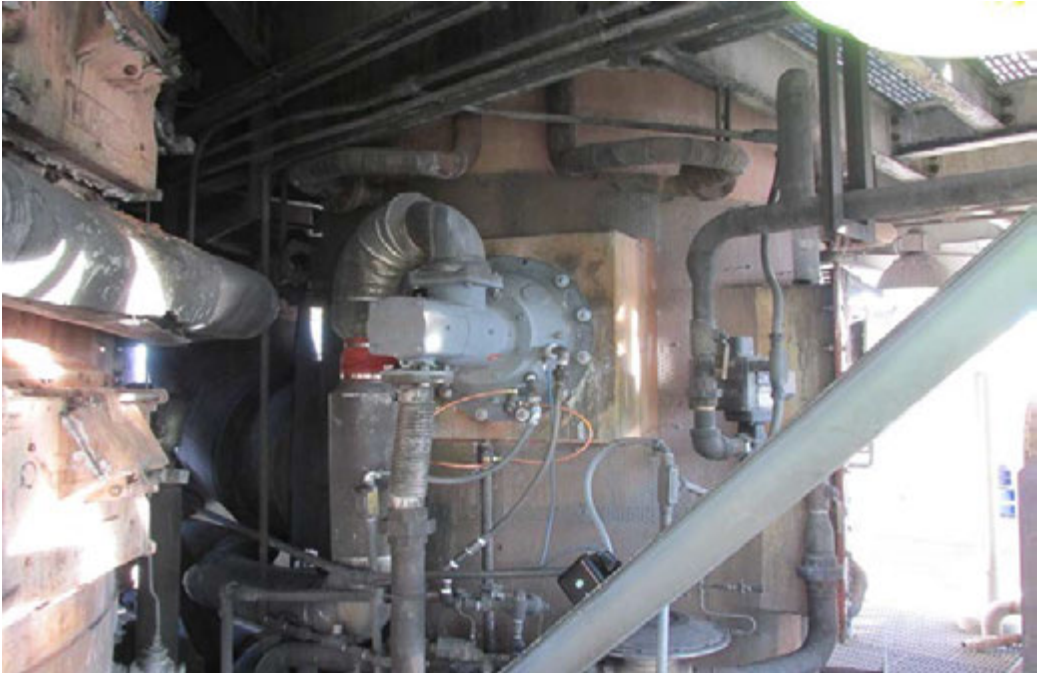
4	RF-2 Air pollution control equipment	
	Afterburner

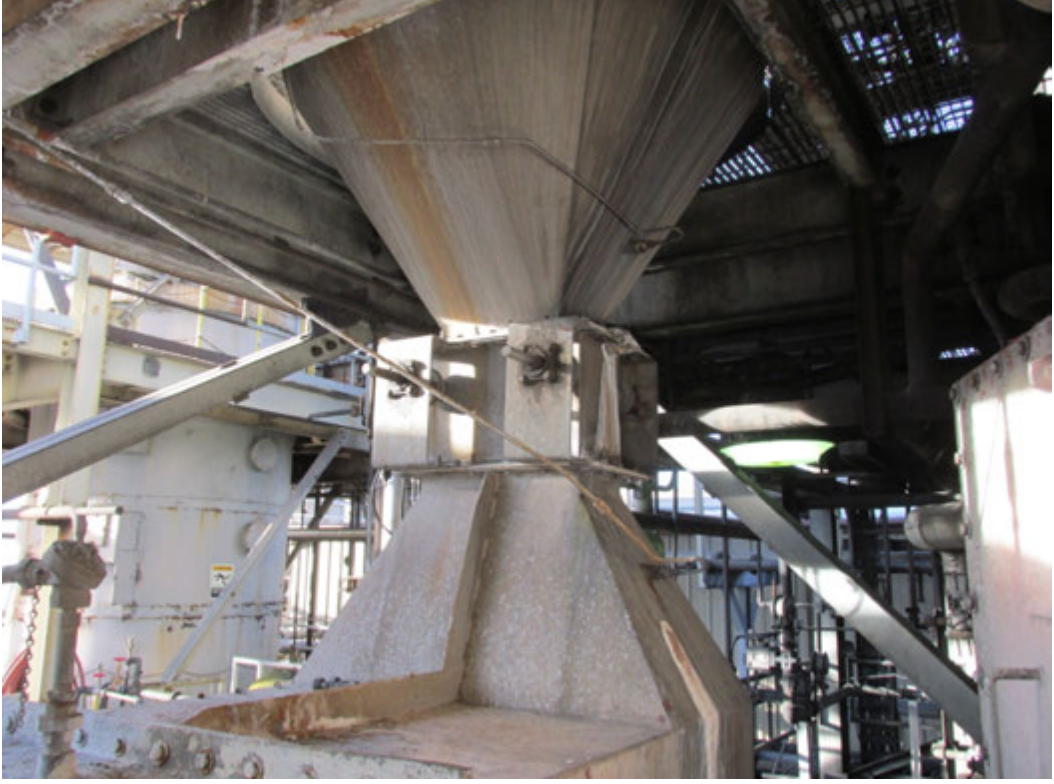
HWMU No.	HWMU Type/Designation	Pictures
	Venturi scrubber

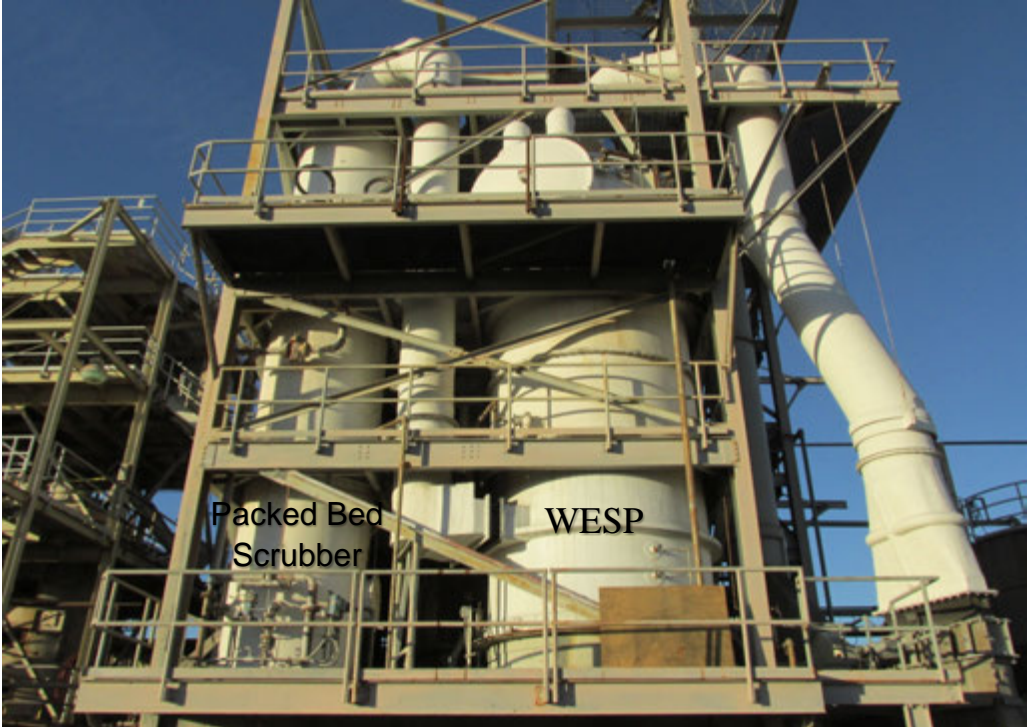
HWMU No.	HWMU Type/Designation	Pictures
	Packed bed scrubber and Wet electrostatic precipitator (WESP)

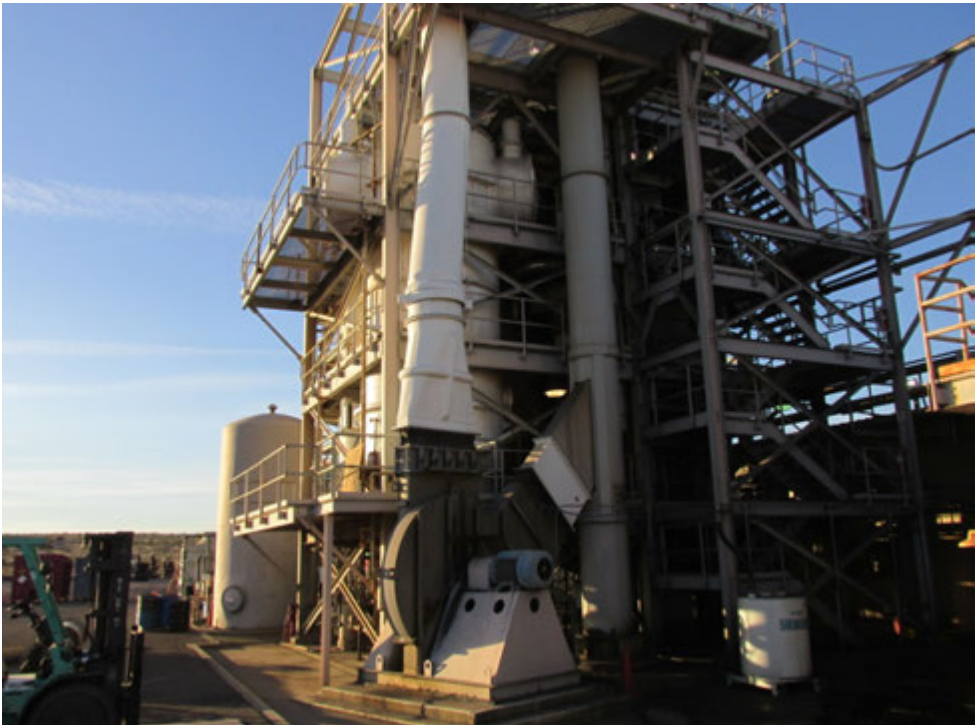
<p>A photograph showing a complex industrial structure with multiple levels of metal scaffolding and walkways. Two large, white, cylindrical tanks are visible, one of which is labeled 'WESP'. To the left, another section is labeled 'Packed Bed Scrubber'. A large white pipe runs vertically on the right side of the structure. The sky is clear and blue.</p>
	Induced draft fan

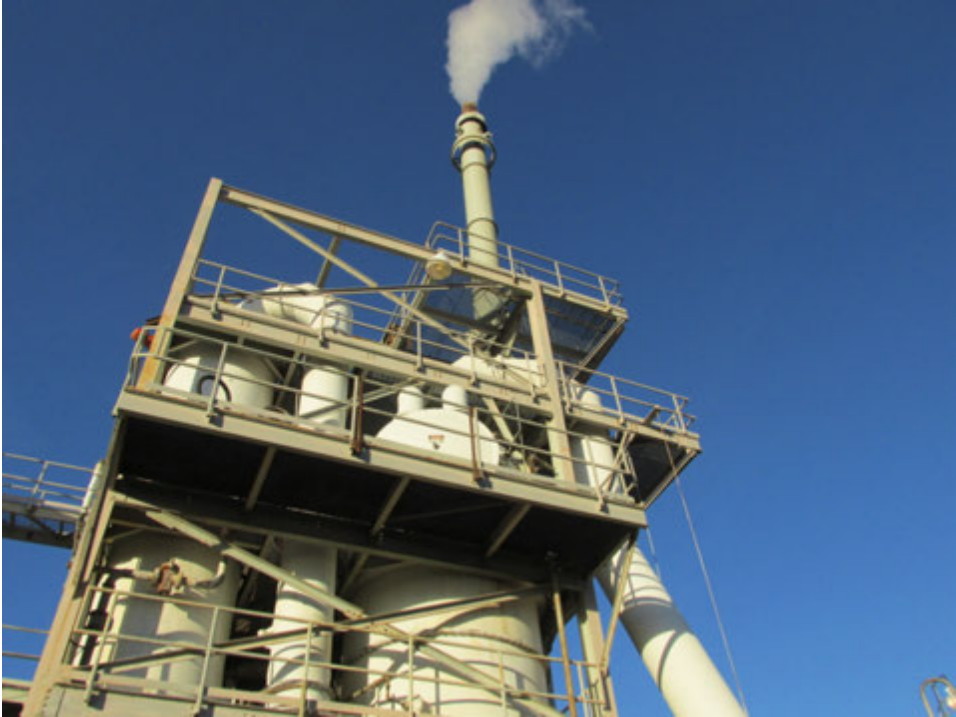
HWMU No.	HWMU Type/Designation	Pictures
	Emissions stack

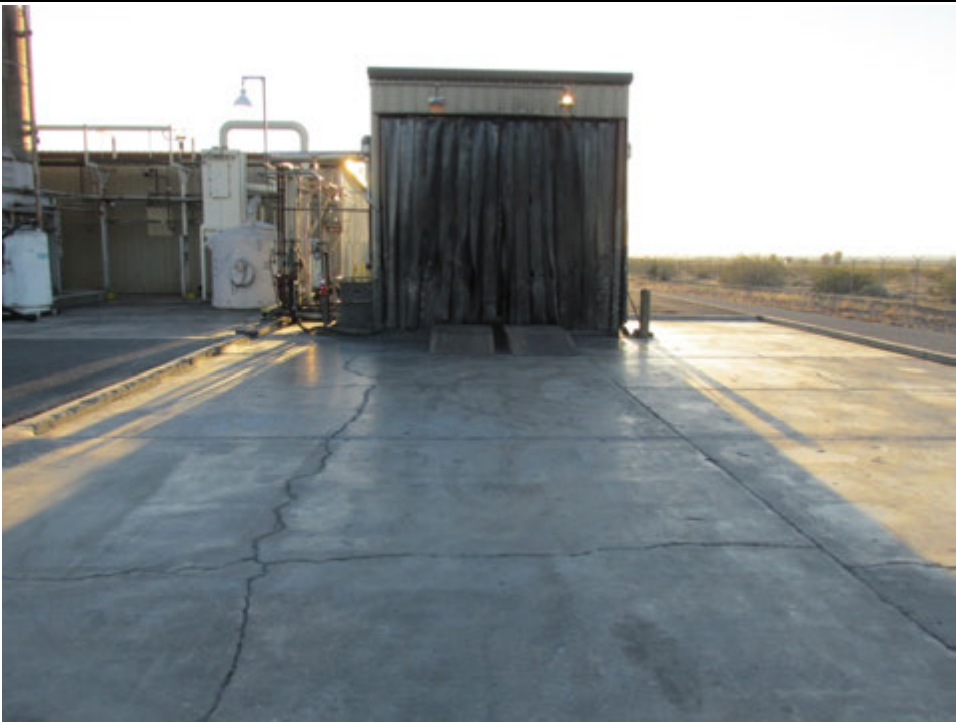
5	Spent carbon unloading hopper H-1  LOCATION: North end of facility on containment

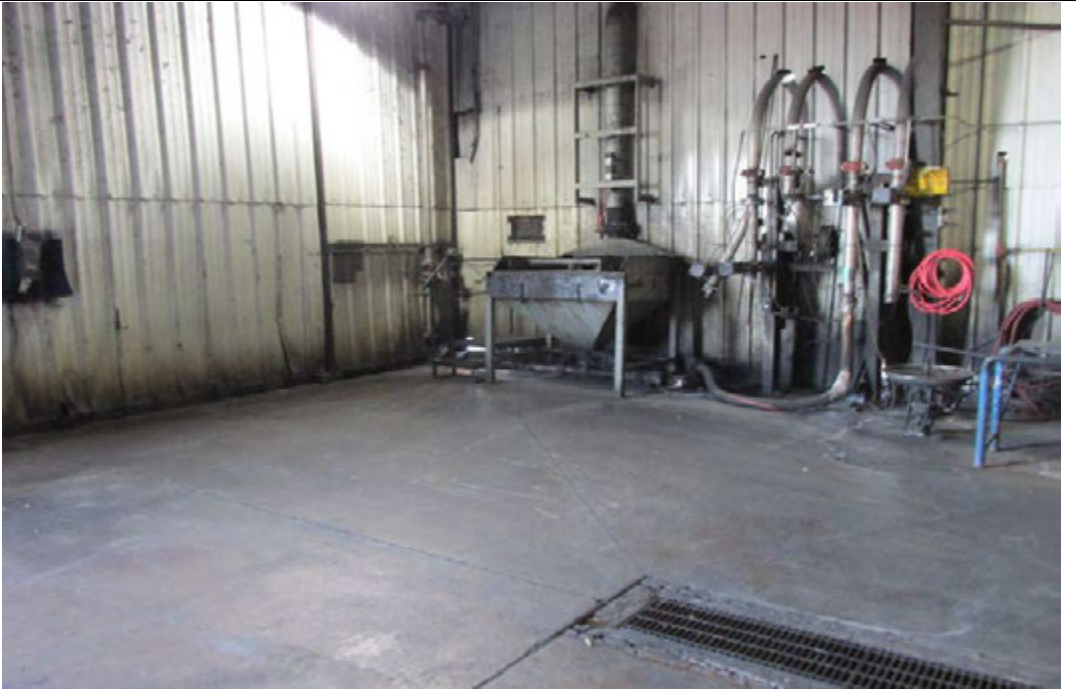
HWMU No.	HWMU Type/Designation	Pictures
6	<p>Spent carbon unloading hopper H-2</p> <p>LOCATION: Inside warehouse facing east wall</p>

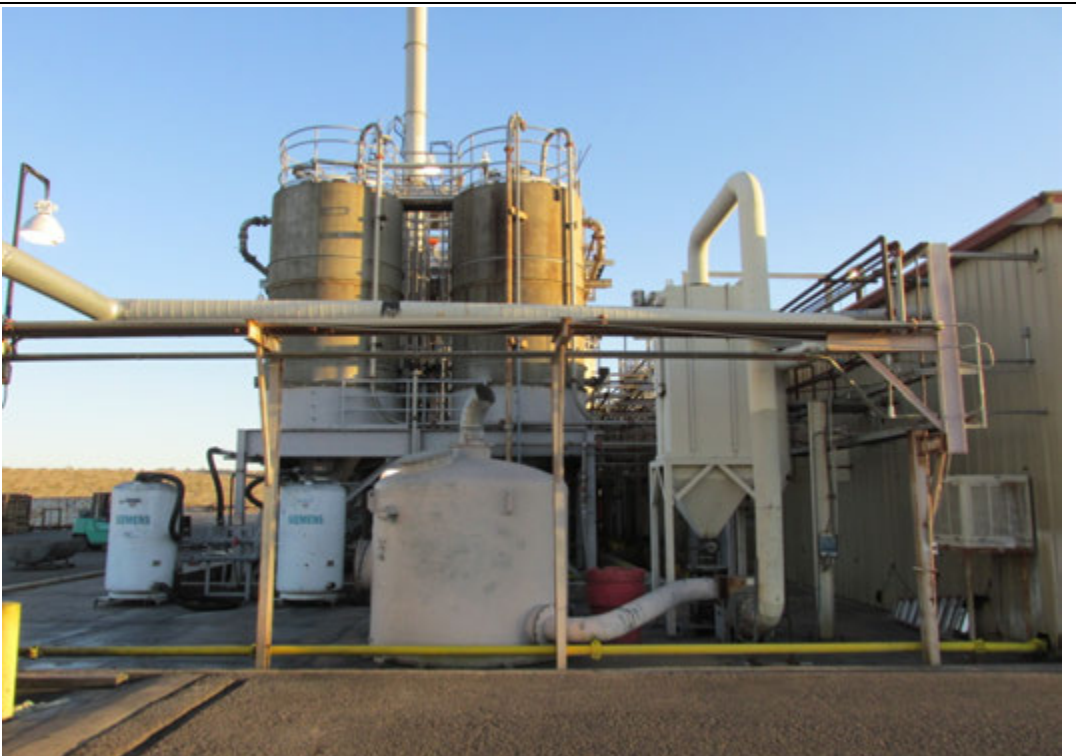
7	<p>Hopper air pollution control equipment piping and baghouse</p> <p>LOCATION: North end of facility on containment</p>

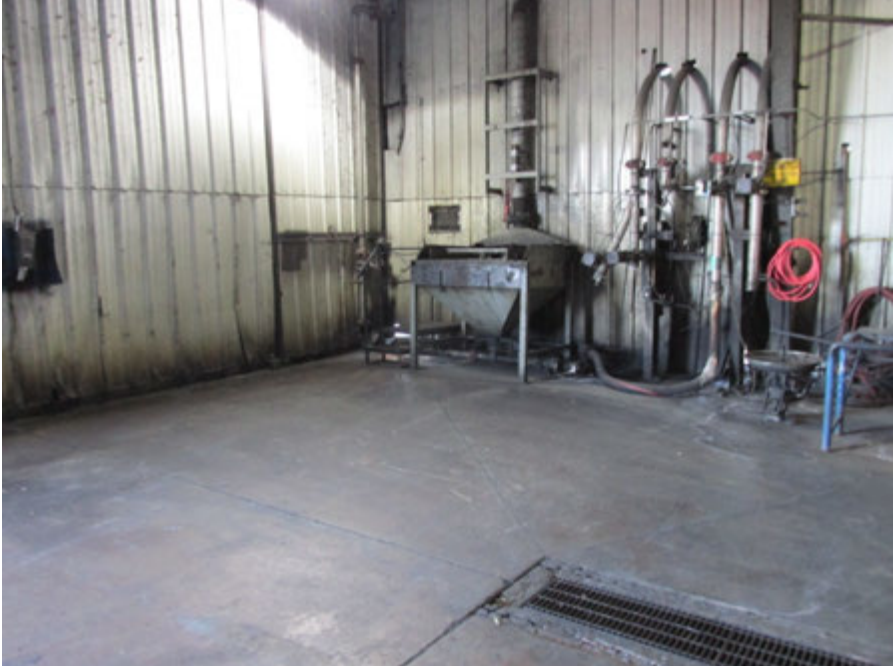
HWMU No.	HWMU Type/Designation	Pictures
8	<p data-bbox="170 426 462 514">Spent carbon slurry and recycle water transfer system</p> <p data-bbox="170 546 397 640">LOCATION: Inside warehouse on containment</p>          <p data-bbox="170 1186 454 1249">LOCATION: Outside on concrete pad</p>

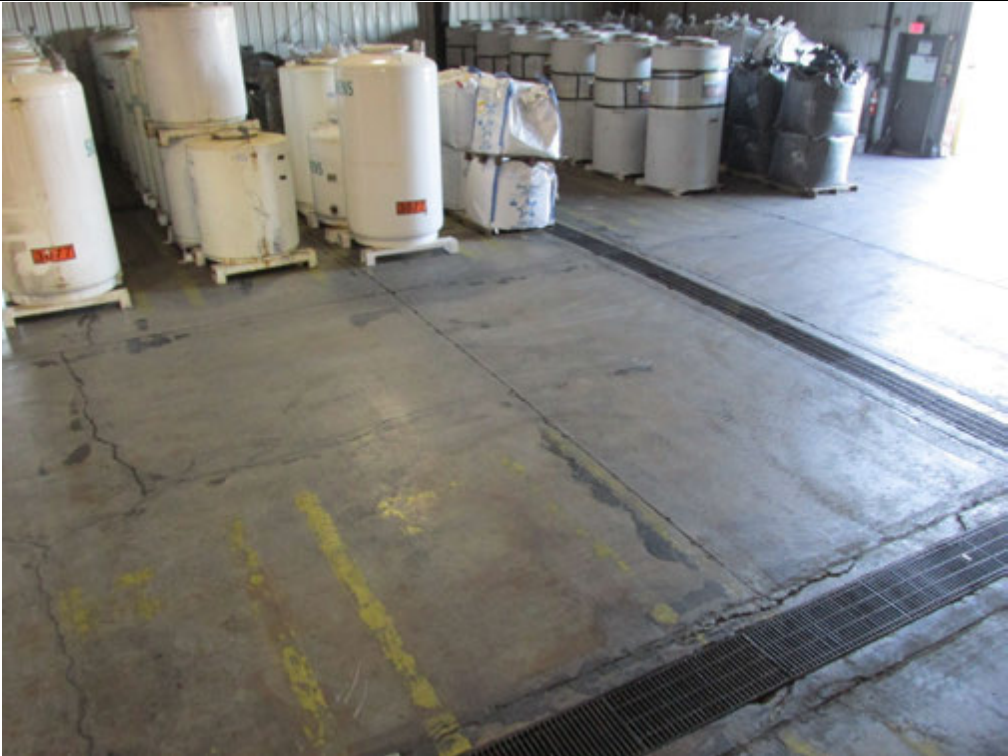
HWMU No.	HWMU Type/Designation	Pictures
9	Spent carbon storage warehouse  LOCATION: Inside warehouse

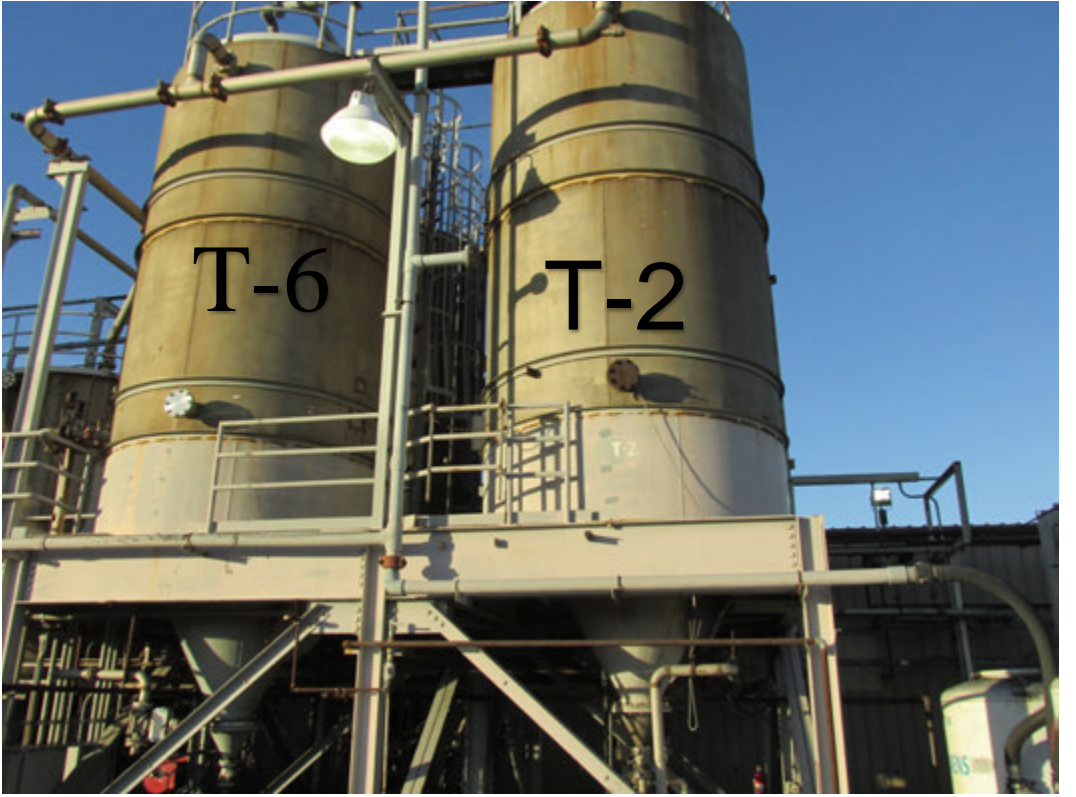
HWMU No.	HWMU Type/Designation	Pictures
11	<p>Spent carbon slurry storage tank, T-2</p> <p>LOCATION: East of warehouse within secondary containment</p>

<p>A photograph showing two large, cylindrical industrial storage tanks. The tank on the left is labeled 'T-6' and the tank on the right is labeled 'T-2'. Both tanks are supported by a metal structure with railings. A bright light fixture is visible between the tanks. The background is a clear blue sky.</p>
12	<p>Spent carbon slurry storage tank, T-5</p> <p>LOCATION: East of warehouse within secondary containment</p> <p>NOTES:</p>

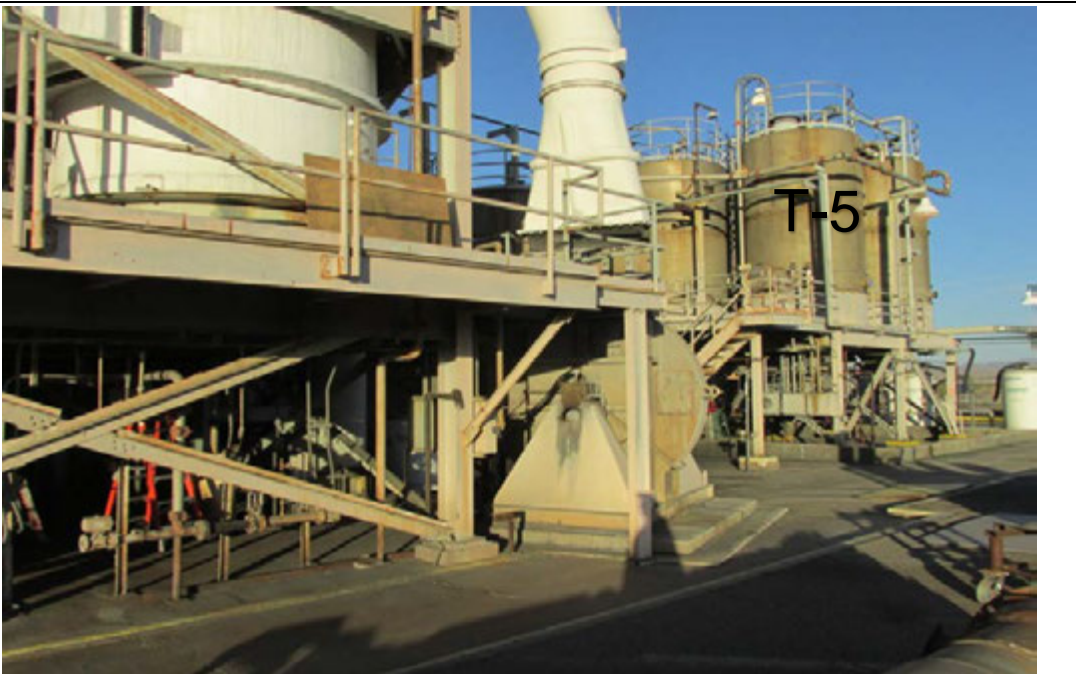
<p>A photograph of an industrial facility. In the foreground, there is a large, white, conical structure. In the background, there are several large industrial tanks and pipes. One of the tanks in the background is labeled 'T-5'. The facility is surrounded by a concrete area with yellow safety lines.</p>

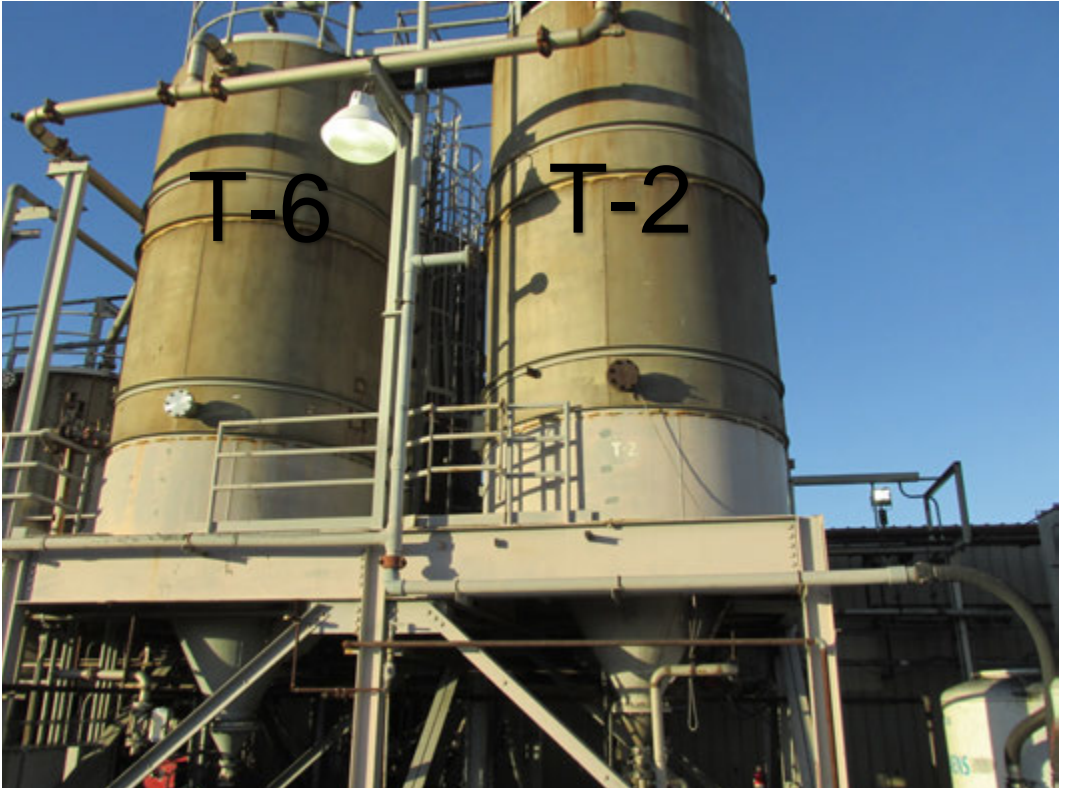
HWMU No.	HWMU Type/Designation	Pictures
13	<p>Spent carbon slurry storage tank, T-6</p> <p>LOCATION: East of warehouse within secondary containment</p> <p>NOTES:</p>

A photograph showing two large, cylindrical industrial storage tanks. The tank on the left is labeled 'T-6' and the tank on the right is labeled 'T-2'. Both tanks are supported by a metal structure with railings. A bright light fixture is visible between the tanks. The background is a clear blue sky.
