REVISED DRAFT  
RCRA FACILITY ASSESSMENT  
REPORT

Evoqua Water Technologies, LLC.  
2523 Mutahar Street  
Parker, Arizona  
AZD 982 441 263

U.S. ENVIRONMENTAL PROTECTION AGENCY  
Region 9  
75 Hawthorne  
San Francisco, CA

Date of Revised Draft	September 2016
US EPA Region 9	
Site No.	AZD 982 441 263
Document Control No.	REPA3-0903-017
Contract No.	68-W-02-022
Draft RFA Prepared by	Booz Allen Hamilton
Revised Draft RFA Prepared By	USEPA Project Manager
Telephone No. (415) 972-3348	“Mike” Mahfouz Zabaneh

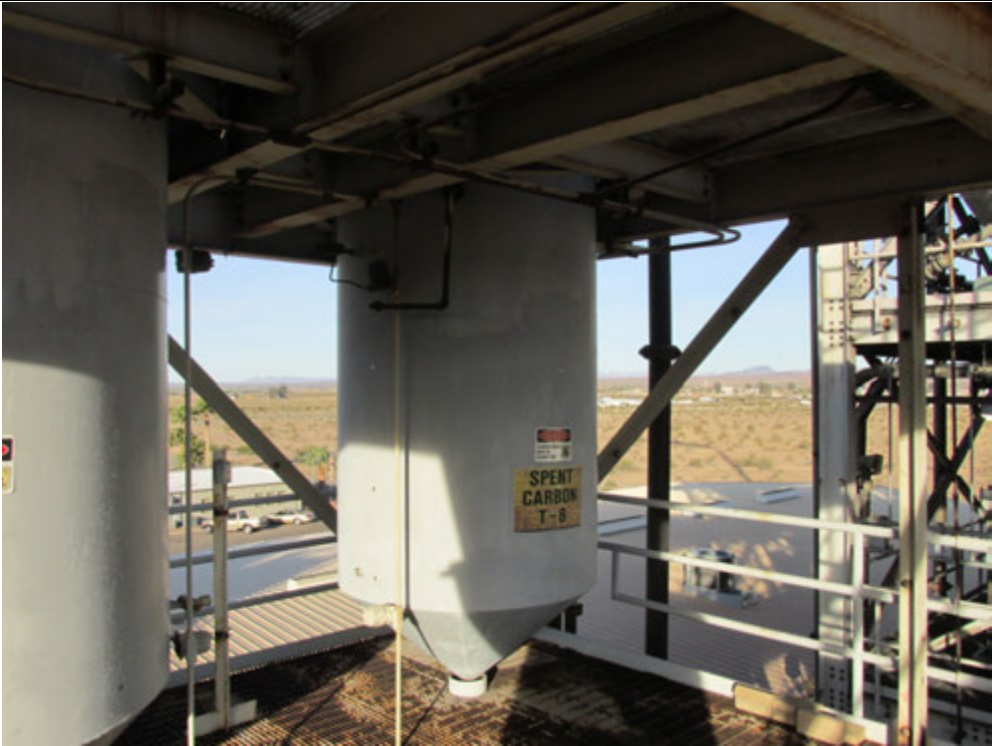
HWMU No.	HWMU Type/Designation	Pictures
14	Furnace Feed System Tank T-8 and Ancillary Equipment  LOCATION: RF-1 Structure

A photograph showing a large, vertical, cylindrical metal tank (Tank T-8) situated on an elevated industrial platform. The tank has a conical bottom and a yellow label that reads "SPENT CARBON T-8". The platform is surrounded by metal railings, and the background shows a clear sky and a distant landscape.
15	T-18 and Ancillary Equipment  LOCATION: RF-2 structure

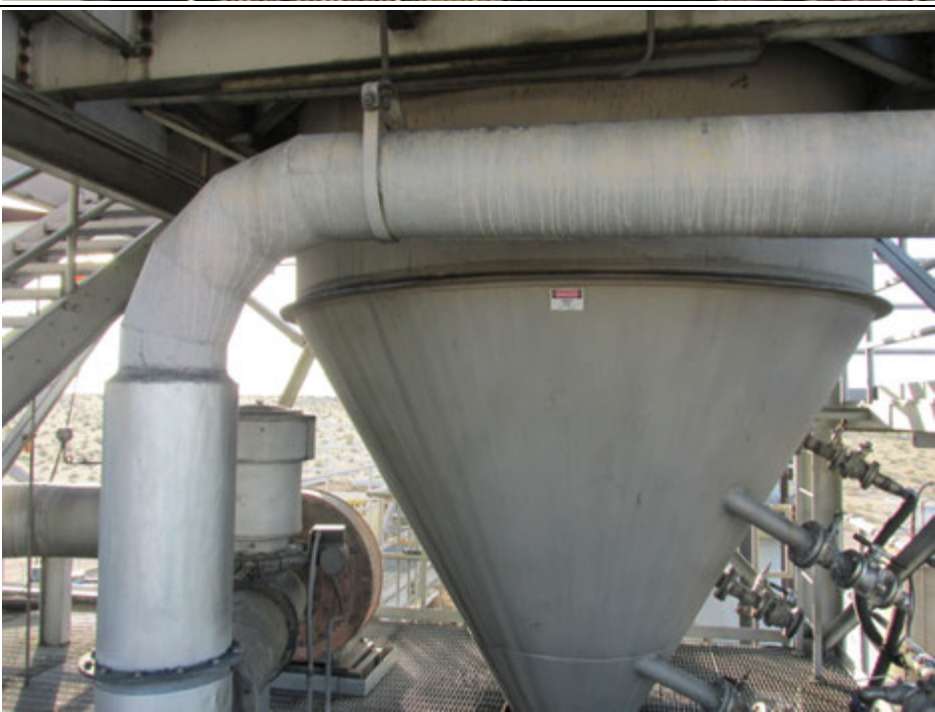
A photograph showing a large, conical metal tank (Tank T-18) with a wide, flared top. The tank is connected to a complex network of pipes and valves. The equipment is located on an elevated industrial platform with metal railings. The background shows a clear sky and a distant landscape.

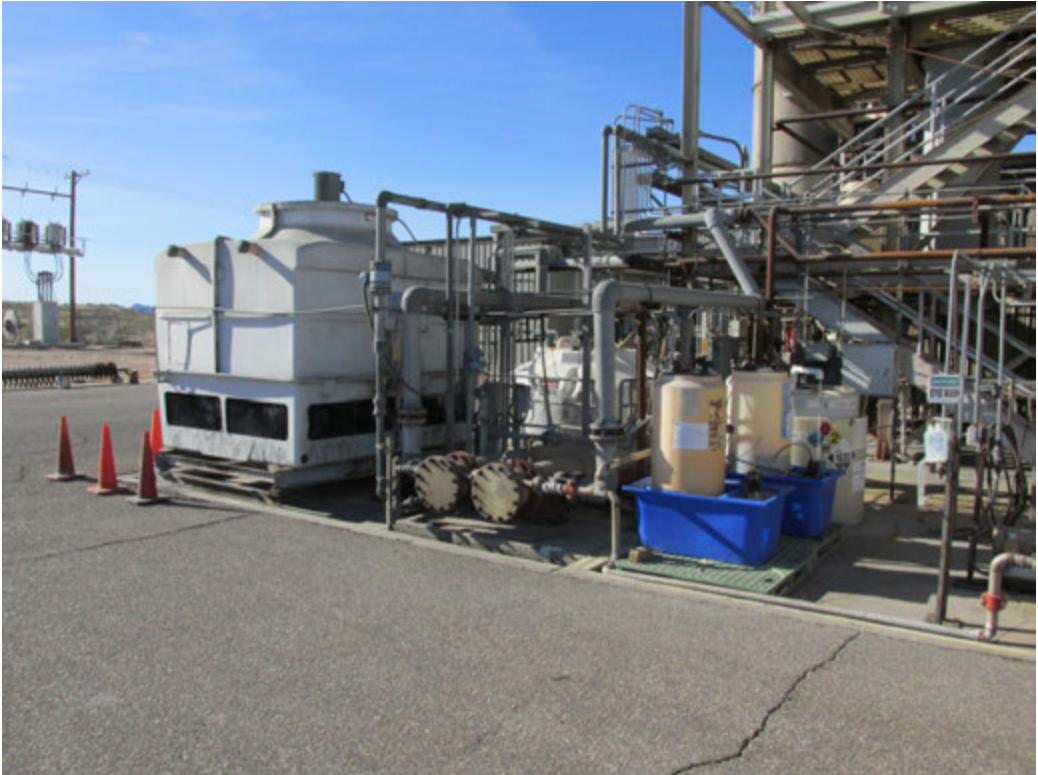
HWMU No.	HWMU Type/Designation	Pictures
16	Wastewater conveyance piping to wastewater treatment tank  LOCATION: East of RF-2 structure

A photograph showing an industrial facility. In the foreground, there is a large white cylindrical tank on a trailer. To its right, there is a complex network of pipes, valves, and a blue storage bin. In the background, there are more industrial structures, including a large metal framework, and a clear blue sky. Three orange traffic cones are visible on the asphalt ground to the left of the white tank.
17	Spent carbon storage warehouse barrel washer  LOCATION: Next to H-2 in warehouse

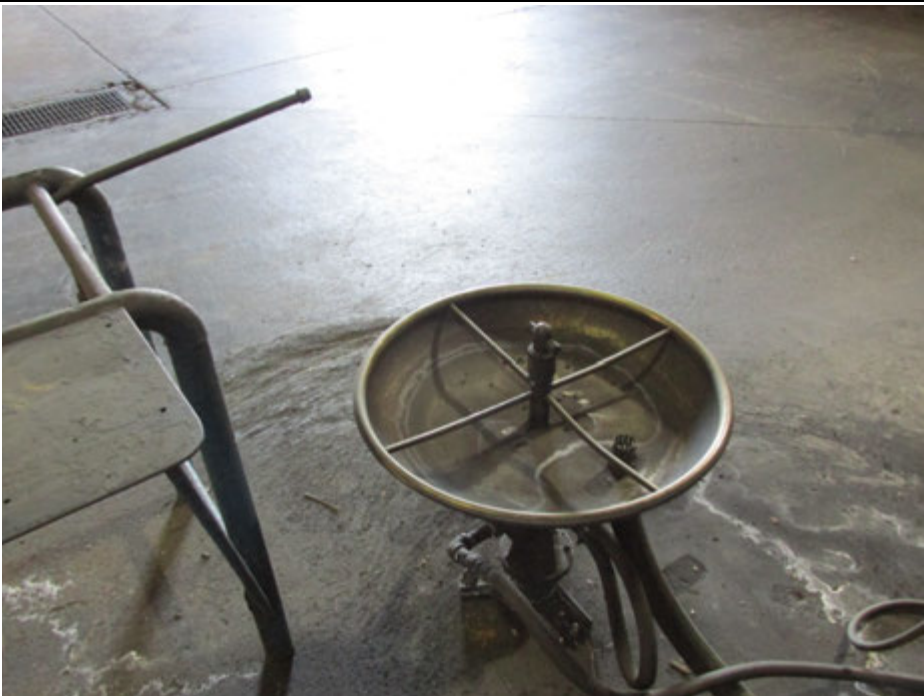
A photograph of a barrel washer inside a warehouse. The machine is a circular metal basin with a central agitator and a handle. It is mounted on a metal frame. The floor is concrete and appears wet. A metal grate is visible in the background.

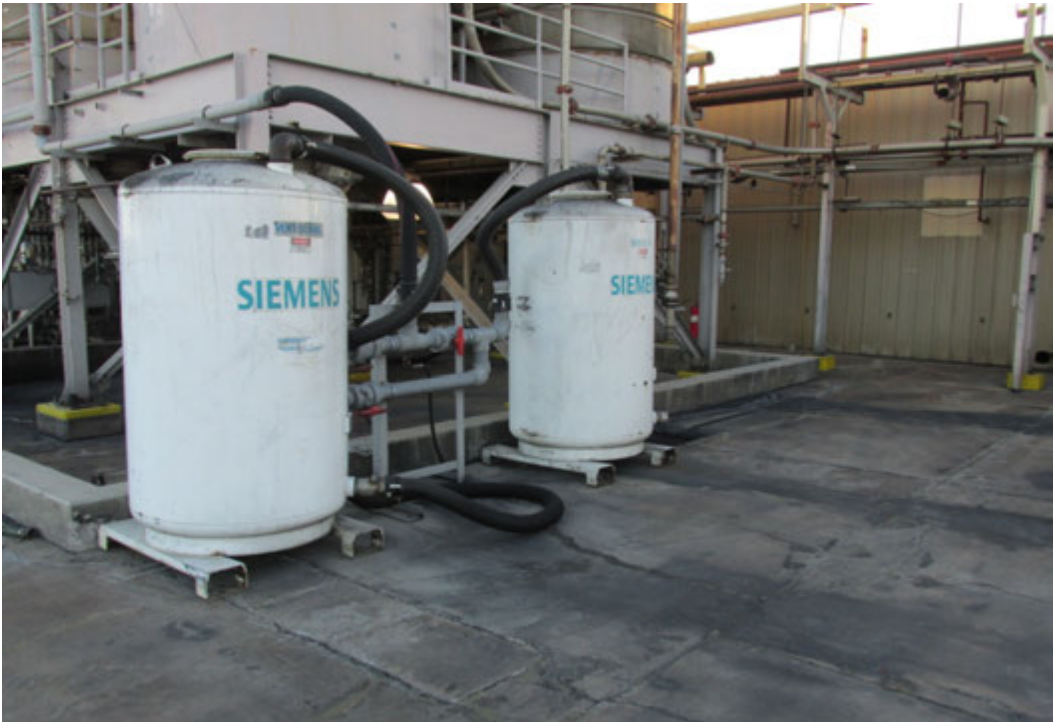
HWMU No.	HWMU Type/Designation	Pictures
18	Carbon adsorber - PV1000  LOCATION:	Equipment does not exist anymore
19	Carbon adsorber WS-1. These are two adsorbers in series (lead – lag configuration)  LOCATION: Beside spent carbon storage tank

A photograph showing two large, white, cylindrical carbon adsorbers (SIEMENS brand) mounted on a concrete pad. They are connected by a network of pipes and hoses, arranged in a lead-lag configuration. The background shows industrial structures and a concrete floor.

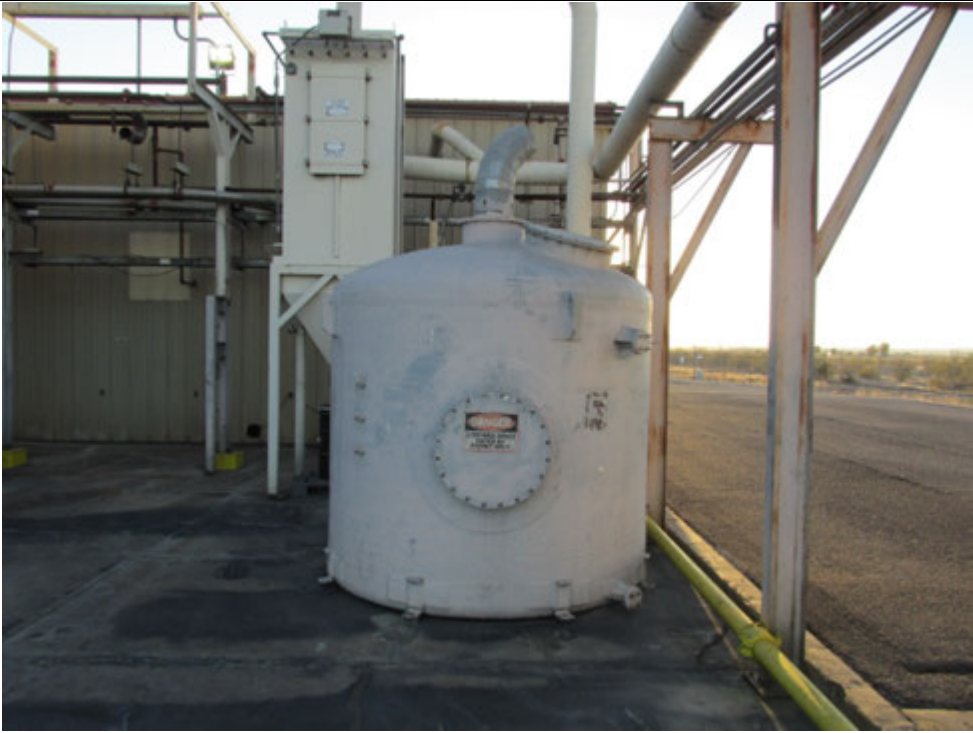
HWMU No.	HWMU Type/Designation	Pictures
20	Carbon adsorber WS-2  LOCATION: Beside Hopper H-1

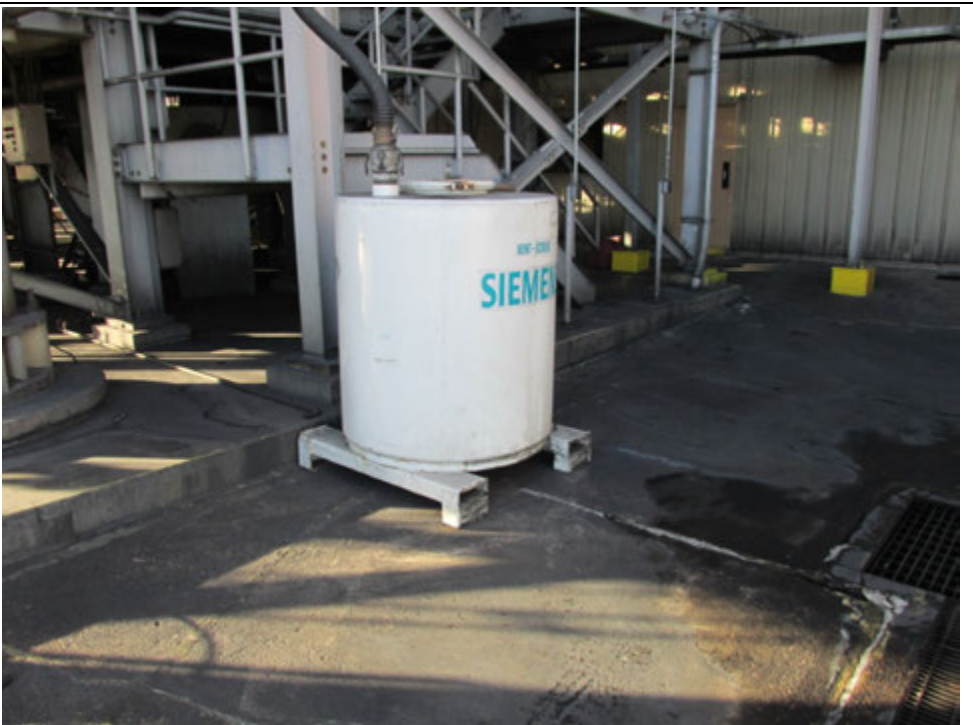
21	Carbon adsorber WS-3  LOCATION: Beside RF-2

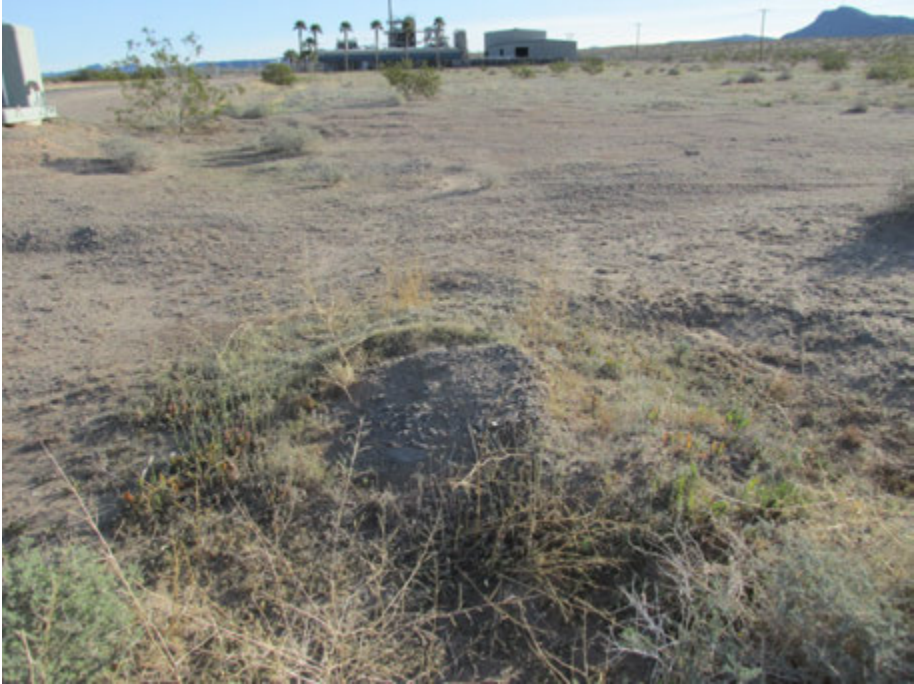
HWMU No.	HWMU Type/Designation	Pictures
22	Slurry transfer inclined plate settler tank  LOCATION: Adjacent to the venturi scrubber	Equipment doesn't exist anymore
23	Scrubber recycle tank T-17 LOCATION: Beside RF-1	Equipment doesn't exist anymore
24	Filter press  LOCATION: Next to scrubber system for RF-1	Equipment doesn't exist anymore
25	New Facility Discharge Piping System  LOCATION: New piping bypasses Lift Station to POTW

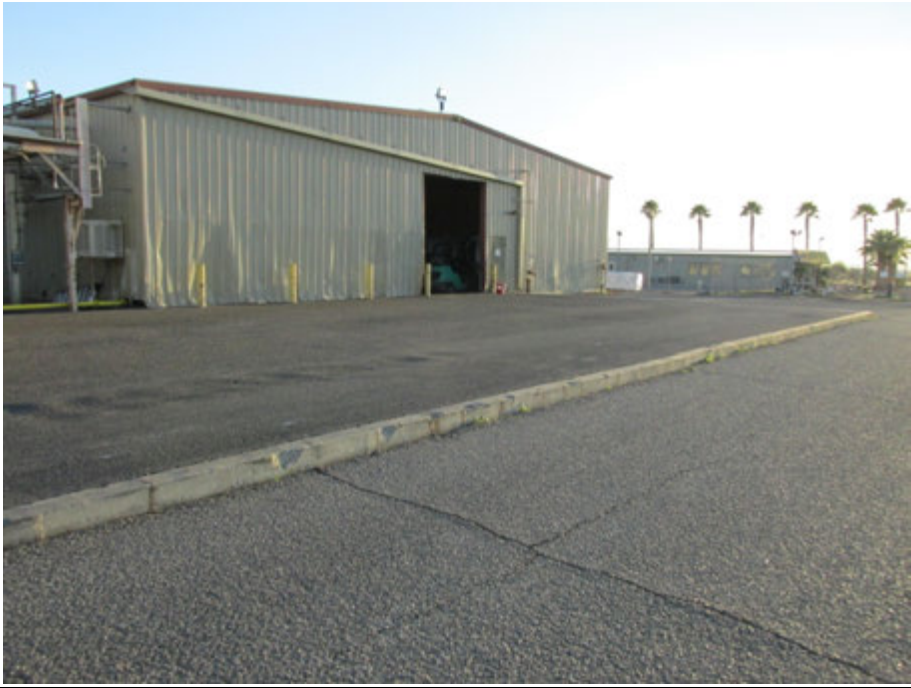
No.	AOC Type/Designation/Location	Management Requirements at Closure
1	Spent carbon unloading and transfer area. LOCATION:

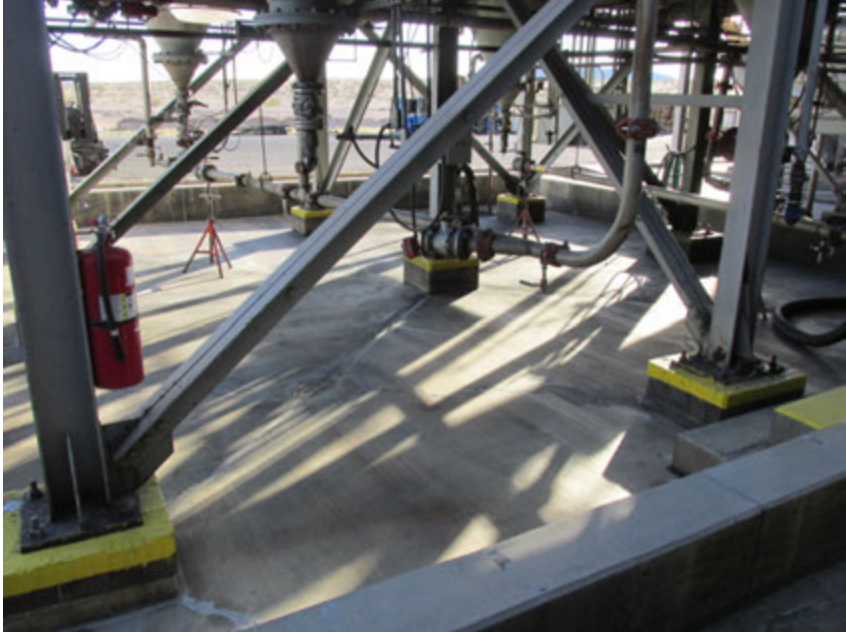
2	Tank area concrete containment pad LOCATION:

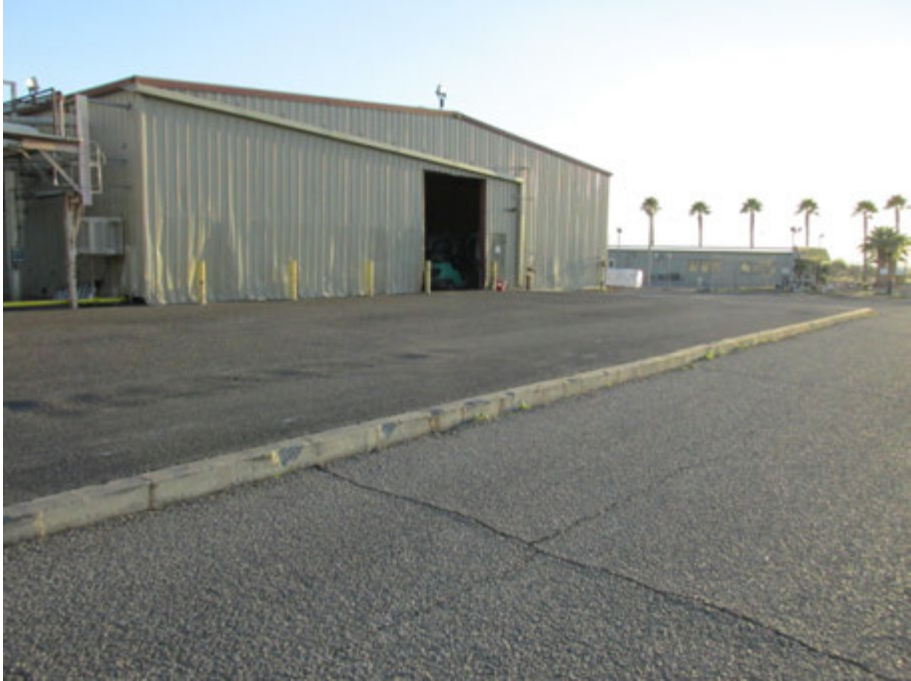
No.	AOC Type/Designation/Location	Management Requirements at Closure
3	Receiving area/pad  LOCATION:

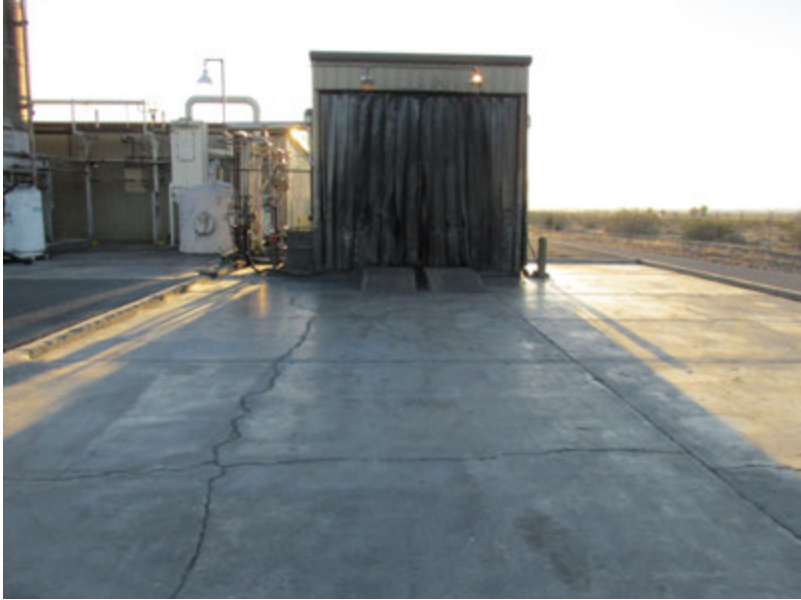
4	Hopper H-1 loading/unloading area LOCATION:

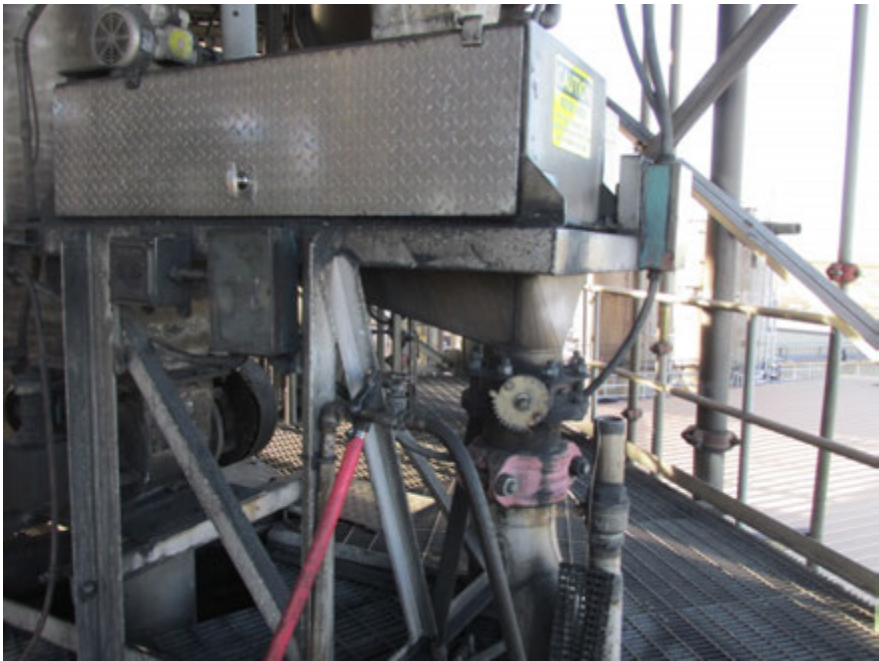
A photograph of a weigh belt scale mechanism. It features a large, heavy-duty metal frame supporting a weighing platform. A red hose is visible in the foreground. The equipment is located on a metal walkway with a grate floor. The background shows industrial railings and a bright light source.

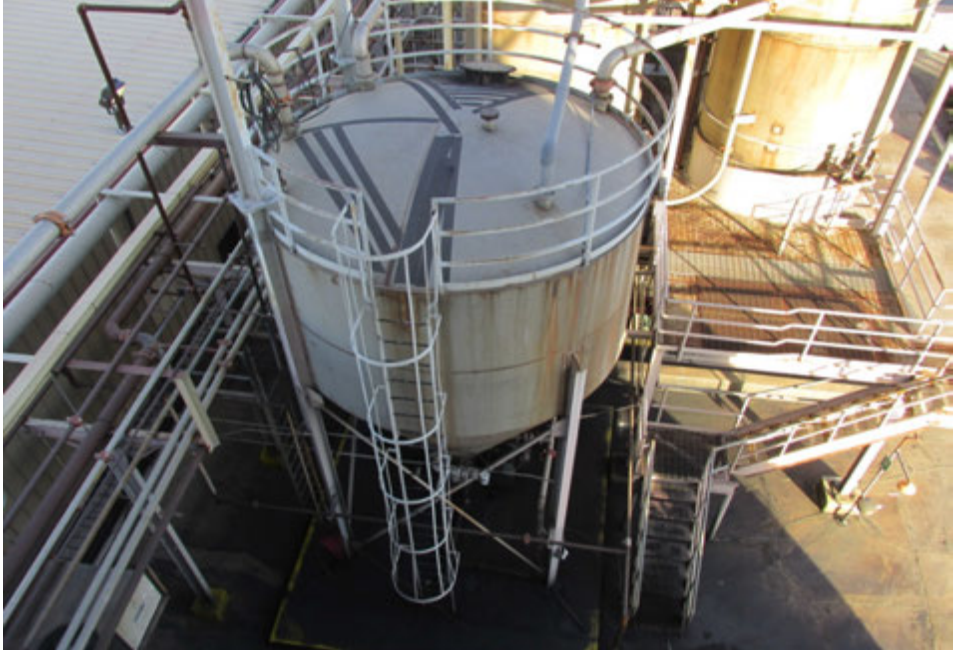
No.	AOC Type/Designation/Location	Management Requirements at Closure
8	Recycled motive water tank T-9  LOCATION:

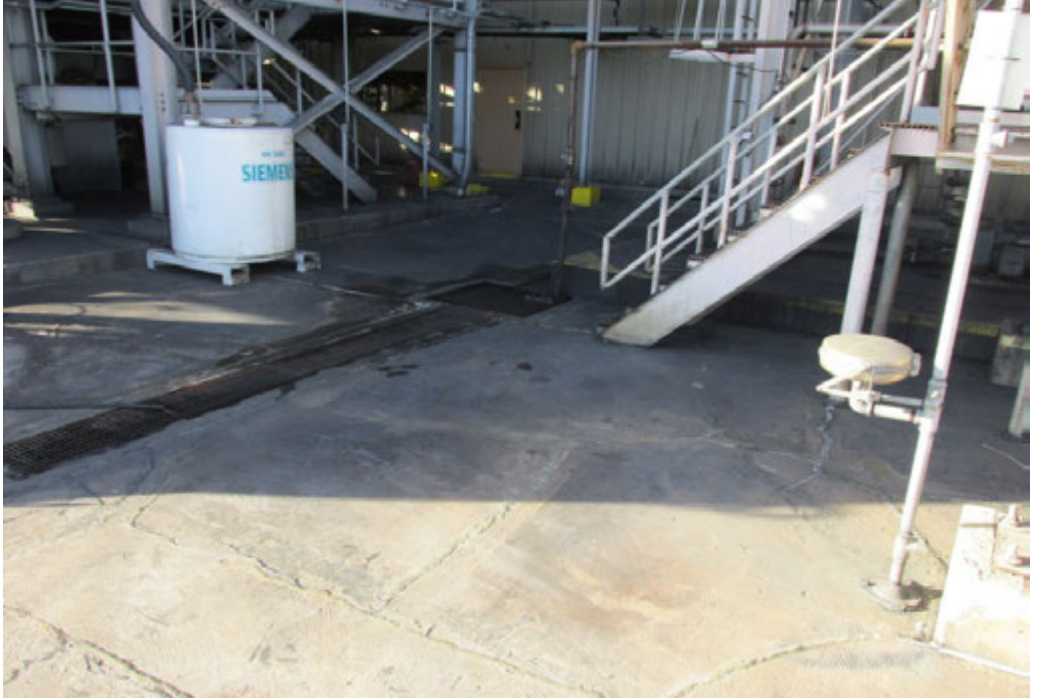
A wide-angle photograph of an industrial interior. A white cylindrical tank with the 'SIEMENS' logo is on the left. A metal staircase with railings is on the right. The floor is concrete with a dark drainage channel. The lighting is bright, suggesting an indoor or well-lit outdoor area.

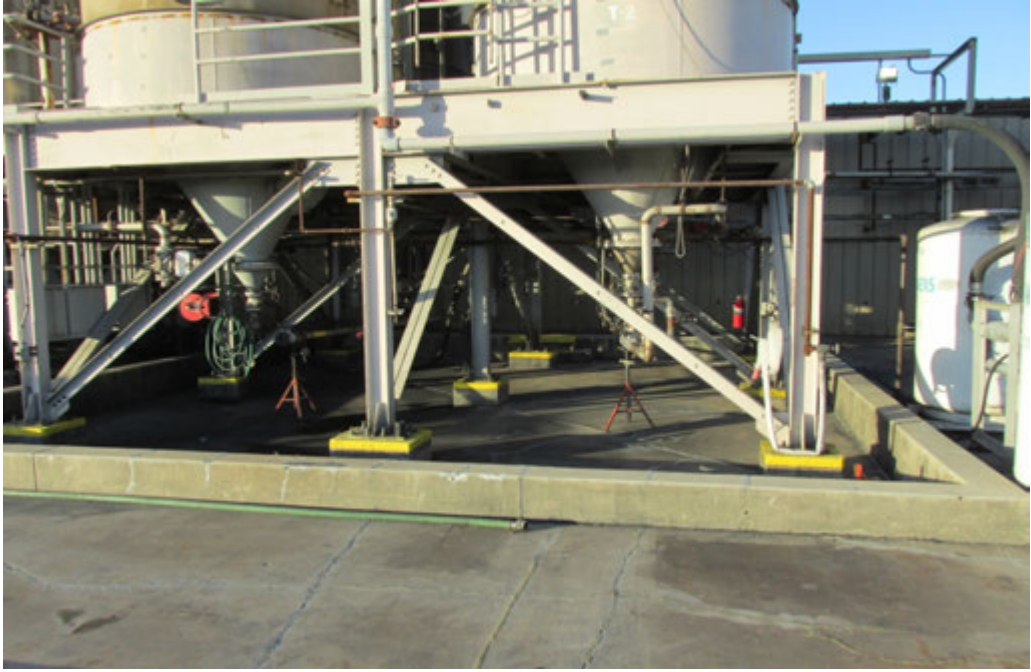
No.	AOC Type/Designation/Location	Management Requirements at Closure
14	Spent carbon storage tanks and carbon adsorbers LOCATION:

A photograph showing industrial equipment, likely spent carbon storage tanks and adsorbers, at a facility. The equipment consists of large, cylindrical tanks supported by a metal frame structure. The tanks are situated on a concrete pad. The background shows other industrial structures and a clear blue sky.

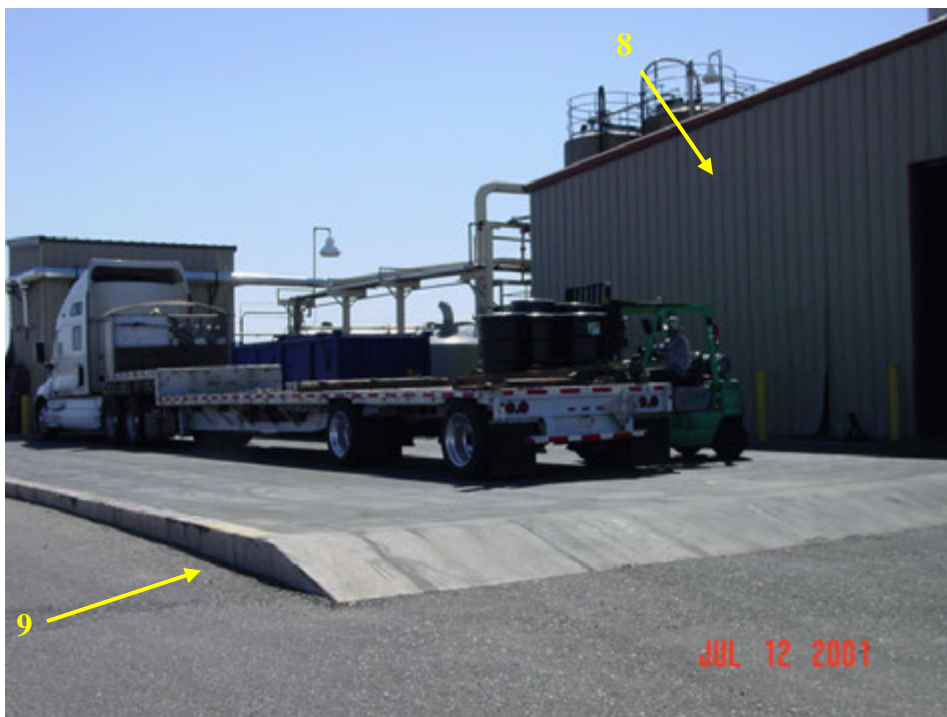
Photograph No.: F-1  
Photographer: Andrea Austin  
SWMU No.: 9  
SWMU Name: Transfer Area  
Containment Pad  
Date: 07/12/2001  
SWMU Description: Concrete loading  
pad with secondary containment berm  
adjacent to the spent carbon storage  
warehouse (SWMU8). No evidence of  
spills.

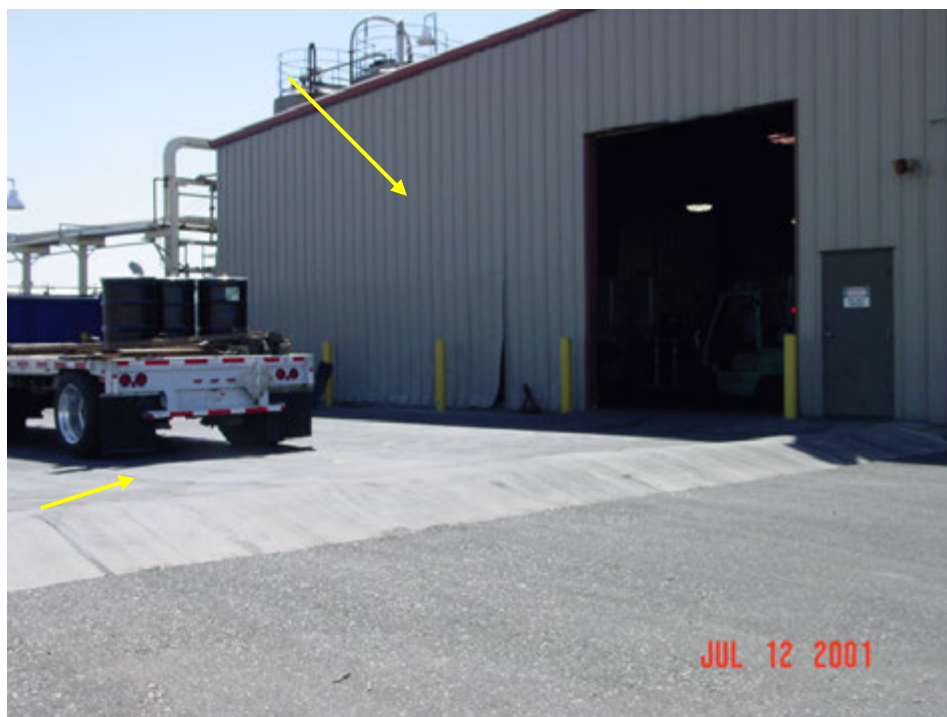
Photograph No.: F-2  
Photographer: Andrea Austin  
SWMU No.: 9  
SWMU Name: Transfer Area  
Containment Pad  
Date: 07/12/2001  
SWMU Description: Concrete loading  
pad adjacent to the spent carbon storage  
warehouse (SWMU 8). No evidence of  
spills.

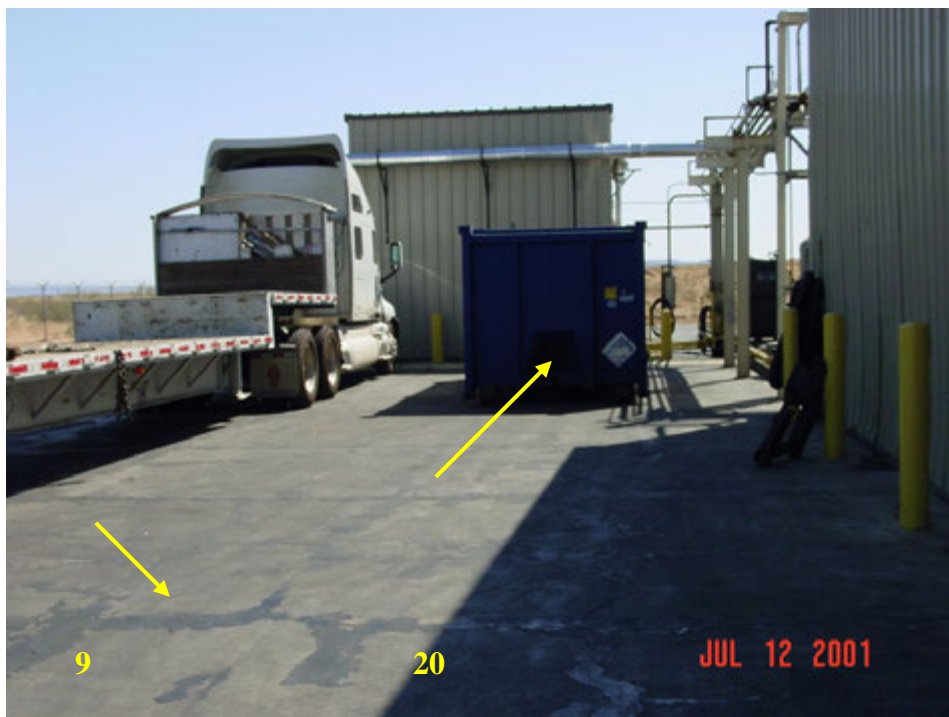
Photograph No.: F-3  
Photographer: Andrea Austin  
SWMU No.: 20  
SWMU Name: Hazardous Waste  
Debris Bin

Date: 07/12/2001  
SWMU Description: Debris bin at spent carbon transfer area containment (SWMU 9); cracks in concrete filled in with a polyresin, Sikadur 35. Debris such as personal protective equipment is stored for less than 90 days. There are three areas inside the spent carbon storage warehouse where the debris is accumulated before putting into the dumpster. Debris bin is closed at all times except to add debris. No evidence of any spill.

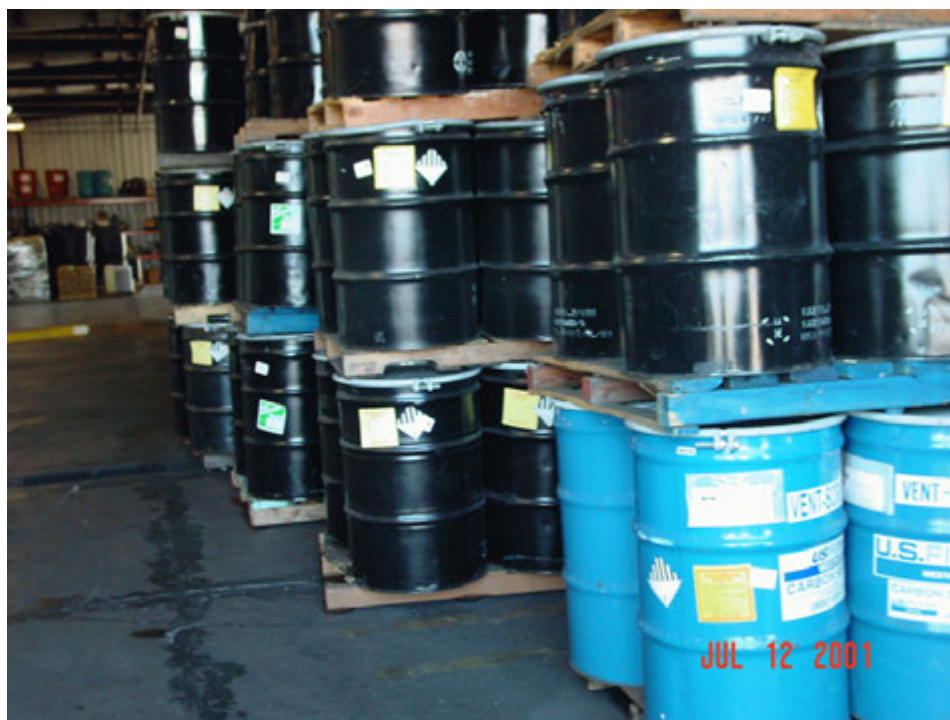
Photograph No.: F-4  
Photographer: Andrea Austin  
SWMU No.: 8  
SWMU Name: Spent Carbon  
Storage  
Warehouse

Date: 07/12/2001  
SWMU Description: About 10 rows plus 10-20 bag filter canisters. Tightly closed / labeled 55-gallon drums of hazardous and non-hazardous waste. Authorized to store 100,000 gallons (approximately 1,818 drums of hazardous waste). Drums are stacked on and separated by wooden pallets. There are four drums per pallet therefore using a total of twenty-four pallets. Crack in floor repaired with a polyresin, Sikadur 35<sup>®</sup>. Grated trenches collect any spill.

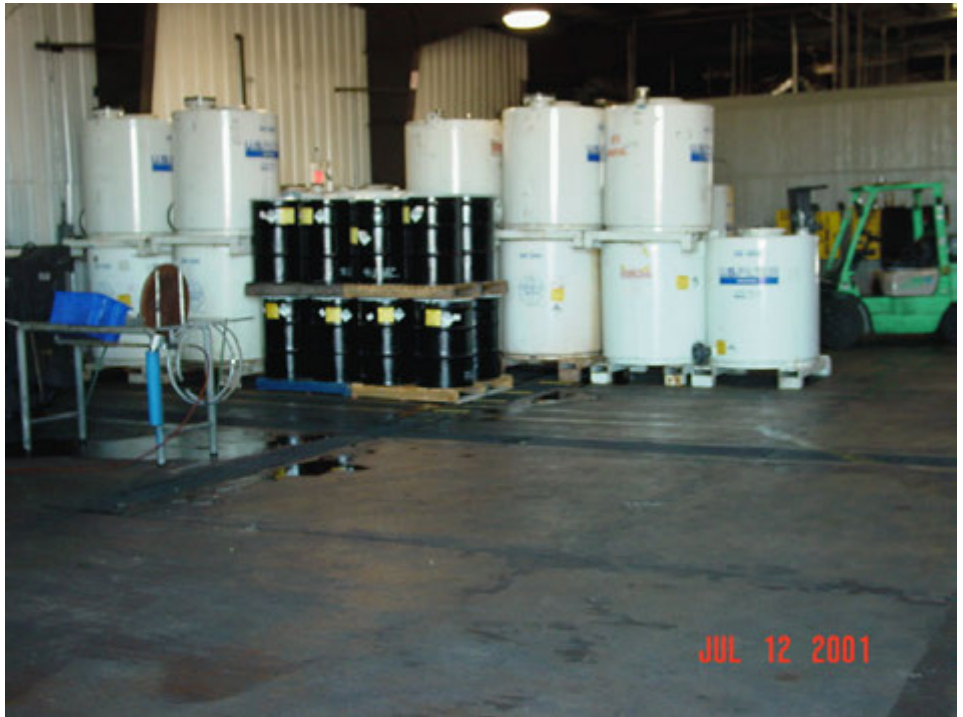
Photograph No.: F-6  
Photographer: Andrea Austin  
SWMU No.: 5  
SWMU Name: Spent Carbon  
Unloading Hopper  
(H-2)  
Date: 07/12/2001  
SWMU Description: Drums of spent  
carbon are emptied into this feed hopper.  
Forty percent of waste is handled at H-2.  
The capacity of H-2 is 500 lbs. No  
evidence of spills were observed.

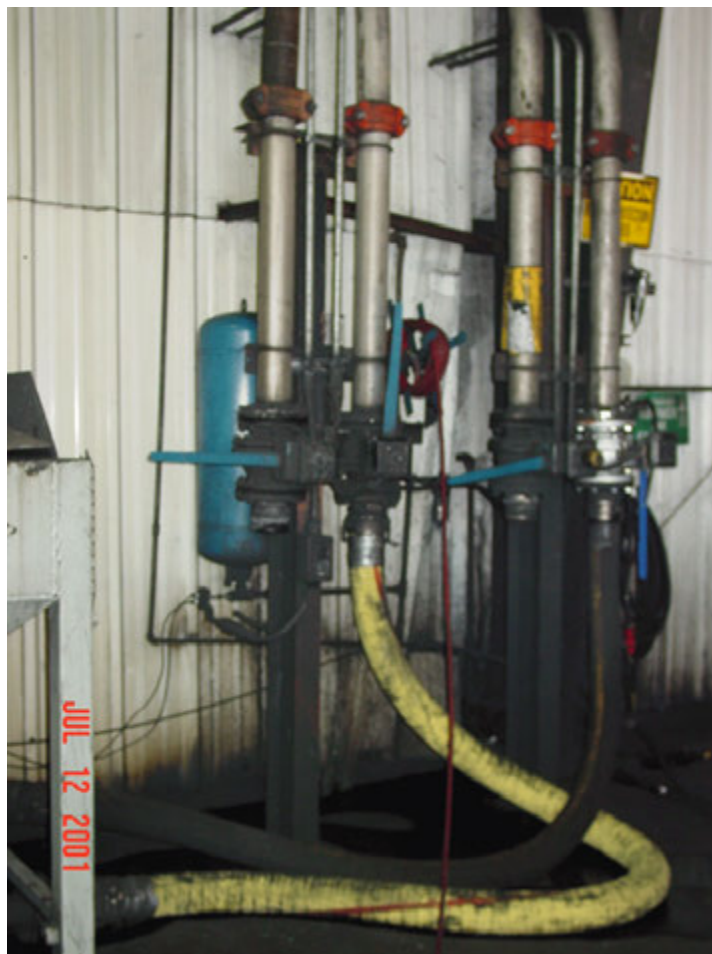
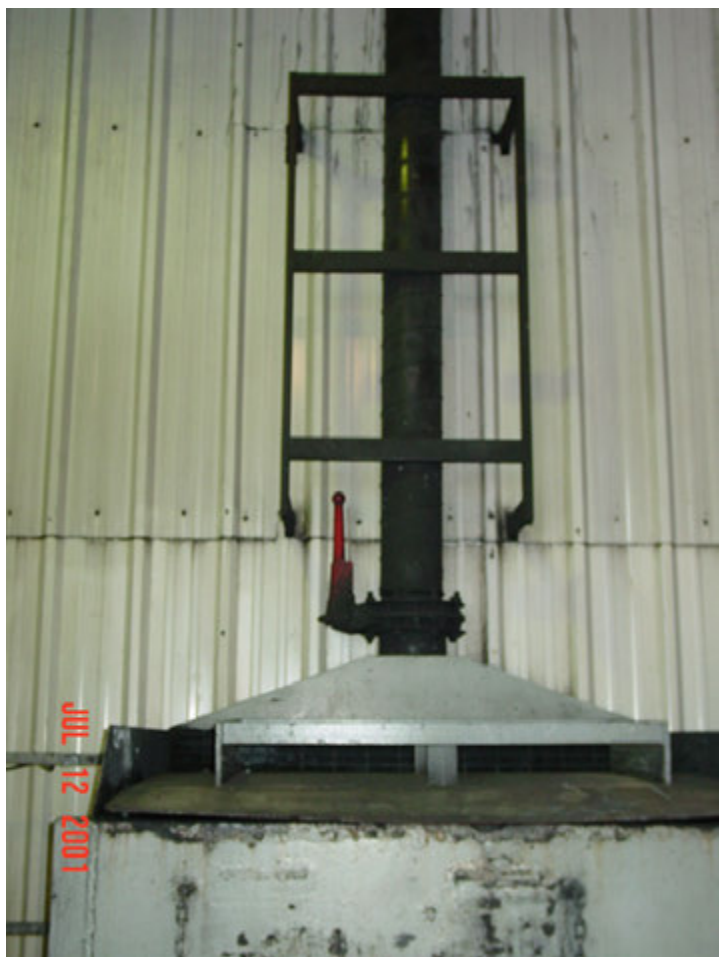
Photograph No.: F-7  
Photographer: Andrea Austin  
SWMU No.: 7  
SWMU Name: Carbon Slurry and Recycle Water Transfer System  
Date: 07/12/2001  
SWMU Description: Piping conveyance system from unloading hopper (H-2) (SWMU 5) to spent carbon slurry storage tanks (SWMUs 10 through 13).

Photograph No.: F-8  
Photographer: Andrea Austin  
SWMU No.: 5  
SWMU Name: Spent Carbon Unloading Hopper (H-2)  
Date: 07/12/2001  
SWMU Description: Piping behind H-2 that draws organic vapors and particulates from spent carbon. The pipe leads to the baghouse and carbon adsorber WS-2 (SWMU 30).

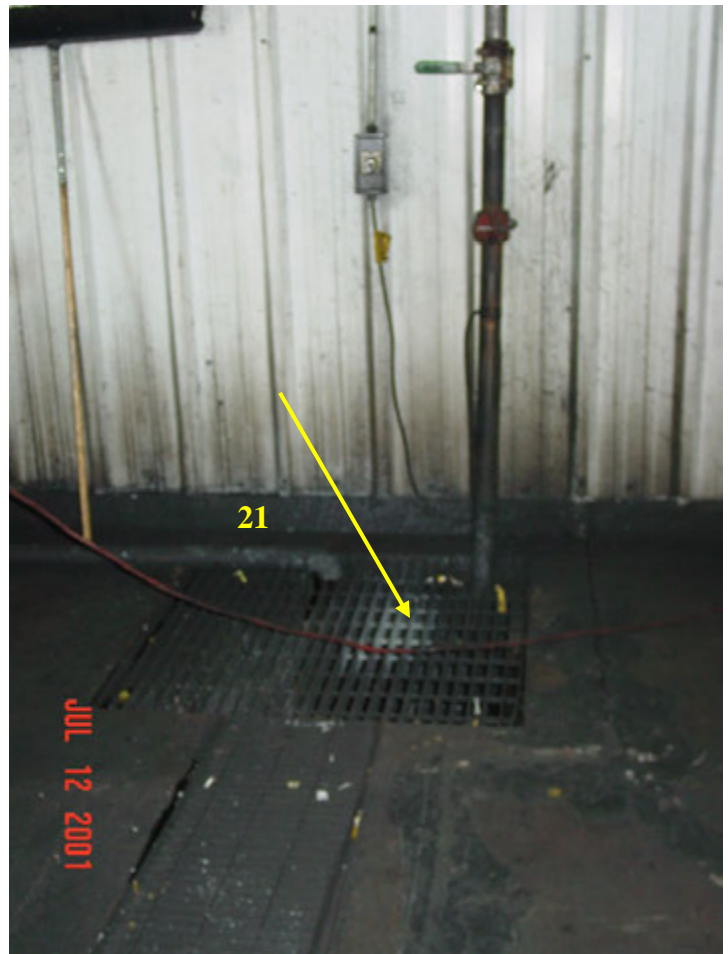
Photograph No.: F-10  
Photographer: Andrea Austin  
SWMU No.: 22  
SWMU Name: Spent Carbon  
Storage  
Warehouse  
Barrel Washer  
Date: 07/12/2001  
SWMU Description: Barrel washer  
adjacent to H-2 (SWMU 5). Water used  
to rinse empty drums drains into  
trenches and flows to the sump and  
vault (SWMU 21) (Photograph No. F-  
9). From there the water is recycled to  
tank T-9 (SWMU 16) or (SWMU 17)  
T-12. Water observed on the floor from  
recent wash-out of empty drums.

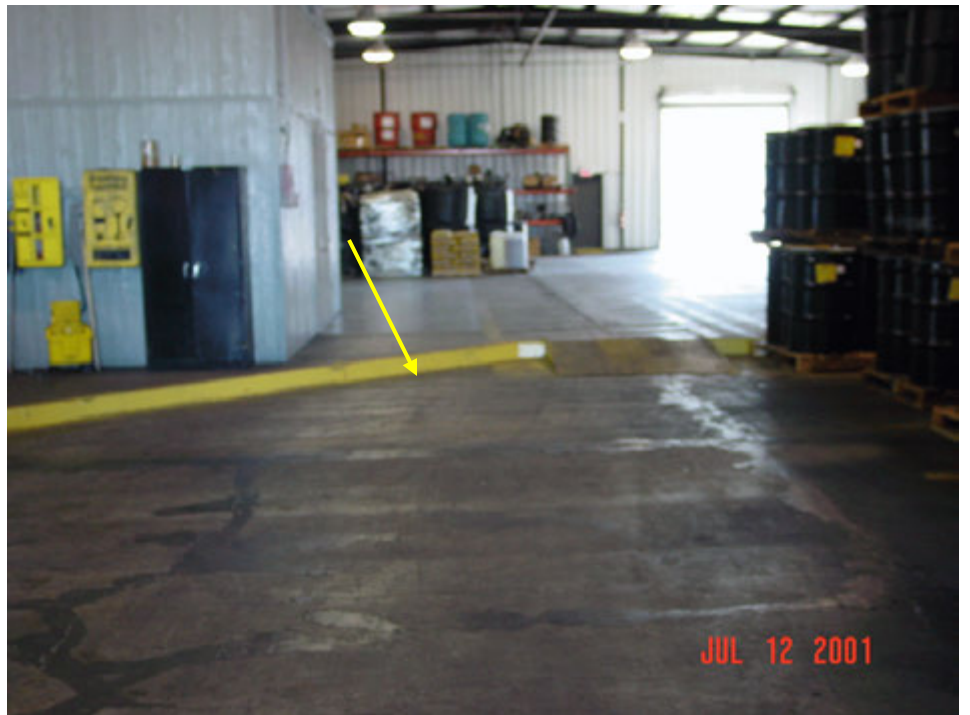
Photograph No.: F-12  
Photographer: Andrea Austin  
SWMU No.: 8  
SWMU Name: Spent Carbon Storage Warehouse  
Date: 07/12/2001  
SWMU Description: Containment berm separating the container storage area from the maintenance area.

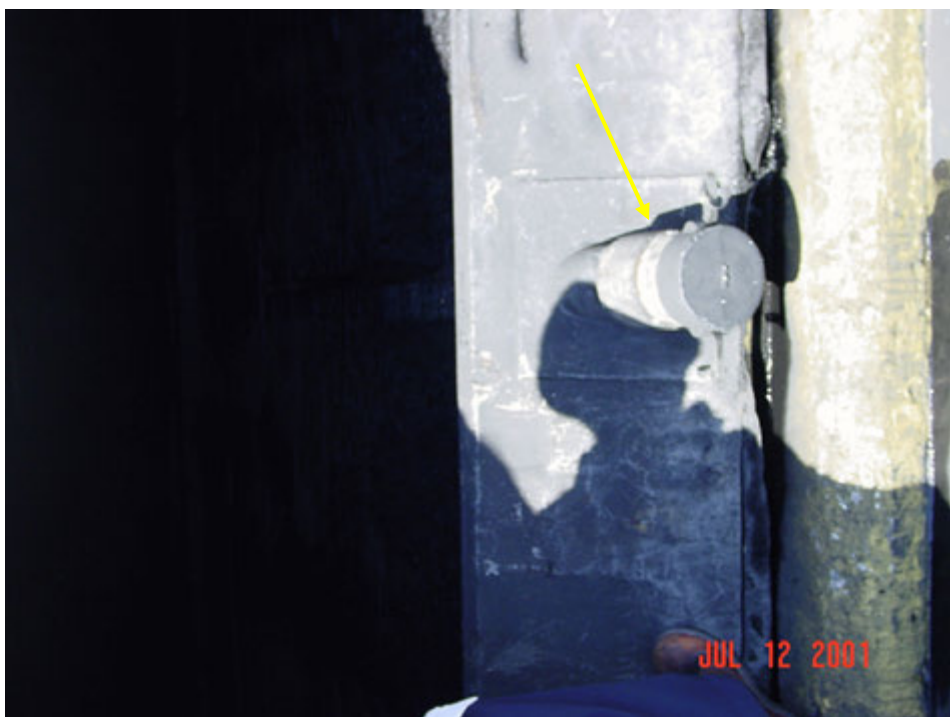
Photograph No.: F-14  
Photographer: Andrea Austin  
SWMU No.: 4  
SWMU Name: Connection Pipe  
for Slurry Trucks  
to Unload to  
Date: 07/12/2001

SWMU Description: Slurry Trucks  
unload by connecting to pipe. Spent  
carbon falls through grate into the  
hopper; eductor at the bottom moves  
the carbon into slurry transfer system  
(SWMU 7).

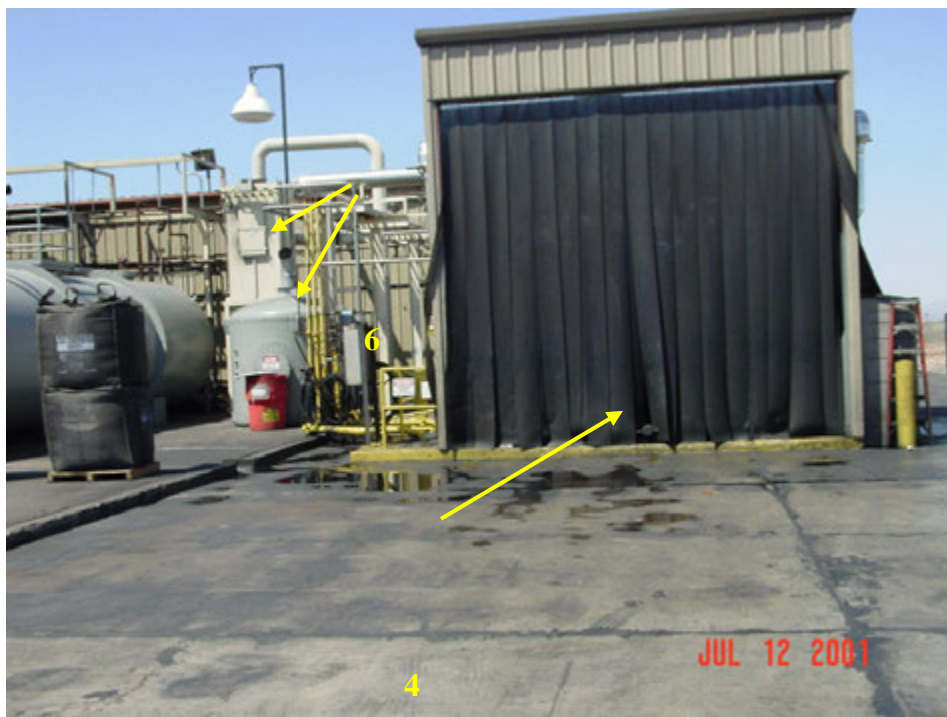
Photograph No.: F-16  
Photographer: Andrea Austin  
SWMU No.: 4  
SWMU Name: Air Pollution Control Equipment  
and Piping to the Baghouse for H-1  
and H-2  
Date: 07/12/2001  
SWMU Description: Unloading hopper H-1 showing  
silver piping leading to air pollution control equipment  
(SWMU 6). Bags of reactivated carbon (nonhazardous) are  
staged adjacent to H-1; used for on-site carbon adsorber  
canisters.

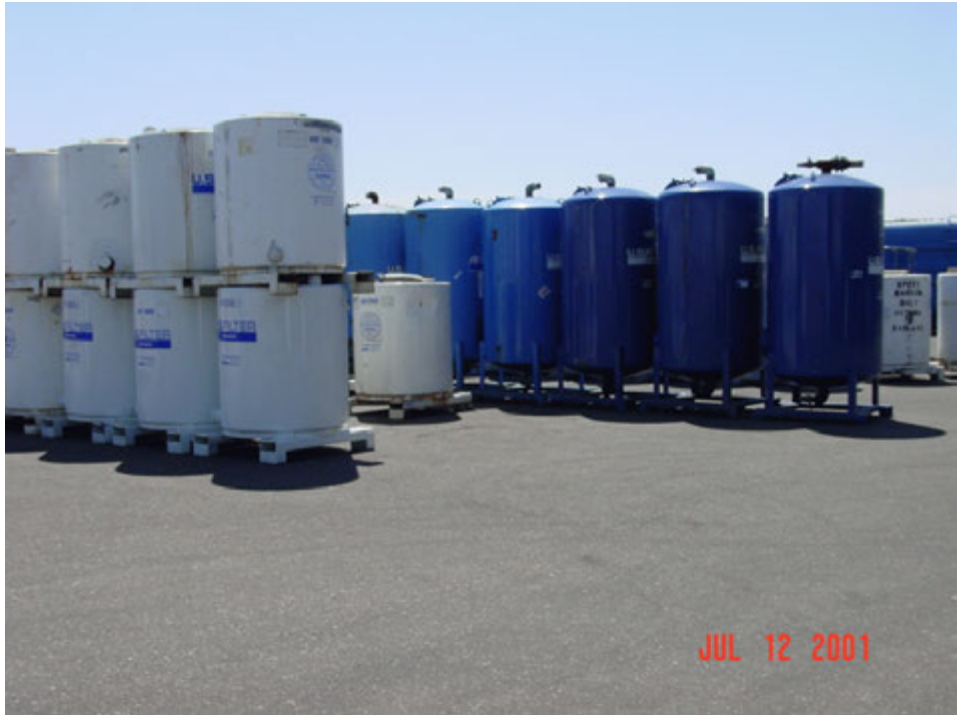
Photograph No.: F-17  
Photographer: Andrea Austin  
Location: Paved Area  
Outside Process  
Area. Not a  
SWMU.  
Date: 07/12/2001  
Description: Staging area for  
empty filter canisters to be recycled  
offsite. No evidence of any spills. This  
area is not used to store waste, and is  
not within a containment pad. White  
filter canisters have 1000 lb. spent  
carbon capacity; blue filter canisters  
have 2000 lb. spent carbon capacity.

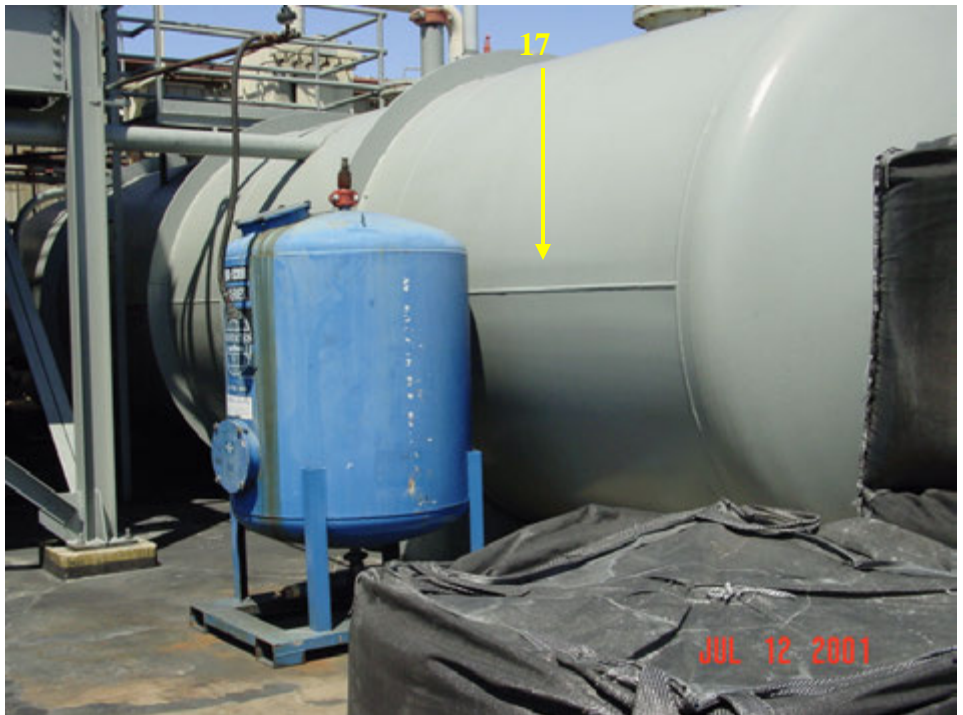
Photograph No.: F-18  
Photographer: Andrea Austin  
SWMU No.: 17  
SWMU Name: Motive Water  
and Rainwater  
Collection Tank  
(T-12)  
Date: 07/12/2001  
SWMU Description: Tank T-12  
receives excess recycle water, rain  
water, and washdown water. The water  
from this tank is recirculated to the  
slurry piping system. No evidence of  
release. Tank and pipe system is close-  
looped. Blue tank is carbon adsorber  
PV 50. This adsorber filters recycle  
water that is discharged to the POTW.

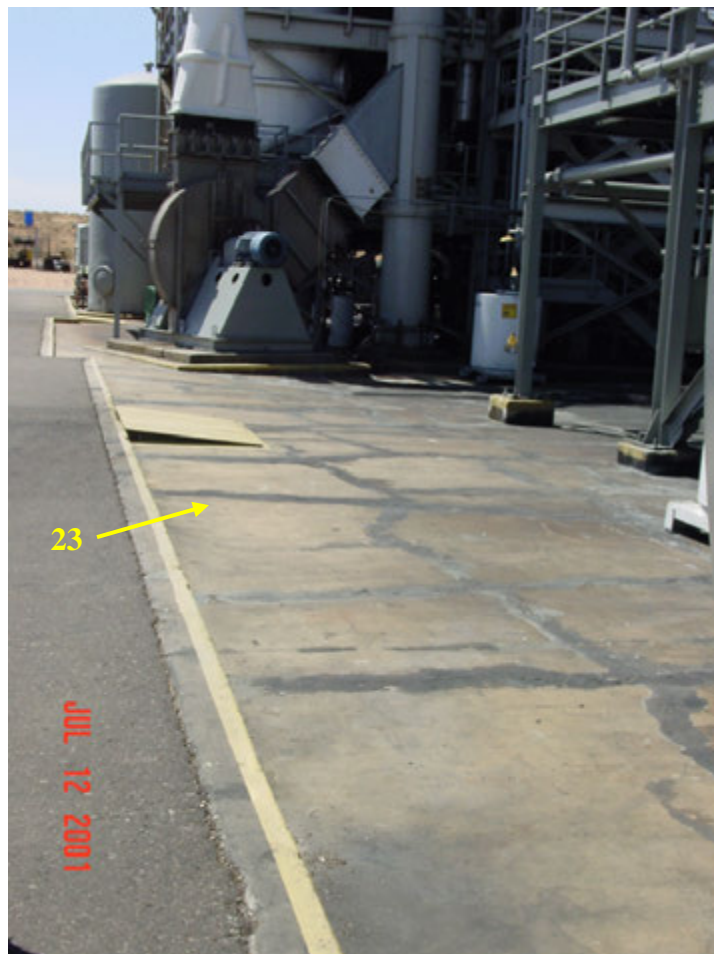
Photograph No.: F-22  
Photographer: Andrea Austin  
SWMU No.: 24  
SWMU Name: Sump by  
Unloading  
Hopper No. 1  
(H-1)  
Date: 07/12/2001  
SWMU Description: Sump collects  
wastewater such as washdown water  
from trucks unloading spent carbon into  
unloading hopper (H-1) (SWMU 4),  
and from (SWMU 9). Captured liquid is  
then transferred to Tank T-9 (SWMU  
16) and T-12 (SWMU 17) via a closed  
piping system. No evidence of overflow  
release to the ground.
