REVISED DRAFT  
RCRA FACILITY ASSESSMENT  
REPORT

Evoqua Water Technologies, LLC.  
2523 Mutahar Street  
Parker, Arizona  
AZD 982 441 263

U.S. ENVIRONMENTAL PROTECTION AGENCY  
Region 9  
75 Hawthorne  
San Francisco, CA

Date of Revised Draft	September 2016
US EPA Region 9	
Site No.	AZD 982 441 263
Document Control No.	REPA3-0903-017
Contract No.	68-W-02-022
Draft RFA Prepared by	Booz Allen Hamilton
Revised Draft RFA Prepared By	USEPA Project Manager
Telephone No. (415) 972-3348	“Mike” Mahfouz Zabaneh

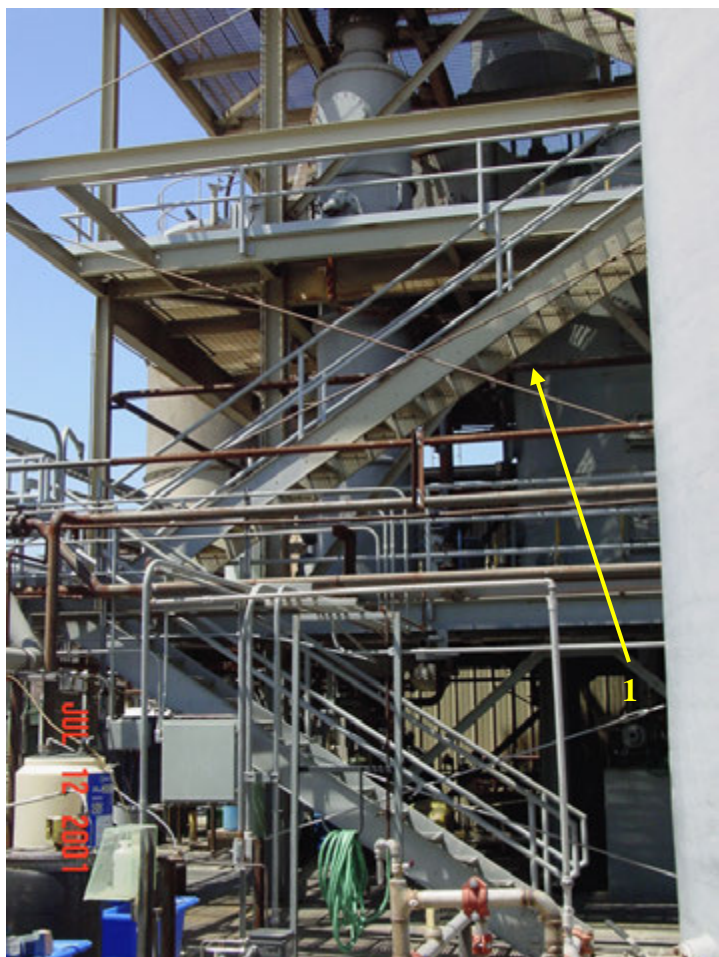
Photograph No.: F-30  
Photographer: Andrea Austin  
SWMU No.: 1  
SWMU Name: Reactivation Furnace No. 1 (RF-1)  
Date: 07/12/2001  
SWMU Description: The idle RF-1 within the platform structure on secondary containment in the Process Area. No evidence of release of hazardous constituents to the containment area under the platform.

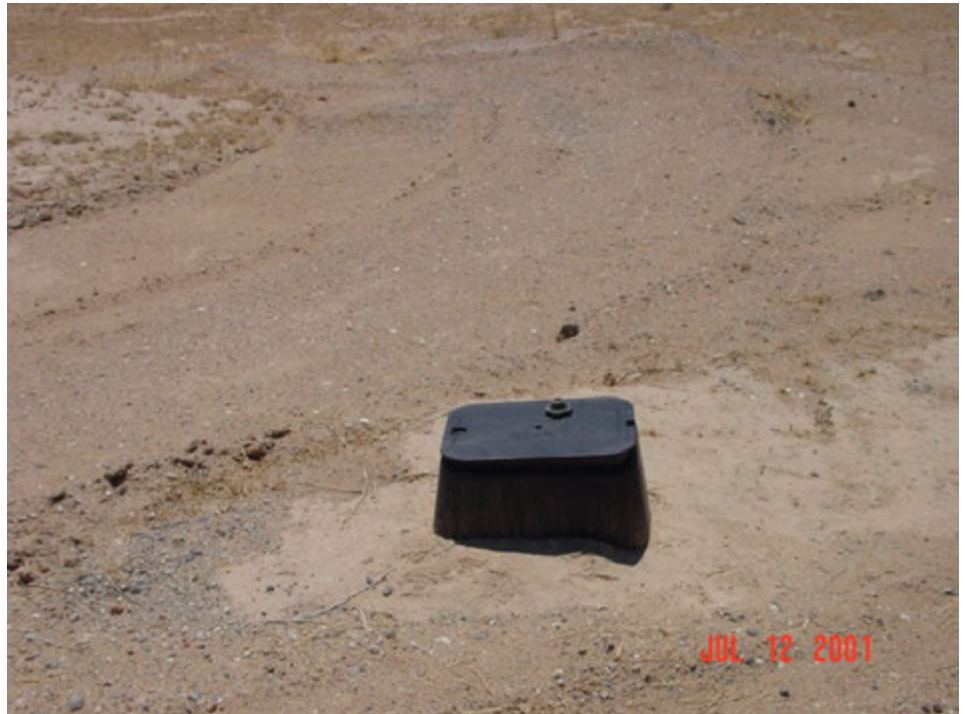
Photograph No.: F-33  
Photographer: Andrea Austin  
Location: Entrance to Facility. Not a SWMU.  
Date: 07/12/2001  
Description: At road entering plant (off Mutahar Street), monitoring well for POTW testing for discharge limits, located adjacent to the Lift Station.

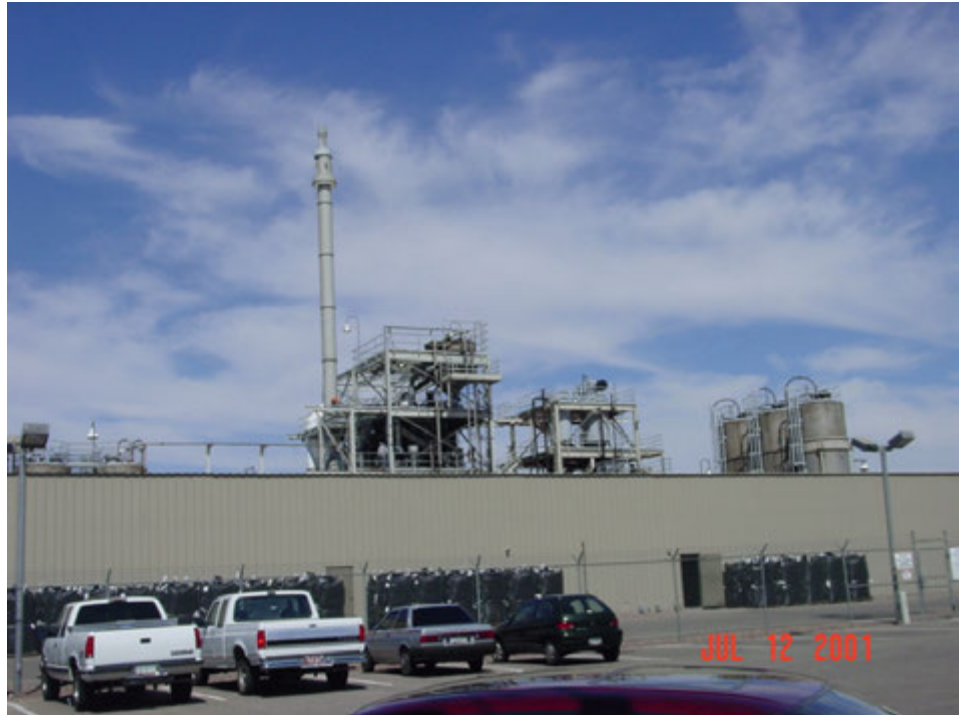
Photograph No.: F-37  
Photographer: Andrea Austin  
SWMU No.: 1, 2, and 3 (not visible)  
SWMU Name: Platform structure for RF-2 and RF-1 and air pollution control equipment (SWMU 3) Stack on the Reactivation Furnace No. 2 (RF-2).  
Date: 07/12/2001  
SWMU Description: Exhaust emitted from RF-2 air pollution control equipment via the stack is barely visible.
