Evaluating Corrosion of the Steel Liners of the Red Hill Tanks

Work Being Done to Safely Store Fuel at Red Hill

Tank Upgrade Alternatives

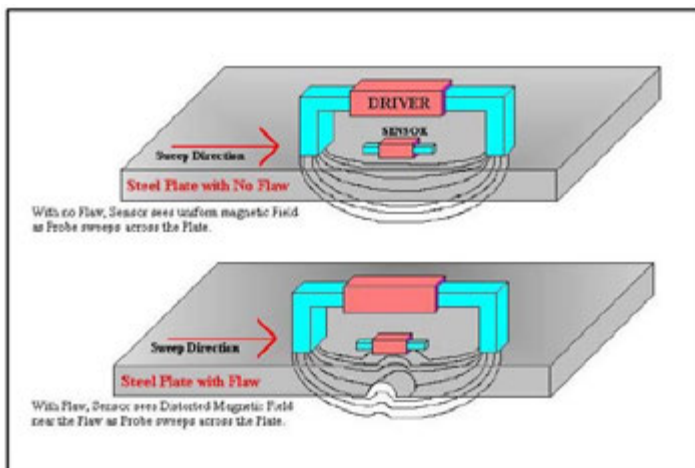
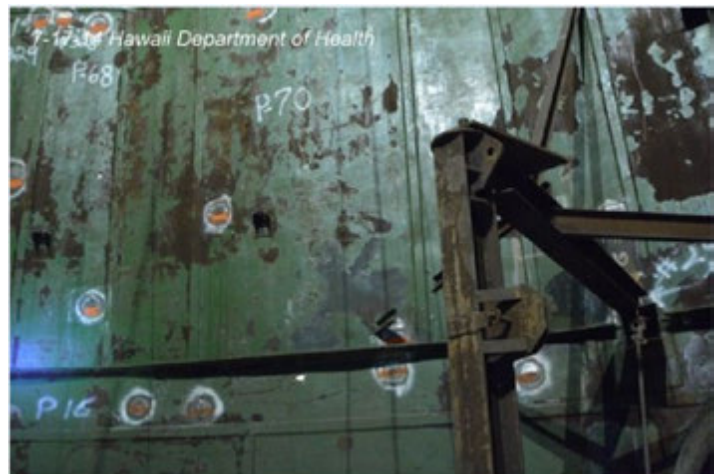
Low Frequency Electronic Testing

- How Corrosion Affects Integrity of the Red Hill Tanks Needs Further Study
- Although the Backside of the Steel Shell Cannot Be Visually Inspected, Non-Destructive Testing (NDT) Techniques Are Being Used to Identify Corrosion and Other Steel Shell Problems
- A Comprehensive Program Utilizing both Destructive and Non-Destructive Methods is Underway

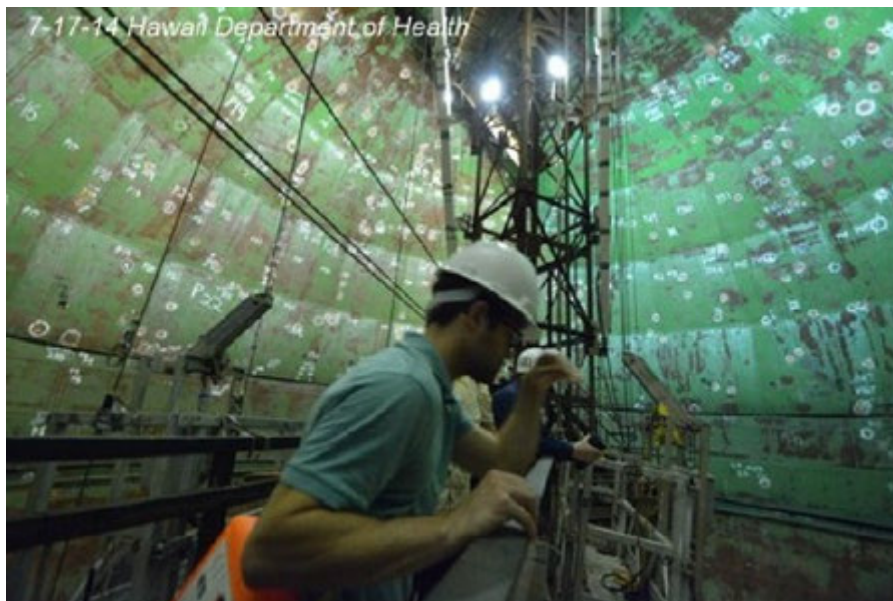
Why Did Tank 5 Leak Approximately 27,000 Gallons of Jet Fuel In January 2014?

- Patch Plates Were Installed to Address Thin Spots / Defects Identified by Non-Destructive Testing (Petroleum Industry Best Practices)
- Weld Quality on Patch Plates Likely Caused Release (Not Corrosion)
- The Quality of the Repairs Including the Welds Were Not Properly and Thoroughly Verified by Navy
- Operators Initially Disregarded Fuel Loss Alarms

- New Repair and Verification Procedures
- More Frequent Tank Tightness Testing
- New Procedures for Filling During Recommissioning After Repair
- New Alarm Response Procedures
- Improvements in Contractor Specifications

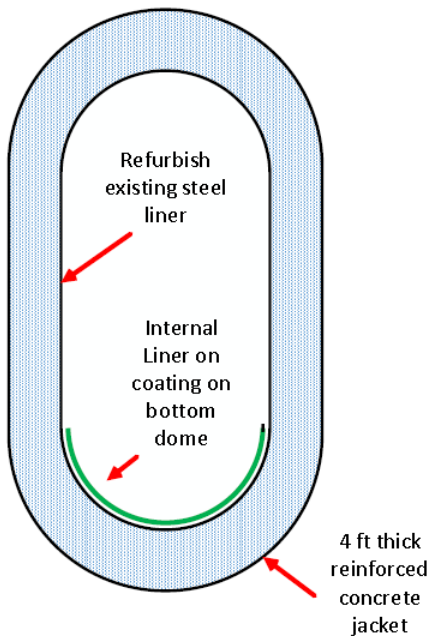
Alternate 1A

1A Single Wall—Restoration of Tank

- ♦ Current approach to inspection and repair with enhanced TIRM

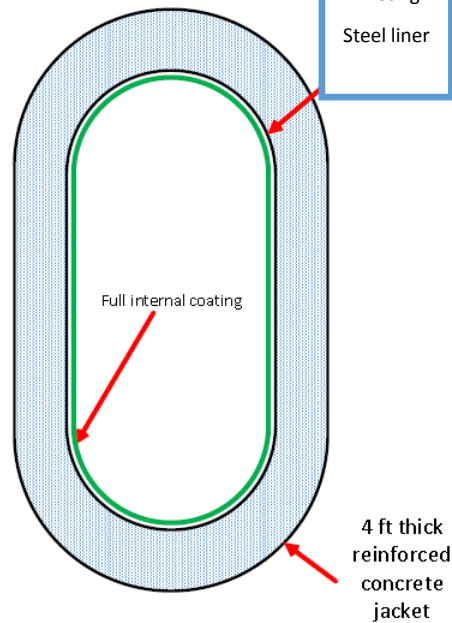
Alternate 1B

1B Single Wall—Restoration of Tank Plus Interior Coating

- ♦ Same as Alternative 1A plus coating of barrel and upper dome

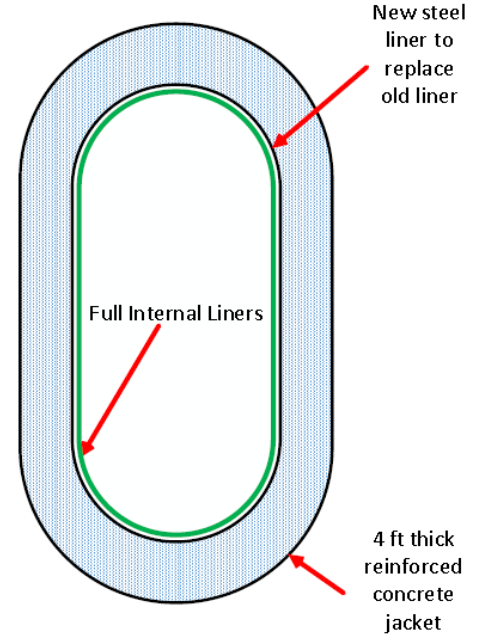
Alternate 1D

1D Single Wall—Remove Steel Liner and Install New Steel Liner

- ♦ Remove existing steel liner in its entirety
- ♦ Provide new steel liner

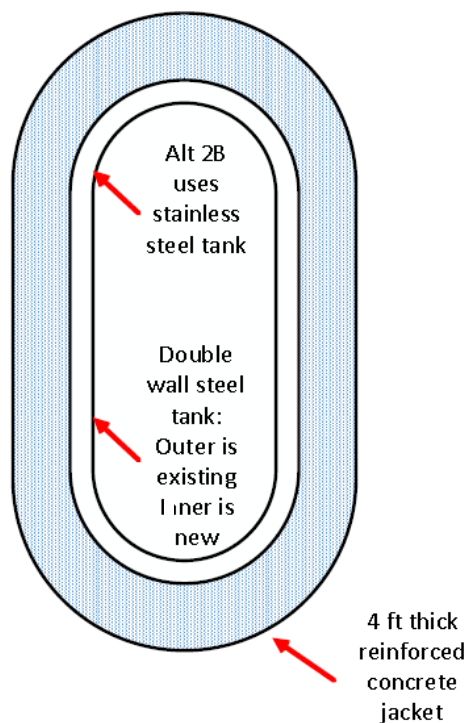
Alternate 2A/B

2A Double Wall—Composite Tank with Second Steel Liner

- ♦ Existing steel liner provides secondary containment
- ♦ Construct steel liner with three inch interstitial space
- ♦ Internal coating of new steel liner

2B Double Wall—Composite Tank with Stainless Steel Liner

- ♦ Same as 2A except new internal liner is stainless steel
- ♦ No internal coating

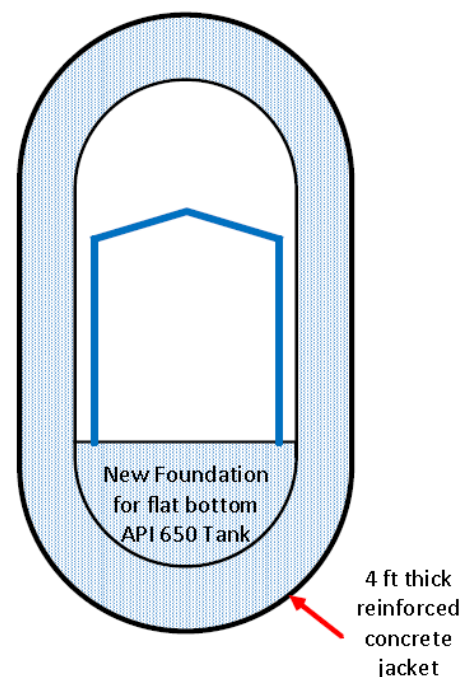
Alternate 3A

3A Double Wall—Tank within a Tank

- ♦ Construct new steel tank with five foot accessible annular space
- ♦ Existing steel liner provides secondary containment
