NONPOINT SOURCE SUCCESS STORY

Maine

Septic System Repairs and Manure Storage Practices Reduce Bacteria Levels in Pottle Brook

EPA 841-F-16-001FF
November 2016

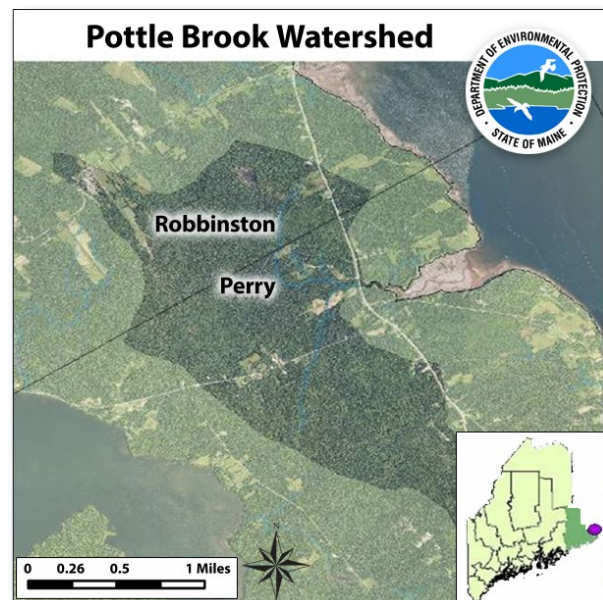
Figure 1. The Pottle Brook watershed (dark green).

Pottle Brook is a small Class B stream in Perry and Robbinston, Maine, with a length of 2 miles and a watershed area of 3.1 square miles (Figure 1). The brook flows easterly and drains into Passamaquoddy Bay. The sparsely populated watershed is only 1 percent developed; the predominant cover type is forest (82 percent), with a small amount of agriculture (3.4 percent) consisting primarily of hayfield.

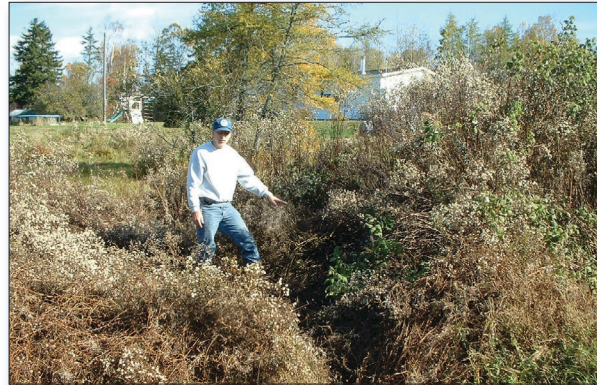
Figure 3. DEP employee performs sanitary survey.

To determine the sources and location of bacteria in the Pottle Brook watershed, Maine DEP and the town of Perry conducted sanitary surveys in 2010–2011 that resulted in 19 properties being inspected (Figure 3). Of the inspected sites, six were identified as having septic system and/or animal waste problems, several of which were located adjacent to a tributary of the brook

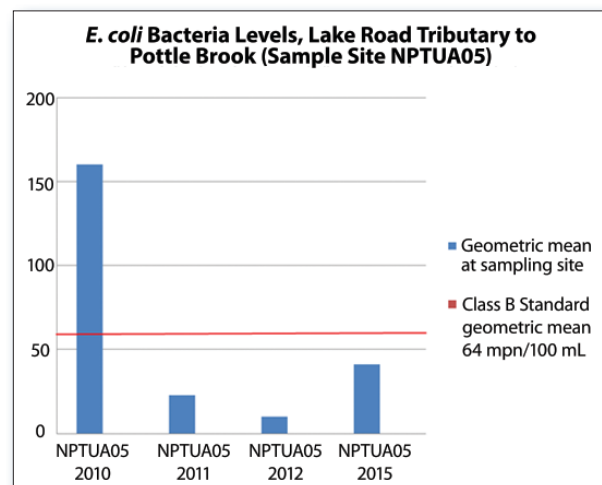
Figure 4. Bacteria levels declined after project implementation.

Bacteria levels have dropped over time. In 2007 and 2010 the *E. coli* bacteria geometric mean for water samples taken from Pottle Brook at sampling site NPT01 was 84 and 129 mpn/100 mL, respectively, exceeding the Maine geometric mean standard of 64 mpn/100 mL for class B waters. In 2015 water quality sampling showed that the *E. coli* geometric mean for Pottle Brook lowered to 77 mpn/100 mL. Also in 2015, five of the six samples were well below the instantaneous (single sample) standard of 236 mpn/100 mL.

This improvement in water quality on the mainstem of Pottle Brook can be partly attributed to reduced bacteria levels observed in the Lake Road tributary (at site NPTUA05), where several malfunctioning septic systems were repaired. In 2010 the geometric

mean for the Lake Road tributary was 154 mpn/100 mL. Following septic system repairs, bacteria levels lowered to less than 44 mpn/100 mL, which attains the class B standard of 64 mpn/100 mL (Figure 4).
