Case Study for Well Integrity over a Full Life Cycle

Lloyd H. Hetrick, PE, CSP
Newfield Exploration Company

Abstract

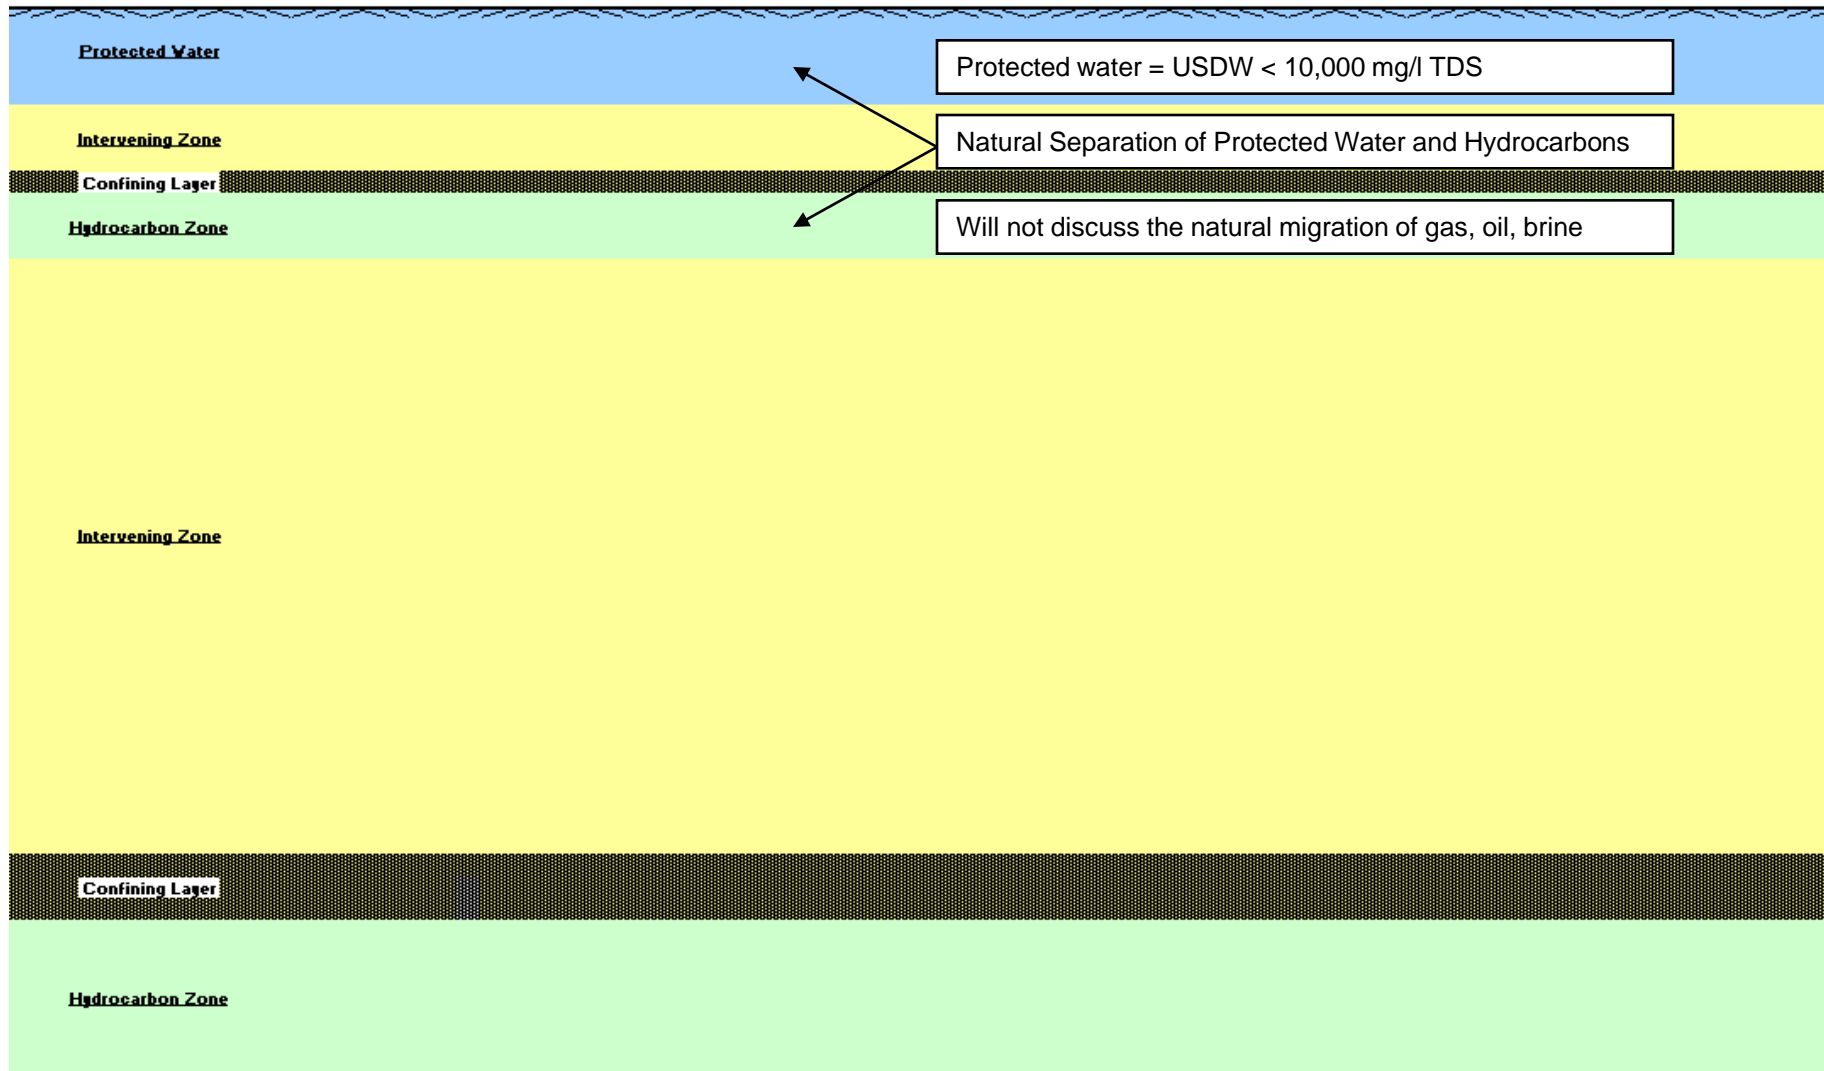
Slide 3 of 22 – Natural Separation of Protected Water and Hydrocarbons, in most cases

Protected water and hydrocarbons have natural separation (5) in most situations. There are however, areas of the country where methane is routinely found to exist naturally in USDWs (6) (7) and has been associated with bubbles in rivers as early as the mid 1800s (8). There are also locations where methane vents to the surface via natural pathways having nothing to do with oil and gas extraction activities (9) (10). It has been estimated from a review of Pennsylvania regulatory records that over 95% of the complaints that oil and gas activities had contaminated private water wells were actually due to preexisting or other land use activities (11). These naturally occurring migrations are not limited to methane, as towns named Oil Springs, KY (12) Oil Springs, Ontario (13) and historical sites such as Seneca Oil Spring, NY (14) and Brine Springs, TX (15) all attest that oil and brine have been observed migrating to the surface dating back to the 1600’s.

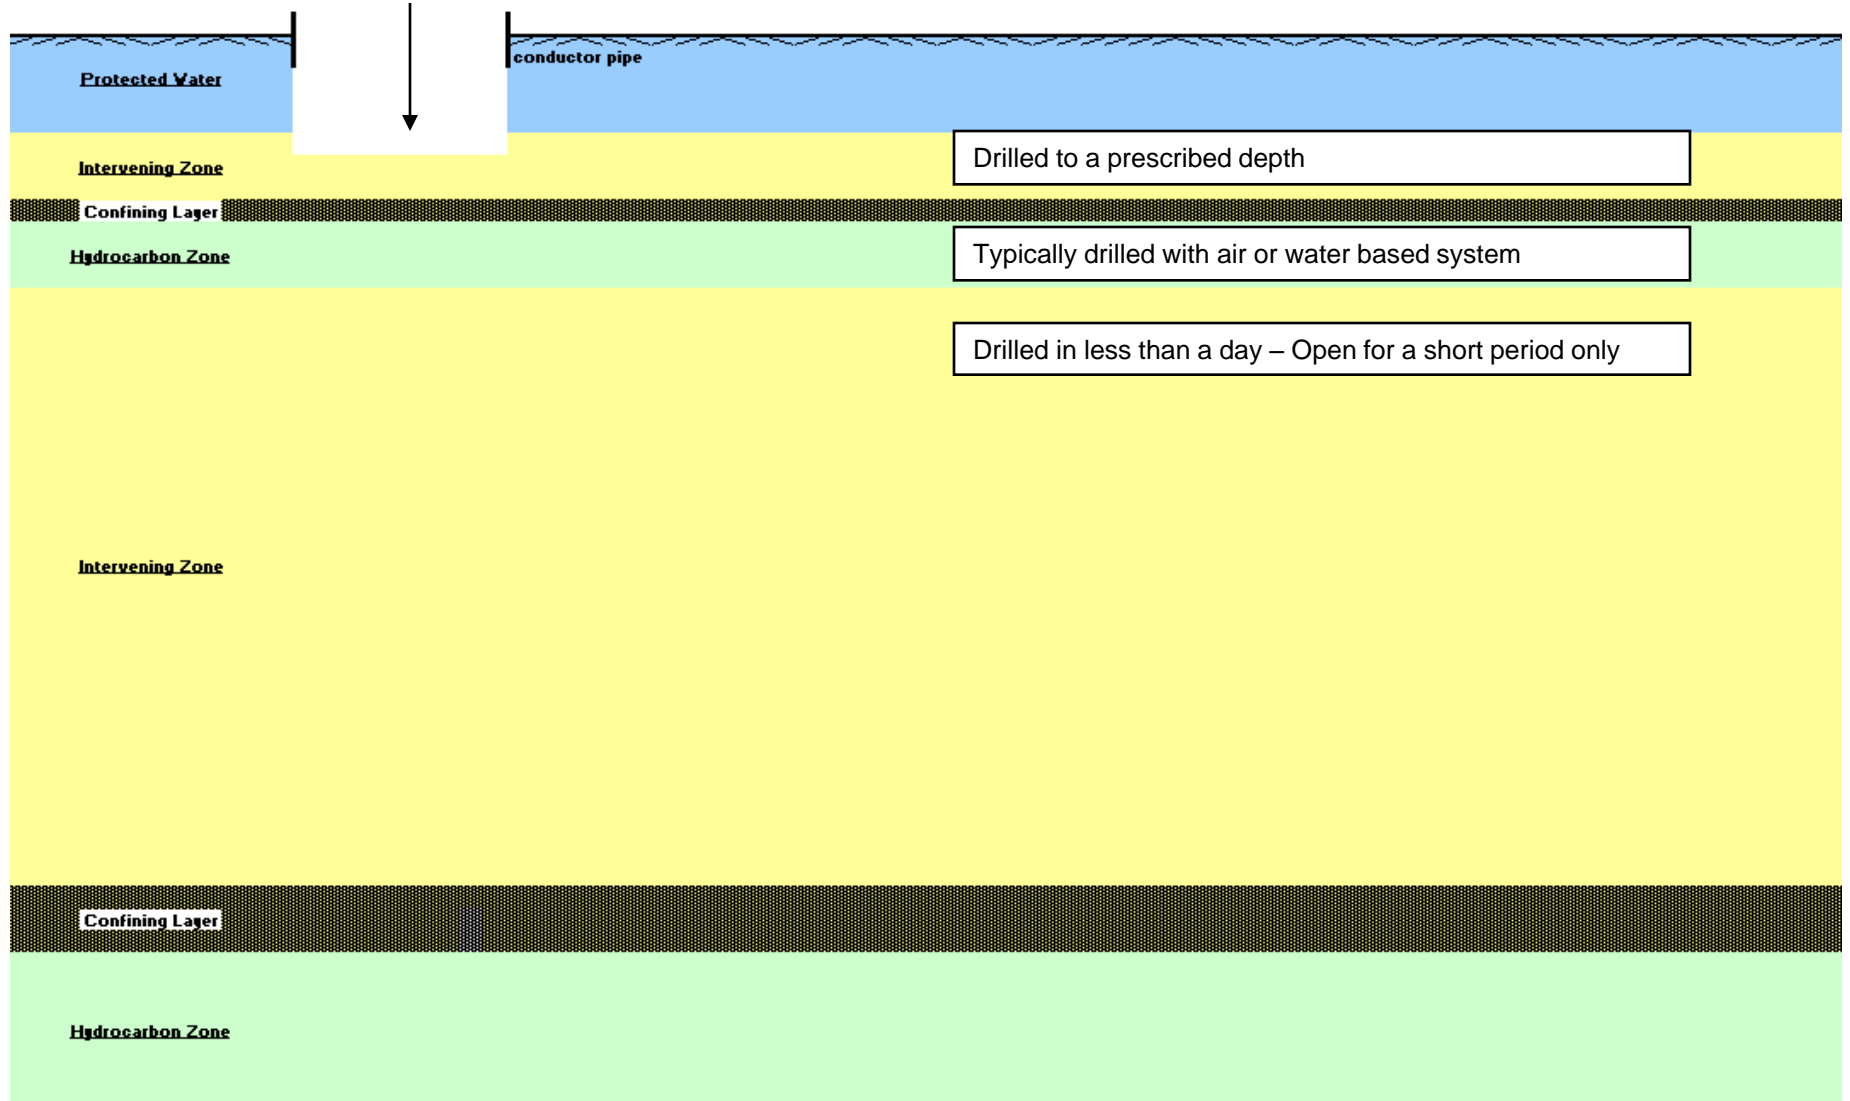
Slide 5 of 22 – Well is drilled to a prescribed depth below Protected Water

The surface hole is drilled to a prescribed depth below the base of protected water. This depth is most often provided by the State Oil and Gas Regulator as in Oklahoma (16), or the State Environmental Protection Regulator as in Texas (17), or not specifically provided other than to protect all USDWs encountered as in Pennsylvania (18). In this latter situation, oil and gas operators typically research a Pennsylvania Groundwater Information System “PaGWIS” database and local water well driller’s records to generate a hydro geological map in order to determine depths of water that need to be protected.

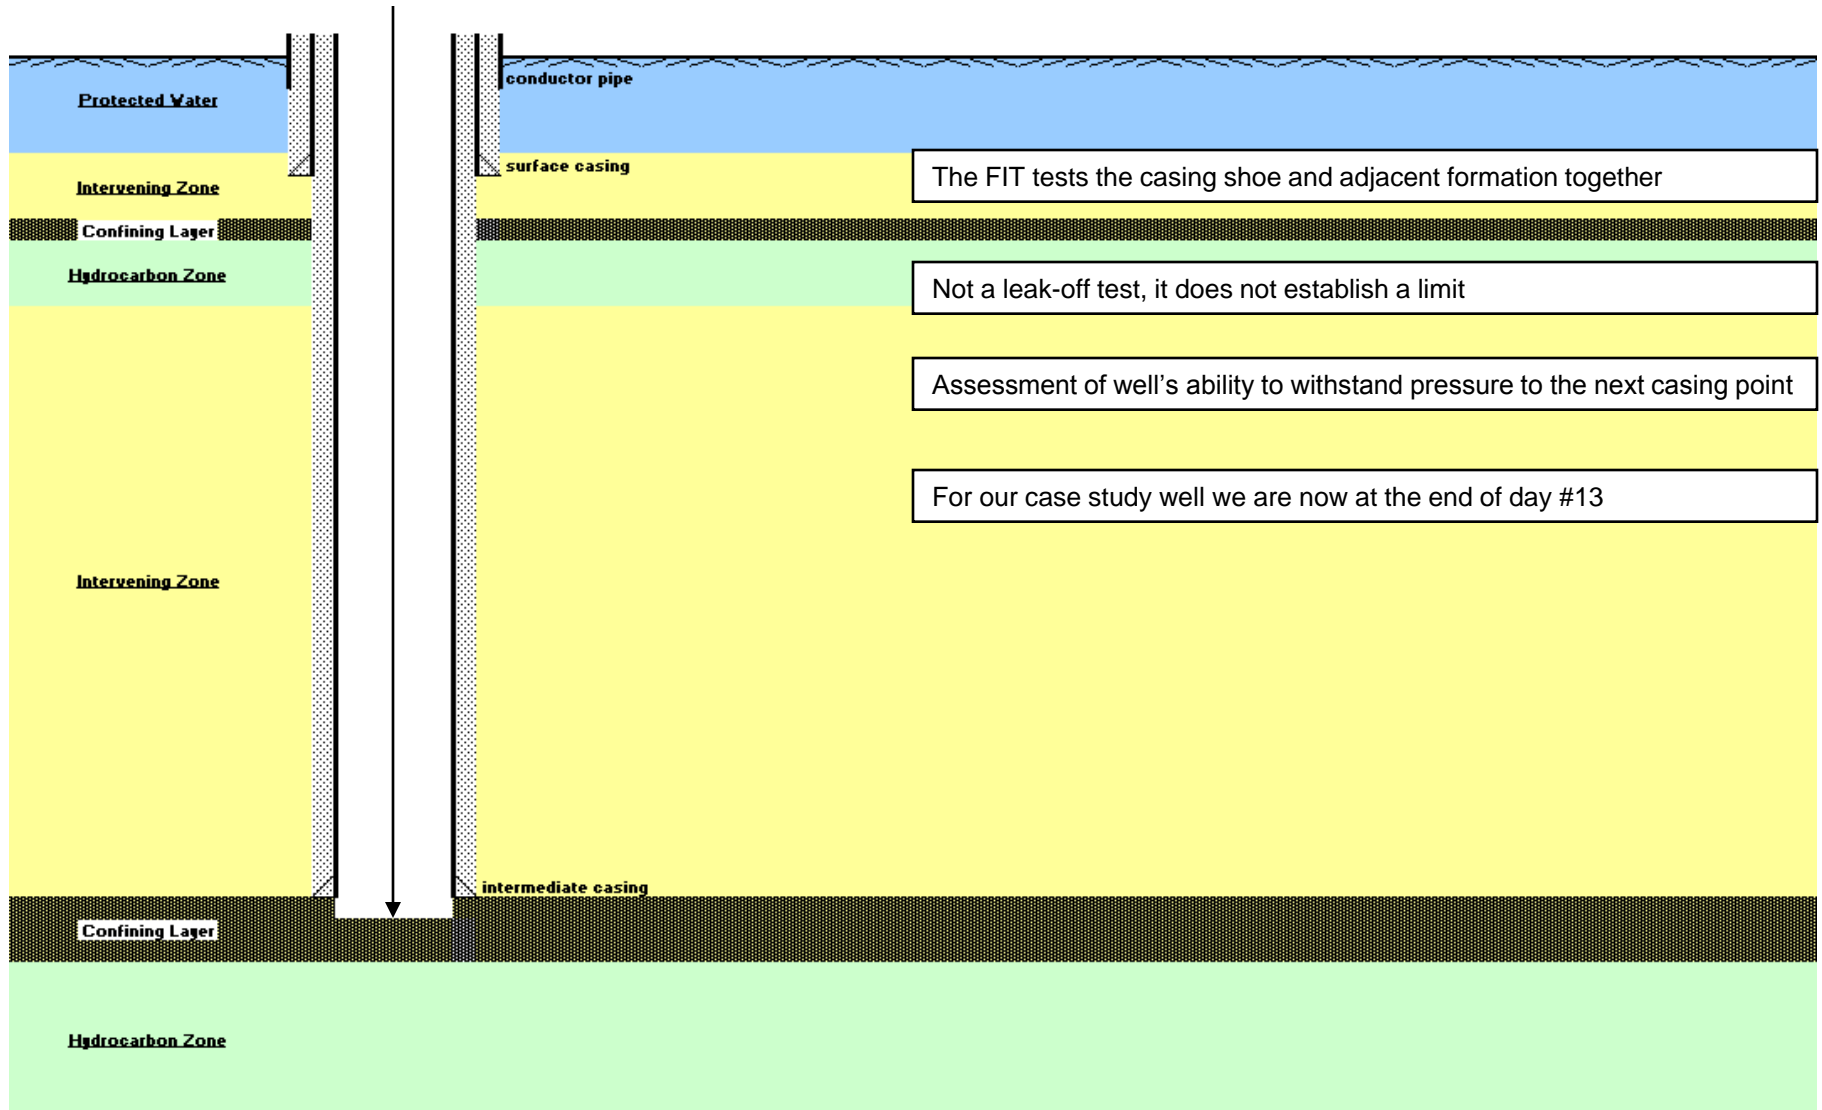
Slide 12 of 22 – Intermediate casing shoe and formation integrity are tested

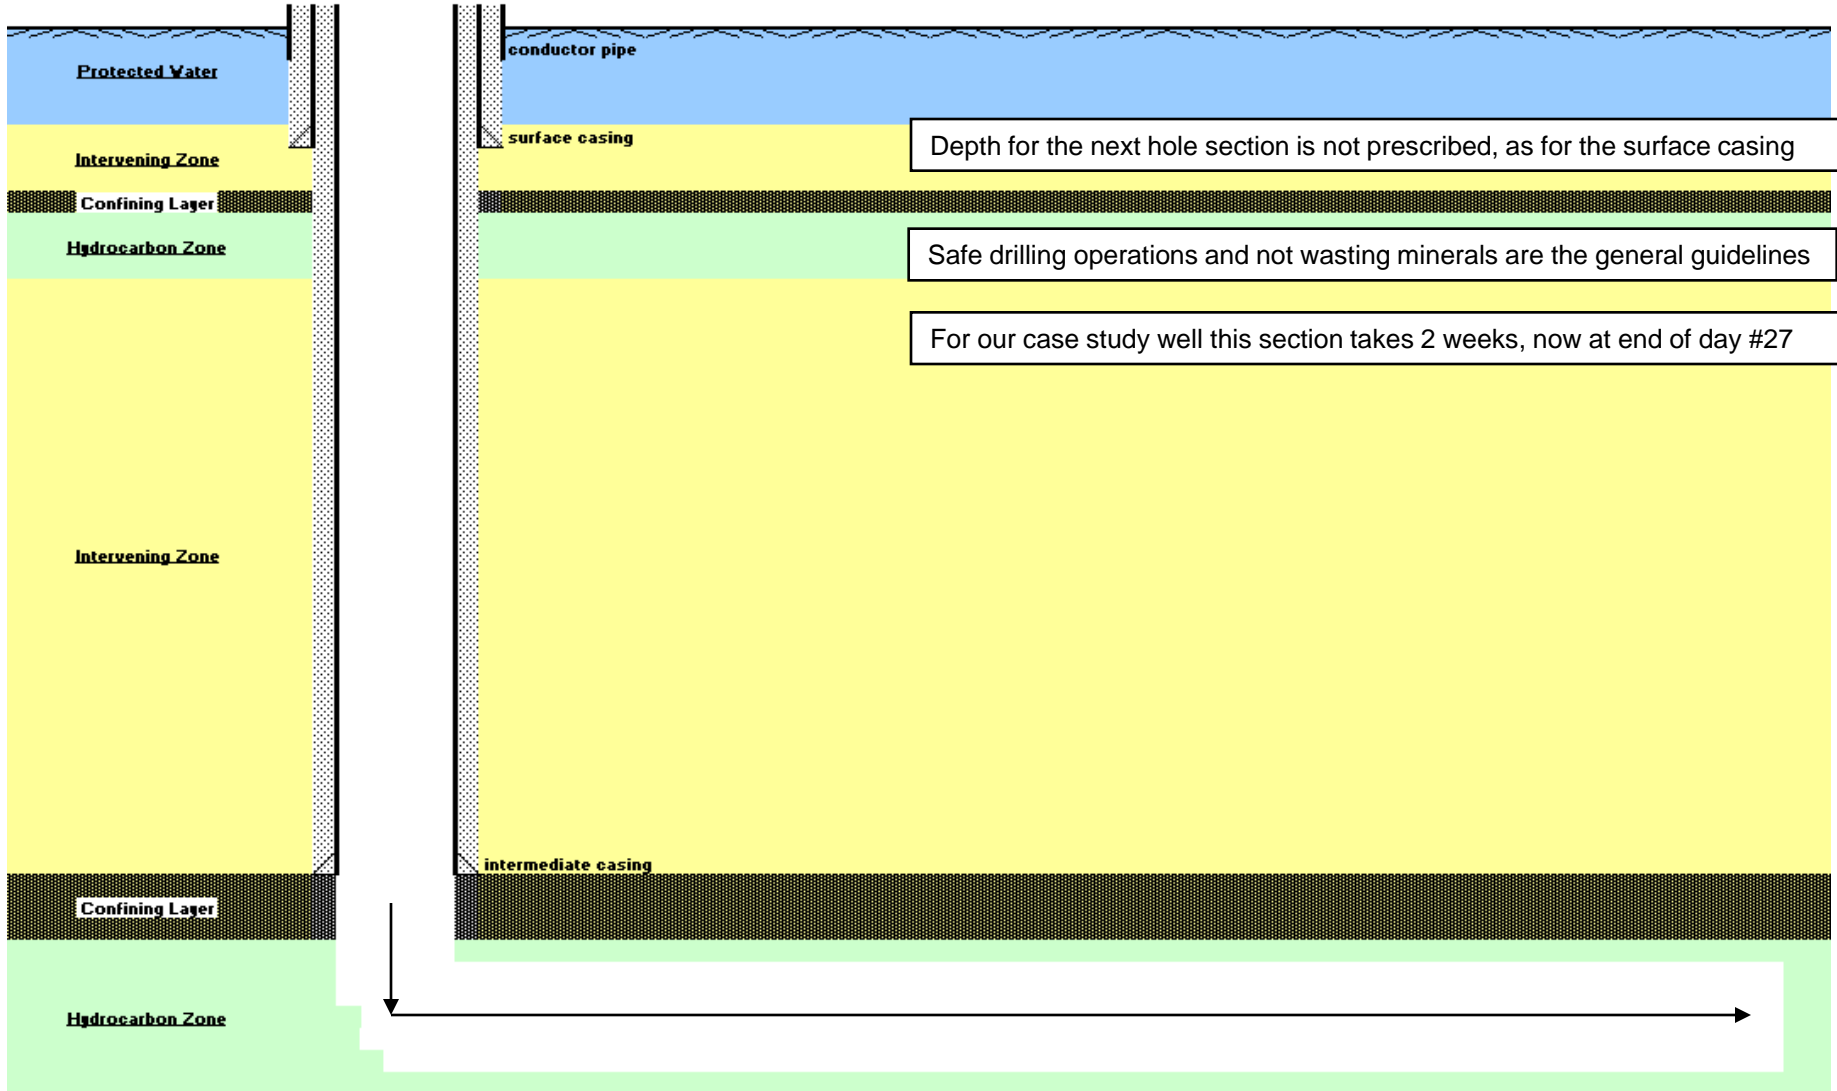
Slide 13 of 22 – Next section of hole is drilled

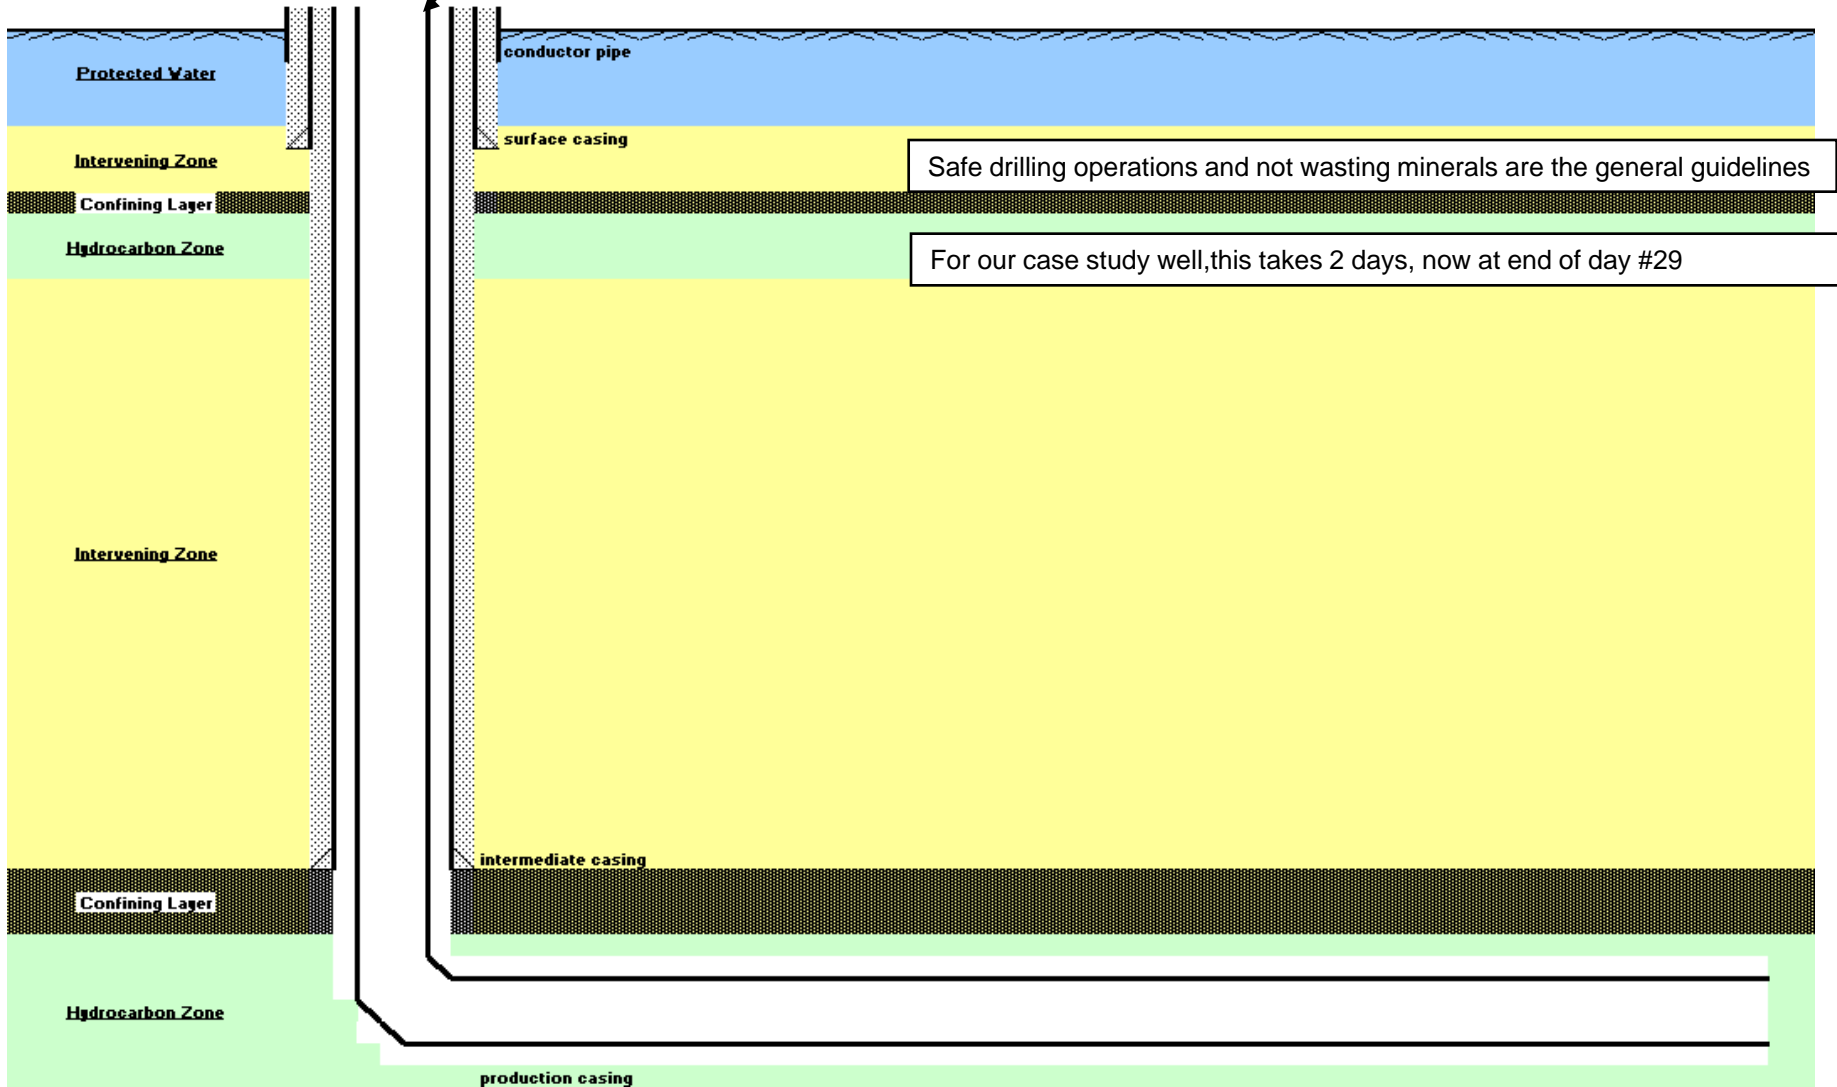
Slide 14 of 22 – Production casing is run

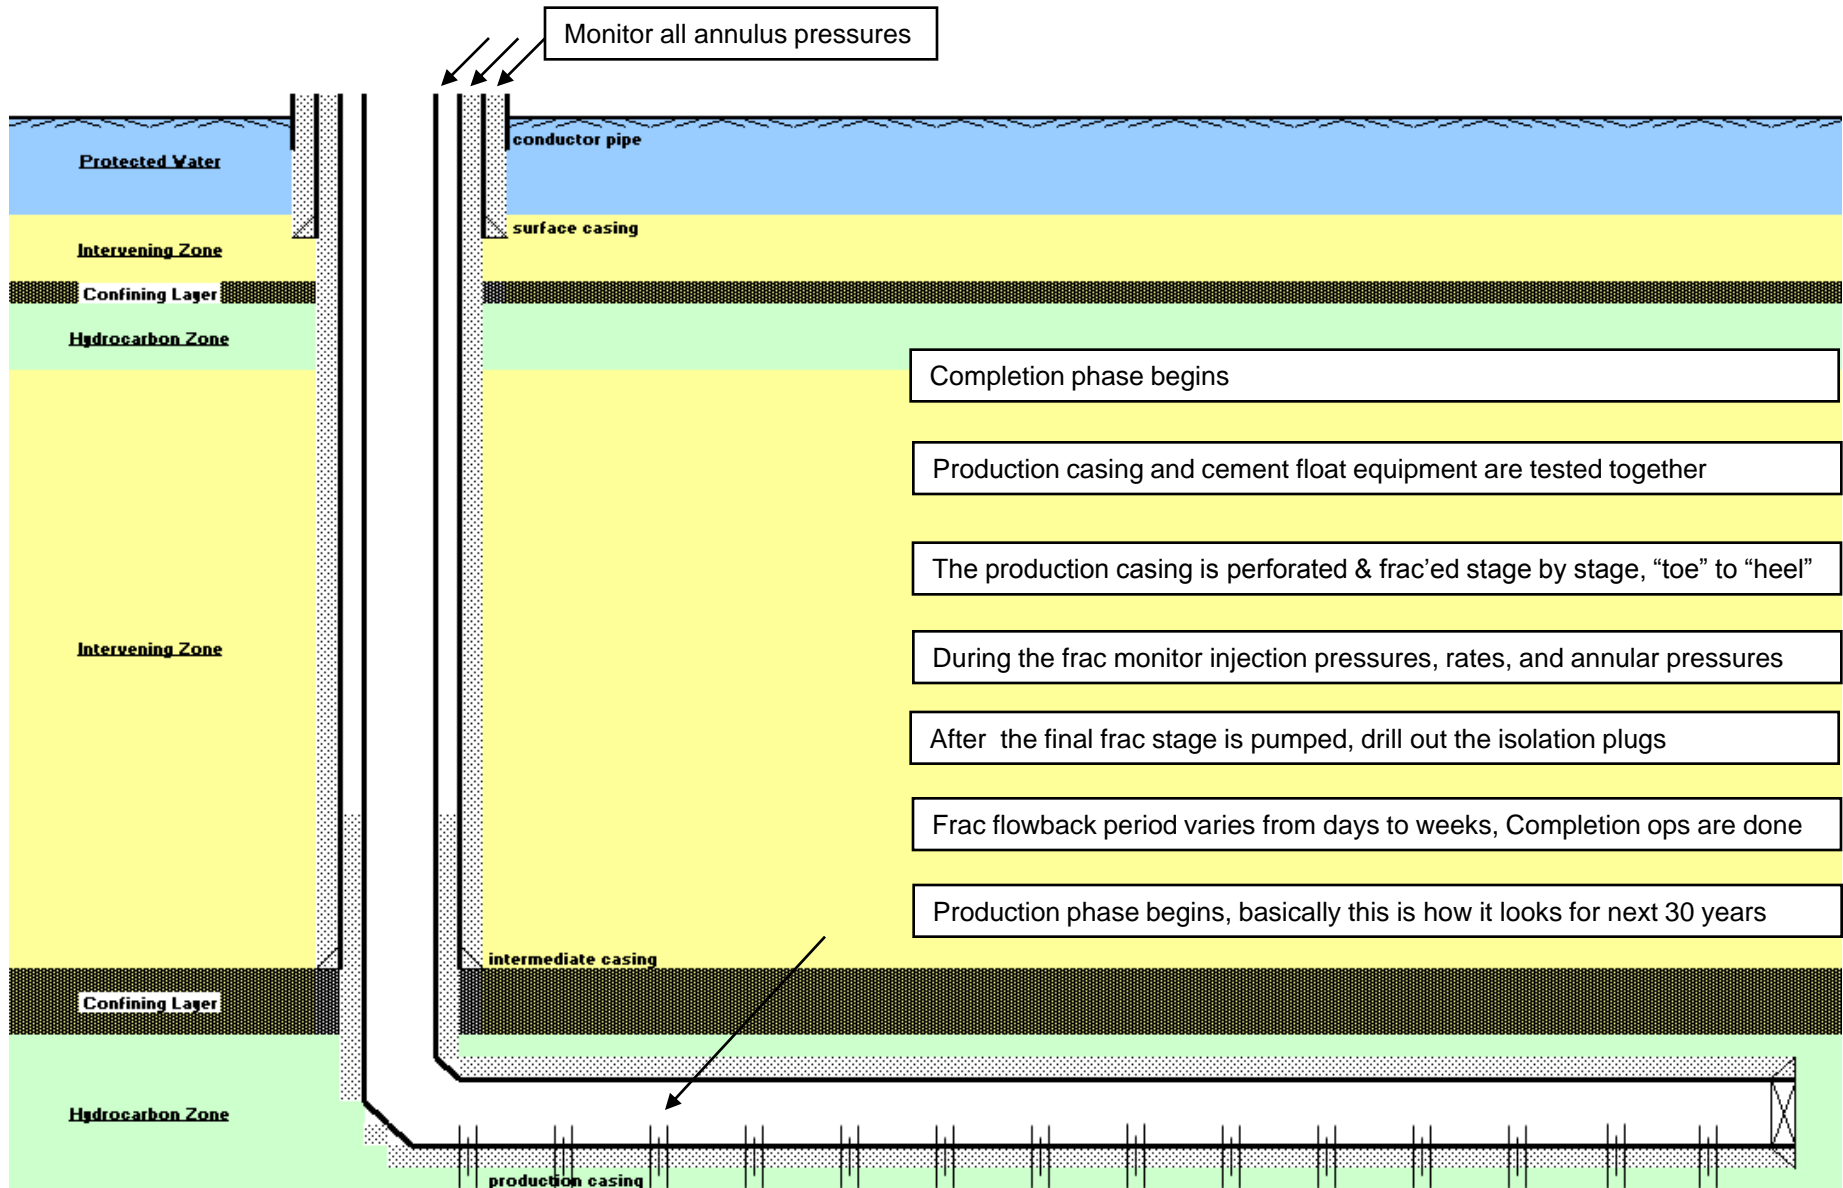
Slide 16 of 22 – Completion phase: perforate, hydraulically frac, flowback, production begins

Well completion is the where the production casing is perforated, the formation is hydraulically fractured, frac fluids are unloaded from the formation, and production operations commence. This is basically the well's configuration for the rest of its life as it relates to protecting USDWs.

Prior to performing the hydraulic frac, the production casing is tested to anticipated frac pressure plus a safety factor, as is the frac tree and all the surface pumping equipment and lines. During the frac, all casing annuli are monitored, as is the injection rate, injection pressure, and slurry properties. If during the frac job, significant pressure is found on the intermediate casing annulus, or there is any indication of communication with the surface casing annulus, the frac job is shut down and not resumed until corrective actions are made that only the intended zone is subject to frac pressures.

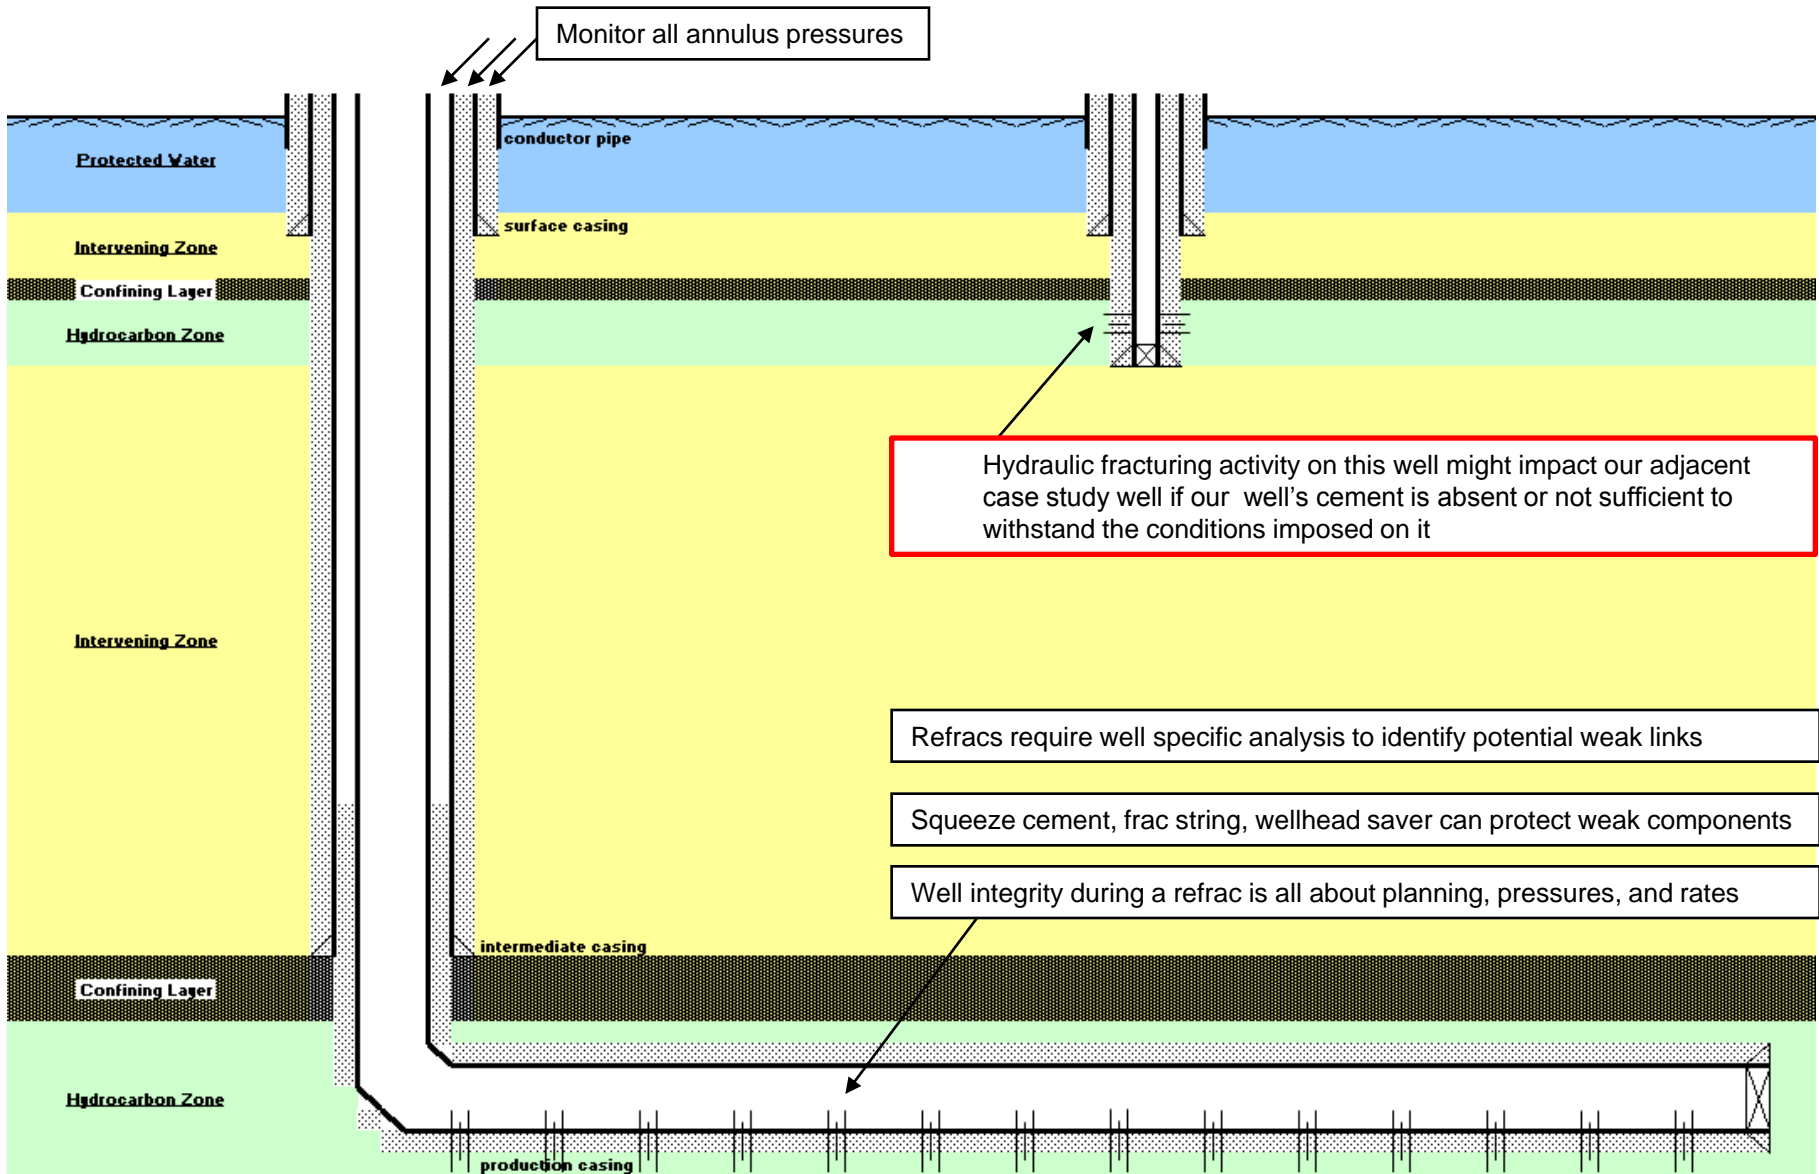
Slide 17 of 22 – Refrac and Adjacent Well Frac Scenarios

Refracs are similar to original fracs as discussed above with the exception that a frac string or wellhead saver might be used to protect older production casing strings and wellheads from frac pressures. This is a case by case situation that requires additional testing and engineering analysis in order to protect both the well and USDWs during refrac operations.

Adjacent well operations may have an impact on mechanical integrity of our case study well. Hydraulic fracturing of a well near our case study well into a zone that is not protected, or not adequately protected for the conditions imposed can lead to unwanted well to well communication. This is currently a void where regulations and industry practices have not fully recognized that well integrity can become a neighborhood issue.

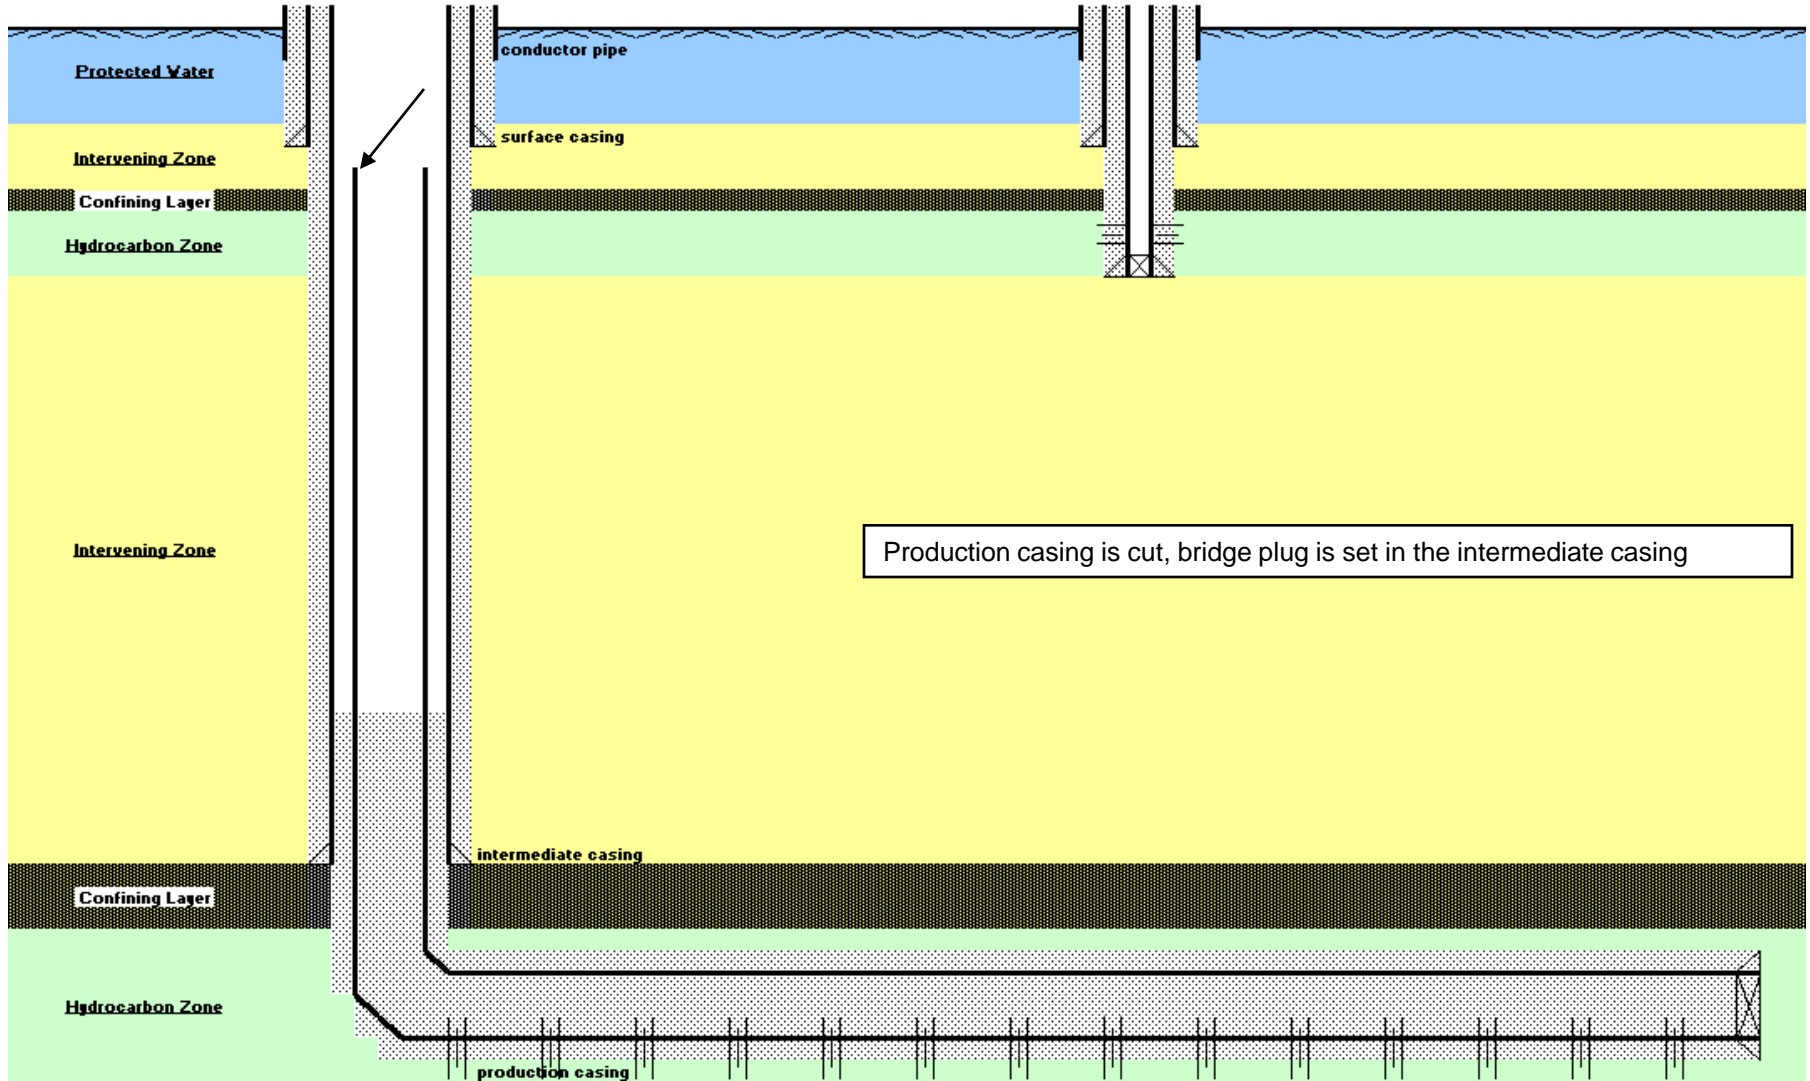
EPA Hydraulic Fracturing Study Technical Workshop #2 March 10-11, 2011
Well Integrity Case Study by Lloyd H. Hetrick
Slide 19 of 22 – Casing is cut or perforated near the surface casing shoe

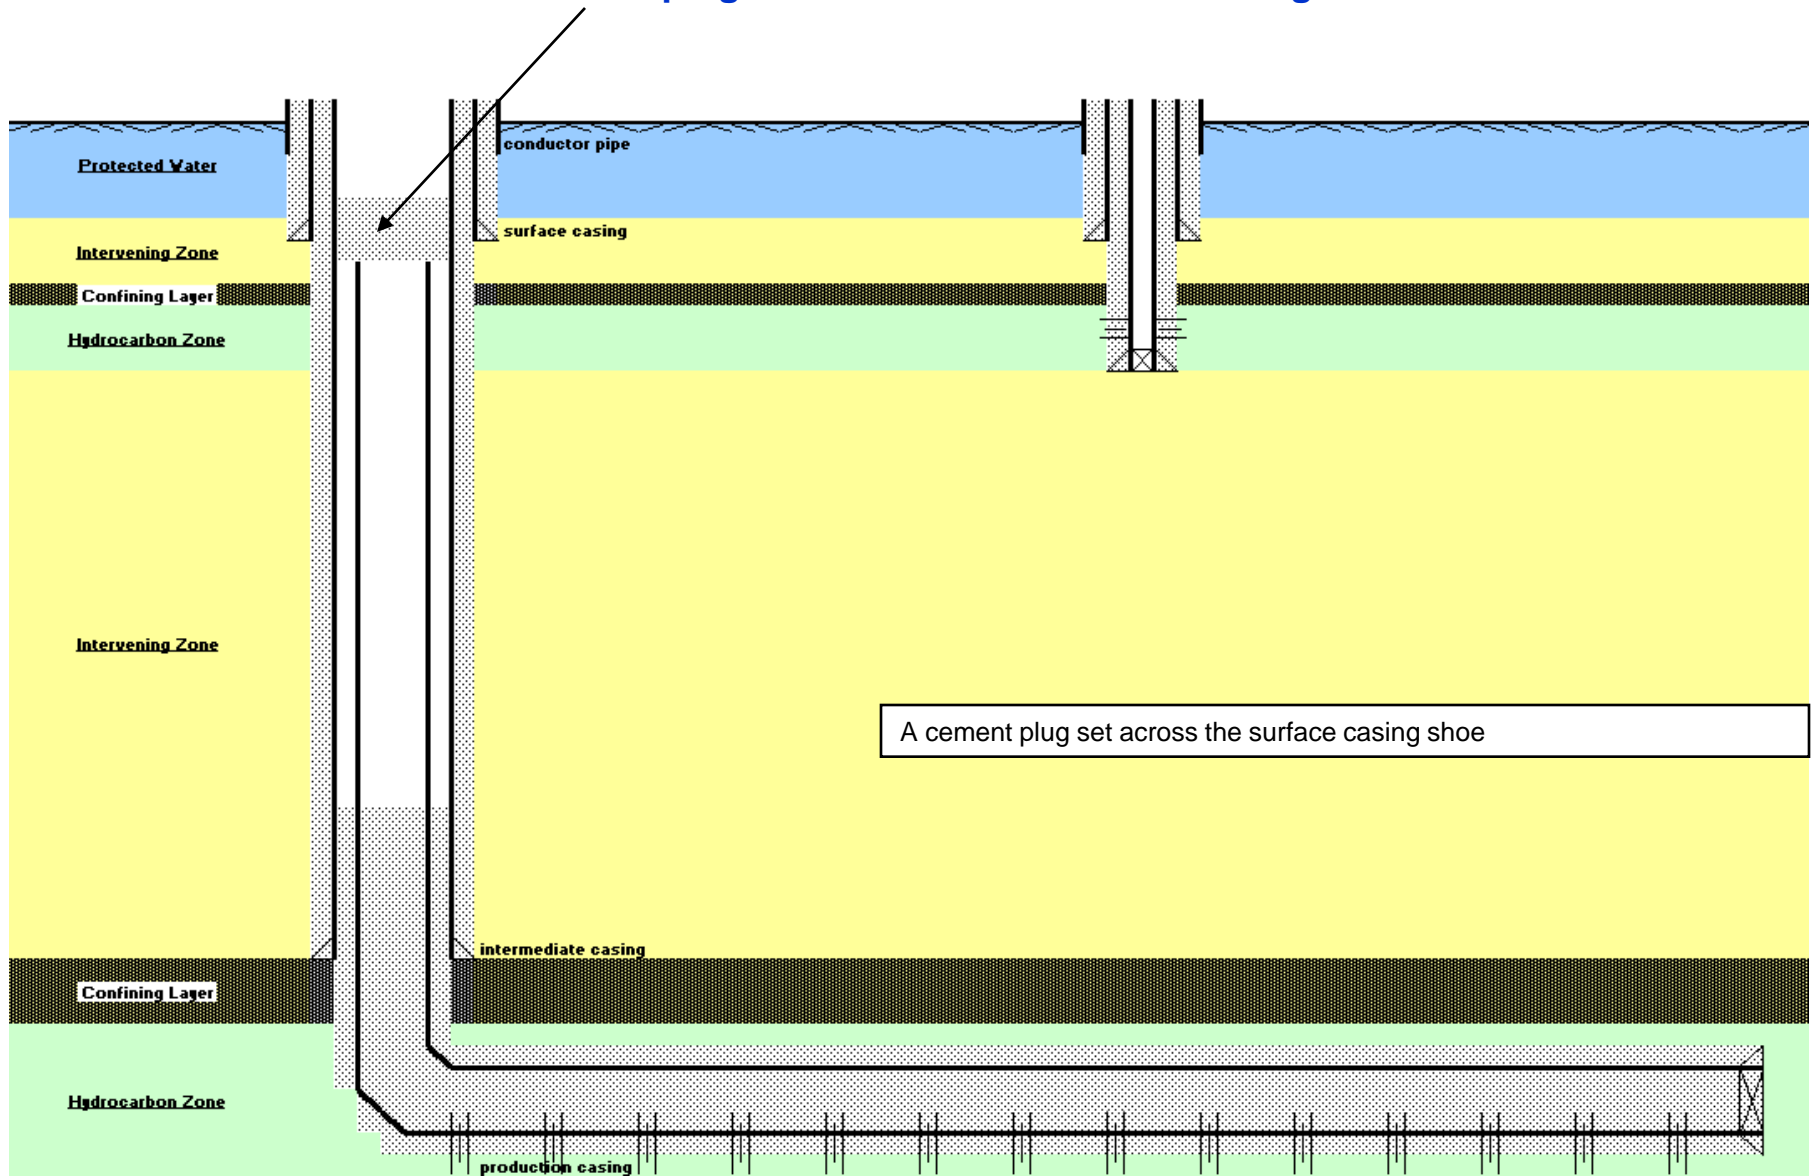
Slide 20 of 22 – Cement plug is set across the surface casing shoe and tested

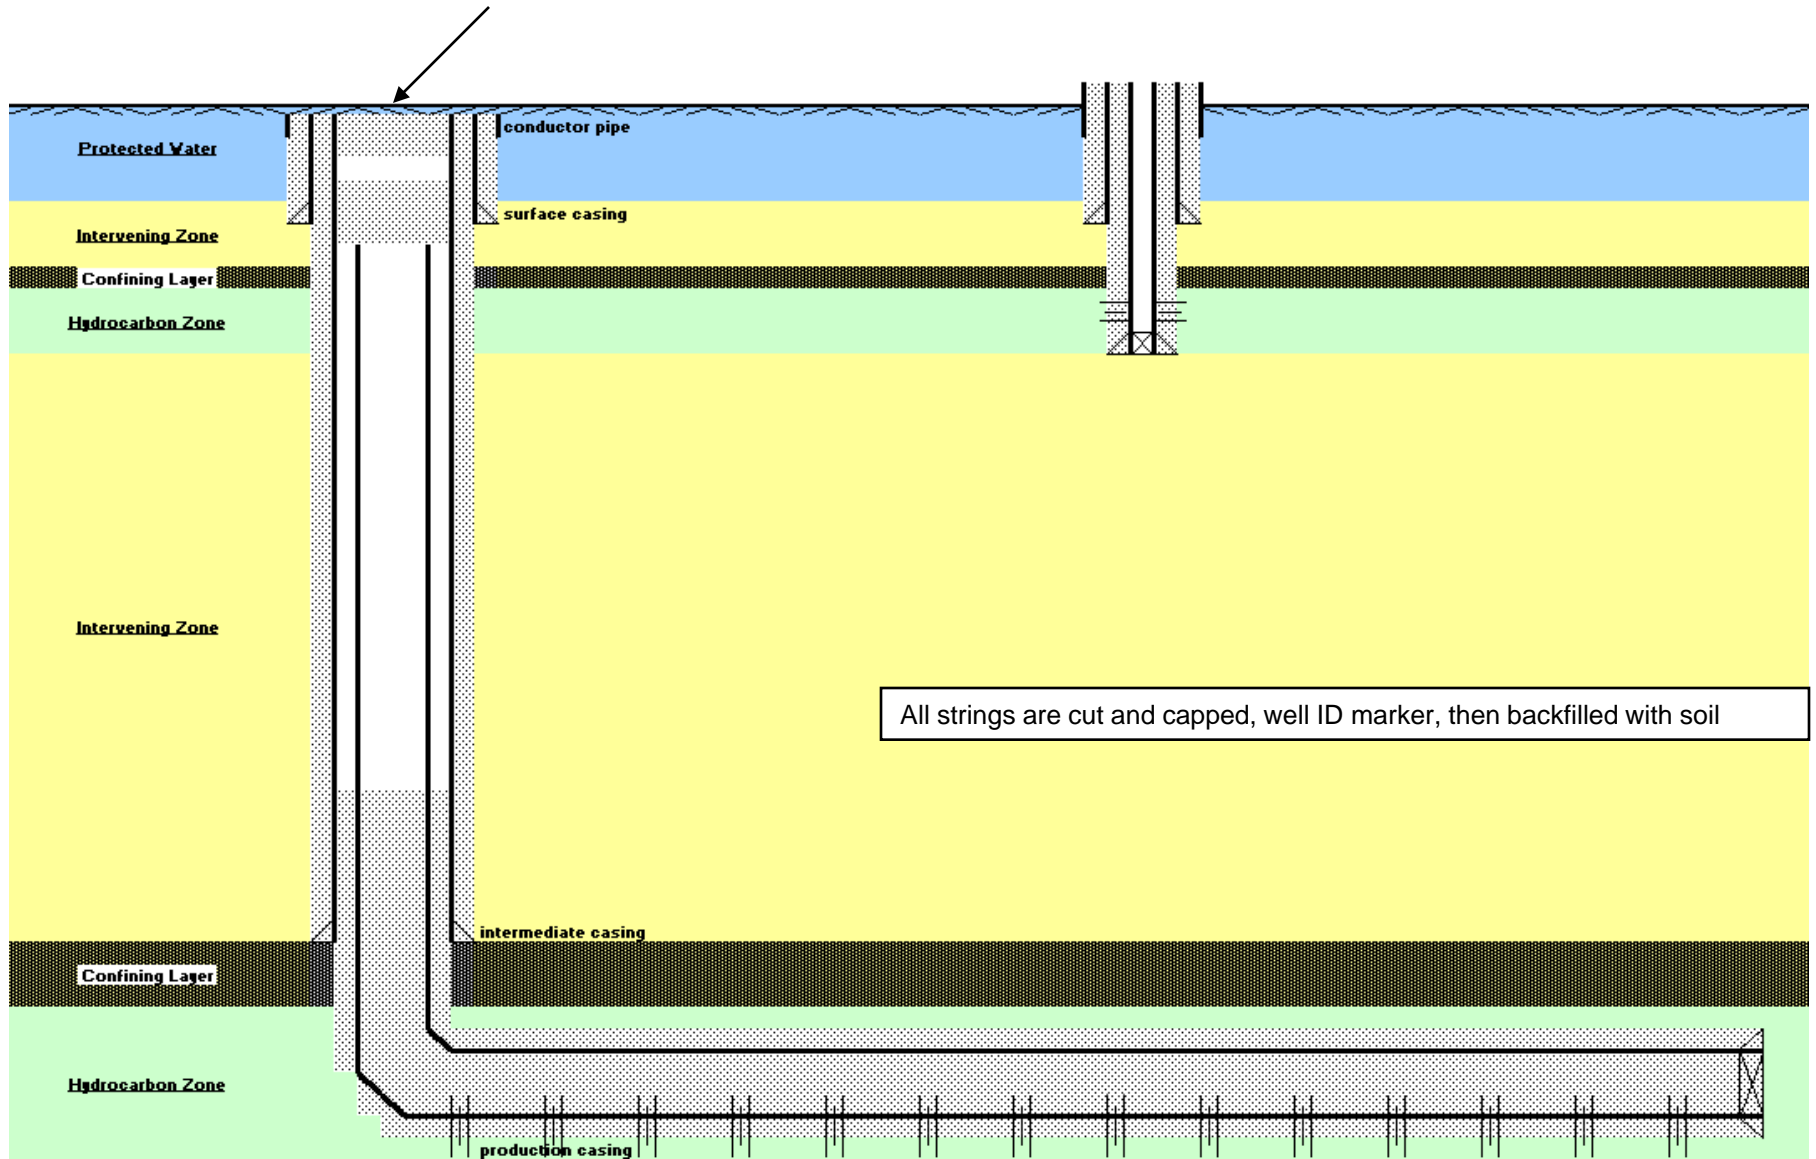
Slide 22 of 22 – Pipe cut-off, cap welded, well ID marker, backfill

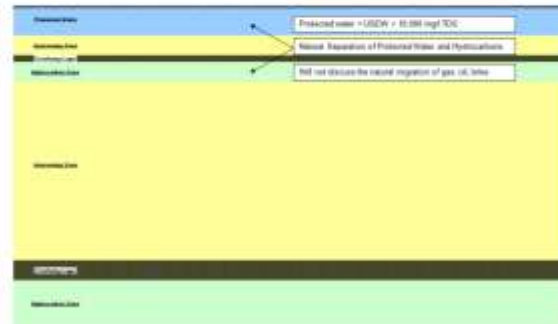
EPA Hydraulic Fracturing Study Technical Workshop #2 March 10-11, 2011
Well Integrity Case Study by Lloyd H. Hellick
Slide 3 of 22 – Natural Separation of Protected Water and Hydrocarbons, in most cases

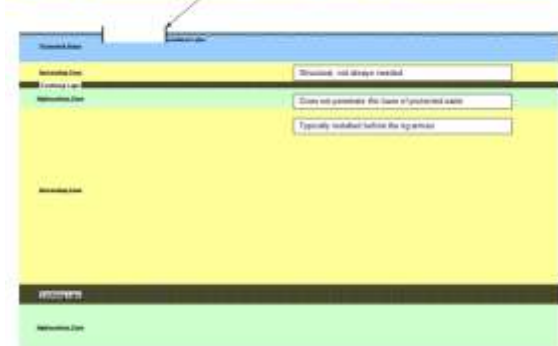
EPA Hydraulic Fracturing Study Technical Workshop #2 March 10-11, 2011
Well Integrity Case Study by Lloyd H. Hellick
Slide 4 of 22 – Spud well with conductor pipe (driven, cased or drilled) no impact on Protected Water

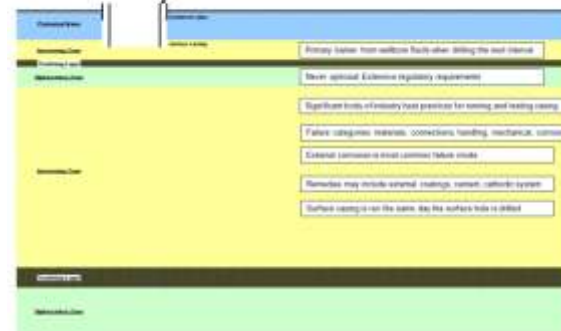
EPA Hydraulic Fracturing Study Technical Workshop #2 March 10-11, 2011
 Well Integrity Case Study by Lloyd H. Hetrick
 Slide 6 of 22 – Surface casing is run

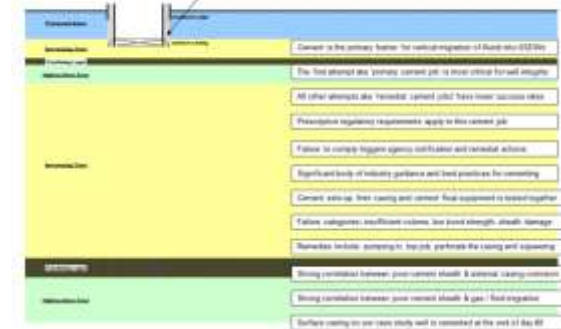
EPA Hydraulic Fracturing Study Technical Workshop #2 March 10-11, 2011
 Well Integrity Case Study by Lloyd H. Hetrick
 Slide 7 of 22 – Surface casing is cemented and tested

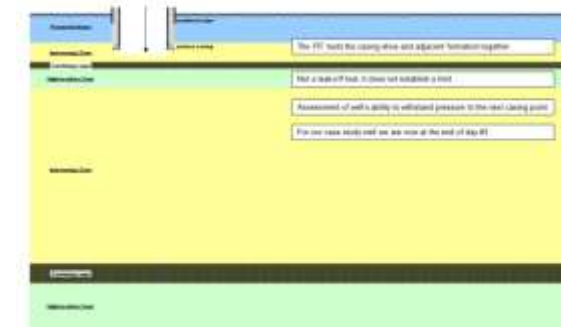
EPA Hydraulic Fracturing Study Technical Workshop #2 March 10-11, 2011
 Well Integrity Case Study by Lloyd H. Hetrick
 Slide 8 of 22 – Surface casing shoe and formation are integrity is tested

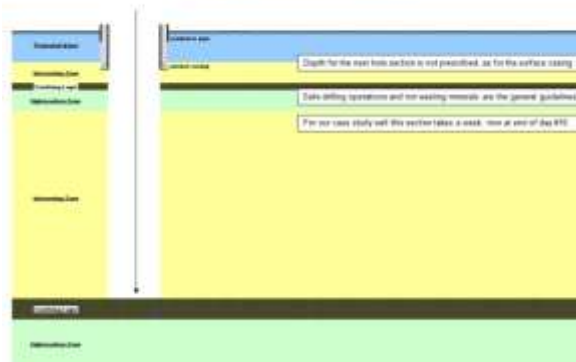
EPA Hydraulic Fracturing Study Technical Workshop #2 March 10-11, 2011
Well Integrity Case Study by Lloyd H. Hetrick
Slide 9 of 22 – Next section of hole is drilled
