Case Study for Well Integrity over a Full Life Cycle

Lloyd H. Hetrick, PE, CSP
Newfield Exploration Company

Abstract

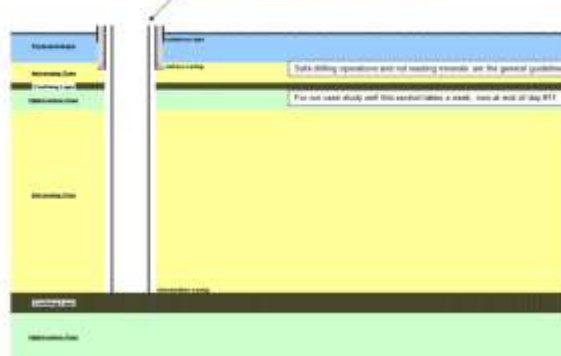
EPA Hydraulic Fracturing Study Technical Workshop #2 March 10-11, 2011
Well Integrity Case Study by Lloyd H. Hetrick
Slide 10 of 22 – Intermediate casing is run

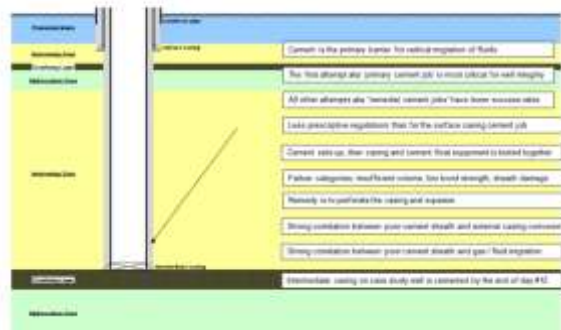
EPA Hydraulic Fracturing Study Technical Workshop #2 March 10-11, 2011
Well Integrity Case Study by Lloyd H. Hetrick
Slide 11 of 22 – Intermediate casing is cemented and tested

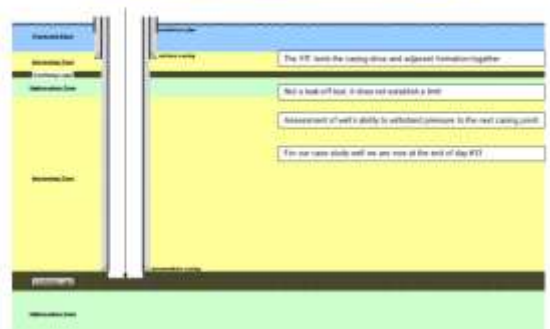
EPA Hydraulic Fracturing Study Technical Workshop #2 March 10-11, 2011
Well Integrity Case Study by Lloyd H. Hetrick
Slide 12 of 22 – Intermediate casing shoe and formation integrity are tested

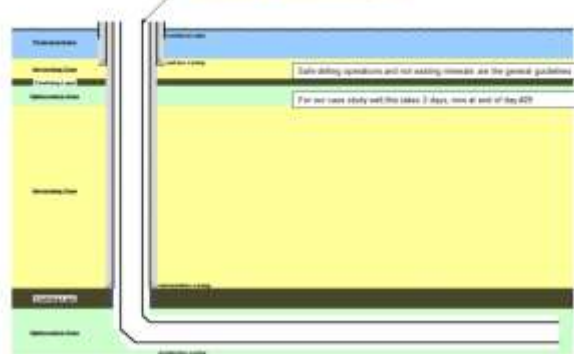
EPA Hydraulic Fracturing Study Technical Workshop #2 March 10-11, 2011
Well Integrity Case Study by Lloyd H. Helwick
Slide 14 of 22 – Production casing is run
