UNITED STATES ENVIRONMENTAL PROTECTION AGENCY  
REGION IX  
75 Hawthorne Street  
San Francisco, CA 94105

Purpose: TSCA Section 6(e), PCB Inspection

Facility: Veolia Environmental Services

Date of Investigation: July 15, 2009

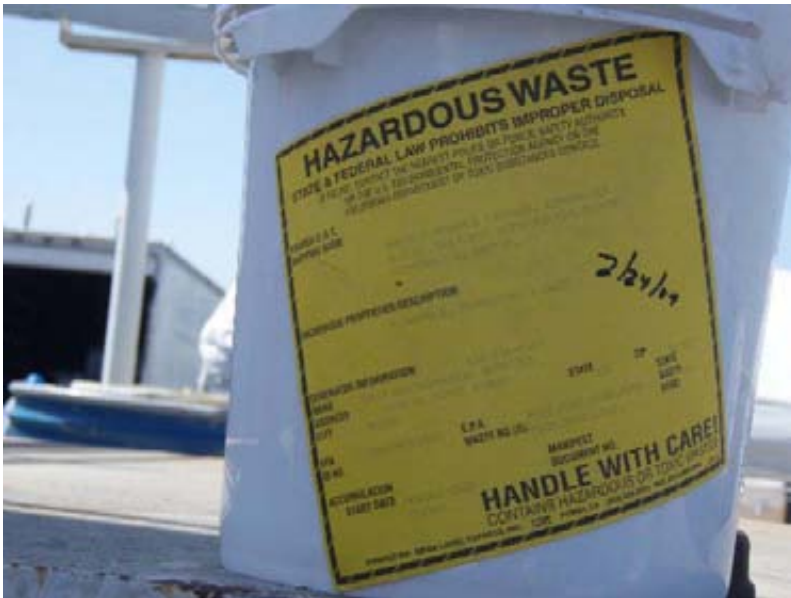
Prior to sampling, the inspectors walked through the facility and inspected the PCB storage shed in the drum storage area, the truck loading area, and the 10-day storage area. Three containers were in the PCB storage shed and two of them were properly labeled. However, a one-gallon poly container had a hazardous waste label indicating it contained PCBs, but it did not have a PCB label (see photo below).

- In the PCB storage shed, a one-gallon poly container had a hazardous waste label indicating it contained PCBs, but it did not have a PCB label.

- On July 16, 2009, the facility emailed a photograph documenting that the one-gallon poly container of PCB waste had been properly labeled.

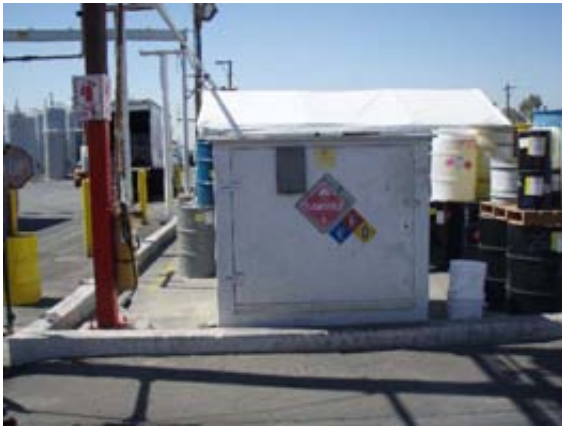
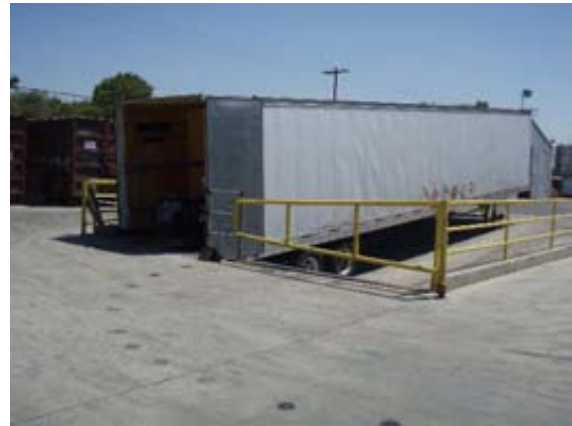
During the facility inspection, the inspectors identified the PCB storage shed and the truck loading area as potential locations for sampling. General photographs of these two areas are shown below, from left to right, respectively.

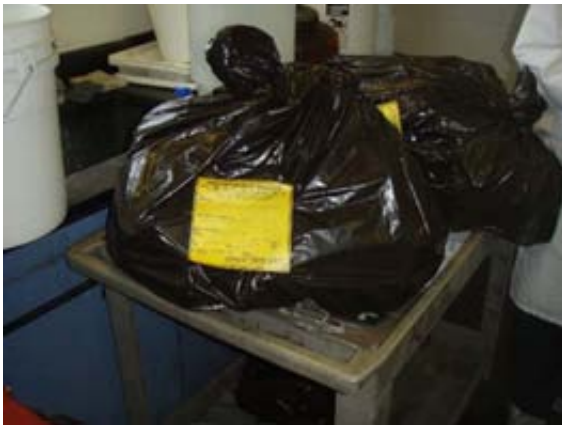
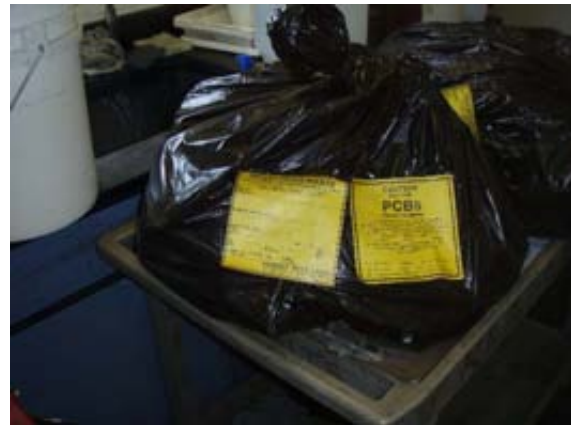
After collecting samples, the inspectors were shown the facility's laboratory and were given an overview of the laboratory's sampling procedures by Dev Maheshwari, the laboratory supervisor. All waste associated with PCB sampling is assumed to be PCB waste. This waste includes personal protective equipment (PPE), acids, solvents, and vials. The laboratory PPE is removed once per week. At the time of the inspection, a cart with two garbage bags of PPE were ready to be taken out to the PCB shed. One of the bags did not have a PCB label on it. The facility corrected this potential violation during the inspection (see before and after photographs below).

- In the on-site laboratory, two garbage bags of PPE were ready to be taken out to the PCB shed and one of the bags did not have a PCB label on it.

- During the inspection, the bag of PPE was labeled as PCB waste.
