**2013 HAWAII OCEAN DISPOSAL SITE MONITORING
SYNTHESIS REPORT**

**Prepared by:
Dredging and Sediment Management Team
USEPA Region 9
San Francisco, CA**

April 27, 2015

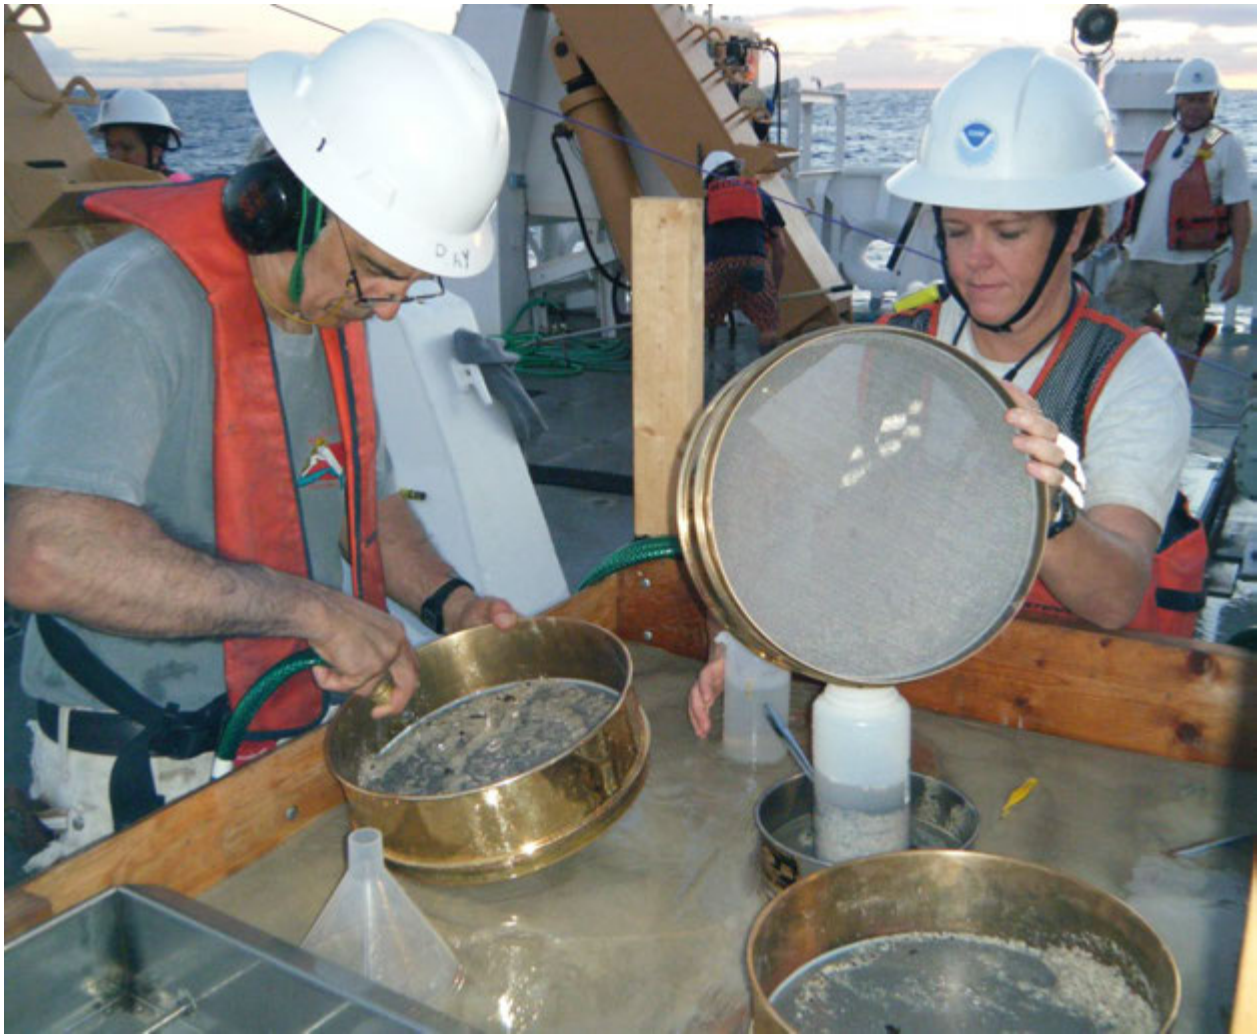
Figure 12. Processing a sediment sample for benthic community analysis.

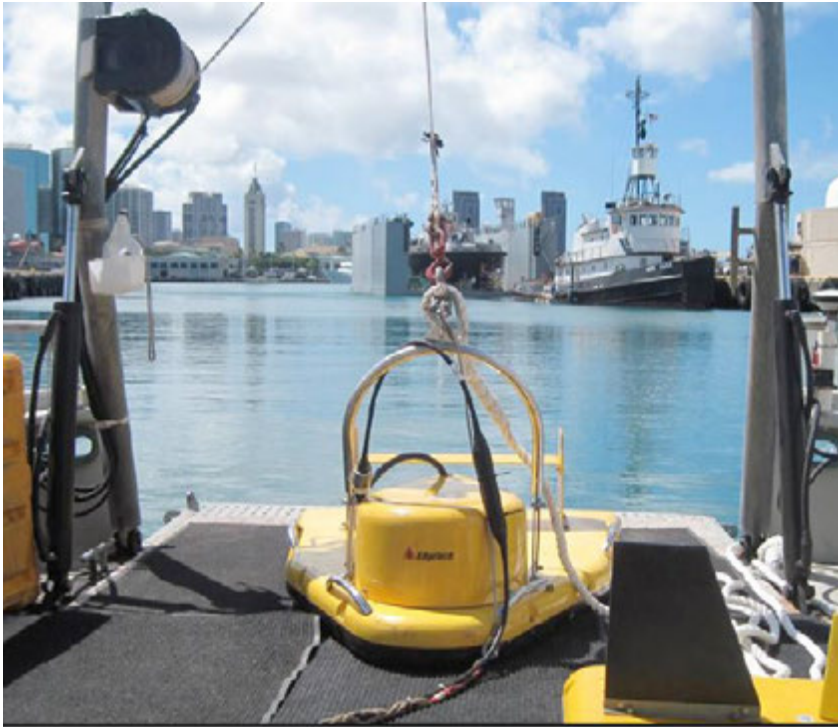
Figure 13. Sub-bottom profiler equipment – used only at the South Oahu site.

The primary purpose of this survey was to collect cross-sectional images of the native sediment layers and layers indicative of the dredged material deposit across a wide area in the environs of the South Oahu ODMDS. (The Hilo site was not surveyed in this manner during this round of surveys because much smaller volumes of dredged material have been disposed there over time which may not be detectable in terms of thickness and contrast.)

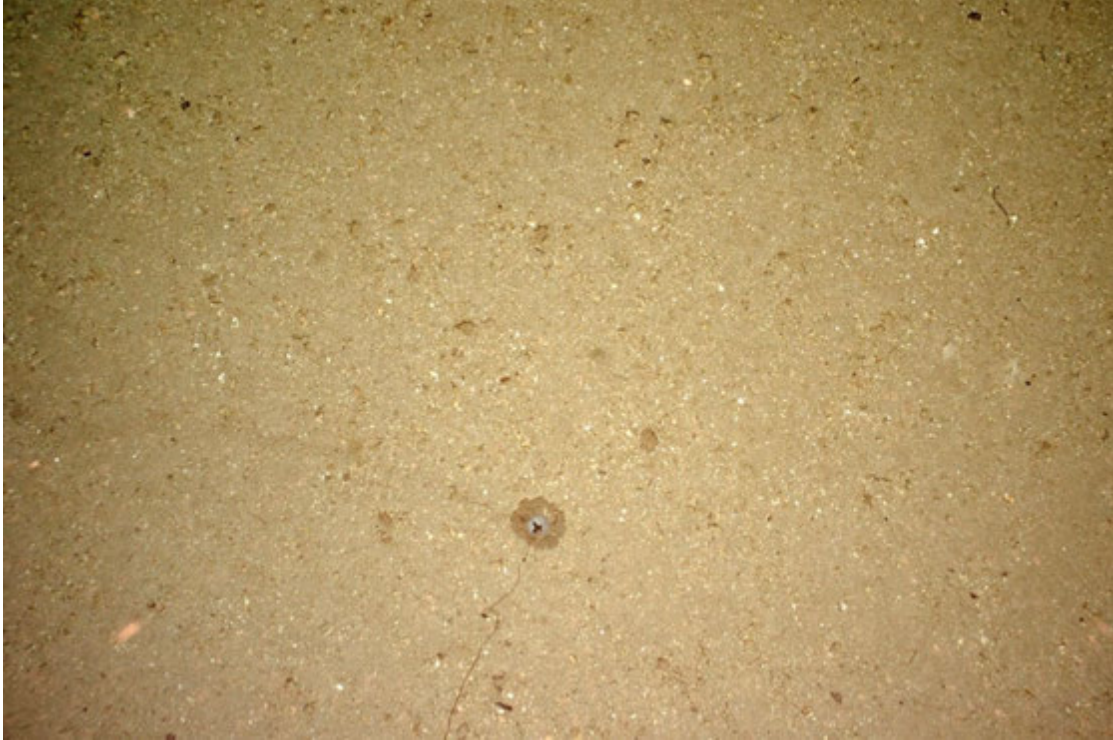
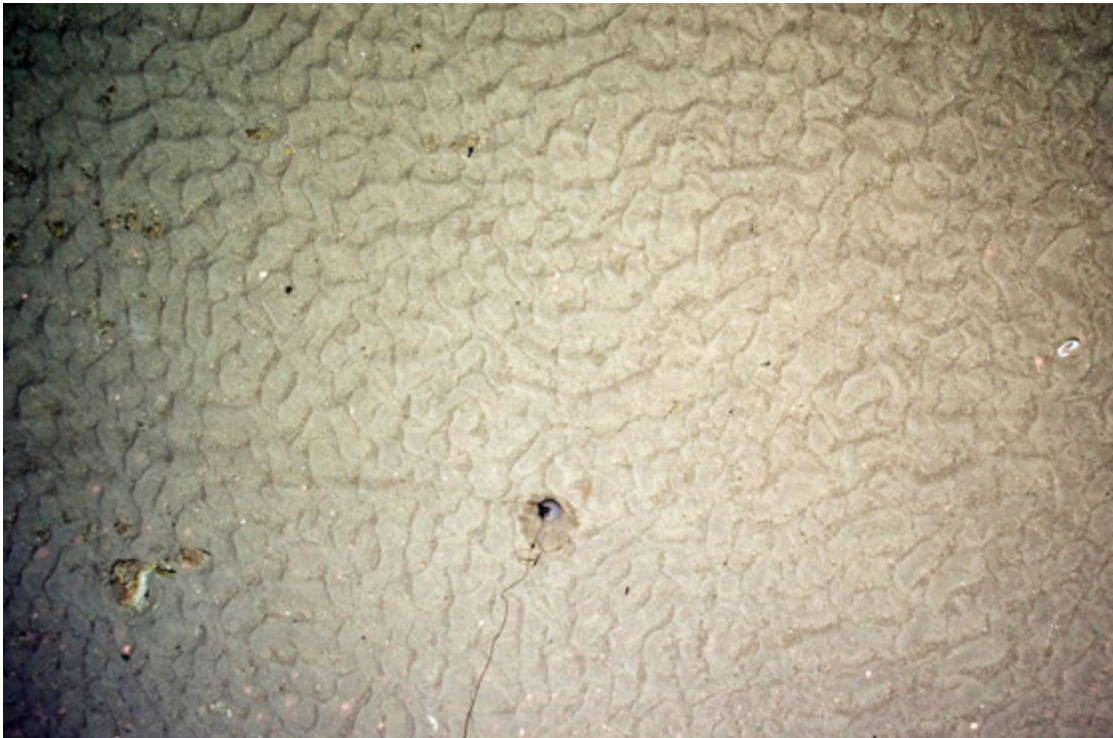
Figure 16. Plan view images of the dredged material deposit compared to the native seafloor at South Oahu. Station C1 on dredged material (top) shows the visual difference in both sediment color and surface texture/features of dredged material compared to the ambient bottom at Station NW6 (bottom). Scale: width of each PV image is approximately 4 m. (Germano & Assoc., 2013)
