Carmel River Watershed: Water Supply Perspective

Western States Source Water and Ground Water Protection Forum

Tuesday, May 5, 2009

Joseph Oliver, Water Resources Manager

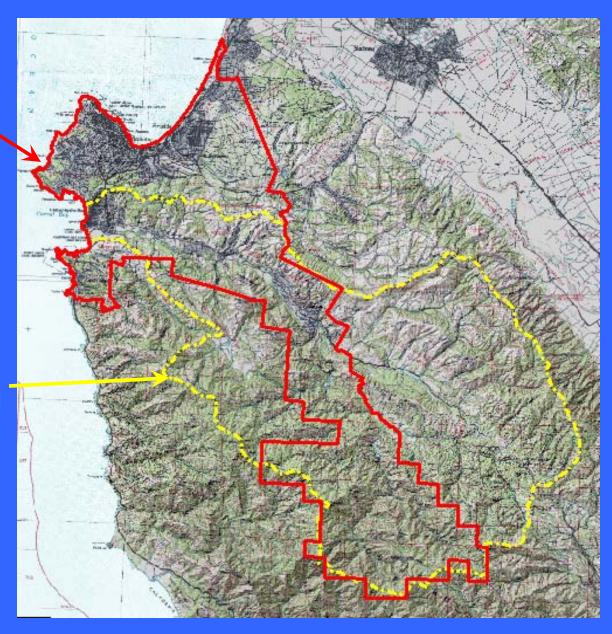
MPWMD Boundary

> Carmel River Watershed Boundary

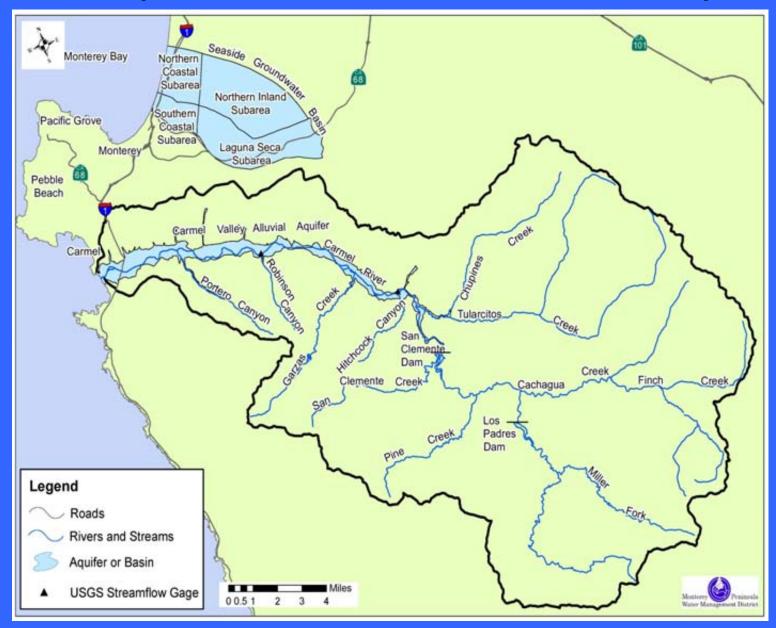
Monterey Peninsula Water Resource System

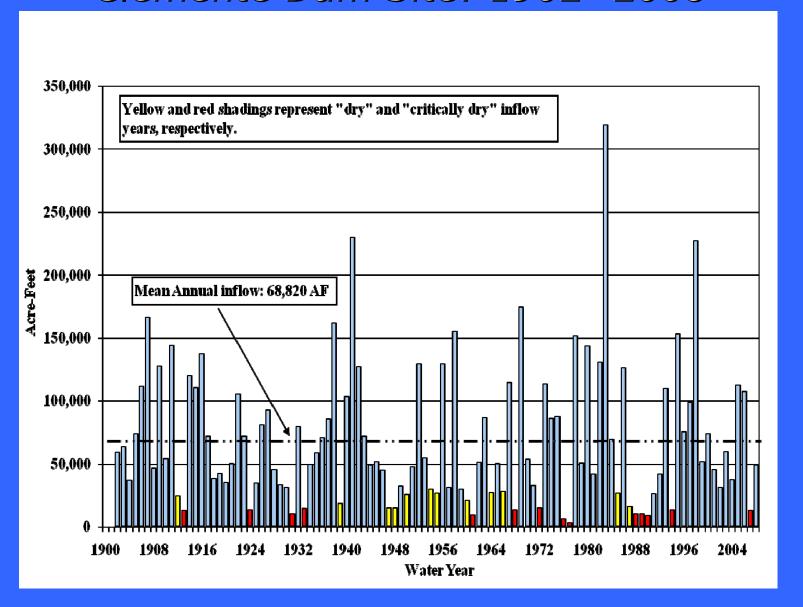
Unimpaired Carmel River Flow at San Clemente Dam Site: 1902-2008

- Rainfall amounts vary significantly geographically and seasonally
 - annual rainfall at San Clemente Dam ranges from <3 inches to >46 inches
 - annual rainfall in the basin ranges
 from <15 inches at the coast to more
 than 40 inches in the headwaters
 - 10-inch overnight accumulations are rare, but occurred in 1995 and 1998

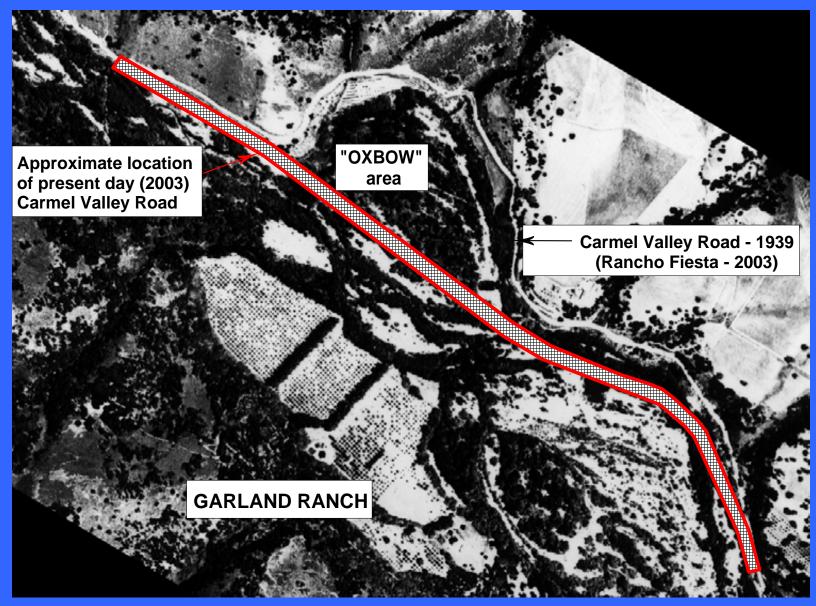
River Straightening

- Highly erodible channel banks
- 19 bridges, 3 dams
- >420 riverfront properties
- >1,500 parcels in 100-year floodplain
- Alluvial portion of the river has been straightened and narrowed since the early 1900's
- About 438 acres of riparian area along the lower 18.6 miles of the river

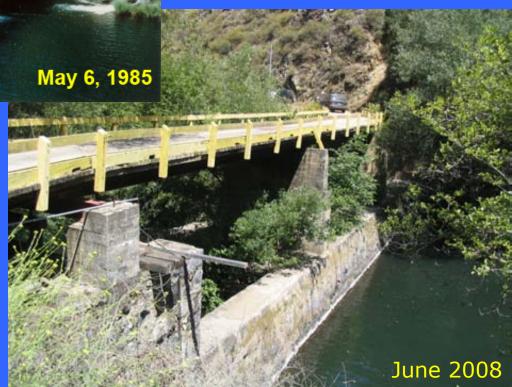
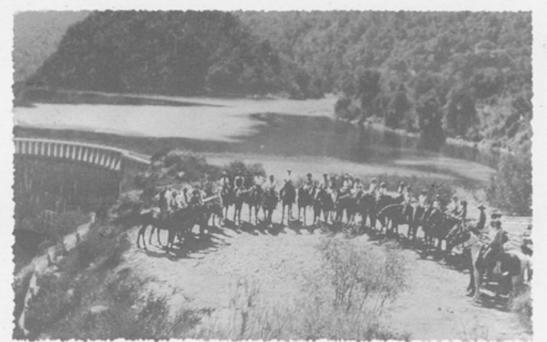
Old Carmel Dam

- 700 Chinese laborers
- 25 miles of 12-inch iron pipe crossed river in five places
- first Monterey Peninsula municipal water supply

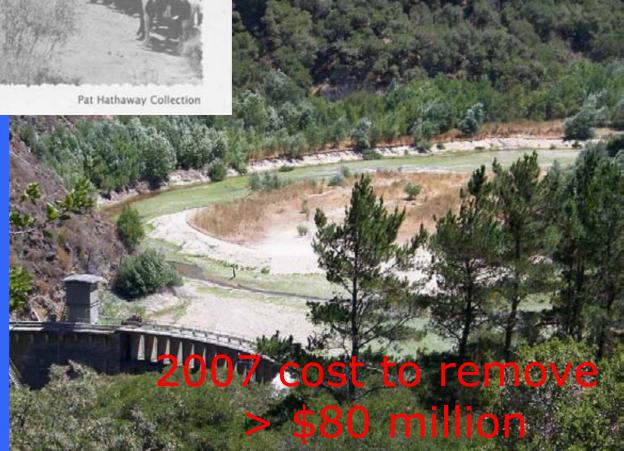
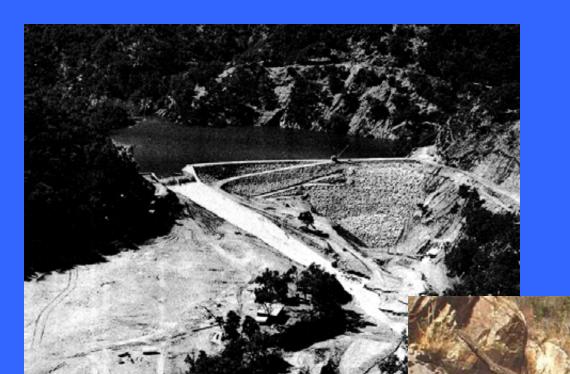
San Clemente Dam

San Clemente Dam . March 29, 1932

Constructed in 1921: \$1-2 million

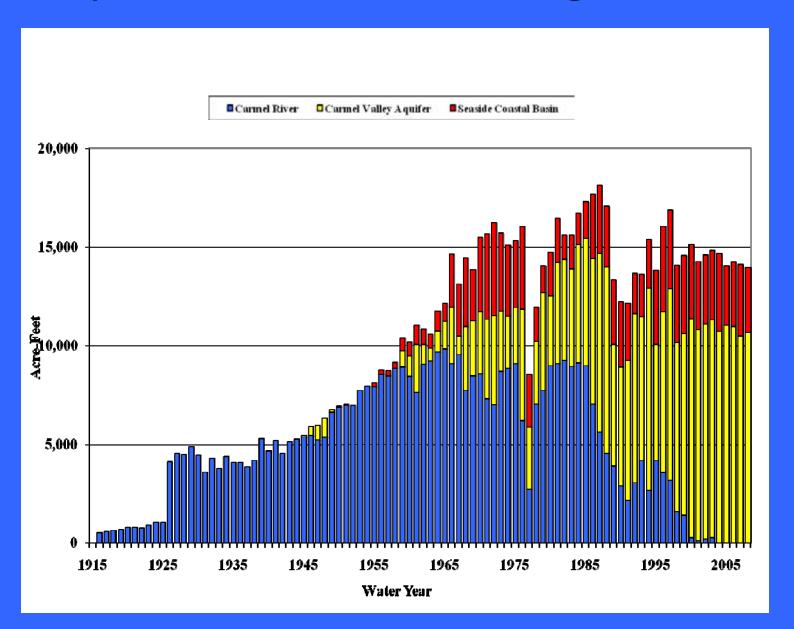
California American Water Production By Source: 1916 through 2008

- Largest municipal water purveyor California
 American Water 15,000 AFY
- Cal-Am water supply from two source areas:
 - 1. Carmel River alluvial aquifer system 75%
 - 2. Seaside Groundwater Basin 25%

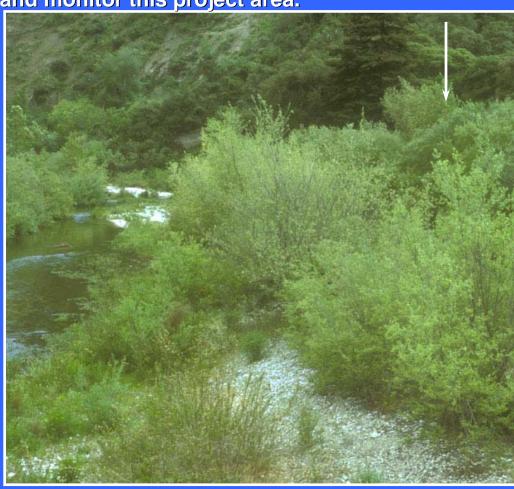
Schulte Project – 1982 and 2003

Left - Looking upstream from Schulte Bridge, April 1982. Note tires, wooden jacks, and concrete rubble dumped by the owner on the streambank to slow erosion.

Right - May 2003 - after MPWMD-sponsored restoration work. The arrow shows where the brown well pump building was at the upper left of the 1982 photo. MPWMD continues to maintain and monitor this project area.

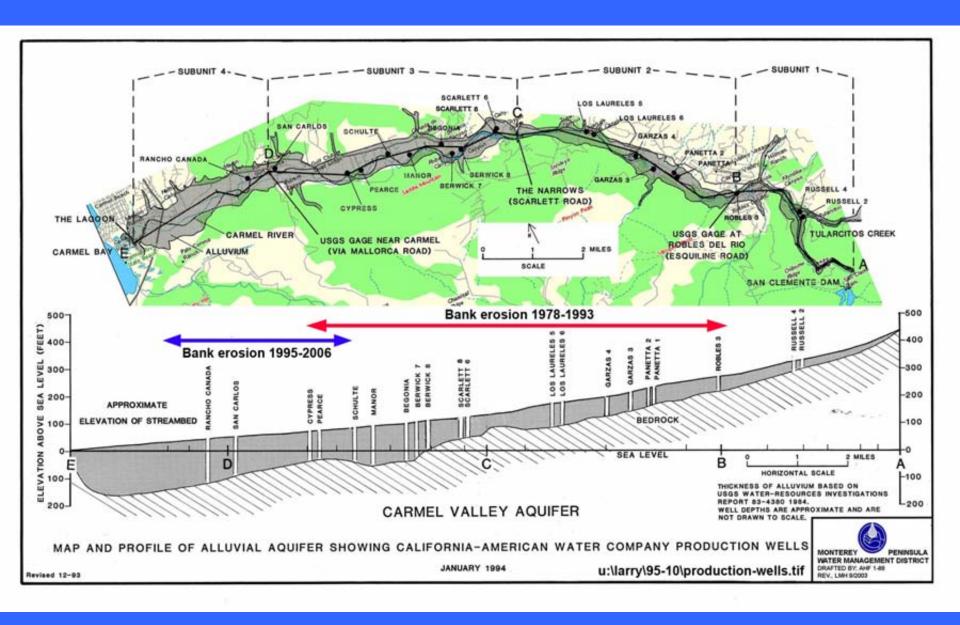
Bank Erosion Problem Areas

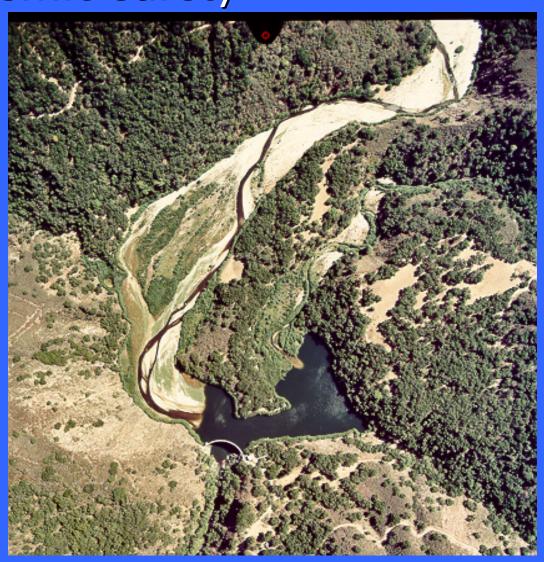
Issue: Reservoir sedimentation and seismic safety

San Clemente Dam and Reservoir

Storage loss

1921: 1,425 acre-feet 2008: < 100 acre-feet

Proposals:

- Strengthen dam
- Remove dam and reroute river

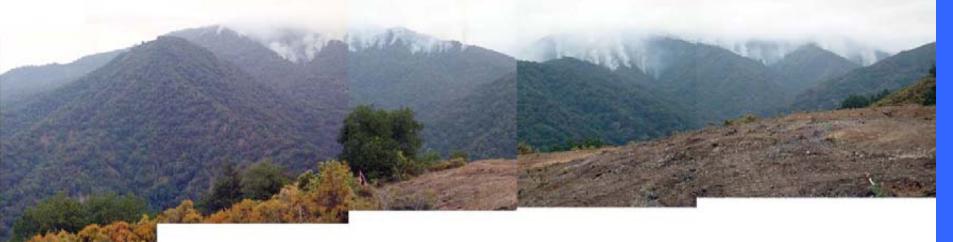
Fire
Hastens
Mass
Wasting

Below - Danish Creek watershed - July 12, 2008

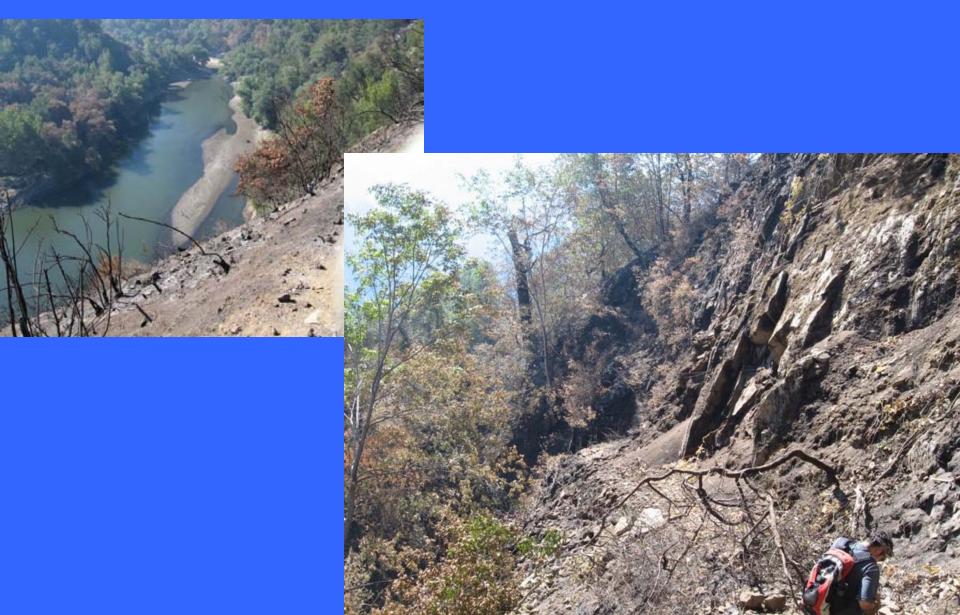
Basin Complex Fire Will Increase Sediment Load into Los Padres Reservoir
