Appendix B
Exhibit Log

Exhibit 6. Sunol Grade/Route 680 Roadway Rehabilitation Project—outstanding issues had not been corrected through adequate enforcement of the contract conditions as of October 7, 2009, the date of the EPA Audit Team’s site visit.

Exhibit 9. Sunol Grade/Route 680 Roadway Rehabilitation Project—Outstanding issues had not been corrected through adequate enforcement of the contract conditions as of October 7, 2009, the date of the EPA Audit Team’s site visit.

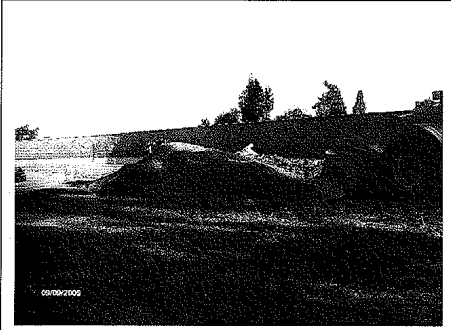
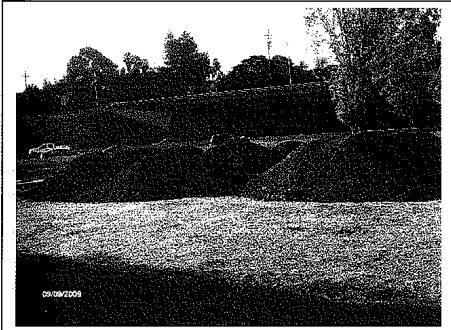
<p>09/09/2009</p>
<p>13. AC grindings should be either covered or perimeter control prior to rain.</p>	<p>14. AC grindings should be either covered or perimeter control prior to rain.</p>

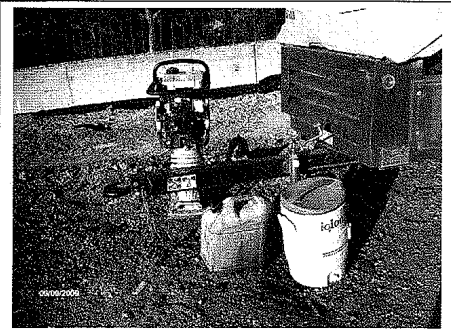
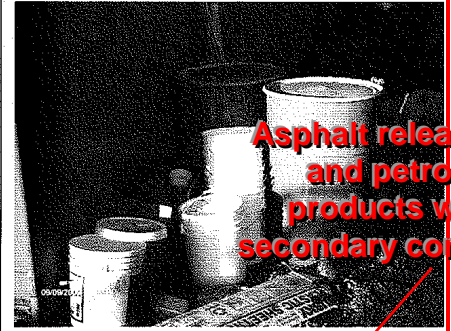
<p>Asphalt release agent and petroleum products without secondary containment</p>
<p>15. Fuel containers should be stored in the back of pick up.</p>	<p>16. Paint buckets curing compound should be stored in the tool shed or secondary container.</p>

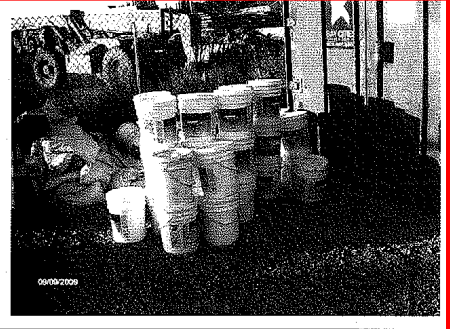
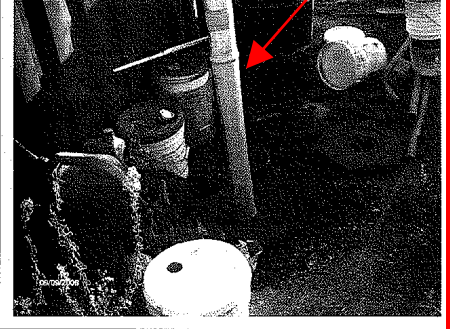
<p>Spilled liquid should be cleaned.</p>
<p>17. Paint buckets should be stored in the tool shed or secondary container.</p>	<p>18. Spilled liquid should be cleaned.</p>

Exhibit 8. Sunol Grade/Route 680 Roadway Rehabilitation Project—Photograph 18 above corresponds to the same asphalt release agent and petroleum products (lacking secondary containment) shown in Appendix E, Site Visit No. 11, Photographs 6—8 of this audit report.

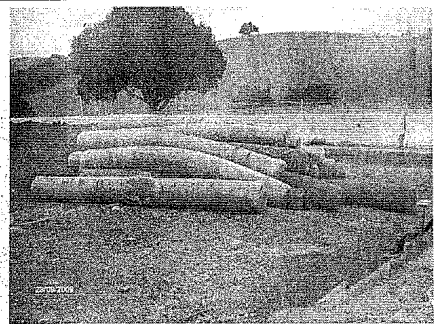
<p>7. Water truck on hand to help keep both dust under control and moisturize the compacting materials</p>	<p>8. Geo textile netting on hand at Vargas Yard.</p>

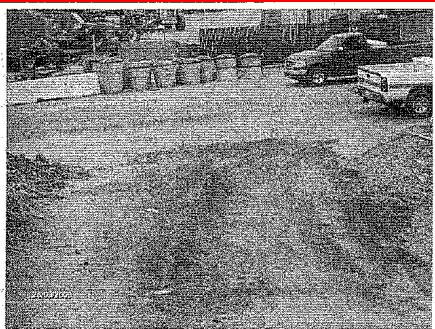
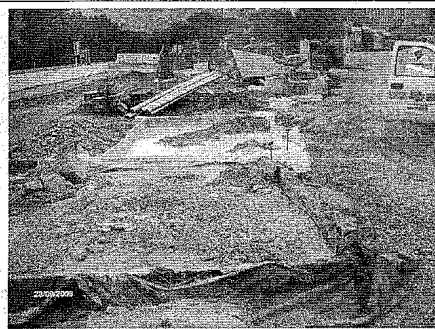
<p>9. It was recommended to install an entrance and exit at this location if it is going to be used as an entrance and exit.</p>	<p>10. Both of these washouts are leaking should be removed and replaced.</p>

Exhibit 10. Sunol Grade/Route 680 Roadway Rehabilitation Project—Photograph 9 above corresponds to the same construction entrance shown in Appendix E, Site Visit No. 15, Photographs 8—9 of this audit report.

The following issues need correction:					
<ol style="list-style-type: none"> An entrance and exit was recommended be installed at this location (photo # 9). Two concrete washouts at Vargas Yard are leaking should be removed and replaced (photo # 10). Secondary containment is an issue it should be corrected by next visit (photo # 11-12). Surplus PCC and AC at retaining walls and side of the road should be picked up (photo # 13-16). Grease dumped on the ground during the maintenance of equipment should be cleaned (photo # 17-18).

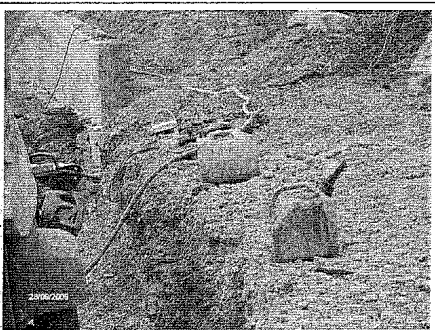
<p>11. Gas containers and pipe soup should be in the back of pick up or secondary container.</p>	<p>12. 5 gallon bucket has oil and two 55 gallons have some curing compound it should be stored in secondary</p>
