Re: May 6, 2010 Storm Water Inspection

NPDES MSGP STORMWATER COMPLIANCE INSPECTION

Report No. 2

Facilities: Apra Harbor Naval Waterfront

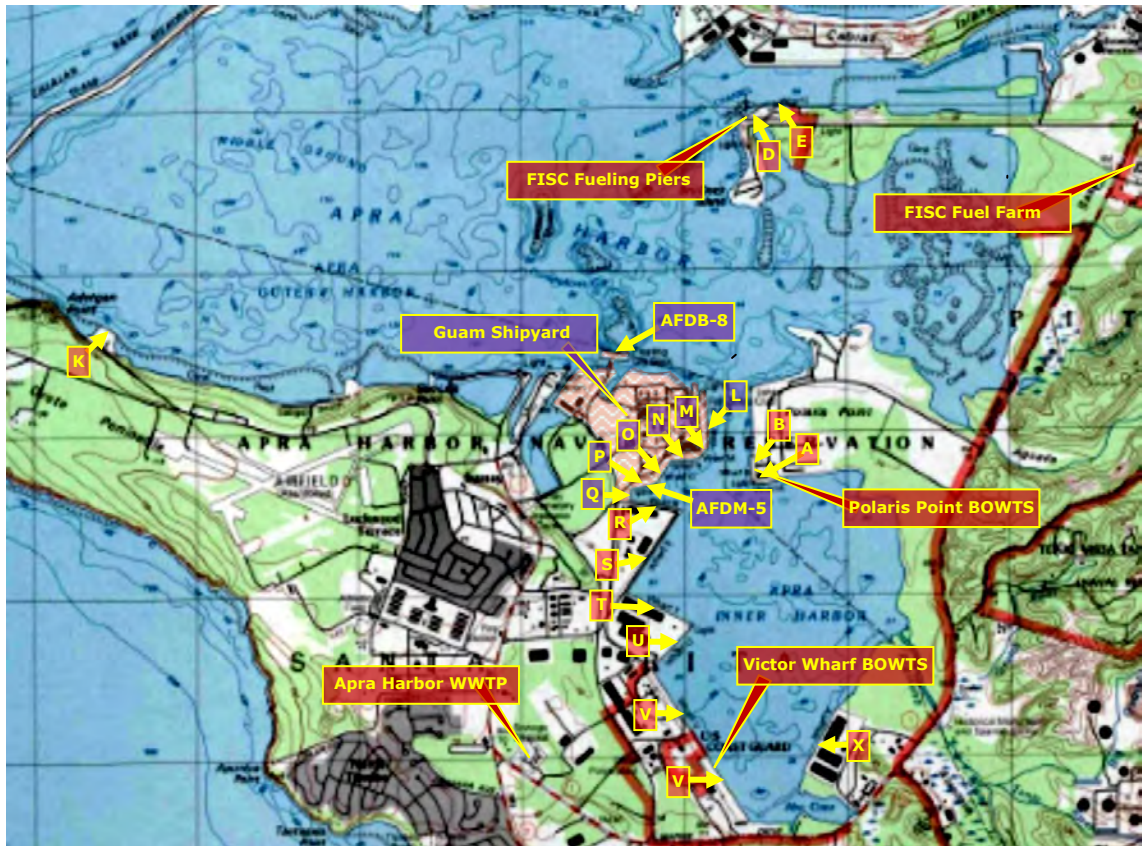
Figure 1.3
Apra Harbor Naval Ports – Wharf and Pier Locations

Location - The Apra Harbor naval port operations consist of wharves and piers located at Orote Point, Polaris Point, the Fueling Depot, and the former Naval Ship Repair Facility.

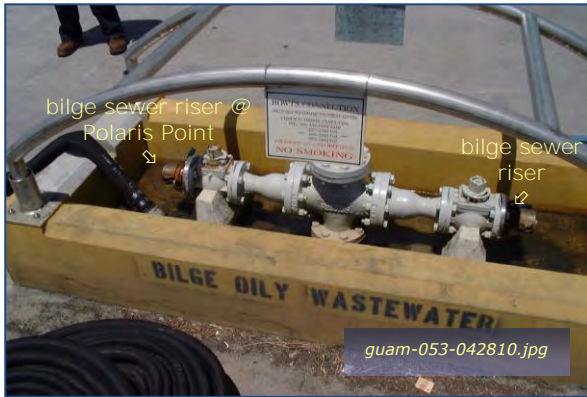
Photo #3-7: Bravo Wharf - Bilge Sewer Riser
Taken By: Greg V. Arthur
Date: 04/28/10

Naval Base Guam, Polaris Point – The Alpha and Bravo Wharves have parallel bilge and CHT sewers. The bilge sewers include seven riser stations that feed to the Polaris Point BOWTS. The Navy Port Operations (through DZSP21) connect and disconnect bilge hoses to the waterfront bilge risers. See Photo #3-7 in Section 3.4 of this report on page 16.

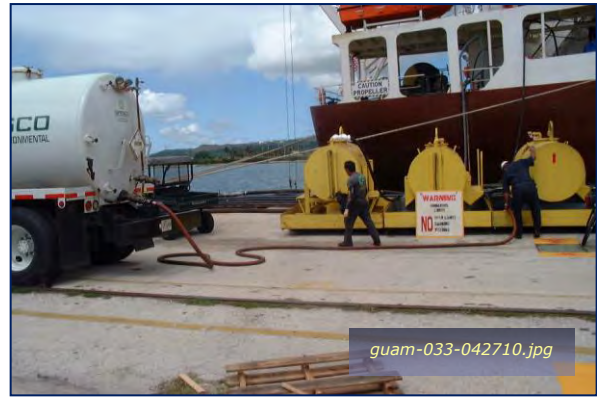
Photo #3-8: Lima Wharf - Bilge to Holding to Tanker
Taken By: Greg V. Arthur
Date: 04/27/10

Guam Shipyard, Papa Wharf – The Guam Shipyard’s Pier Services Department off-loads bilge from berthed or dry docked ships to truck tankers or on-shore tanks for delivery either to the Papa Wharf oil water separator or to off-site disposal by Gresco or Unitek. The Guam Shipyard SWPPP has specific BMPs for the waterfront. See Photos #3-8 and #3-9 in Section 3.4 of this report on page 16.

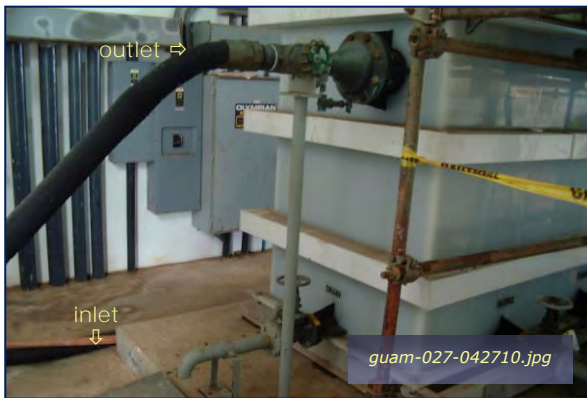
Photo #3-9: Papa Wharf - Bilge Oily Water Separator
Taken By: Greg V. Arthur
Date: 04/27/10

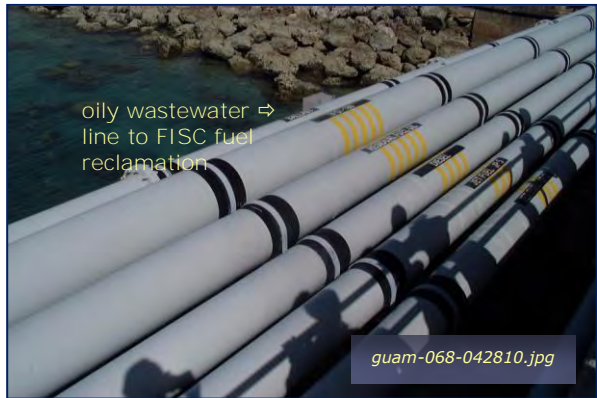
Photo #3-10: Fueling Piers - Bilge and Ballast Line
Taken By: Greg V. Arthur
Date: 04/28/10

Naval Base Guam, Fueling Piers – The FISC fueling piers are constructed with containment pits built into the piers and located beneath the pumps and valving used in the off- and on-loading of fuel to and from ships at berth. Drainages, captured contamination, and off-loaded bilge all are conveyed by the dedicated „ballast’ pipeline to the fuel reclamation system. The Navy Port Operations have a specific SWPPP covering the operation of the fueling piers including the handling of bilge waters and drainages, and the deployment of booming. See Photo #3-10 in Section 3.4 of this report on page 16.

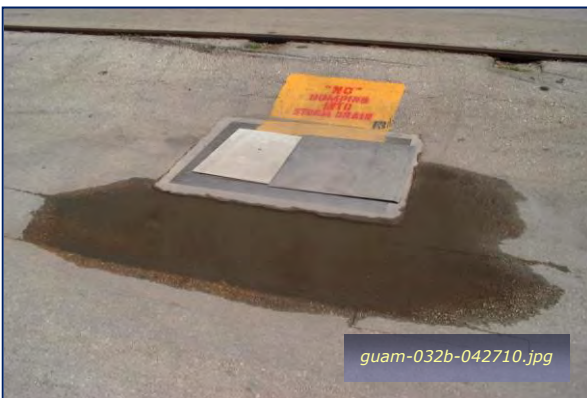
Photo #3-11: November Wharf - Covered Drain
Taken By: Greg V. Arthur
Date: 04/27/10

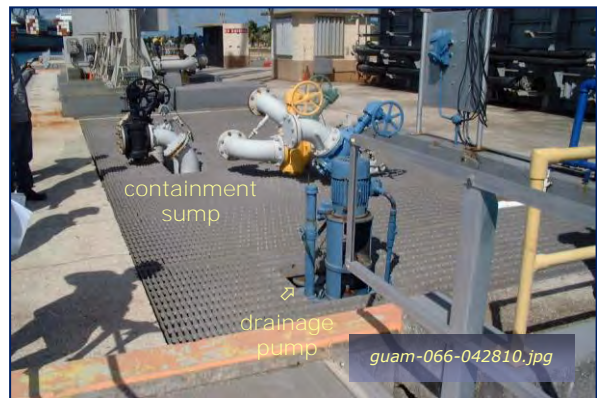
Photo #3-12: Delta Fueling Pier - Containment Sumps
Taken By: Greg V. Arthur
Date: 04/28/10

Fueling Piers – There were no fueling operations observed during the April 28th inspection of the fueling piers, fuel farm, and fuel reclamation unit. Nevertheless, a number of effective control measures were observed in-place and in operation. See Photos #3-4, #3-10, #3-12, and #3-14 in Section 3.4 of this report on pages 15, 16, and 17.

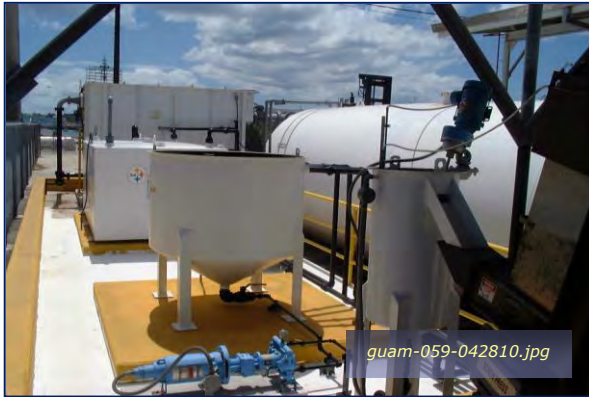
*Photo #3-13: Beta Wharf – Curbing Around BOWTS
Taken By: Greg V. Arthur
Date: 04/28/10*

Polaris Point – Submarines were observed at berth during the April 28th inspection of the Polaris Point BOWTS, but all had departed by the May 6th inspection of the waterfront. As a result, there were no waterfront activities observed during this inspection and thus no control measures were needed or deployed. See Photos #3-7, #3-13 in Section 3.4 of this report on pages 16 and 17.

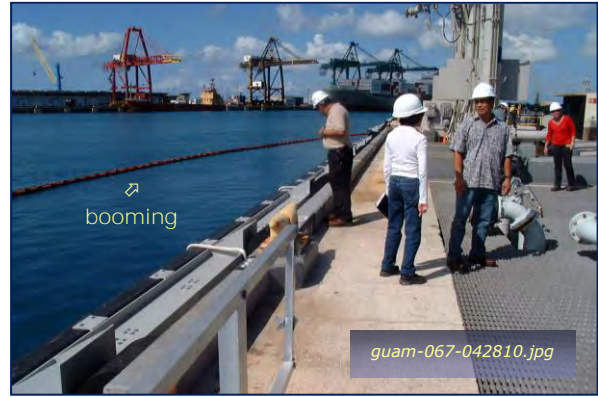
*Photo #3-14: Echo Fueling Pier – Boom Deployment
Taken By: Greg V. Arthur
Date: 04/28/10*
