NPDES and MSGP STORM WATER COMPLIANCE INSPECTION

Report No. 3

Permittee: Guam Shipyard
(NPDES GU0020362)
(NPDES 2008 MSGP - GUR05A267)

Facilities: AFDB-8 Machinist Floating Dry Dock
Shipyard Waterfront Wharves, Piers, and On-Shore Shops

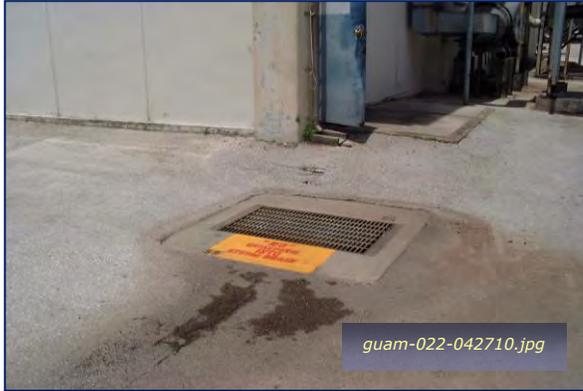
Photo #1-1: Near Bldg 2063 – Open Storm Drain
Taken By: Greg V. Arthur
Date: 04/27/10

- Bldg 2063 Boat Shop - This inactive materials storage building had no materials or debris exposed to storm water. Nearby open storm drain inlets were stenciled with “no dumping into storm drain”. See Photo #1-1 in Section 1.4 of this report on page 6.

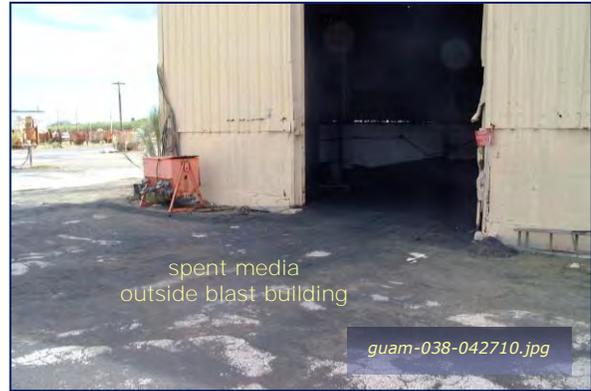
Photo #1-2: Bldg 2100 – Spent Blasting Grit
Taken By: Greg V. Arthur
Date: 04/27/10

- Bldg 2100 Media Blasting - Guam Shipyard performs depainting and surface preparation of parts with copper slag media inside a covered building. On the first day of this inspection, deposits of spent media grit were found on the ground outside the building bay. See Photo #1-2 in Section 1.4 of this report on page 6.

- The floating dry dock deck was rusty and in need of protective coating.
- Deposits of spent copper slag media grit was found outside of the sandblasting building.

- The floating dry dock deck should be swept and protective coated to prevent the discharge of rust.
- Spent media blasting grit should be contained within the sandblasting building.

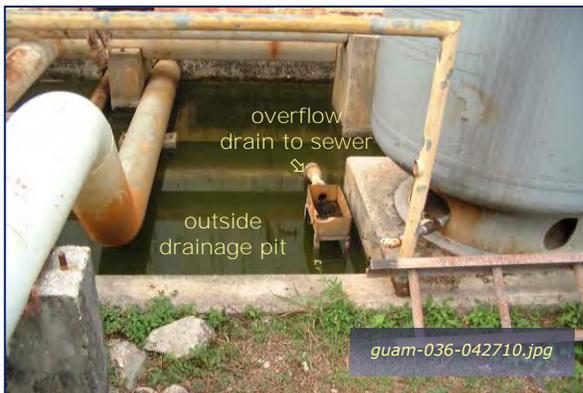
Photo #1-3: Bldg 2078 – Drainage Overflow Inlet
Taken By: Greg V. Arthur
Date: 04/27/10

- Bldg 2078 Compressor Plant - Condensate and cooling tower bleed accumulates in an outside pit with a weir-leveled sewer connection. Captured drainage discharges to the sewers. See Photo #1-3 in Section 1.4 of this report on page 6.

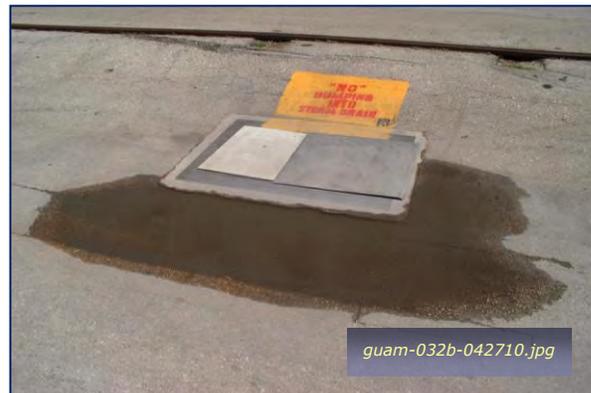
Photo #1-4: November Wharf - Covered Drain
Taken By: Greg V. Arthur
Date: 04/27/10

- Bldgs 20, 21, and 22 - The machine, structural, and paint shop operations are housed indoors, with the nearby storm drain inlets stenciled and, if in the proximity of the waterfront activities, covered. See Photo #1-4 in Section 1.4 of this report on page 6.

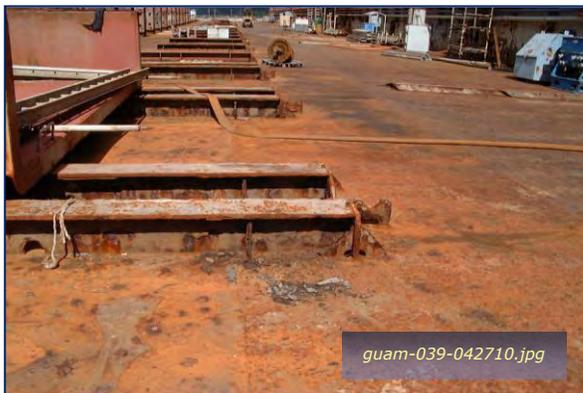
Photo #1-5: Floating Dry Dock – Rusty Deck
Taken By: Greg V. Arthur
Date: 04/27/10

- Rusty Conditions - The floating dry dock deck had substantial oxidation of the metal surfaces throughout. During this inspection, the Guam Shipyard proposed to refurbish the deck during the upcoming dry season through the installation of new painted panels, and by painting the exposed deck, tanks, and wing walls. Deck refurbishment should be verified in the next inspection. See Photo #1-5 in Section 1.4 of this report on page 6.

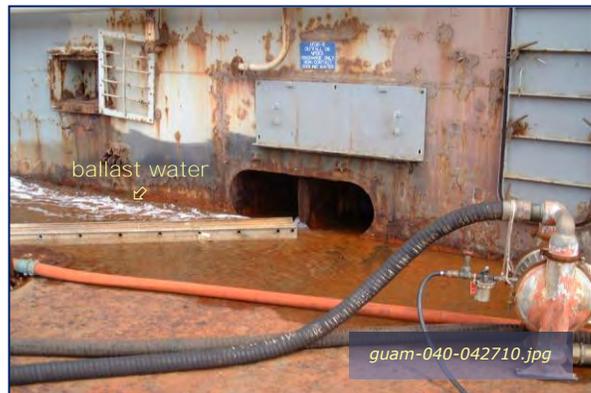
Photo #1-6: Floating Dry Dock – Scupper Outlet
Taken By: Greg V. Arthur
Date: 04/27/10

- Blanked Scuppers - The Guam Shipyard normally blocks all but one scupper on the deck to be opened only if necessary. See Photo #1-6 in Section 1.4 of this report on page 6.

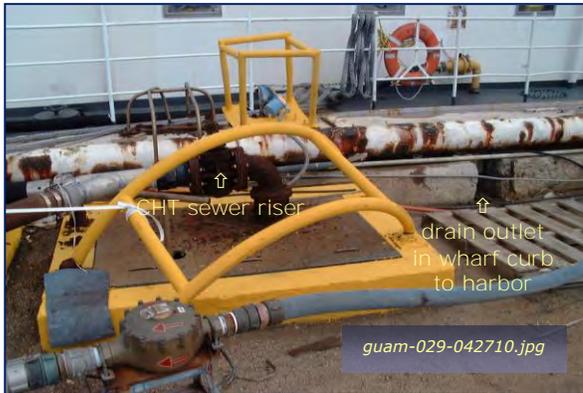
*Photo #1-7: Oscar Wharf – Damaged CHT Riser
Taken By: Greg V. Arthur
Date: 04/27/10*

- (corrected) Guam Shipyard does not have written operating procedures covering the CHT.
- (corrected) Not all CHT ships sanitary risers were found in good condition.

manner, (6) committed to block pier scuppers during the transfer of ships bilge to shore, and (7) is preparing an SOP covering the use of the CHT ships sanitary risers. See Photos #1-7 through #1-12 in Section 1.4 of this report on page 7.

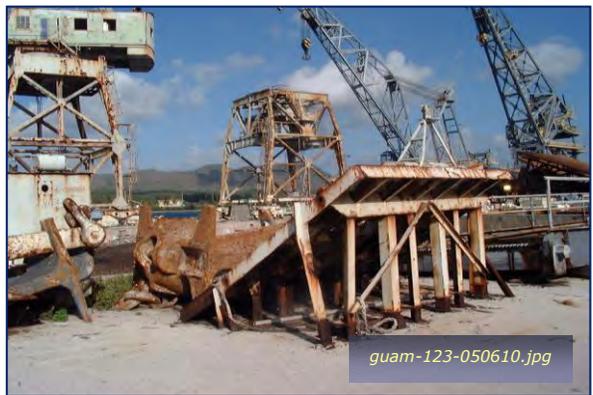
*Photo #1-12: Finger Pier – Scrapyard
Taken By: Greg V. Arthur
Date: 05/06/10*

- (corrected) Debris hauling is scheduled weekly but rusty debris was found on the wharves.
- (addressed) Recyclable materials have remained staged for off-hauling and thus exposed to storm water contact for long periods of time.

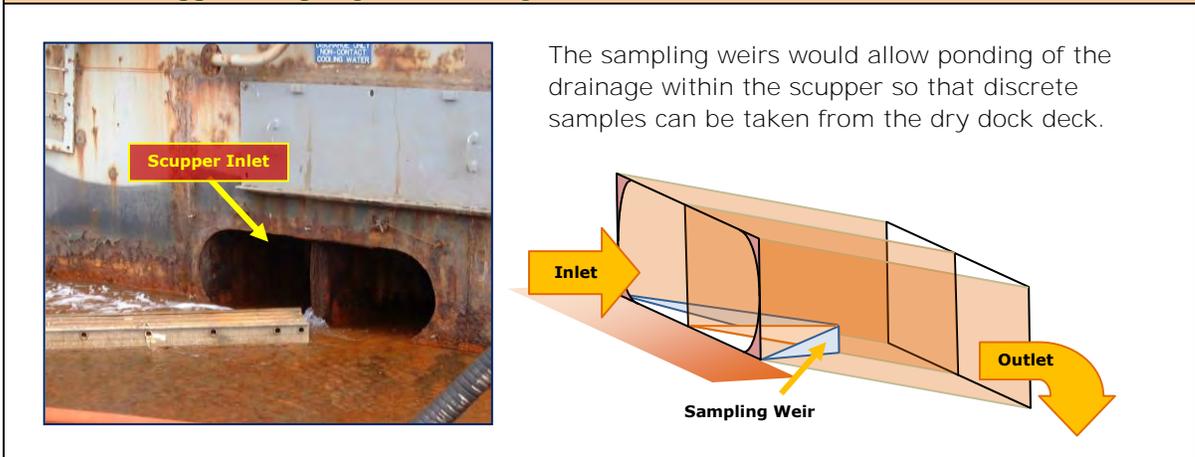
Figure 4.1
Possible Scupper Sampling Weir Configuration

The sampling protocol appears to have a number of shortcomings. First, the collection of mixed deck drainage and harbor waters at the waterline does not produce a discrete sample of deck drainage. A mixture of drainage with harbor waters cannot be compared against permit limits established for the deck drainage alone. A mixture also cannot be compared against the permit limits that establish maximum deviations from ambient in deck drainage water quality. Second, manual compositing of samples of the separate scupper discharges is not flow proportioned. Discrete samples would need to be paired with flow rate estimates in order to produce a single discrete composite sample for the dry dock, representative of all scupper discharges. The manual compositing of ambient harbor samples collected between the scuppers is discrete without flow proportioning. Third, discrete sampling on deck at the scupper inlets proves difficult since drainage discharges as sheet flow through the scuppers.

- One scupper (or one each starboard and port) should be outfitted with a sampling weir, operated normally open, and designated for routine sampling of all dry dock drainage.
- All other scuppers should be operated normally closed in order to cause all dry dock drainage to combine and discharge through the designated sampling scupper(s).
- The dry dock sampling protocols should involve opening the normally closed scuppers only after the collection of discrete sample(s) from the designated sampling scupper(s).
- Unregulated discharges under the NPDES permit, such as dry dock ballast, should not discharge through the designated sampling scupper(s).
- The dry dock sampling protocols should identify an ambient sampling location and describe the procedures to collect a discrete sample of ambient conditions.

Sampling weirs installed in the two mid-ship scuppers (one starboard and one port) and scupper SOPs to block the other scuppers until after collection of combined samples at the
