**MUNICIPAL SEPARATE STORM
SEWER SYSTEM (MS4)
COMPLIANCE INSPECTION**

**SACRAMENTO COUNTY,
CALIFORNIA**

INSPECTION REPORT

**Inspection Date:
August 15-16, 2012**

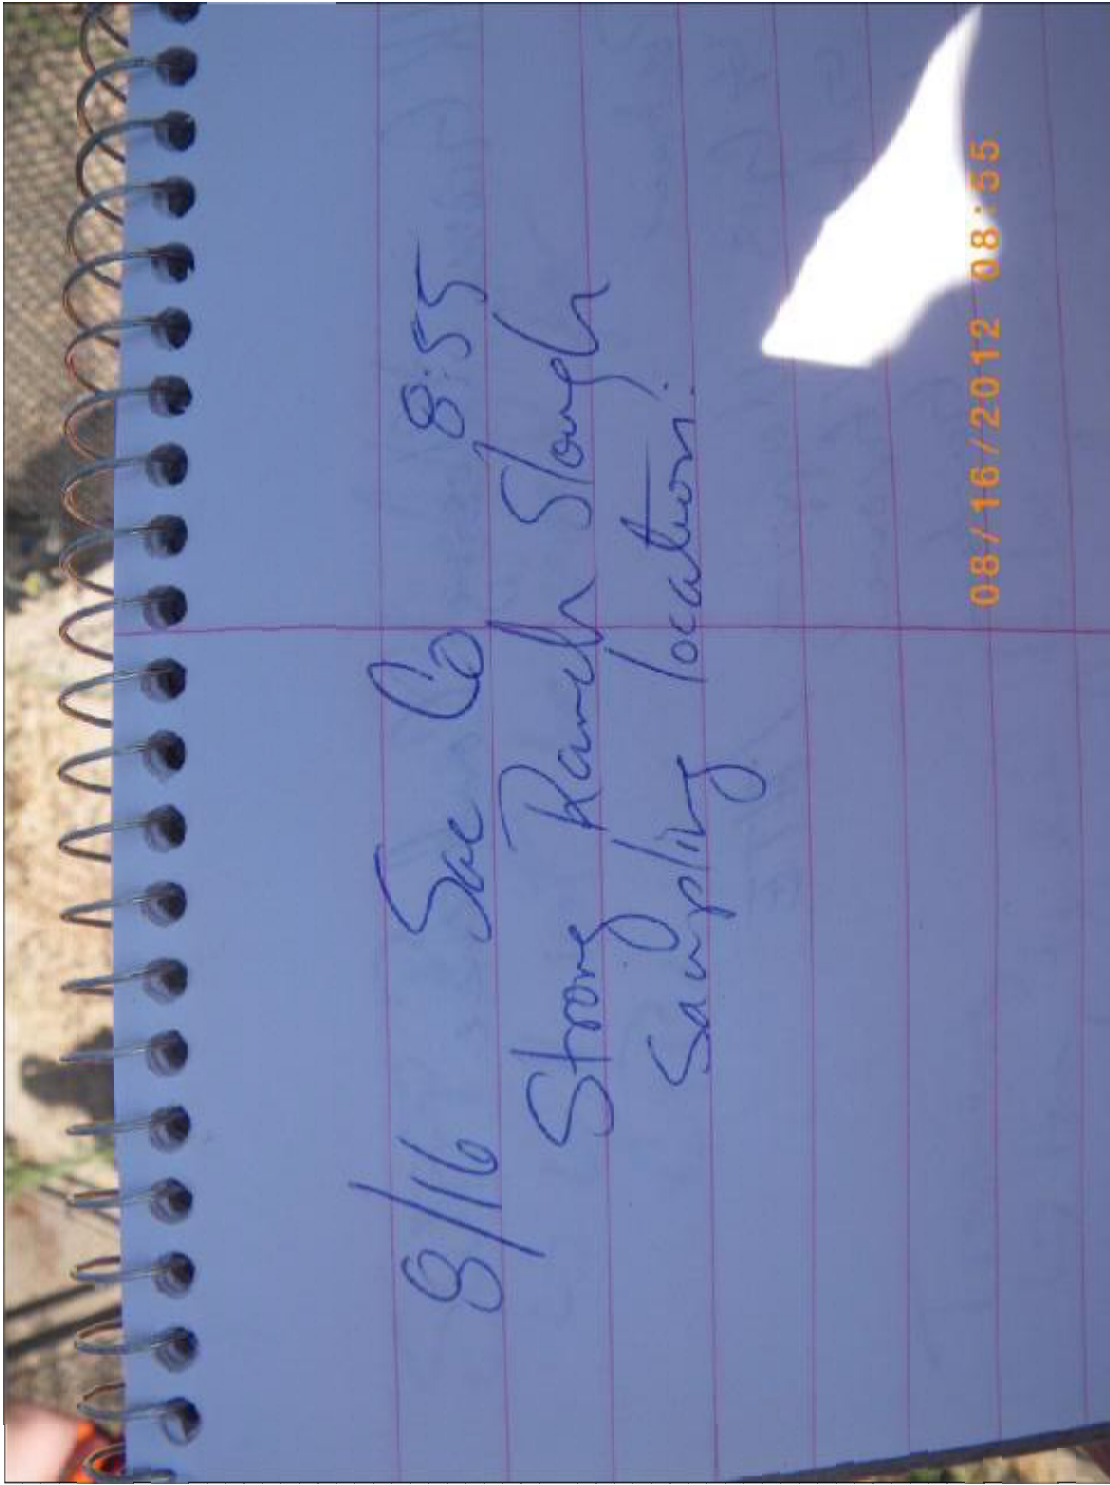
IMG0918

IMG0918: Title Page

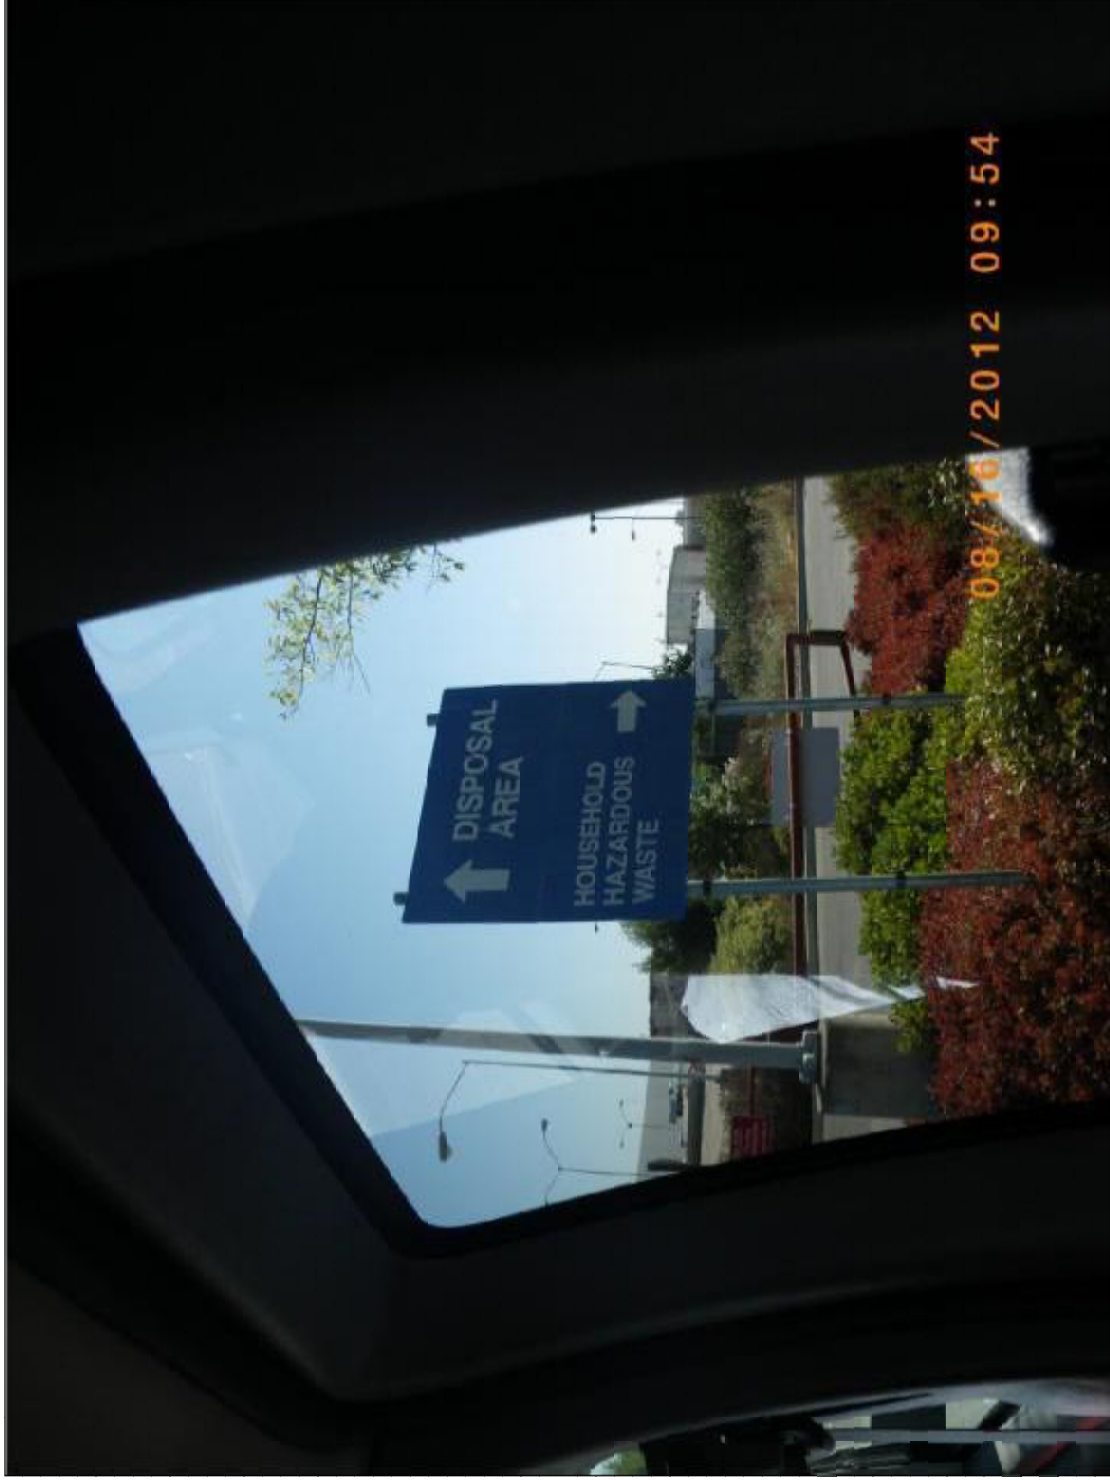
IMGP0931

IMG0931: Main entrance to the facility with a vegetated and storm water detention basin which treats most of the facility's storm water prior to discharge to the MS4. Filter fabric was also observed in the drop inlet.

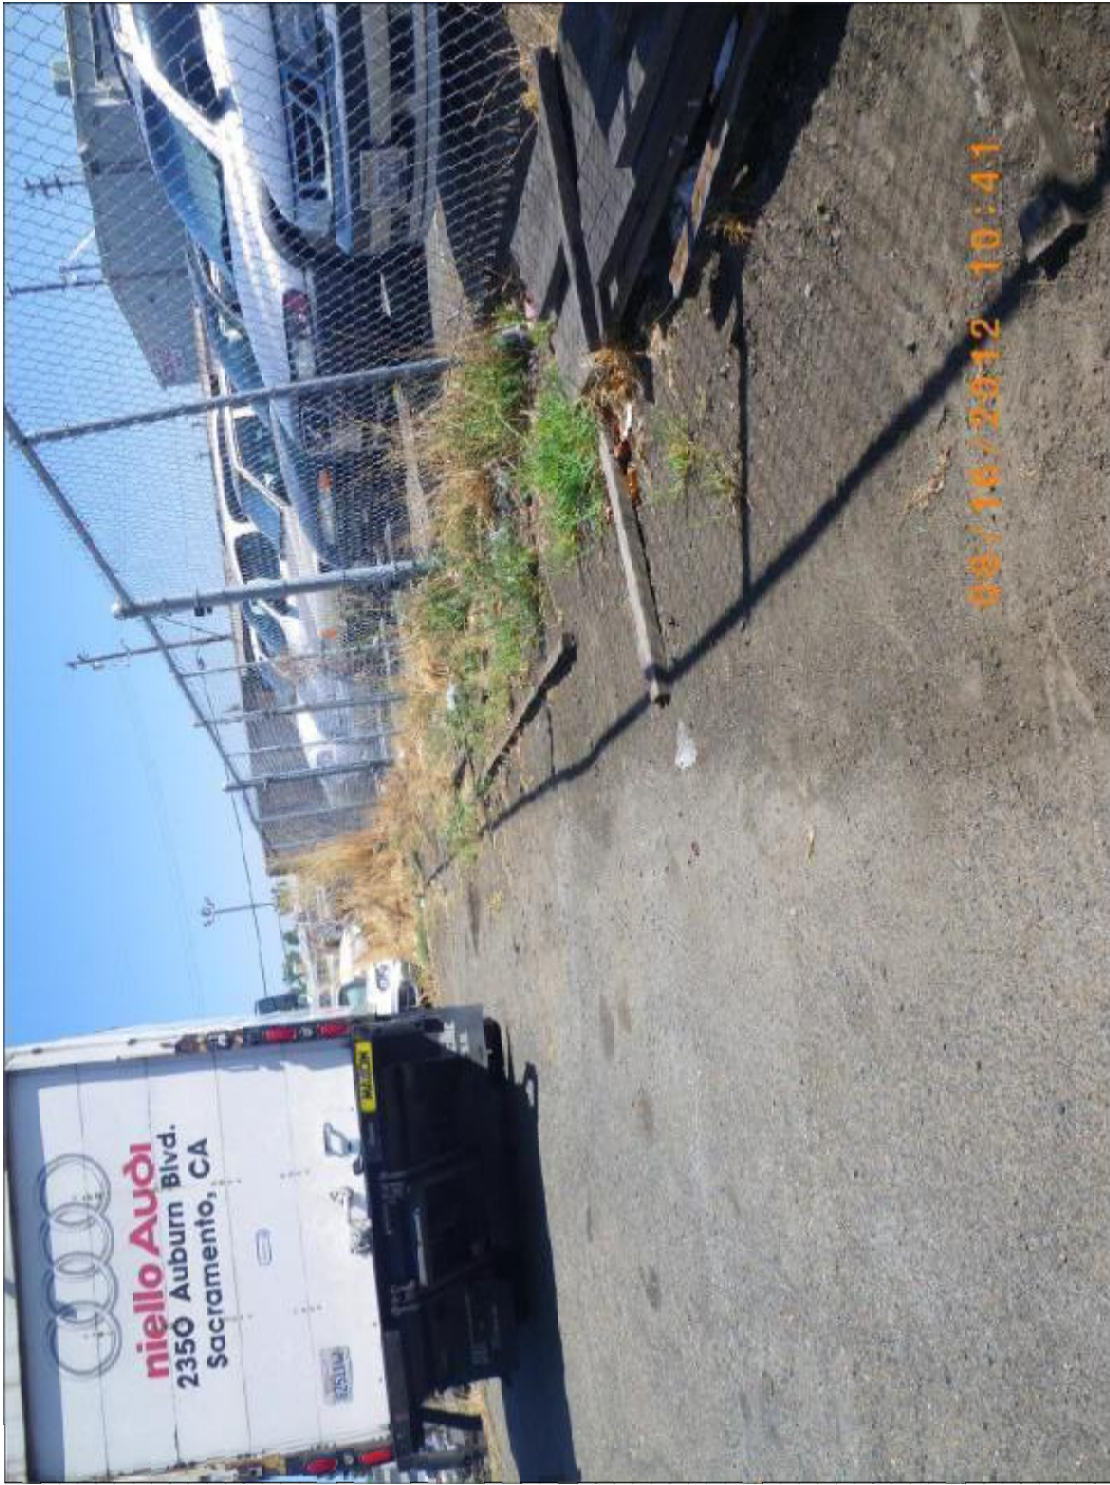
IMGP0945

- Coverage for scrap equipment and parts was marginal and there was not a regular schedule for pick up.
- The Inspector raised concerns about the northeast corner of the facility due to oil staining, accumulation of sediment and trash, and being the storm water discharge point from the facility.

IMG0945: Low point in the yard, where storm water discharges, accumulations of dirt, roof gravels, weeds and trash. Oil staining was also observed in the soils.

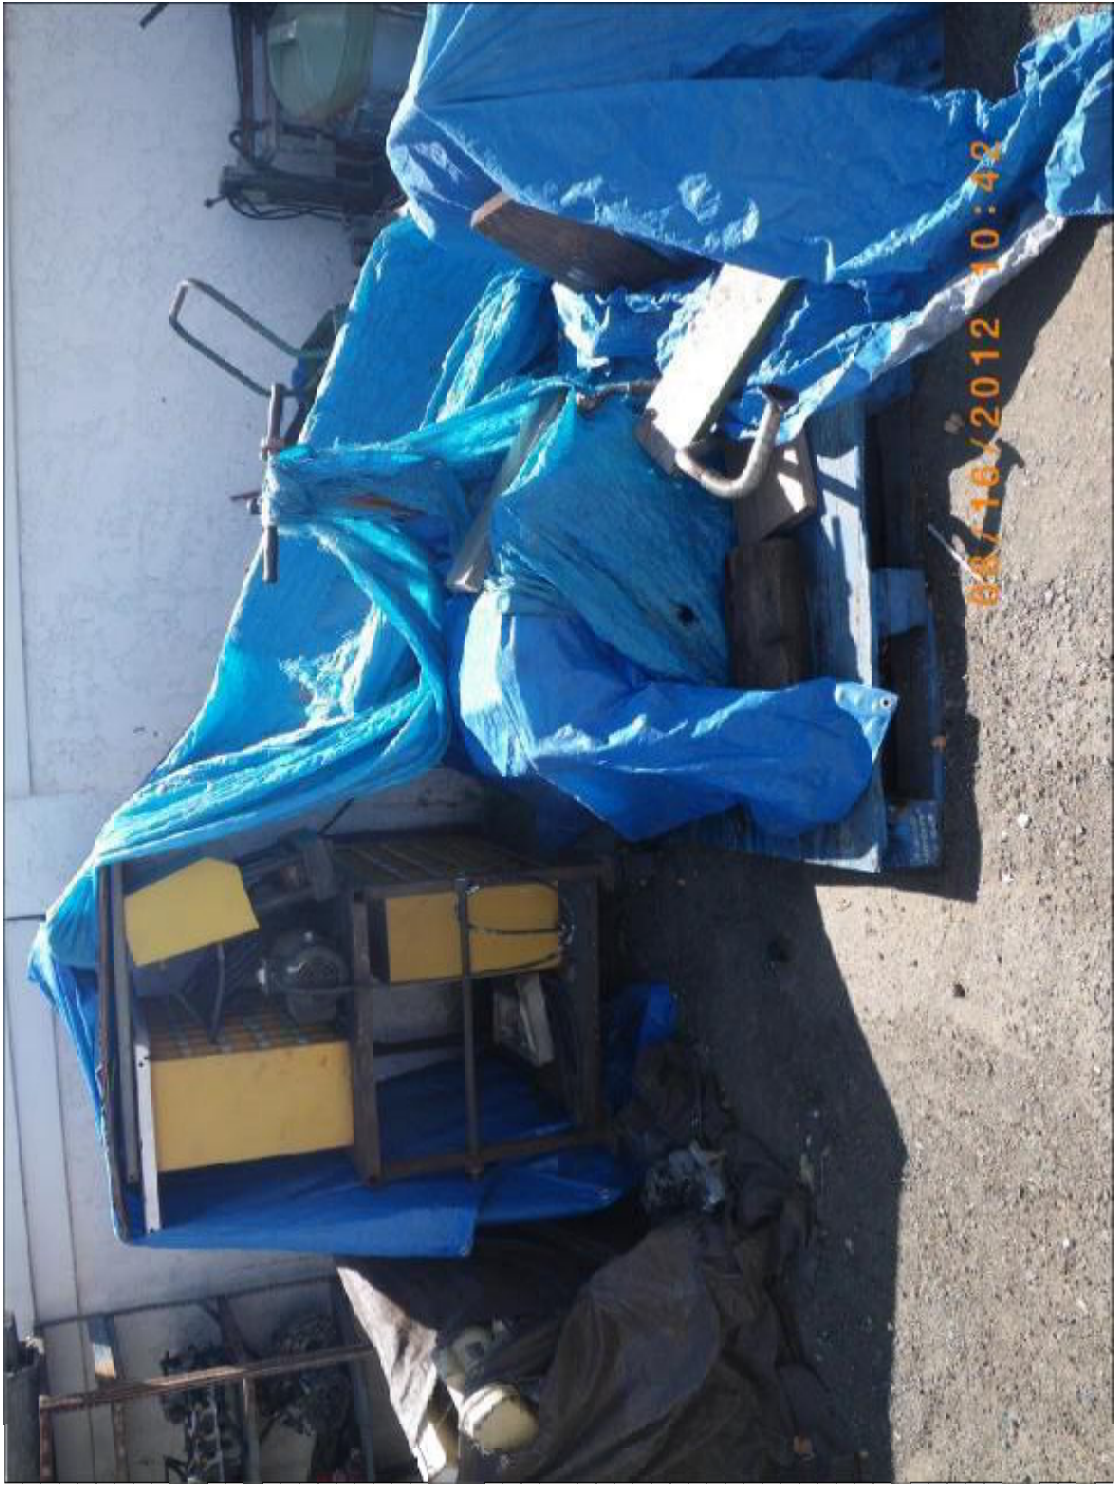
IMGP0947

IMG0947: Palletized scrap metals partially covered by a tattered tarp.

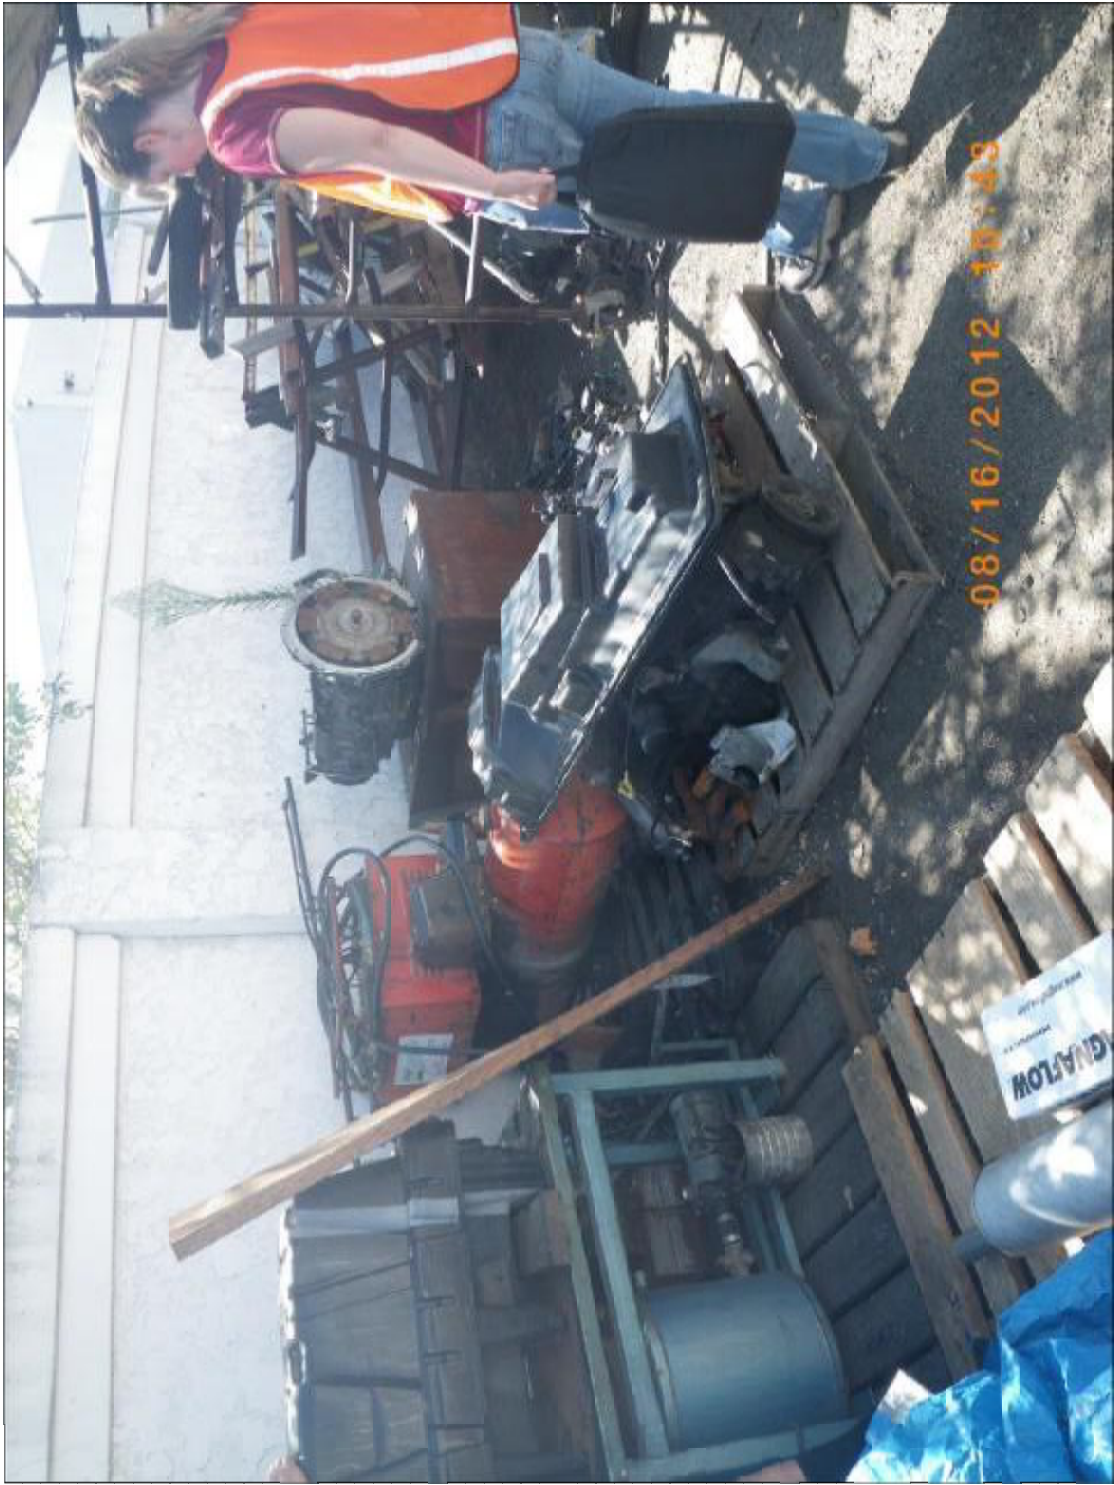
IMGP0948

IMG0948: Other palletized scrap metals with minimal coverage.

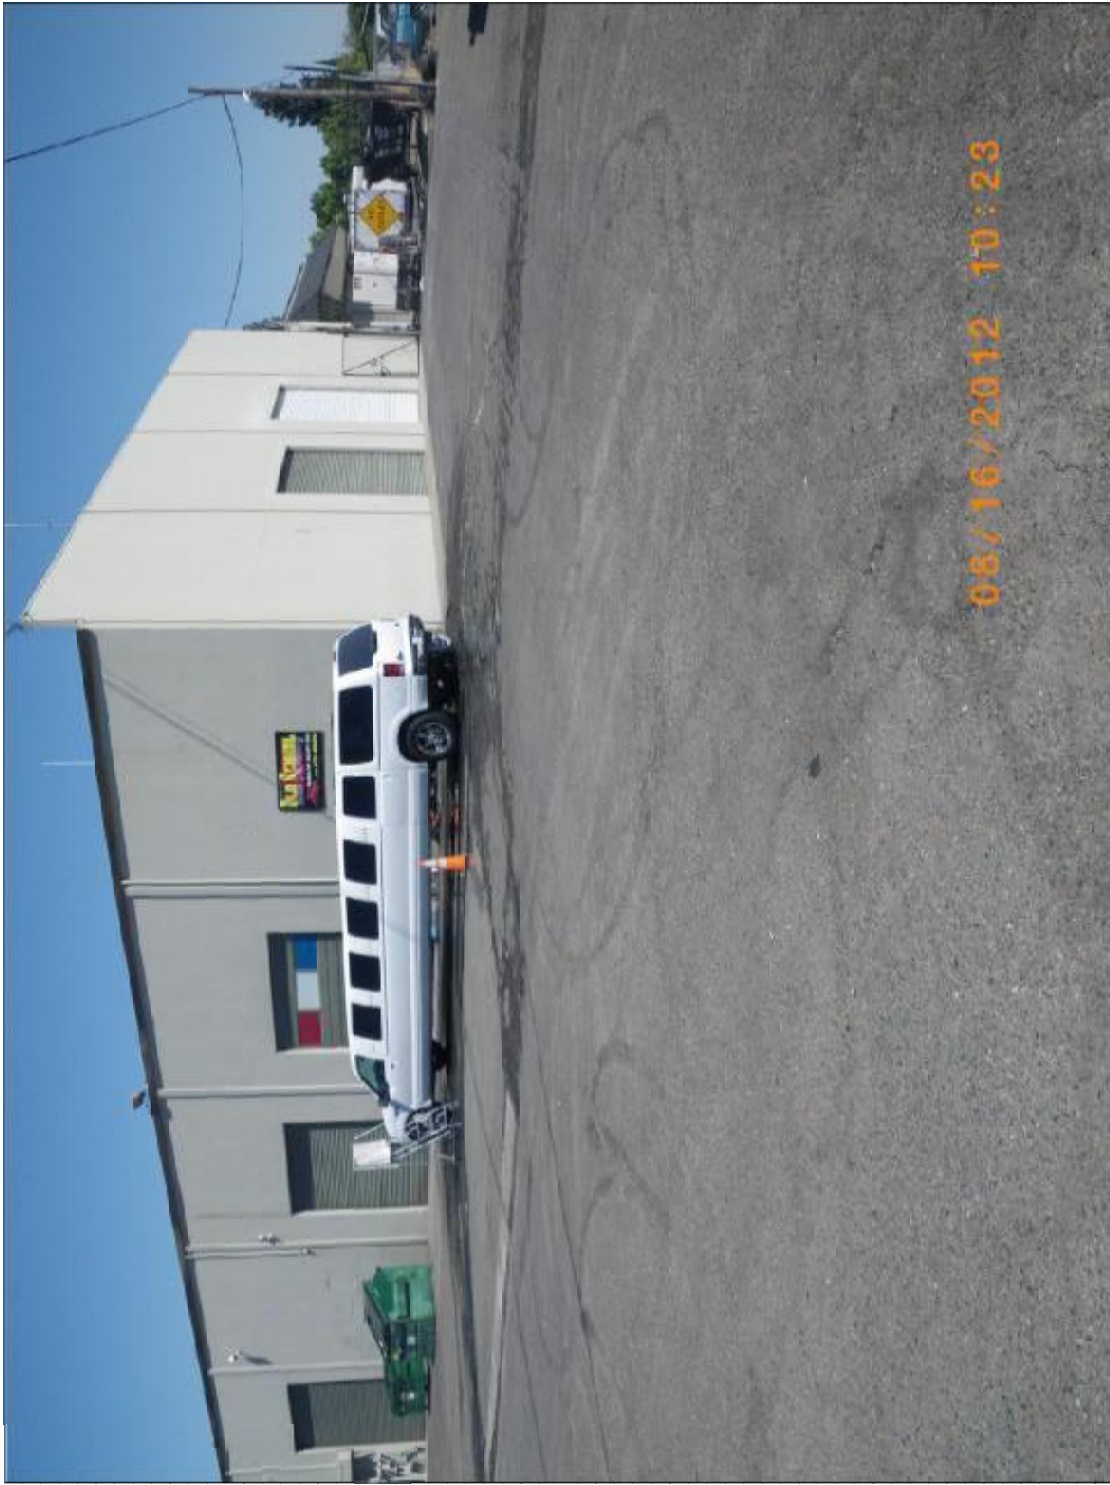
IMGP0941

While en-route to a planned inspection at O'Donnell Truck and Engine Repair, the inspection party encountered Old School Auto Detailing discharging prohibited wash water rinsate to the County MS4. The wash water was observed to be flowing directly to the storm drain and soap suds were observed within the drop inlet. A County Official and an EPA representative contacted the operator and provided storm water compliance information. County staff informed the business of county code that prohibited discharges of washwater to the storm drain system. The operator was aware of the stormwater ordinance prohibiting the discharge of wash water; however, no BMPs to prevent the discharge were observed by the EPA. County staff worked with the operator, who offered to install a barrier and pump system to collect the washwater. County staff stated they will write a follow-up letter to the operator, and will perform random drive-by inspections in the future to verify compliance.

IMGP0941: Stretched luxury vehicle in the process of being washed and detailed, rinsate discharging to MS4. This photo was take while en-route to O'Donnell Truck and Engine Repair inspection. All following photos were taken approximately 50 minutes later.

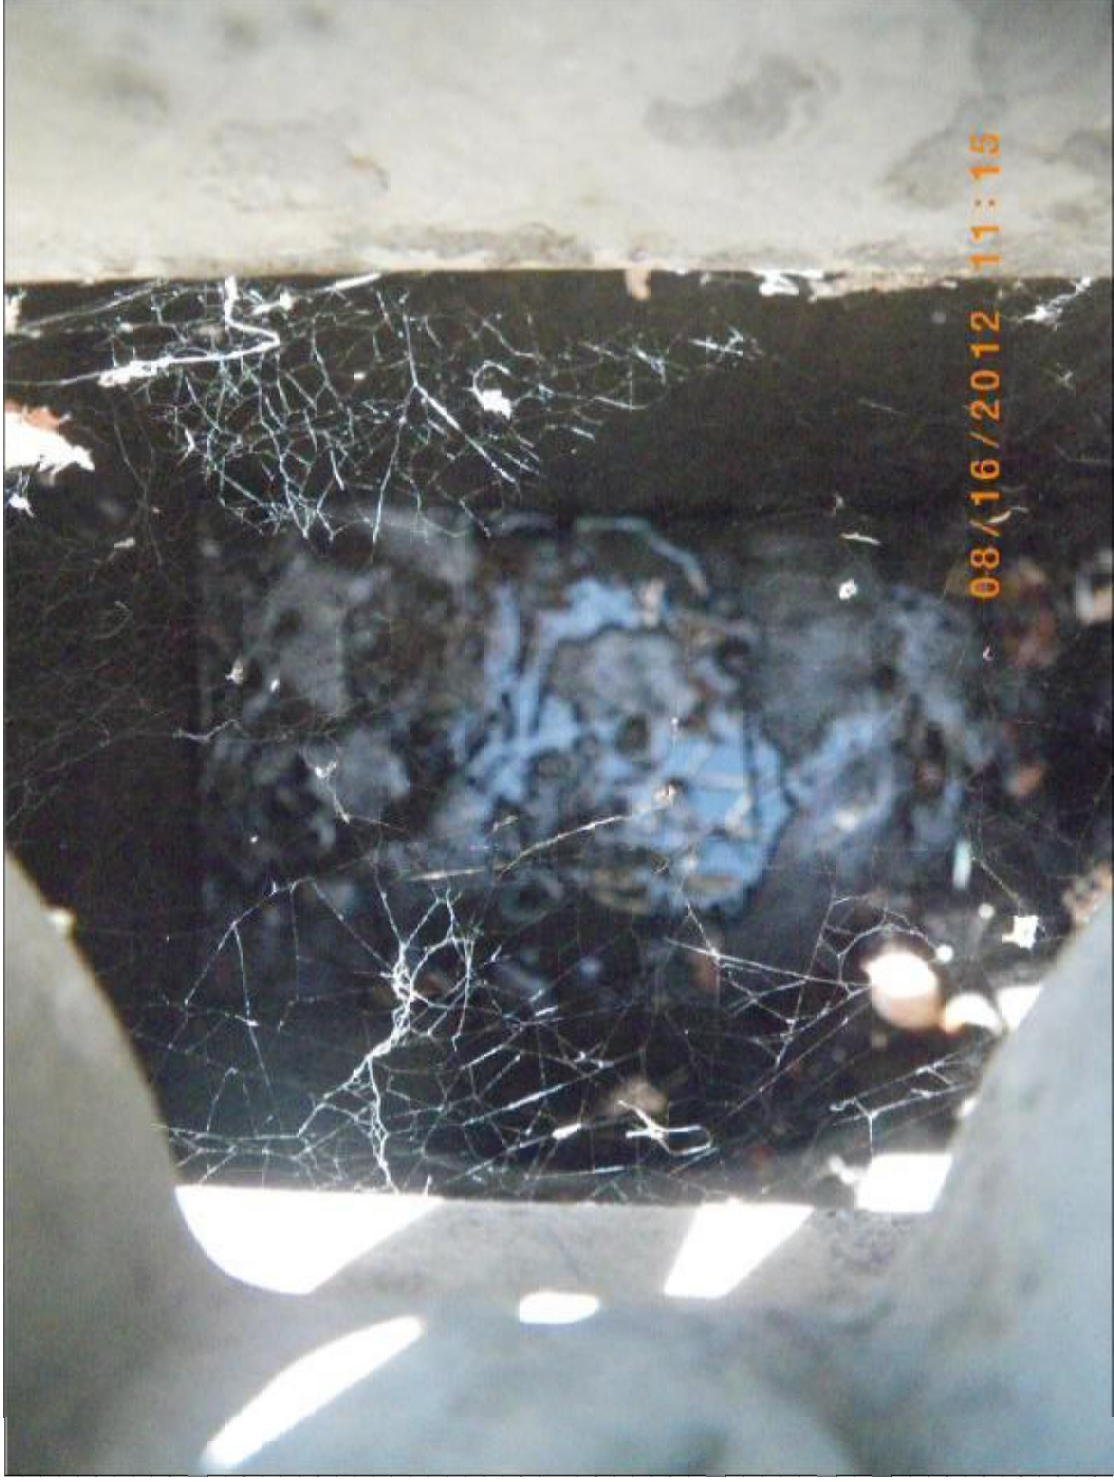
IMGP0956: Same as IMGP0956 however; depicting soap bubbles.

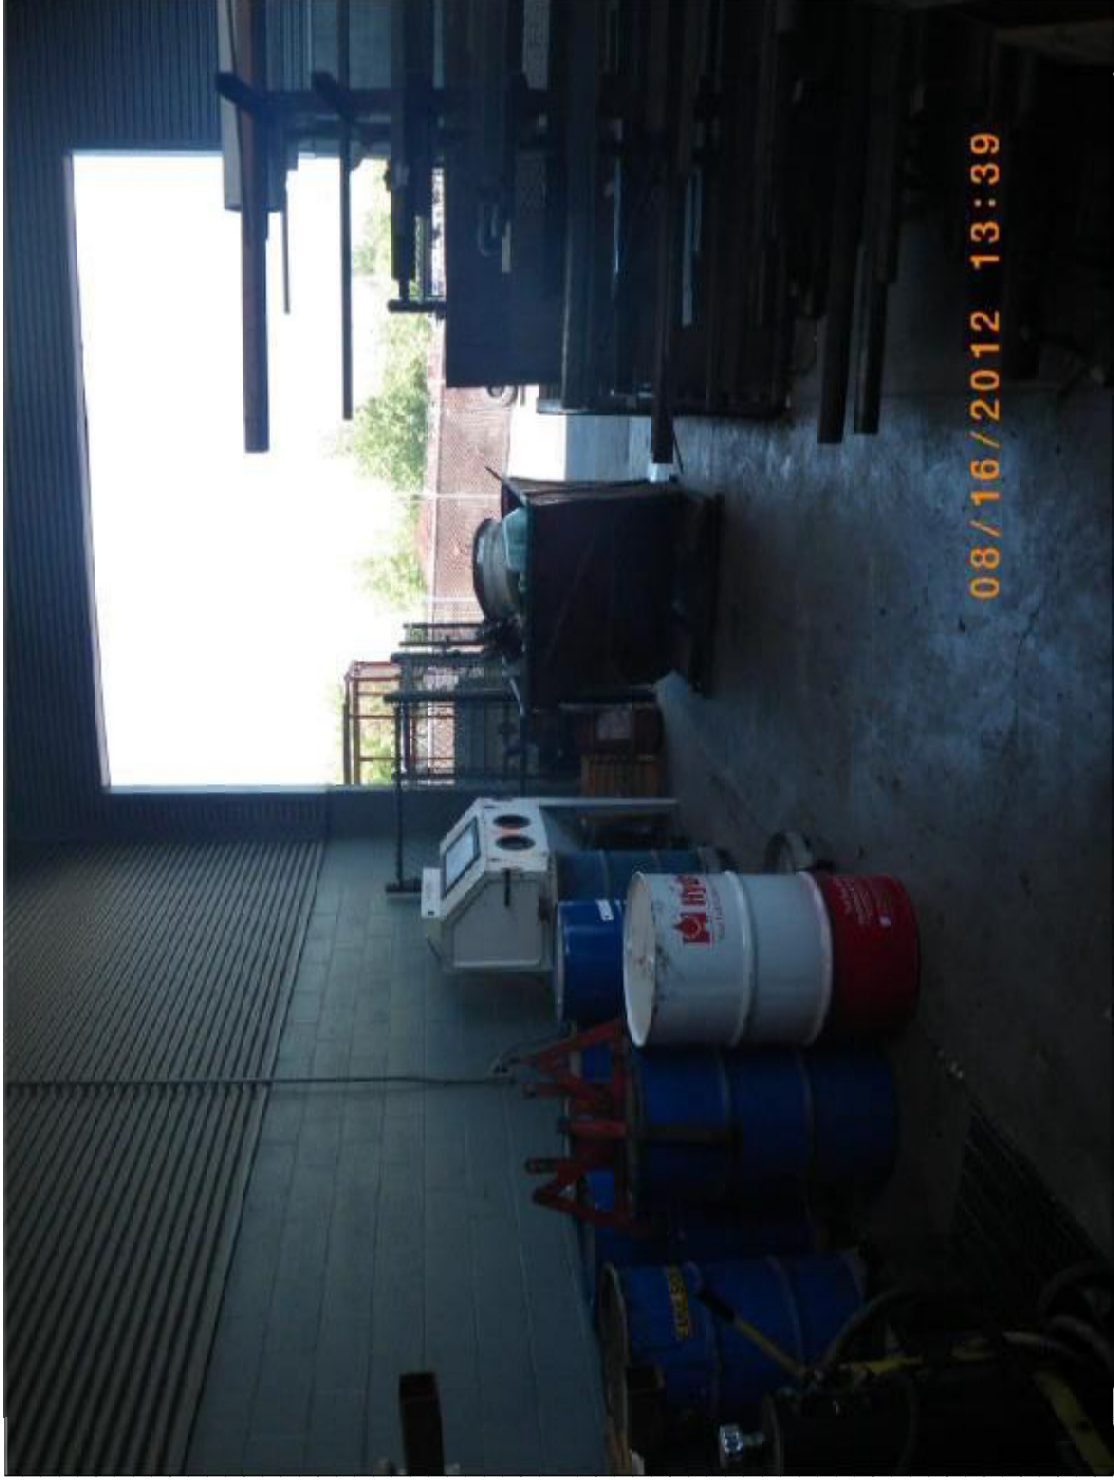
IMGP0966

IMGP0966: Ancillary, covered staging/storage bay with secondary containment for hazardous fluids such as fuel and hydraulic fluids.

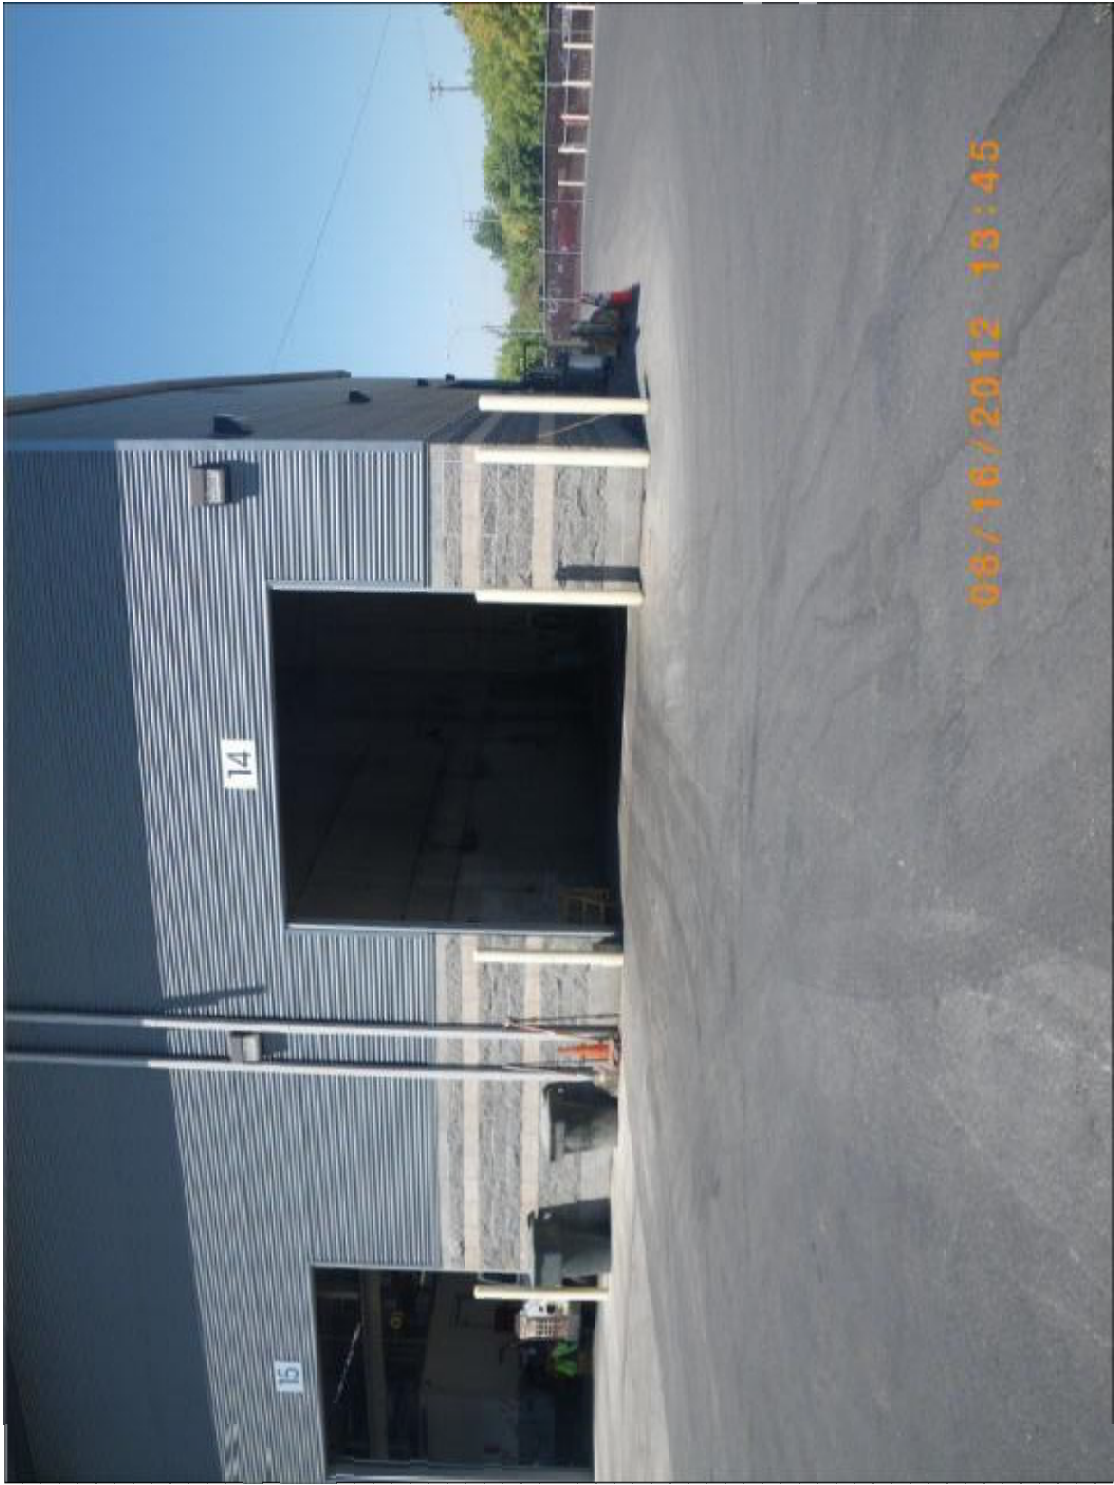
IMG0971

IMGP0971: Brown tarp described in previous image was in good condition, weighted down, and also bungee-corded (not depicted).

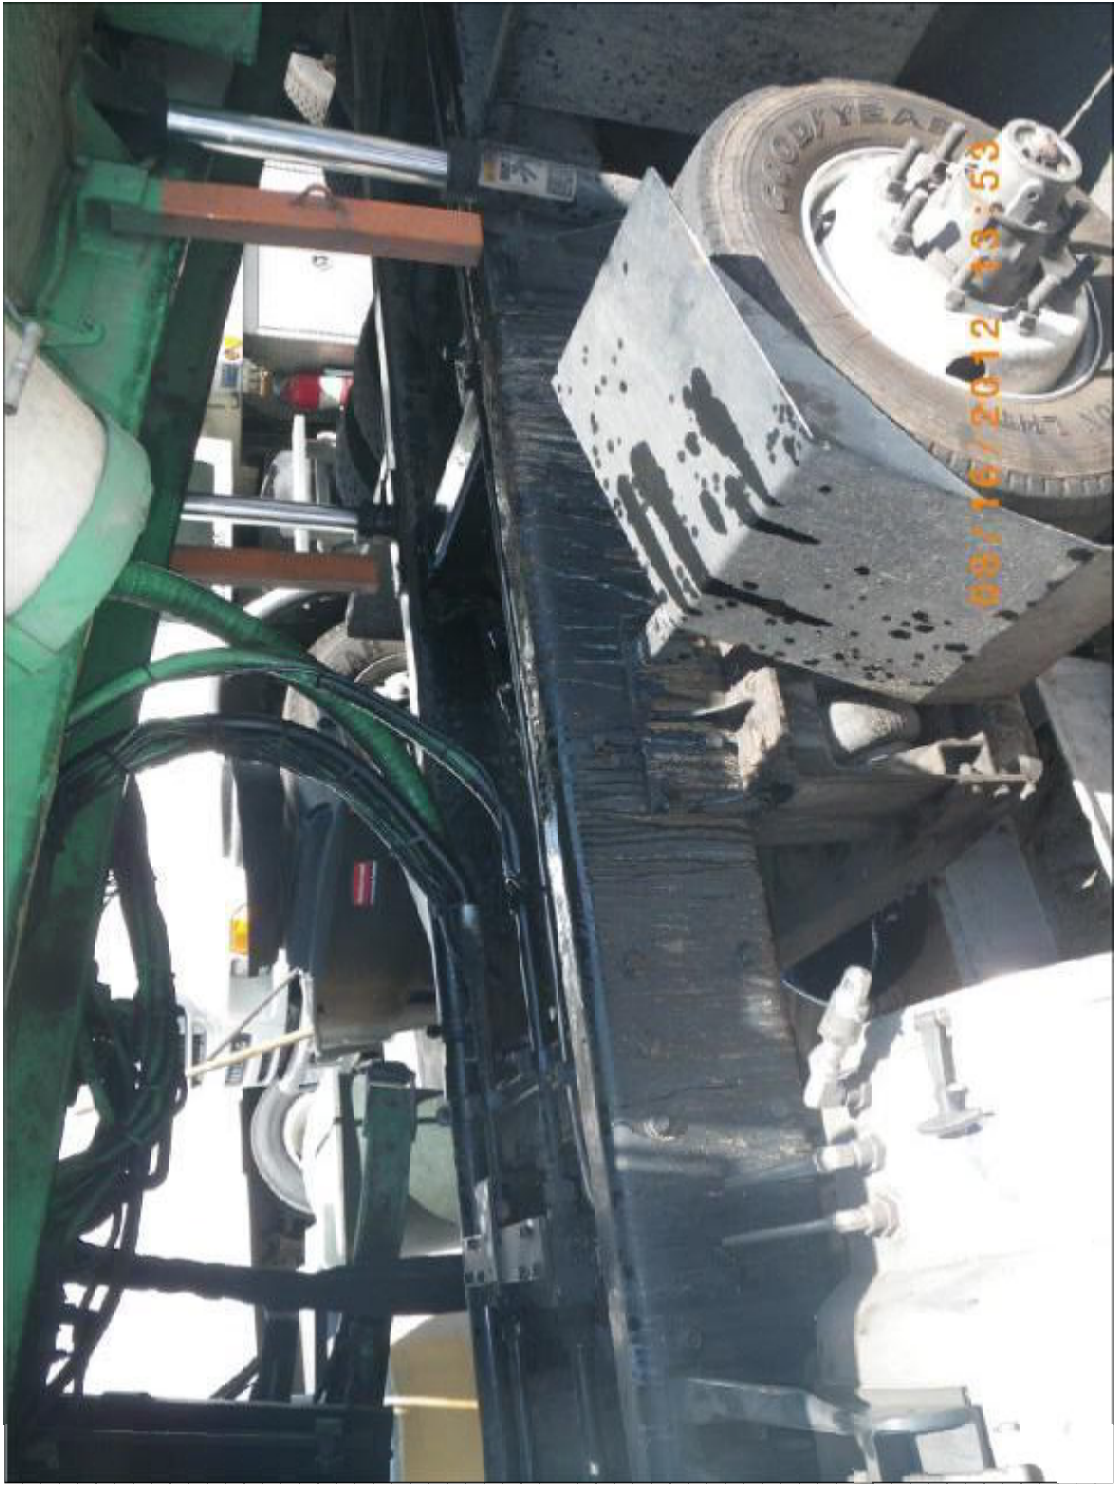
IMGP0973

IMGP0973: Garbage truck that had been in an accident and was sequestered to the yard as evidence had been drained of hazardous fluids. Some staining was evident from the fluid removal as was absorbent material used in response to the spill. A drip pan was staged under the oil pan to collect any residual dripping.

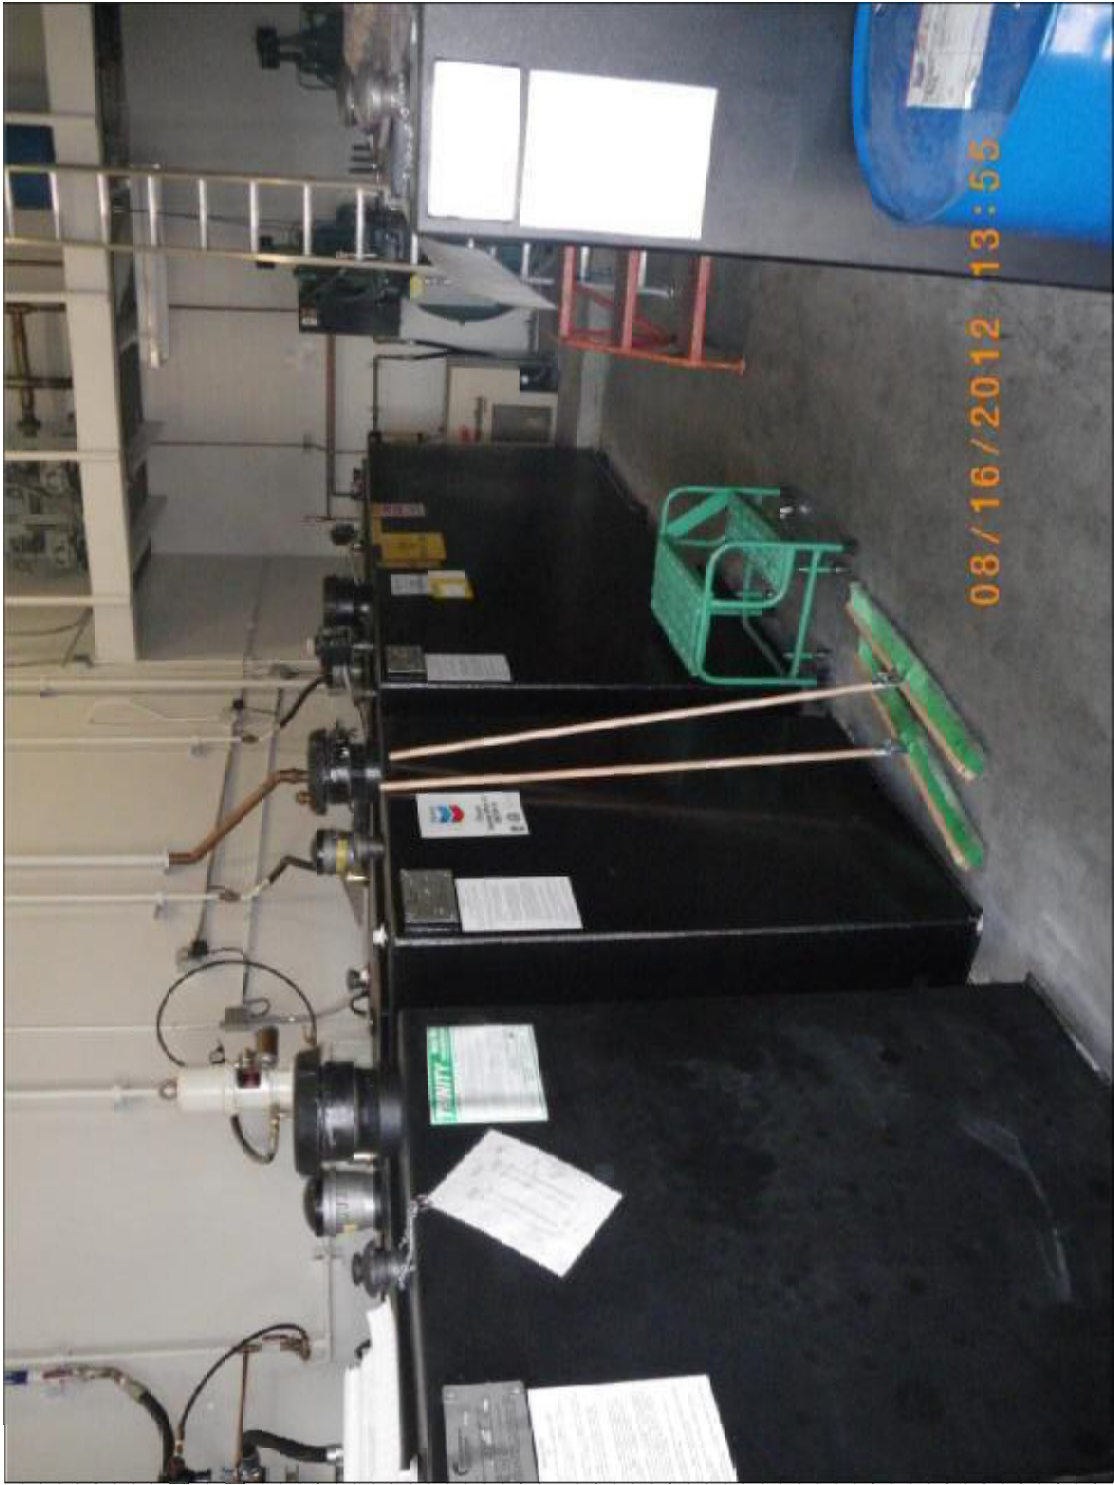
IMGP0974

IMGP0974: Garbage (different than the one depicted in IMGP0973) truck with a ruptured hydraulic line during a maintenance inspection. Yard staff responded to the spill with absorbent and drip pans.

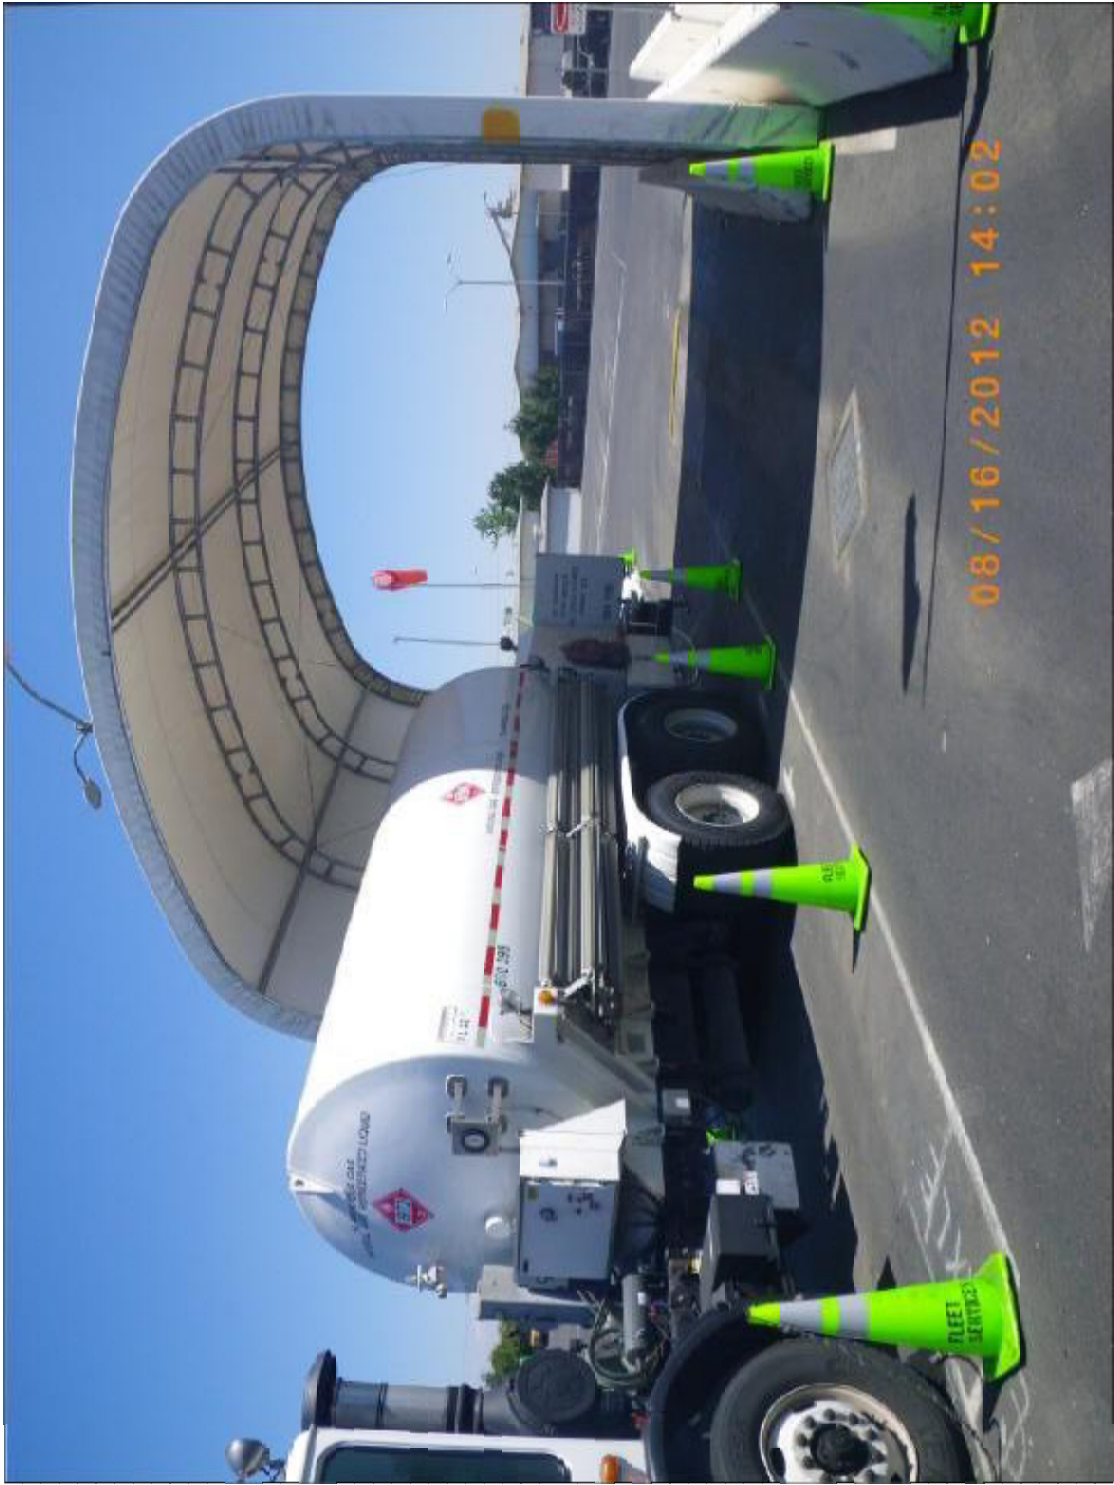
IMGP0980

- The SWPPP describes catch basin filter inserts as a BMP used throughout the yard and the facility maps show which catch basins should have filters installed. During the site tour, EPA observed that some catch basins identified on the facility maps lacked such inserts (see photos IMG0980 and IMG0982).
