**EPA Evaluation of Subsurface Engineered  
Barriers at Waste Sites**

**Volume II  
Appendix B**

**Appendix B**

**Site Summaries**

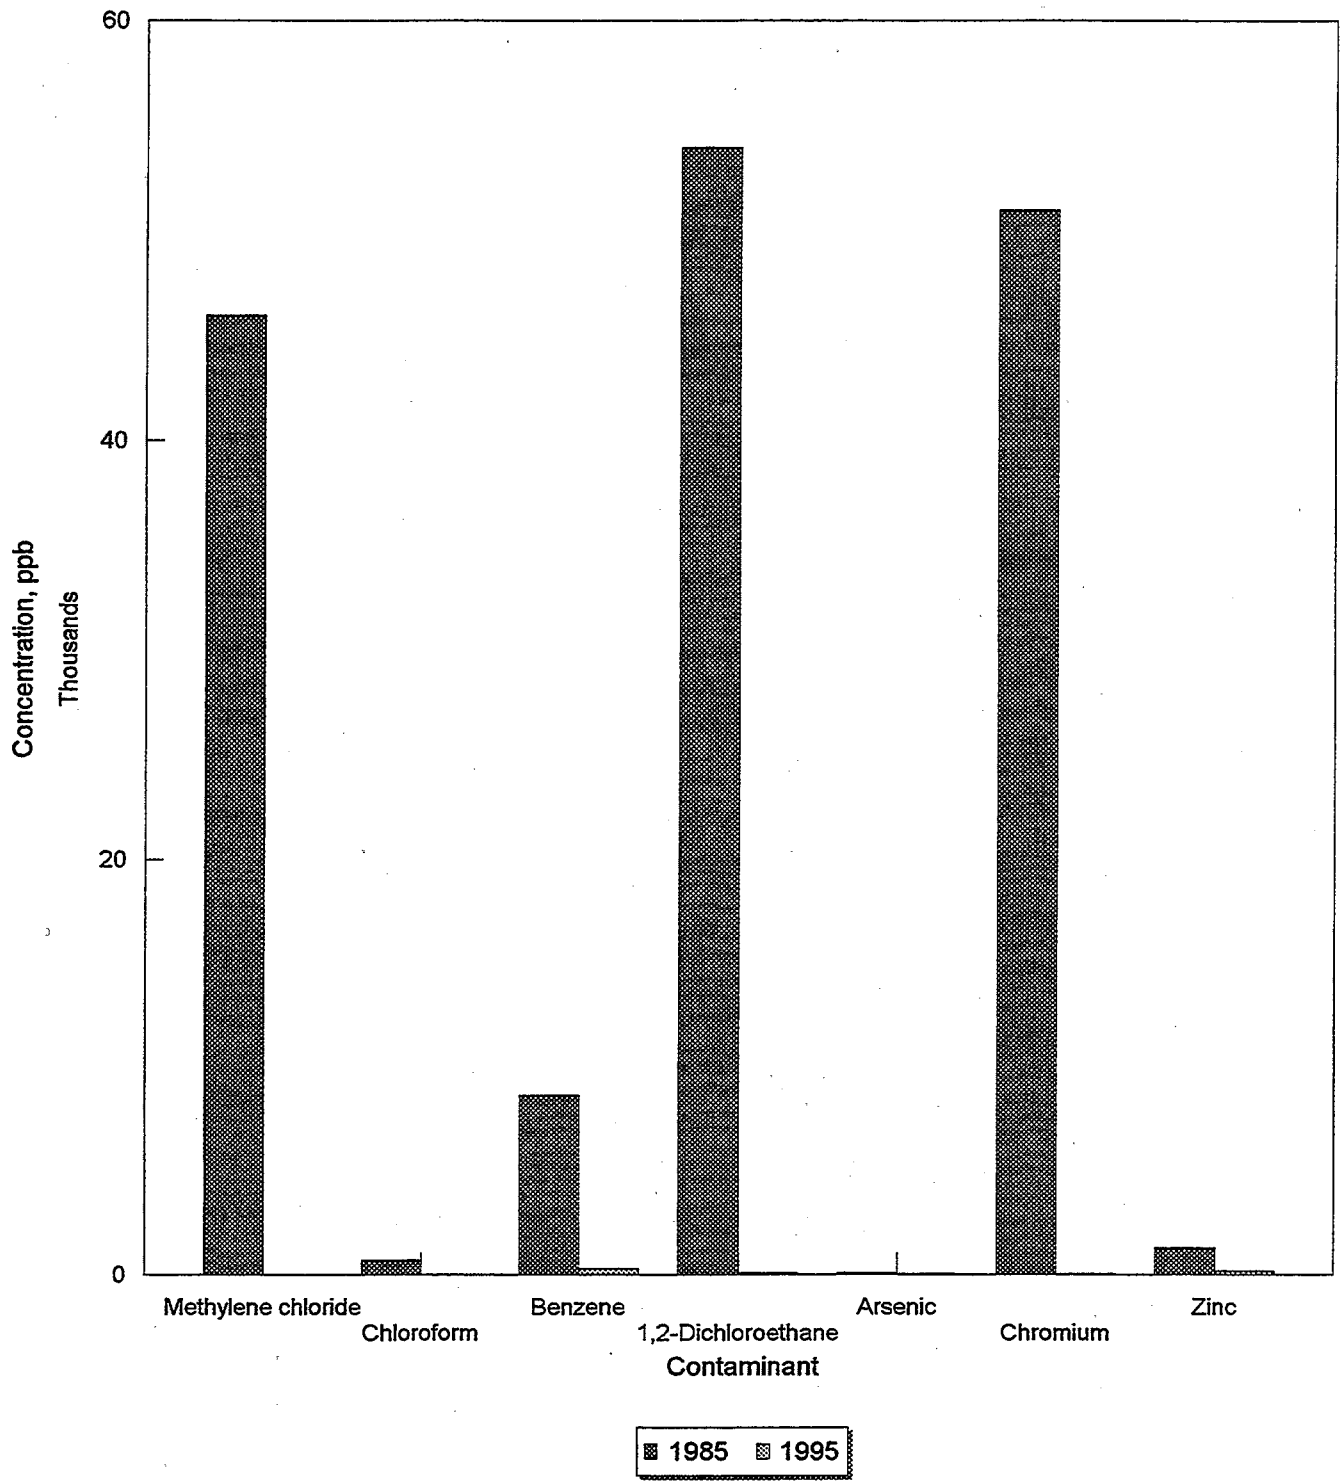
Site 13
FIGURE 2
CONTAMINANT CONCENTRATION vs. TIME

The monitoring system was rated slightly better than acceptable. Monitoring has shown the concentration of site contaminants to be decreasing in the shallow groundwater outside of the barrier while the groundwater flushing and treatment system is functioning to remove contaminated groundwater from the site. The contaminant levels have been gradually decreasing over time as shown above. Decreases are shown on Figure 2. Groundwater head differentials across the barrier are apparently greater than anticipated and have created some operational restrictions and perhaps increased barrier leakage. Groundwater extraction rates have not achieved predicted rates. Reduced groundwater extraction may lengthen predicted cleanup time needed to flush the landfill. Seeps and leakage down gradient from the barrier have been greater than expected but have been controlled with drain systems. Despite operational difficulties, the containment and flushing system continues to manage contamination offsite and slowly reduce contaminants inside the barrier.

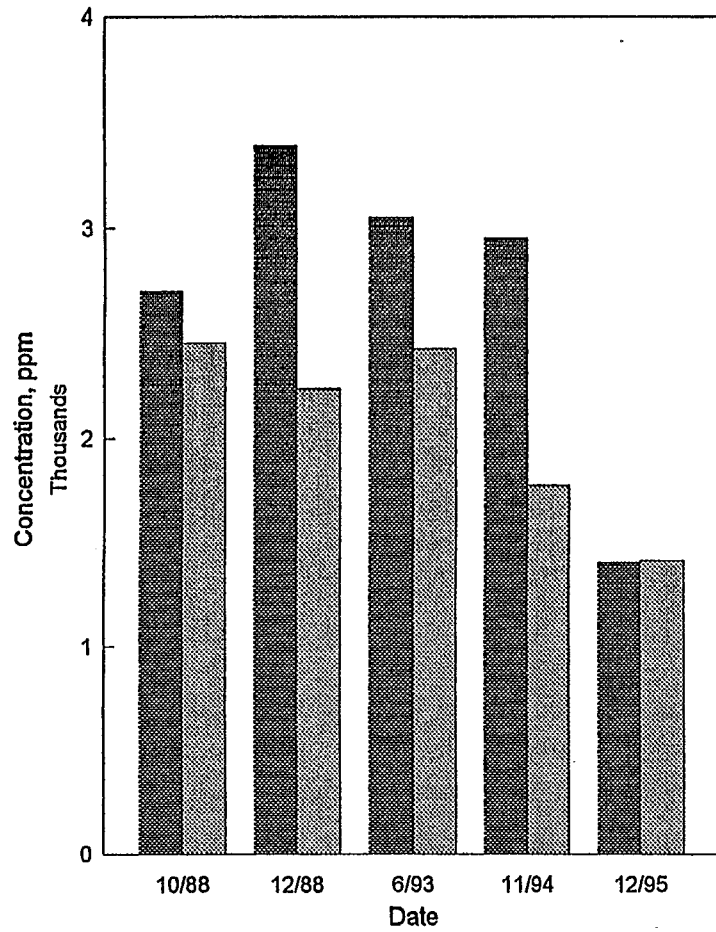
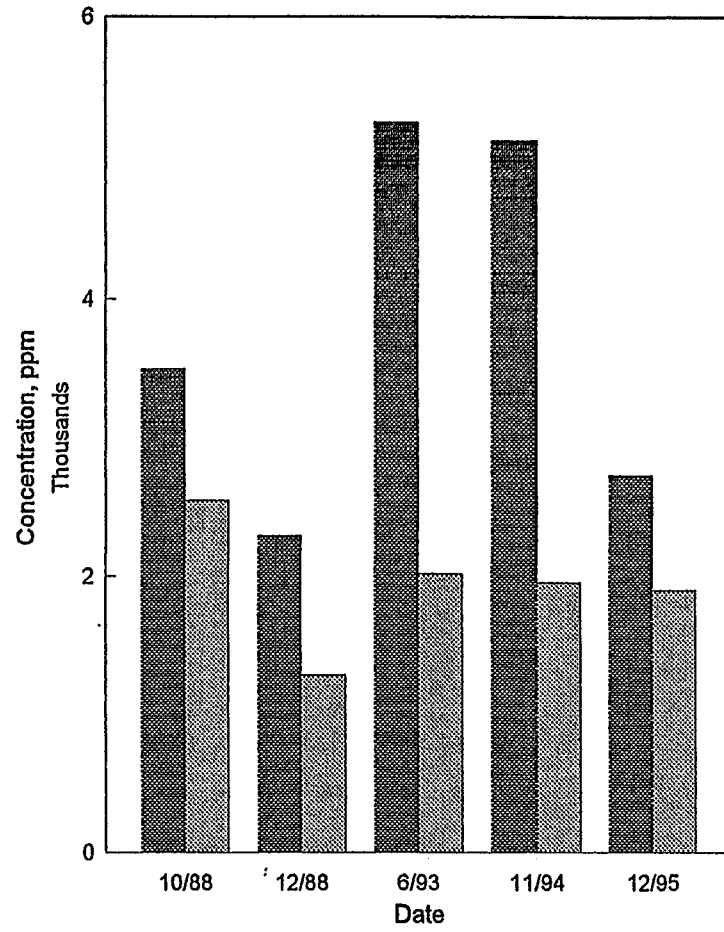
Site 16  
FIGURE 3  
CONCENTRATION vs TIME  
Tetra Tech EM Inc.

The design was rated acceptable and CQA/CQC of the cutoff wall was rated less than acceptable. However, the hydraulic, chemical, and physical monitoring of the cutoff wall involved better than acceptable efforts. Measurements of hydraulic head over time have shown consistently lower head inside the wall. The groundwater quality data does not show discernible trends and actually shows increased concentrations downgradient of the cutoff wall at some locations, presumably because of the presence of source material and dissolved constituents. Overall, the cutoff wall and associated elements appear to have been effective in meeting the original objectives of intercepting DNAPL migration and allowing free-phase DNAPL removal by other means.

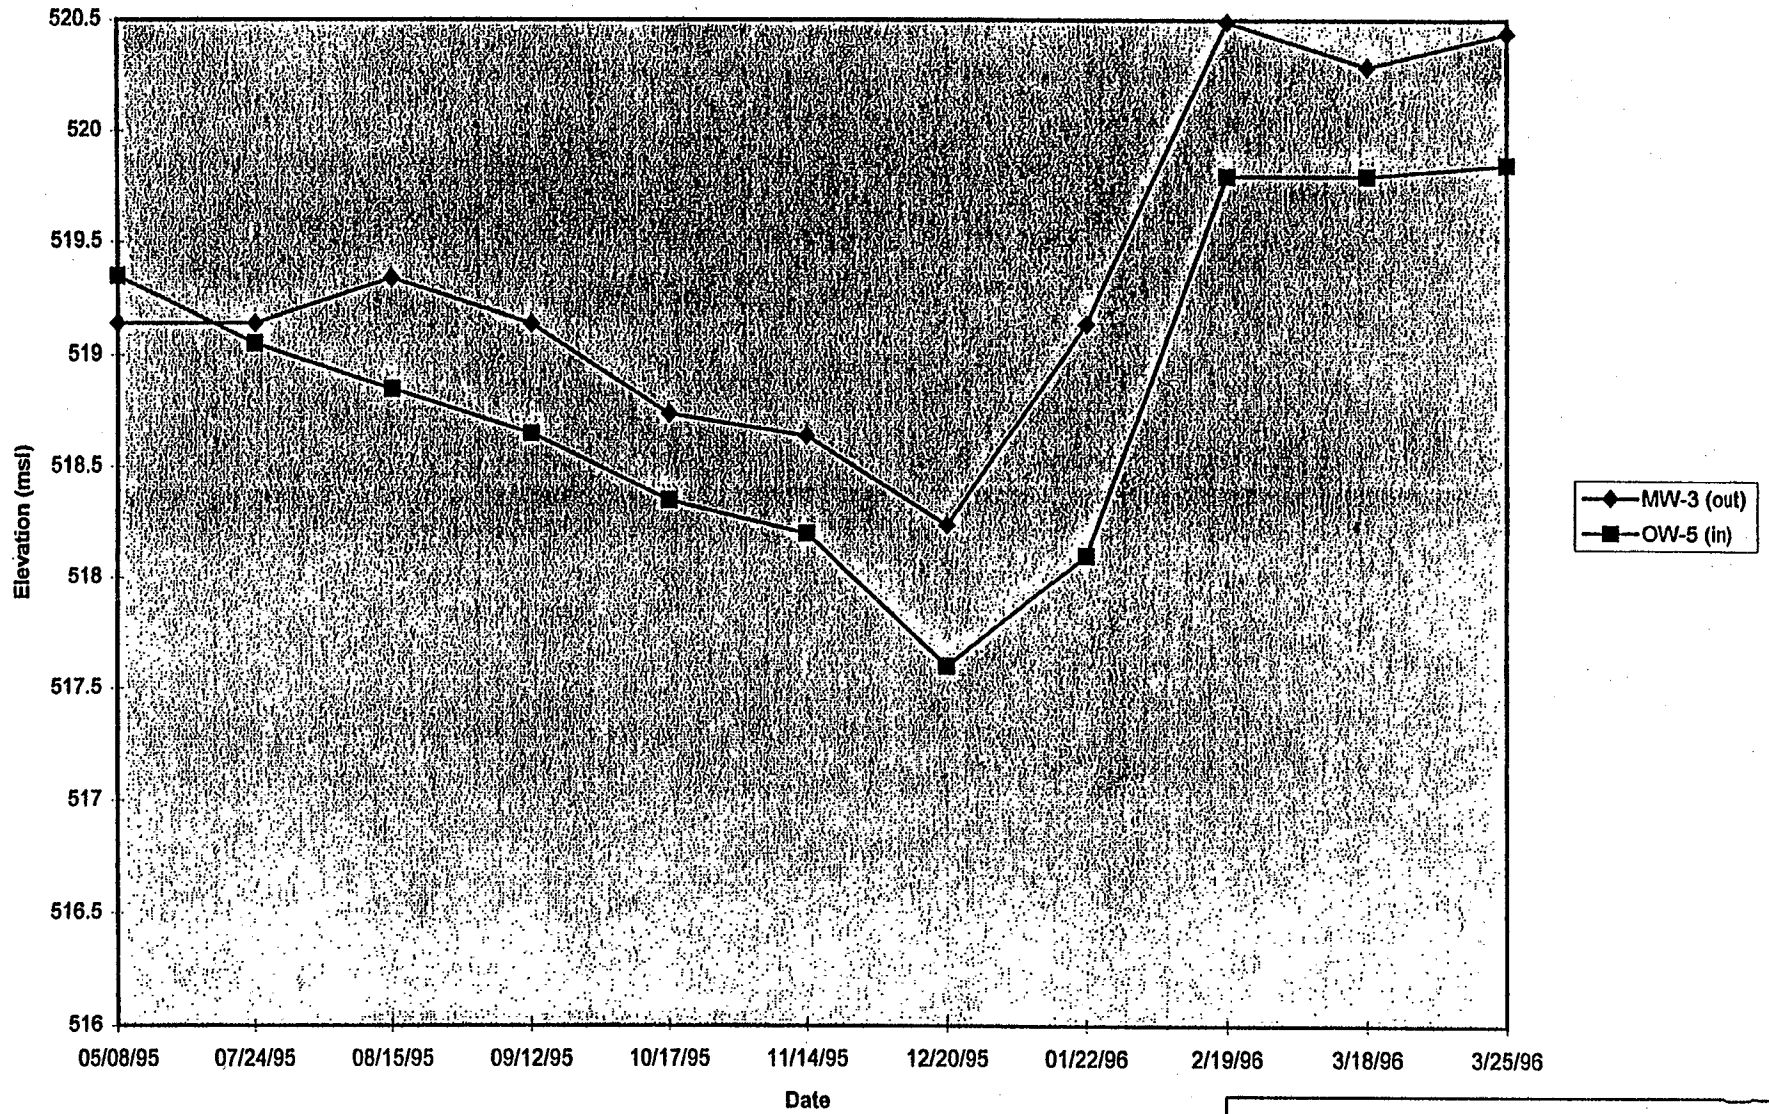
Site 18  
**FIGURE 2**  
**GROUNDWATER ELEVATIONS**

Data for four pairs of wells was compared to determine the existence of an inward gradient. MW-2/OW-4, OW-5/MW-3, OW-6/OW-7, and OW-8/MW-12 are located at the "corners" of the perimeter wall, with one well of each pair located inside the barrier and the other located outside. Figure 2 shows the water level elevations in well pair OW-5/MW-3 beginning on May 8, 1995 (to represent conditions before pumping began), and continuing with monthly measurements from July 1995 through March 1996. Figure 2 demonstrates that an inward gradient has developed across the barrier wall. The site contractor noted that the rising groundwater levels inside and outside the containment area between December 1995 and February 1996 was likely due to higher than expected leakage into the containment area.

The remedy is performing as designed, with pumping from the extraction well operating at design rates. An inward gradient has developed, and will be maintained through pumping the wells within the barrier wall. The water quality in pumping and monitoring wells outside the barrier wall are improving.

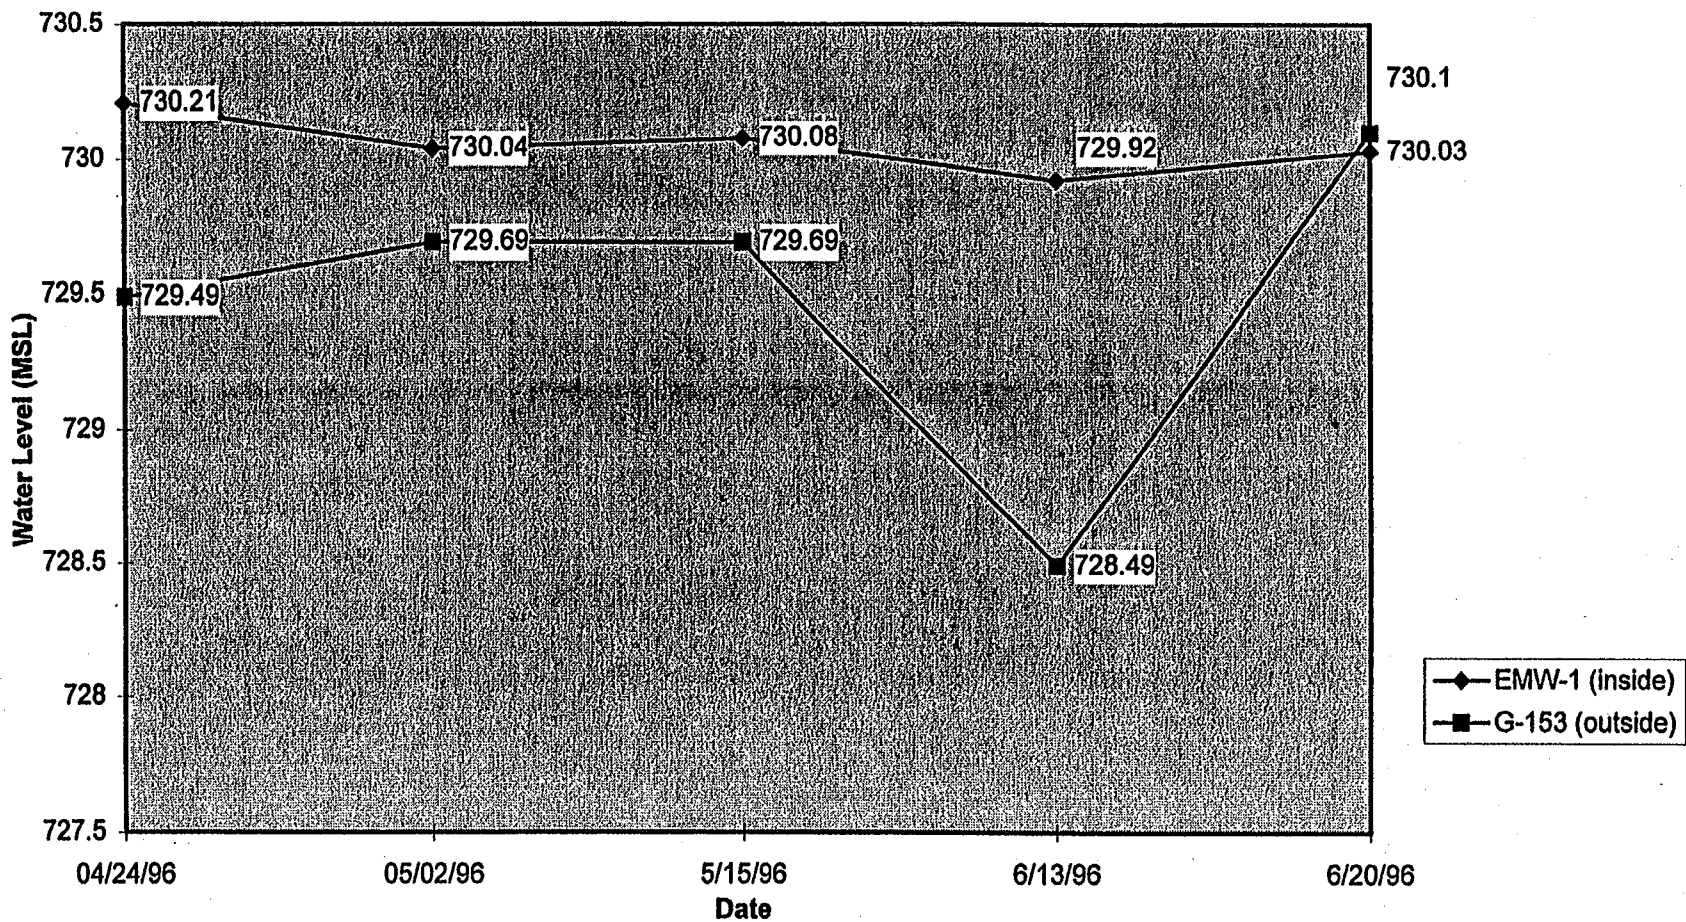
Site 21
FIGURE 2 GROUNDWATER ELEVATIONS

Groundwater quality data is collected quarterly and indicates that contaminant concentrations are decreased rapidly after construction of the wall and cap, but remain in the mg/L range. Overall, there is insufficient data to determine if remedial objectives had been met.

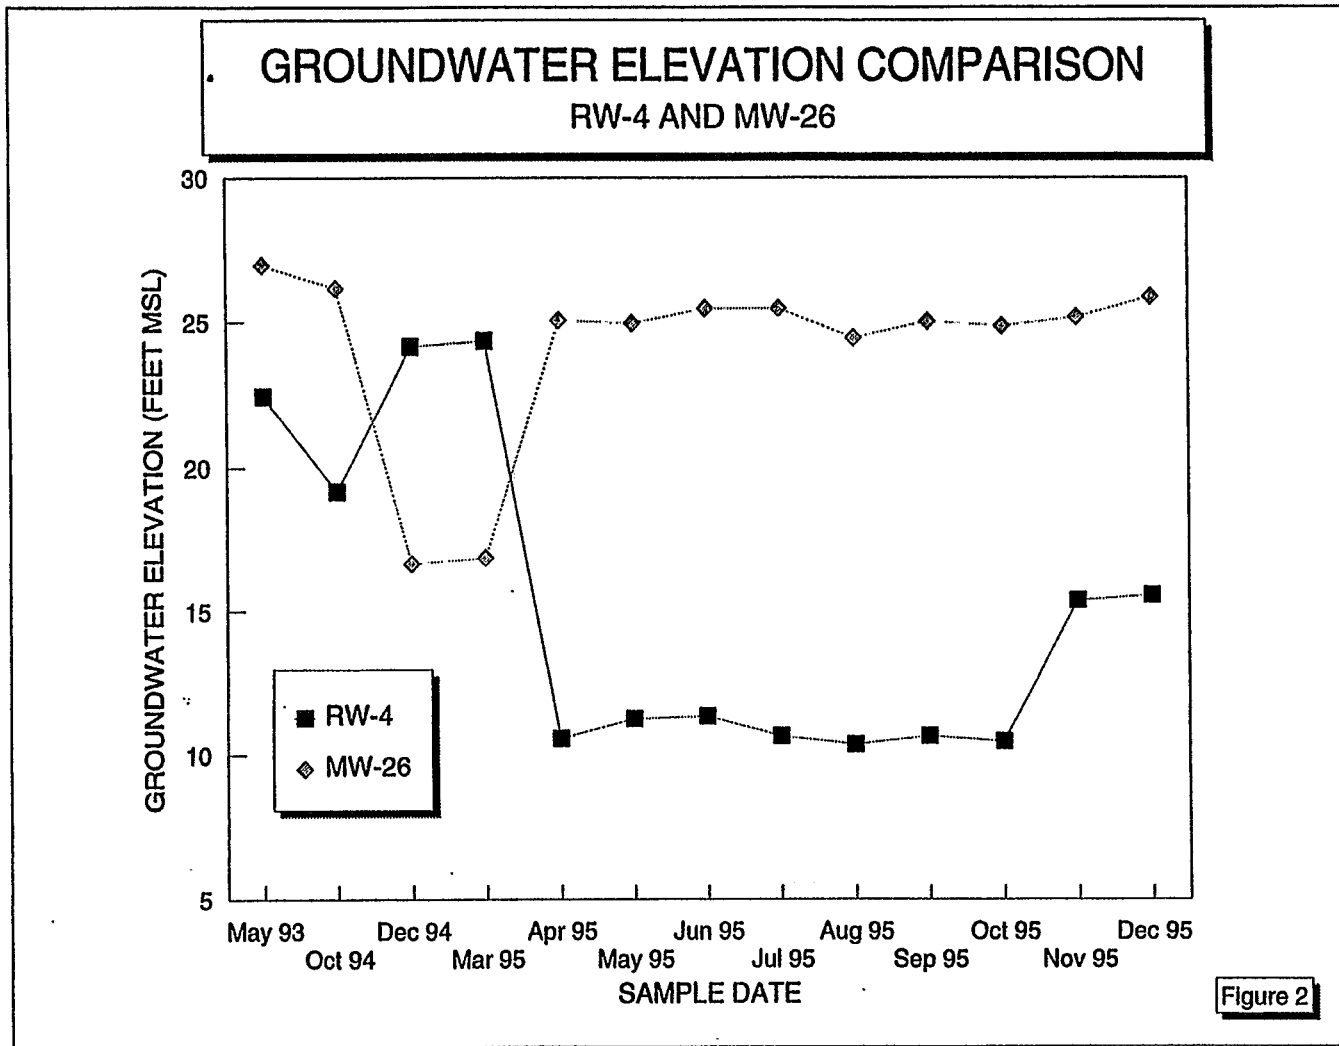
Site 24
FIGURE 2 GROUNDWATER ELEVATION COMPARISON

No operation and maintenance (O&M) specific procedures for the slurry wall are specified in the O&M plan. The slurry wall is covered by the edge of the cap and is therefore not accessible for visual inspection. However, the O&M plan indicates that the hydraulic gradient across the slurry wall will be evaluated after each monthly monitoring event to confirm the presence of an inward gradient.

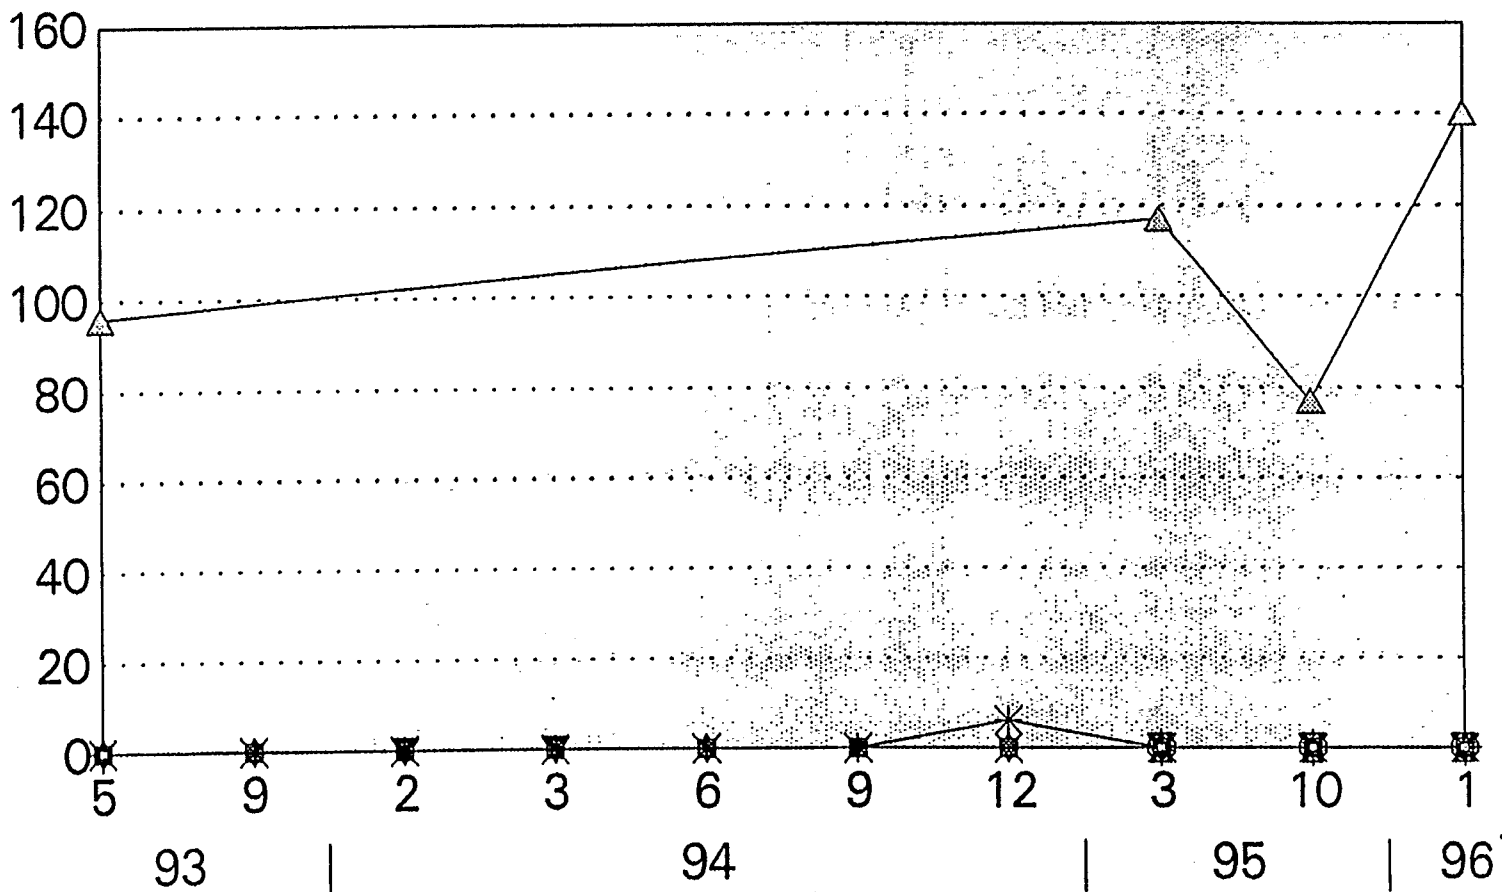
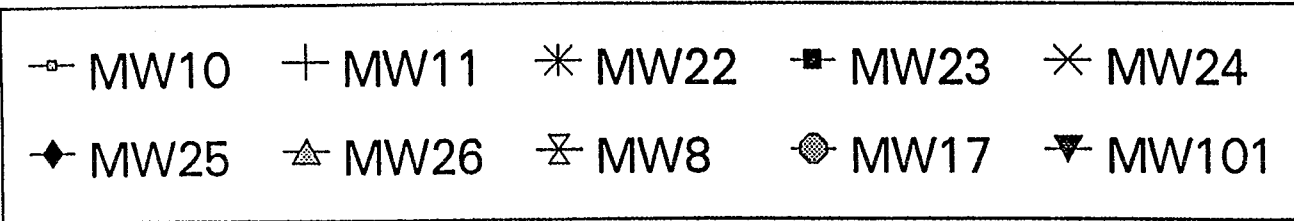
Site 24  
**FIGURE 4**  
 MONITORING WELL TCE (ppb)  
 CHEMICAL ANALYSIS SUMMARY

Monitoring wells MW-26 and MW-10 were located in areas of known contamination. TCE concentrations in groundwater have not changed significantly since the recovery system began operation in 1993. Groundwater samples collected from MW-26 have consistently contained about 100 µg/L TCE, and in December 1995, a concentration of 3,000 µg/L PCB was detected (see Figure 4 and 5).

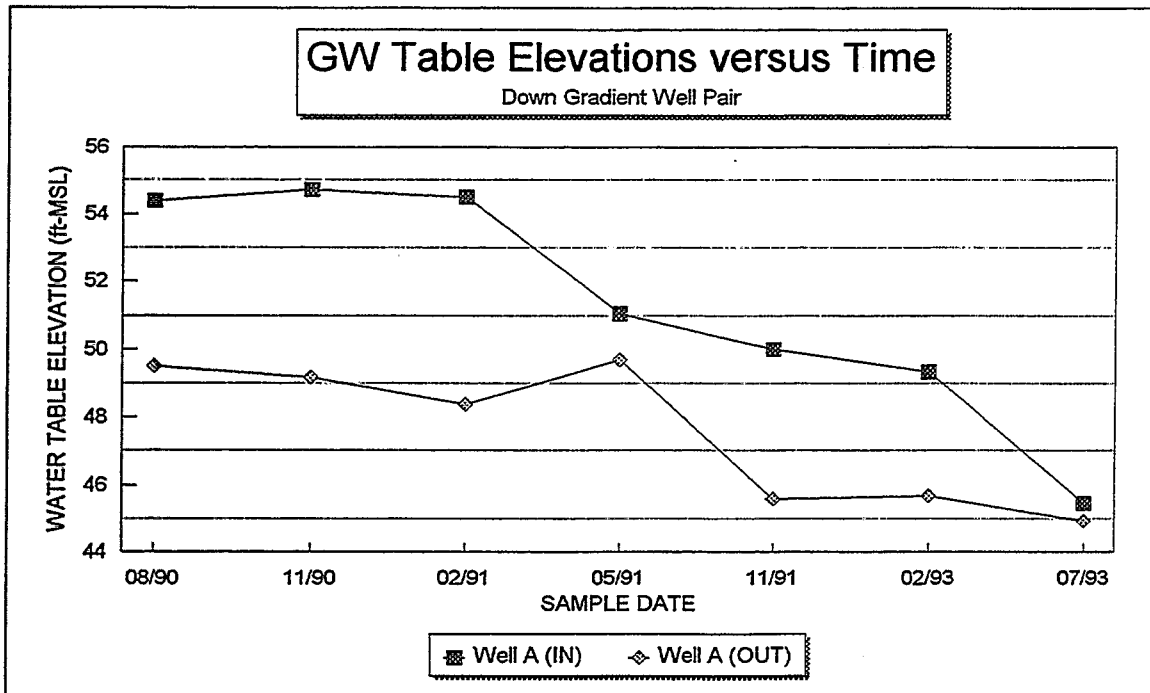
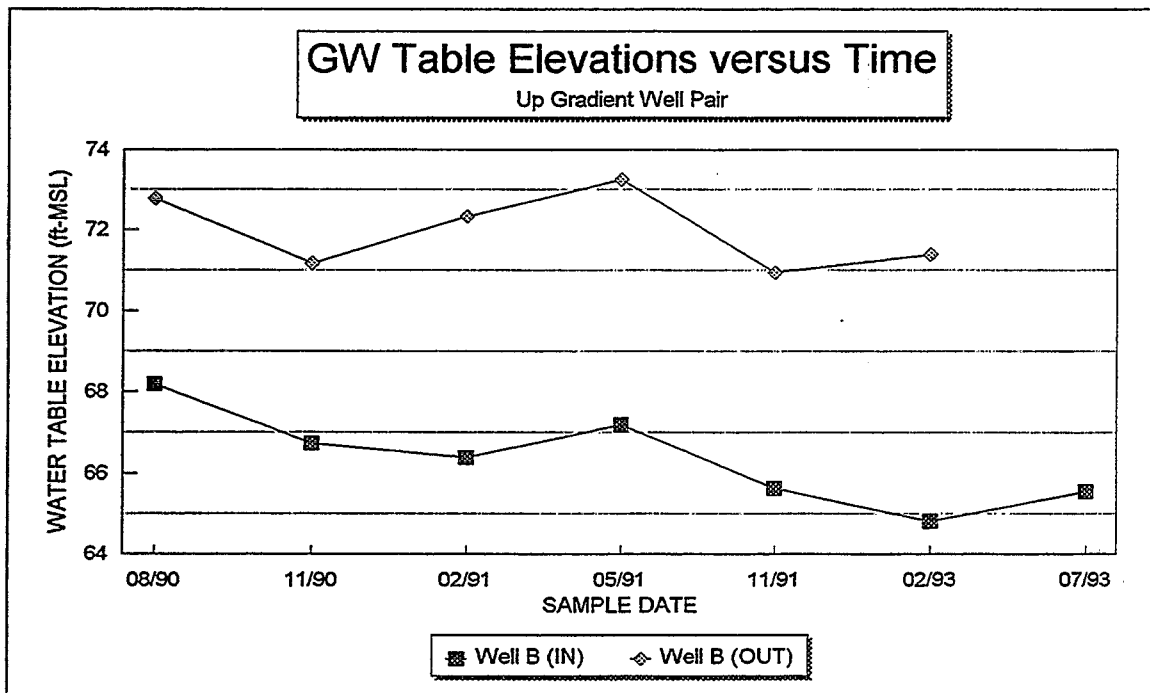
**FIGURE 2**

**GW TABLE ELEVATIONS versus TIME**

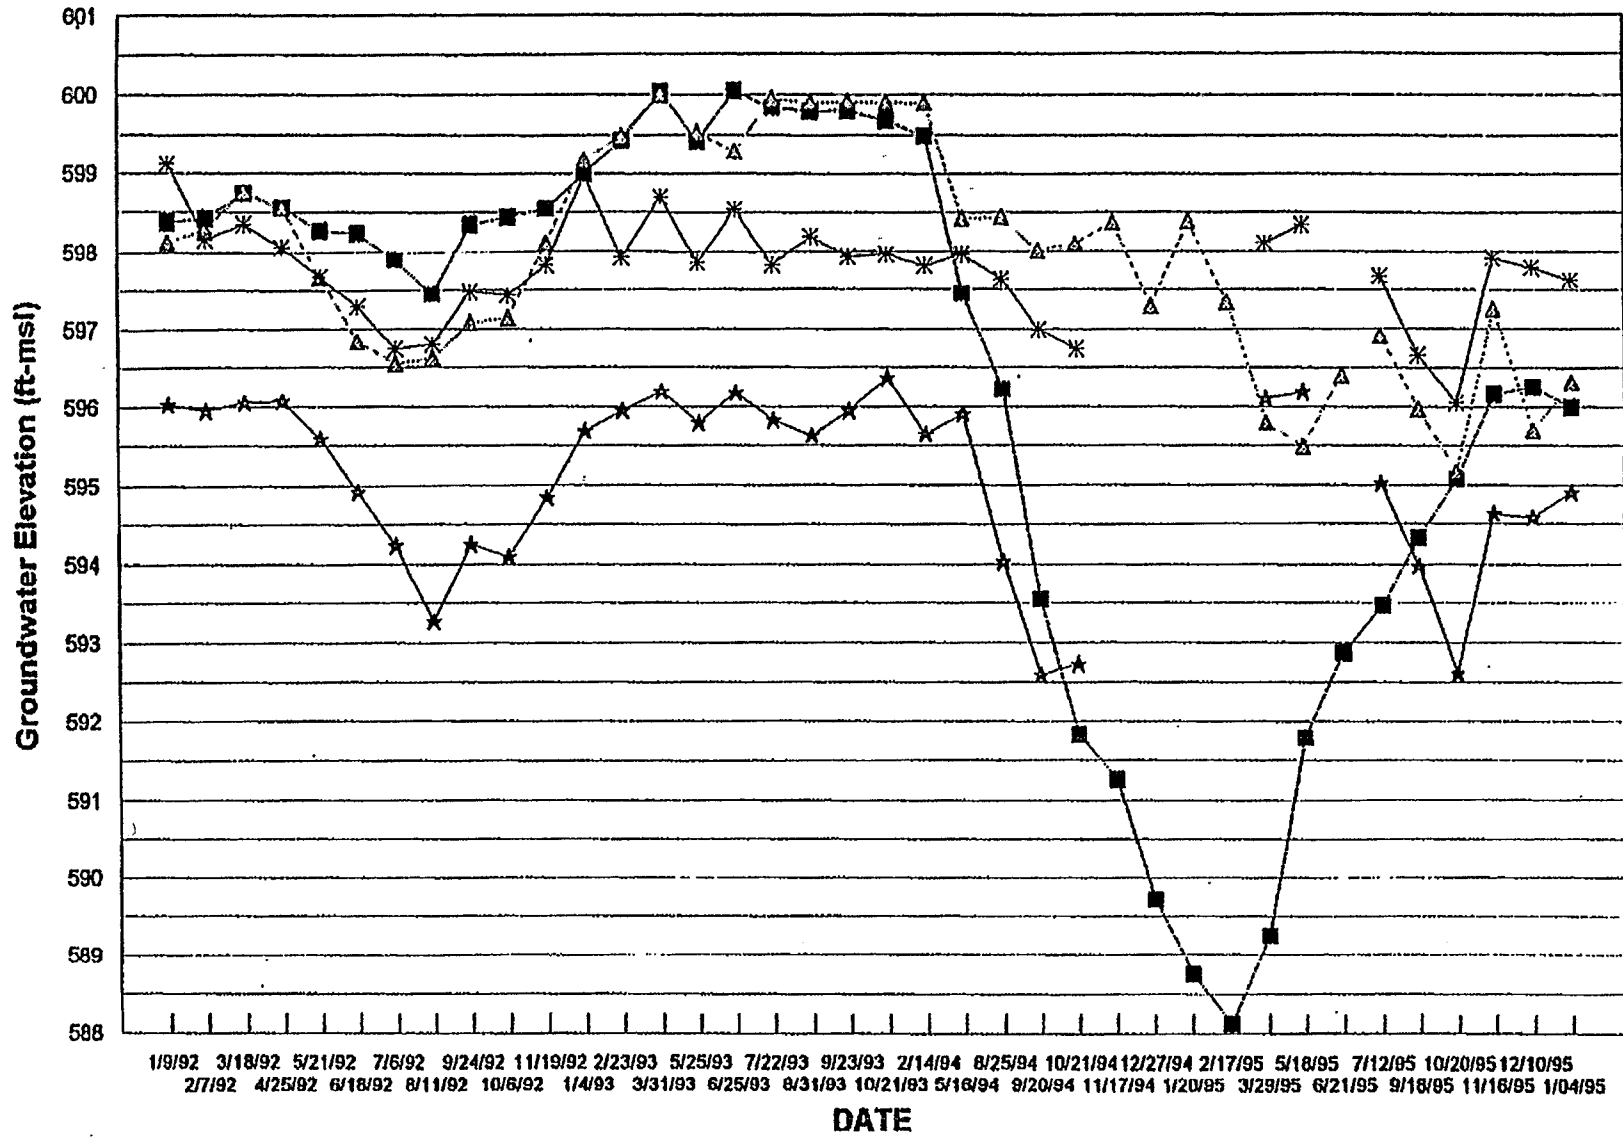
Site 30  
**FIGURE 3**  
**GROUNDWATER ELEVATIONS**

Long-term monitoring was rated average compared to standard industry practice. Groundwater elevation measurements were compared to determine the existence of an inward gradient. Figure 3 shows water level elevations in down- and upgradient perimeter wells, in a pumping well within the PCA under the RCRA cap, and in the ponds beginning in January 1992.

The water level elevations in the upgradient well located outside of the slurry wall reflect an inward gradient beginning in August 1994 and remaining through March 1996 monitoring. The downgradient well does not indicate an inward gradient except perhaps between October 1994 and July 1995. The graph clearly shows that once groundwater extraction was stopped in February 1995, the water level within the PCA rebounded or leveled out. Figure 4 shows the water levels for a downgradient well pair. Again, this figure shows that an inward gradient was not established. The infiltration gallery and the existence of surface water in on-site ponds and wetlands may influence the water level within the PCA. The surface water level in the ponds and wetlands fluctuated between 595.5 to 600 feet above mean sea level from January 1992 to October 1995.

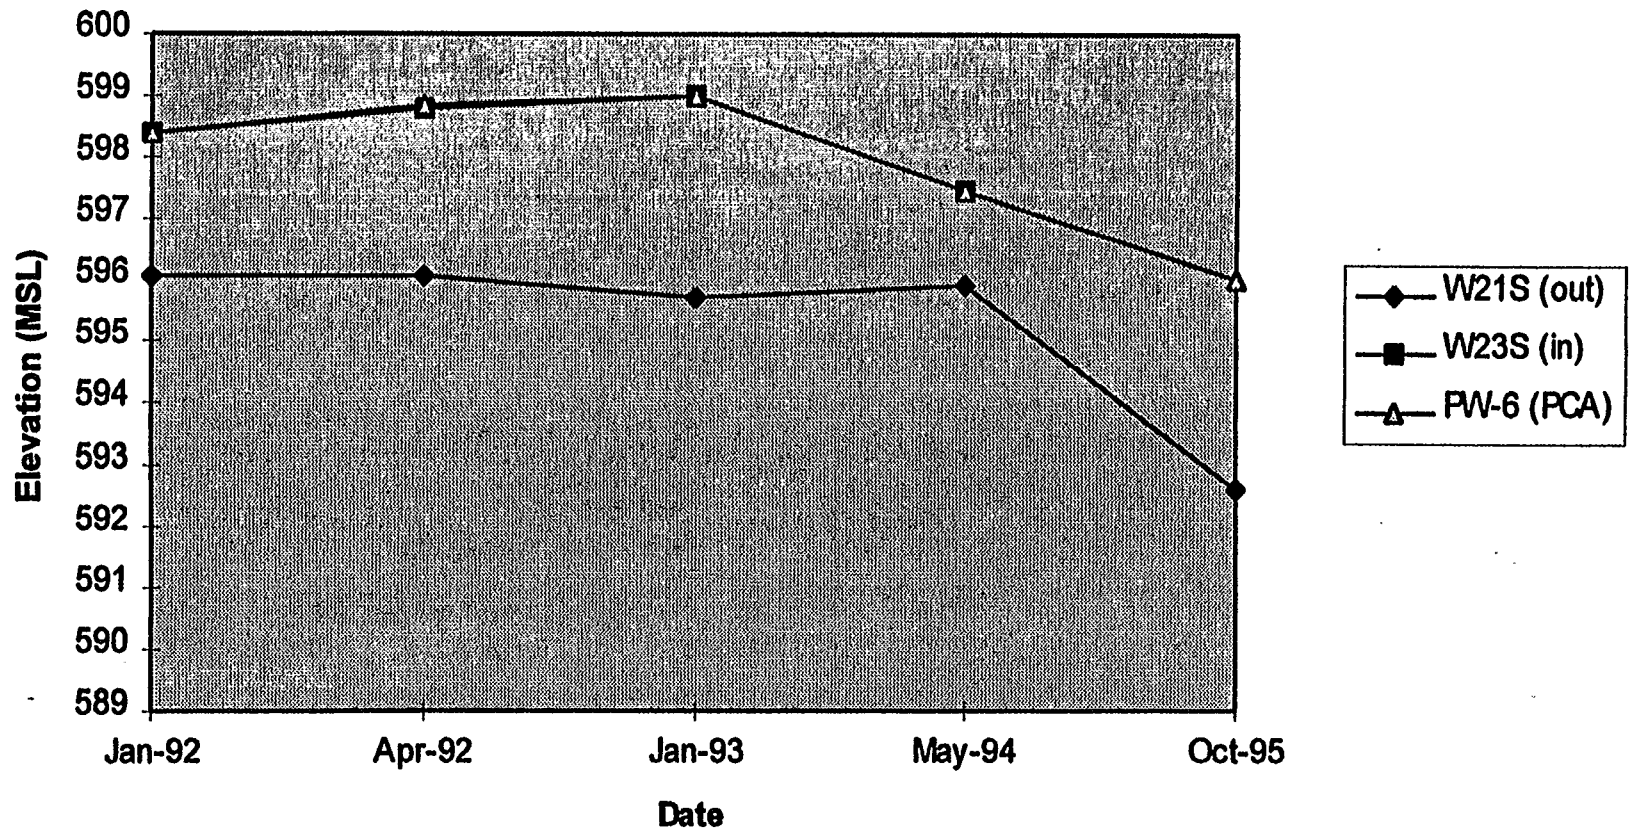
Site 30
FIGURE 4 GROUNDWATER ELEVATIONS

### Well Pair W21S and W23S Downgradient - Northeast

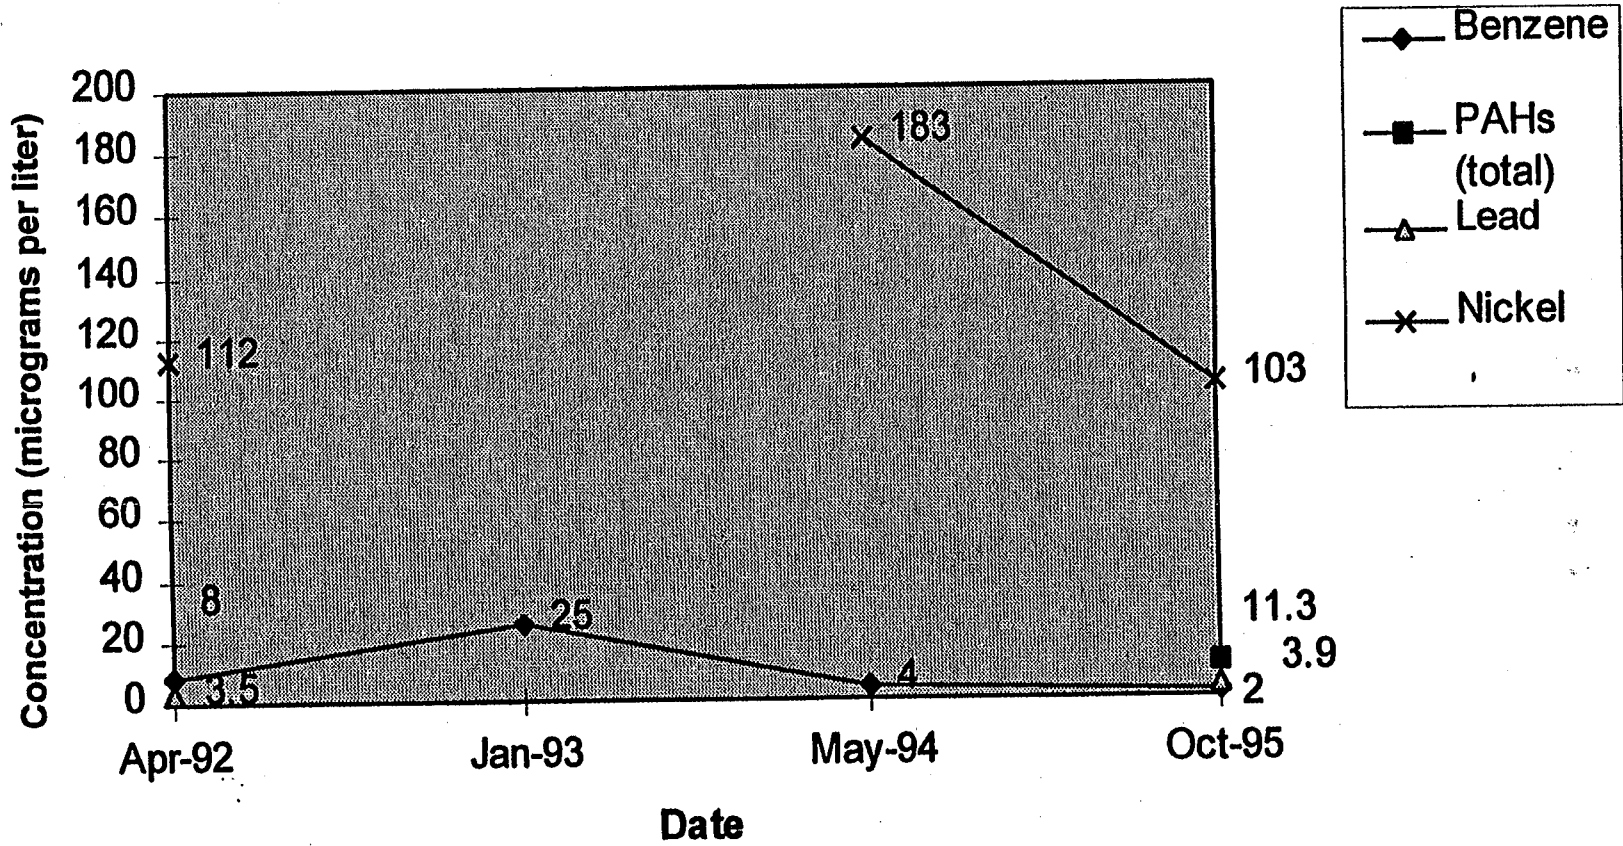
Site 30  
FIGURE 5  
CONTAMINANT CONCENTRATIONS  
Tt Tetra Tech EM Inc.

Benzene, total PAHs, lead, and nickel were selected to represent on-site contamination because groundwater was analyzed for these chemicals during all sampling rounds and they represent several primary contaminants of concern. Figure 5 shows the concentration of contaminants detected in well W21S, the downgradient well outside the barrier. Well W21S is located along the primary slurry wall (only one barrier between the pumping well field and W21S). Benzene concentrations appear to be declining since January 1993, and total PAHs remained below detection limits until October 1995. Lead levels, when detected, are stable. Nickel concentrations vary from below detection limits to 183  $\mu\text{g/L}$ , with no apparent correlation with time. Additional results from sampling round 10 indicate no significant changes in groundwater chemistry outside of the primary slurry wall.

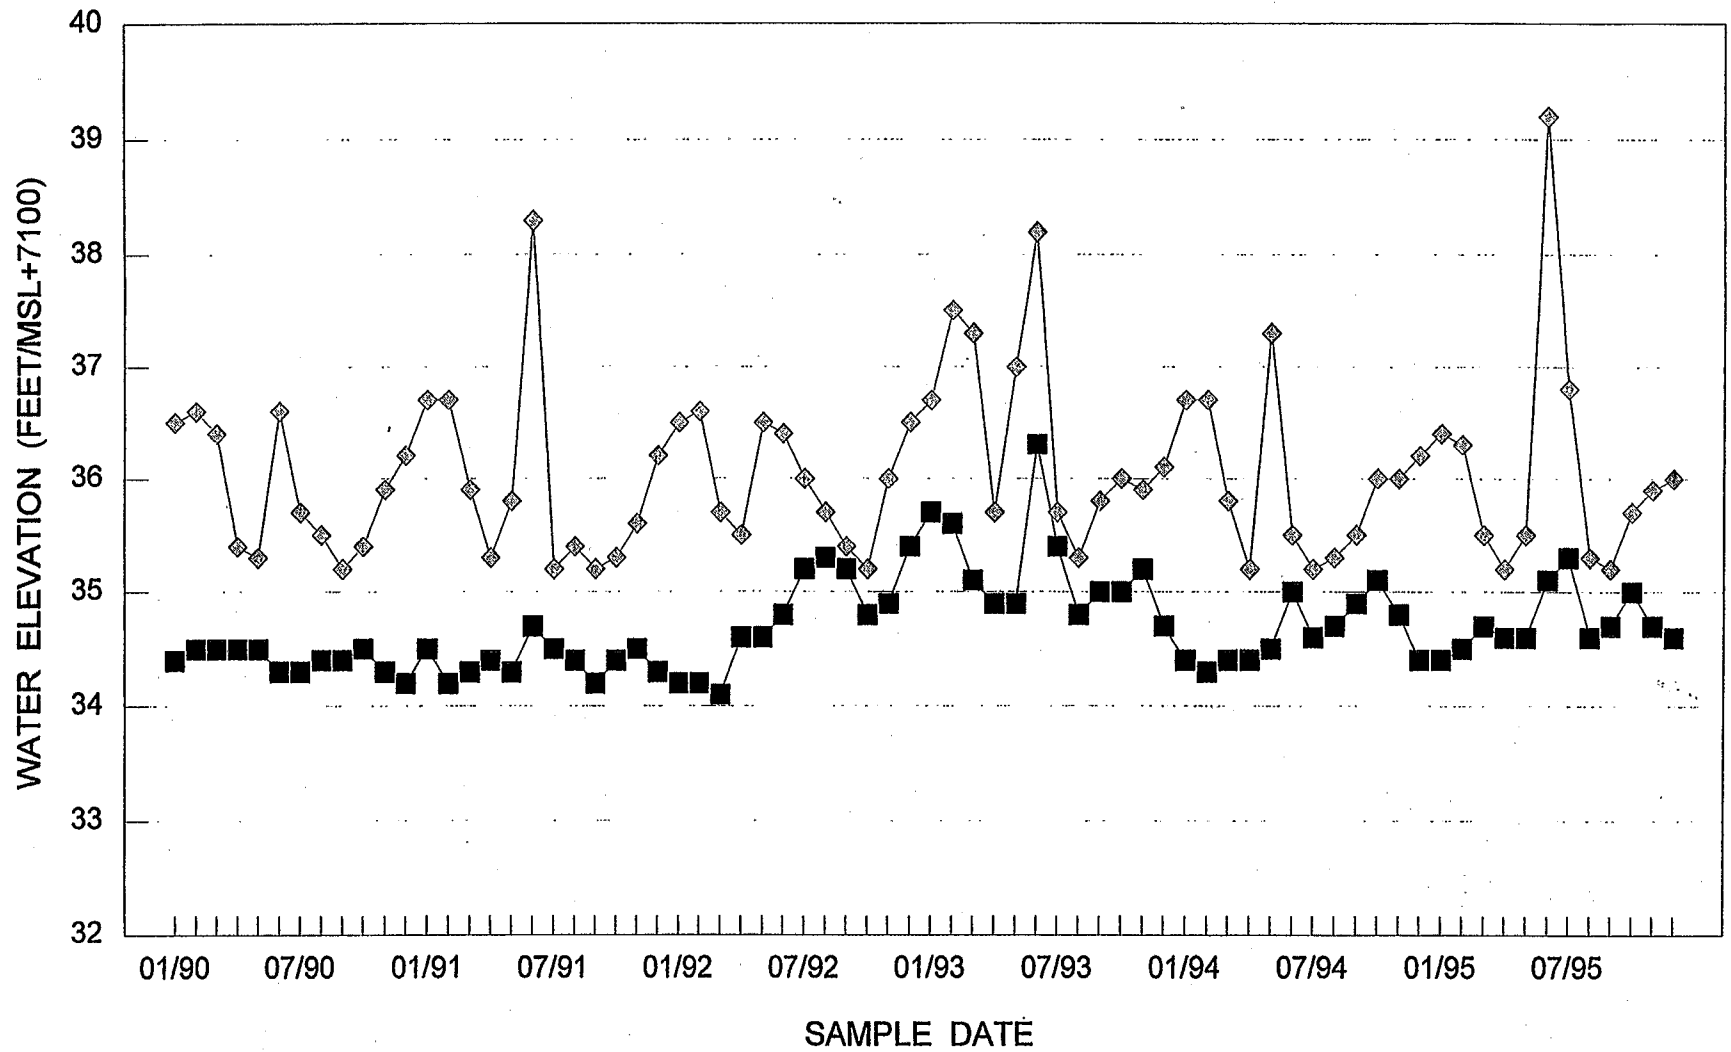
Site 31  
FIGURE 4  
WEST WALL HYDROGRAPHS  
Tetra Tech EM Inc.

Alluvial water level data from December 1986 indicates that water levels were higher inside the barrier wall than outside along the western and most of the northern segments of the wall. This finding reflects conditions before the startup of the CIS. By April 1987, groundwater elevations had dropped along the southern, northern, and western segments of the wall, as a result of CIS operation. An inward gradient was detected at three of the eight alluvial monitoring well pairs straddling the barrier wall. Groundwater levels measured during May 1987 indicate the presence of an inward gradient at all eight alluvial monitoring well pairs straddling the barrier wall. According to quarterly monitoring reports, this inward gradient has been maintained through the most recent sampling date (June 15, 1995). The most recent alluvial potentiometric map shows groundwater at the site flowing toward the interior drains and shows lower alluvial water levels inside the barrier wall than outside.

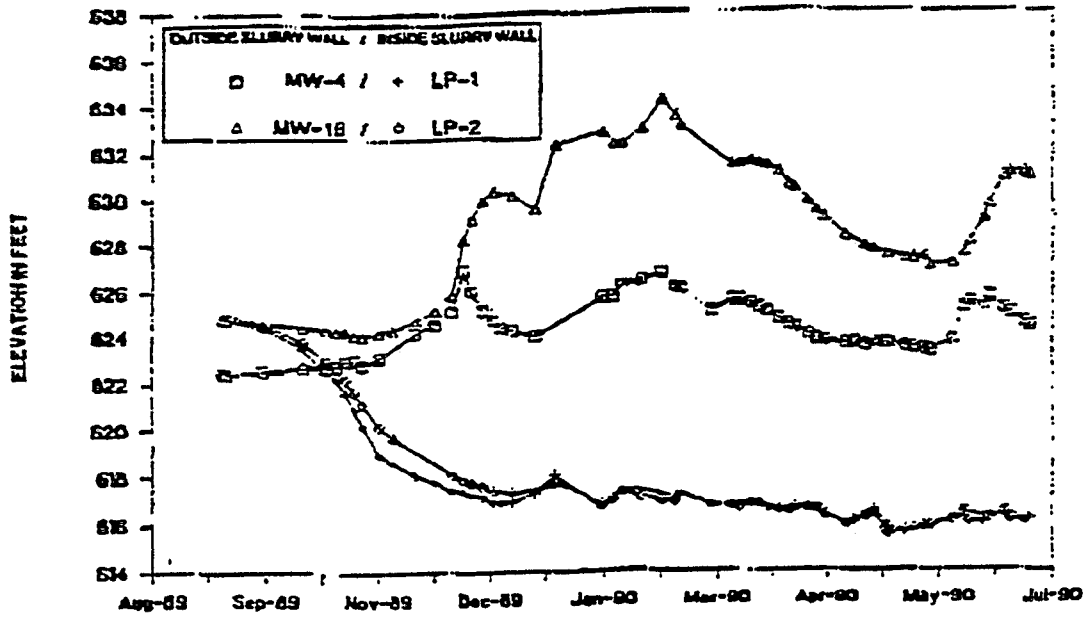
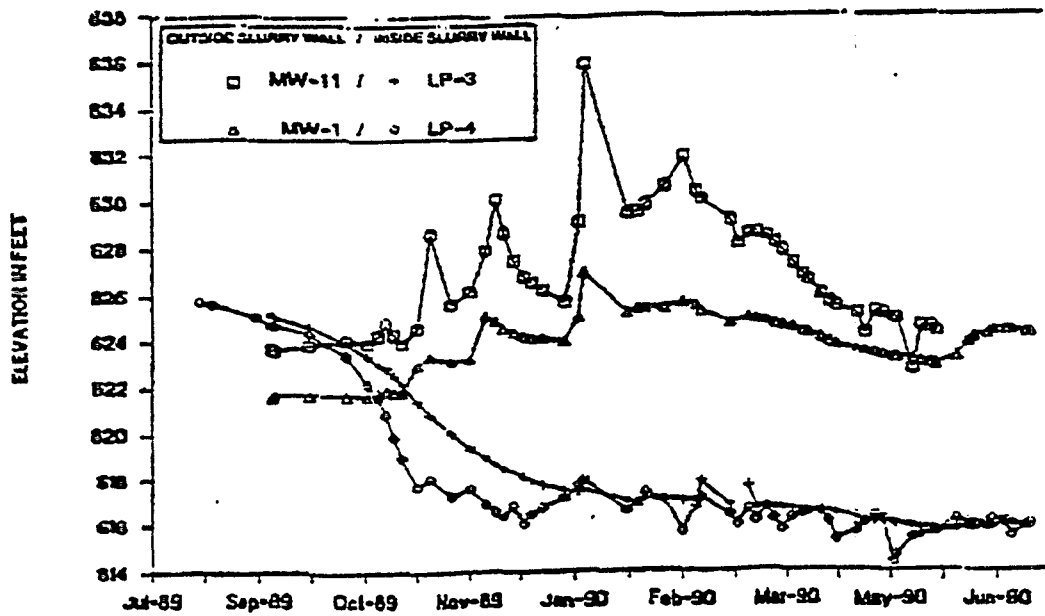
FIGURE 3  
GROUNDWATER DRAWDOWN ELEVATIONS

In a recent publication, after analysis of the available data, representatives of the operators concluded that the inward hydraulic gradient has been maintained as per design objective and that the groundwater monitoring shows "ten statistically significant reductions in the selected leachate indicator parameters, two increases (neither statistically significant) and are unchanged condition", thereby demonstrating that "the shallow aquifer remediations have reduced off-site migration".

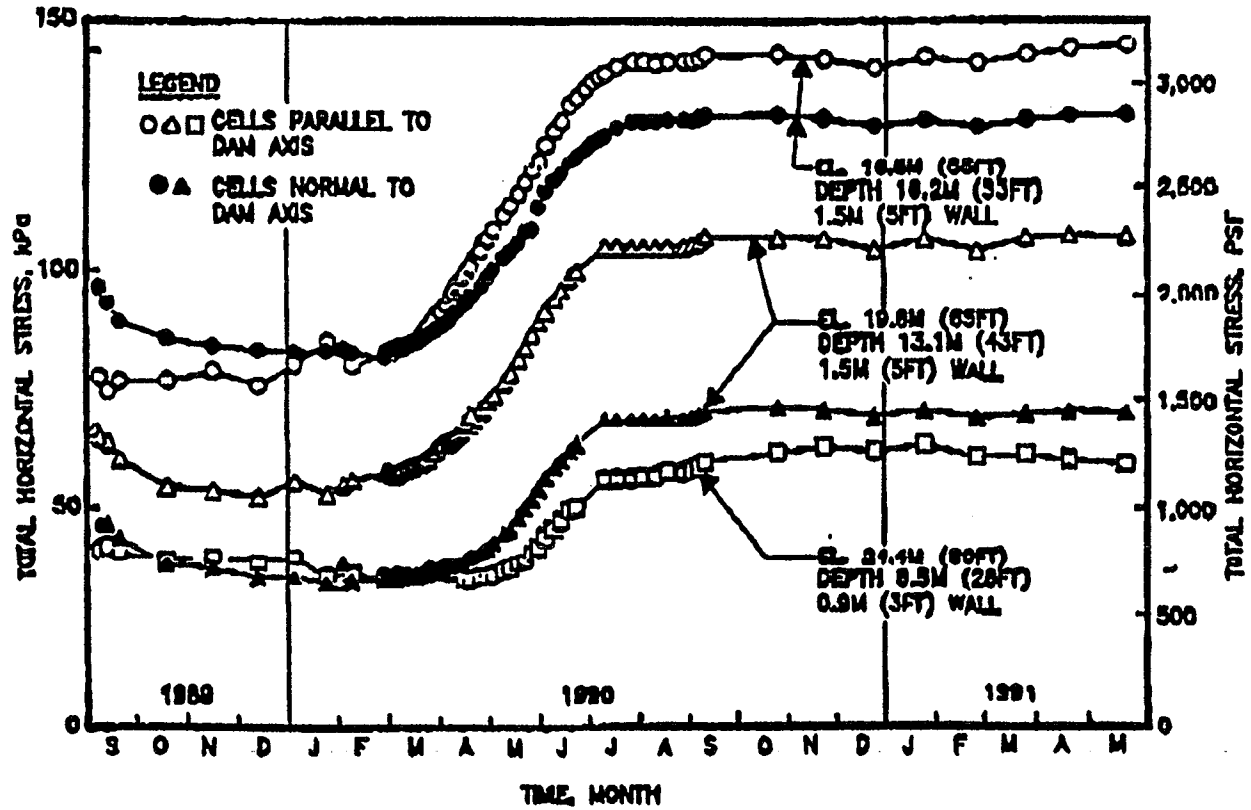
Site 34
FIGURE 3
TOTAL HORIZONTAL STRESSES IN S-B WALL

- No appreciable settlement of the top of the backfill has been noted.
- The total flow rate of seepage measured at the flow weirs at the base of the dam has remained below 12 gallons per minute. This flow rate did not increase as the reservoir was filled.
- The piezometers have registered a head drop across of nearly 30 feet across the wall.
