**EPA Evaluation of Subsurface Engineered  
Barriers at Waste Sites**

**Volume II  
Appendix B**

**Appendix B**

**Site Summaries**

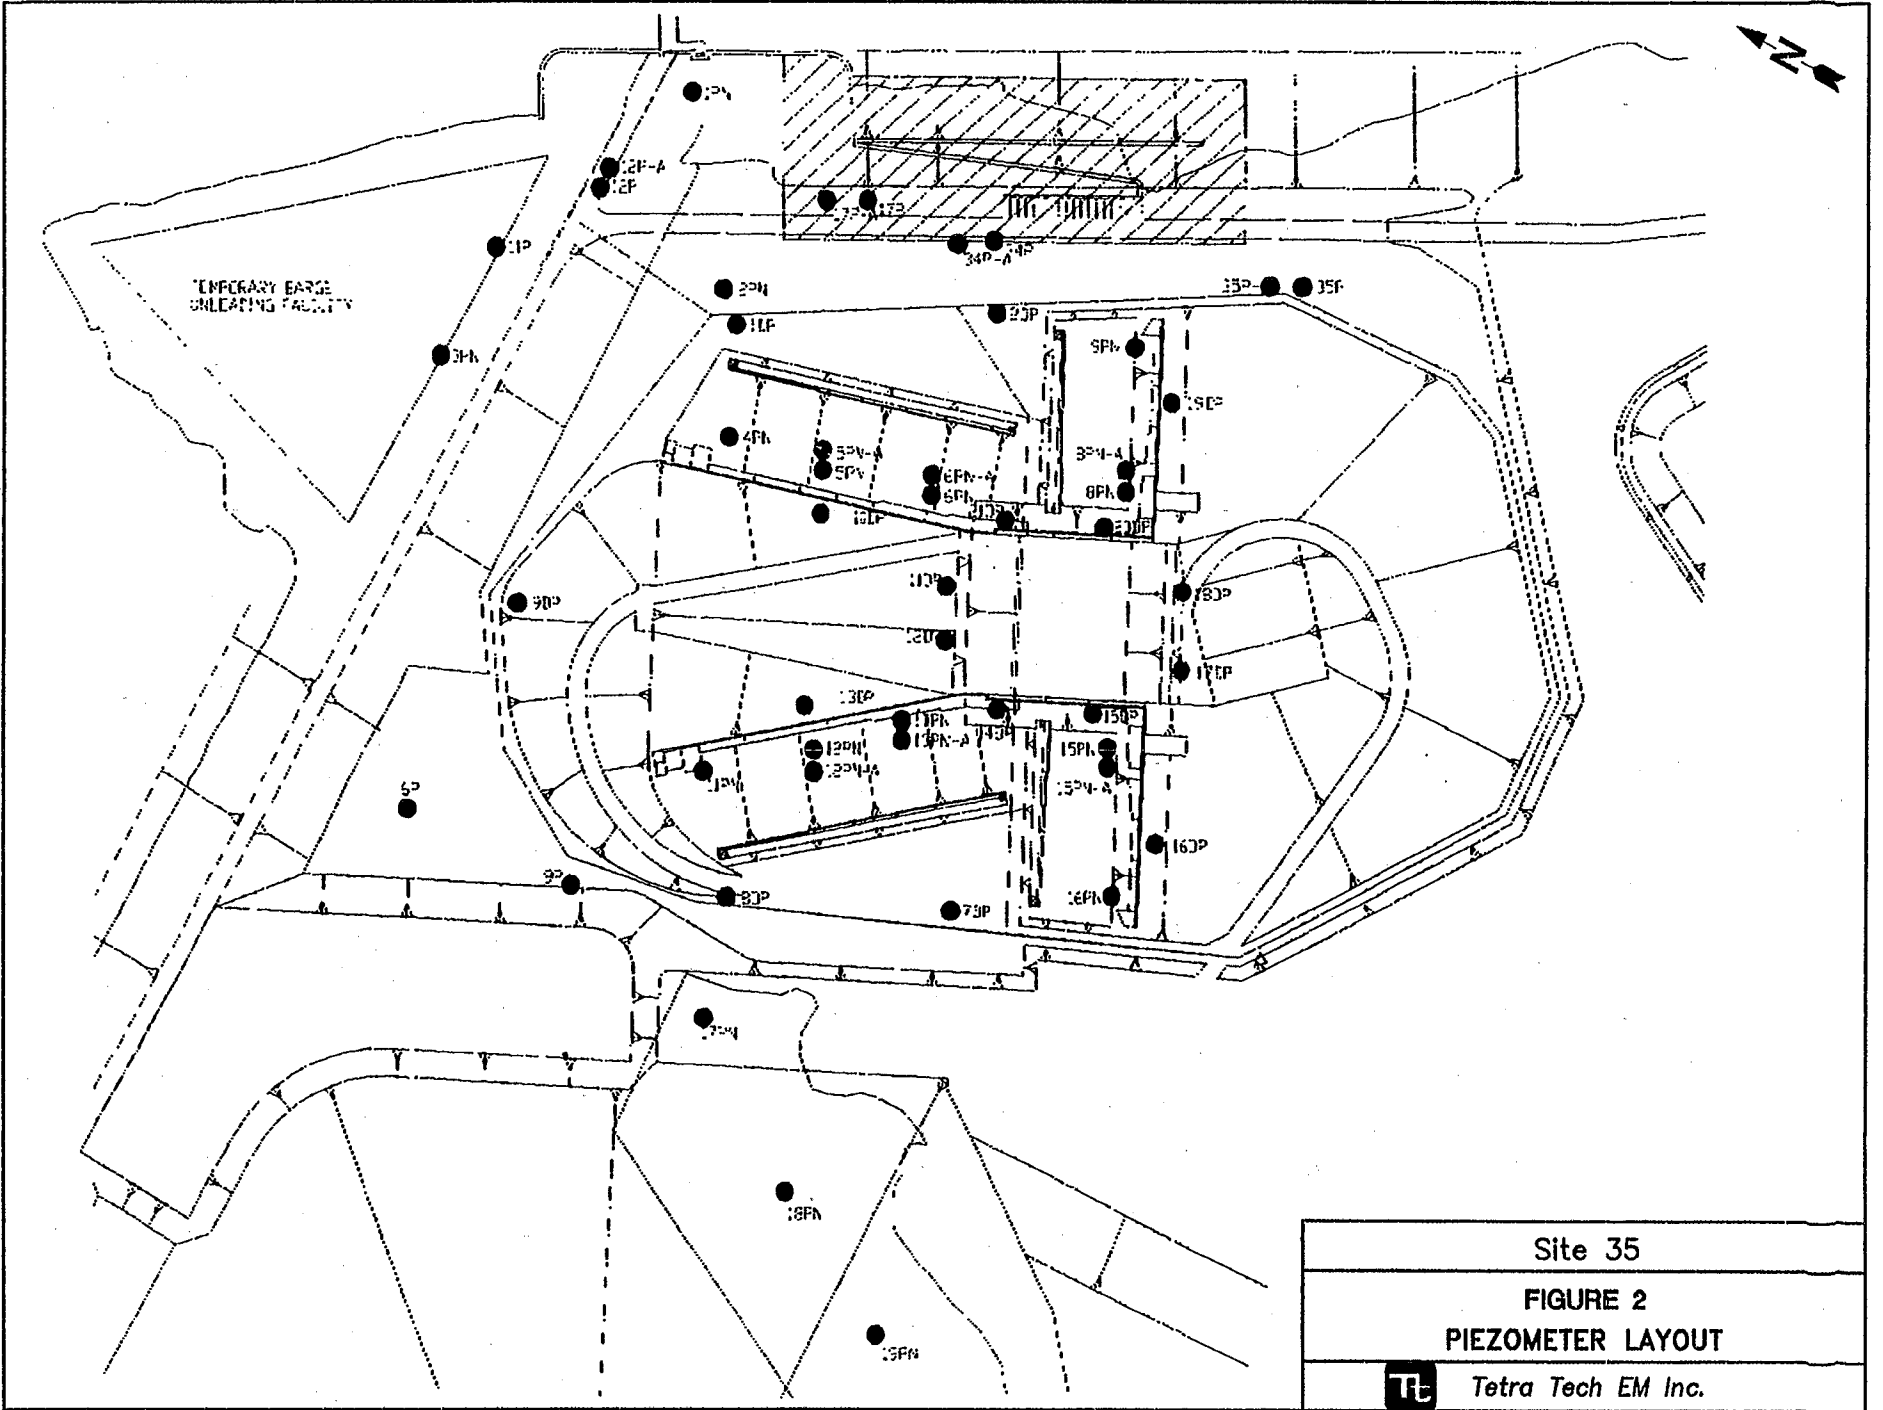
Site 35
FIGURE 2 PIEZOMETER LAYOUT

Site 35 contains no contamination. A 150-foot-deep, plastic concrete cutoff wall was required at the site to allow a 90-foot excavation in the immediate vicinity of a large river. The design, CQA/CQC, and monitoring of the cutoff wall were rated better than acceptable. The pumping system inside the excavation employs conventional deep wells. The plastic concrete cutoff wall is subject to a 95-foot head. The mass excavation was completed by January 1996. The dewatering flow rate meets the designed rate, and indicates excellent performance by the cutoff wall.
