**SUBJECT:** Transmittal of Final Report - High Lead at Three Residences in Flint, Michigan

## High Lead Levels in Flint, Michigan

The purpose of this report is to present the findings of activities conducted in response to high lead levels in drinking water reported to the United States Environmental Protection Agency Region 5 Office (EPA) by a resident in the City of Flint, Michigan.

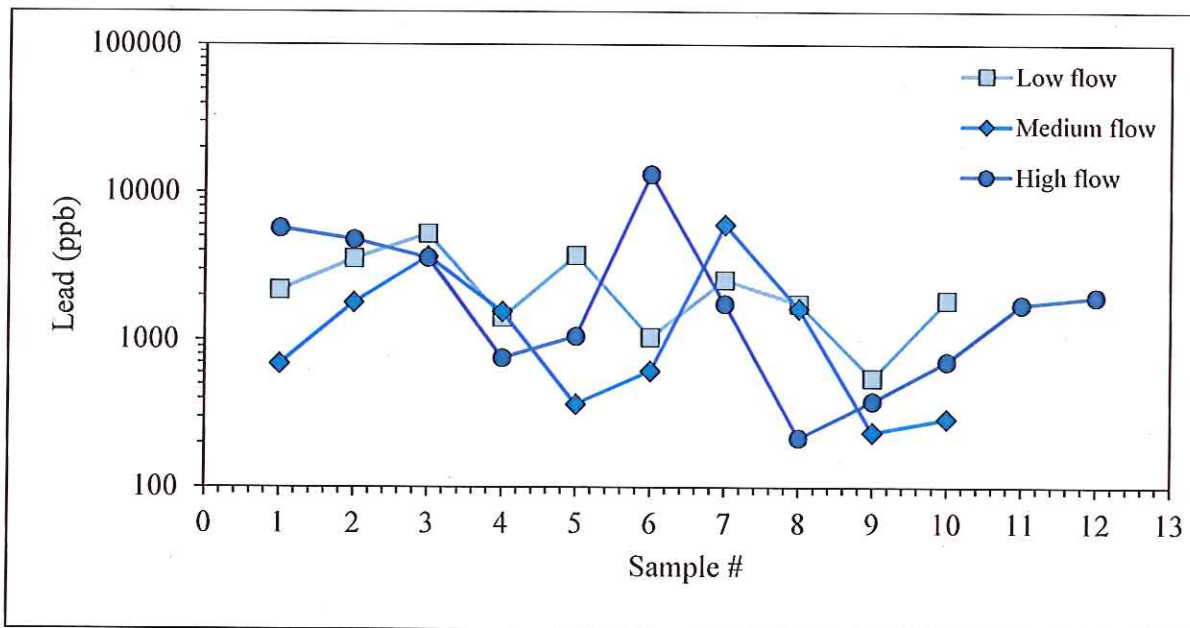
*Virginia Tech Sampling Results (provided courtesy of Virginia Tech)*

Samples were collected from the [redacted] home following an extended stagnation period (April 3, 2015 to April 27, 2014) after the water at the [redacted] residence had been shut off. The water was turned back on and three sets of sequential samples were collected on April 28, 2015, at different flow rates (low, medium and high).
