**Operating Experience
Overview and
SF₆ Emission
Reduction Efforts at
Seabrook Station**

Seabrook Station

345-kV Distribution System

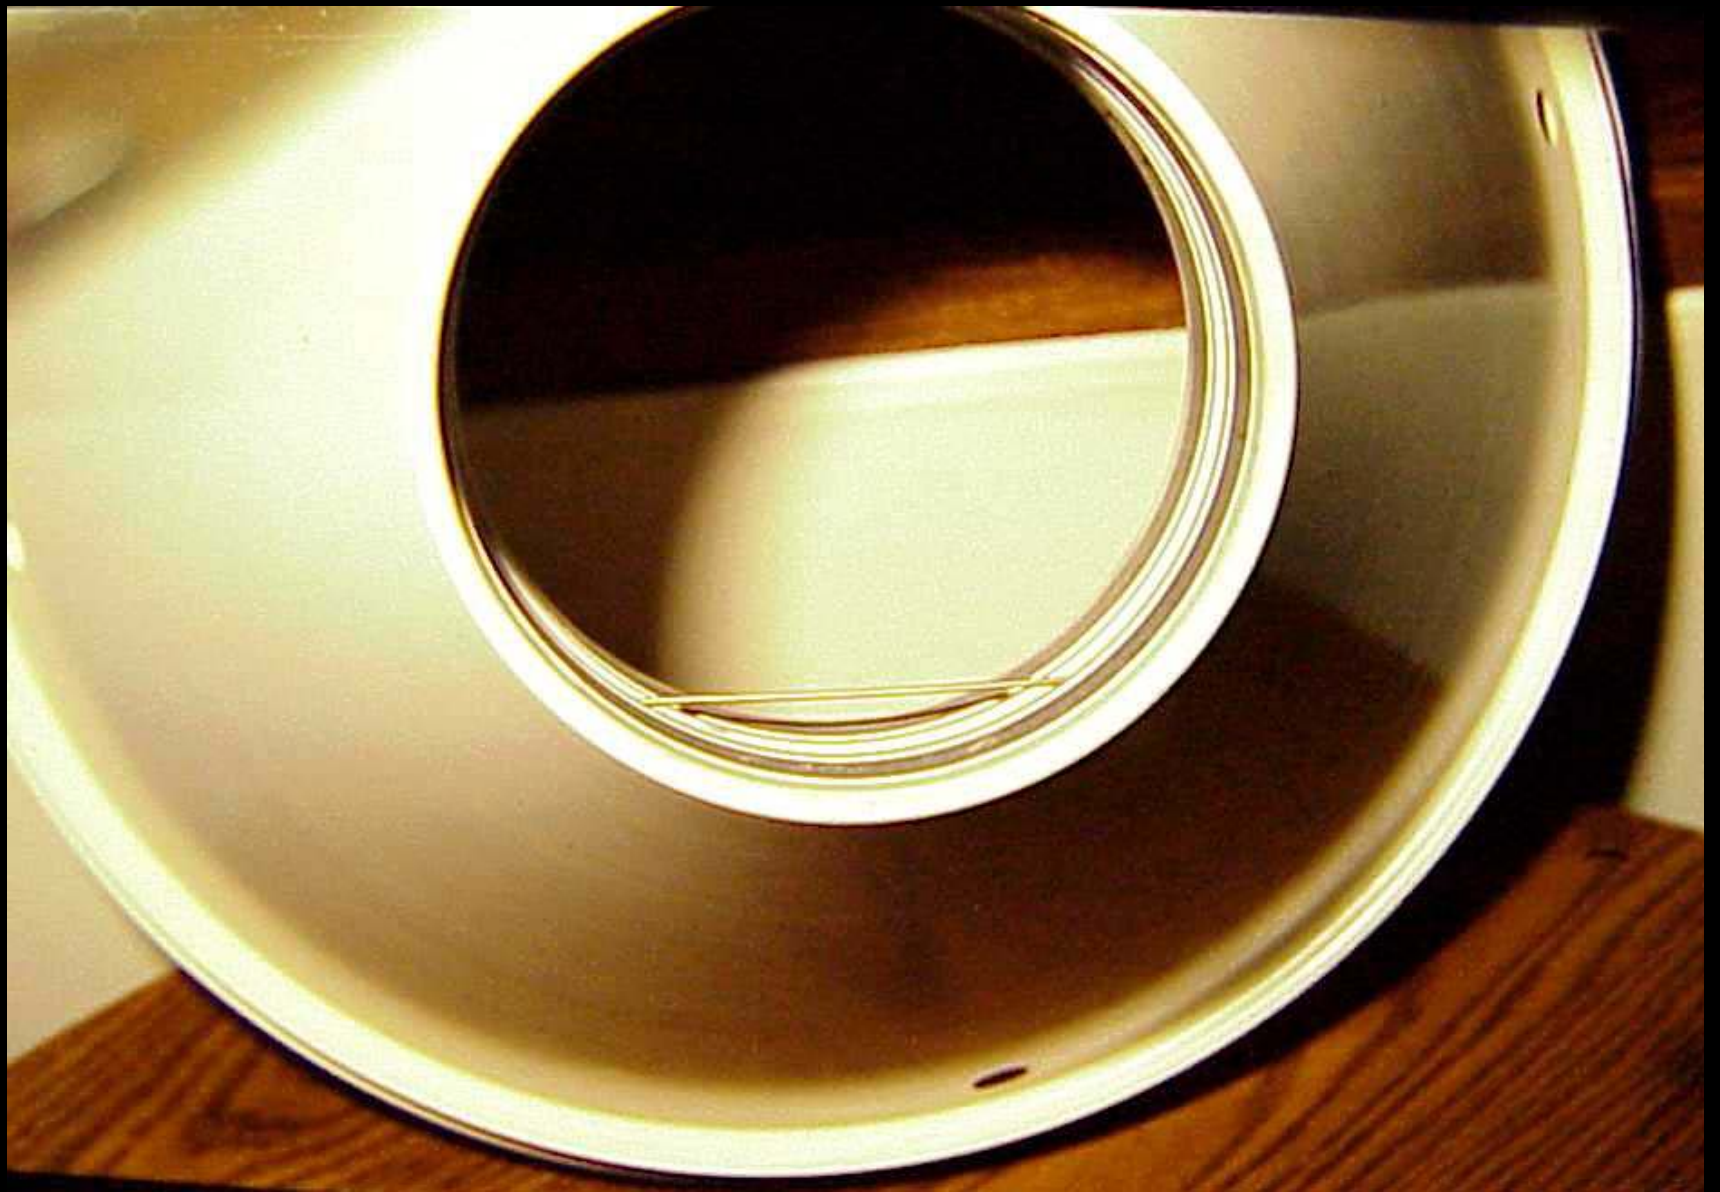
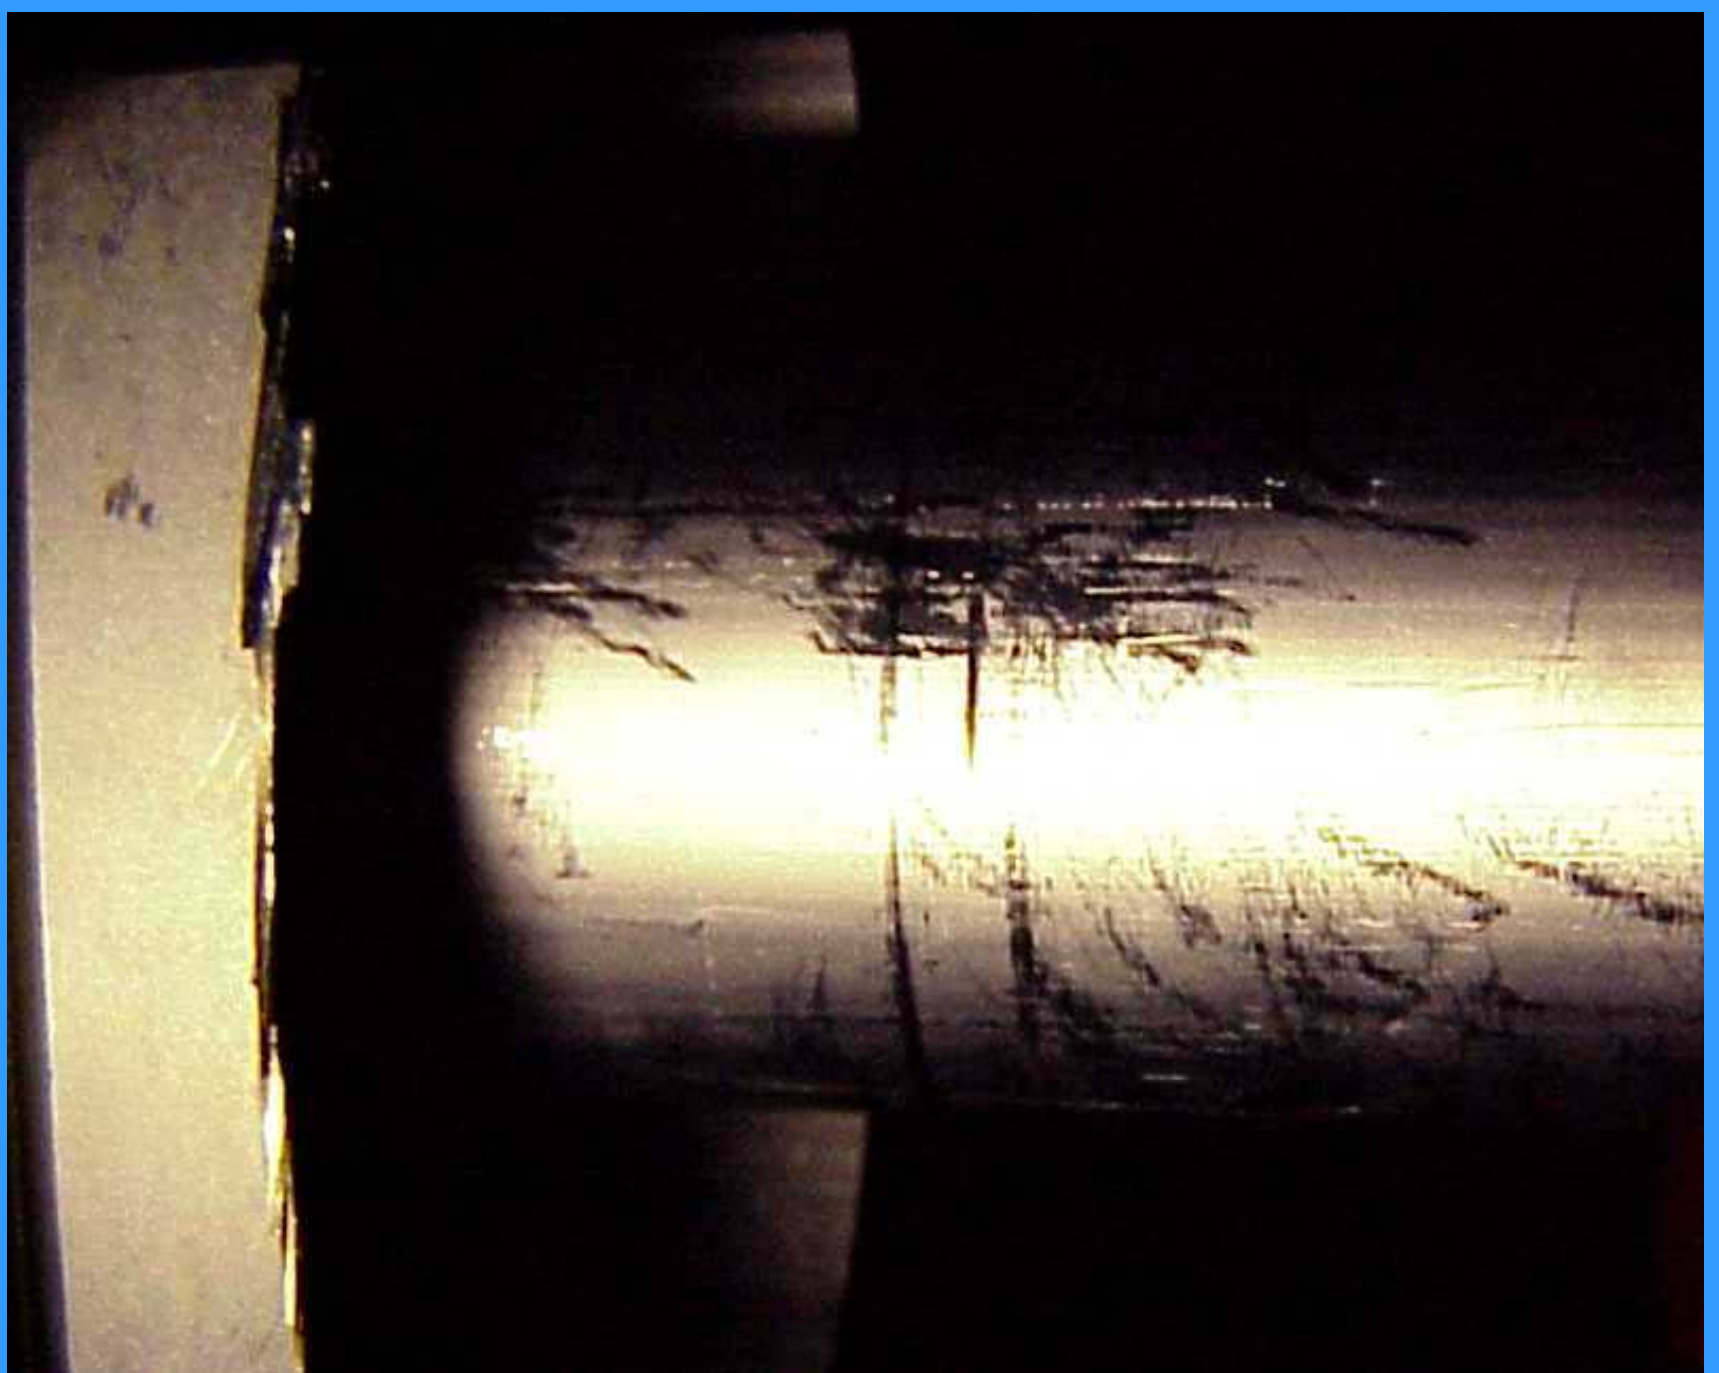
SF6 INSULATOR
WITH CENTER CONDUCTOR

- **Insulator failures (8 total) attributed to:**
 - **Aluminum particle contamination, resulting in partial discharges and SF₆ breakdown (1 failure).**
 - **Loss of spring contact at the conductor surface resulting in a floating component (4 failures).**
 - **Voids between epoxy coating and the aluminum insert (2 failures).**
 - **Indeterminate (1 failure).**
- **Air bushing failures (2 total) attributed to:**
 - **Excessive mechanical loading from cable contraction during cold conditions.**
 - **Excessive mechanical loading from cable sway during wind conditions.**

- **Bus duct modifications, Zones 2 and 4 – replace with new Westinghouse/ABB design.**
 - Implemented in 1992 for Zone 2.
 - Implemented in 1997 for Zone 4.
 - Cost: \$1.9 million.
- **Porcelain air bushing replacement with epoxy composite bushings.**
 - Replacement implemented in 1993, but not before two additional failures occurred in 1991 and 1992.
 - Cost: \$900,000 for 9 composite bushings.
- **Establish an on-site facility for repair of SF₆ bus duct sections and power circuit breakers.**
 - Implemented in 1992.
 - Cost: \$430,000.
