City of Colorado Springs Phase I MS4 Inspection Report
Colorado Discharge Permit System, Permit # COS000004

Inspection Dates: August 18, 2015–August 19, 2015

Prepared by
PG Environmental, LLC

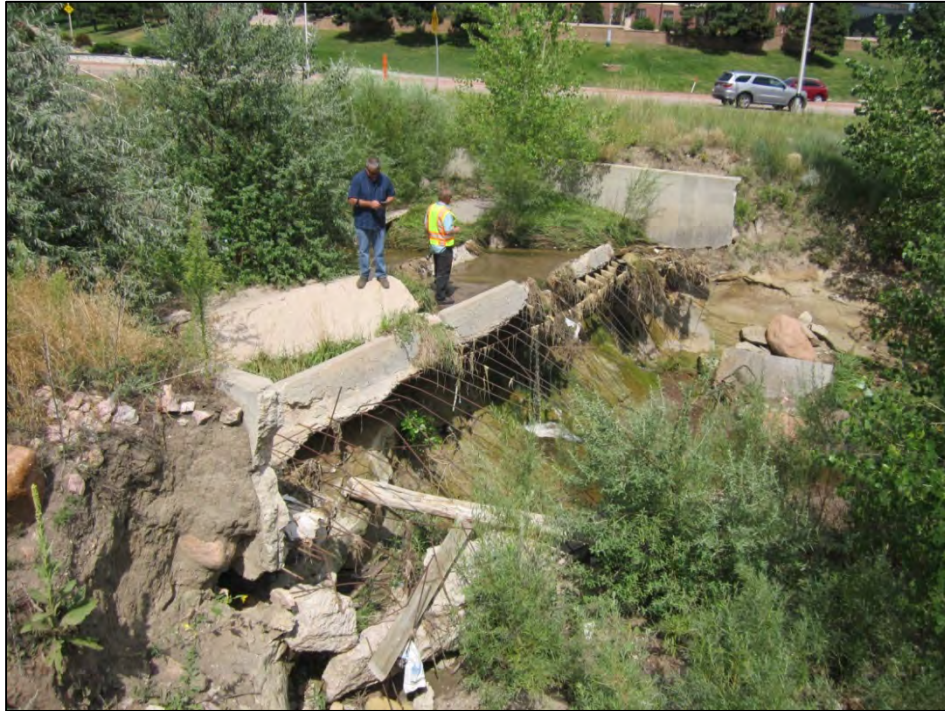
View of significant erosion and scouring of N. Douglas Creek downstream of I-25 box culvert outlet. The vertical dirt embankment was estimated to be approximately a 40 feet high. Portions of the concrete box culvert were present in N. Douglas Creek below the area of this photograph. Also, note that the Creek bed would have been approximately even with the base of the culvert at the time the culvert was constructed and at the time of the 2015 Inspection it appears to be almost 6 feet lower. In addition there is significant undercutting beneath the base of the culvert.

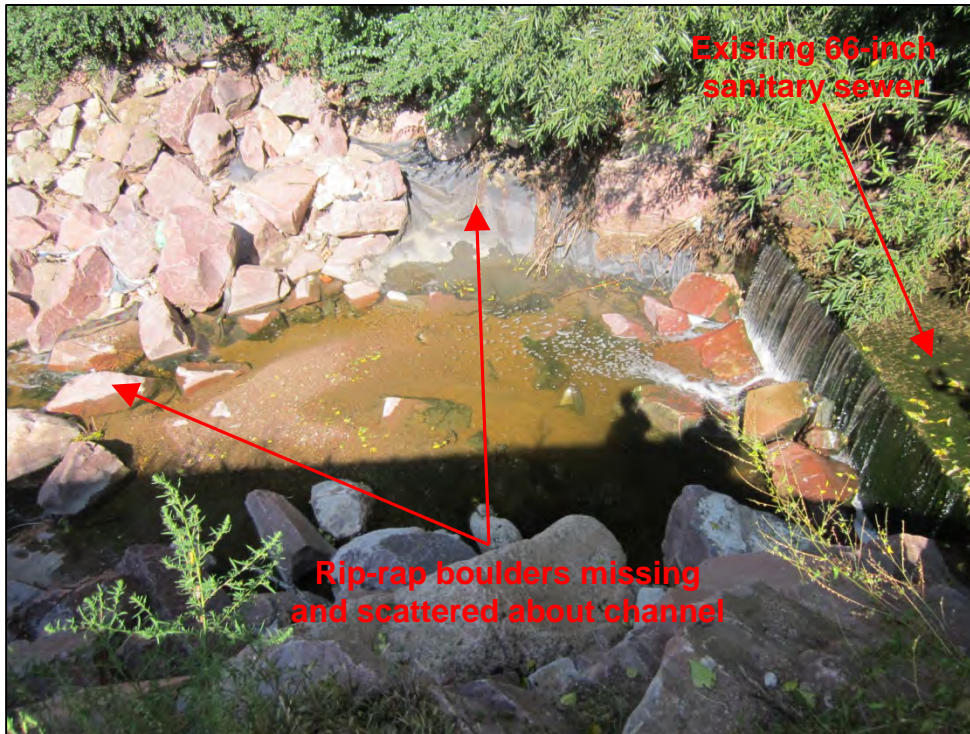
Photograph 1. View of unmaintained rip-rap boulders and channel lining on Shooks Run near the confluence with Fountain Creek.

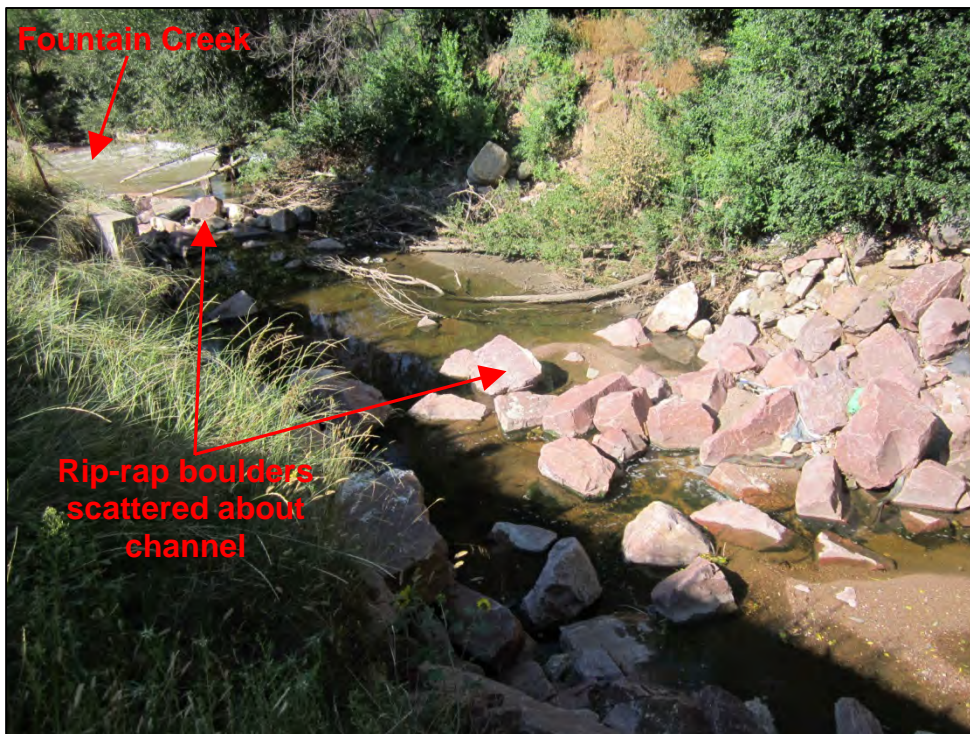
Photograph 2. View of rip-rap boulders and debris scattered throughout the Shooks Run channel near the confluence with Fountain Creek.

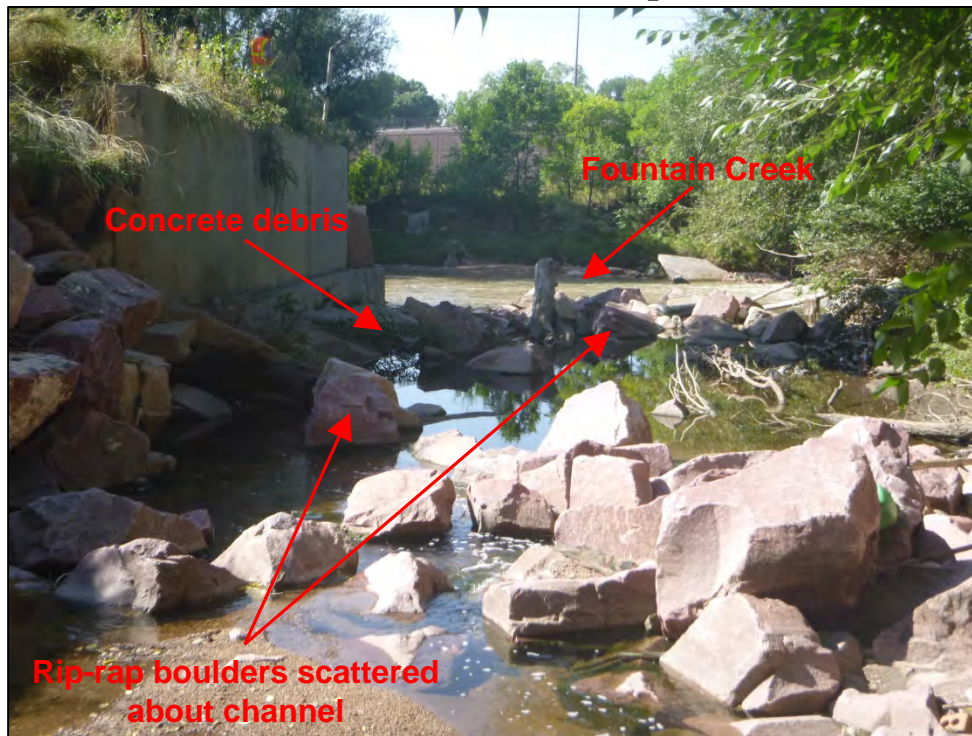
Photograph 3. View of rip-rap boulders scattered throughout Shooks Run channel near confluence with Fountain Creek. Also note the concrete retaining wall debris located in Shooks Run.

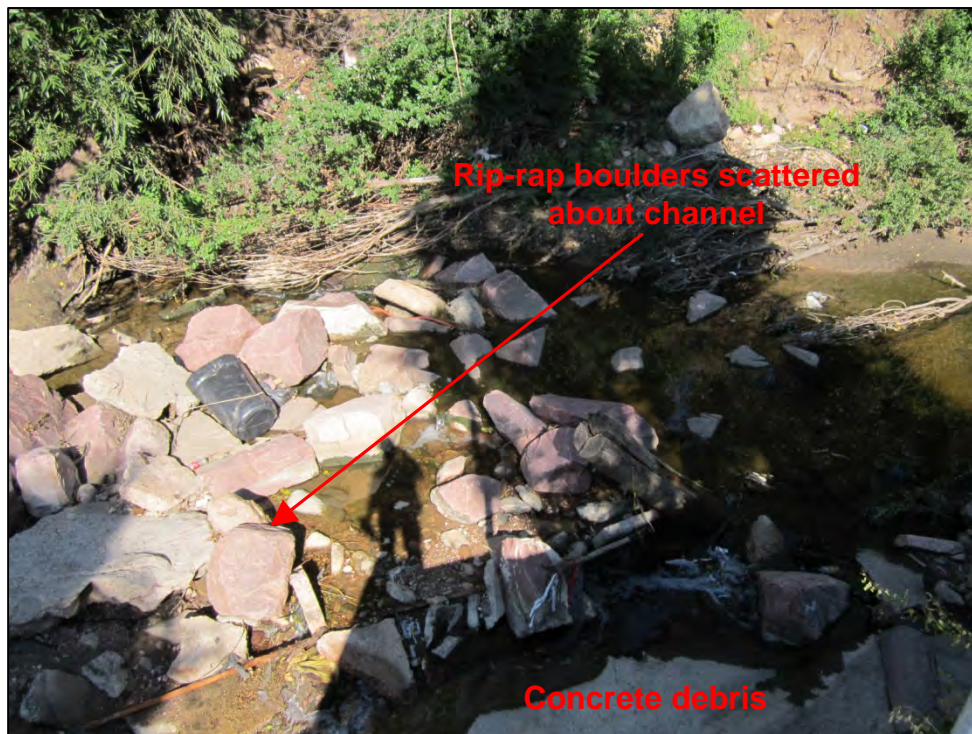
Photograph 4. Close-up view of the rip-rap boulders, concrete debris, and waste scattered throughout the Shooks Run channel near the confluence with Fountain Creek, shown in Photographs 2 and 3 above.

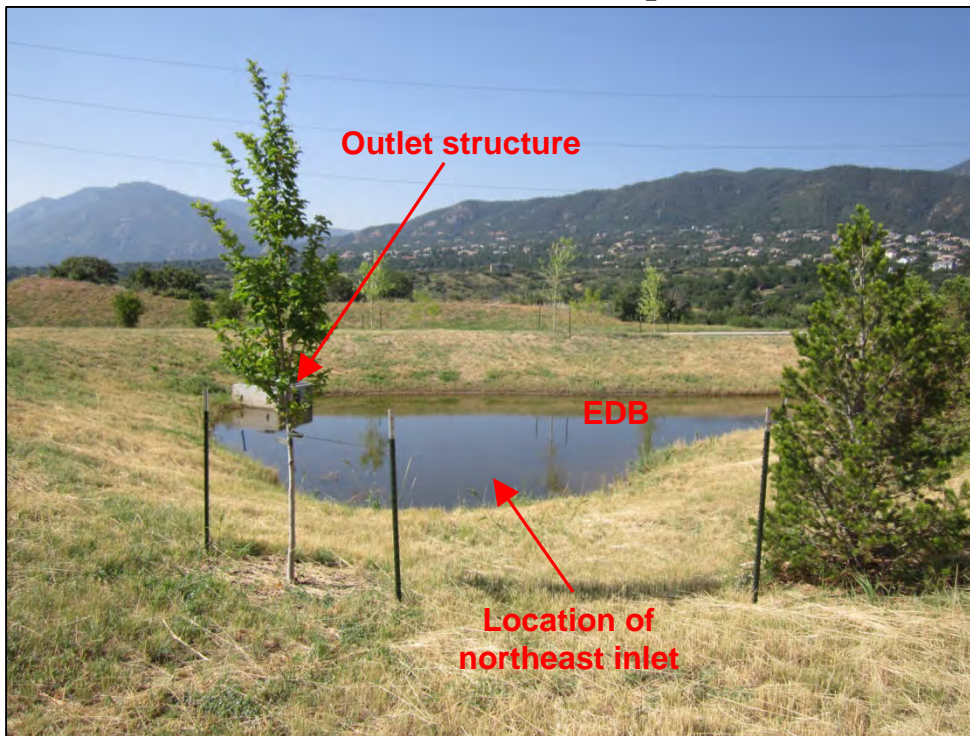
Photograph 5. View of ID-158 Morning Star at Bear Creek EDB and associated outlet structure and northeast inlet. Note the standing water within the EDB during dry weather. The drain time for WQCV did not appear to be in accordance with specifications and details.

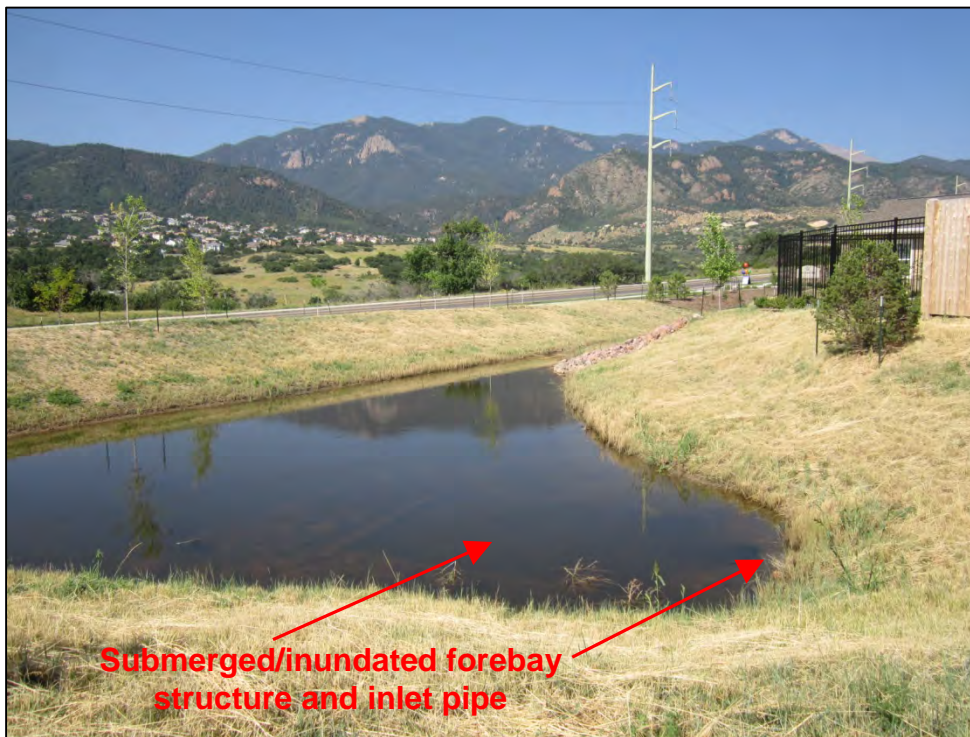
Photograph 6. View of EDB submerged/inundated northeast inlet forebay structure.

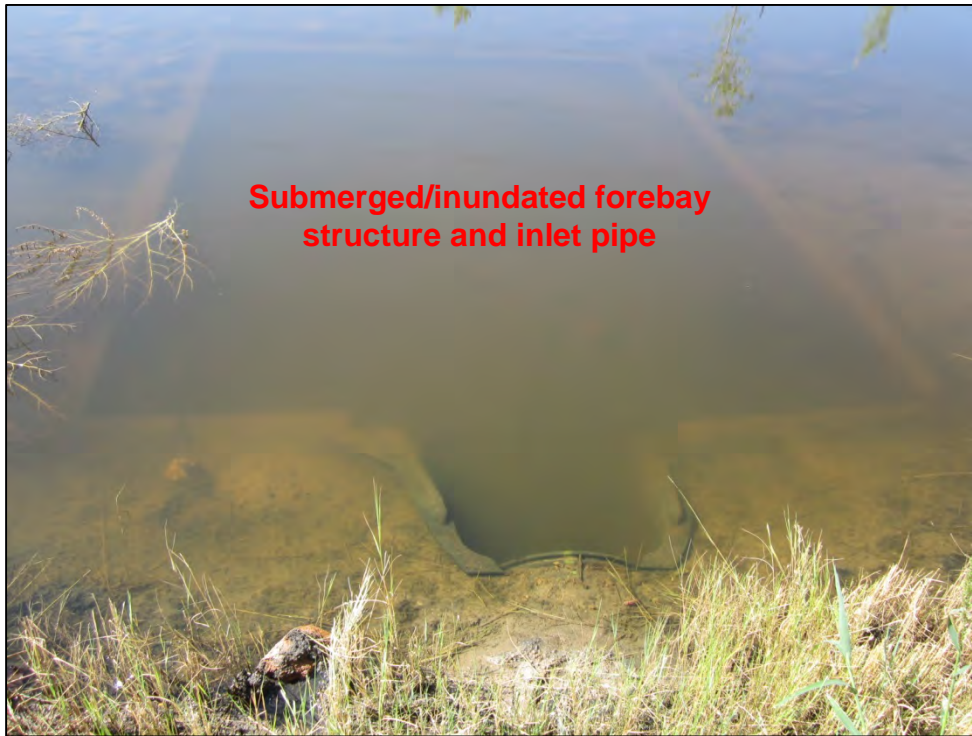
Photograph 7. Close-up view of the EDB submerged/inundated northeast inlet pipe and forebay structure, shown in Photographs 5 and 6. Note that the elevation of this inlet pipe and forebay was approximately one foot lower than the EDB outfall pipe.

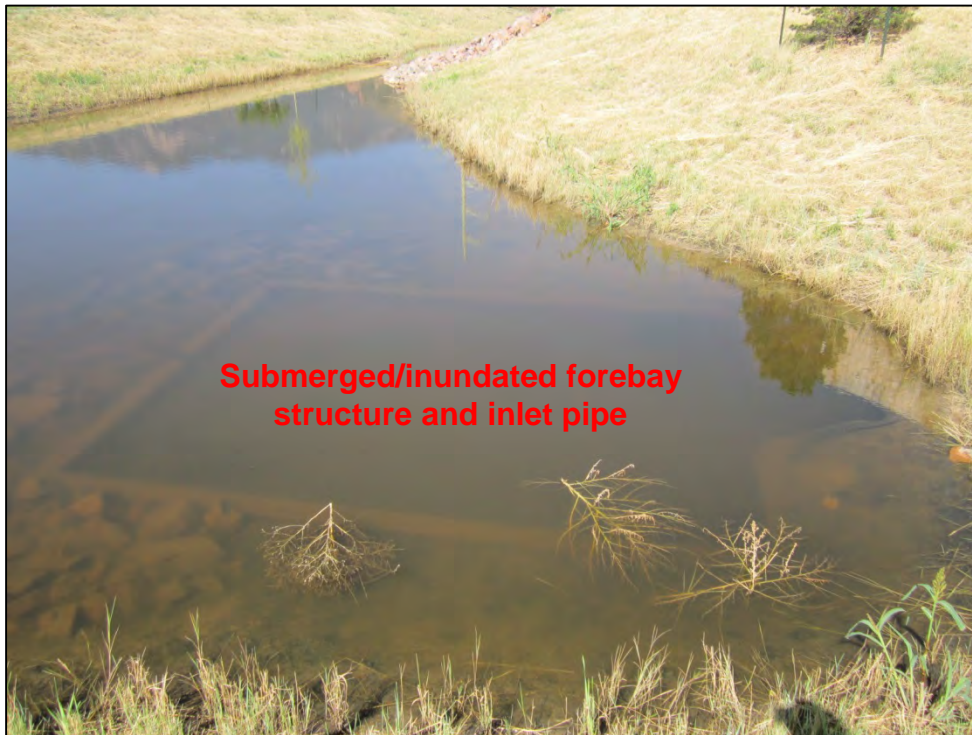
Photograph 8. Additional close-up view of the submerged/inundated northeast inlet pipe and forebay structure, shown in Photograph 7. Note the forebay design (i.e., energy dissipation and sediment removal) was impaired due to the elevations of these structures being approximately one foot lower than the outfall pipe invert.

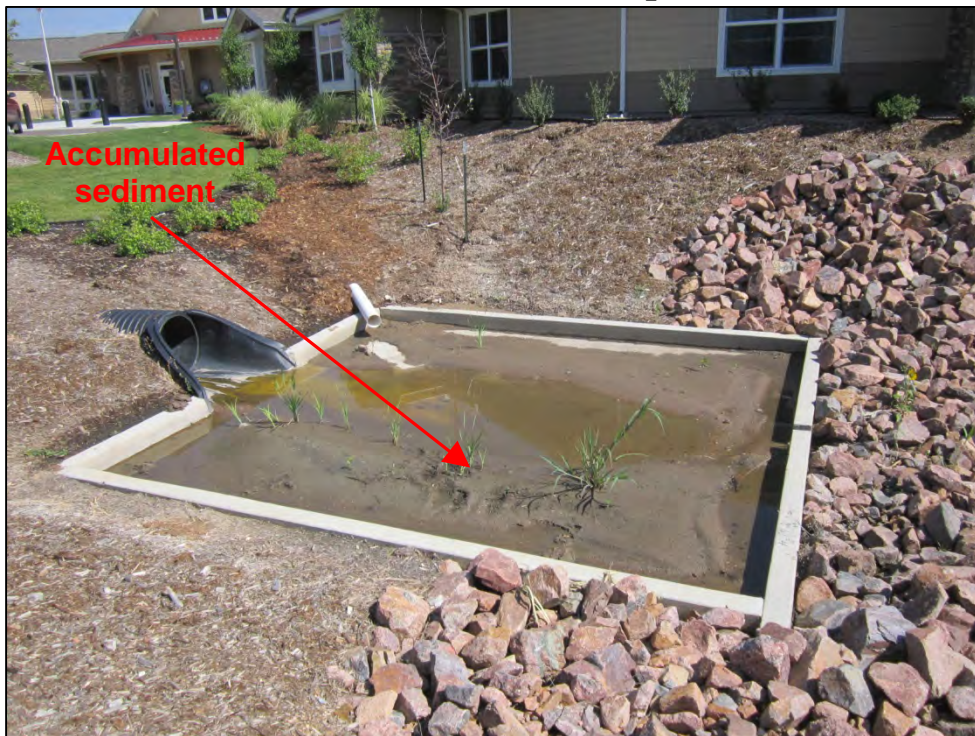
Photograph 9. View of accumulated sediment and debris in the western inlet forebay. Note that this did not appear to have been identified on City inspection reports. Also note that the western inlet forebay had not been adequately maintained.

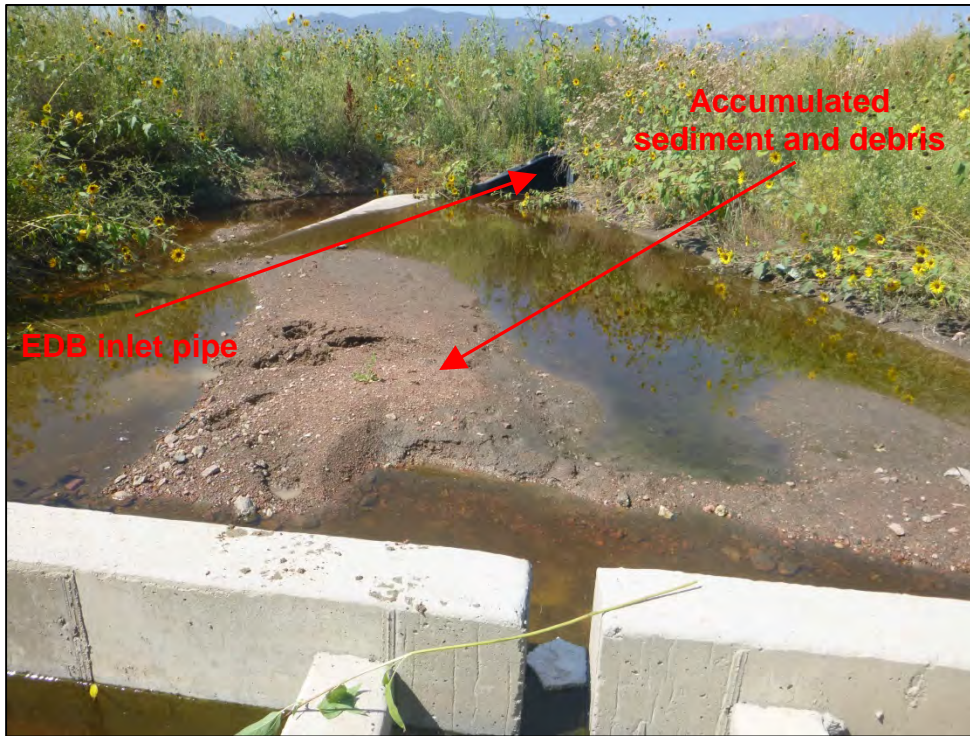
Photograph 11. View of ID-57 VA Hospital EDB inlet forebay with accumulated sediment and debris.

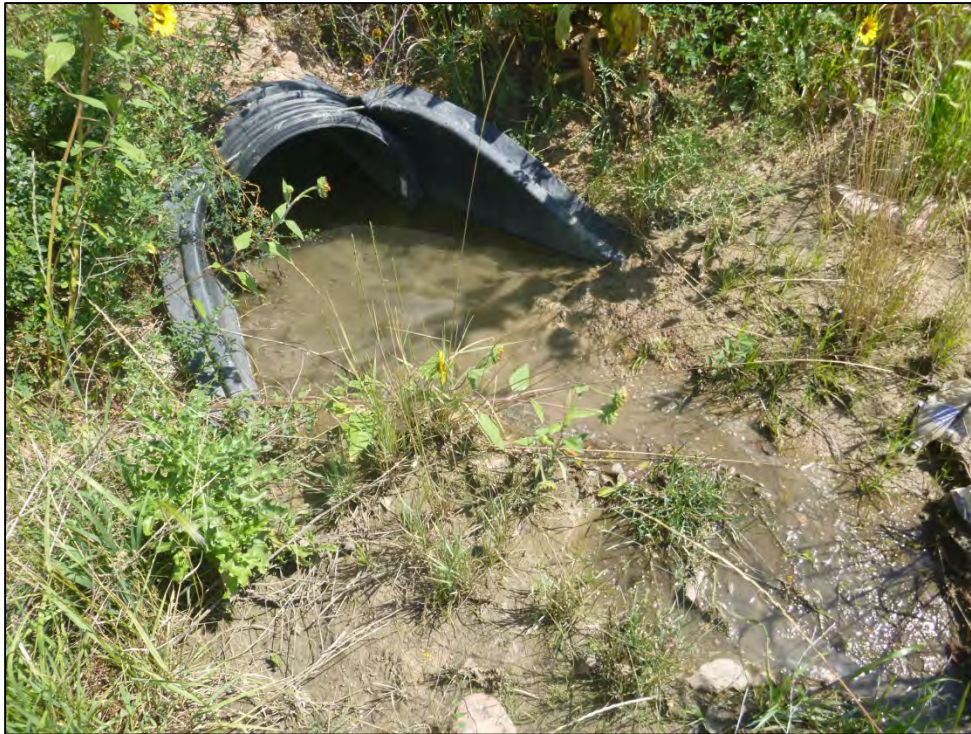
Photograph 12. View of accumulated sediment and vegetative growth at additional inlet pipe to the VA Hospital EDB.

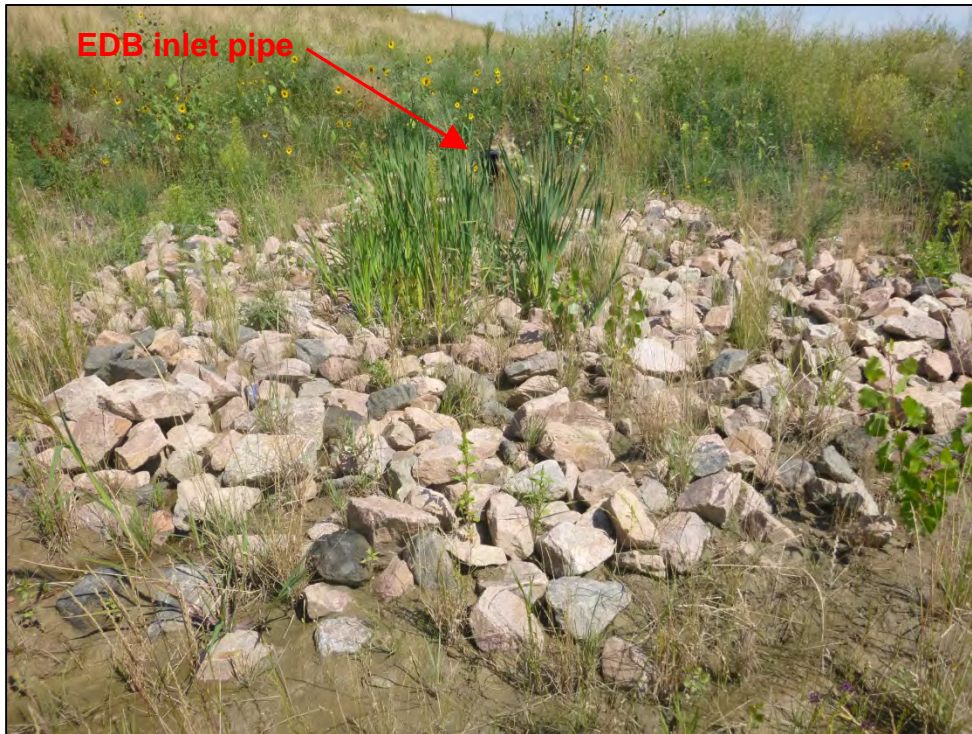
Photograph 13. View of vegetative growth in flow dissipation (rip-rap) device downgradient of the inlet pipe, shown in Photograph 12.

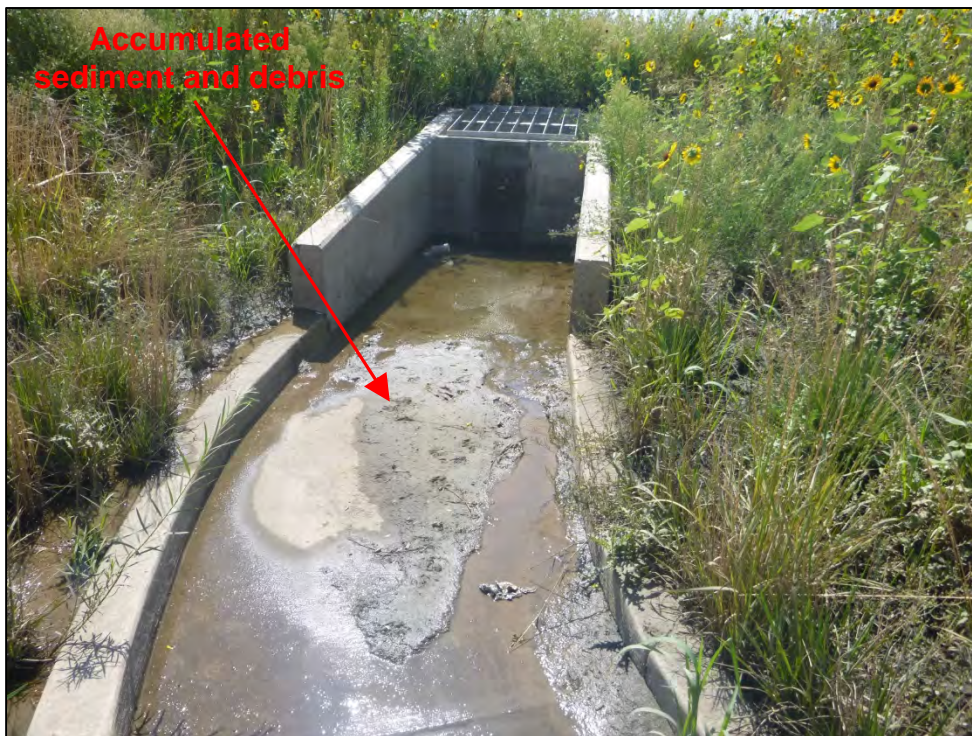
Photograph 14. View of accumulated sediment and debris within the trickle channel and micropool adjacent to the outlet structure. Also note the dense vegetative growth adjacent to the EDB outlet structure.

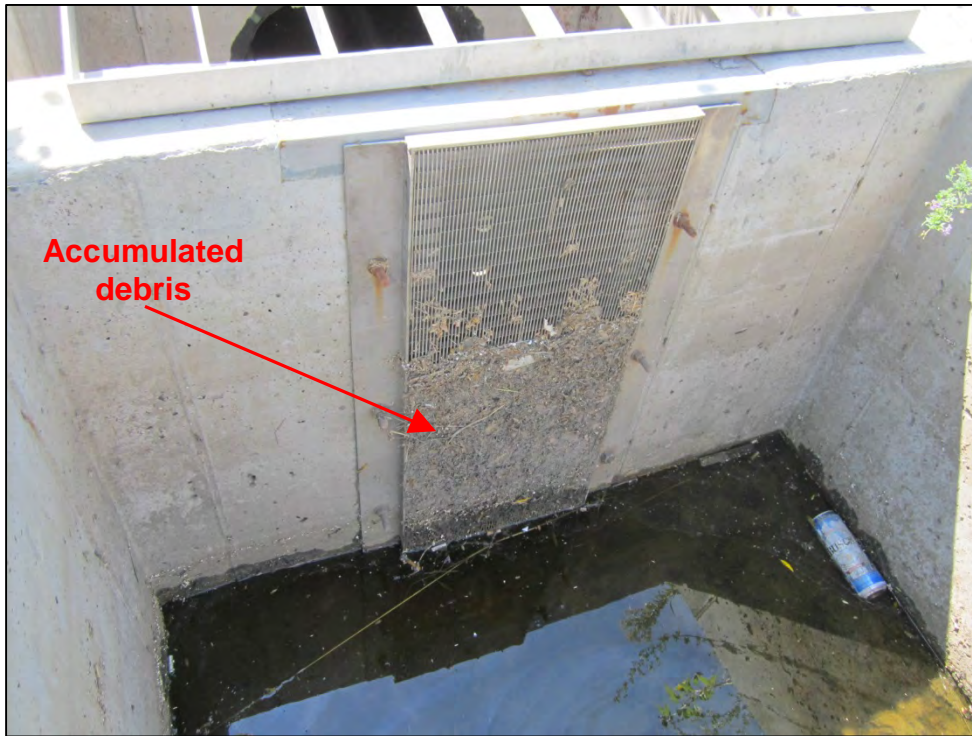
Photograph 15. Close-up view of accumulated debris on the outlet structure screen orifice plate.

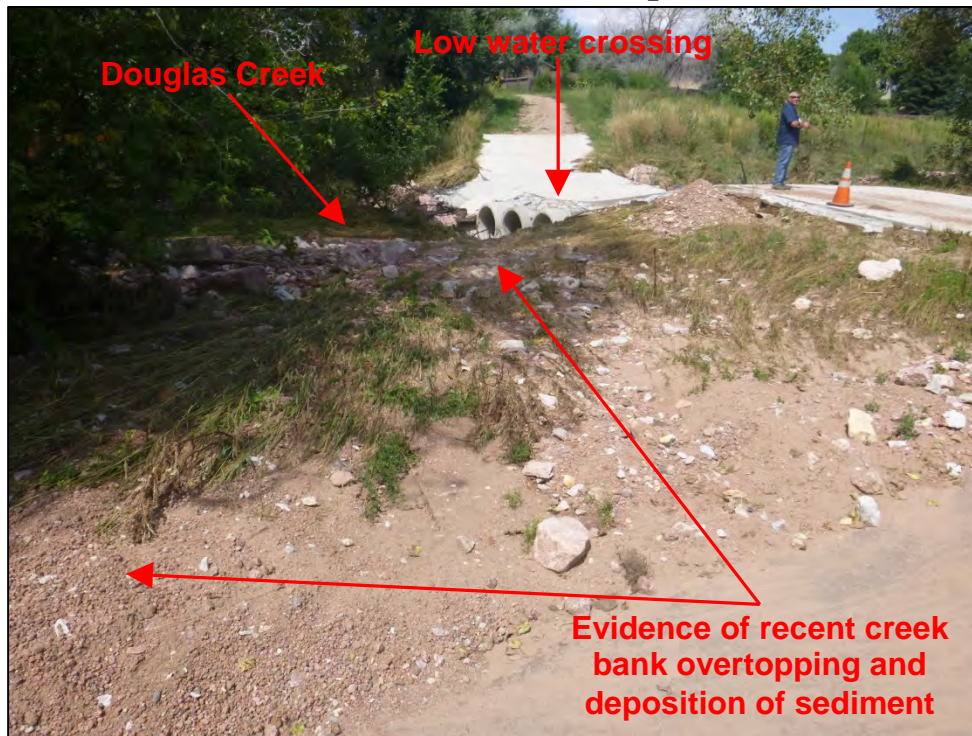
Photograph 19. View of recent evidence of creek bank and culvert pipe overtopping with deposition of sediment.

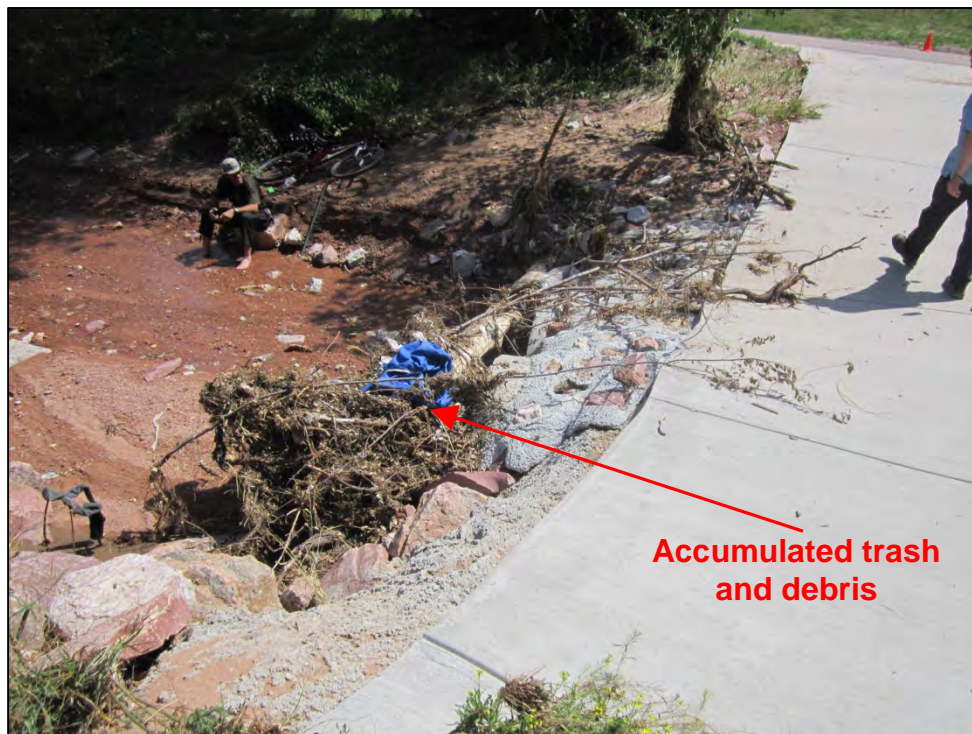
Photograph 20. Close-up view of accumulated trash and debris at culvert pipe inlets on the upstream side of the Douglas Creek low water crossing.

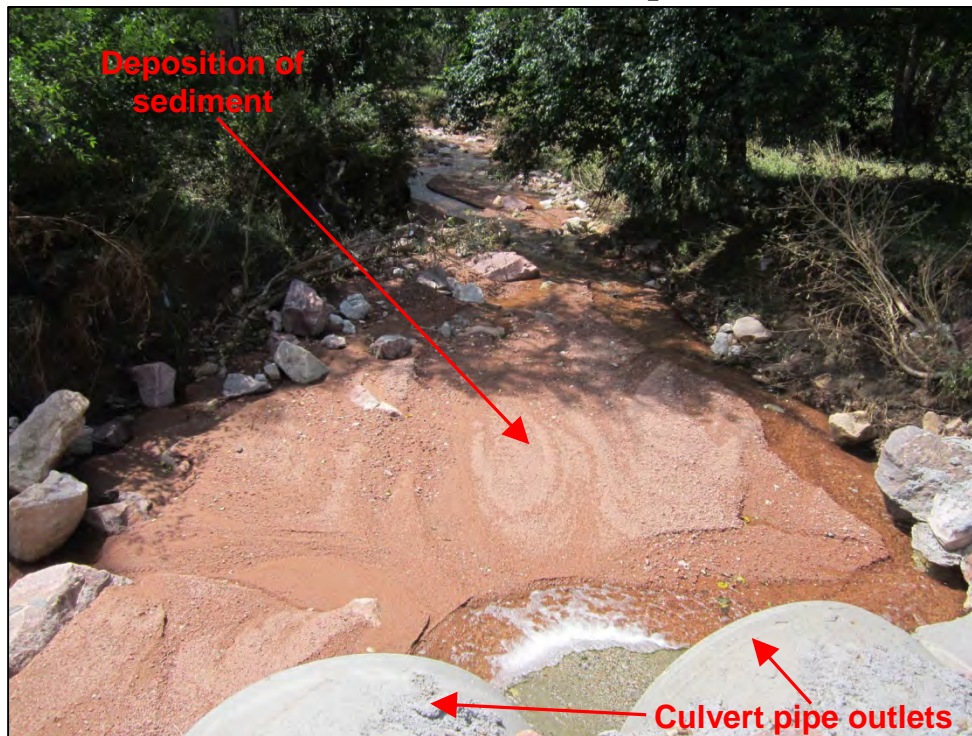
Photograph 21. View facing downstream of Douglas Creek low water crossing. Note the deposition of sediment within the Douglas Creek channel downstream of the low water crossing culvert pipe outlets.

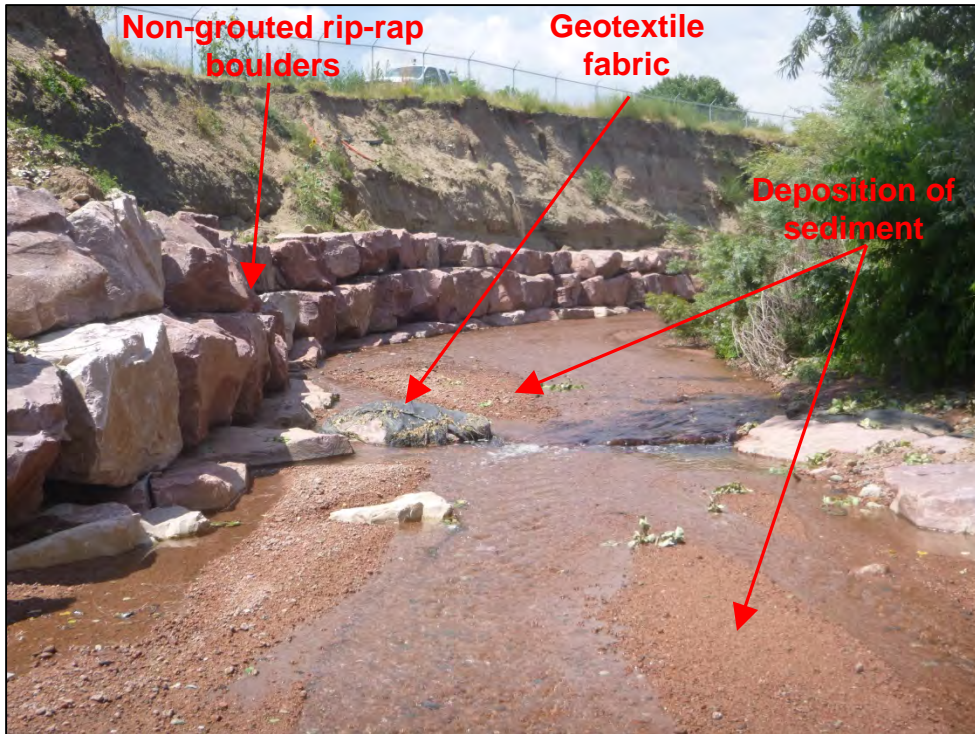
Photograph 26. View, facing upstream, of CS – 017 Location No. 1 N. Douglas Creek bank stabilization project. Note the non-grouted rip-rap boulders utilized for bank stabilization, deposition of sediment within the channel, and geotextile fabric.

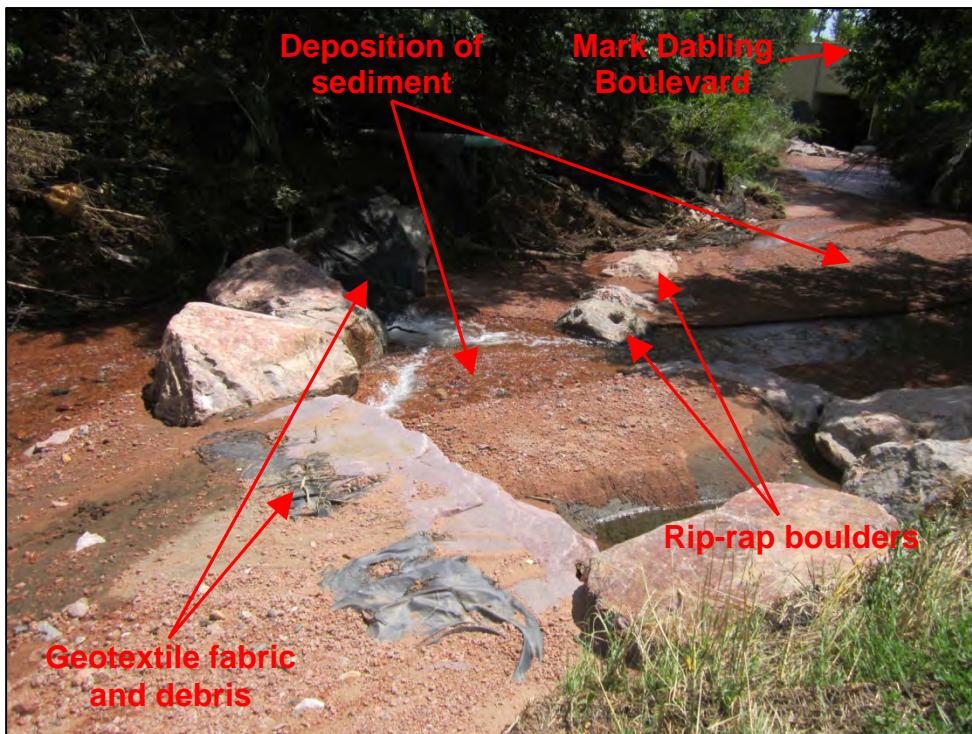
Photograph 30. View, facing downstream, of Douglas Creek. Note the geotextile fabric, debris, and rip-rap boulders scattered about the channel. Also note the deposition of sediment in the channel.

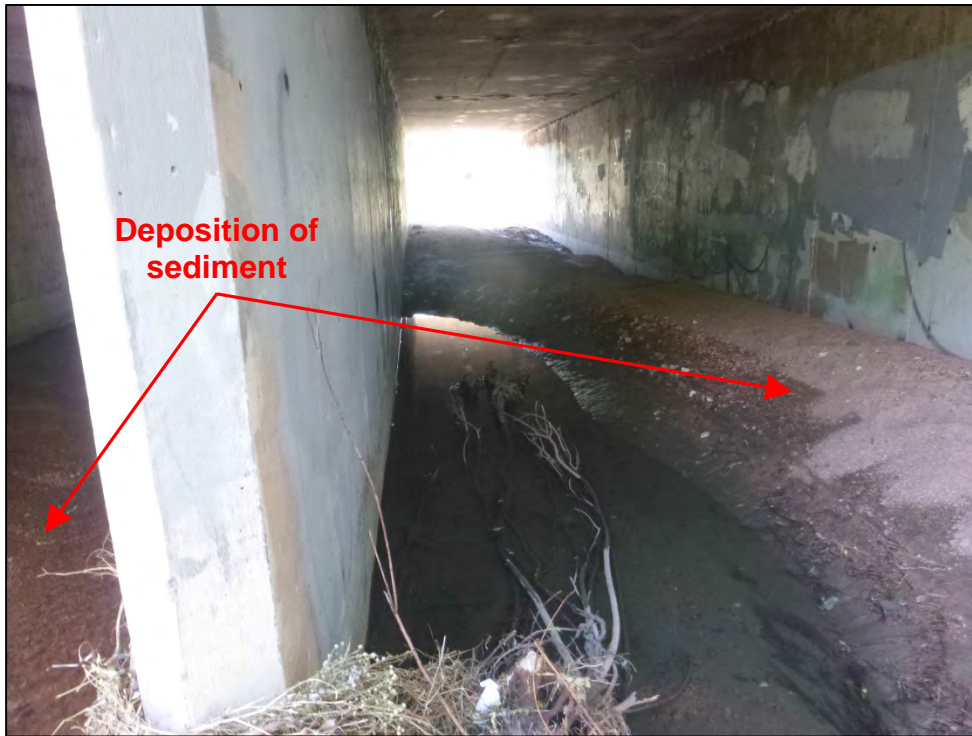
Photograph 31. Close-up view of significant deposition of sediment in the box culvert under Mark Dabling Boulevard on N. Douglas Creek.

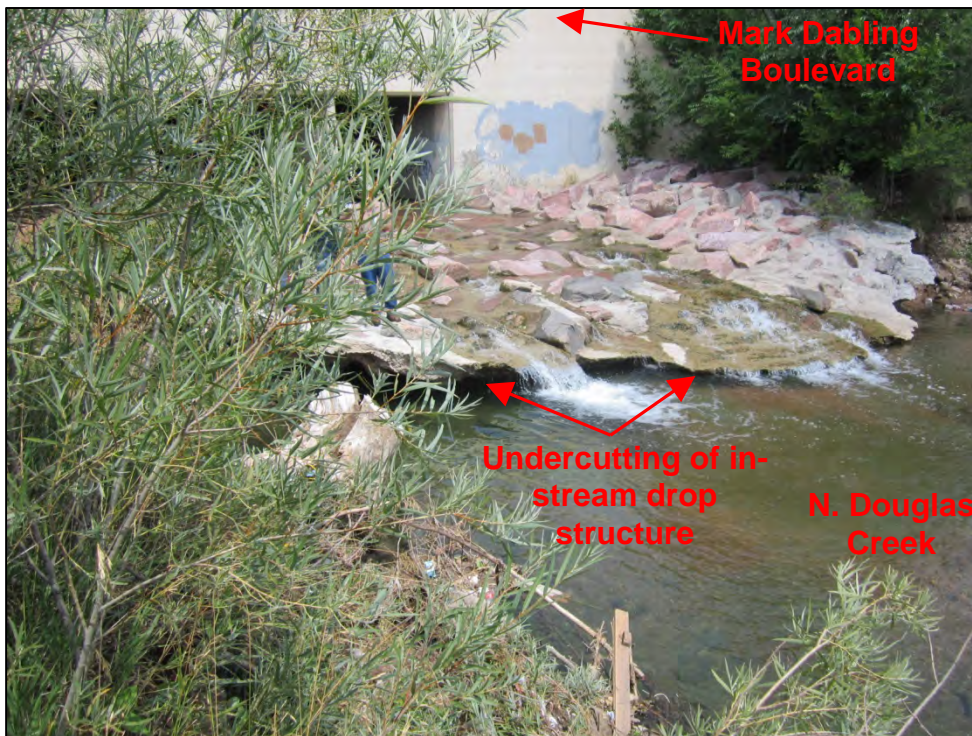
Photograph 32. View of unmaintained in-stream drop structure in N. Douglas Creek downstream of Mark Dabling Boulevard.

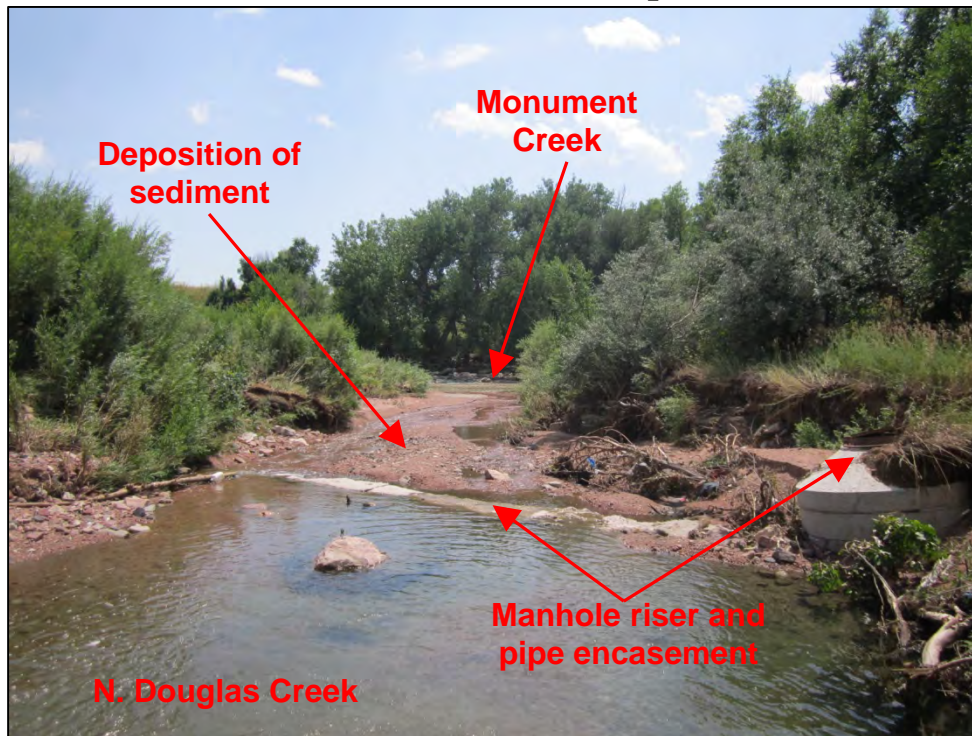
Photograph 33. View of abandoned wastewater manhole riser and pipe encasement downstream of Mark Dabling Boulevard near the confluence of N. Douglas Creek and Monument Creek. Also note the deposition of sediment near the confluence.

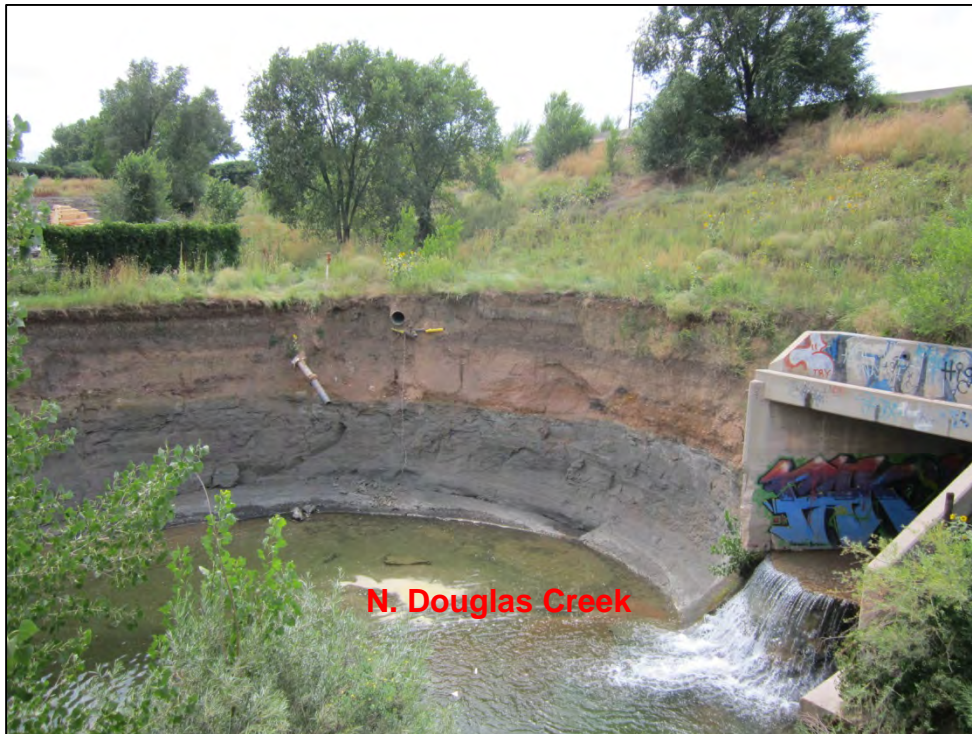
CS – 017 Location No. 2 box culvert is located along North Douglas Creek, immediately east of Interstate 25. At the time of the inspection, the EPA Inspection Team and City representatives accessed the location on foot. The box culvert, shown in Appendix B – MS4 Inspection Photograph Log, Photographs 35, 36, and 37, clearly exhibits the impact of long-standing neglect. Concrete wing walls from the box culvert, drainage infrastructure, and sediment were observed in North Douglas Creek immediately downstream of the degraded box culvert. A substantial area surrounding the box culvert had been severely eroded, resulting in significant sediment discharges to the creek. The discharge of these pollutants was adversely affecting the environment and also posed a public health concern as access to the site was not restricted or marked as a hazard. The following photograph shows some of the adverse effect on the environment and the potential for harm to human health.

Photograph 35. View of significant erosion and scouring of N. Douglas Creek downstream of I-25 box culvert outlet. The vertical embankment was estimated to be approximately 40 feet high. Portions of the concrete box culvert were present in N. Douglas Creek below the area of this photograph. Also, note that the creek bed would have been approximately even with the base of the culvert at the time the culvert was constructed and at the time of the 2015 Inspection it appears to be almost 6 feet lower. In addition, there was significant undercutting beneath the culvert.

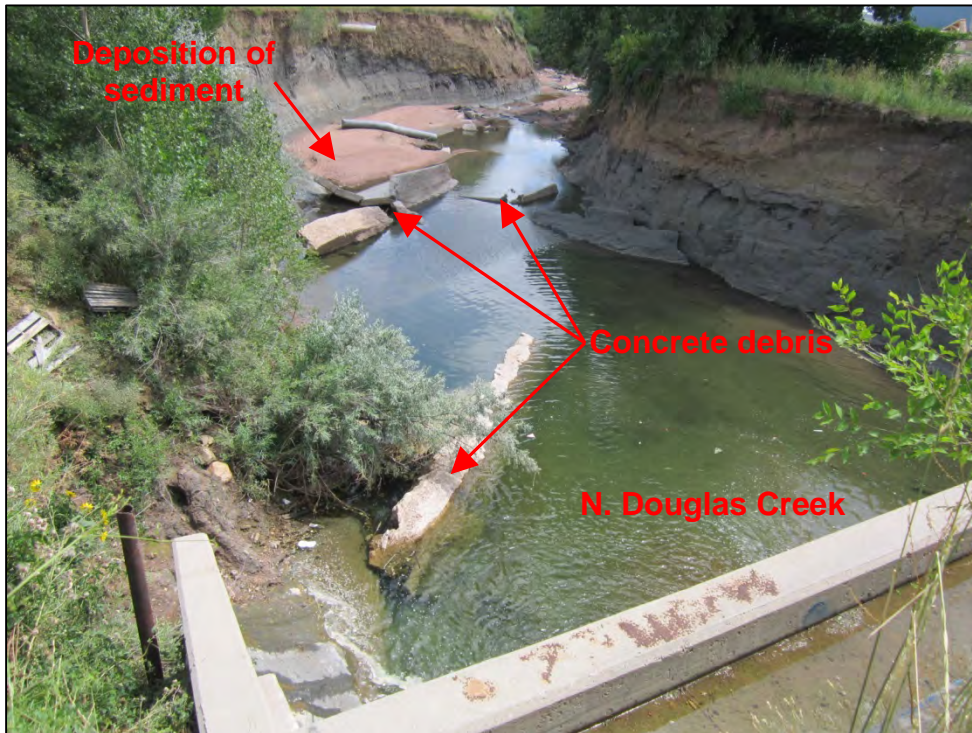
Photograph 36. Additional view of erosion and scouring, concrete debris, and deposition of sediment in the N. Douglas Creek channel downstream of the I-25 box culvert outlet.

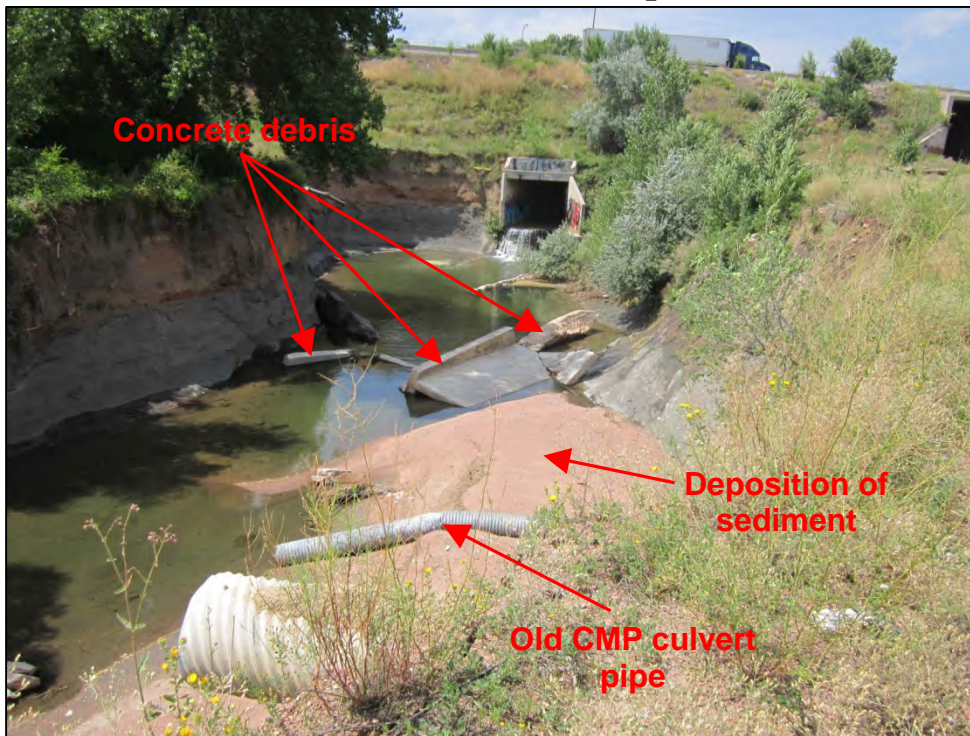
Photograph 37. Additional view, facing upstream, of erosion and scouring, concrete debris, old CMP culvert pipe, and deposition of sediment in the N. Douglas Creek channel.

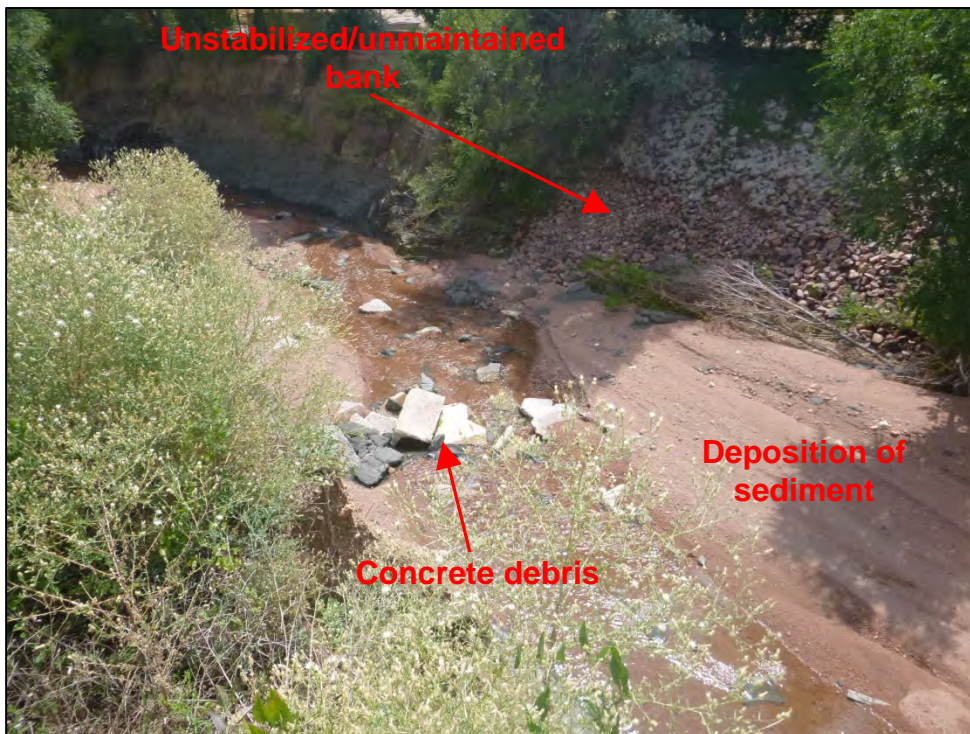
Photograph 38. View of concrete debris and deposition of sediment in N. Douglas Creek. Also note the unstabilized/unmaintained bank stabilization measure along N. Douglas Creek.

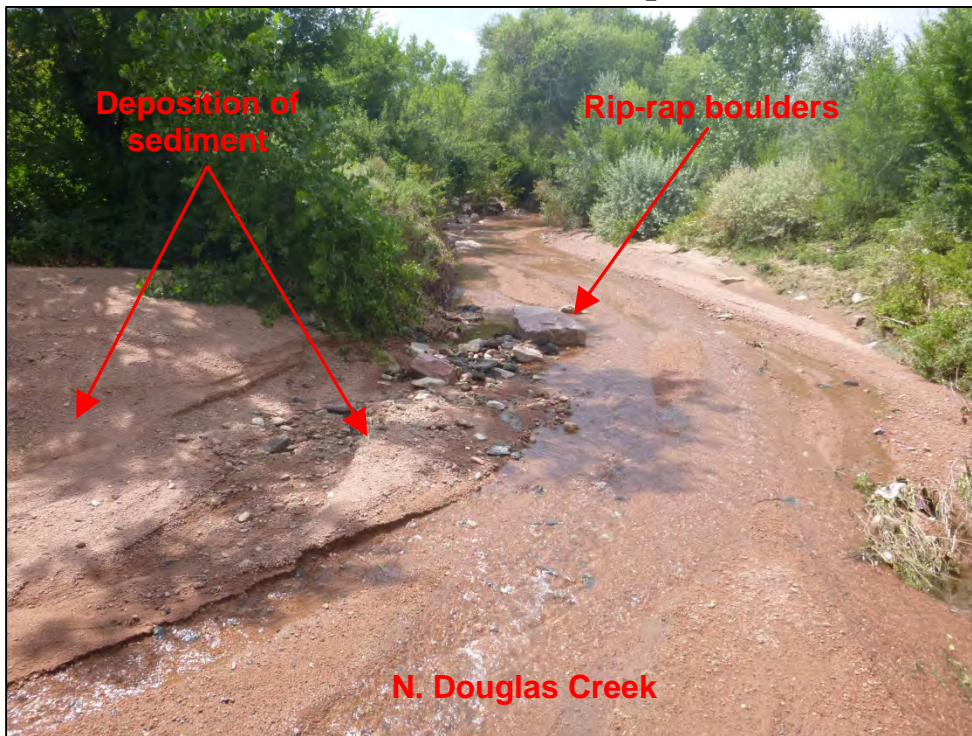
Photograph 39. View of deposition of sediment and rip-rap boulders in the N. Douglas Creek channel.

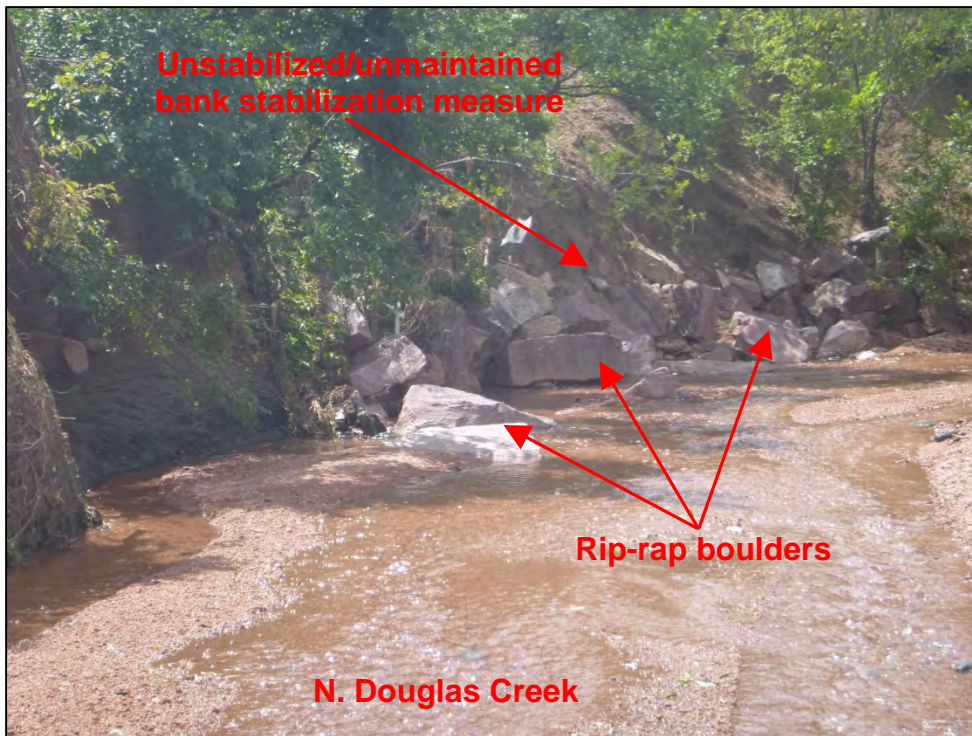
Photograph 40. View of unstabilized/unmaintained bank stabilization measure along N. Douglas Creek. Note the ungrouted rip-rap boulders scattered about the N. Douglas Creek channel.
