City of Colorado Springs Phase I MS4 Inspection Report
Colorado Discharge Permit System, Permit # COS000004

Inspection Dates: August 18, 2015–August 19, 2015

Prepared by
PG Environmental, LLC

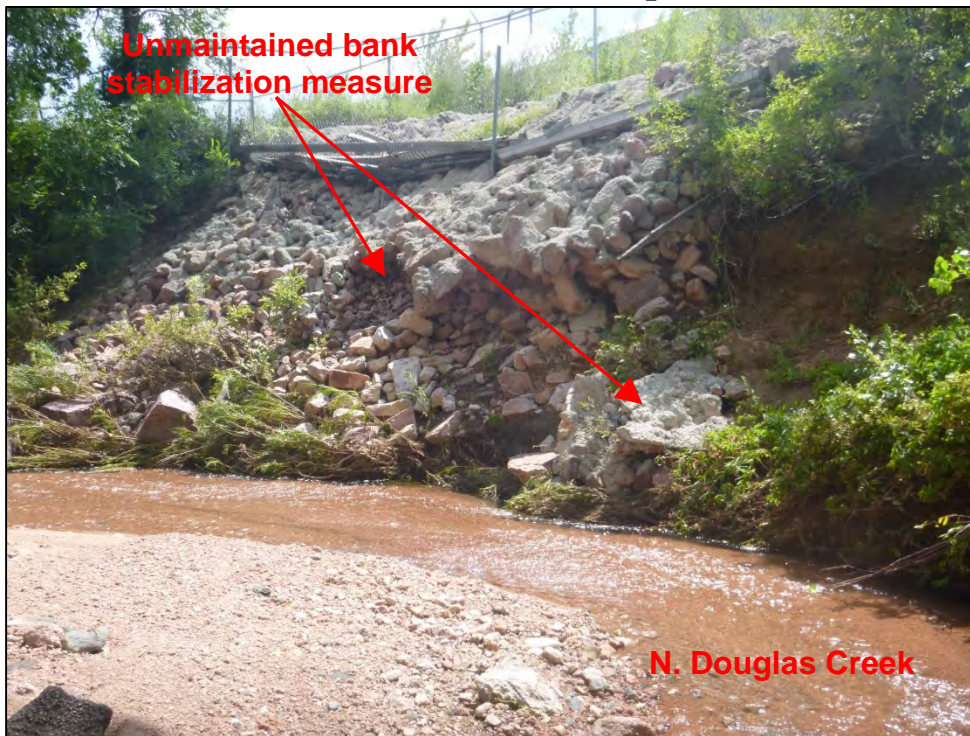
Photograph 41. View of unmaintained bank stabilization measure located just upstream of Norfolk Southern railroad bridge.

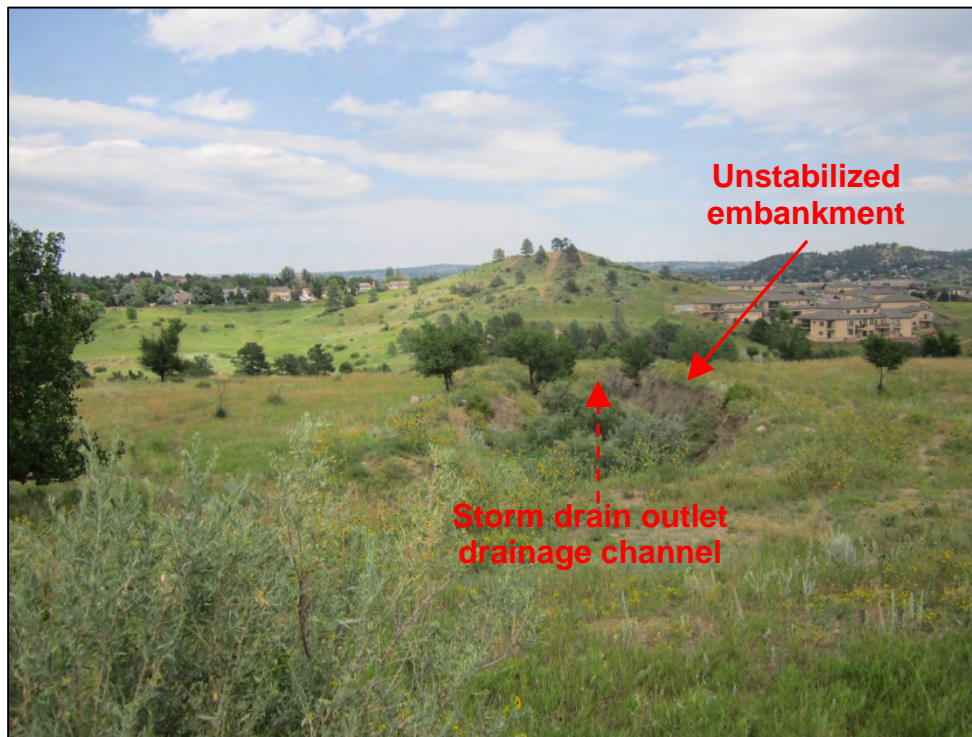
Photograph 44. View, facing downgradient, of the location of the storm drain outlet and drainage channel for the storm drain shown in Photograph 43. Note the erosion and unstabilized embankments of the drainage channel which subsequently drains to Rockrimmon Channel.

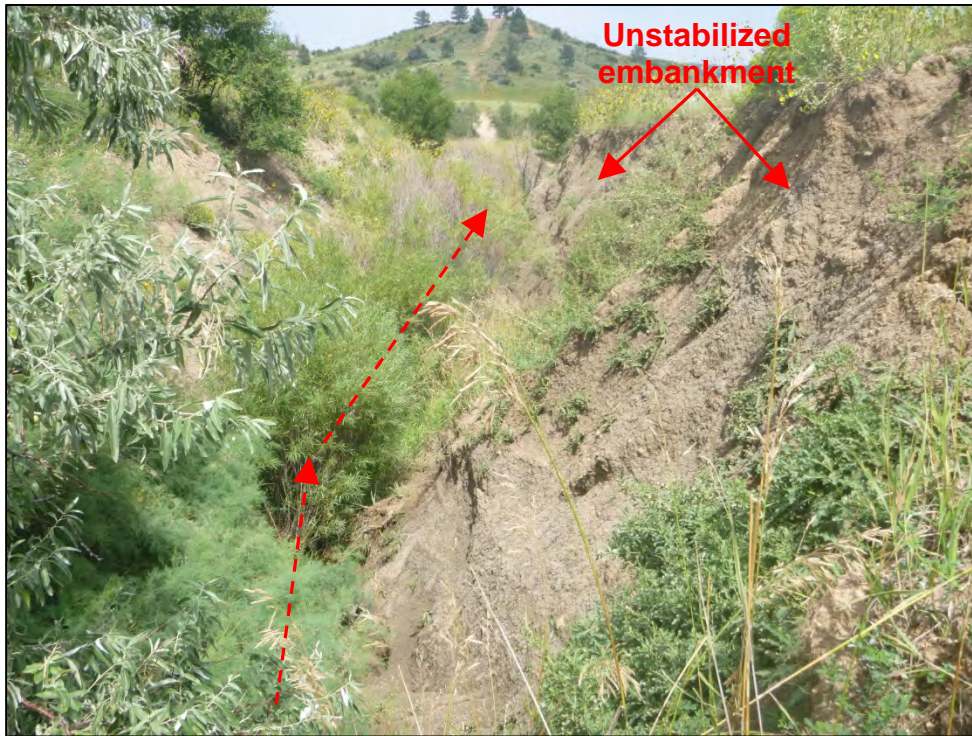
Photograph 45. Close-up view of the drainage channel and unstabilized embankment downgradient of the storm drain outlet for the storm drain shown in Photograph 43.

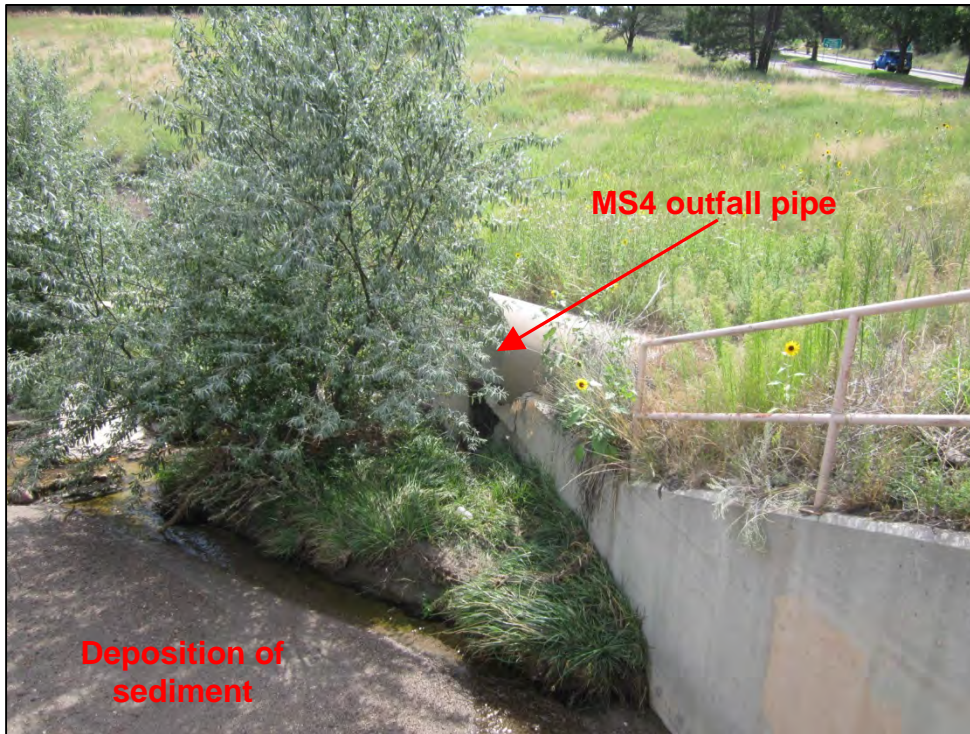
Photograph 53. View of the MS4 outfall pipe to Rockrimmon Channel near the intersection of Rockrimmon Boulevard and Pro Rodeo Drive. Note the deposition of sediment.

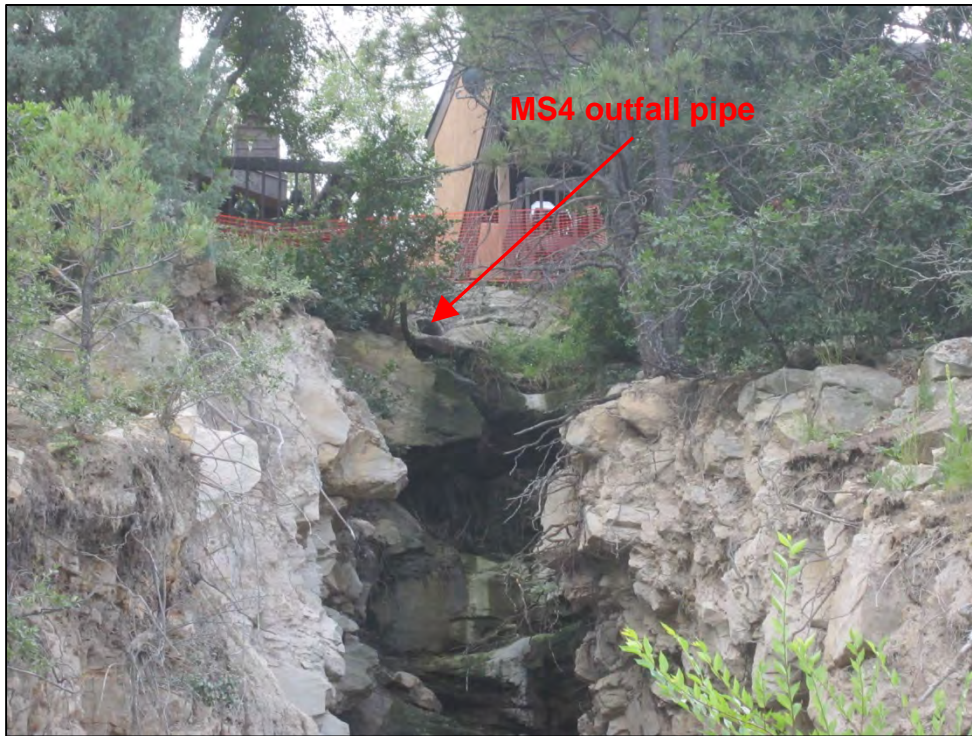
- Significant erosion and scouring and the formation of a large ravine adjacent to and downgradient of the City’s MS4 outfall for CS – 022.
- The photos CH2MHill included in their 2013 report for location CS – 060 showed accumulated trash and debris on the culvert pipe inlet trash rack. Additional accumulated sediment, trash, debris and vegetative growth was observed by the EPA Inspection Team at this location during the inspection. The Streets Department staff stated that they did not have any records of maintenance at this location; therefore, it appeared that the additional accumulated sediment, trash, debris, and vegetative growth observed at this location at the time of the inspection was due to a lack of maintenance at this site.

Photograph 59. Close-up view of the MS4 outfall pipe and ravine/cliff area adjacent to the outfall.

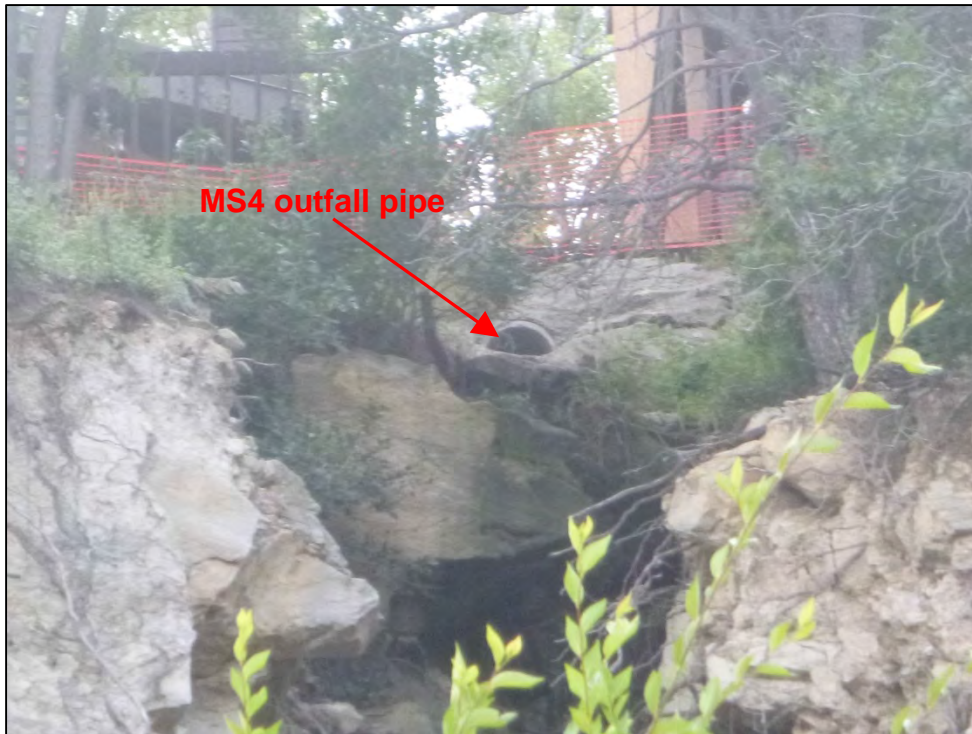
Photograph 60. Additional close-up view of the MS4 outfall pipe and ravine/cliff area adjacent to the outfall.

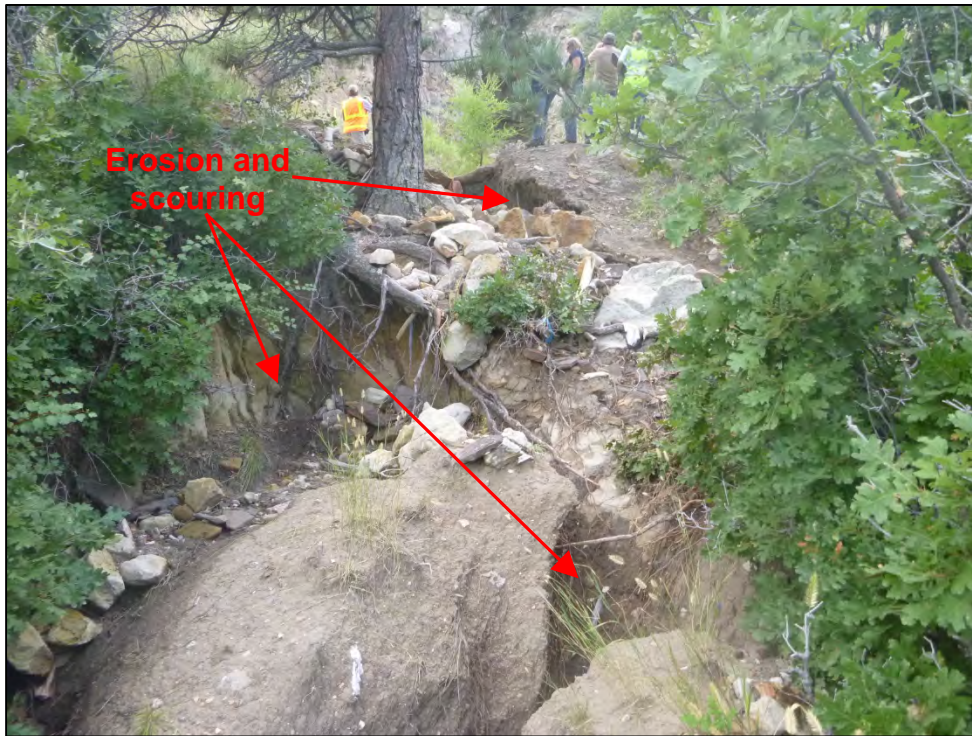
Photograph 61. View of erosion (e.g., gully formation) and scouring on private property located downgradient of MS4 outfall pipe, shown in Photograph 58.

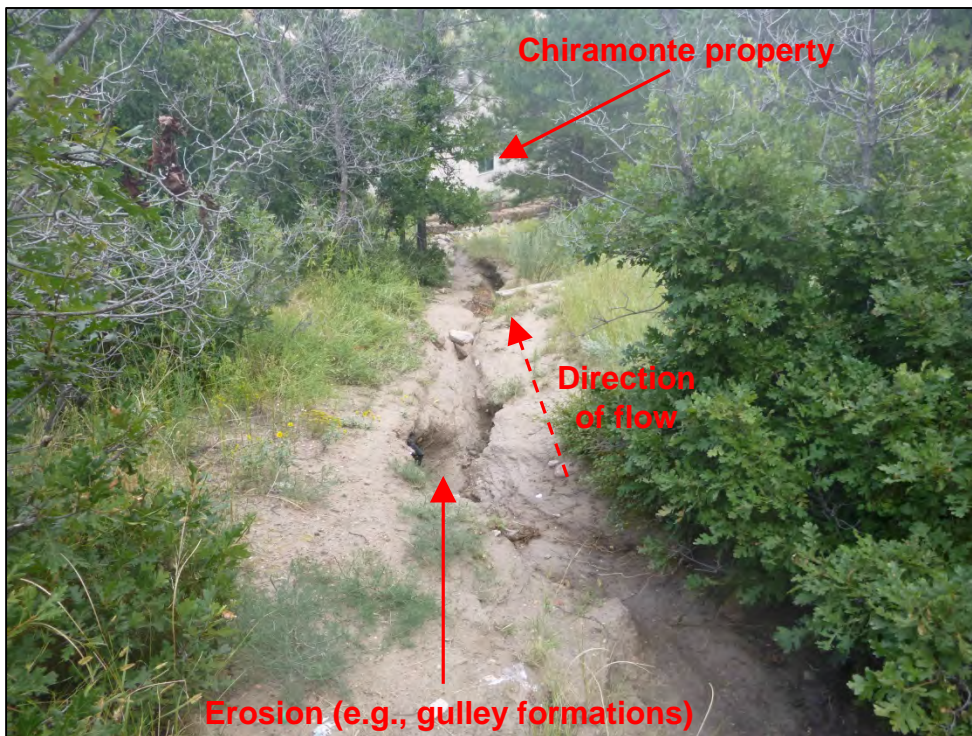
Photograph 62. Additional view of erosion (e.g., gully formations) on private property located downgradient of the MS4 outfall pipe. Note the location of the Chiramonte private property and residence located directly downstream of this drainage area.

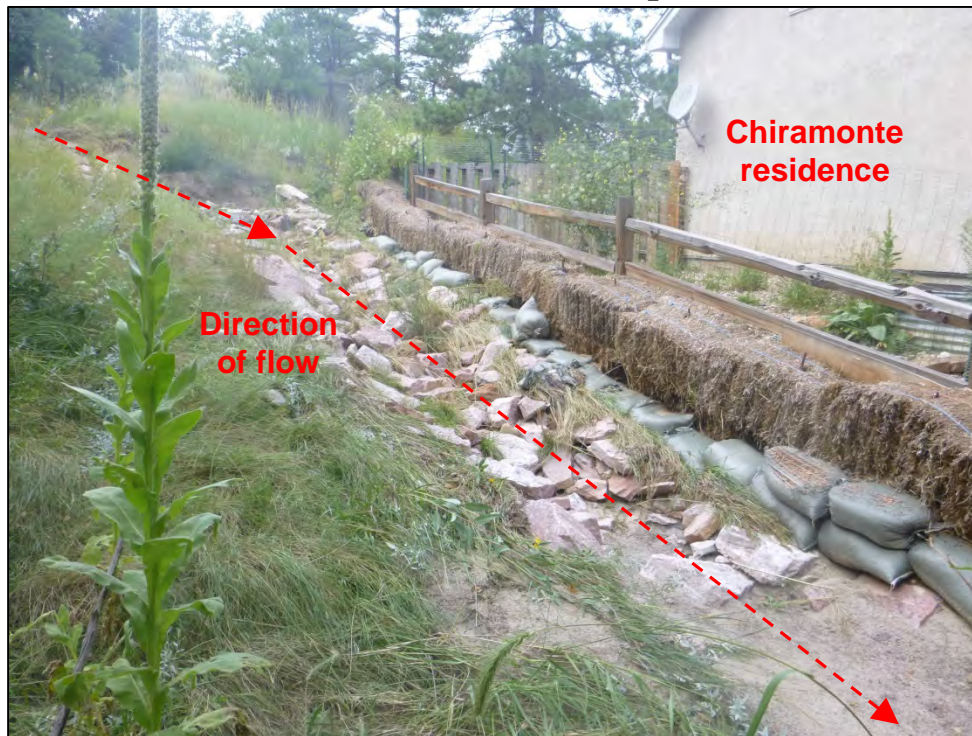
Photograph 63. View of evidence of previous stormwater runoff and erosion adjacent to the Chiramonte private property. Note the City had implemented straw bales and sand bag BMPs along the property boundary.

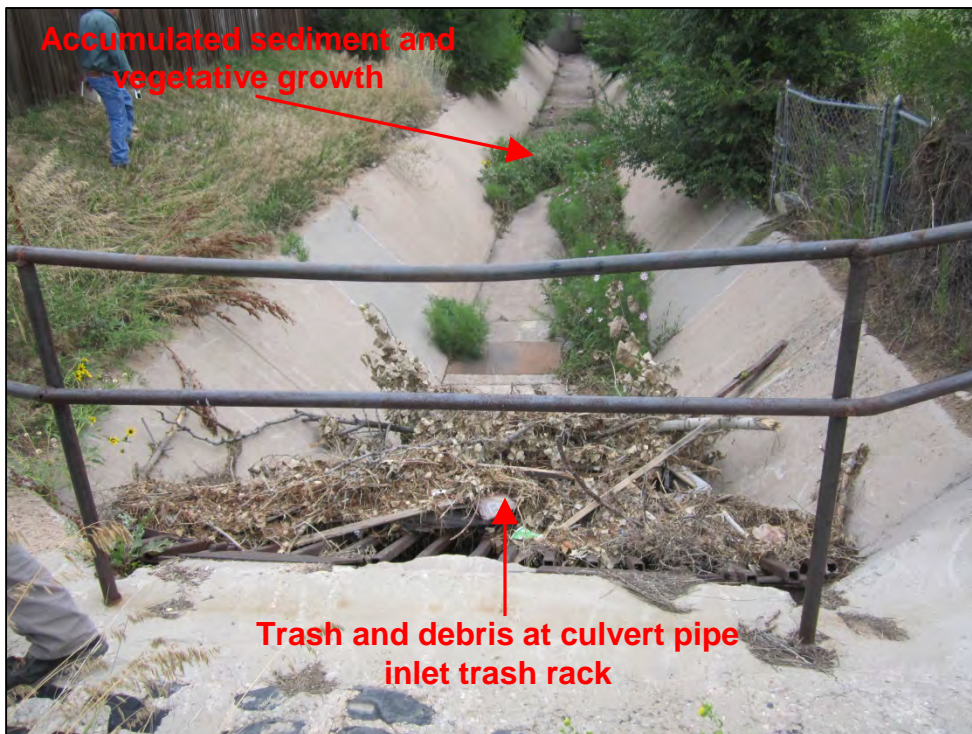
EPA Inspection Date	ID or Functional Location	Feature Description	EPA Findings	Photos	Exhibits
			Refer to Appendix B, Photograph Log, for supporting photo documentation and Appendix C, Exhibit Log, for supporting documentation.		
08/19/2015	CS – 060 Hancock Expressway Drainage	Peterson Field drainage channel and culvert	<p>The EPA Inspection Team observed, at the time of the inspection, the Peterson Field concrete lined conveyance channel and culvert pipe beneath the Hancock Expressway near Clarendon Drive that did not appear to be properly installed and maintained. Specifically, the culvert pipe beneath Hancock Expressway did not appear to be installed at the proper grade to convey flow as standing water was observed within the culvert pipe during dry weather. Trash, debris, unmaintained/deteriorated concrete lining, and accumulated sediment was observed within the concrete lined conveyance channel and on the trash rack at the culvert pipe inlet beneath Hancock Expressway. It should be noted that the 2013 CH2MHill Report previously identified the culvert pipe installation issue and accumulated trash and debris at the culvert pipe inlet trash rack; however, these items had not been addressed in the field at the time of the inspection. Additionally, the EPA Inspection Team observed an old storm drain inlet protection BMP within the Peterson Field concrete lined conveyance channel located upstream at the Newton Drive box culvert crossing. City representatives stated that the City Streets Division was responsible for maintenance on this channel; however, they were unaware of the last maintenance activities conducted at this location. The Peterson Field drainage channel drains to Sand Creek.</p> <p>Refer to Appendix B, Photograph Log, for supporting photo documentation and Appendix C, Exhibit Log, for supporting documentation.</p>	64 to 71	14

Photograph 66. View, facing upstream, in channel of trash, debris, accumulated sediment and vegetative growth at the culvert pipe inlet trash rack and within the concrete lined channel itself.

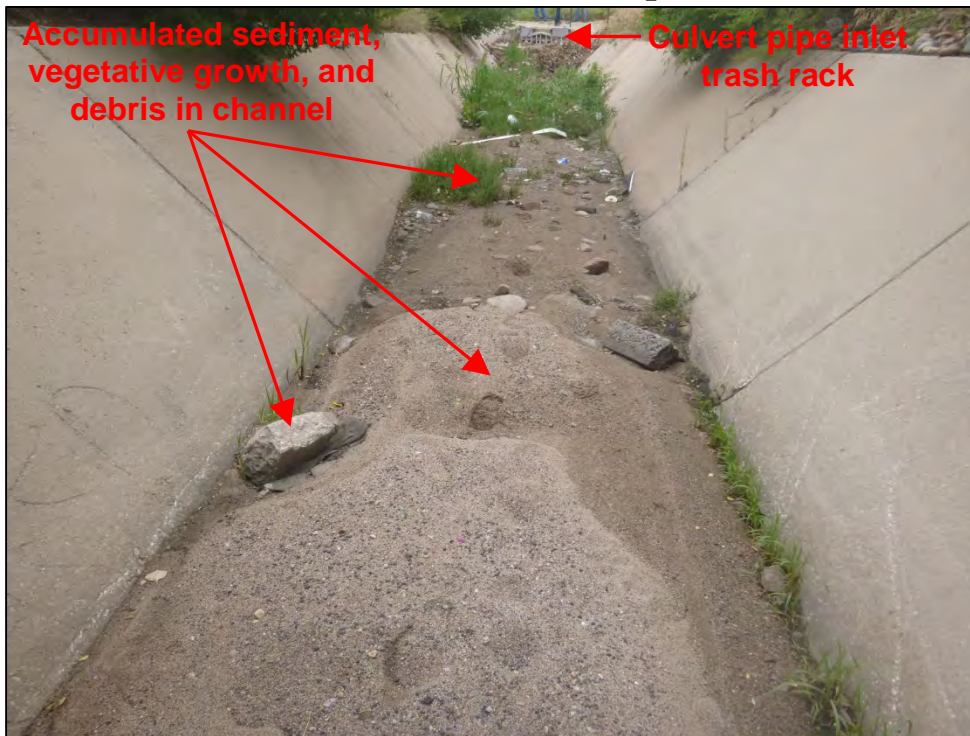
Photograph 67. View, facing downstream, in channel of accumulated sediment, vegetative growth, and debris within the concrete lined channel located just upstream of the culvert pipe inlet trash rack, shown in Photograph 66.

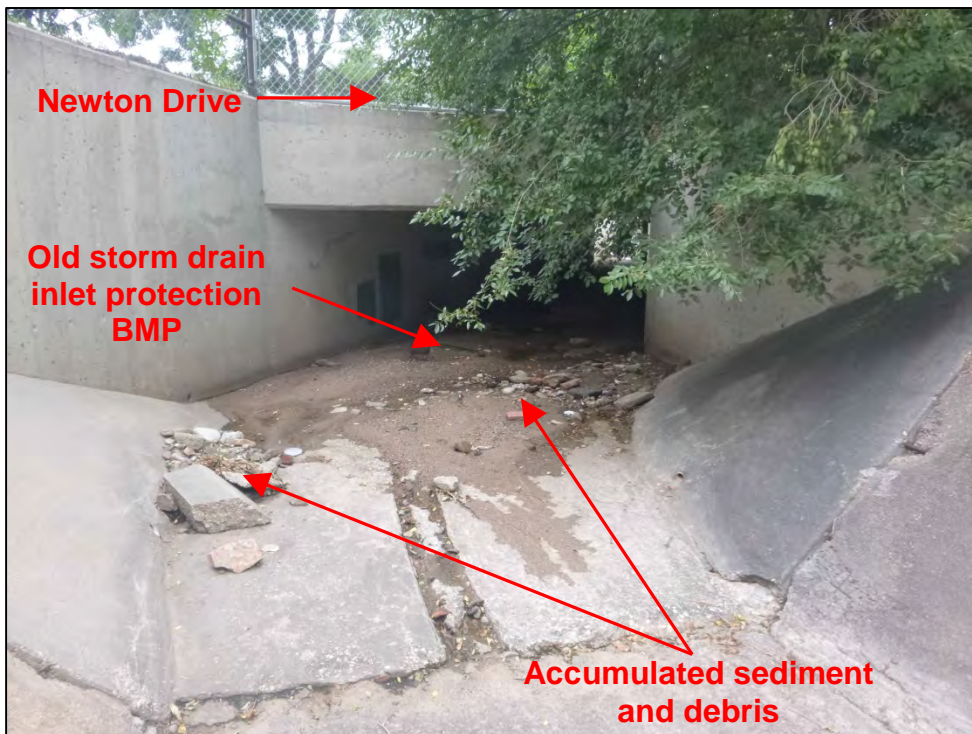
Photograph 70. View, facing upstream, in channel at Newton Drive. Note the accumulated sediment and debris, and old storm drain inlet protection within the channel.

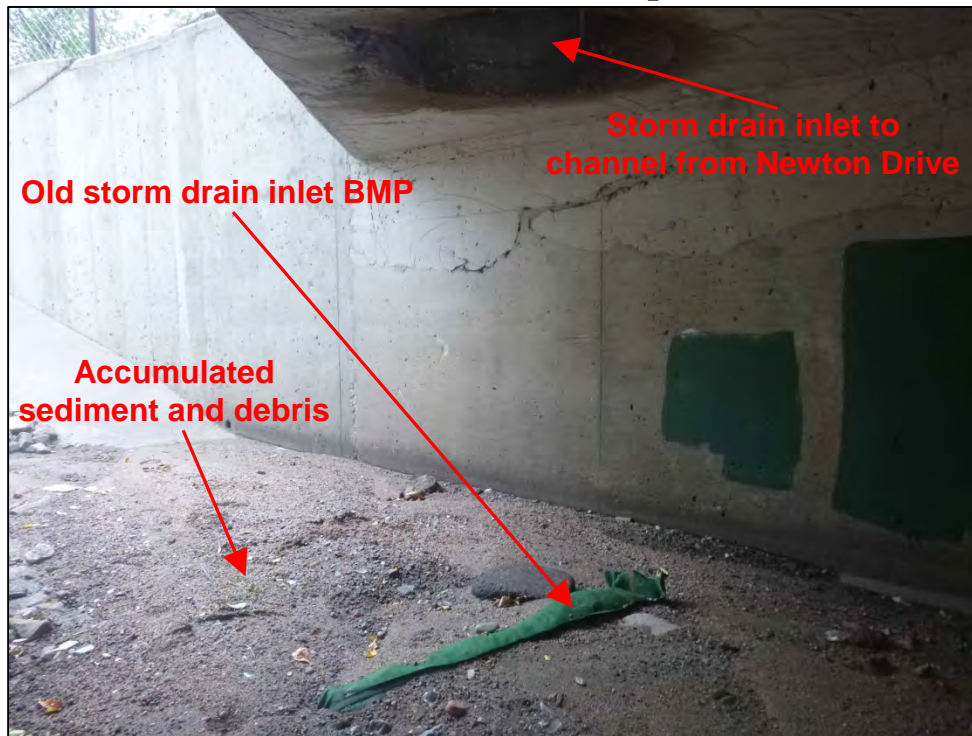
Photograph 71. Close-up view of old storm drain inlet protection within the channel and box culvert beneath Newton Drive, shown in Photograph 70. Note the accumulated sediment and debris.

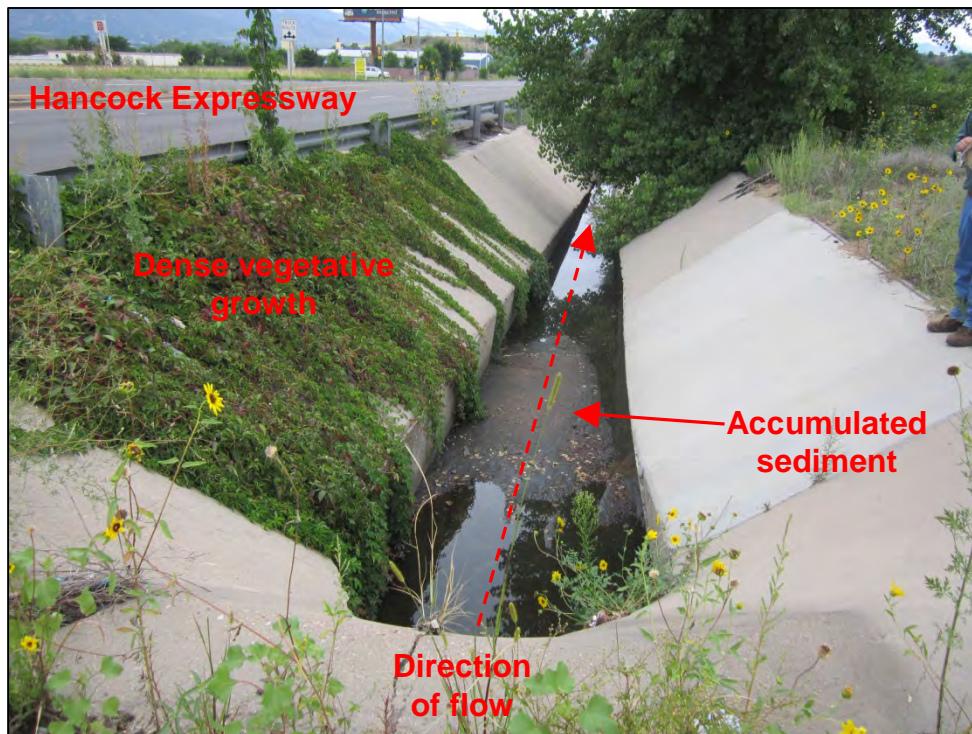
08/19/2015	CS – 130	Concrete lined MS4 conveyance channel to Sand Creek	<p>The EPA Inspection Team observed, at the time of the inspection, an unmaintained/deteriorated concrete lined MS4 conveyance channel with accumulated sediment and dense vegetative growth located along Hancock Expressway between King Soopers, Astrozon Boulevard and Sand Creek. City representatives stated that this conveyance channel receives stormwater runoff from the Hancock Expressway roadway and associated upgradient stormshed and subsequently discharges to Sand Creek. Additionally, the</p>	72 to 81	N/A

Photograph 72. View of CS – 130 concrete lined MS4 conveyance channel. Note the dense vegetative growth and accumulated sediment in the channel located along Hancock Expressway.

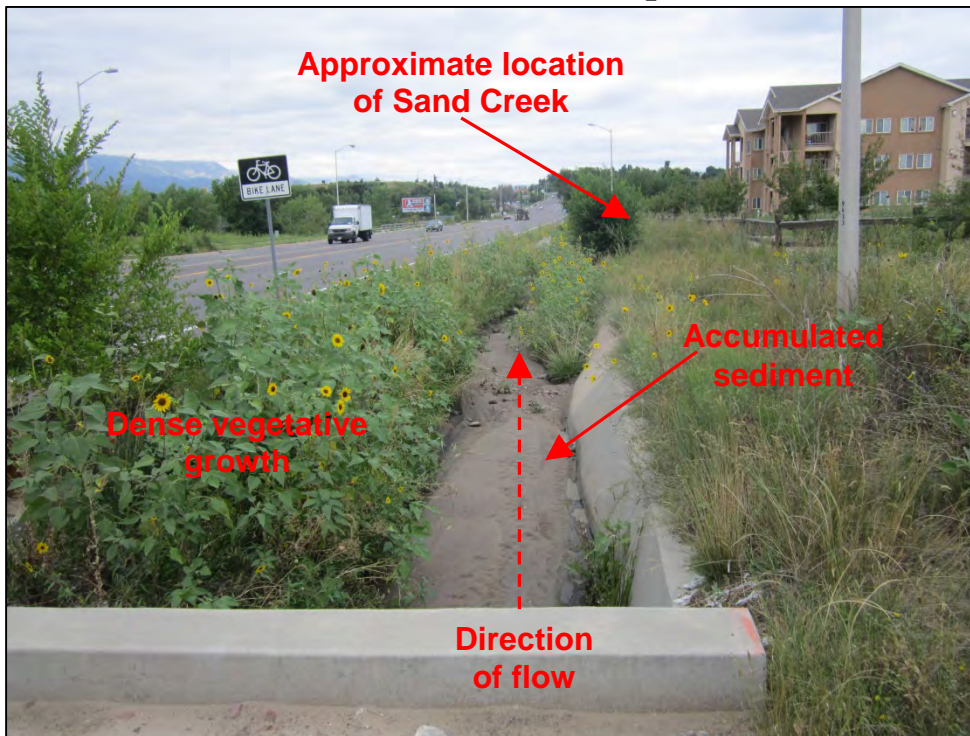
Photograph 77. View, facing downstream, of concrete lined MS4 conveyance channel located along Hancock Expressway near Bentley Point. Note the dense vegetative growth (e.g., shrubs) and accumulated sediment in the channel.

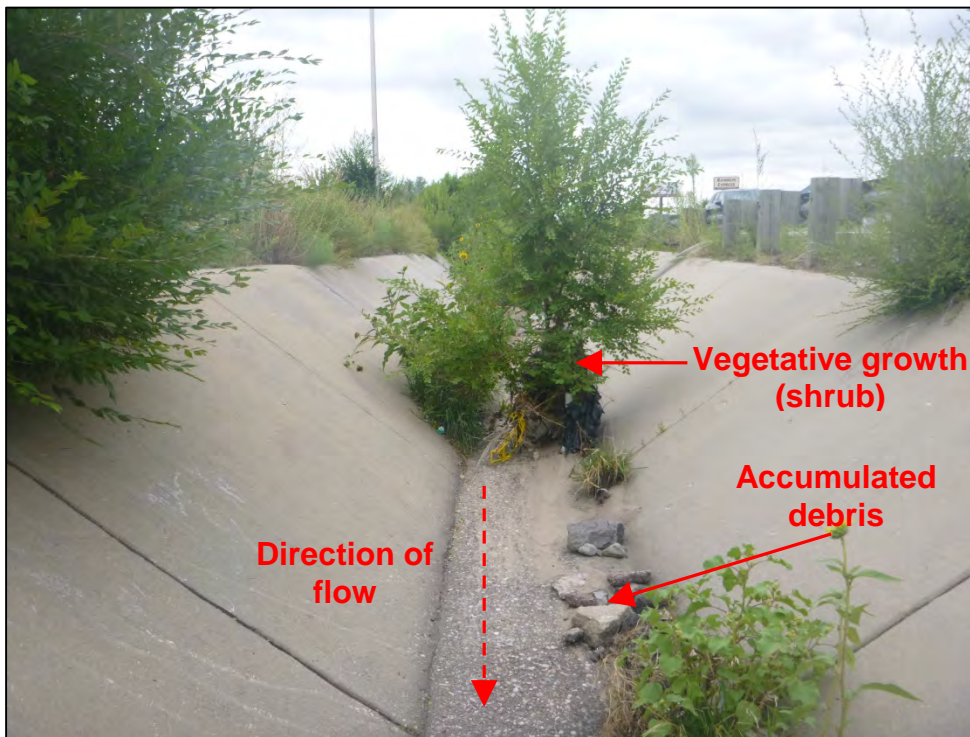
Photograph 78. Close-up view of vegetative growth (e.g., shrubs) and accumulated debris in the channel.

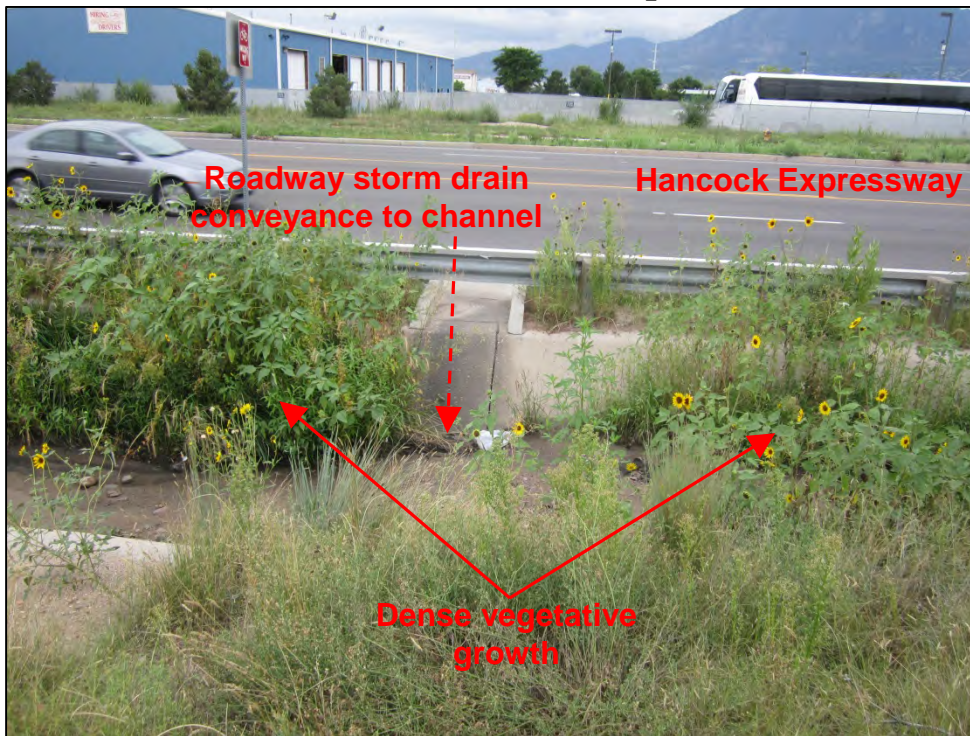
Photograph 79. View of a Hancock Expressway storm drain conveyance to channel and dense vegetative growth in the channel.

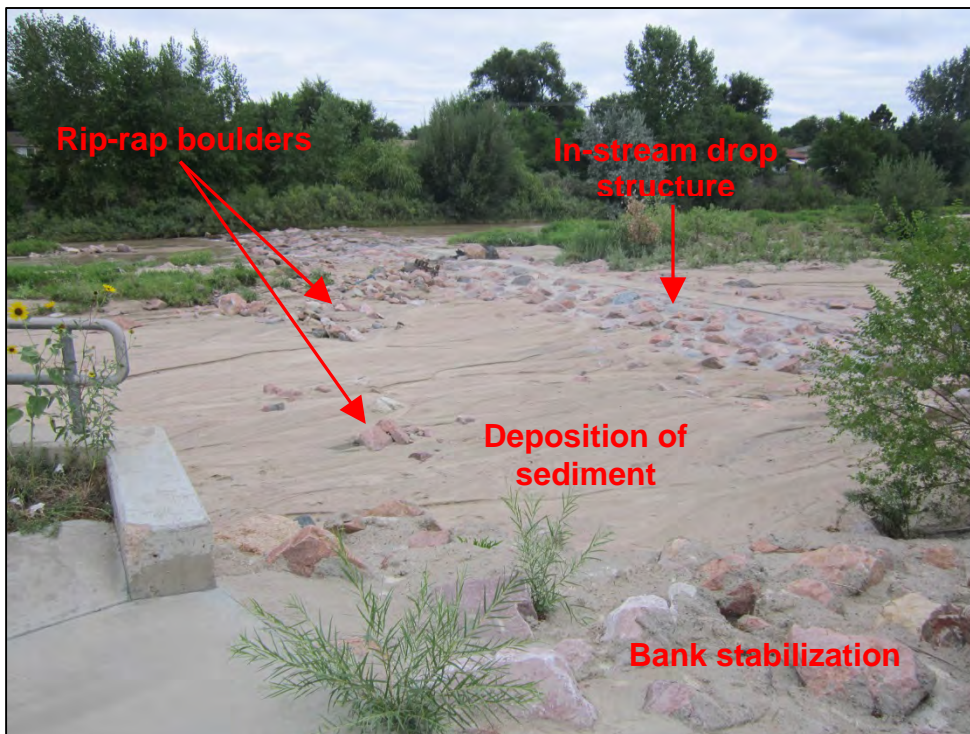
Photograph 80. View of Sand Creek just upstream of MS4 conveyance channel (shown above) outfall. Note the deposition of sediment and rip-rap boulders scattered about Sand Creek in the vicinity of a constructed in-stream drop structure.

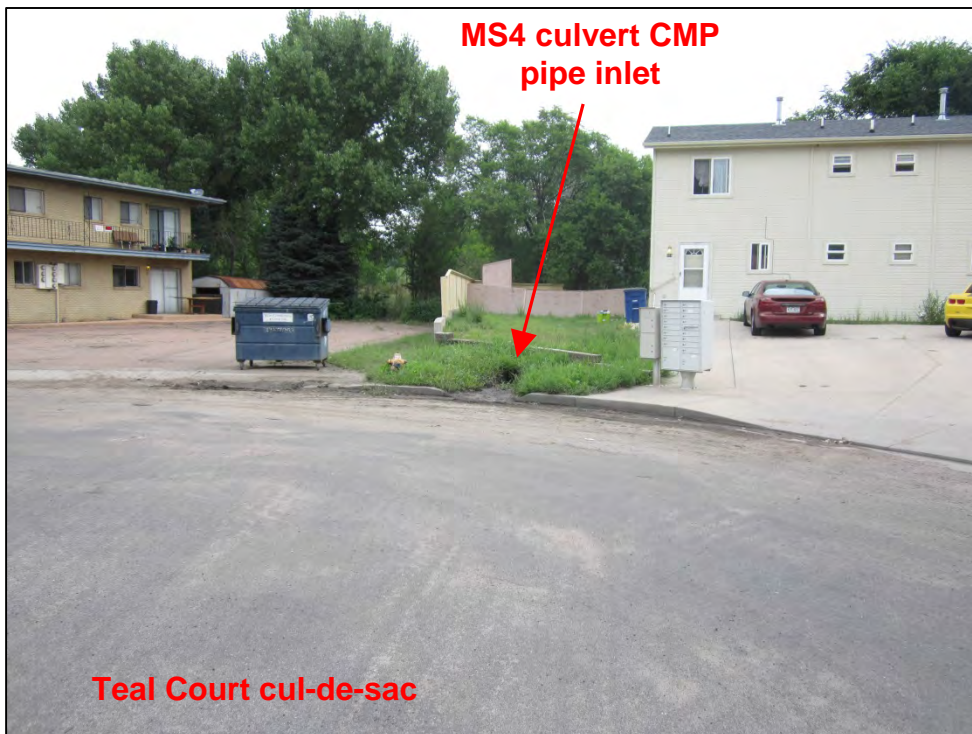
EPA Inspection Date	ID or Functional Location	Feature Description	EPA Findings	Photos	Exhibits
			EPA Inspection Team observed a deteriorated (e.g., undercut) Sand Creek bank stabilization control near the MS4 conveyance channel outfall to Sand Creek and deposition of sediment and rip-rap boulders scattered about and within Sand Creek downgradient of a constructed in-stream drop structure. Refer to Appendix B, Photograph Log, for supporting photo documentation.		
08/19/2015	CS – 137 902 Teal Court	MS4 conveyance to Spring Creek	The EPA Inspection Team observed, at the time of the inspection, an MS4 culvert CMP pipe conveyance at the Teal Court cul-de-sac that had not been maintained and significant deposition of sediment in Spring Creek. Specifically, accumulated sediment and debris was observed at the culvert pipe inlet, outlet, and within the pipe itself. Based on information provided to the EPA Inspection Team this culvert pipe had historically been a source of flooding complaint issues by local residents. The EPA Inspection Team observed an overland conveyance from the Teal Court culvert pipe outlet to a second culvert CMP pipe outlet into what appeared to be a wetland area behind the residences with no clear connection to the adjacent Spring Creek. Additionally, the EPA Inspection Team observed significant deposition of sediment in Spring Creek located behind these residences. City representatives did not appear to be aware of installation or maintenance issues with this MS4 conveyance and City documented maintenance activities for these MS4 conveyances were not conducted or available at the time of the inspection. Refer to Appendix B, Photograph Log, for supporting photo documentation.	82 to 87	N/A

Photograph 82. View of CS – 137 902 Teal Court and City MS4 culvert CMP pipe inlet.

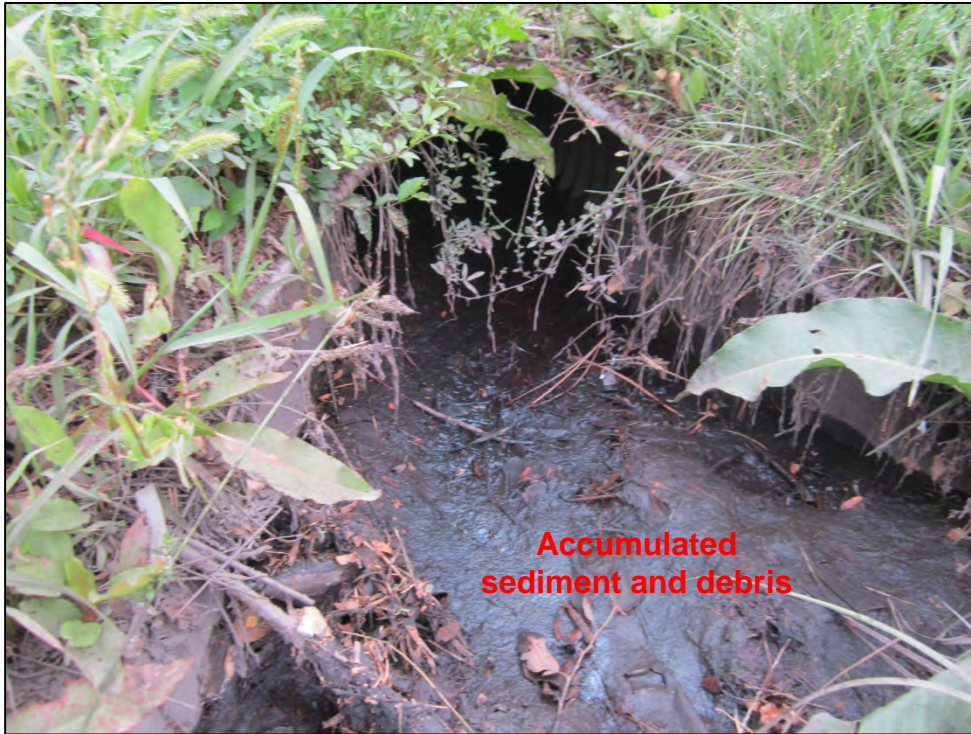
Photograph 83. Close-up view of accumulated sediment and debris at MS4 culvert pipe inlet, shown in Photograph 82.

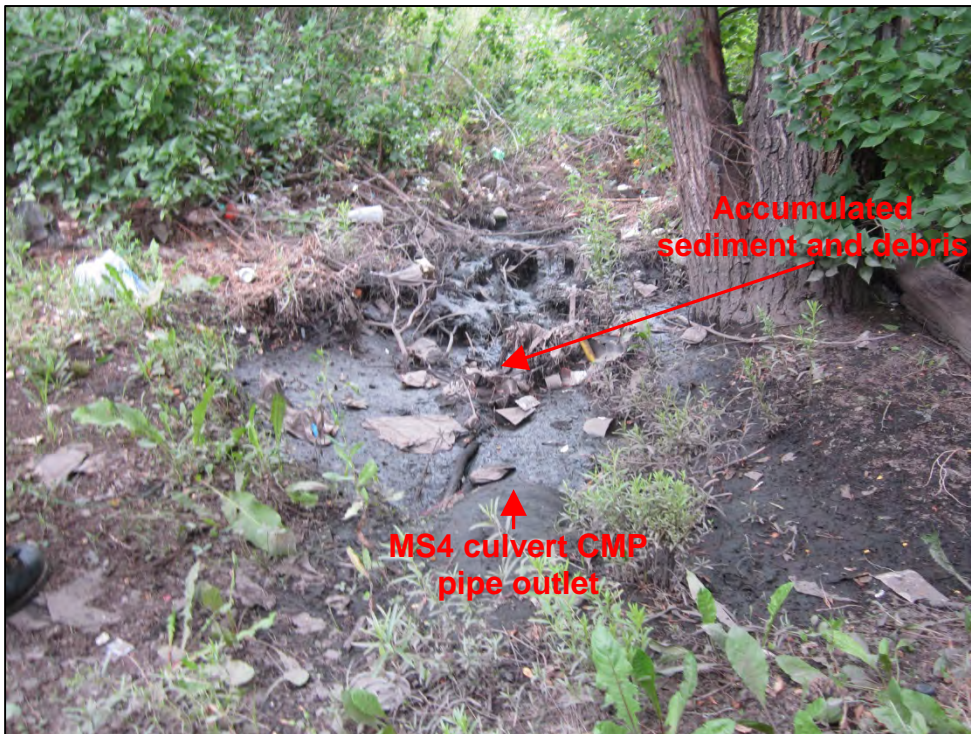
Photograph 84. View of accumulated sediment and debris at the City MS4 culvert pipe outlet.

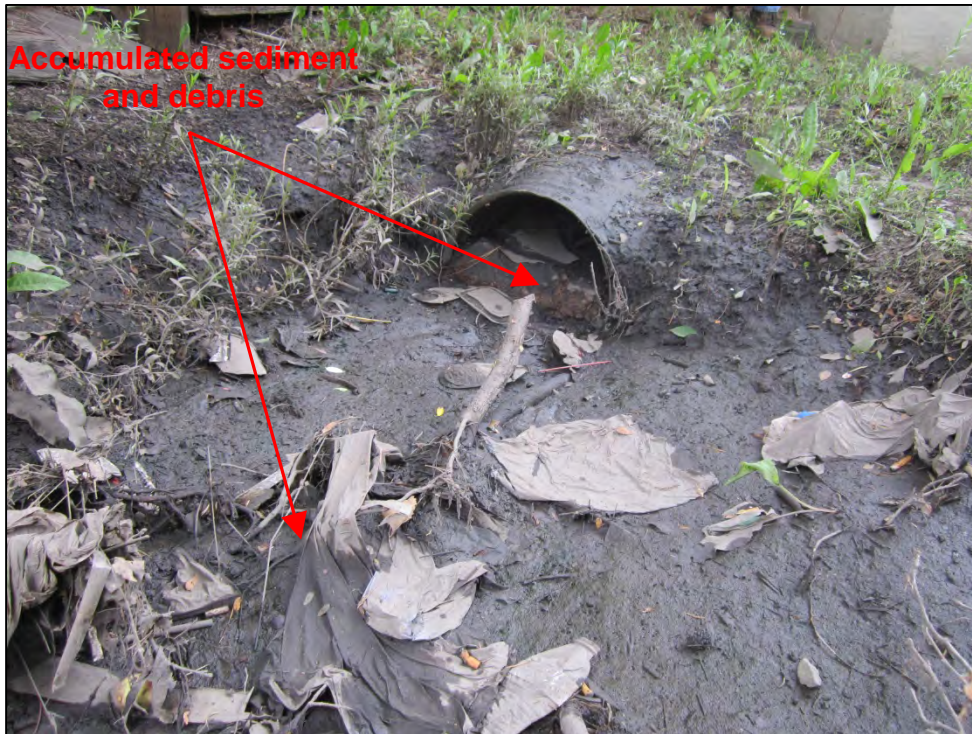
Photograph 85. Close-up view of accumulated sediment and debris at MS4 culvert pipe outlet, shown in Photograph 84. Note the CMP pipe appeared to be at approximately 50 percent capacity due to accumulated sediment and debris within the pipe.

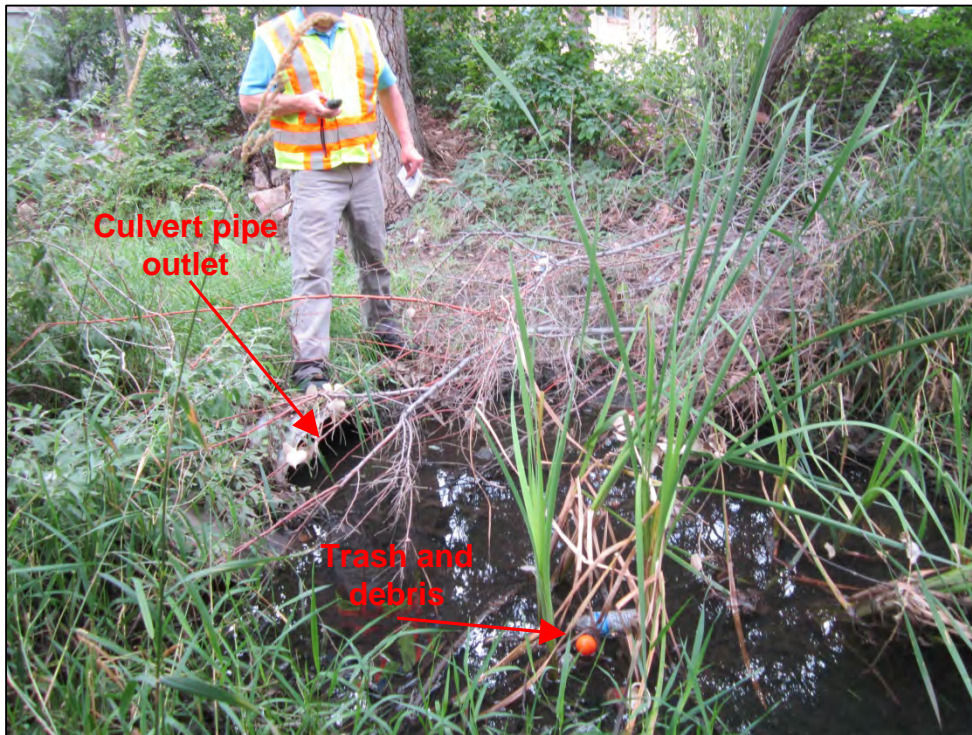
Photograph 86. View of second culvert CMP pipe outlet into what appeared to be a wetland area behind the residences. Note the standing water and trash and debris.

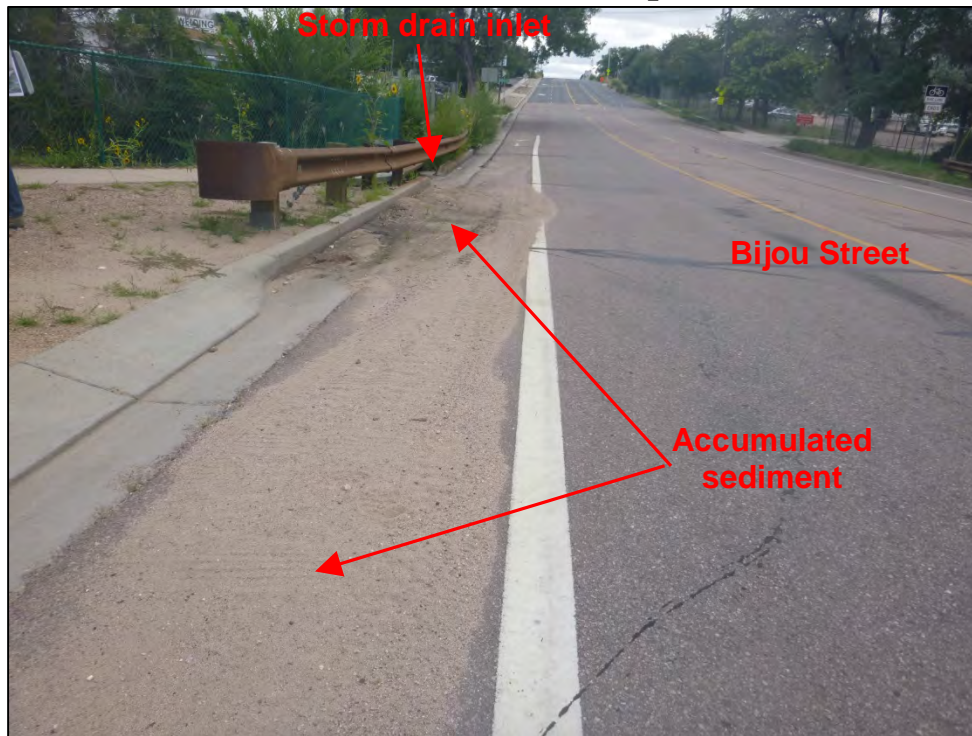
08/19/2015	CS – 362 Spring Creek near 3667 E. Bijou Street	Culvert embankment stabilization	The EPA Inspection Team observed, at the time of the inspection, a Spring Creek box culvert embankment stabilization control that had not been maintained and accumulated sediment on Bijou Street directly adjacent to storm drain inlets which drain directly to Spring Creek. Specifically, the EPA Inspection Team observed an unmaintained concrete bank stabilization control (e.g., undercut) and accumulated sediment adjacent to and within the storm drain inlet which subsequently drains directly to Spring Creek. It should be noted that this location was directly adjacent to the City Fire Department logistics and transportation office. It did not appear to the EPA	88 to 91	N/A

Photograph 89. View of accumulated sediment on roadway adjacent to a storm drain inlet that drains directly to Spring Creek.

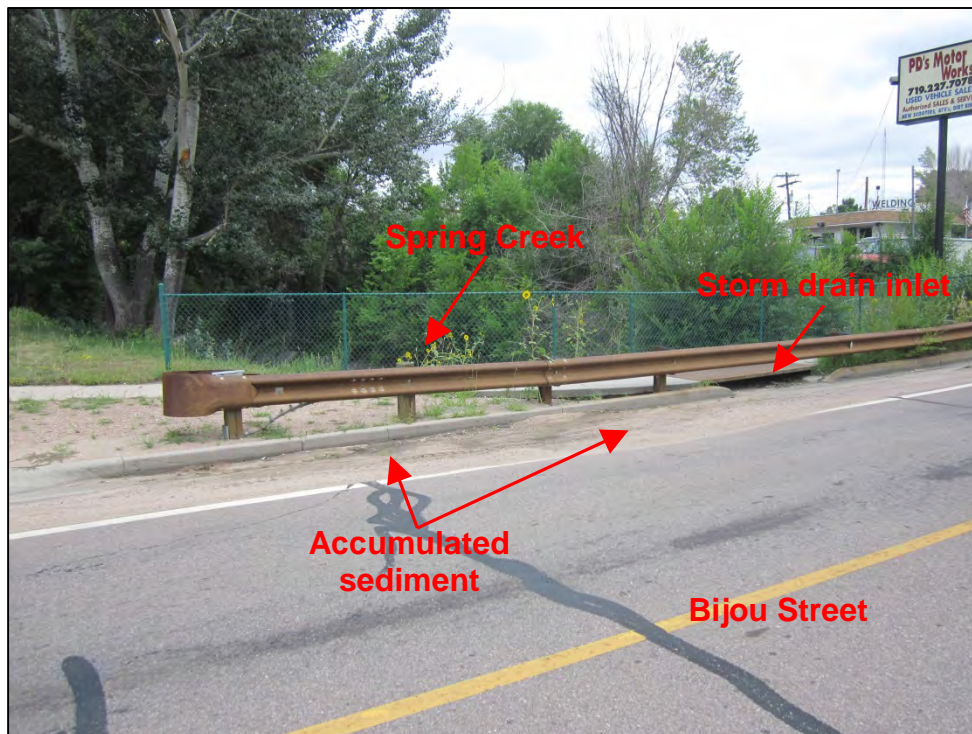
Photograph 90. View of accumulated sediment on the roadway and adjacent to the storm drain inlet on the other side of Bijou Street, shown in Photograph 89. Note that this storm drain inlet also drains directly to Spring Creek.

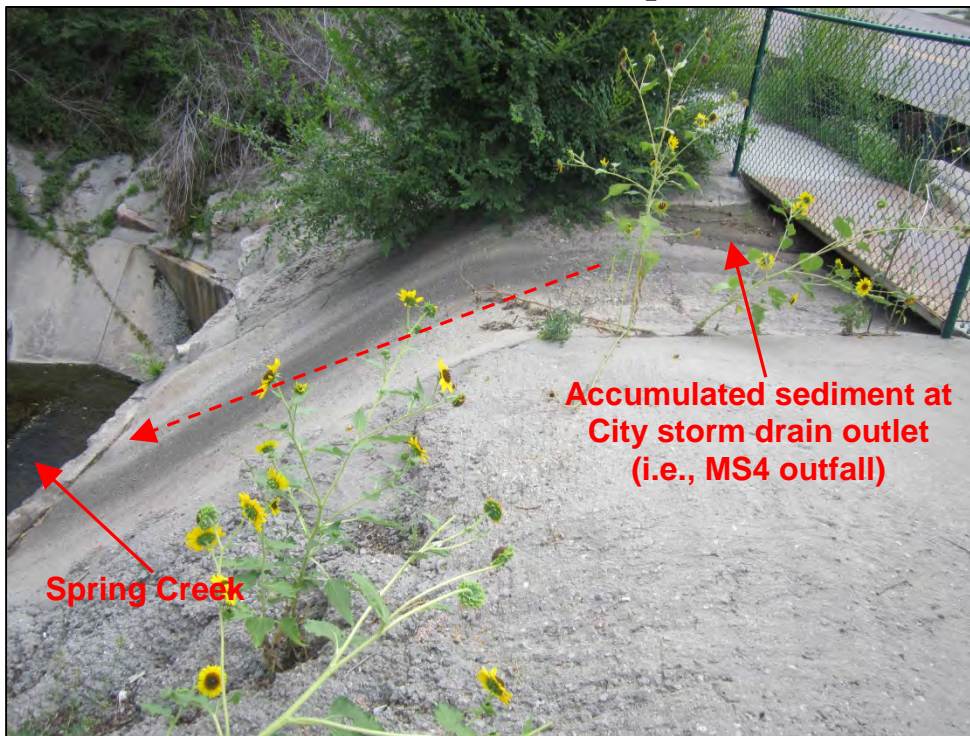
Photograph 91. View of accumulated sediment at City storm drain outlet (i.e., MS4 outfall) shown in Photograph 90.

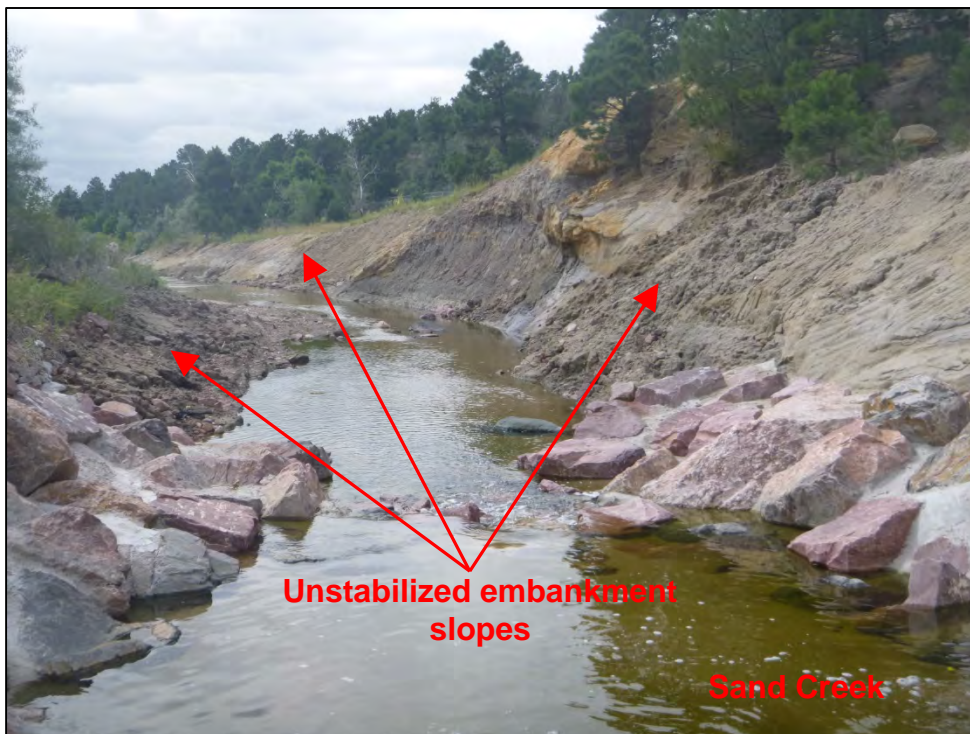
Photograph 92. View of CS – 259 channel/grade control and stream stabilization on Sand Creek. Note the unstabilized Sand Creek channel embankment slopes.

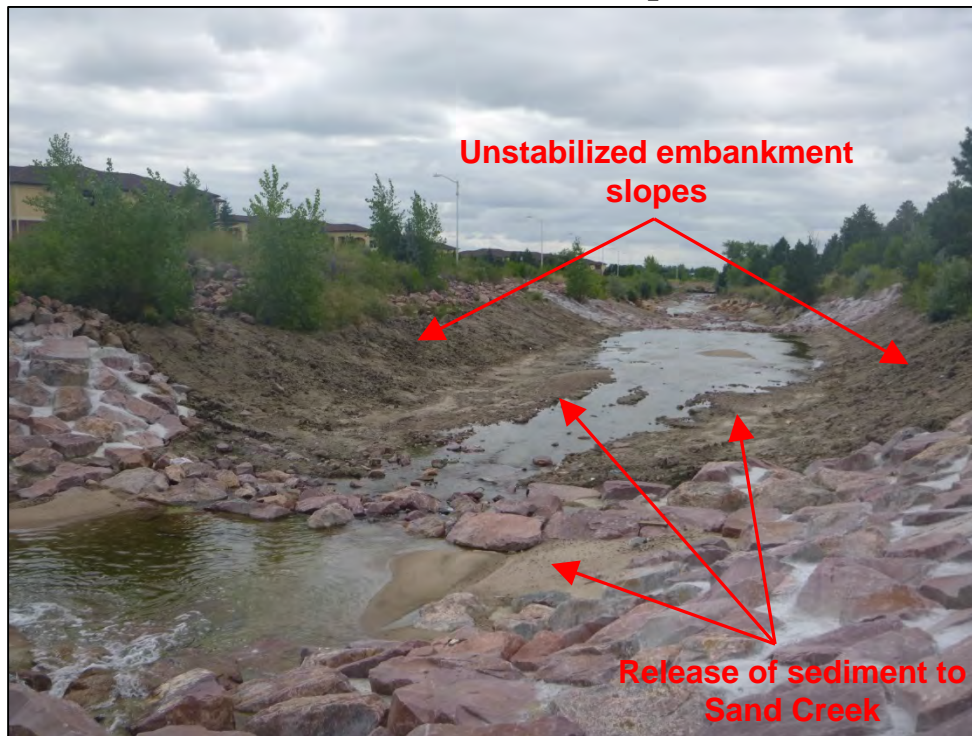
Photograph 93. View of unstabilized Sand Creek embankment slopes associated with the project and evidence of a previous release of sediment to Sand Creek.
