City of Colorado Springs Phase I MS4 Inspection Report
Colorado Discharge Permit System, Permit # COS000004

Inspection Dates: August 18, 2015–August 19, 2015

Prepared by
PG Environmental, LLC

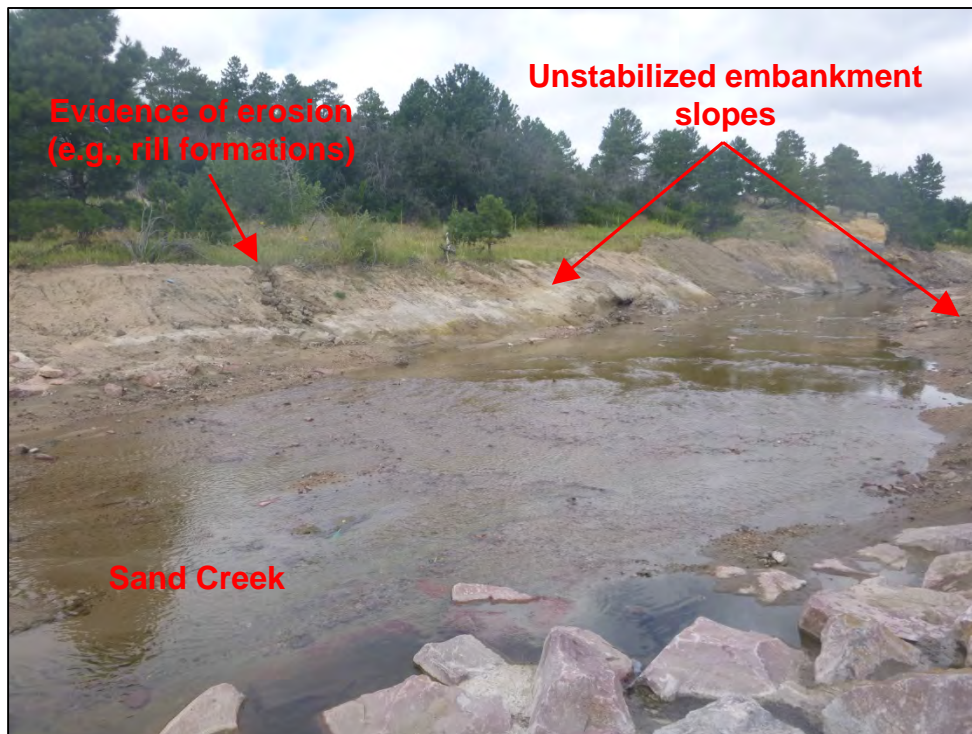
Photograph 94. View of unstabilized Sand Creek embankment slopes with evidence of erosion (e.g., rill formations).

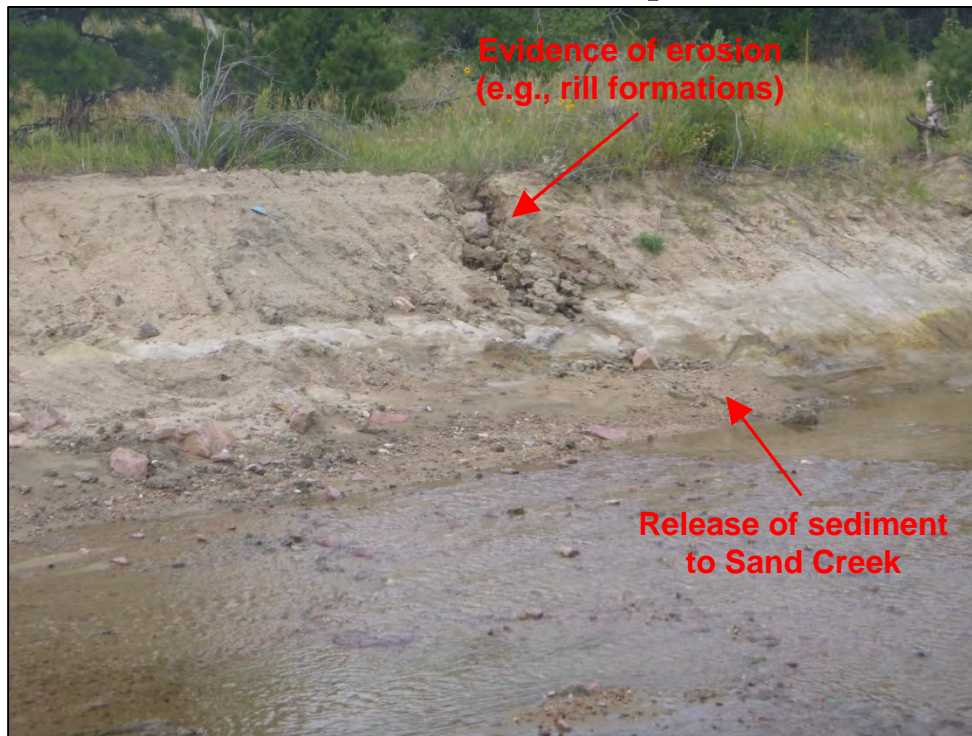
Photograph 95. Close-up view of the unstabilized Sand Creek embankments slopes with evidence of erosion (e.g., rill formations) and a release of sediment to Sand Creek.

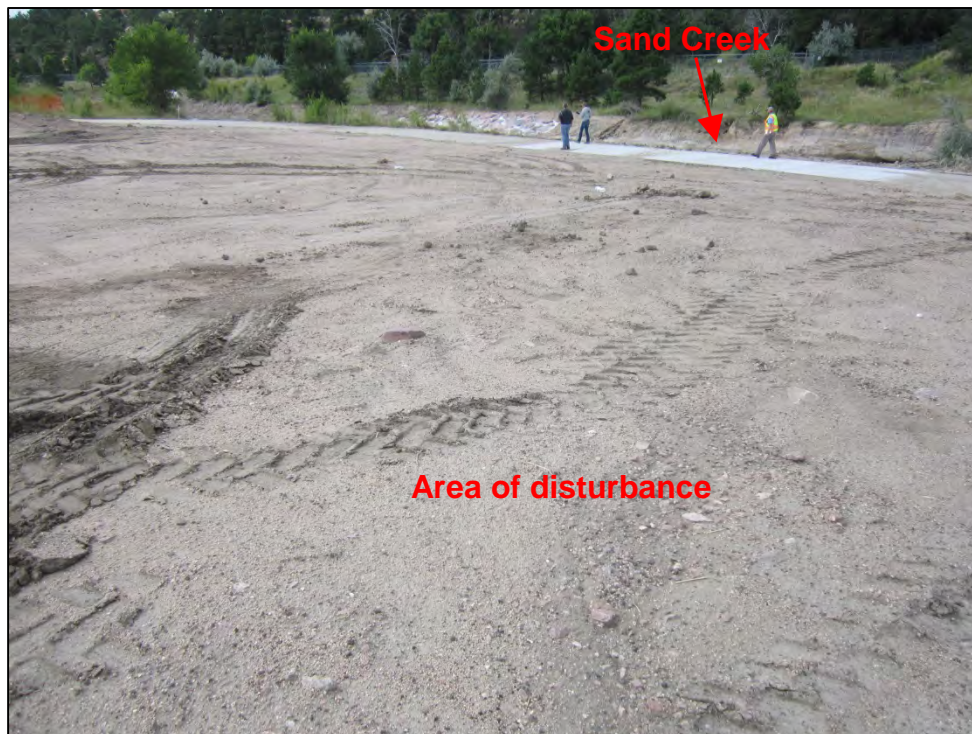
Photograph 96. View of the denuded area of disturbance utilized by the City's contractor as a staging area for the in-stream Sand Creek project located near 1355 Space Center Drive. Note the lack of erosion, sediment, and perimeter controls.

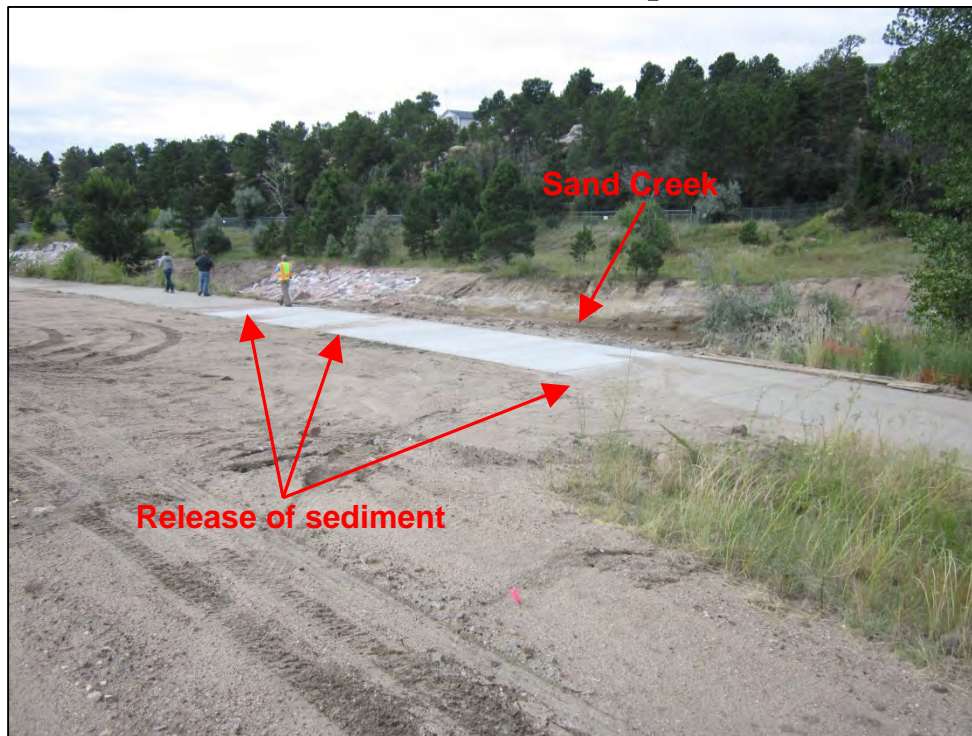
Photograph 97. View of evidence of previous erosion and the release of sediment across the sidewalk toward Sand Creek from the area of disturbance at the staging area, shown in Photograph 96.

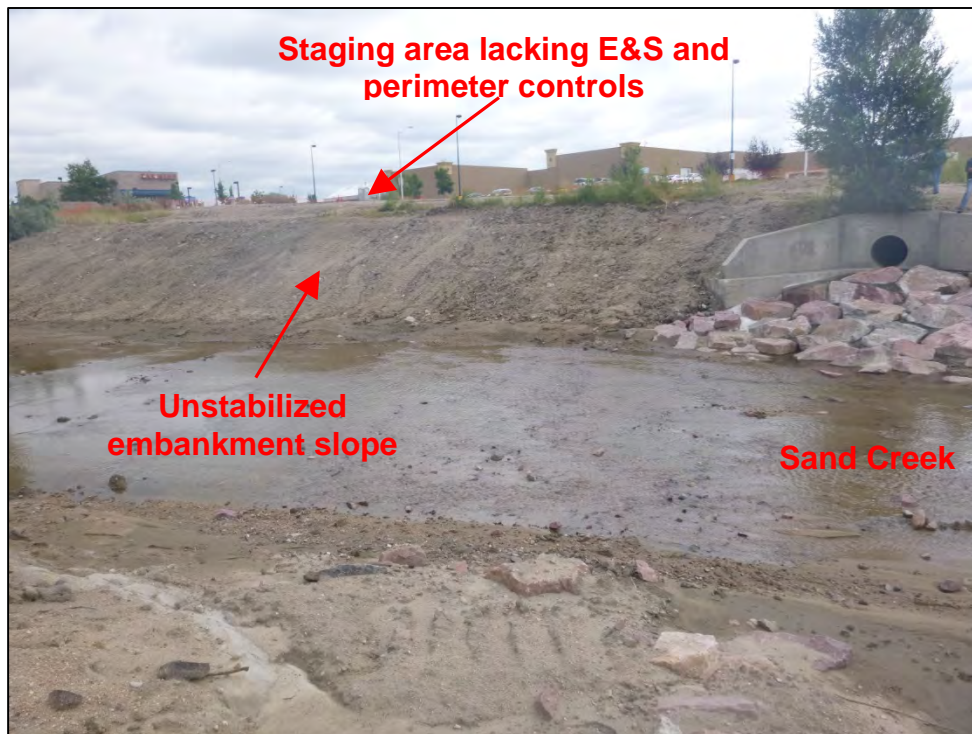
Photograph 98. View of the unstabilized Sand Creek embankment slope located downgradient of the City contractor's staging area for the project. Note that stormwater runoff from this staging area may have been accentuating erosion of this Sand Creek embankment slope.

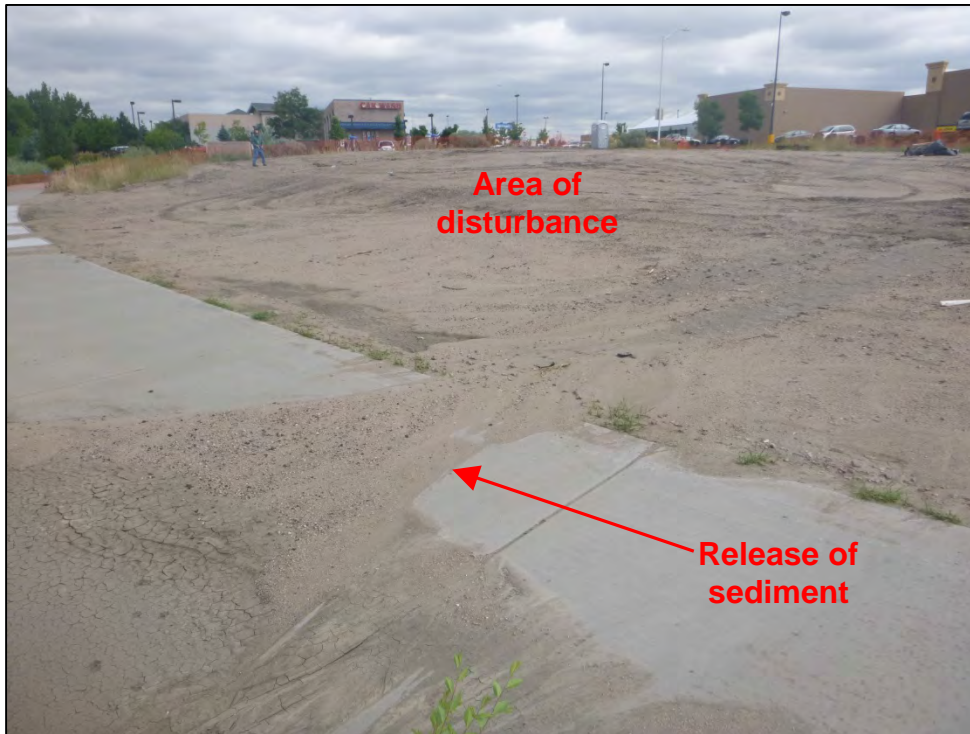
Photograph 99. Close-up view of a previous release of sediment across the sidewalk from the City contractor's unstabilized area of disturbance (i.e., staging area), shown in Photograph 97. Note the lack of erosion, sediment, and perimeter controls.

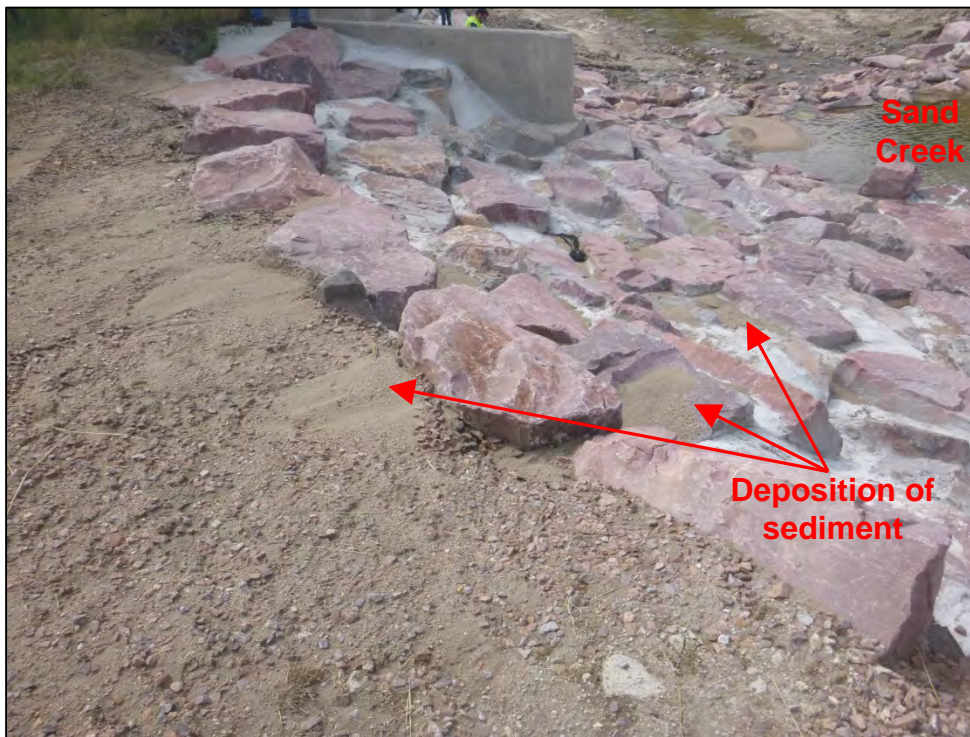
Photograph 100. View, facing downgradient, of the release of sediment across the sidewalk, shown in Photograph 99. Note the evidence of the previous release of sediment and deposition of sediment into Sand Creek.

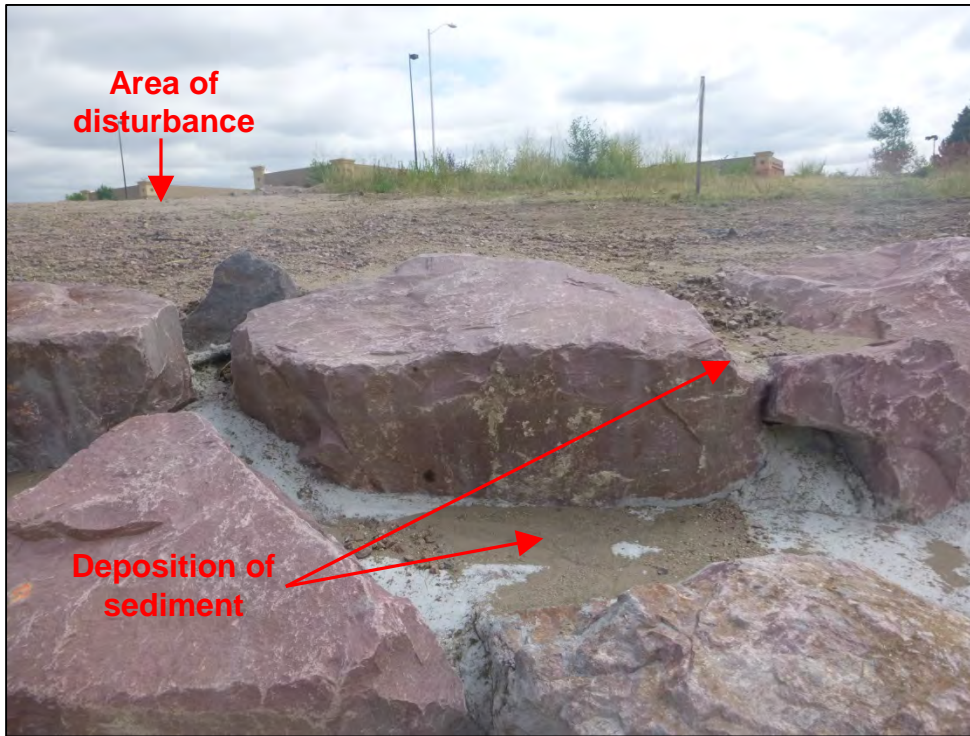
Photograph 101. View, facing upgradient, toward the unstabilized area of disturbance (i.e., staging area) and close-up of the evidence of the previous release and deposition of sediment to the Sand Creek embankment slope.

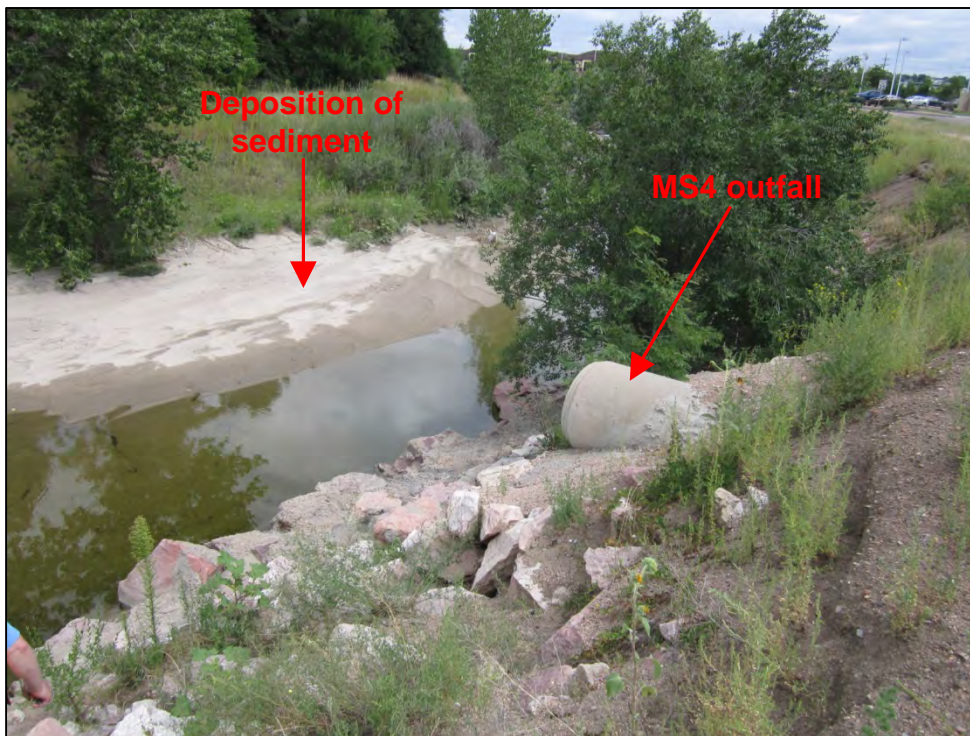
Photograph 102. View of deposition of sediment in Sand Creek adjacent to a City MS4 outfall.

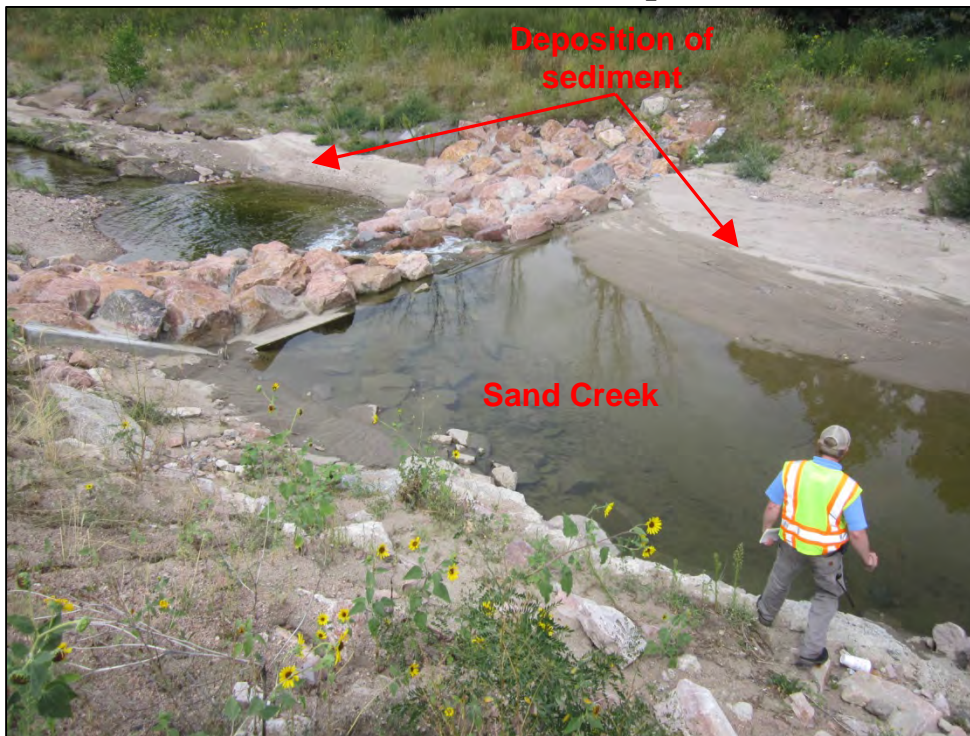
Photograph 103. View of an in-stream engineered drop structure. Note the deposition of sediment upstream and downstream of the structure.

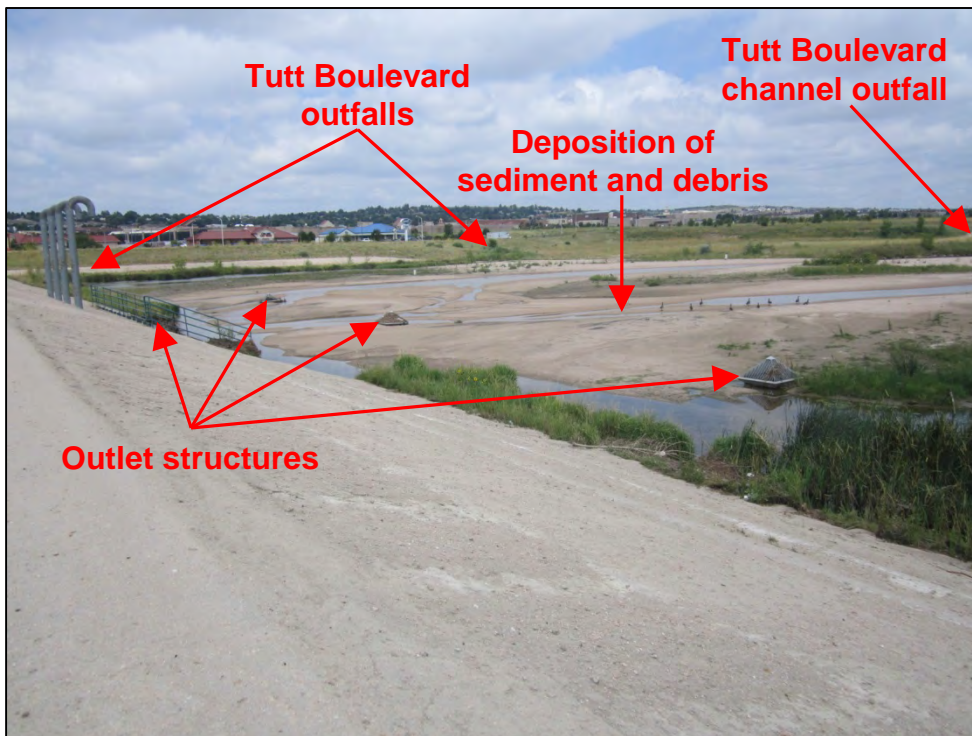
Photograph 110. Vantage point view of Sand Creek Detention Basin No. 1, Tutt Boulevard outfalls, and Tutt Boulevard channel outfall. Note the outlet structures and deposition of sediment and debris in the basin.

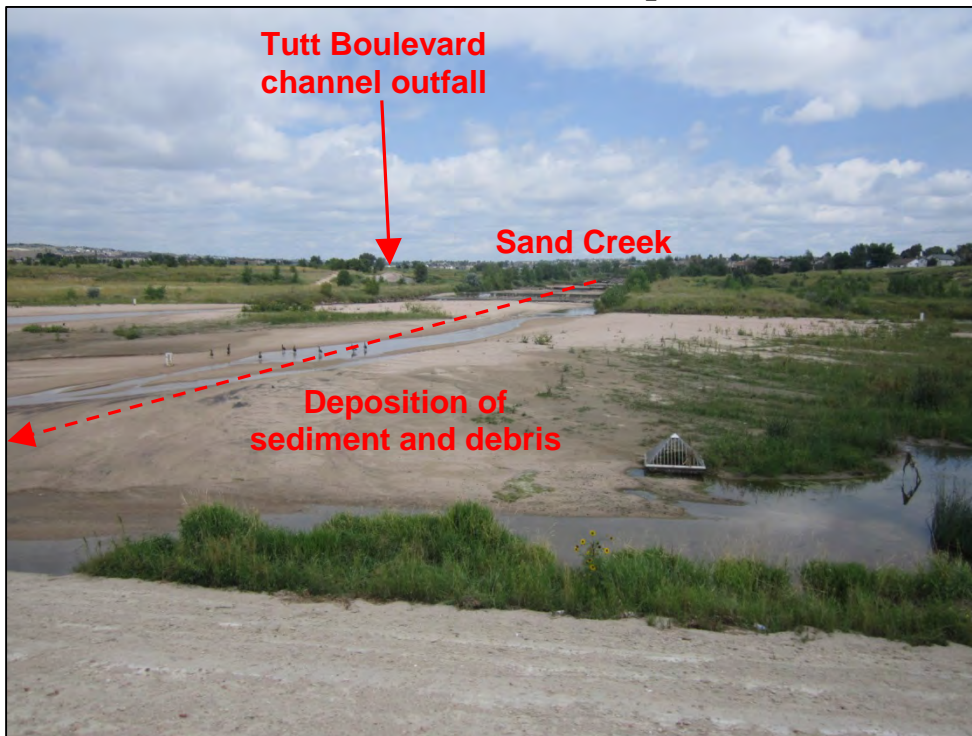
Photograph 111. View, facing upstream, of the deposition of sediment and debris in the detention basin.

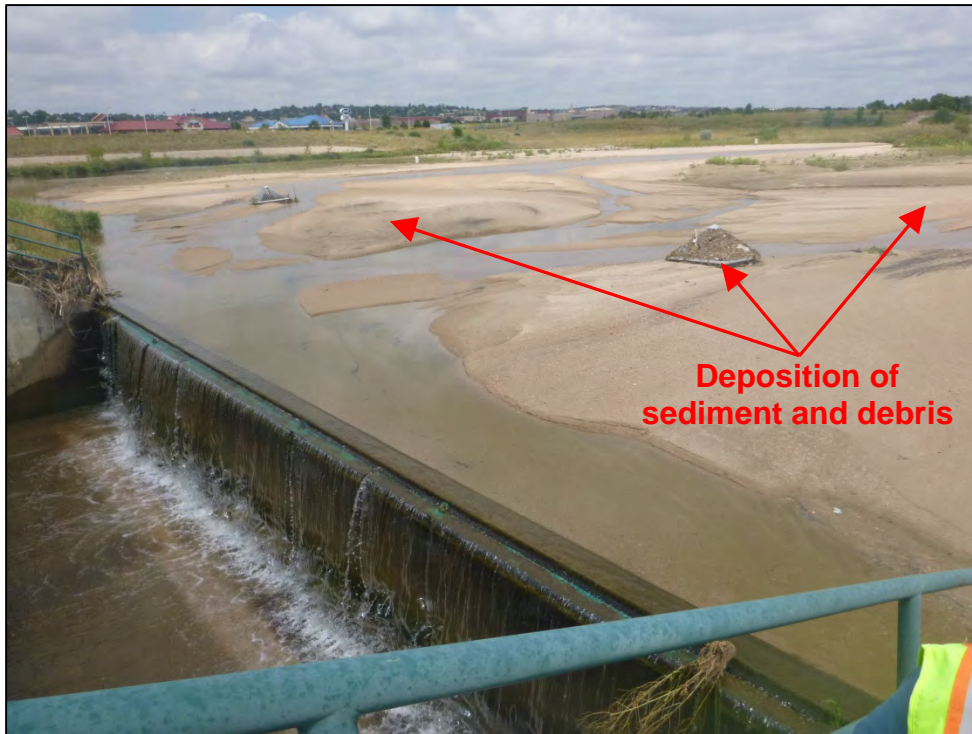
Photograph 112. Close-up view of the deposition of sediment and debris adjacent to the outlet structures.

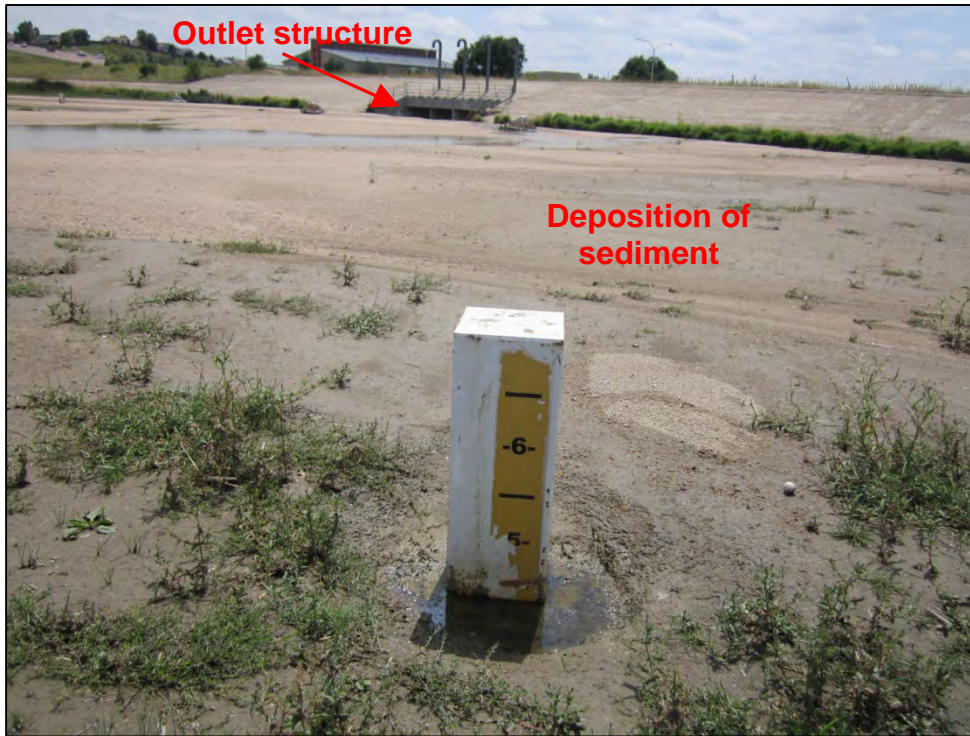
Photograph 113. View of one of six fixed vertical sediment markers with a reading of approximately four and one-half feet.

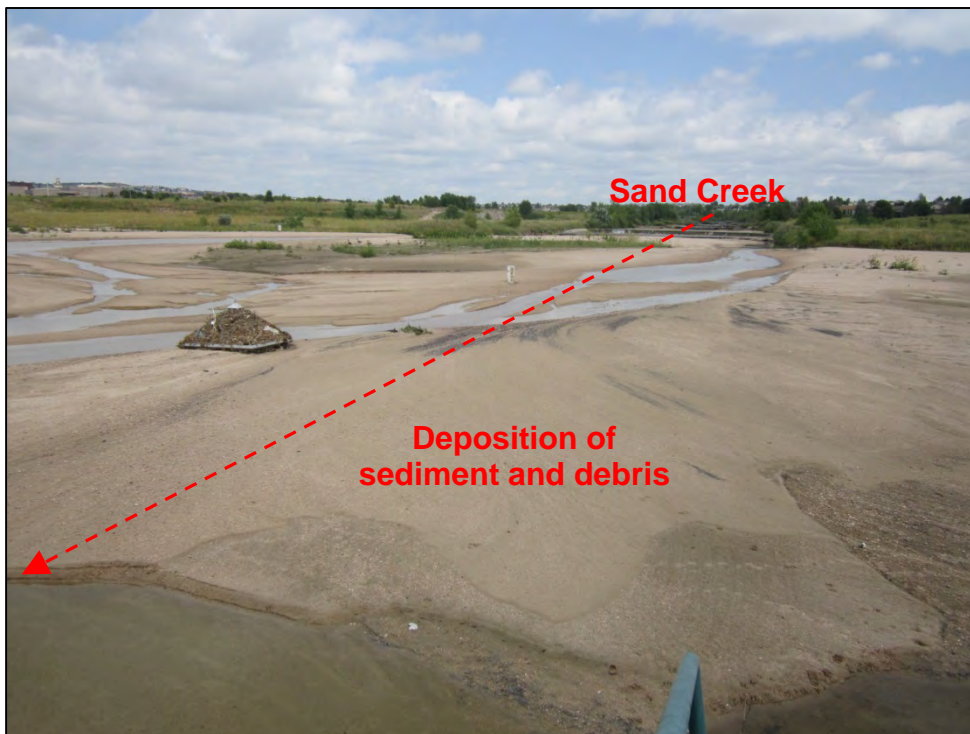
Photograph 114. Additional view, facing upstream, from outlet structure of the deposition of sediment and debris in the detention basin.

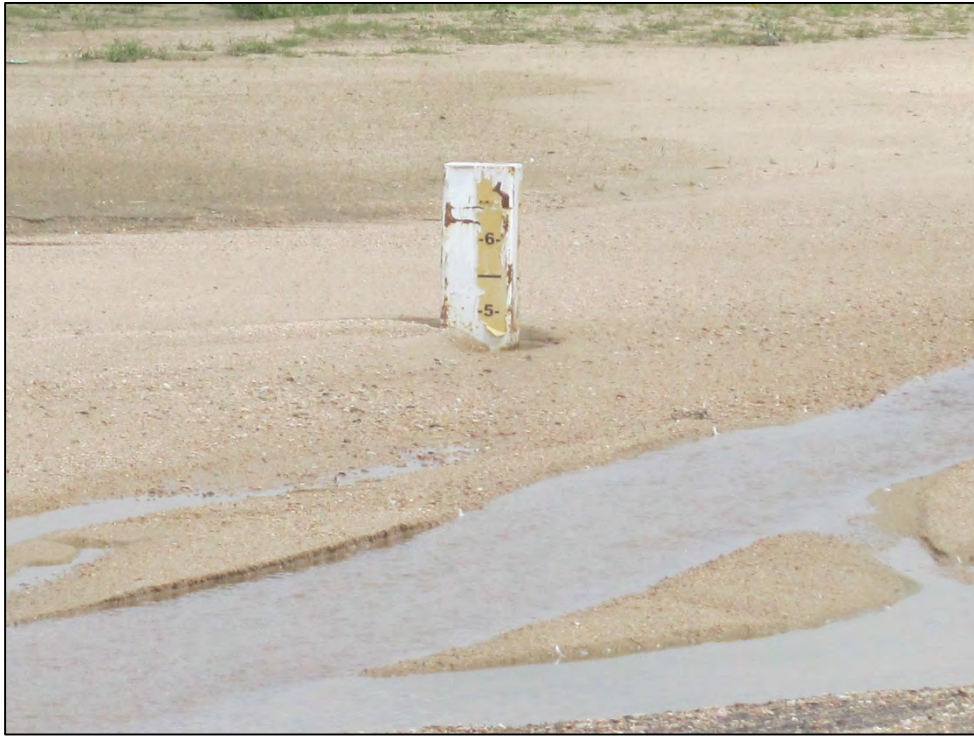
Photograph 115. Additional view of one of six fixed vertical sediment markers with a reading of approximately five feet.

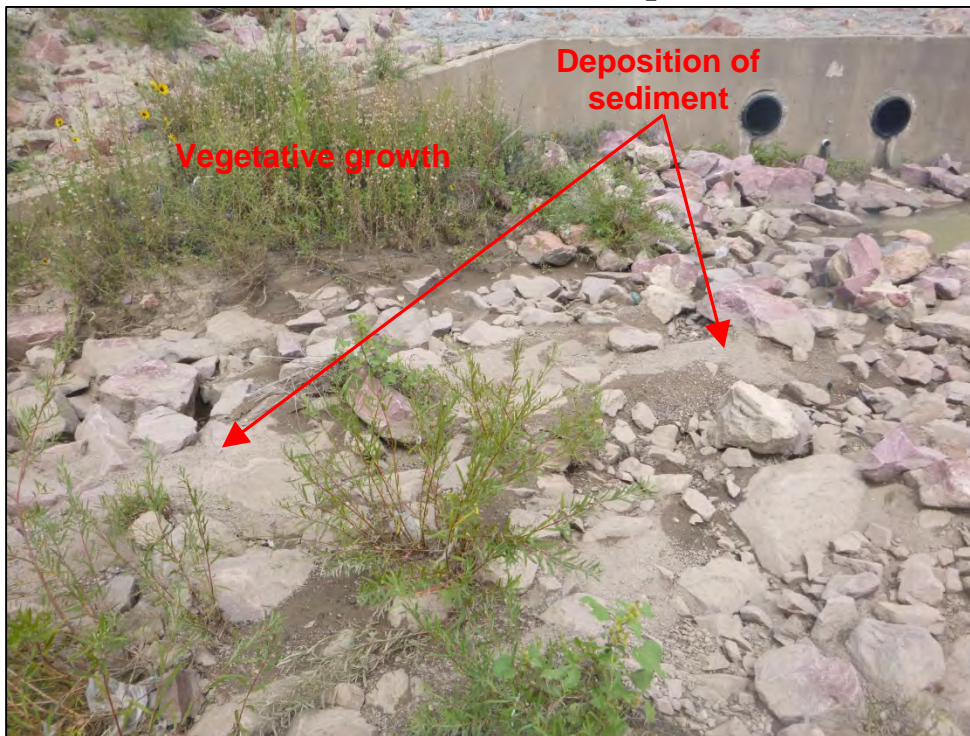
Photograph 117. View of the deposition of sediment and vegetative growth at the Tutt Boulevard channel outfall. Note the rip-rap flow dissipation device had become mired with accumulated sediment and did not appear to have been adequately maintained.

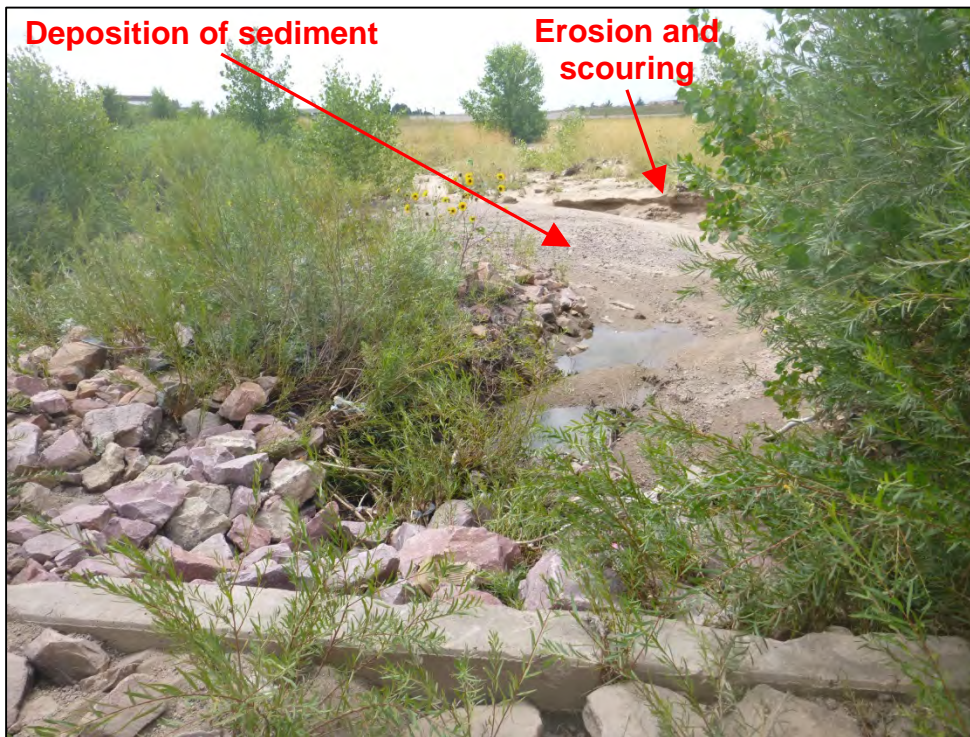
Photograph 118. View, facing downstream, of Tutt Boulevard channel outfall. Note the deposition of sediment and erosion and scouring of the channel, which subsequently drains to the Sand Creek Detention Basin No. 1.

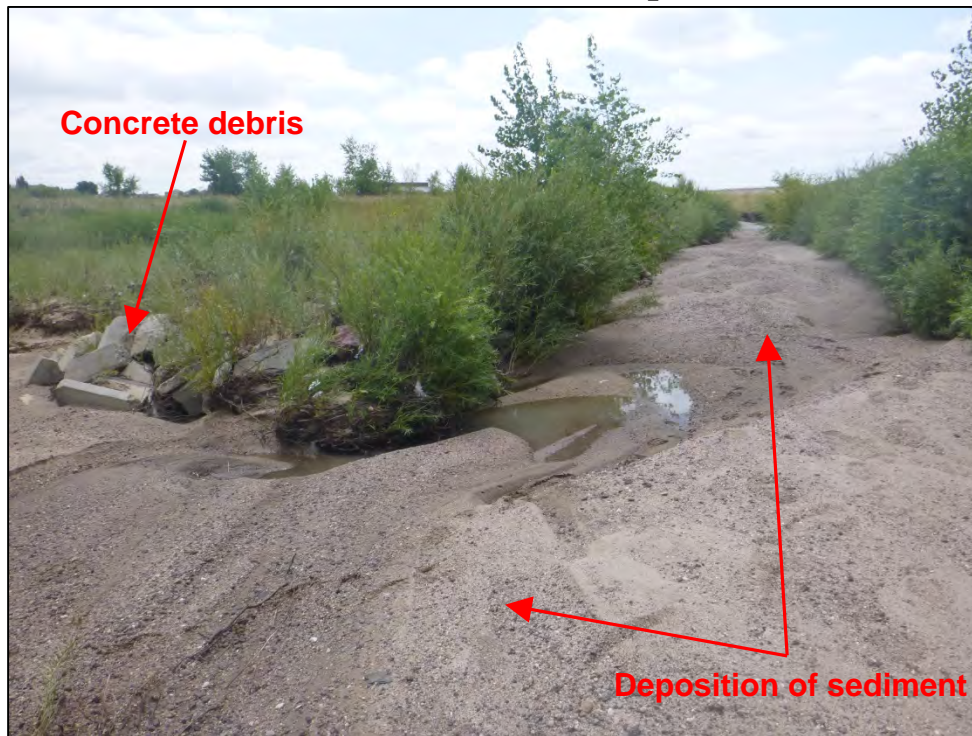
Photograph 120. Close-up view of the concrete debris in the channel, shown in Photograph 119.

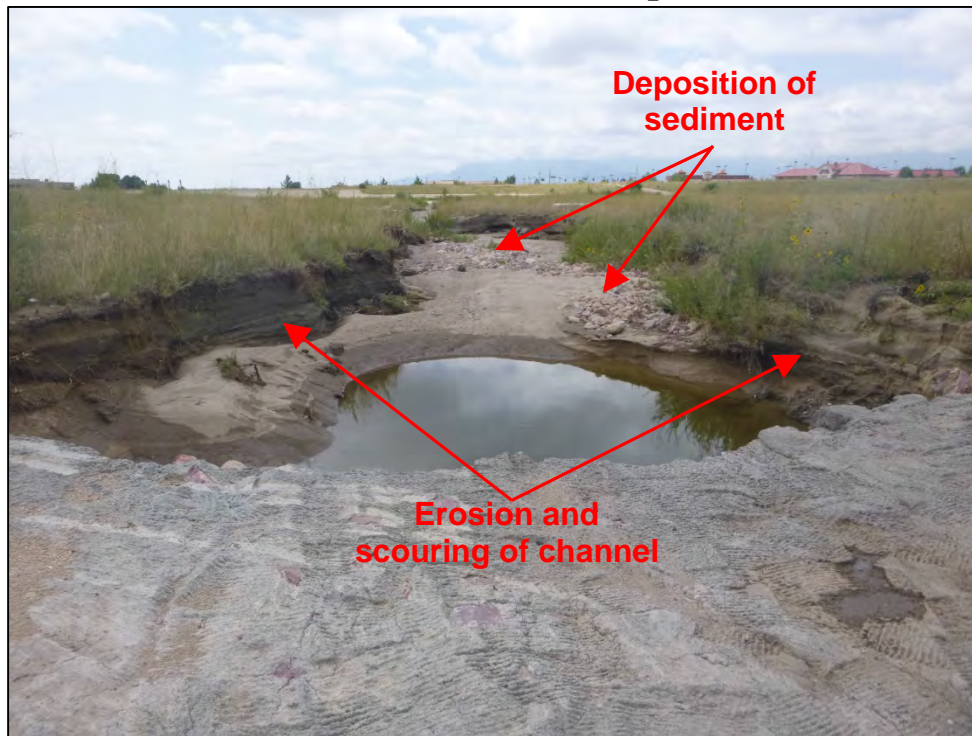
Photograph 122. View, facing upstream, of a deteriorated and unmaintained concrete channel crossing downgradient of the Tutts Boulevard channel outfall which drains to Sand Creek Detention Basin No. 1.

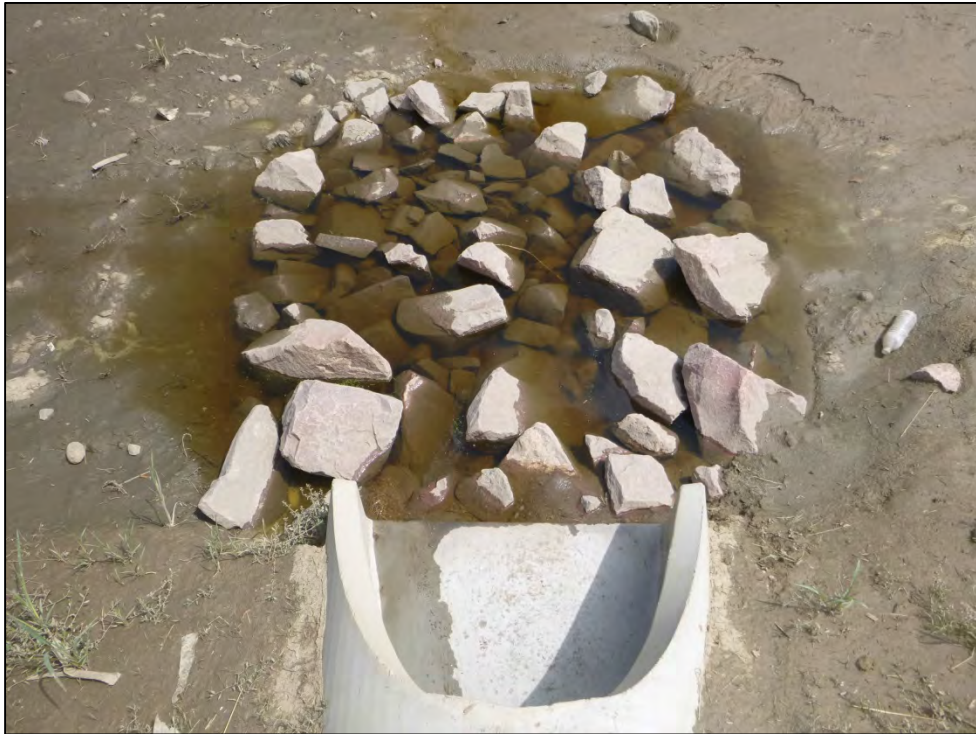
Photograph 128. View of accumulated sediment and debris at an additional inlet and associated forebay.

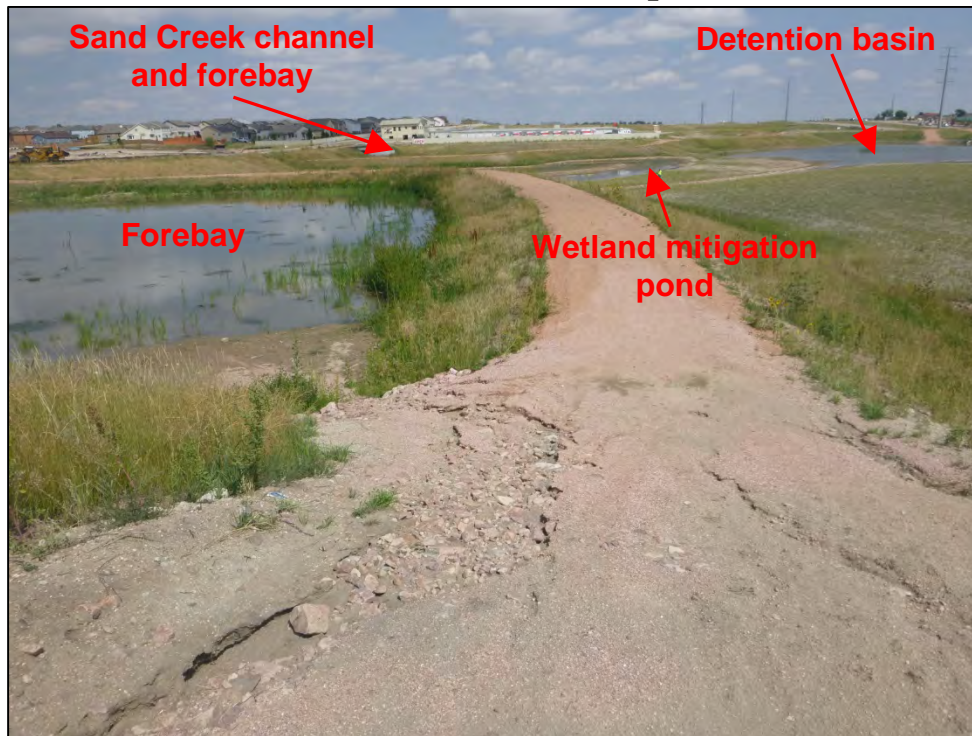
Photograph 134. View of what appeared to be a tributary of Sand Creek and one of two constructed forebays.

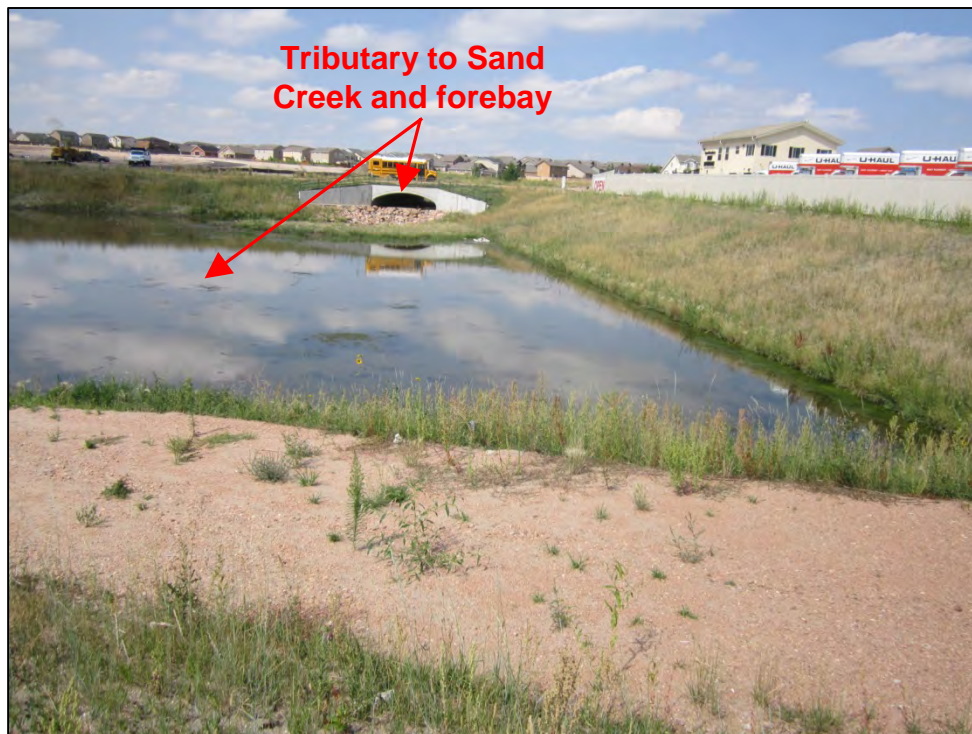
Photograph 135. View of second forebay and inlet with deposition of sediment and unmaintained flow dissipation device (e.g., rip-rap scattered in forebay).

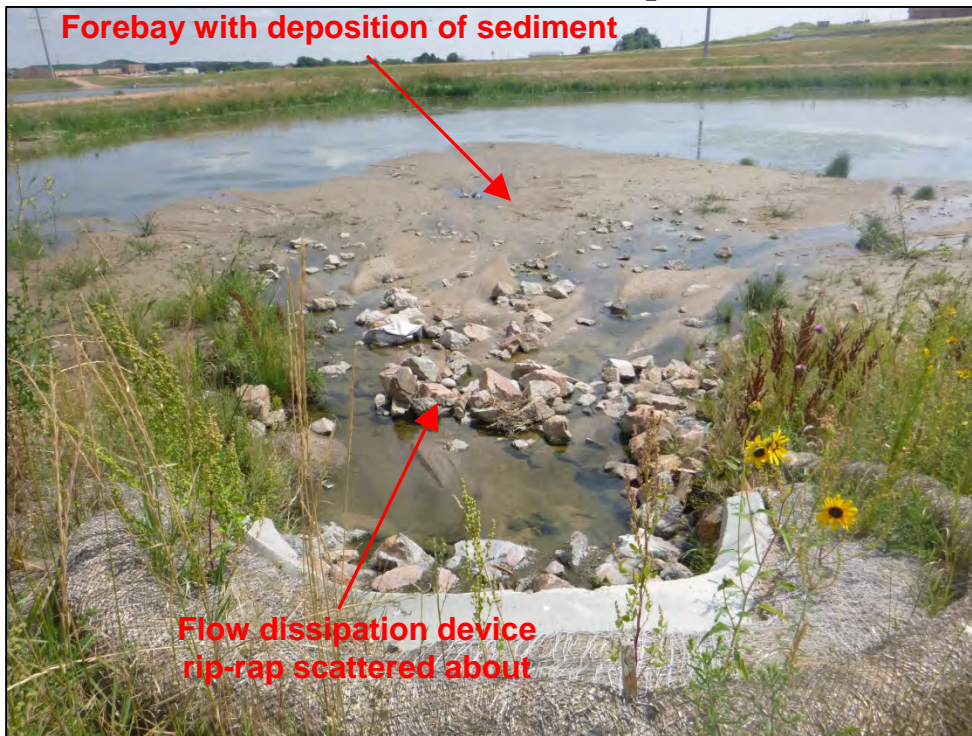
Photograph 136. Additional view of inlet and the deposition and accumulation of sediment in the forebay, shown in Photograph 135.

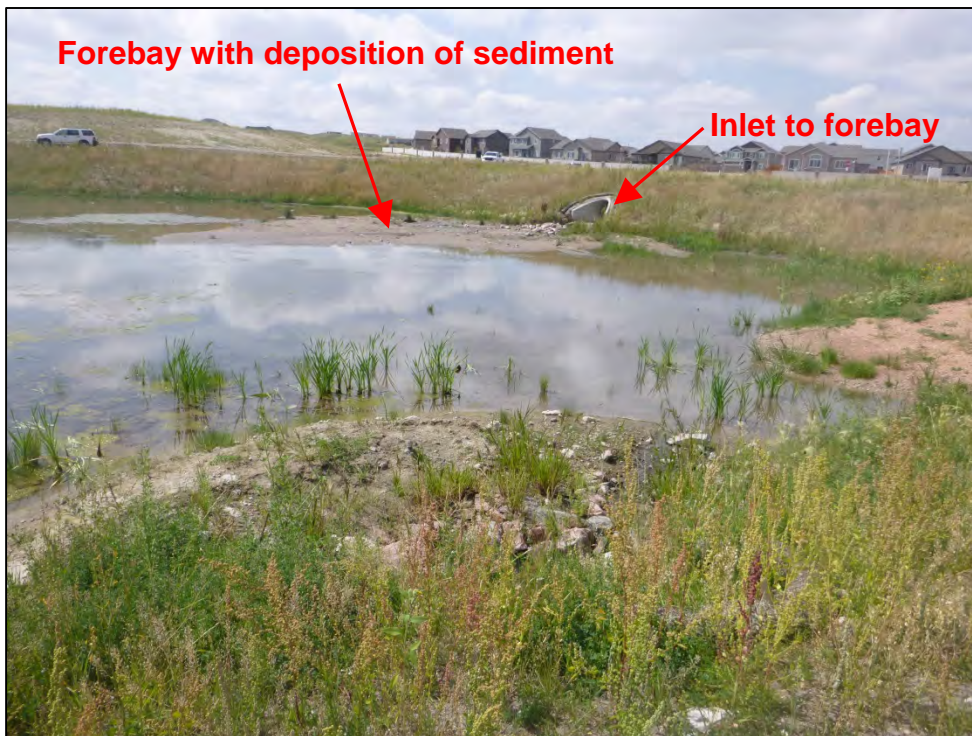
Photograph 137. View of evidence of previous erosion and deposition of sediment in forebay, shown in Photograph 135 and 136.

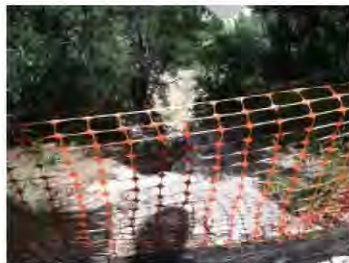
The canyon is on a bluff between Popes Valley and Pebblewood drives. Runoff from homes above a cliff have eroded a canyon in the bluff which becomes a waterfall during heavy rain.

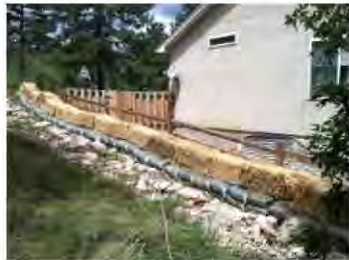
Flooding has washed out landscaping and soaked the home's basement, forcing the family to replace part of their driveway. Chiramonte said insurance doesn't cover damage amounting to nearly \$20,000.

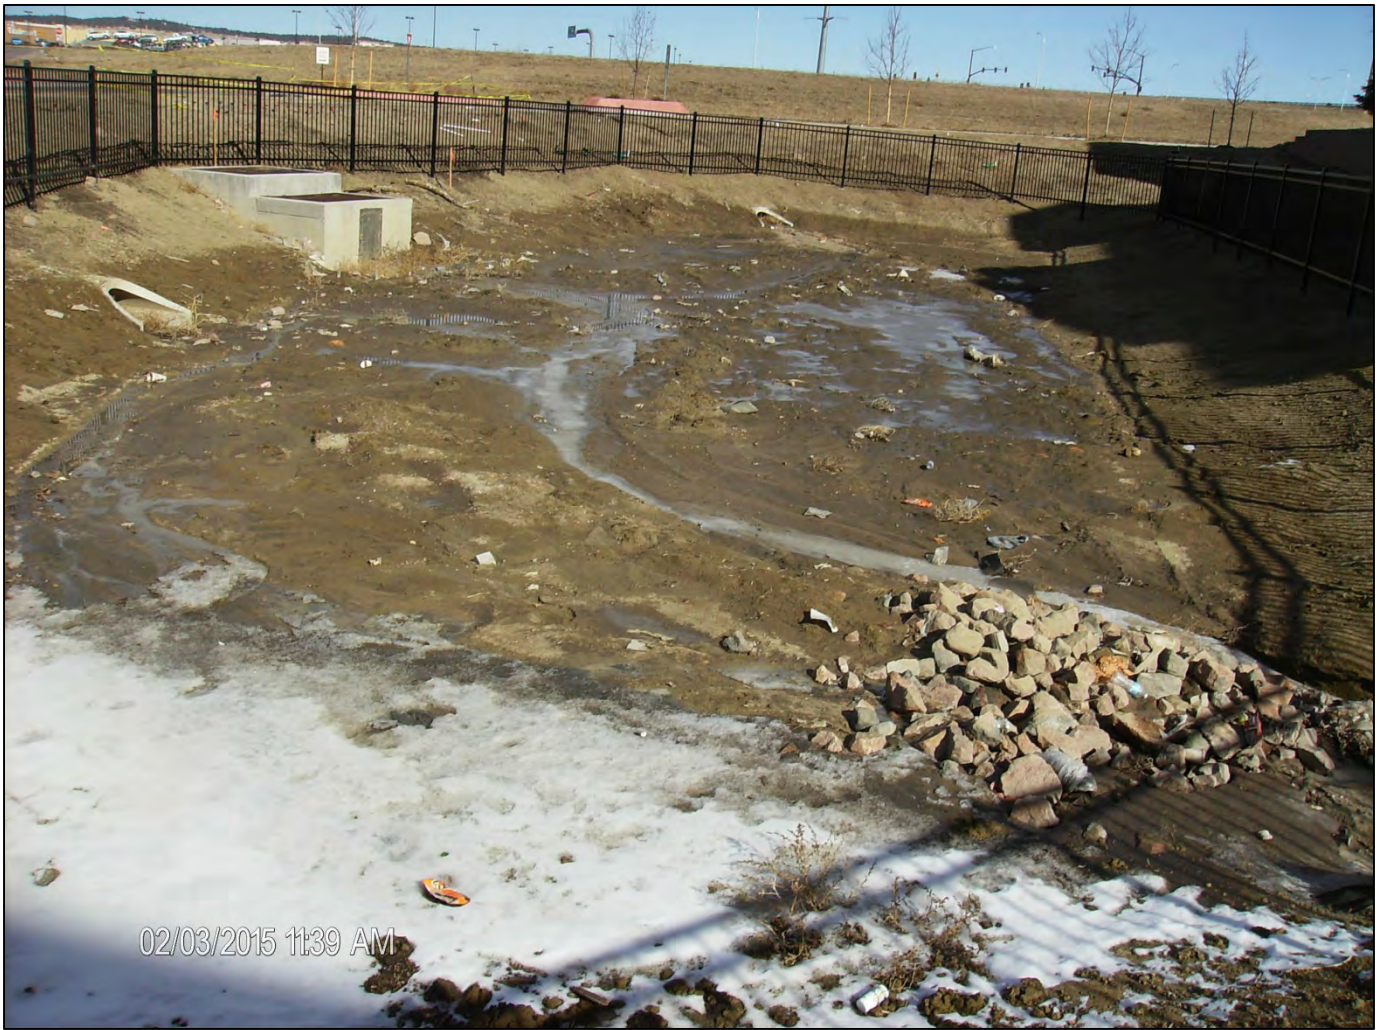
Exhibit 19. City provided photograph of ID – 070 Woodmen Ridge Apartments EDB, dated February 3, 2105. Note that the EDB was unstabilized and contained accumulated sediment and debris.

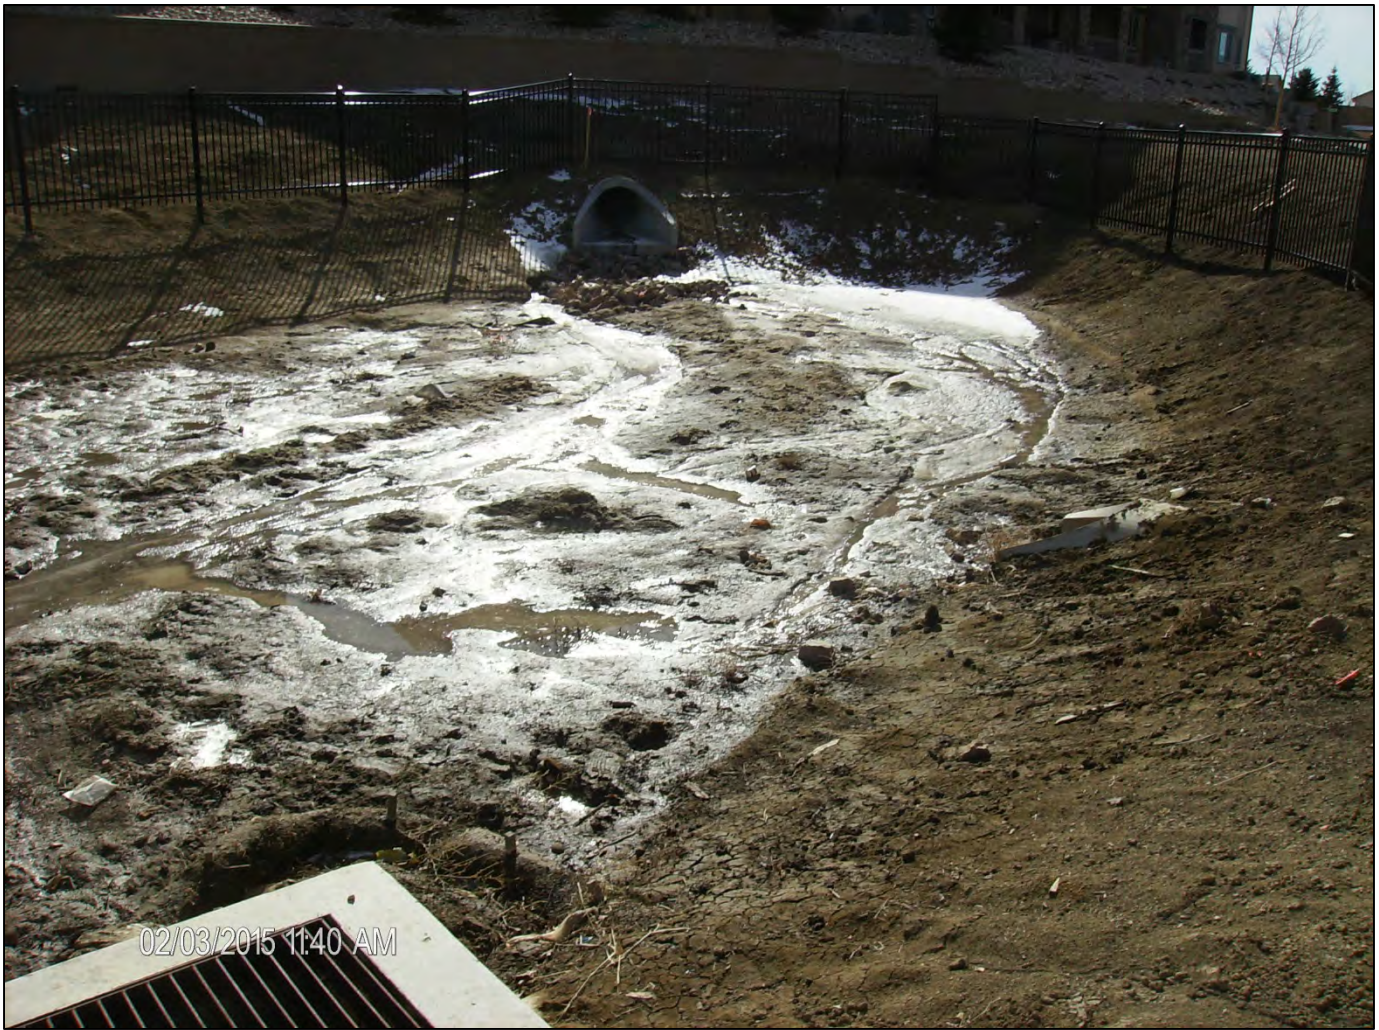
Exhibit 20. City provided photograph of ID – 070 Woodmen Ridge Apartments EDB, dated February 3, 2105. Note that the EDB was unstabilized and contained accumulated sediment and debris.
