City of Colorado Springs Phase I MS4 Inspection Report
Colorado Discharge Permit System, Permit # COS000004

Inspection Dates: August 18, 2015–August 19, 2015

Prepared by
PG Environmental, LLC

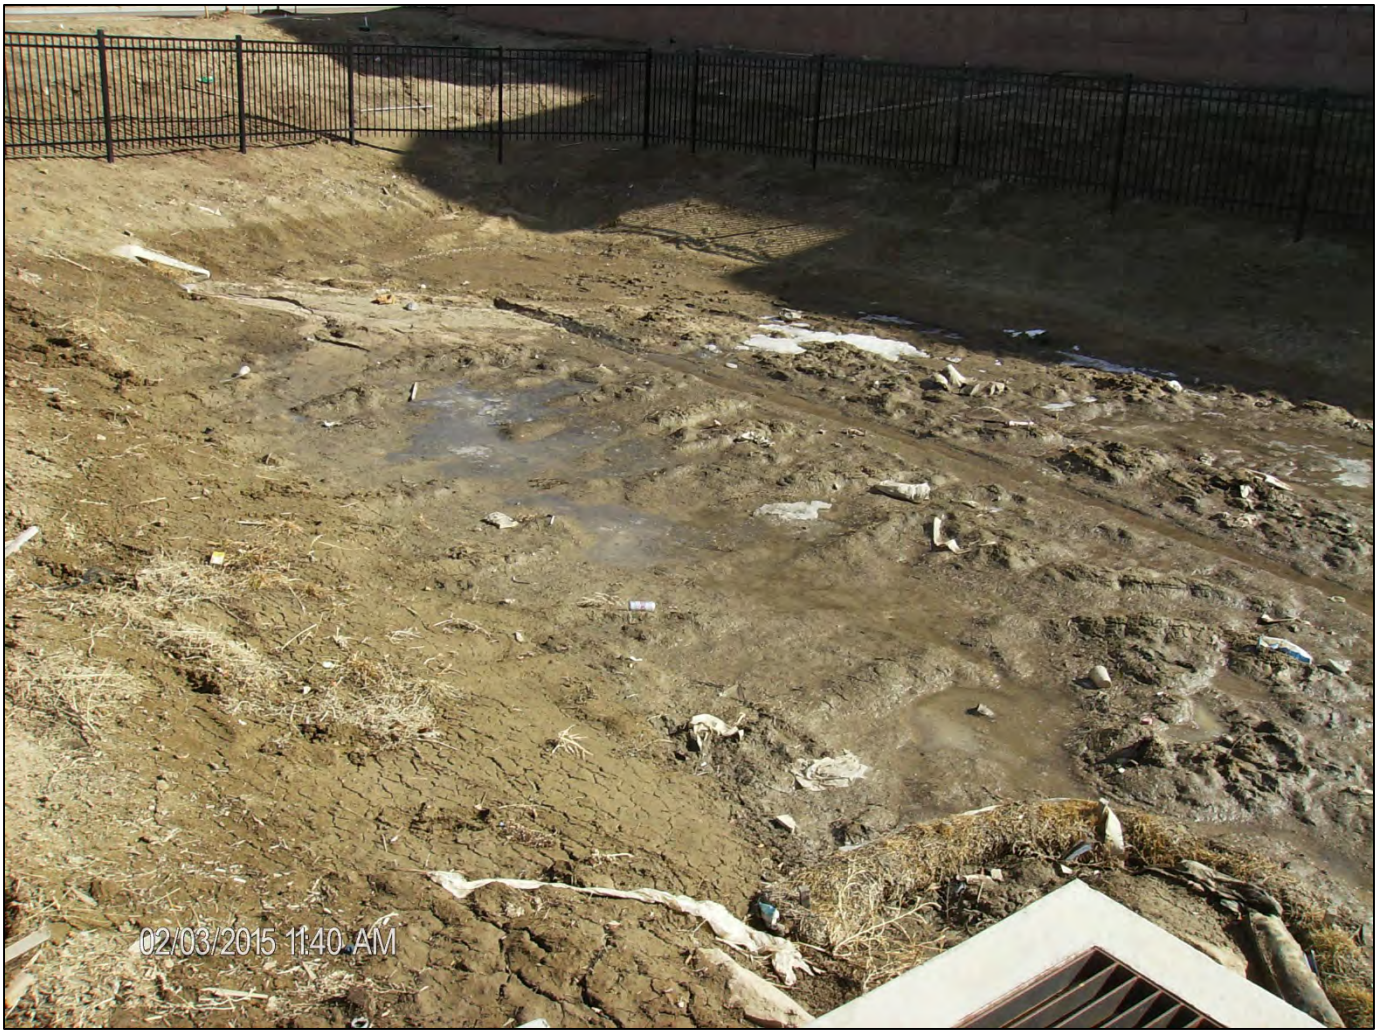
Exhibit 21. City provided photograph of ID – 070 Woodmen Ridge Apartments EDB, dated February 3, 2105. Note that the EDB was unstabilized and contained accumulated sediment and debris.
