UNITED STATES ENVIRONMENTAL PROTECTION AGENCY  
REGION 8

Re: Municipal Storm Water Inspection Report,  
NPDES Permit Number – COS000004

Enclosed is a copy of the inspection report for the Environmental Protection Agency's (EPA's) inspection of the City of Colorado Springs Municipal Separate Storm Sewer System on February 4-7, 2013. Findings were noted during the inspection and are summarized in the enclosed report.

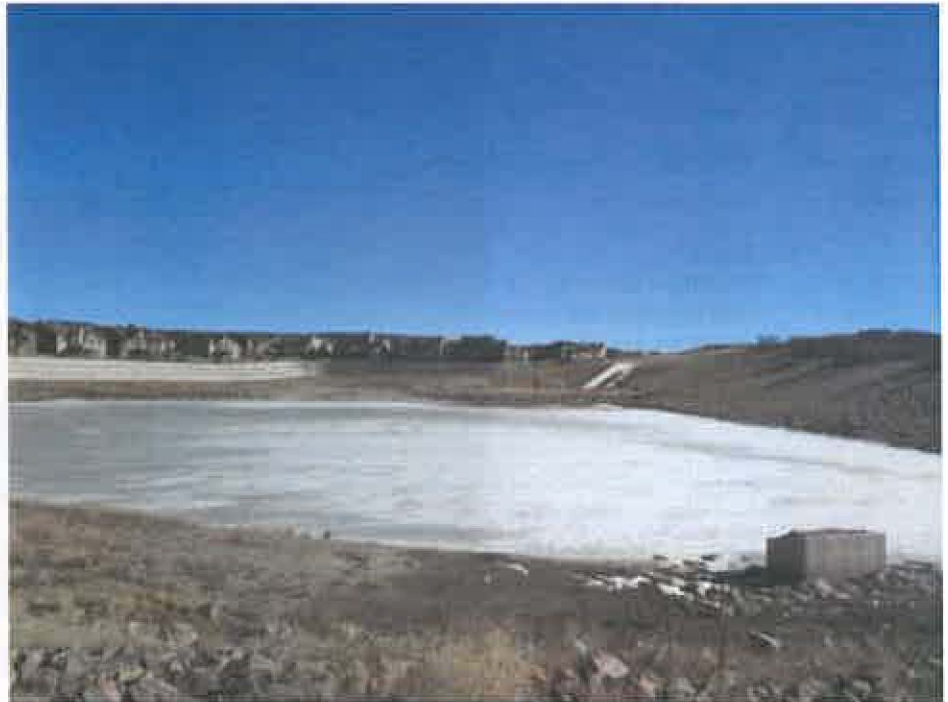
**Photo Number** 10  
**Inspection Date** 2/6/2013  
**Photographer** K. Sable  
**Description** Flying Horse Pond -  
Flying horse pond -  
(facing toward pipe  
where storm flow  
enters pond).

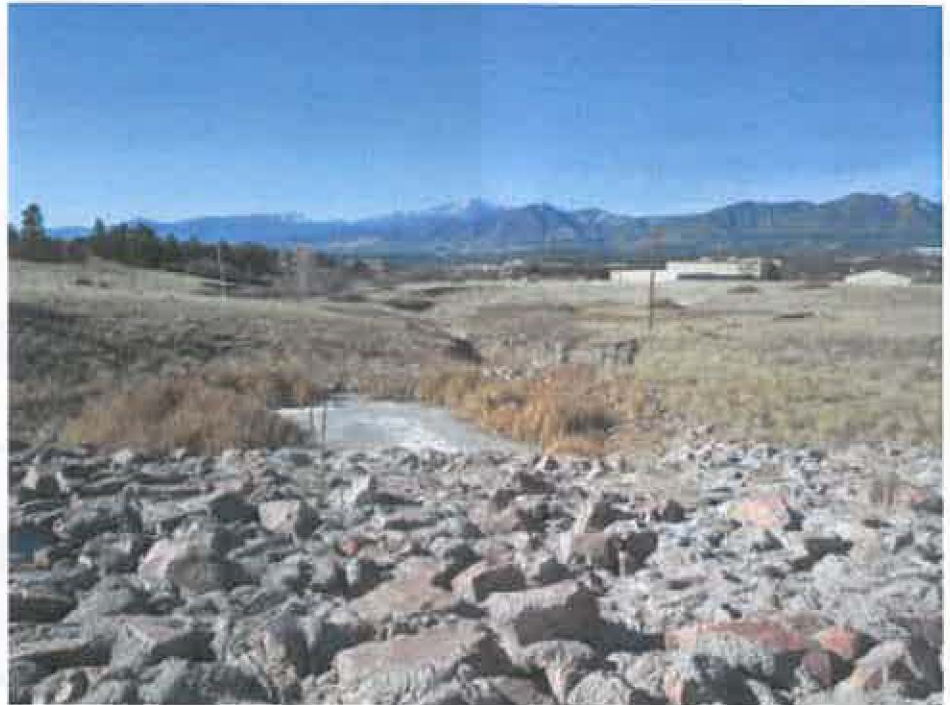
**Photo Number** 11  
**Inspection Date** 2/6/2013  
**Photographer** K. Sable  
**Description** Flying Horse Pond - Photographer standing on rip rap apron of pond, facing downstream from pond where storm flow was discharging.

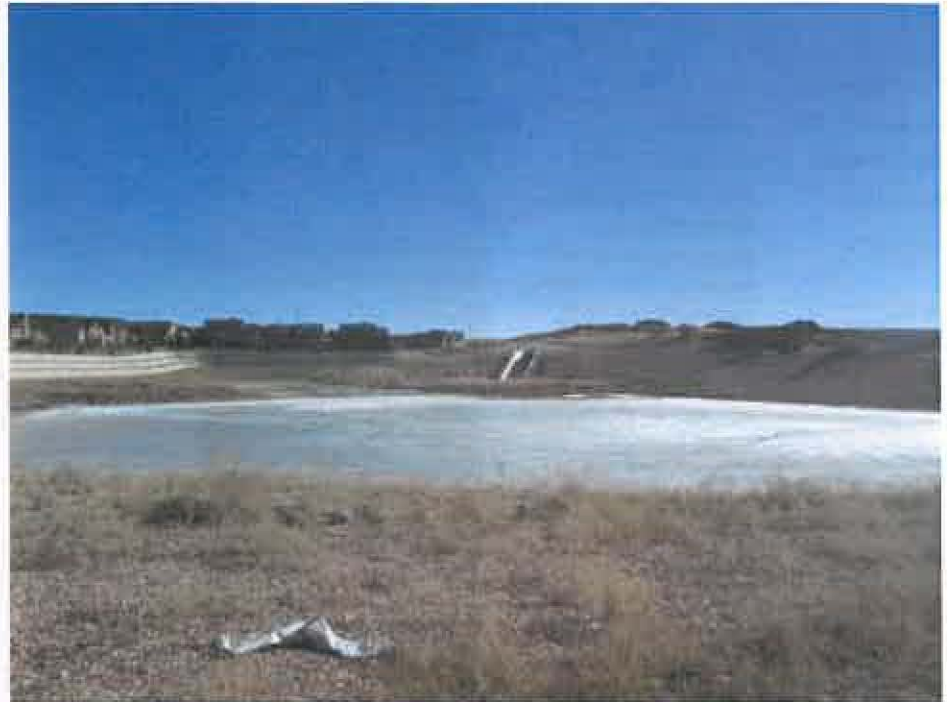
**Photo Number** 13  
**Inspection Date** 2/6/2013  
**Photographer** K. Sable  
**Description** Flying Horse Pond -  
Photo taken facing  
toward pipe where  
storm flow entered  
pond.

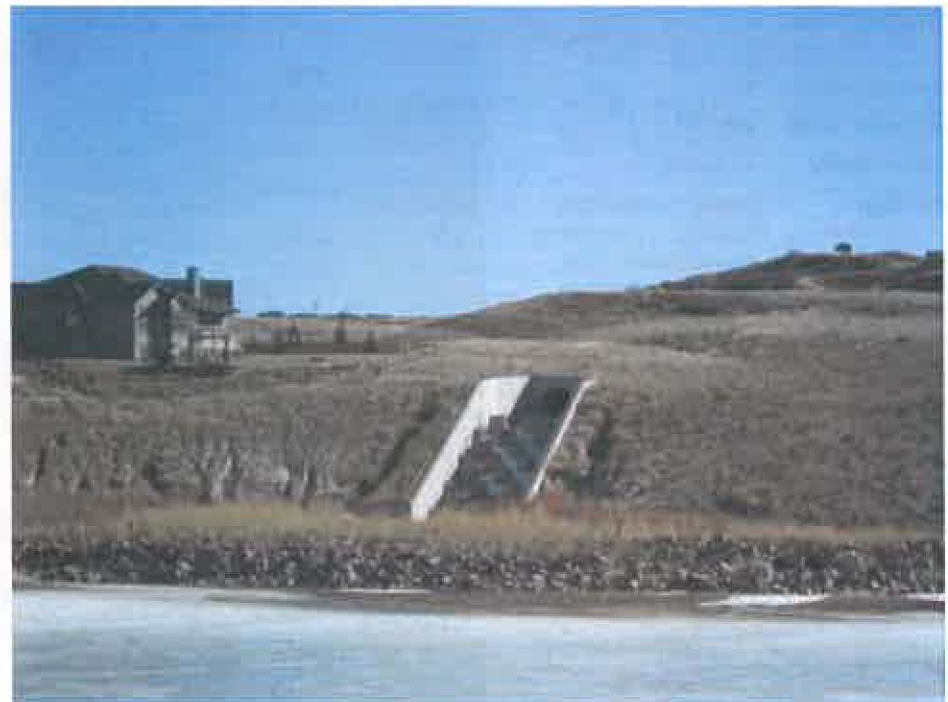
**Photo Number** 14  
**Inspection Date** 2/6/2013  
**Photographer** K. Sable  
**Description** Flying Horse Pond -  
Close up, photo  
taken facing toward  
pipe where storm  
flow entered pond.

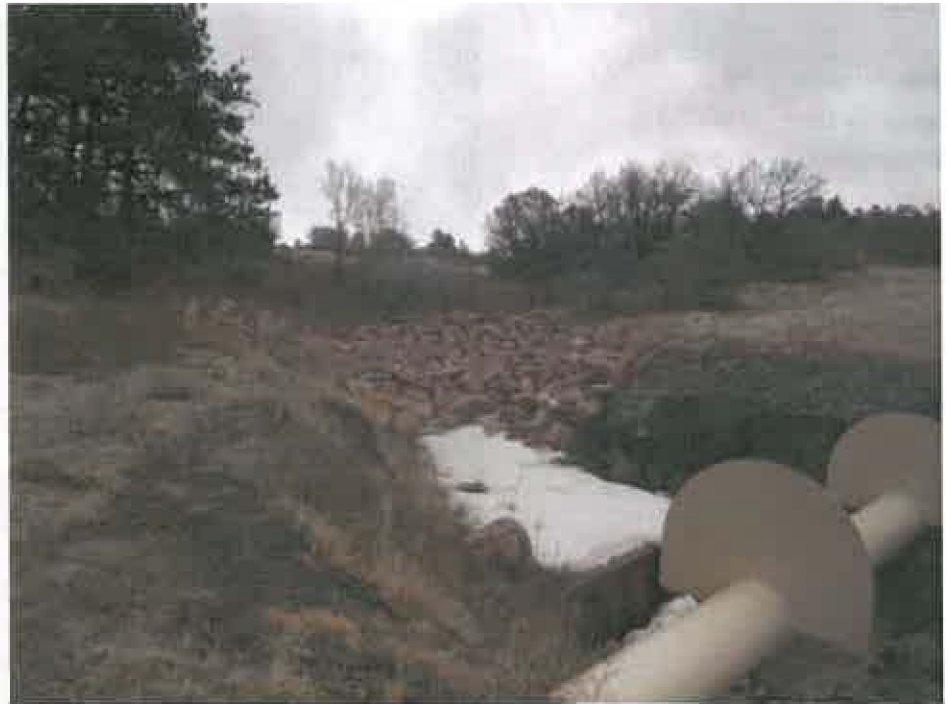
**Photo Number** 17  
**Inspection Date** 2/6/2013  
**Photographer** K. Sable  
**Description** Monument Branch-  
behind TCA school -  
Photo taken facing  
upstream of sewer  
line showing rip rap  
apron.

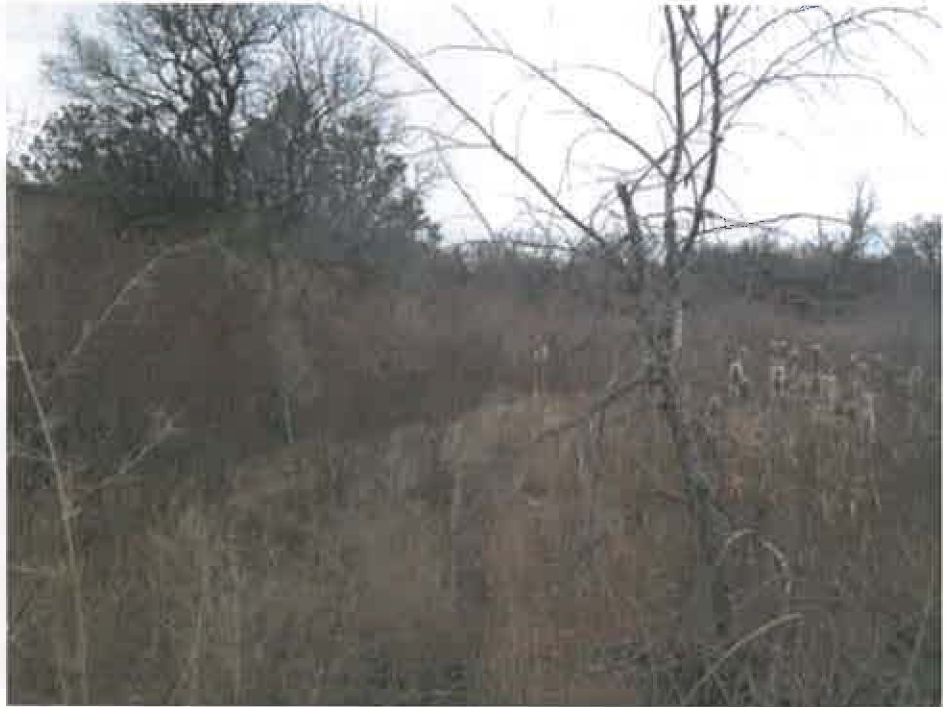
**Photo Number** 23  
**Inspection Date** 2/6/2013  
**Photographer** K. Sable  
**Description** Monument Branch, southwest of pond and north of TCA school - Photo taken facing west in Monument Branch channel.

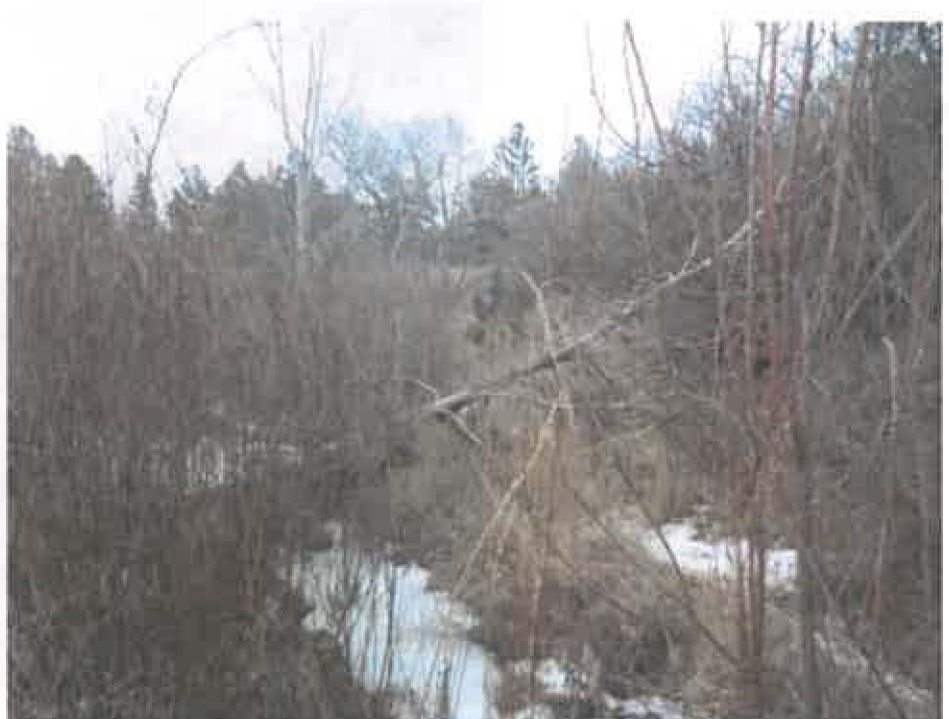
**Photo Number** 24  
**Inspection Date** 2/6/2013  
**Photographer** K. Sable  
**Description** Monument Branch, southwest of pond and north of TCA school - Photo taken facing east in Monument Branch channel.

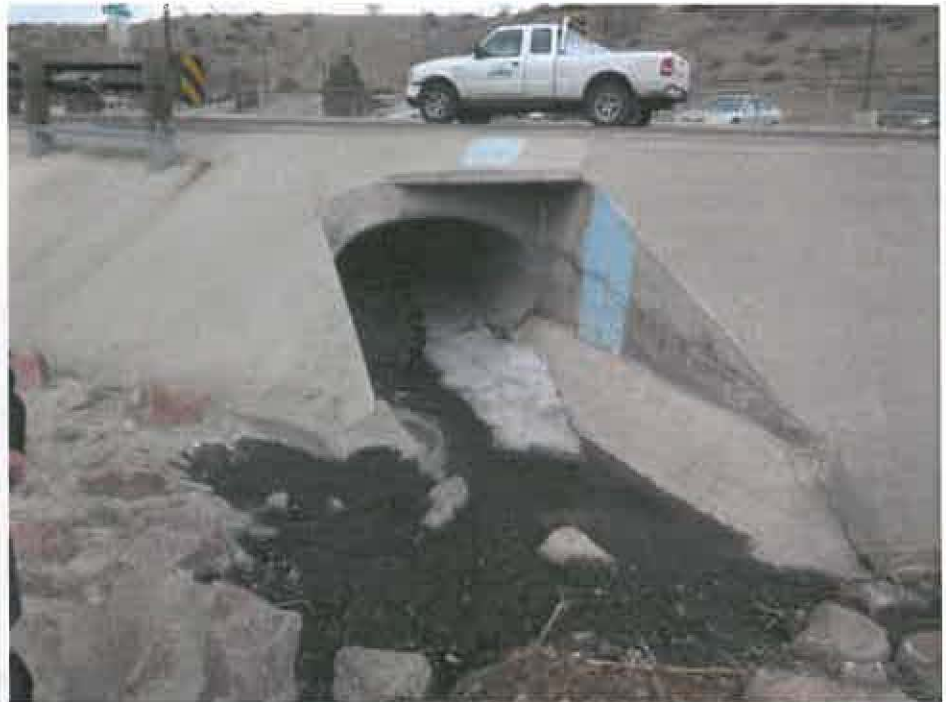
**Photo Number** 25  
**Inspection Date** 2/6/2013  
**Photographer** K. Sable  
**Description** Neighborhood downstream of Cathedral Ridge - Discharge location of storm flow conveyed via pipe from Cathedral Ridge to open channel in neighborhood.

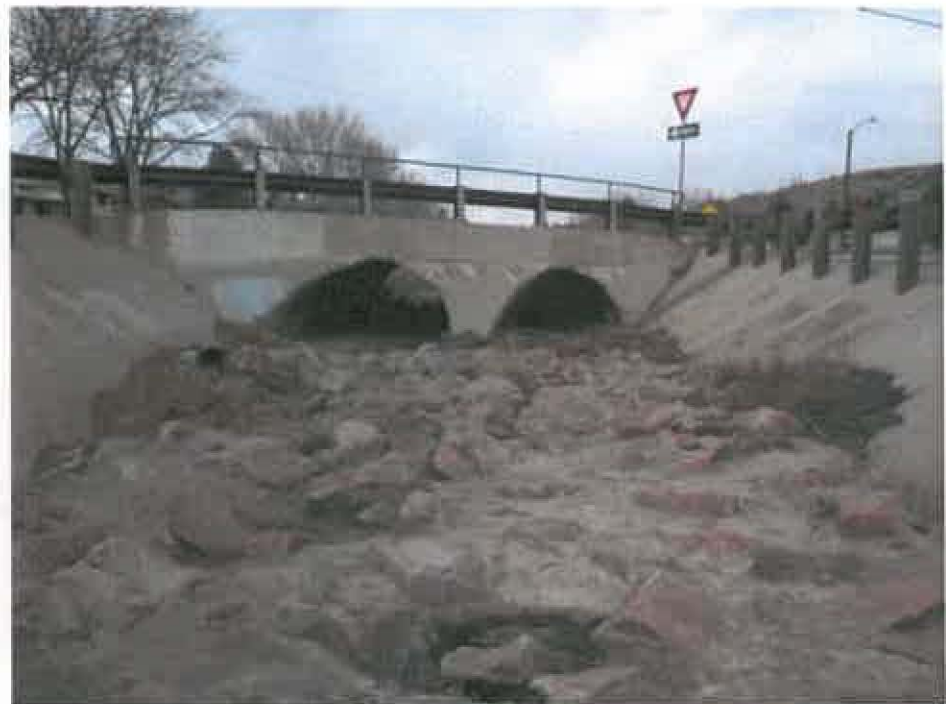
**Photo Number** 26  
**Inspection Date** 2/6/2013  
**Photographer** K. Sable  
**Description** Neighborhood downstream of Cathedral Ridge - Open channel, facing upstream.

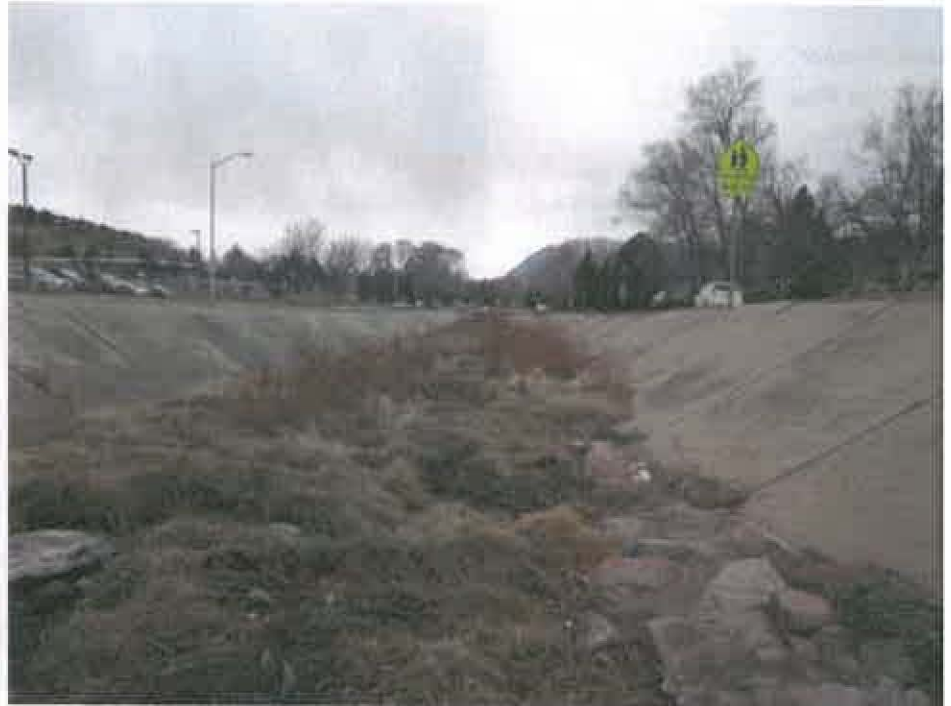
**Photo Number** 27  
**Inspection Date** 2/6/2013  
**Photographer** K. Sable  
**Description** Neighborhood downstream of Cathedral Ridge - Open channel, facing downstream.

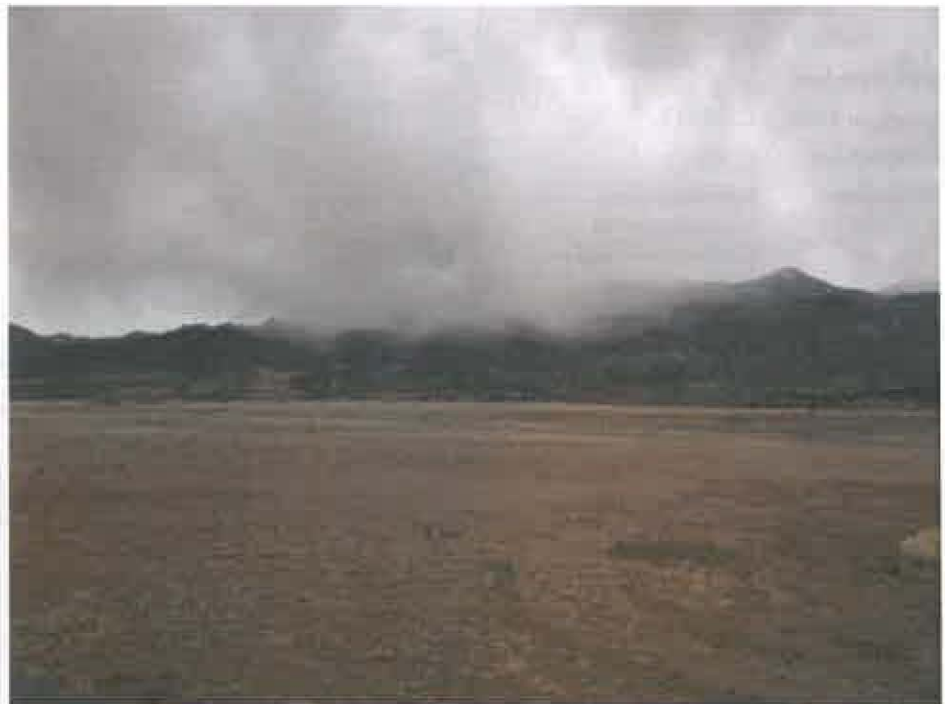
**Photo Number** 29  
**Inspection Date** 2/6/2013  
**Photographer** K. Sable  
**Description** Cathedral Ridge -  
Development area.

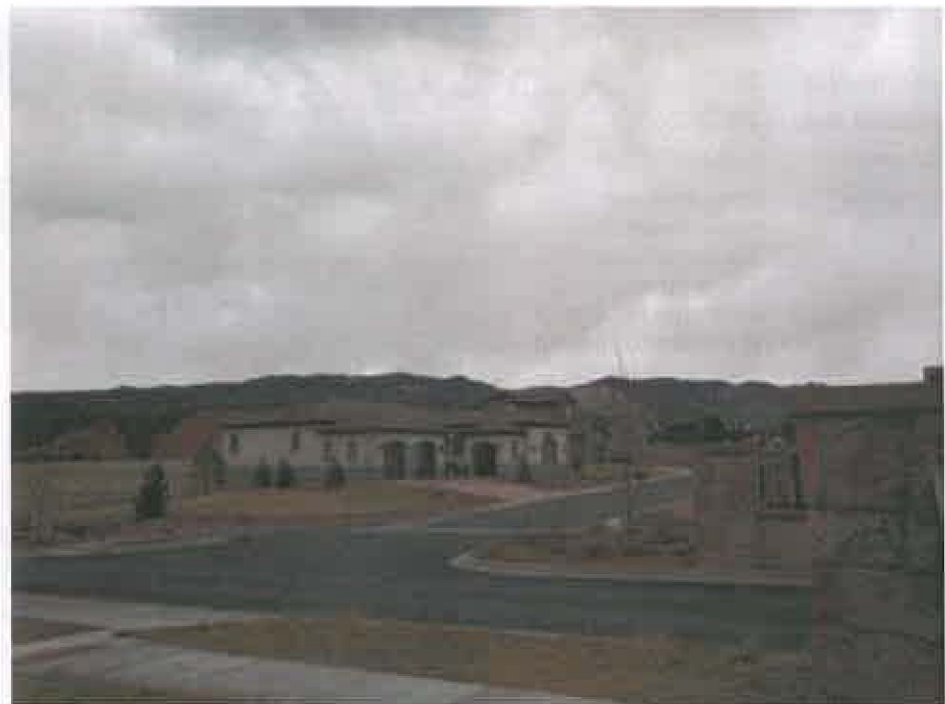
**Photo Number** 30  
**Inspection Date** 2/6/2013  
**Photographer** K. Sable  
**Description** Cathedral Ridge -  
Development area.

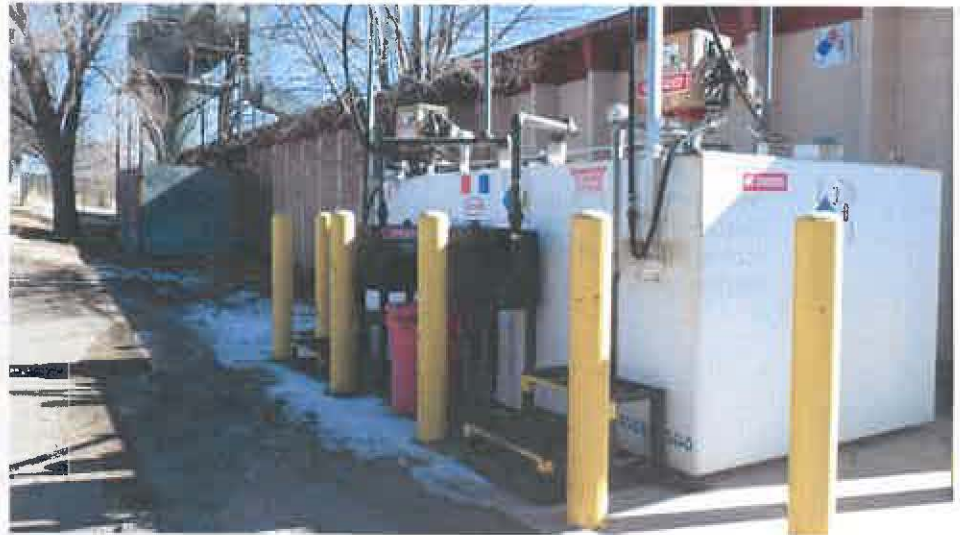
During the inspection of the Patty Jewett Golf Course Maintenance Facility, the site and its relevant best management practices (BMPs) appeared to be installed and well maintained. The only issue noted was that the floor dry used to cleanup spilled fuel at the site was normally stored in a red container adjacent to the fueling area (photo 663); this container was empty during the inspection. According to site staff, during the winter, the facility stored the floor dry in a separate container indoors to prevent it from freezing. No other concerns were noted with the facility in relation to the site's implementation of the MFRCP.

**Photo Number** 663  
**Inspection Date** 2/5/2013  
**Photographer** D. Gwisdalla  
**Description** Patty Jewett golf course maintenance facility: Fueling area. The red container next to fuel tank is suppose to contain dry absorbent.

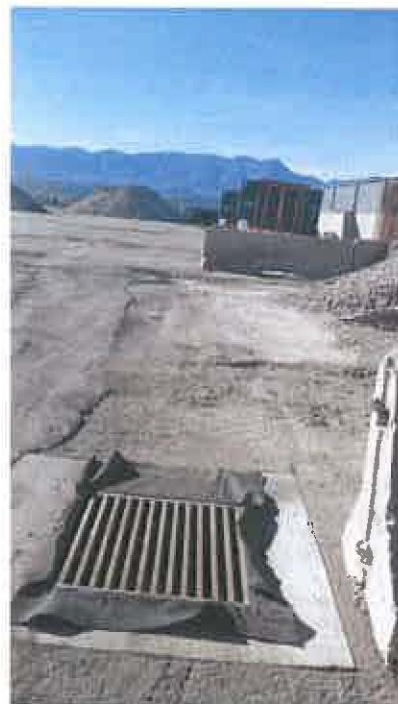
The site appeared to have been recently maintained (photo 664) and was overall in good condition. The site had minor staining under equipment parking areas. Discharge point number six (DP6) had a permanent BMP installed (a large grate inlet) with hay bale protection to reduce sediment from going into the inlet (photo 665). At DP6, below the outlet, rock and soil staining from what appeared to be salt was evident (photo 666). No other concerns were noted with the facility in relation to the site's implementation of the MFRCP.

**Photo Number** 664  
**Inspection Date** 2/5/2013  
**Photographer** D. Gwisdalla  
**Description** Briargate Service Center: Storm drain inlet (with insert) on the north side of the property taken looking to the west.

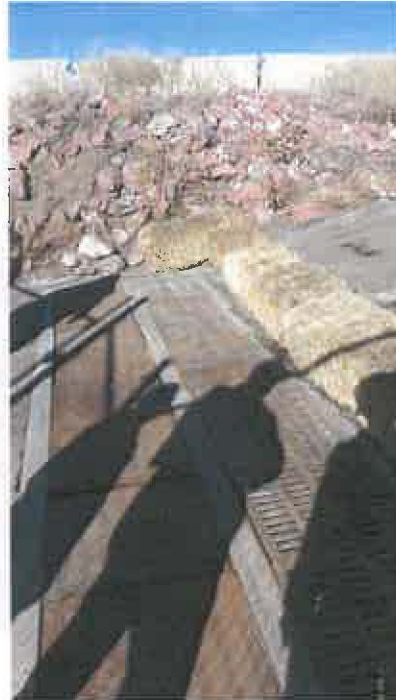
**Photo Number** 665  
**Inspection Date** 2/5/2013  
**Photographer** D. Gwisdalla  
**Description** Briargate Service Center: Storm drain inlet (with hay bale protection) on the southwest side of the property taken looking to the northwest.

The City should evaluate its procedures to reduce the discharge of salt from site activities at the Briargate Service Center (2385 Briargate Blvd.). While the site appeared to be in good condition, discharge point number six (DP6), had evidence of salt staining downstream of DP6.

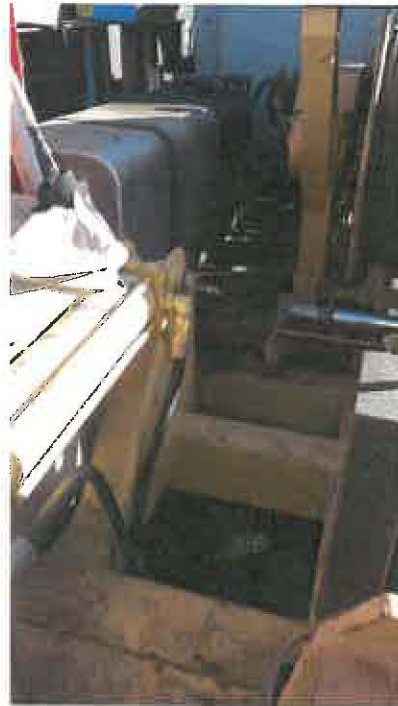
**Photo Number** 671  
**Inspection Date** 2/5/2013  
**Photographer** D. Gwisdalla  
**Description** Close-up of the leaking equipment shown in photo 670.

Provide photo documentation for the following issues observed during the inspection and a date when they were addressed at the CSU, Pinkerton Service Center (7710 Durant Dr.):

1. The "TransGuard Hydraulic Tract Fluid" spill (photos 667 to 669).
2. The leaking/dripping equipment observed during the inspection (photos 670 and 671).

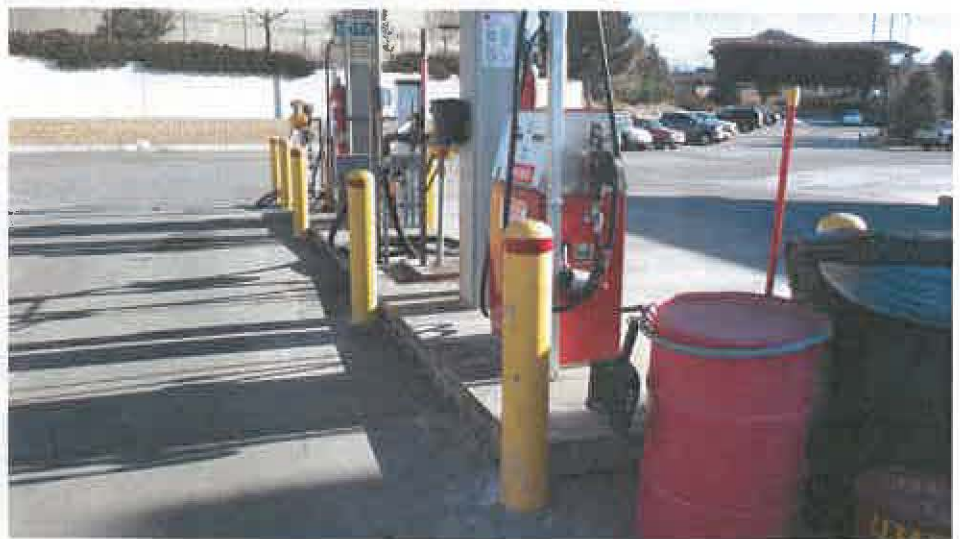
**Photo Number** 672  
**Inspection Date** 2/5/2013  
**Photographer** D. Gwisdalla  
**Description** CSU, Pinkerton Service Center: Fueling station on the central southern portion of the site. Note the red dry absorbent container in the bottom right portion of the photo.

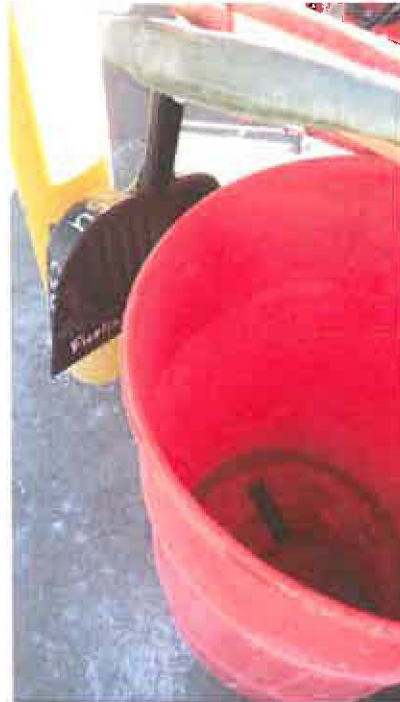
The site was in good condition in relation to its MFRCP. Three items related to material storage, equipment storage and good housekeeping were noted during the inspection. The site was storing outdoors "TransGuard Hydraulic Tract Fluid", whereby the material was spilled or dripping causing staining of the soil and retaining wall (photos 667 to 669). While a large number of vehicles and equipment were stored at the site, oil/fuel staining at the parking locations was minimal. However, one piece of equipment was observed as leaking during the inspection (photos 670 and 671). The fueling island's spill kit dry absorbent was noted as empty (photos 672 and 673). No other concerns were noted with the facility in relation to the site's implementation of the MFRCP. On February 14, 2013, photographic evidence was provided by the City illustrating the spill kit dry absorbent containers were now filled.

**Photo Number** 673  
**Inspection Date** 2/5/2013  
**Photographer** D. Gwisdalla  
**Description** Close-up of the red container shown in photo 672. It was noted as being empty at the time of the inspection.

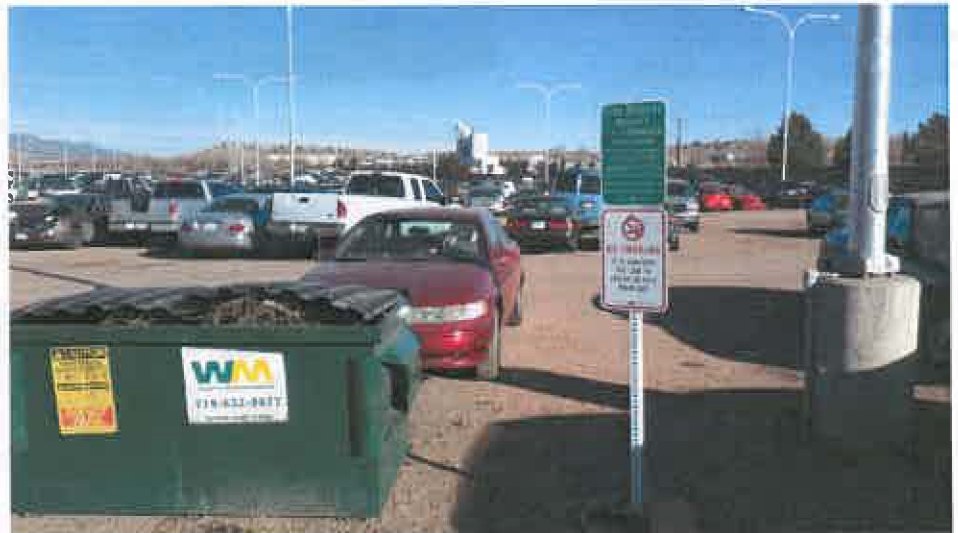
**Photo Number** 674  
**Inspection Date** 2/6/2013  
**Photographer** D. Gwisdalla  
**Description** Police Impound Facility: Waste storage. Also note the green sign in the impound yard, it outlines how persons at the site can protect stormwater at the site.

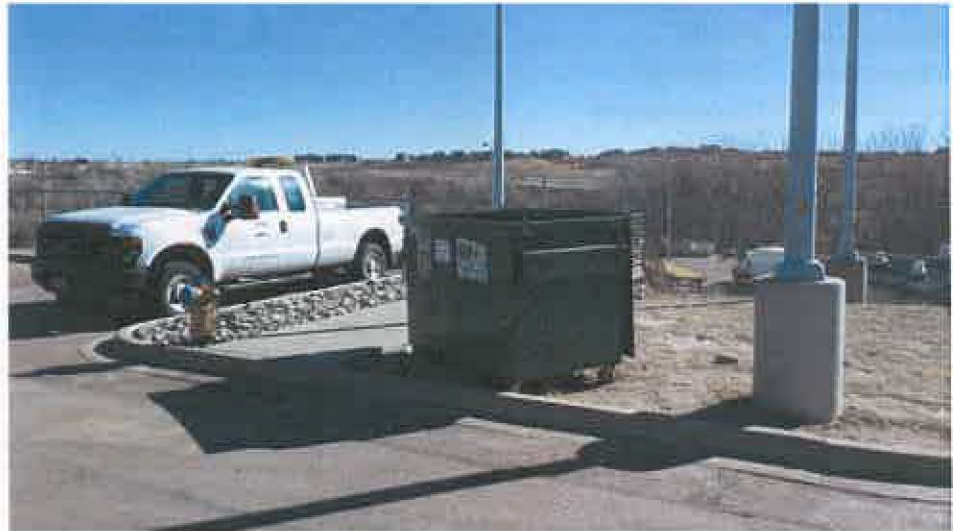
The site was in good condition in relation to its MFRCP. The only issue observed during the inspection was that one of the site's dumpster lids was open and should be closed (photo 677). No other concerns were noted with the facility in relation to the site's implementation of the MFRCP.

**Photo Number** 677  
**Inspection Date** 2/6/2013  
**Photographer** D. Gwisdalla  
**Description** CSU, Leon Young Service Center: A solid waste dumpster being used without a cover.

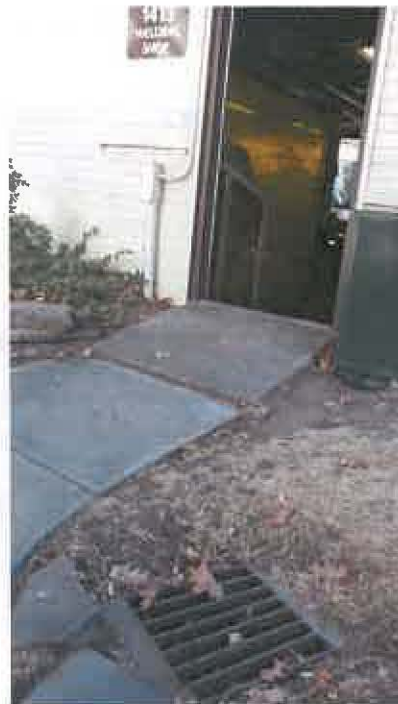
**Photo Number** 678  
**Inspection Date** 2/6/2013  
**Photographer** D. Gwisdalla  
**Description** Parks and Recreation, Central Mechanics: Note the storm drain inlet at building 1413. It was unclear where this inlet flowed, it was not depicted on the site map, and the inlet was full of leaves.

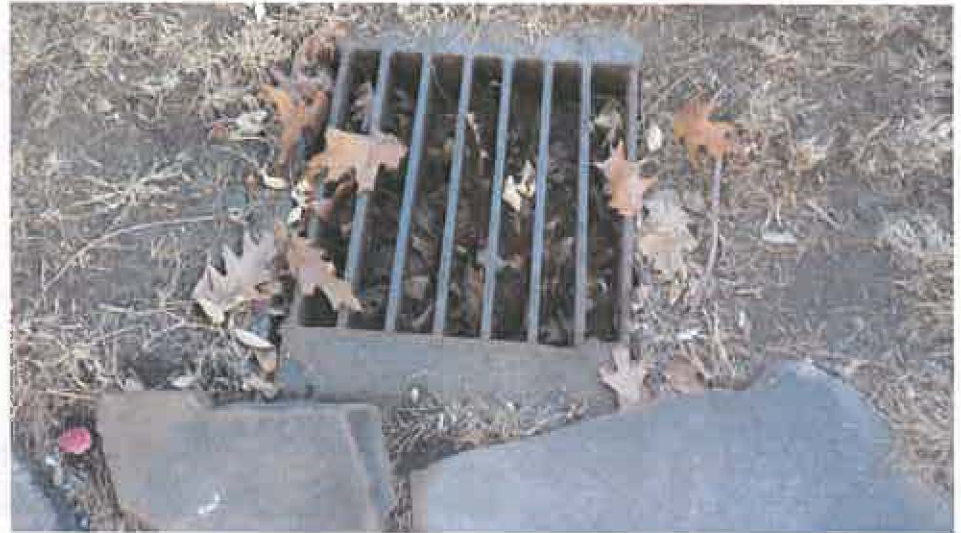
**Photo Number** 679  
**Inspection Date** 2/6/2013  
**Photographer** D. Gwisdalla  
**Description** Storm drain inlet shown in photo 678. Note the leaves in the drain.

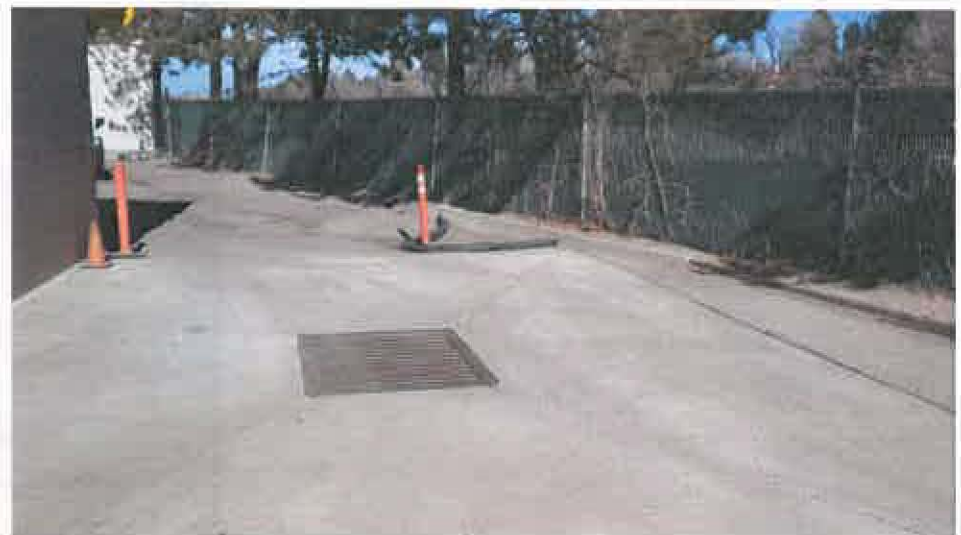
**Photo Number** 680  
**Inspection Date** 2/6/2013  
**Photographer** D. Gwisdalla  
**Description** Parks and Recreation, Central Mechanics: Washrack for the site on the east side of the facility. The wash rack reportedly flows to the sanitary system. There is an inlet adjacent to the wash rack located at the orange pylon in the center of the photo.

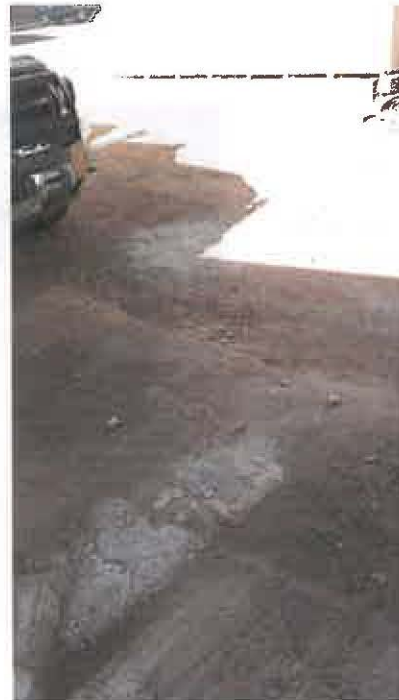
**Photo Number** 682  
**Inspection Date** 2/6/2013  
**Photographer** D. Gwisdalla  
**Description** White discoloration shown in photo 681. The discoloration is believed to be cement that was washed down into/towards the storm drain inlet as shown in the following photos.

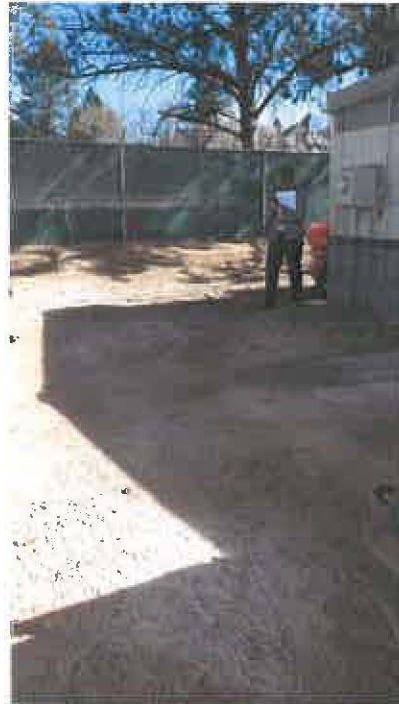
**Description** Overview of the location shown in photo 681-683. The flow of the cement appeared to flow in the general direction of the person standing in the center of the photo.

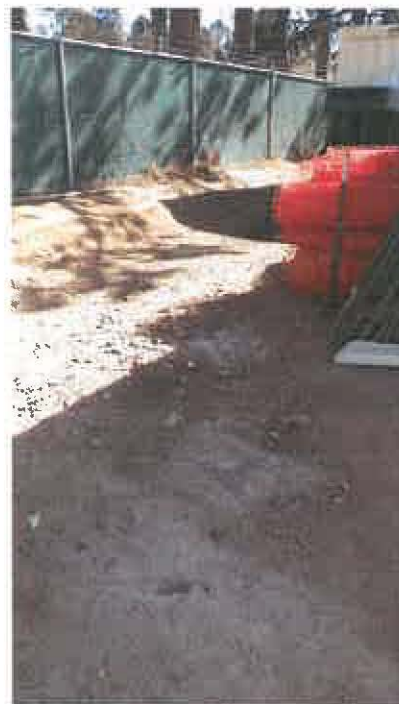
**Photo Number** 684

**Description** More staining on the ground down gradient of the previous photos. The site was observed by the EPA inspector to have been recently maintained and portions of the ground appeared to have been raked.

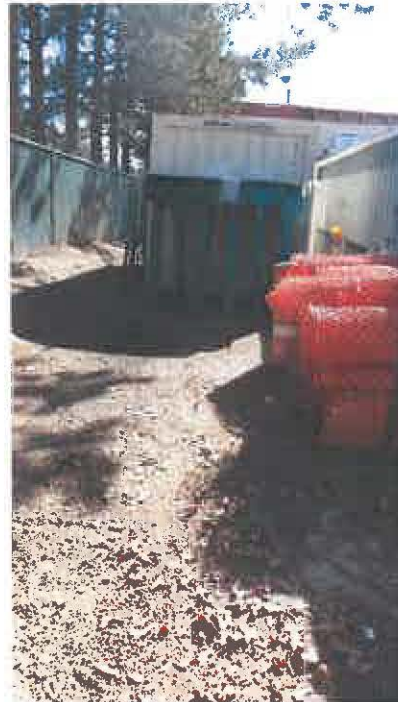
**Photo Number** 685  
**Inspection Date** 2/6/2013  
**Photographer** D. Gwisdalla  
**Description** Overview of photo 684. The traces of the cement staining were observed to have flowed to the white Conex box in the center of the photo; note the green bird houses against the Conex box.

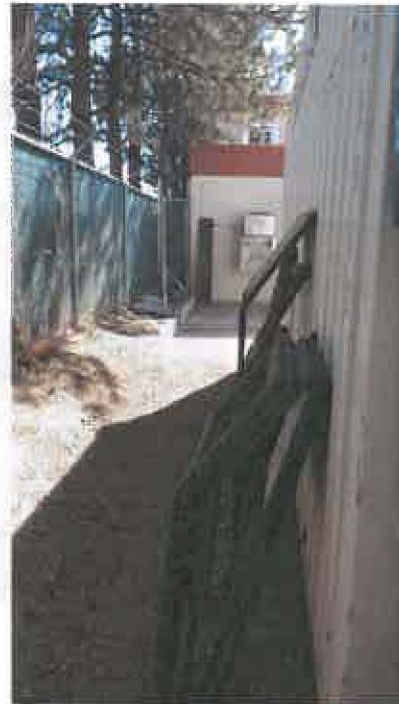
**Description** Eastern edge of the Conex box shown in photo 685 to illustrate the location of the discharge point into the inlet from the Conex box. Note the green column in the center of the photo beyond the Conex box.

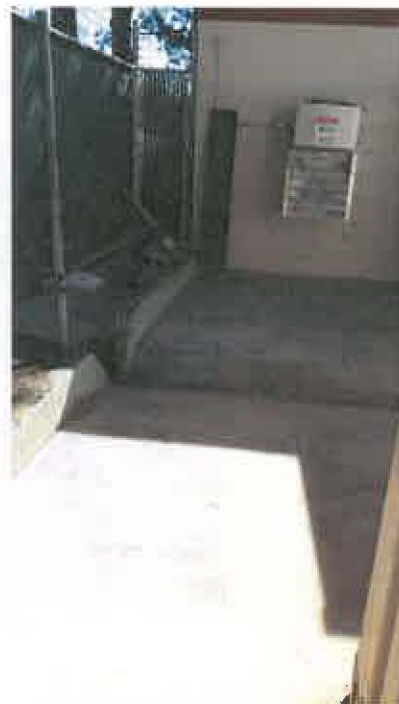
**Photo Number** 688

**Description** Parks and Recreation, Central Mechanics: Location of the outfall on the eastern edge of the property flowing into the adjacent creek. The discharge location was as shown further south of the Conex box in photo 687.

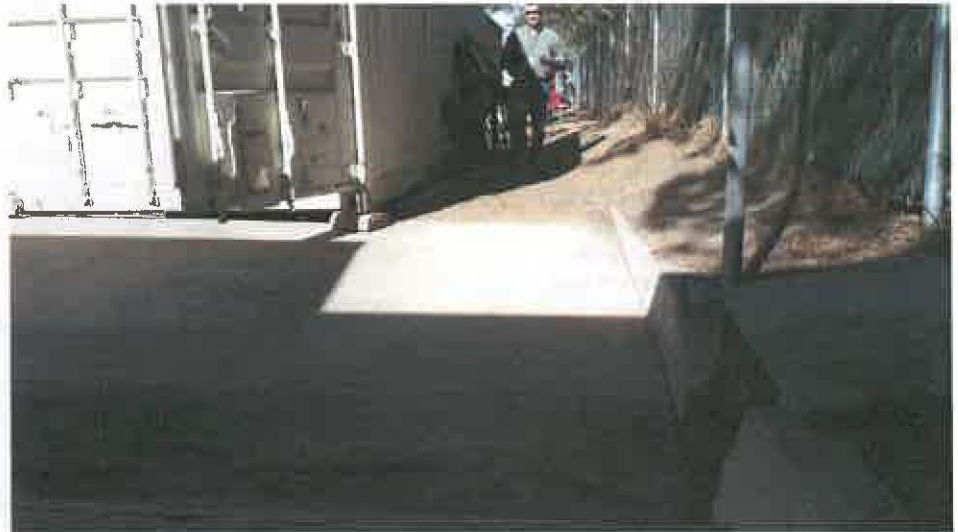
**Photo Number** 689  
**Inspection Date** 2/6/2013  
**Photographer** D. Gwisdalla  
**Description** Location of the outfall on the eastern edge of the property flowing into the adjacent creek. A photo to the north back at the Conex box from discharge location adjacent to the stormwater inlet on the right of the photo (as shown in photo 691).

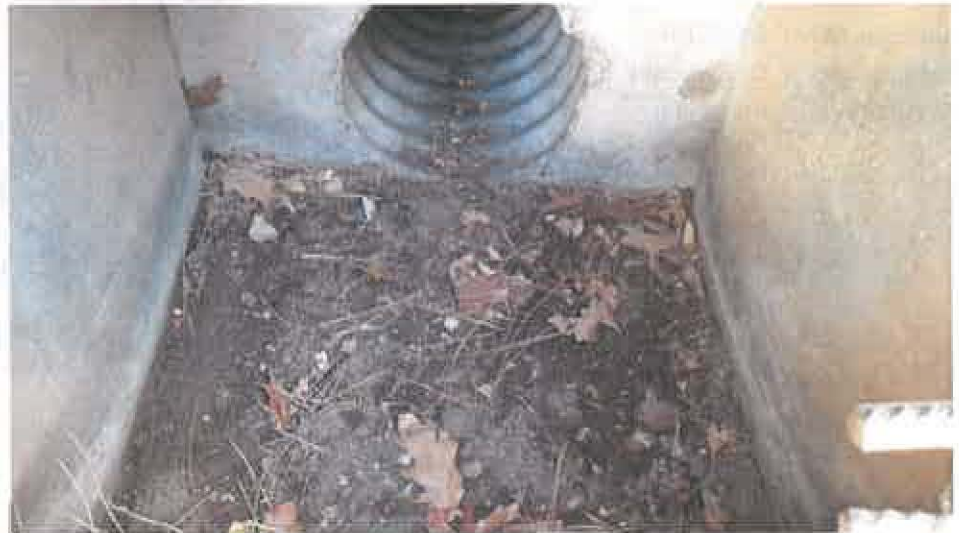
**Photo Number** 690  
**Inspection Date** 2/6/2013  
**Photographer** D. Gwisdalla  
**Description** Parks and Recreation, Central Mechanics: Outfall shown in photo 689 and directly in photo 691.

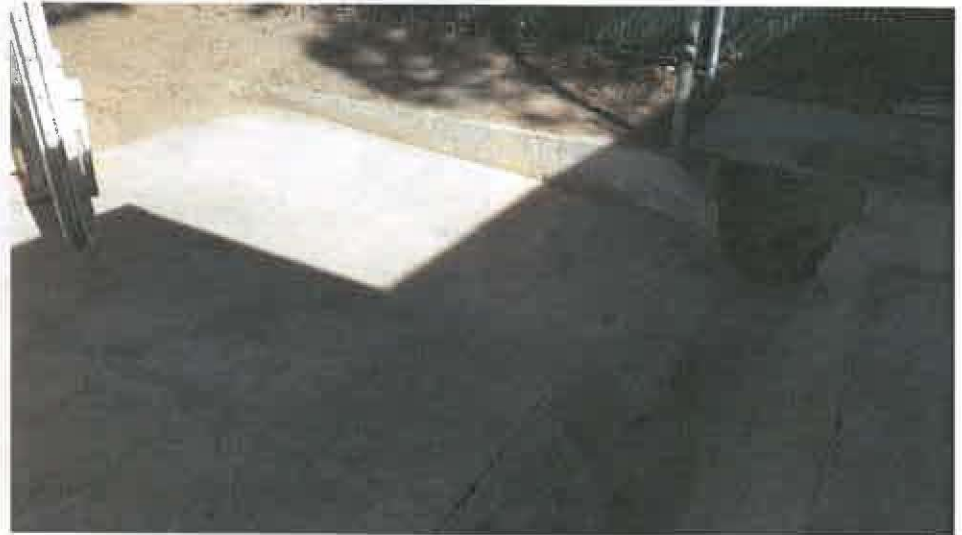
**Photo Number** 691  
**Inspection Date** 2/6/2013  
**Photographer** D. Gwisdalla  
**Description** Parks and Recreation, Central Mechanics: Location of the outfall on the eastern edge of the property flowing into the adjacent creek. The discharge location was as shown further south of the Conex box in photo 687.

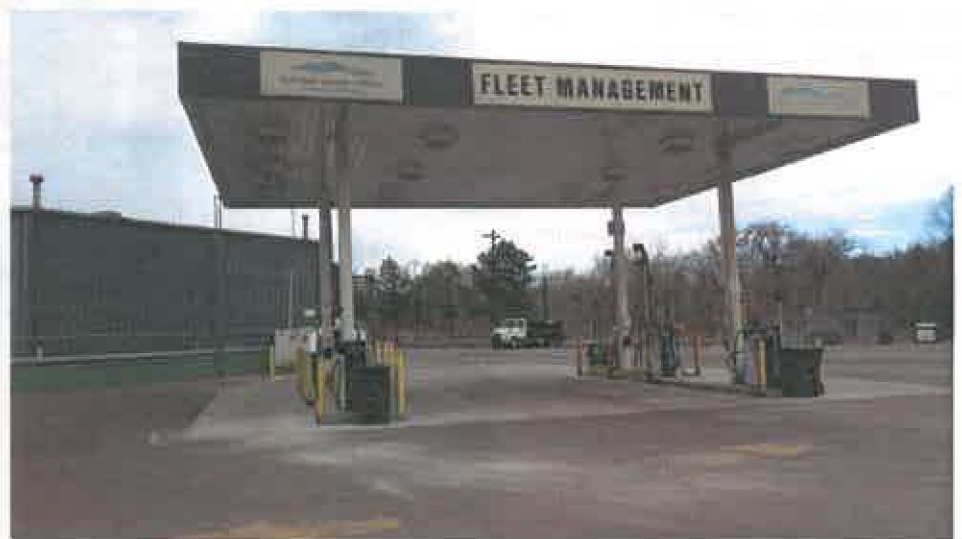
**Photo Number** 692  
**Inspection Date** 2/6/2013  
**Photographer** D. Gwisdalla  
**Description** Fontanero Service Center's Fleet Maintenance: Fueling station.

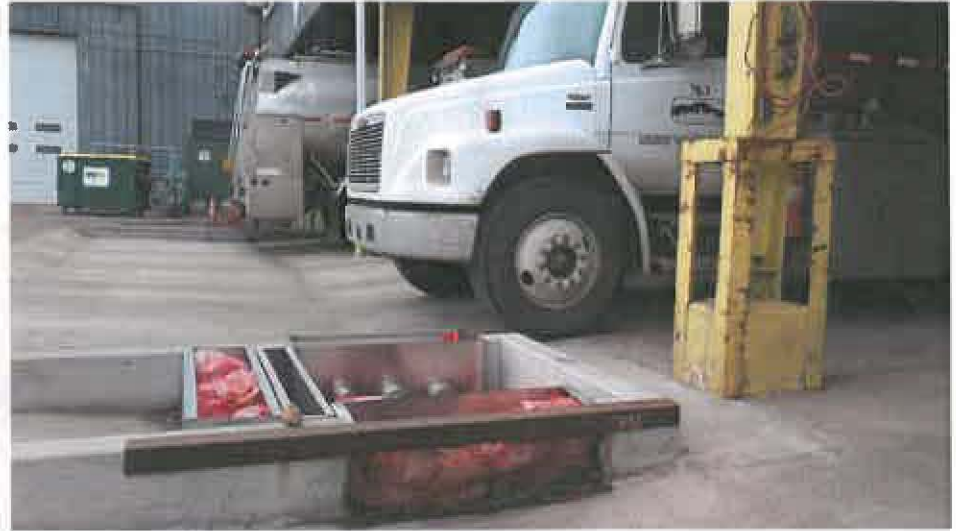
**Photo Number** 693  
**Inspection Date** 2/6/2013  
**Photographer** D. Gwisdalla  
**Description** Fontanero Service Center, Fleet Maintenance. Note the discharge control structures with absorbent materials.

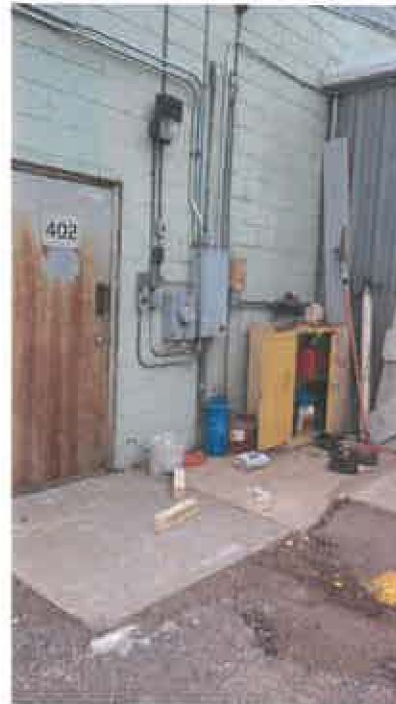
Other areas owned and operated by the CCS Street Division, CSU and the Traffic Engineering Department were also inspected by the EPA inspector. On the north side of the Traffic Engineering facility, poor housekeeping of fuels and oils (photo 695) was observed. The facility supervisor was notified and stated that he would address the issue. The EPA inspector asked for photo documentation

**Photo Number** 695  
**Inspection Date** 2/6/2013  
**Photographer** D. Gwisdalla  
**Description** Traffic Engineering facility at the Fontanero Service Center. Note the poor housekeeping at the site (outside door 402).

illustrating it was corrected. A photo of the site, taken on February 8, 2013, was provided to the EPA on February 11, 2013 illustrating that the issue was corrected. No other concerns were noted with the facility related to the site's implementation of the MFRCP.

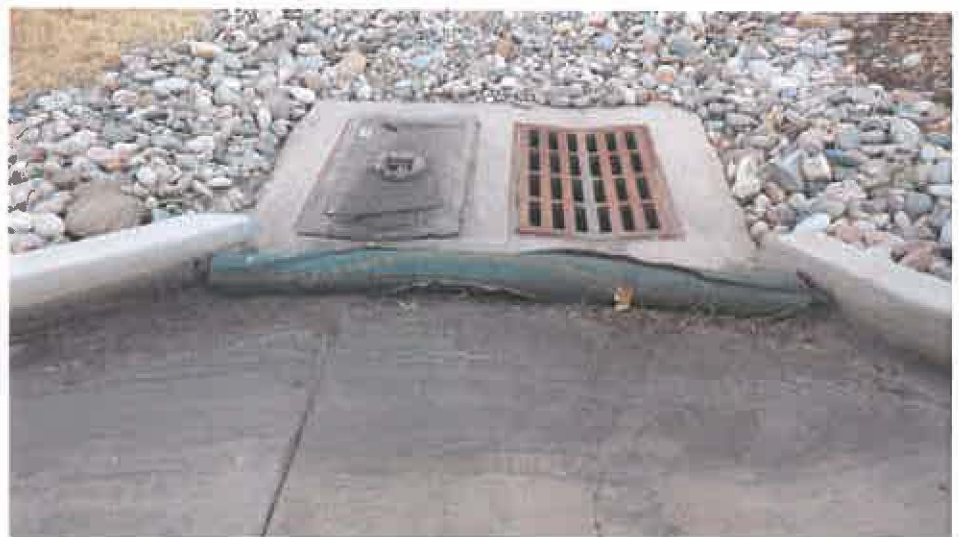
At the CSU Facilities Building 456 (at 416 Fontanero), on the southeast side of the facility, an inlet with two grates was missing a BMP over one of the inlets (photo 696). The inlet protection shown in the photo was not on the site map, it was reportedly left over from when the facility was being constructed. The remaining BMP had not failed but, rather than disposing of it, it was left in place. The other BMP was removed because it was no longer serviceable. No other concerns were noted with the facility in relation to the site's implementation of the MFRCP.

**Photo Number** 696  
**Inspection Date** 2/6/2013  
**Photographer** D. Gwisdalla  
**Description** CSU facility at the Fontanero Service Center. Stormwater inlet protection. Note one of the inlets was covered with additional protection; the other was not protected.

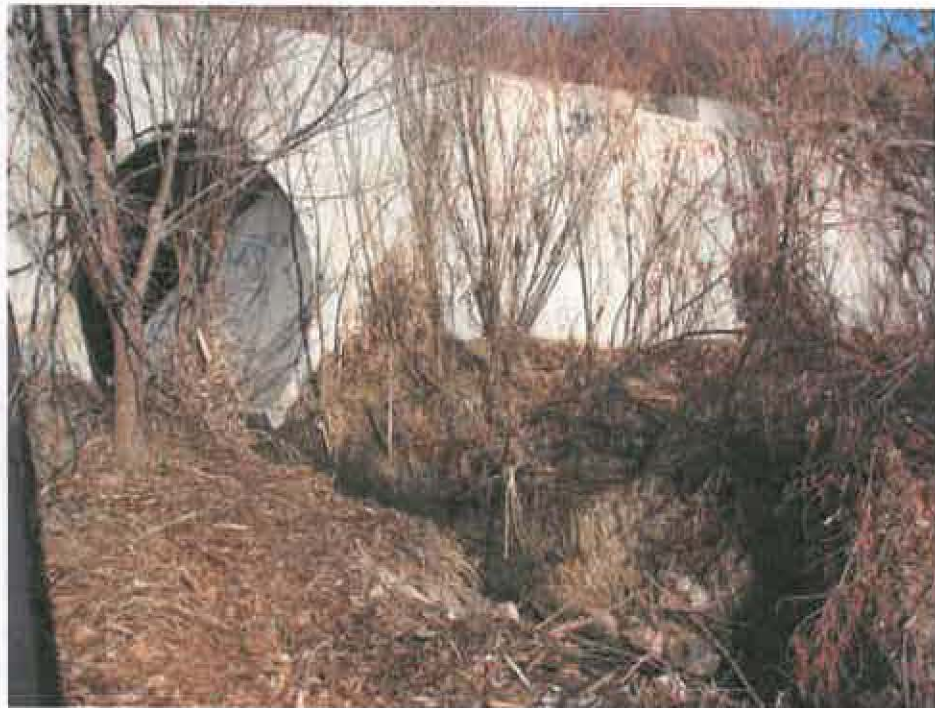
**Photo Number** 1  
**Inspection Date** 2/7/2013  
**Photographer** Monia Ben-Khaled  
**Description** Overview of outfall MOCR02621797, located at Monument Creek by Goose Gossage baseball field. The outfall discharges into Monument Creek.

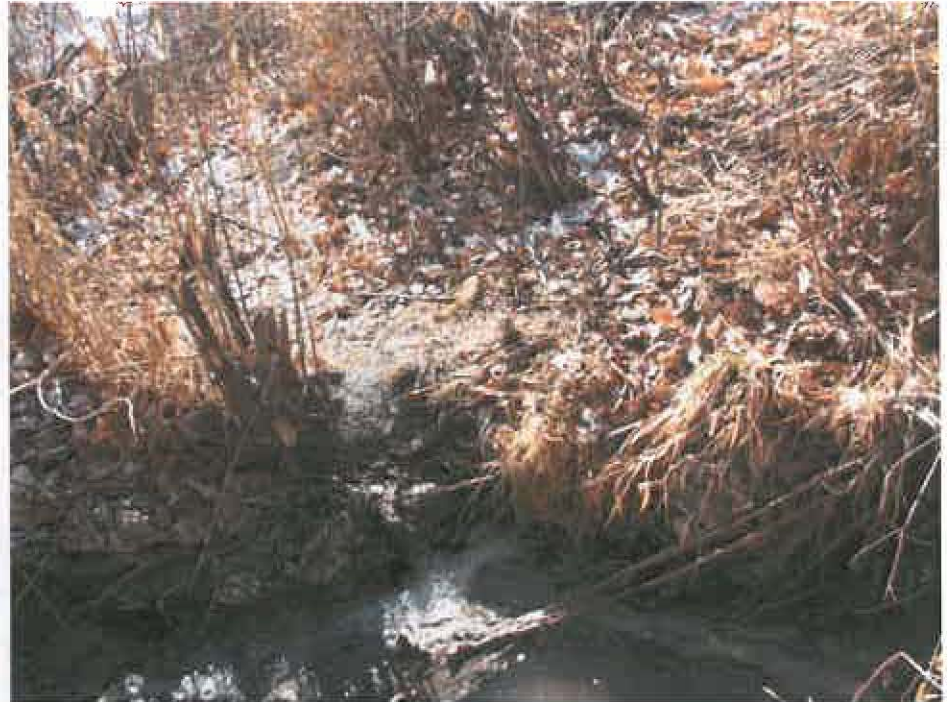
**Photo Number** 3  
**Inspection Date** 2/7/2013  
**Photographer** Monia Ben-Khaled  
**Description** Closeup of outfall MOCR02622397, located by Douglas Creek. The outfall discharges into Douglas Creek. The discharge appeared foamy but had no distinct smell.
