UNITED STATES ENVIRONMENTAL PROTECTION AGENCY  
REGION 8

Re: Municipal Storm Water Inspection Report,  
NPDES Permit Number – COS000004

Enclosed is a copy of the inspection report for the Environmental Protection Agency's (EPA's) inspection of the City of Colorado Springs Municipal Separate Storm Sewer System on February 4-7, 2013. Findings were noted during the inspection and are summarized in the enclosed report.

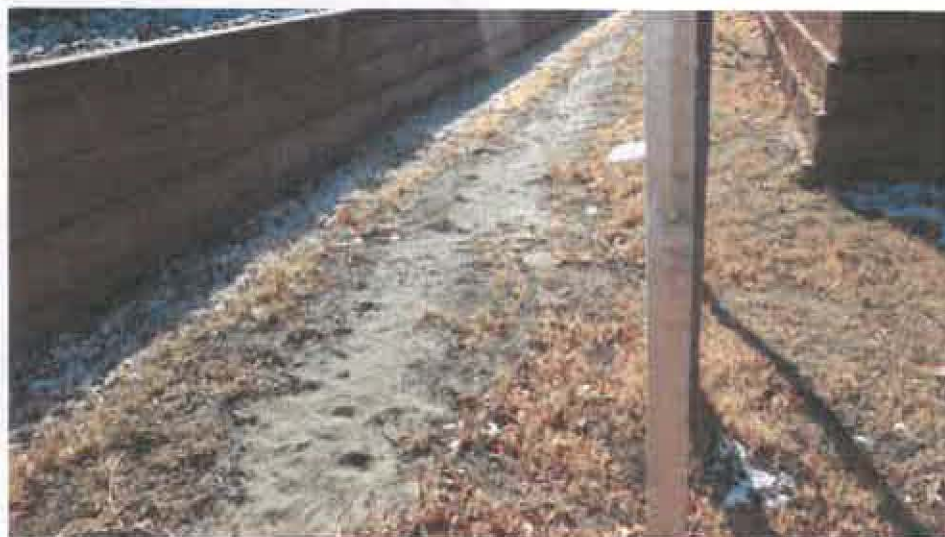
**Description** The Village at Homewood Point - Sediment build-up in center of channel leading to detention basin. Photo taken facing south.

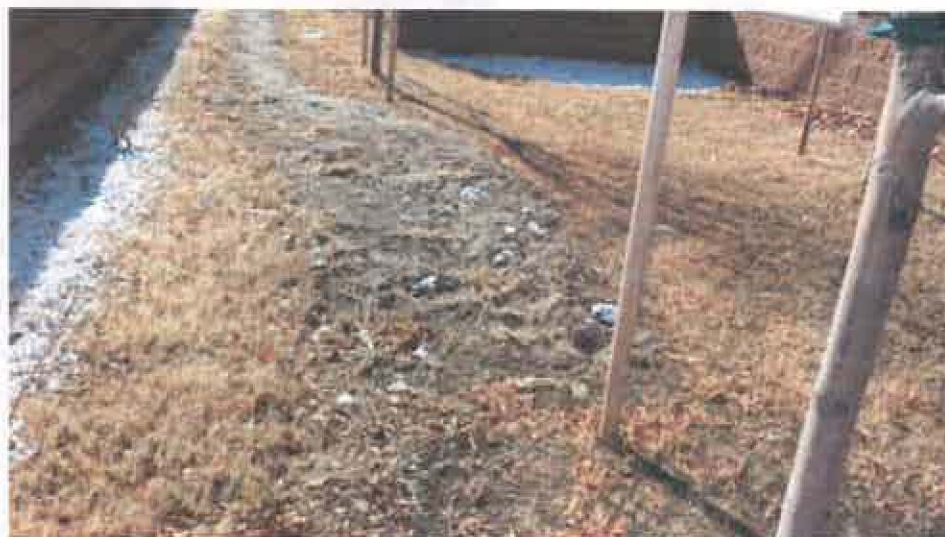
**Photo Number** 276

**Description** The Village at Homewood Point - Sediment build-up in center of the detention basin. Photo taken facing south.

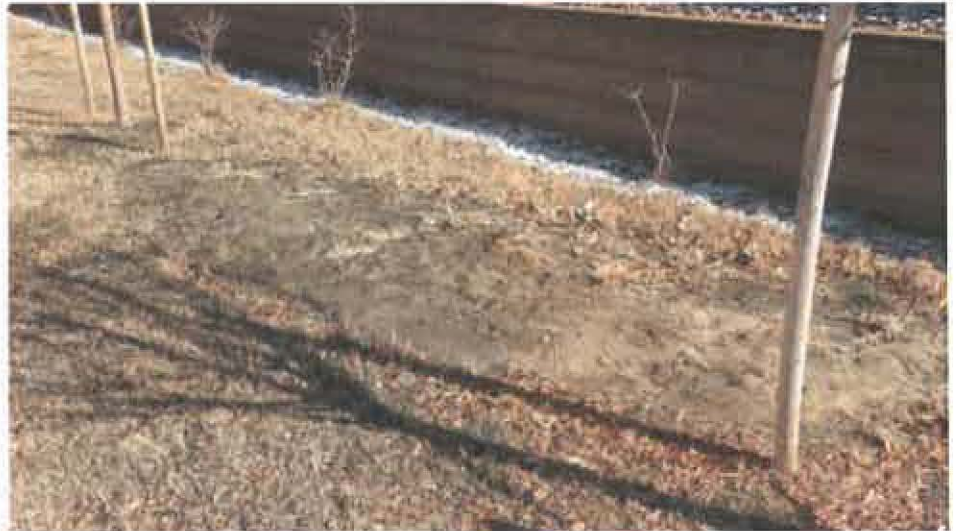
**Description** The Village at Homewood Point - Sediment build-up in center of the detention basin. Photo taken facing east.

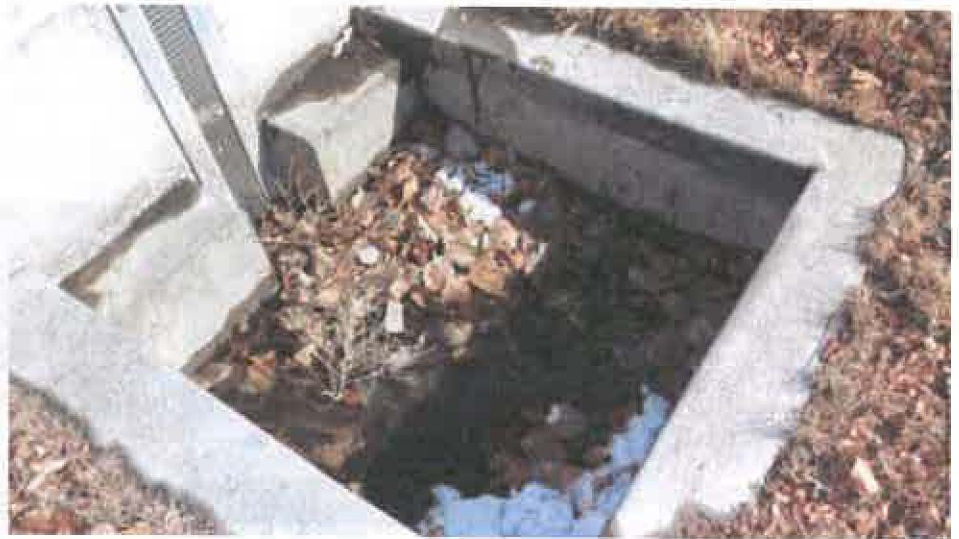
**Description** The Village at Homewood Point - Micropond. Surface of water in the pond was frozen with leaves on top of the water.

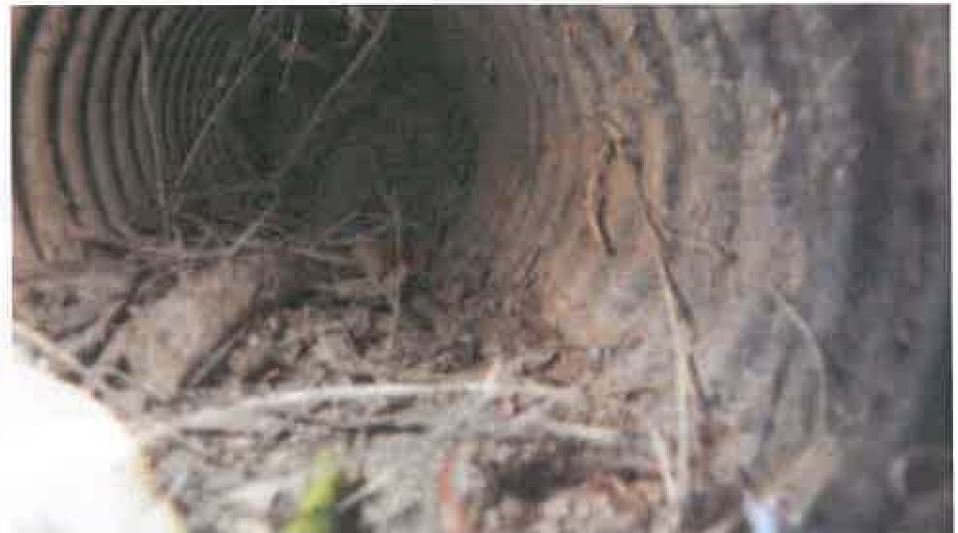
**Photo Number** 282  
**Inspection Date** 2/7/2013  
**Photographer** A. Tien  
**Description** The Village at  
Homewood Point -  
Close-up photo of  
pipe (photo 283)  
leading into  
detention basin. The  
pipe appeared to be  
filled in and was not  
discharging into the  
basin.

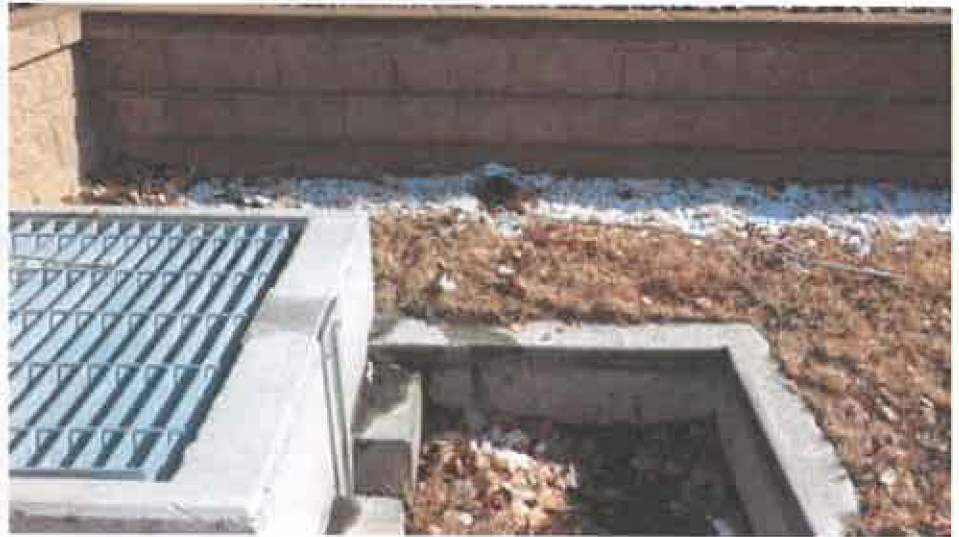
**Description** The Village at Homewood Point - Photo of pipe leading into detention basin. The pipe appeared to be filled in and was not discharging into the basin. Photo taken facing east.

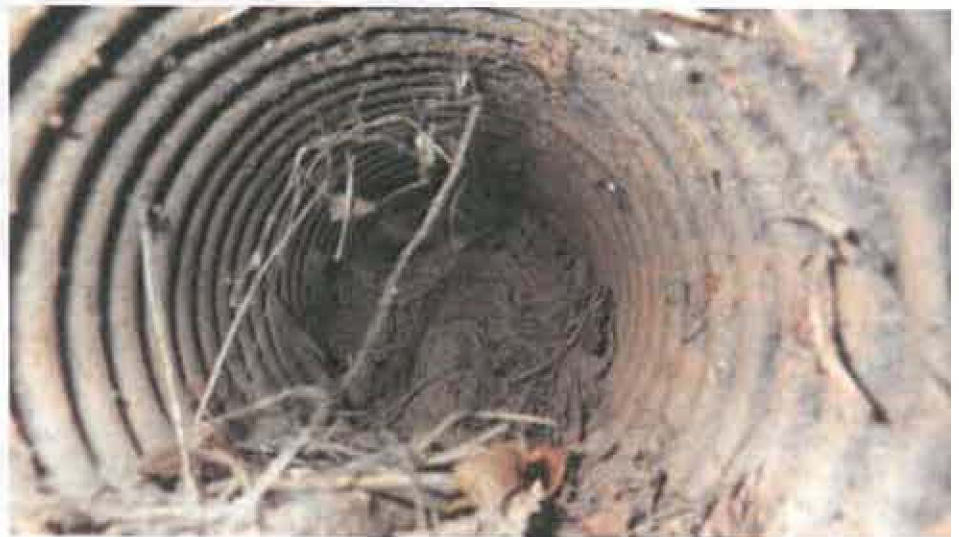
**Photo Number** 284

**Description** The Village at Homewood Point - Close-up photo of pipe (photo 283) leading into detention basin. The pipe appeared to be filled in and was not discharging into the basin.

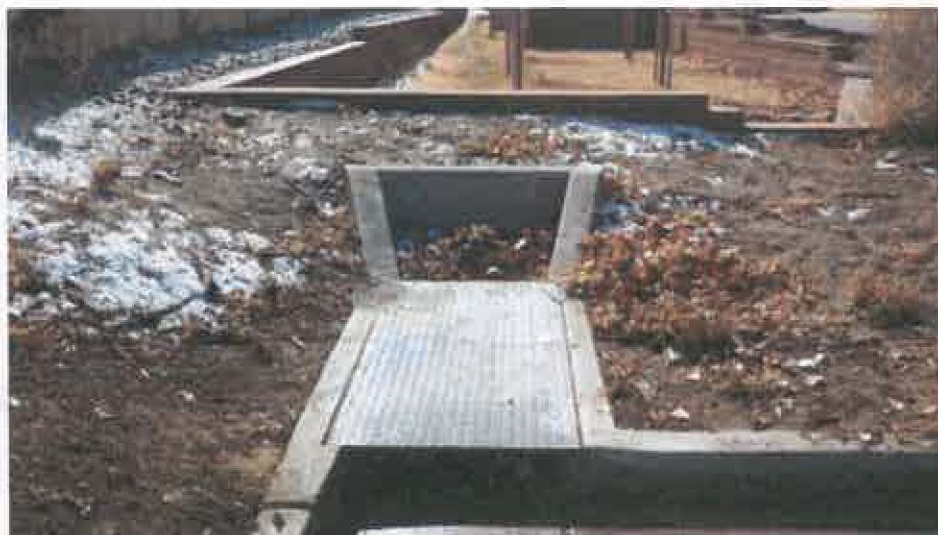
**Photo Number** 286  
**Inspection Date** 2/7/2013  
**Photographer** A. Tien  
**Description** The Village at  
Homewood Point -  
Photo of outlet facing  
south. Note- leaf  
build-up inside of  
structure.

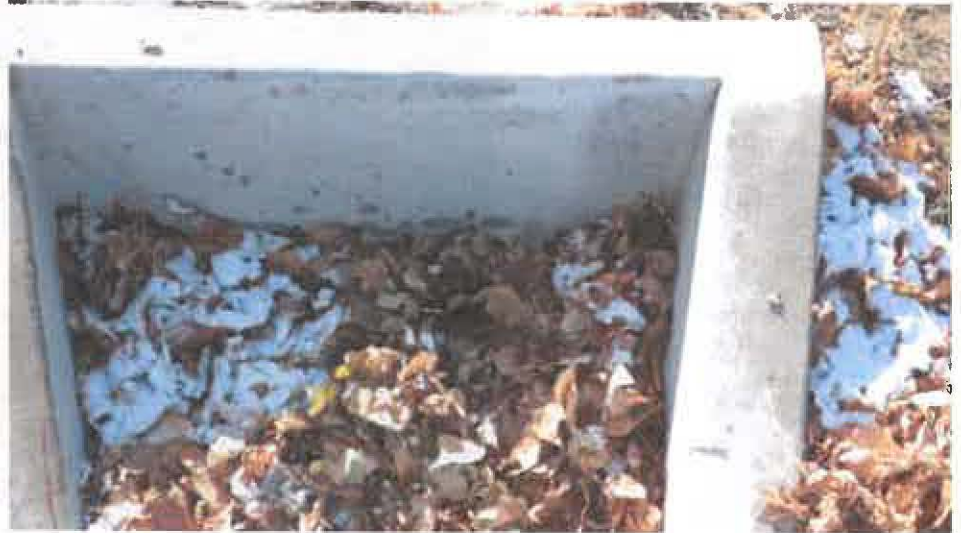
**Description** The Village at Homewood Point - Close-up photo of outlet. Note- leaf build-up inside of structure.

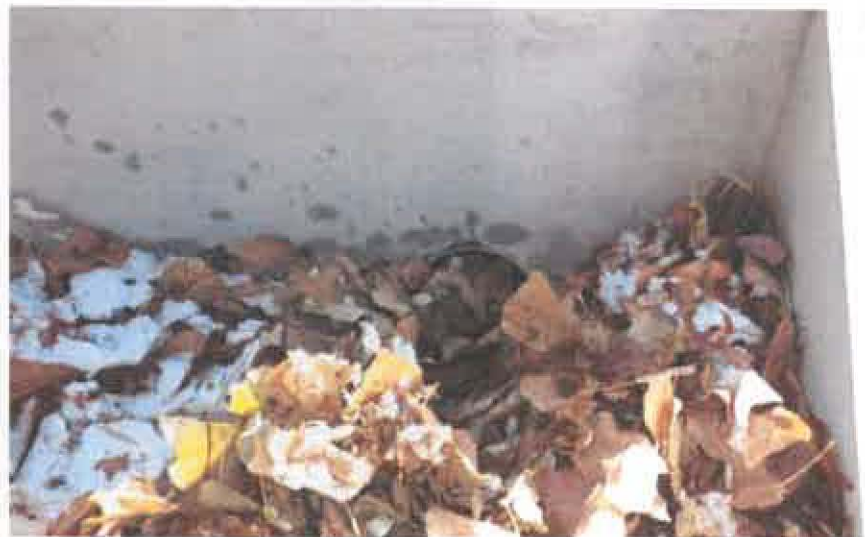
**Photo Number** 288

**Description** The Village at Homewood Point - Close-up photo of outlet. Note- leaf build-up inside of structure.

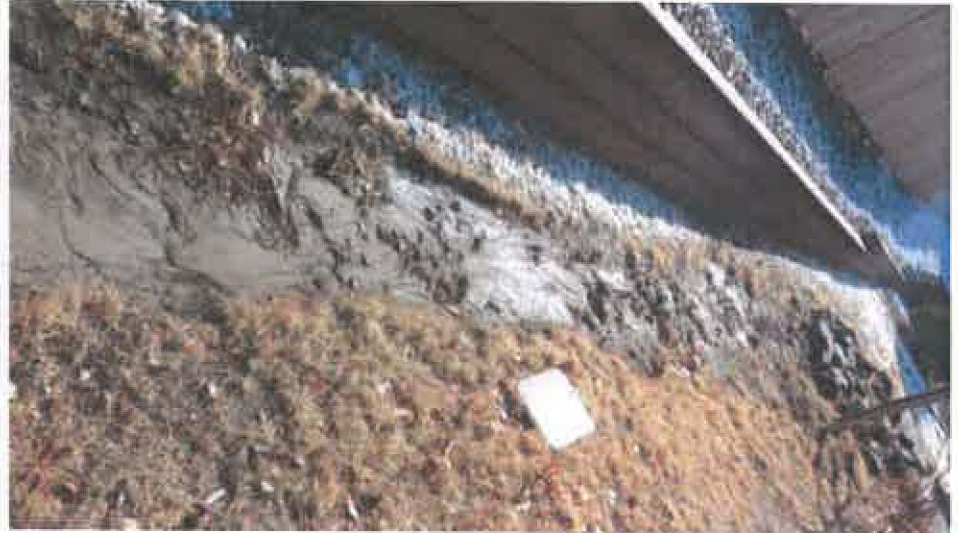
**Description** The Village at Homewood Point - Overview photo of sediment build-up in channel entering south side of pond from parking area. Photo taken facing south.

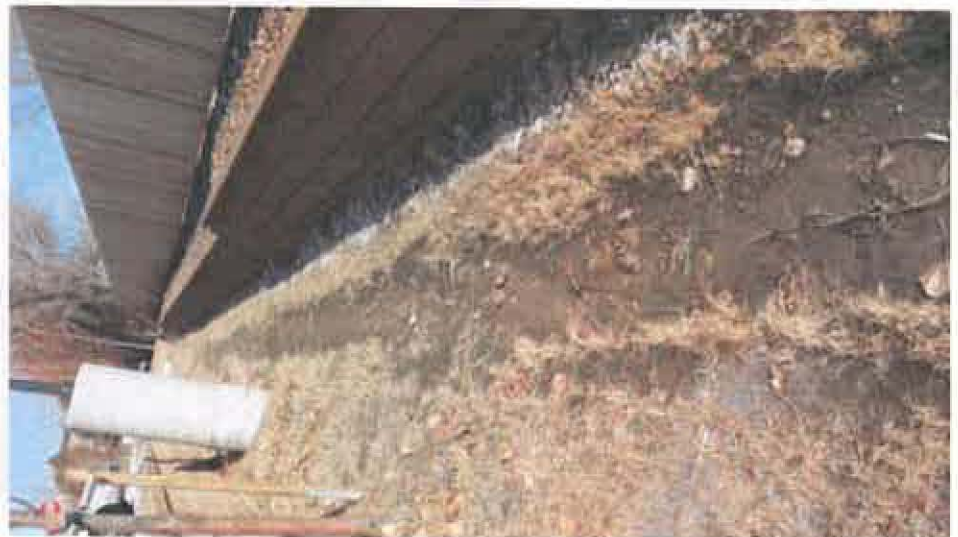
**Photo Number** 292

**Description** The Village at Homewood Point - Overview photo of sediment build-up in channel entering south side of pond from parking area. Photo taken facing north.

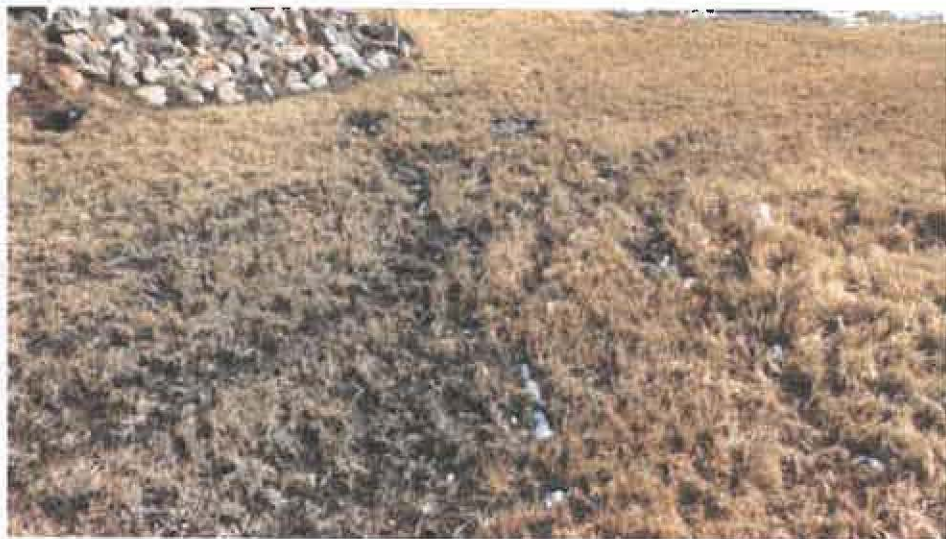
**Photo Number** 303  
**Inspection Date** 2/7/2013  
**Photographer** A. Tien  
**Description** Rudy's BBQ -  
Sediment  
accumulation in  
center area of basin.

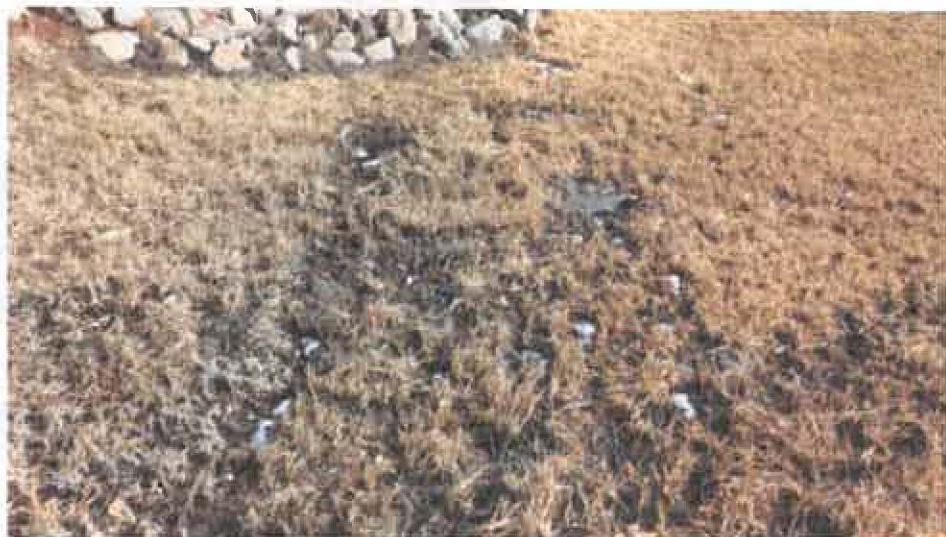
**Photo Number** 304  
**Inspection Date** 2/7/2013  
**Photographer** A. Tien  
**Description** Rudy's BBQ -  
Sediment  
accumulation in  
center area of basin.

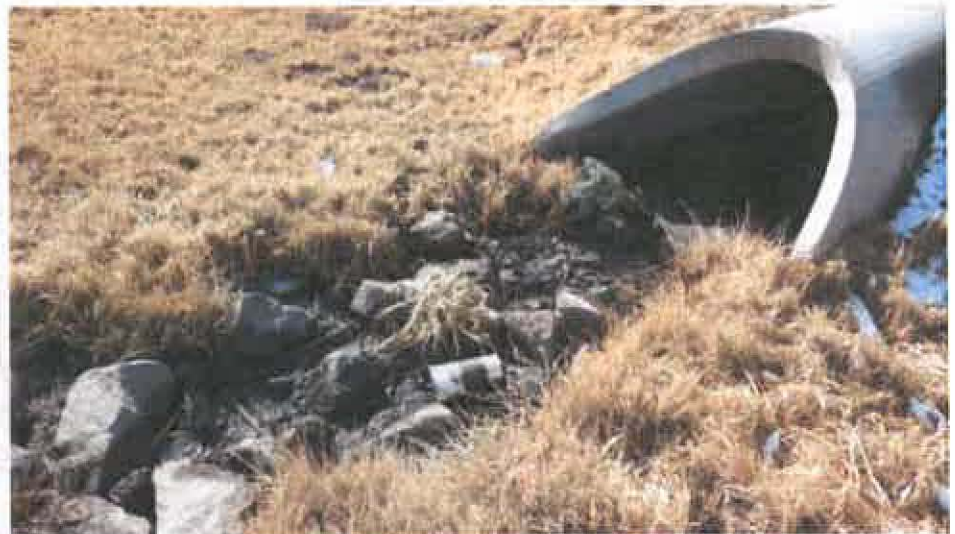
**Photo Number** 305  
**Inspection Date** 2/7/2013  
**Photographer** A. Tien  
**Description** Rudy's BBQ - Inlet structure into basin from parking area.  
Note: some sediment and trash accumulation.

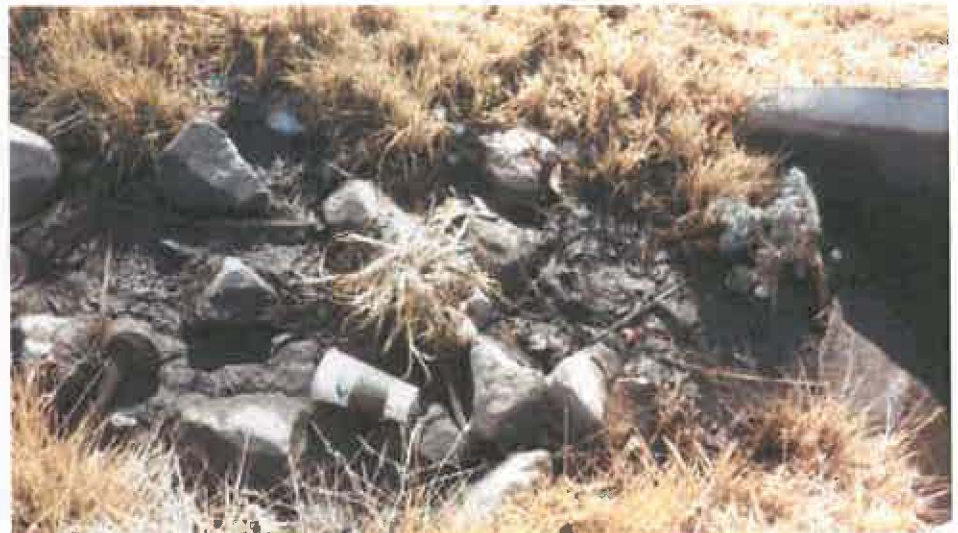
**Photo Number** 306  
**Inspection Date** 2/7/2013  
**Photographer** A. Tien  
**Description** Rudy's BBQ - Inlet structure into basin from parking area.  
Note: some sediment and trash accumulation.

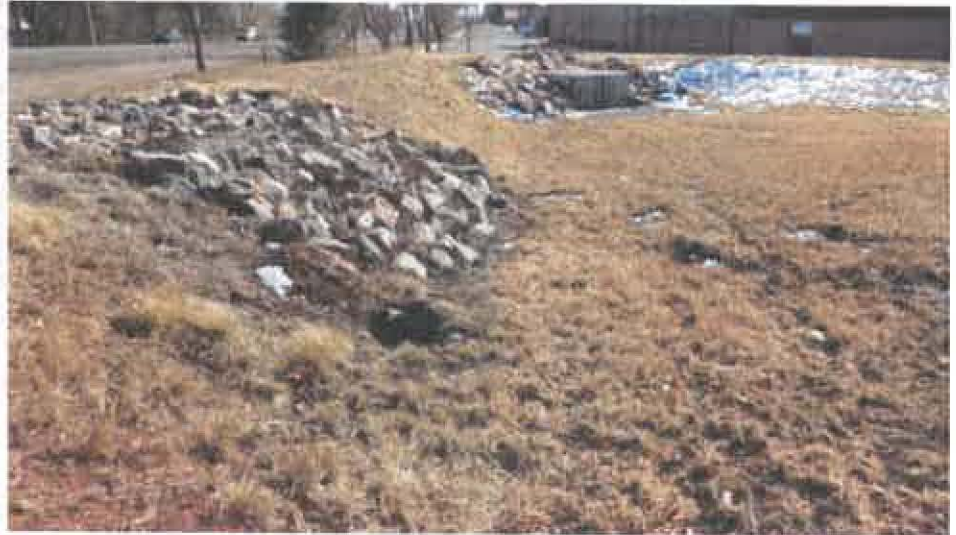
**Photo Number** 307  
**Inspection Date** 2/7/2013  
**Photographer** A. Tien  
**Description** Rudy's BBQ -  
Detention basin  
facing southeast.  
Note: hole along east  
side of basin  
(towards center for  
photo).

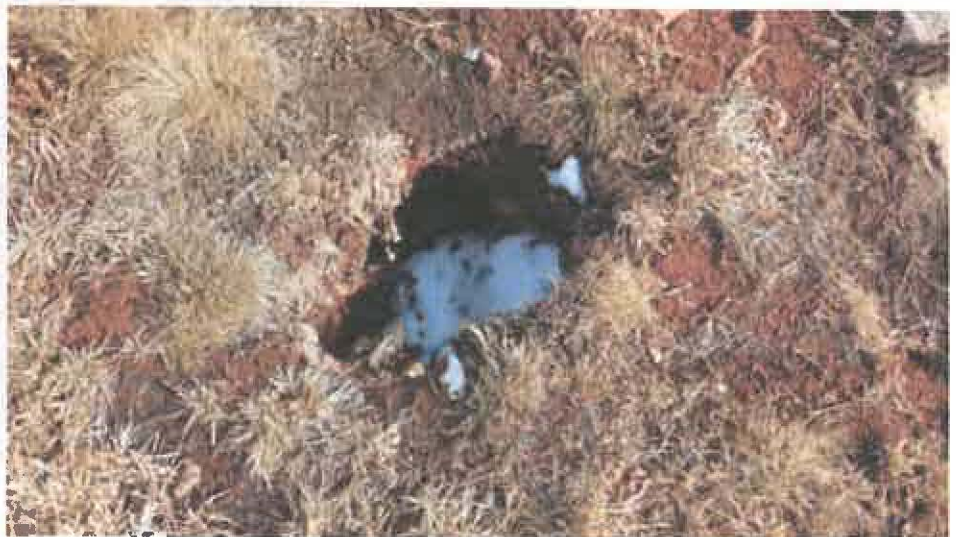
**Photo Number** 308  
**Inspection Date** 2/7/2013  
**Photographer** A. Tien  
**Description** Rudy's BBQ - Close-  
up photo of hole in  
detention basin.

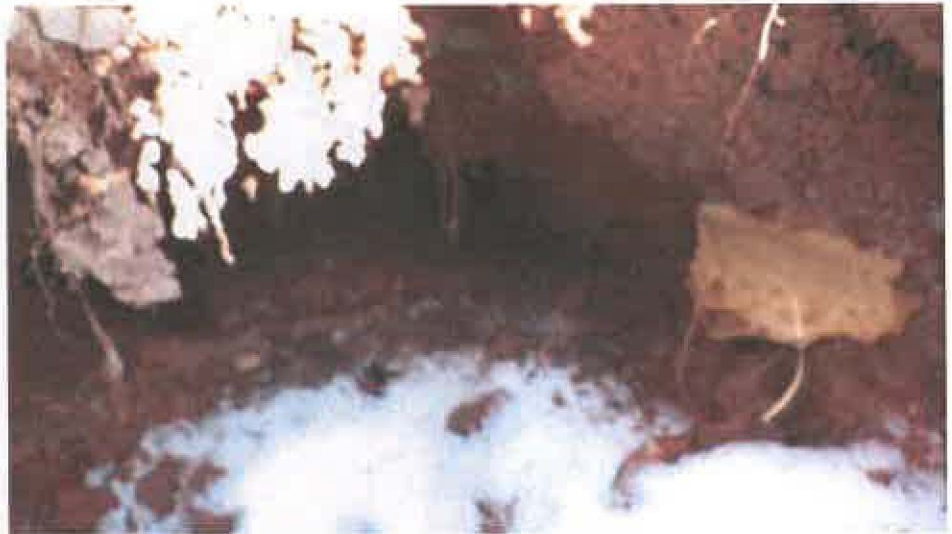
**Description** Rudy's BBQ - Close-up photo of hole in detention basin. Unsure of where the outlet for the hole is located.

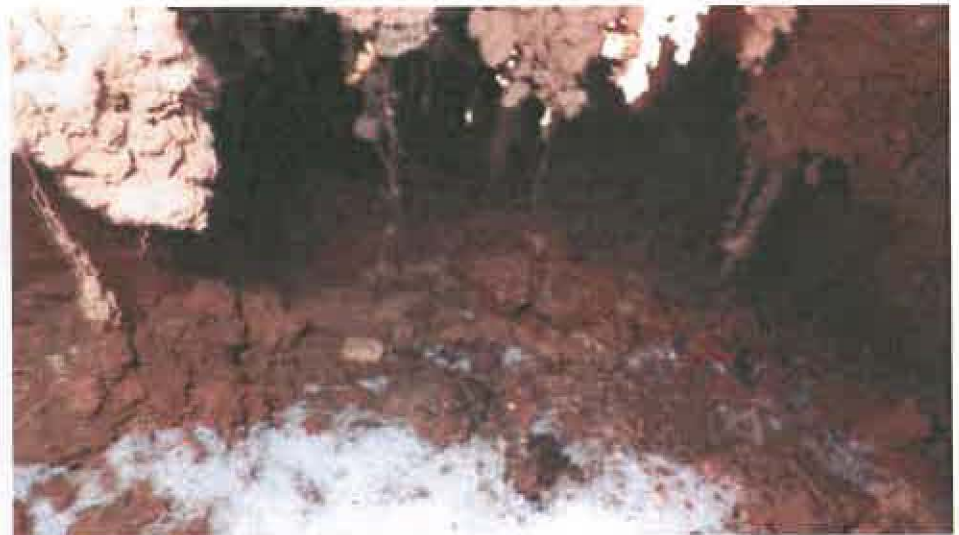
**Photo Number** 310

**Description** Rudy's BBQ - Close-up photo of hole in detention basin. Unsure of where the outlet for the hole is located.

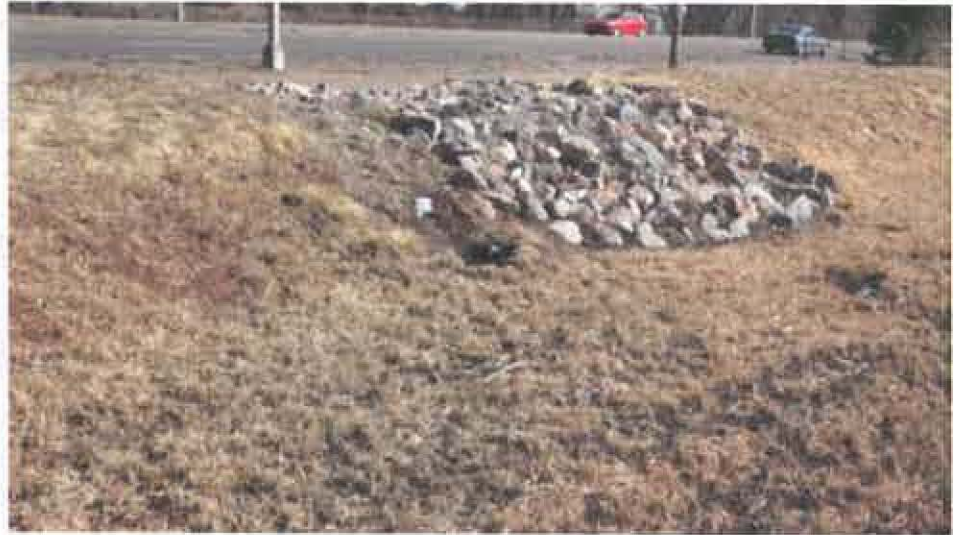
**Description** Rudy's BBQ -  
Detention basin with  
hole along east side  
of basin (towards  
center for photo).

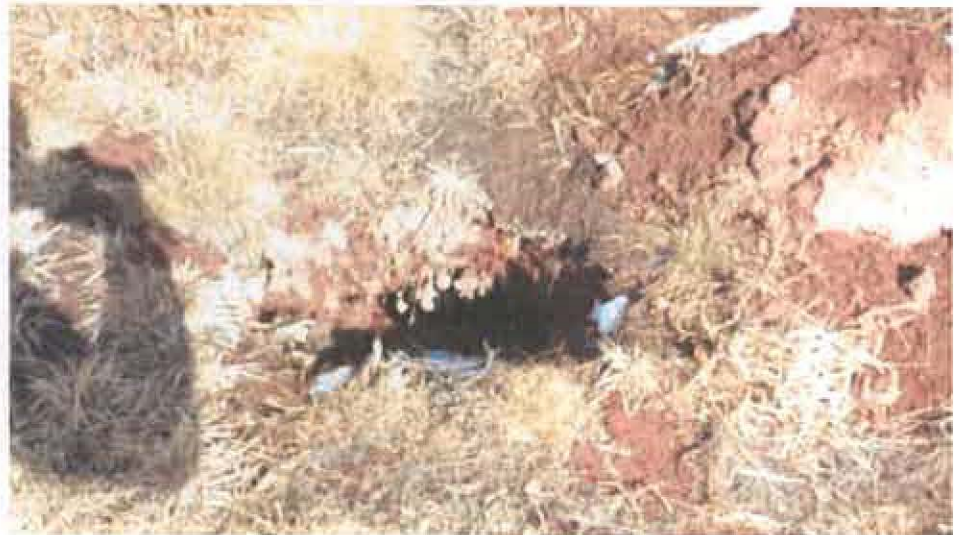
**Photo Number** 312

**Description** Rudy's BBQ - Close-  
up photo of hole in  
detention basin.  
Unsure of where the  
outlet for the hole is  
located.

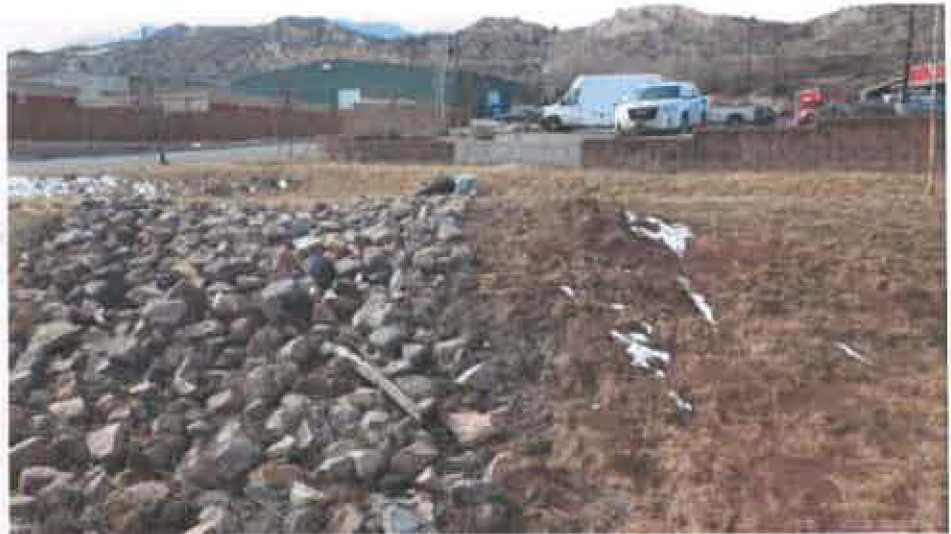
**Description** Rudy's BBQ - Photo taken of east side of berm along the east side of the basin. Photo taken facing west. Did not see any outlet for the hole observed on the other (west) side of the berm (photo 309).

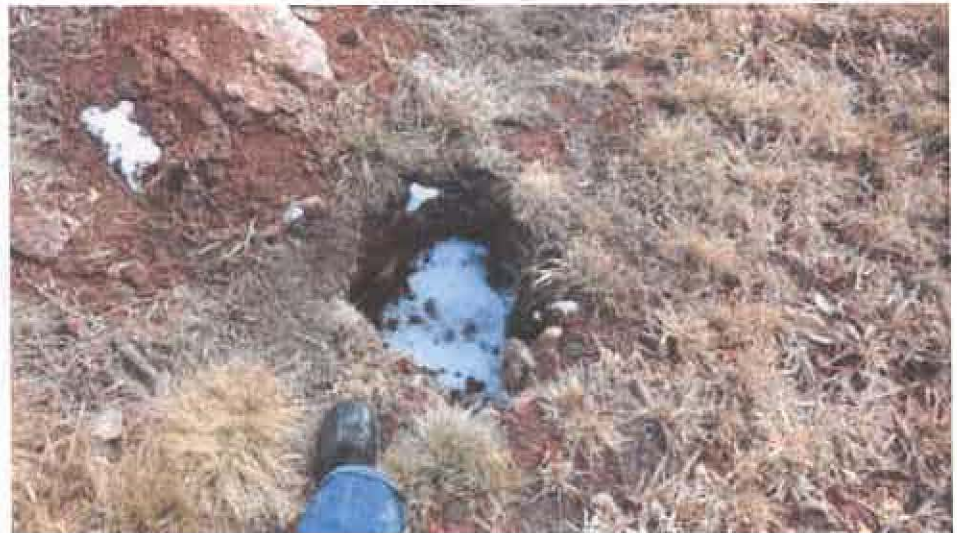
**Photo Number** 314

**Description** Rudy's BBQ - Additional photo of hole along east side of detention basin (photo taken with inspector's foot for scale).

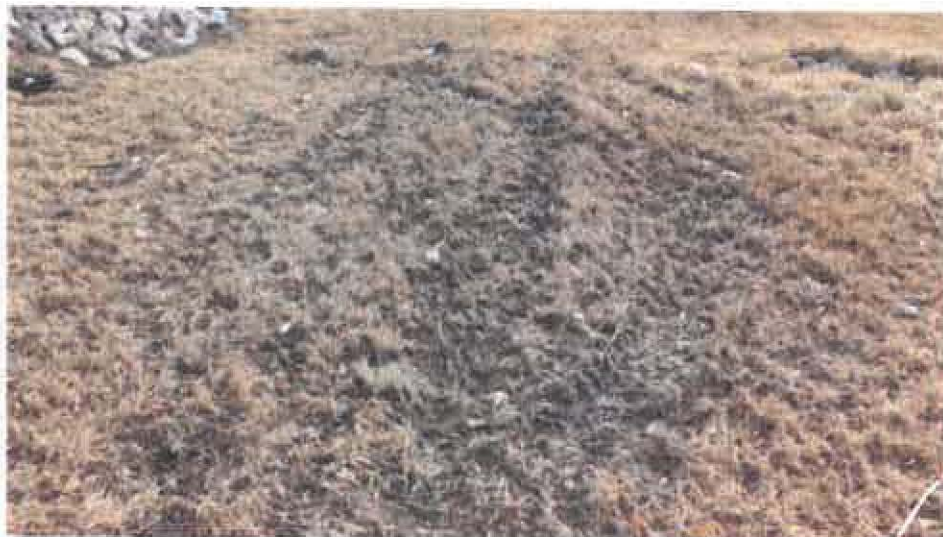
**Photo Number** 315  
**Inspection Date** 2/7/2013  
**Photographer** A. Tien  
**Description** Rudy's BBQ -  
Additional photo of  
sediment  
accumulation in  
center area of basin.

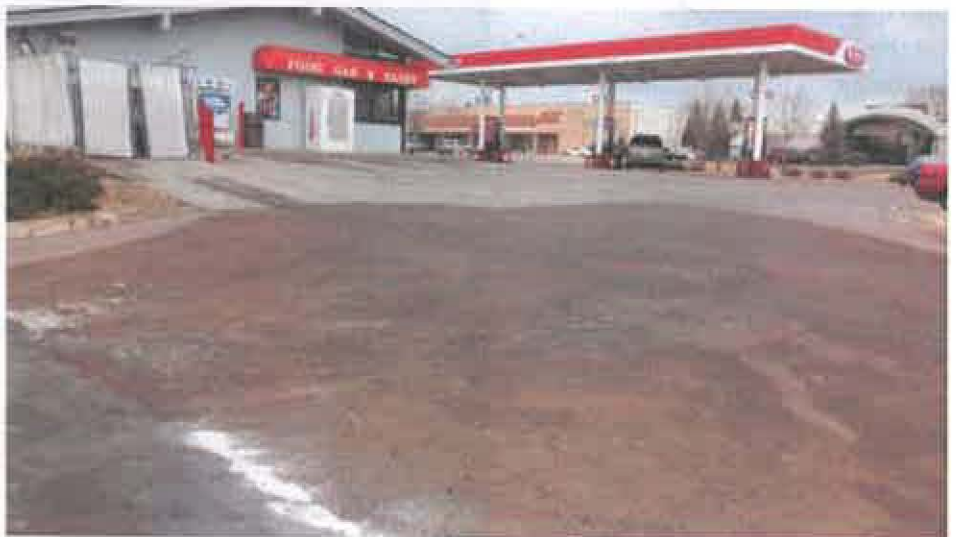
**Description** Conoco Site Visit-  
Photo of gasoline  
spill location. Note:  
staining on  
pavement.

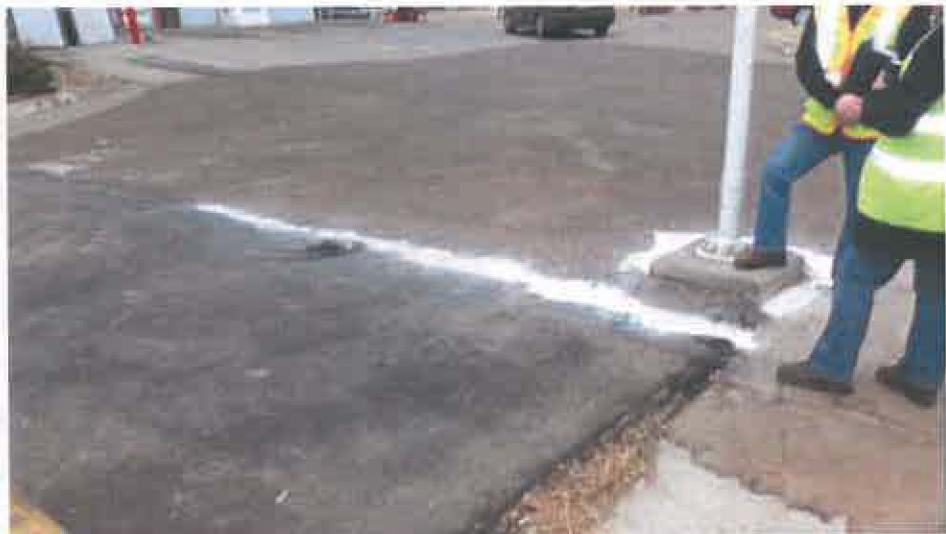
**Photo Number** 259  
**Inspection Date** 2/6/2013  
**Photographer** A. Tien  
**Description** Conoco Site Visit-  
Photo of gasoline  
spill area. Note  
staining on  
pavement and  
residual white dry  
clean-up chemicals  
remaining on site.

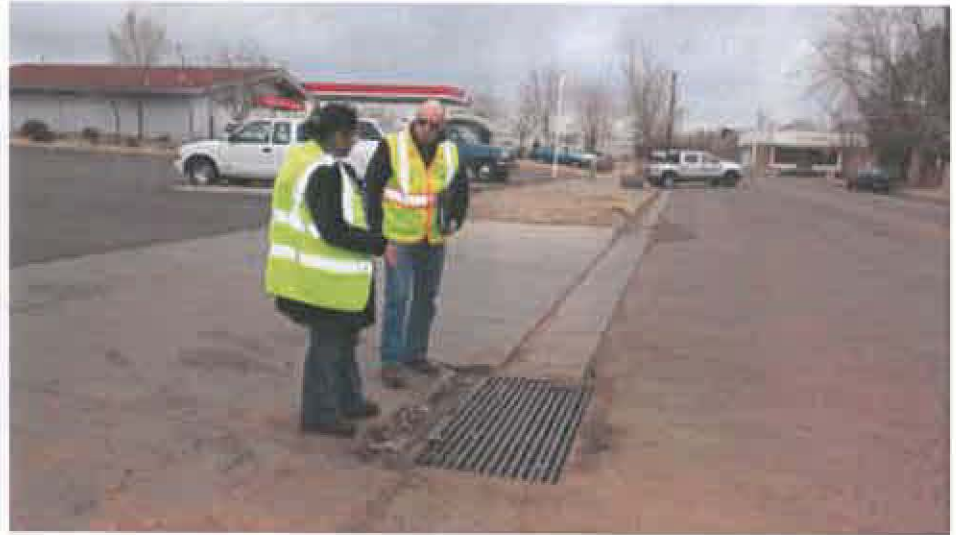
**Photo Number** 261  
**Inspection Date** 2/6/2013  
**Photographer** A. Tien  
**Description** Conoco Site Visit-  
Photo of MS4  
stormwater inlet. It  
was reported that  
gasoline from the  
spill at the gas  
station (seen in  
background) flowed  
down into this  
stormwater inlet  
location.

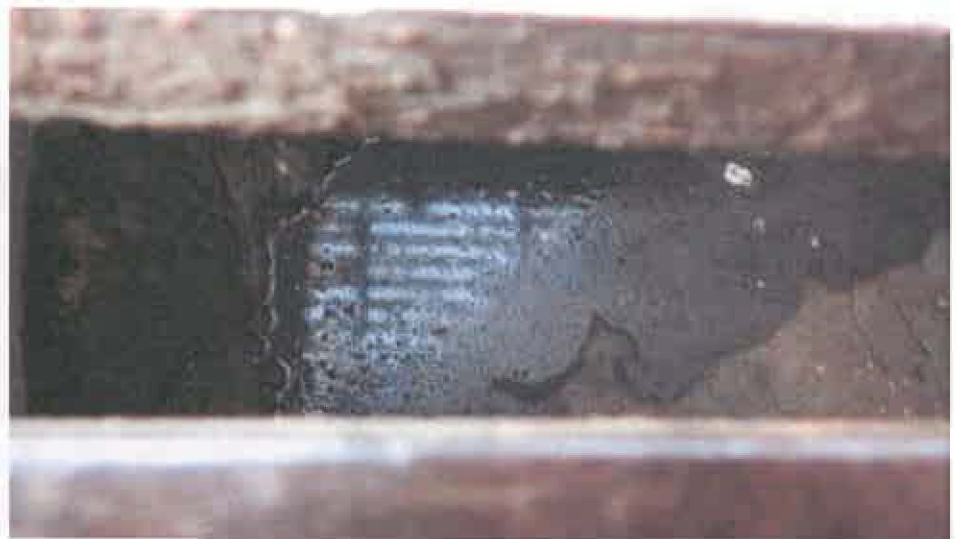
**Photo Number** 262  
**Inspection Date** 2/6/2013  
**Photographer** A. Tien  
**Description** Conoco Site Visit-  
Close-up photo of  
sheen material in  
MS4 stormwater  
inlet. It was reported  
that gasoline from  
the spill at the gas  
station flowed down  
into this stormwater  
inlet location.

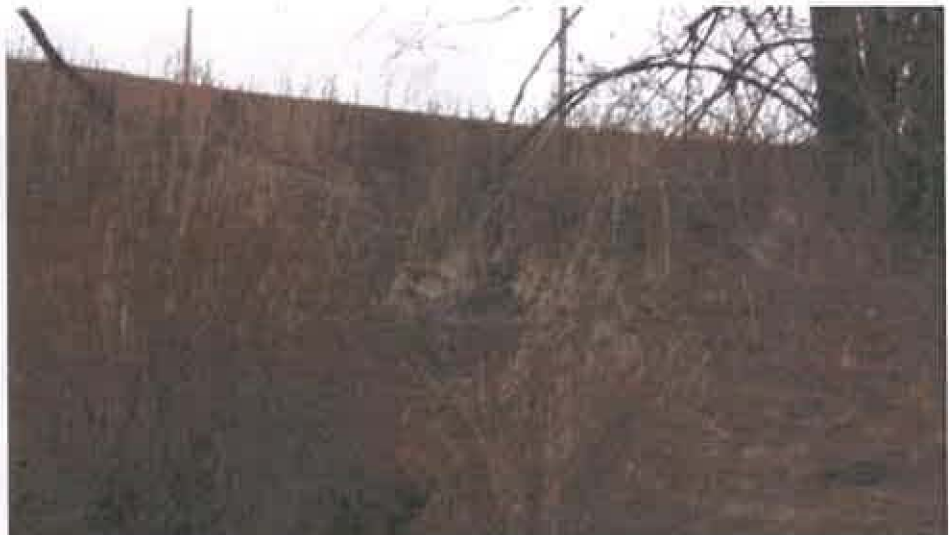
**Photo Number** 264  
**Inspection Date** 2/6/2013  
**Photographer** A. Tien  
**Description** Sunrise Kennels and  
Dog Training Center  
Site Visit - Close- up  
of pipe (center of  
photo) with evidence  
of discharge along  
the hillside behind  
the facility.

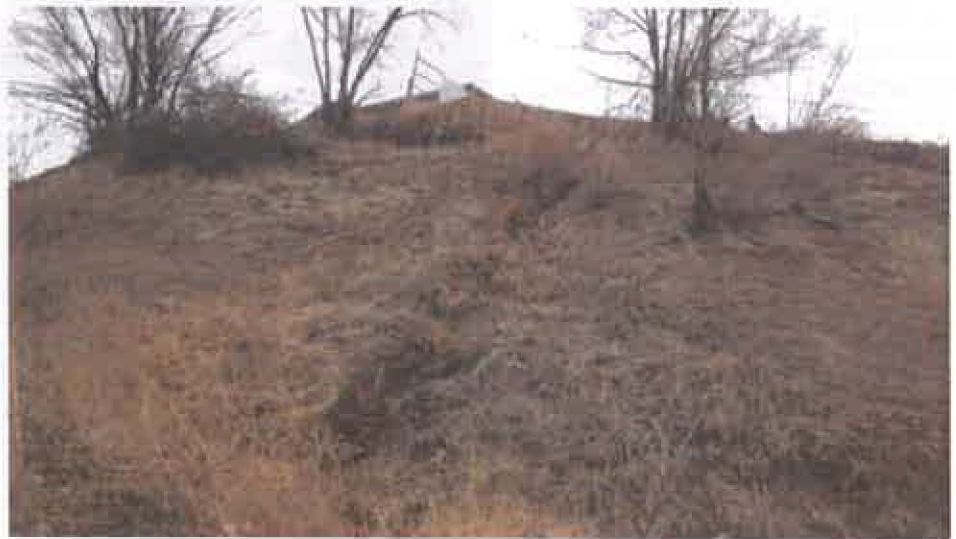
**Description** Sunrise Kennels and Dog Training Center Site Visit - Hillside behind the facility. Fence surrounding the facility can be seen at the top of the hill. Note: evidence of past discharge channel running down center of hillside.

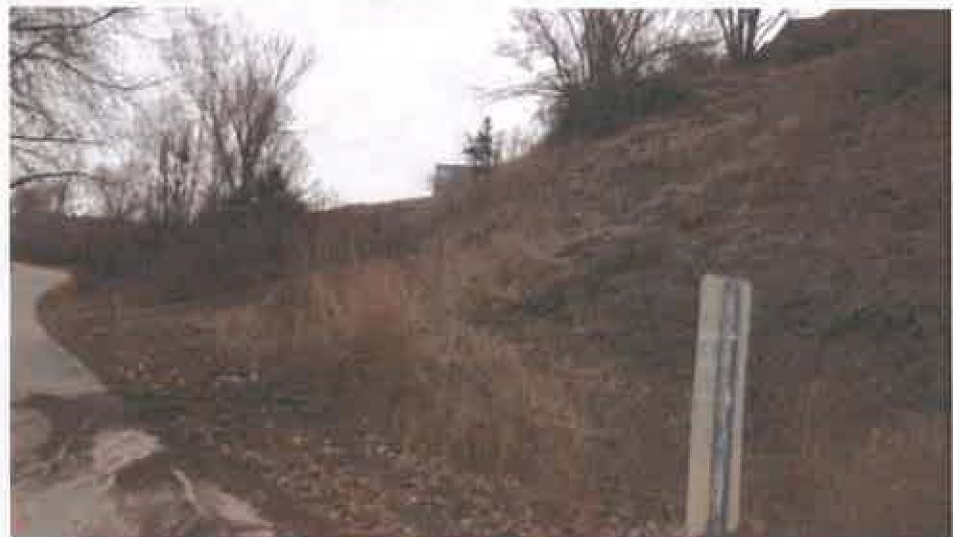
**Photo Number** 266

**Description** Sunrise Kennels and Dog Training Center Site Visit - Hillside behind the facility. Note: evidence of discharge along hillside and onto pavement on bottom left of photo.

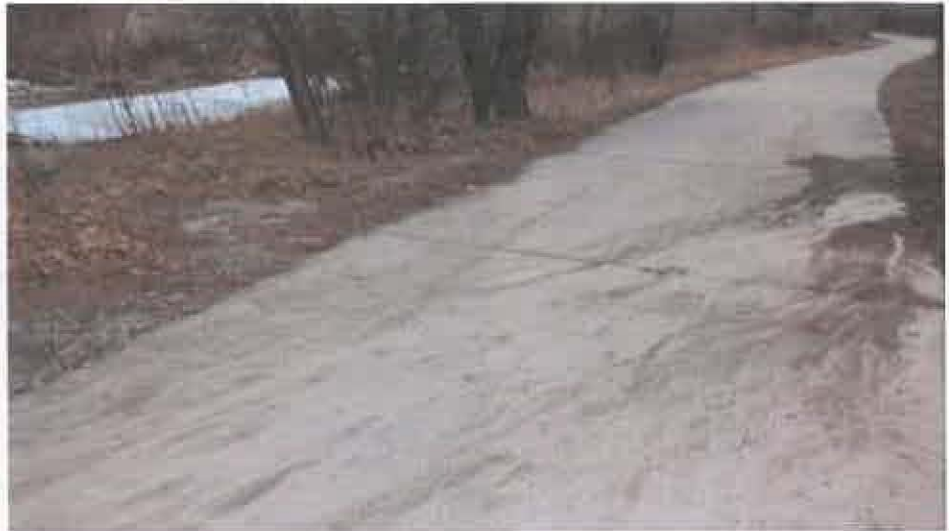
**Photo Number** 267  
**Inspection Date** 2/6/2013  
**Photographer** A. Tien  
**Description** Sunrise Kennels and Dog Training Center Site Visit - Evidence of discharge along pathway behind hillside.

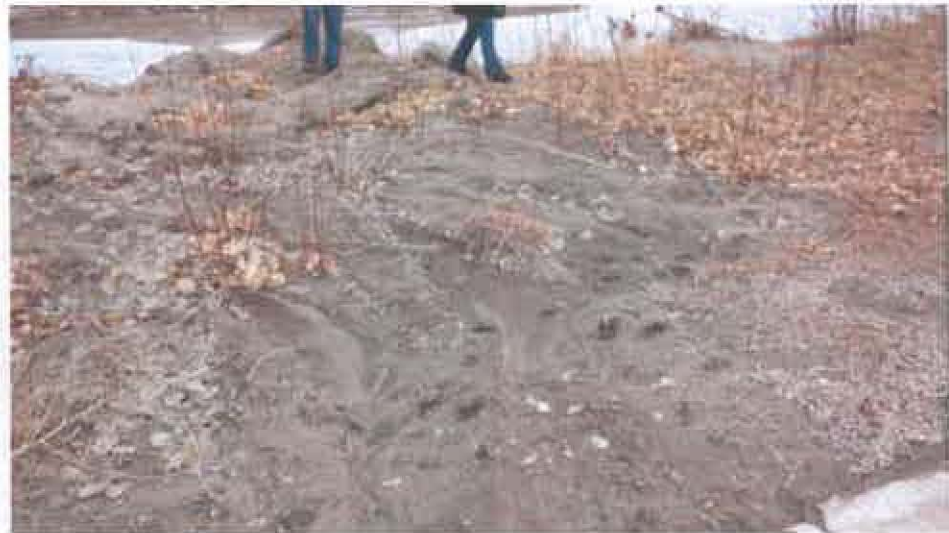
**Photo Number** 268  
**Inspection Date** 2/6/2013  
**Photographer** A. Tien  
**Description** Sunrise Kennels and Dog Training Center Site Visit - Evidence of discharge off of path and towards Cottonwood Creek (seen in background of photo). Could not be determined whether past discharge had actually made it to the creek.

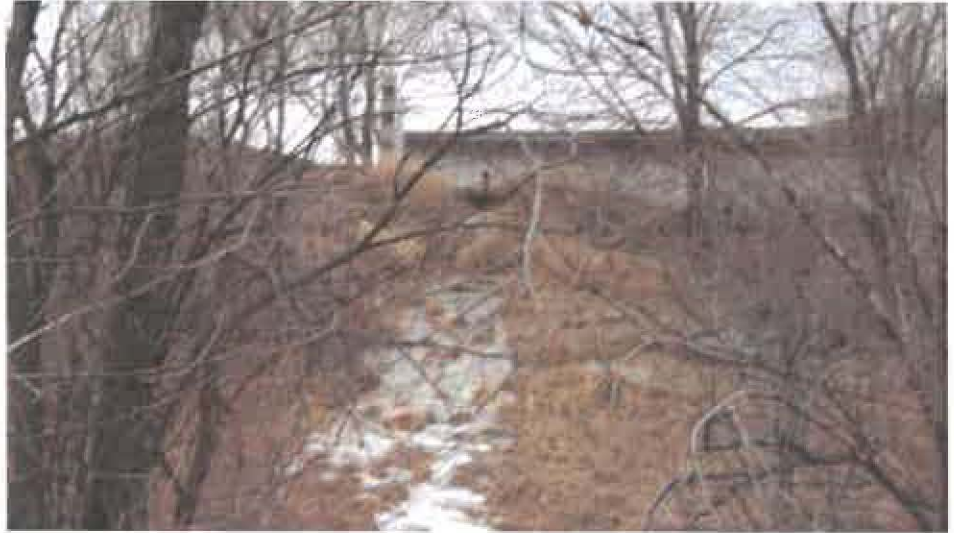
**Description** Sunrise Kennels and Dog Training Center Site Visit - Evidence of discharge along hillside from a facility next to the Sunrise Kennels and Dog Training facility. No evidence that discharge flowed beyond hillside/pathway to Cottonwood Creek.

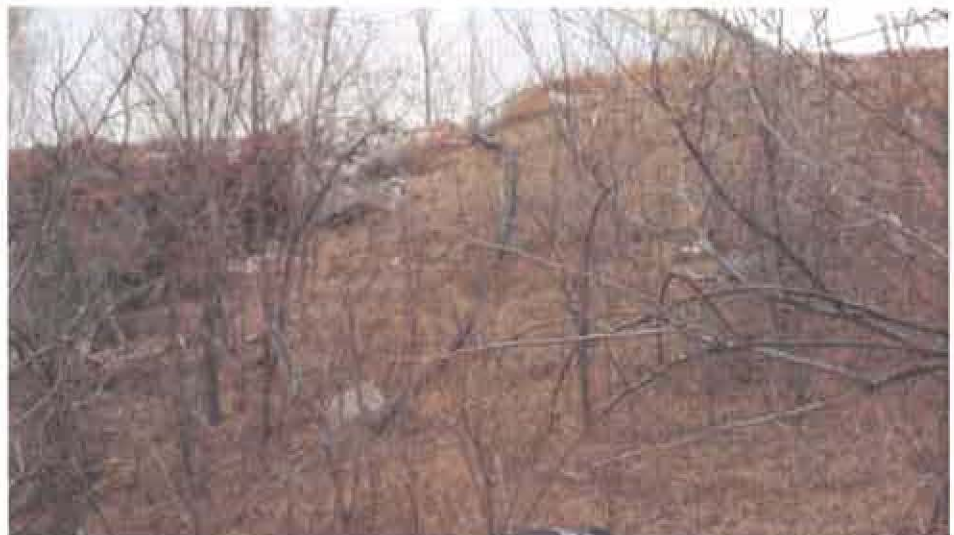
**Photo Number** 270

**Description** Sunrise Kennels and Dog Training Center Site Visit - Pipe and evidence of discharge along hillside from a facility next to the Sunrise Kennels and Dog Training facility. No evidence that discharge flowed beyond hillside/pathway to Cottonwood Creek.
