U.S.-Canada Power System Outage Task Force

Final Report on the August 14, 2003 Blackout in the United States and Canada: Causes and Recommendations

April 2004

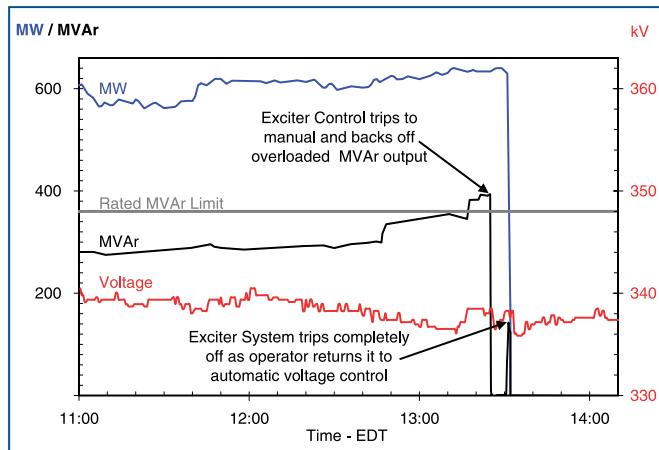
Figure 4.3. MW and MVar Output from Eastlake Unit 5 on August 14

- ◆ Eastlake Unit 5 is a 597 MW (net) generating unit located west of Cleveland on Lake Erie. It is a major source of reactive power support for the Cleveland area. It tripped at 13:31 EDT. The cause of the trip was that as the Eastlake 5 operator sought to increase the unit's reactive power output (Figure 4.3), the unit's protection system detected that VAr output exceeded the unit's VAr capability and tripped the unit off-line. The loss of the Eastlake 5 unit did not put the grid into an unreliable state—i.e., it was still able to withstand safely another contingency. However, the loss of the unit required FE to import additional power to make up for the loss of the unit's output (612 MW), made voltage management in northern Ohio more challenging, and gave FE operators less flexibility in operating their system (see details on pages 45-46 and 49-50).

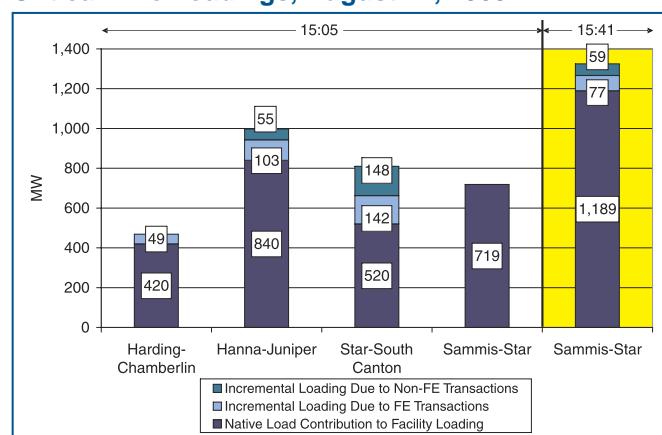
Figure 4.6. Impacts of Transactions Flows on Critical Line Loadings, August 14, 2003

Figure 4.6 shows how all of the transactions flowing across the Cleveland-Akron area on the afternoon of August 14 affected line loadings at key FE facilities, organized by time and types of transactions. It shows that before the first transmission line failed, the bulk of the loading on the four critical FirstEnergy circuits—Harding-Chamberlin, Hanna-Juniper, Star-South Canton and Sammis-Star—was to serve Cleveland-Akron area native load. Flows to serve native load included transfers from FE's 1,640 MW Beaver Valley nuclear power plant and its Seneca plant, both in Pennsylvania, which have been traditionally counted by FirstEnergy not as imports but rather as in-area

Power flow patterns on August 14 did not cause the blackout in the Cleveland-Akron area. But once the first four FirstEnergy lines went down, the magnitude and pattern of flows on the overall system did affect the ultimate path, location and speed of the cascade after 16:05:57 EDT.³

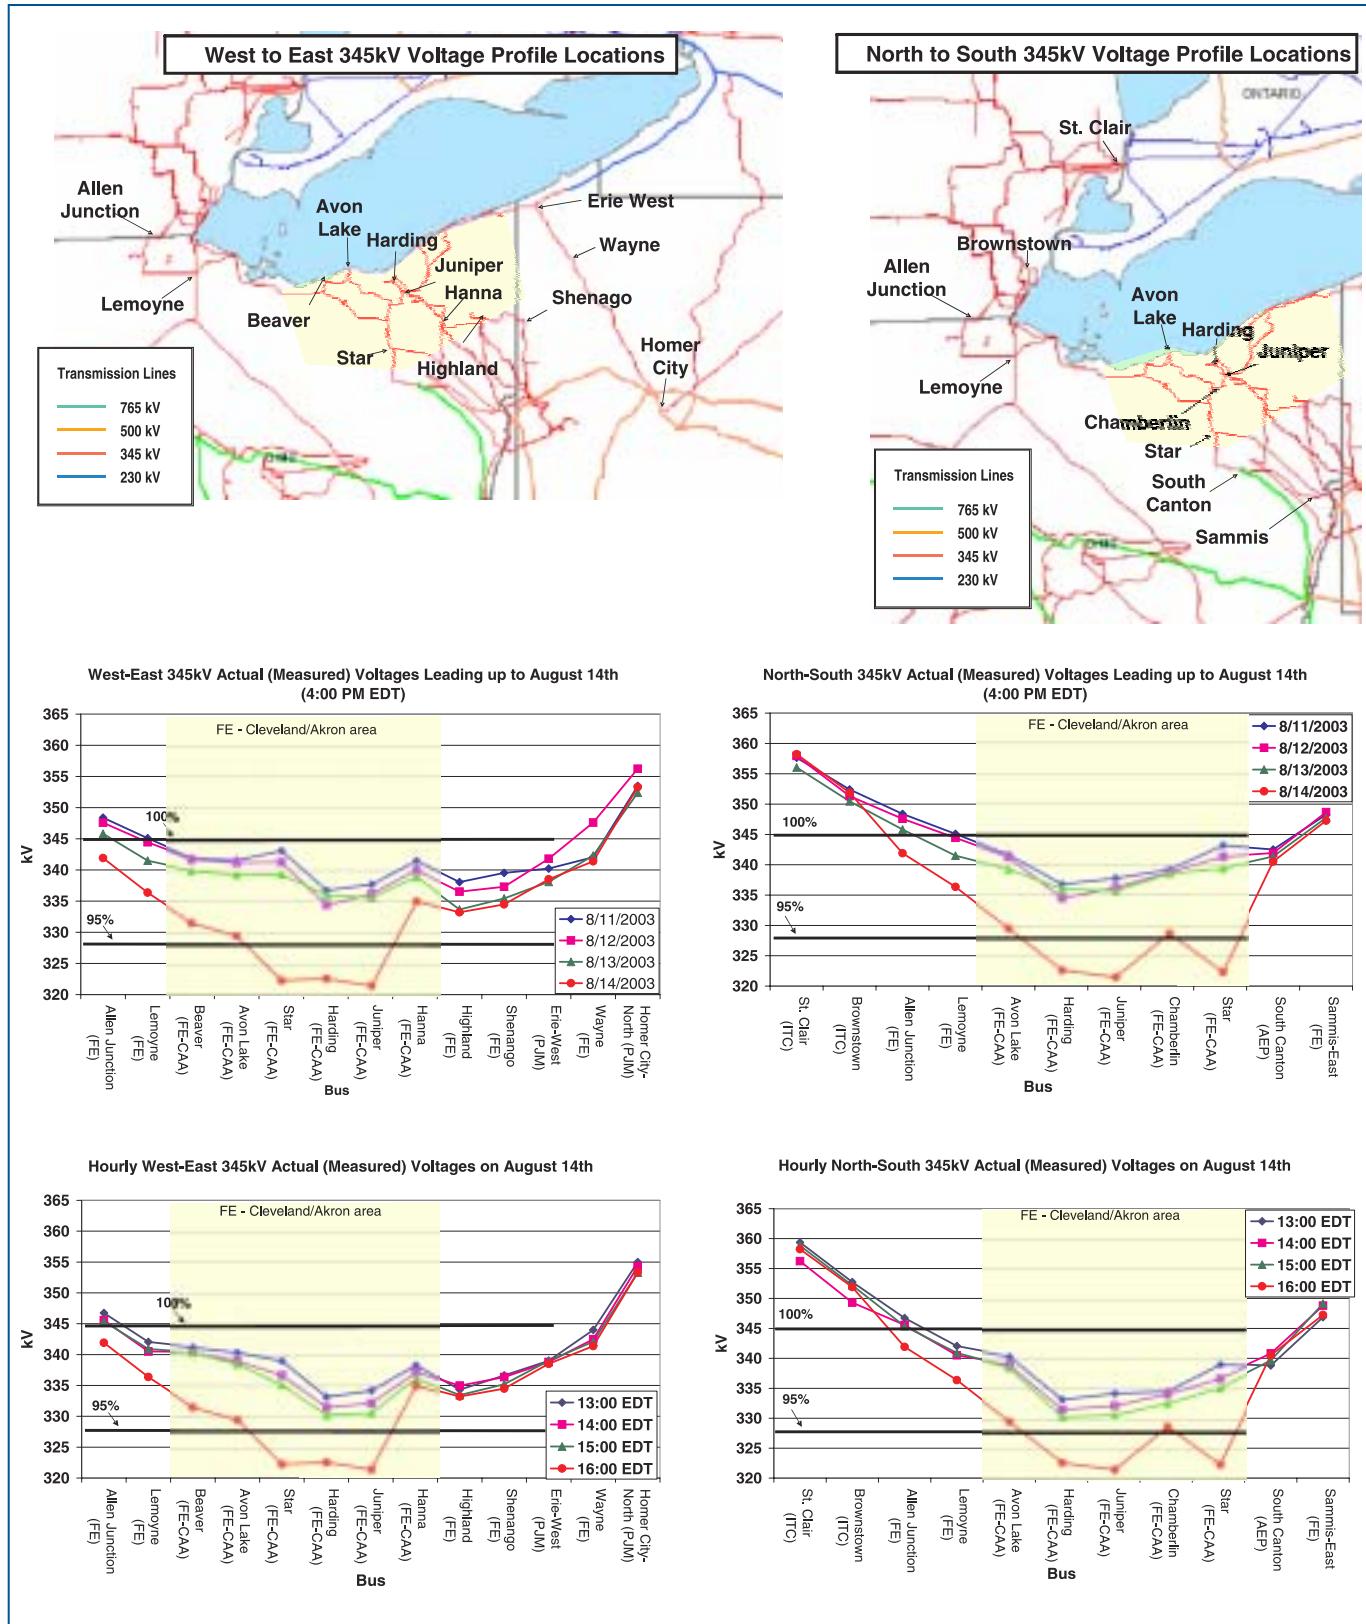
Figure 4.7. Actual Voltages Across the Ohio Area Before and On August 14, 2003

Figure 4.7 shows the profile of voltage levels at key buses from southeast Michigan across Ohio into western Pennsylvania from August 11 through 14 and for several hours on August 14. These transects show that across the area, voltage levels were consistently lower at the 345-kV buses in the Cleveland-Akron area (from Beaver to Hanna on the west to east plot and from Avon Lake to Star on the north to south plot) for the three days and the 13:00 to 15:00 EDT period preceding the blackout. Voltage was consistently and considerably higher at the outer ends of each transect, where it never dropped below 96% even on August 14. These profiles also show clearly the decline of voltage over the afternoon of August 14, with voltage at the Harding bus at 15:00 EDT just below 96% before the Harding-Chamberlin line tripped at 15:05 EDT, and dropping down to around 93% at 16:00 EDT after the loss of lines and load in the immediate area.

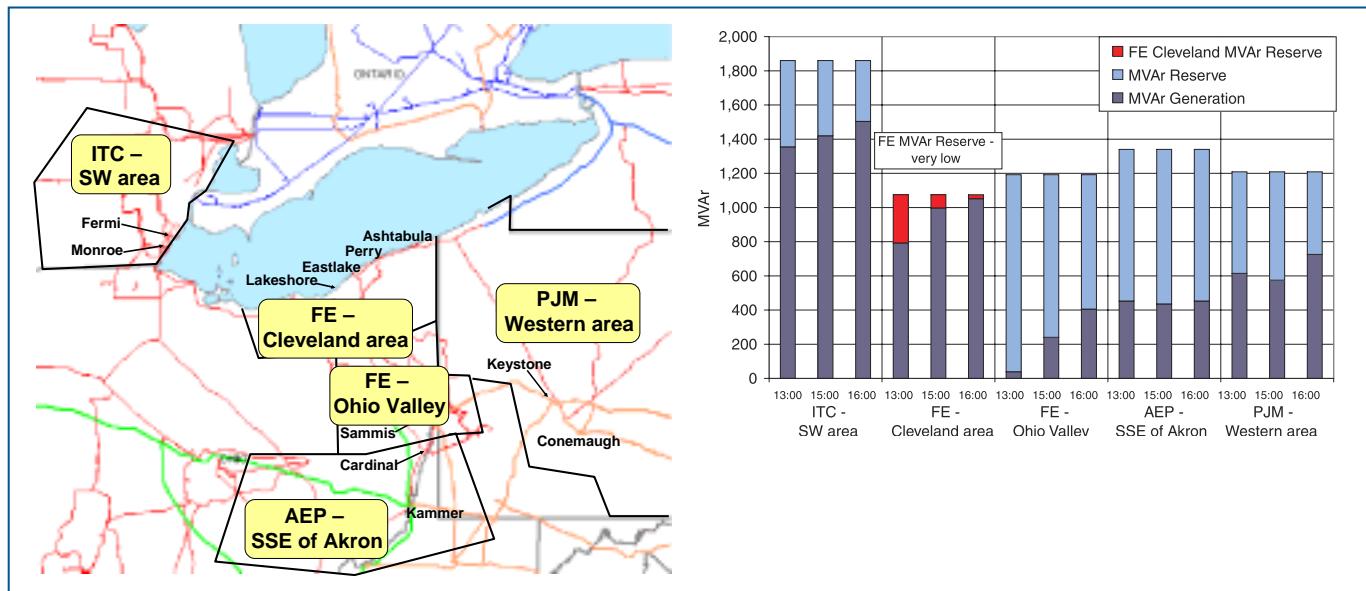
Figure 4.8. Reactive Reserves Around Ohio on August 14, 2003, for Representative Generators in the Area

local sources, these healthy reserves nearby could not support the Cleveland-Akron area's reactive power deficiency and growing voltage problems. Even FE's own generation in the Ohio Valley had reactive reserves that could not support the sagging voltages inside the Cleveland-Akron area.

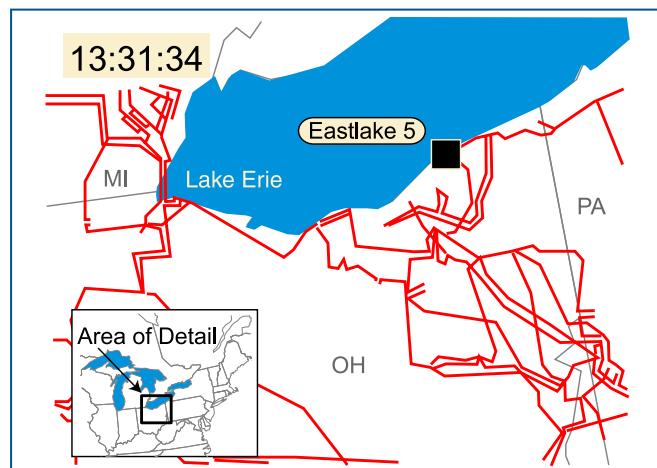
Figure 5.3. Eastlake Unit 5

Eastlake Unit 5 (rated at 597 MW) is in northern Ohio along the southern shore of Lake Erie, connected to FE's 345-kV transmission system (Figure 5.3). The Cleveland and Akron loads are generally supported by generation from a combination of the Eastlake, Perry and Davis-Besse units, along with significant imports, particularly from 9,100 MW of generation located along the Ohio and Pennsylvania border. The unavailability of

FE did not perform a contingency analysis after the loss of Eastlake 5 at 13:31 EDT to determine whether the loss of further lines or plants would put their system at risk. FE also did not perform a contingency analysis after the loss of Harding-Chamberlin at 15:05 EDT (in part because they did not know that it had tripped out of service), nor does the utility routinely conduct such studies.⁷ Thus FE did not discover that their system was no longer in an N-1

Recommendations
3, page 143, 22, page 159

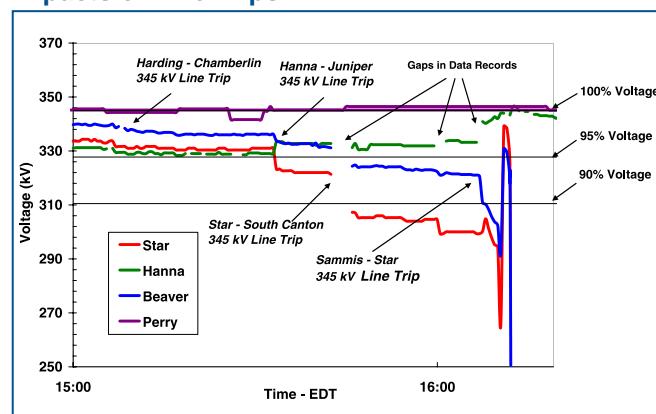
Figure 5.6. Voltages on FirstEnergy's 345-kV Lines: Impacts of Line Trips

From 15:05:41 EDT to 15:41:35 EDT, three 345-kV lines failed with power flows at or below each transmission line's emergency rating. These line trips were not random. Rather, each was the result of a contact between a line and a tree that had grown so tall that, over a period of years, it encroached into the required clearance height for the line. As each line failed, its outage increased the loading on the remaining lines (Figure 5.5). As each of the transmission lines failed, and power flows shifted to other transmission paths, voltages on the rest of FE's system degraded further (Figure 5.6).

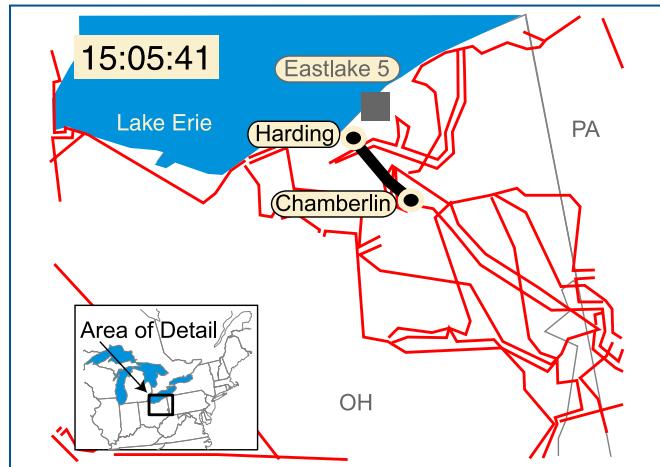
Figure 5.8. Harding-Chamberlin 345-kV Line

A short-circuit occurred on the Harding-Chamberlin 345-kV line due to a contact between the line conductor and a tree. This line failed with power flow at only 44% of its normal and emergency line rating. Incremental line current and temperature increases, escalated by the loss of Harding-Chamberlin, caused more sag on the Hanna-Juniper line, which contacted a tree and failed with power flow at 88% of its normal and emergency line rating. Star-South Canton

At 15:05:41 EDT, FE's Harding-Chamberlin line (Figure 5.8) tripped and locked out while loaded at 44% of its normal and emergency rating. At this low loading, the line temperature would not exceed safe levels—even if still air meant there

Harding-Chamberlin was not one of the flowgates that MISO monitored as a key transmission location, so the reliability coordinator was unaware when FE’s first 345-kV line failed. Although MISO received

Recommendation
30, page 163

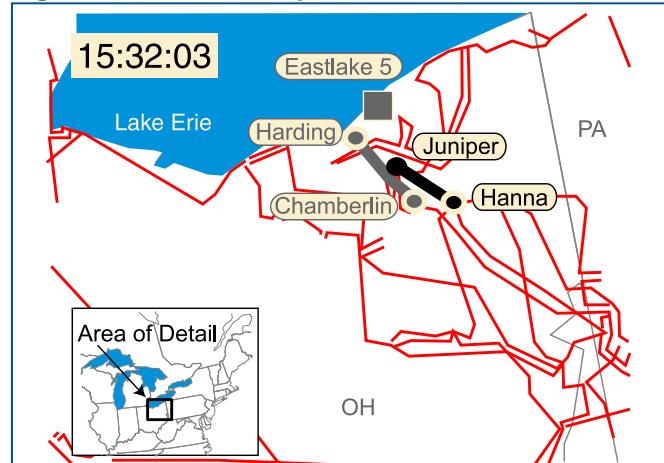
Figure 5.9. Hanna-Juniper 345-kV Line

At 15:32:03 EDT the Hanna-Juniper line (Figure 5.9) tripped and locked out. A tree-trimming crew was working nearby and observed the tree/line contact. The tree contact occurred on the south phase, which is lower than the center phase due to construction design. Although little evidence remained of the tree during the field team’s visit in October, the team observed a tree stump 14 inches (35.5 cm) in diameter at its ground line and talked to an individual who witnessed the contact on August 14.²⁶ Photographs clearly indicate that the tree was of excessive height (Figure 5.10). Surrounding trees were 18 inches (45.7 cm) in diameter at ground line and 60 feet (18.3 meters) in

Hanna-Juniper was loaded at 88% of its normal and emergency rating when it tripped. With this line open, over 1,200 MVA of power flow had to find a new path to reach its load in Cleveland. Loading on the remaining two 345-kV lines increased, with Star-Juniper taking the bulk of the power. This caused Star-South Canton's loading to rise above its normal but within its emergency rating and pushed more power onto the 138-kV system. Flows west into Michigan decreased slightly and voltages declined somewhat in the Cleveland area.

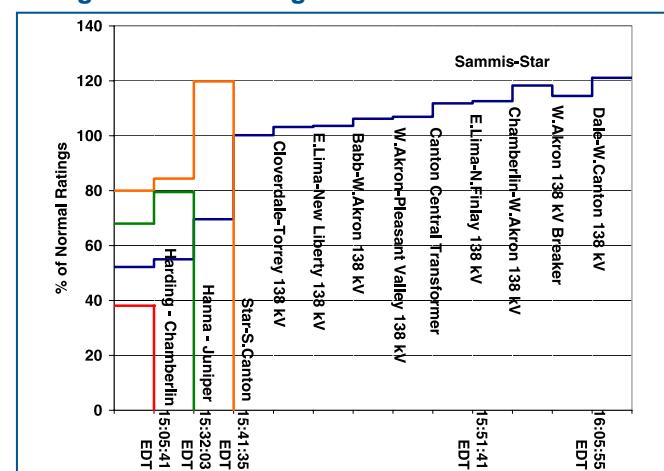
Figure 5.12. Cumulative Effects of Sequential Outages on Remaining 345-kV Lines

the loss of the Harding-Chamberlin 345-kV line. Figure 5.12 shows the line loadings estimated by investigation team modeling as the 345-kV lines in northeast Ohio began to trip. Showing line loadings on the 345-kV lines as a percent of normal rating, it tracks how the loading on each line increased as each subsequent 345-kV and 138-kV line tripped out of service between 15:05 EDT (Harding-Chamberlin, the first line above to stair-step down) and 16:06 EDT (Dale-West Canton). As the graph shows, none of the 345- or 138-kV lines exceeded their normal ratings until after the combined trips of Harding-Chamberlin and Hanna-Juniper. But immediately after the second line was lost, Star-South Canton's loading jumped from an estimated 82% of normal to 120% of normal (which was still below its emergency rating) and remained at the 120% level for 10 minutes before tripping out. To the right, the graph shows the effects of the 138-kV line failures (discussed in the next phase) upon the two remaining 345-kV lines—i.e., Sammis-Star's loading increased steadily above 100% with each succeeding 138-kV line lost.

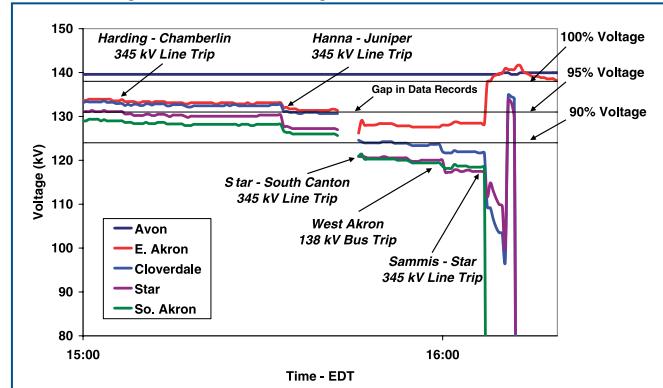
Figure 5.14. Voltages on FirstEnergy's 138-kV Lines: Impact of Line Trips

Figure 5.14 shows how actual voltages declined at key 138-kV buses as the 345- and 138-kV lines were lost. As these lines failed, the voltage drops caused a number of large industrial customers with voltage-sensitive equipment to go off-line automatically to protect their operations. As the 138-kV lines opened, they blacked out customers in Akron and the areas west and south of the city, ultimately dropping about 600 MW of load.

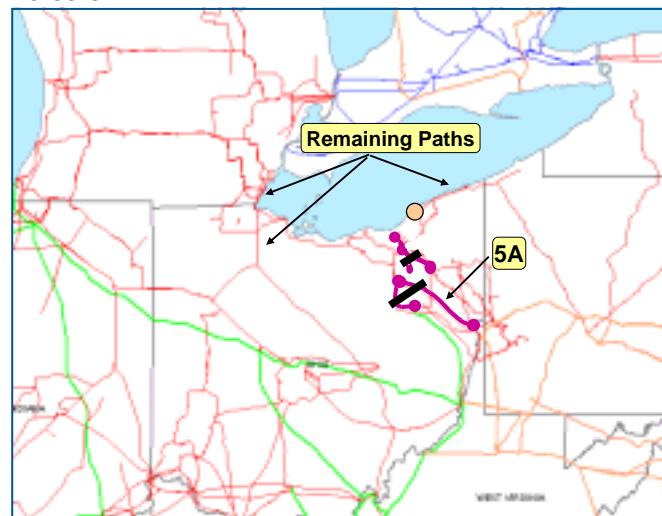
Figure 6.3. Sammis-Star 345-kV Line Trip, 16:05:57 EDT

Sammis-Star did not trip due to a short circuit to ground (as did the prior 345-kV lines that tripped). Sammis-Star tripped due to protective zone 3 relay action that measured low apparent impedance (depressed voltage divided by abnormally high line current) (Figure 6.4). There was no fault and no major power swing at the time of the trip—rather, high flows above the line's emergency rating together with depressed voltages caused the overload to appear to the protective relays as a remote fault on the system. In effect, the relay could no longer differentiate between a remote three-phase fault and an exceptionally high line-load condition. Moreover, the reactive flows (VAr) on the line were almost ten times higher than they had been earlier in the day because of the current overload. The relay operated as it was designed to do.

The Sammis-Star 345-kV line trip completely severed the 345-kV path into northern Ohio from southeast Ohio, triggering a new, fast-paced sequence of 345-kV transmission line trips in which each line trip placed a greater flow burden on those lines remaining in service. These line outages left only three paths for power to flow into western Ohio: (1) from northwest Pennsylvania to northern Ohio around the south shore of Lake Erie, (2) from southwest Ohio toward northeast Ohio, and (3) from eastern Michigan and Ontario. The line interruptions substantially weakened northeast Ohio as a source of power to eastern Michigan, making the Detroit area more reliant on 345-kV lines west and northwest of Detroit, and from northwestern Ohio to eastern Michigan. The impact of this trip was felt across the grid—it caused a 100 MW increase in flow from PJM into New York and through to Ontario.¹ Frequency in the Eastern Interconnection increased momentarily by 0.02 Hz.

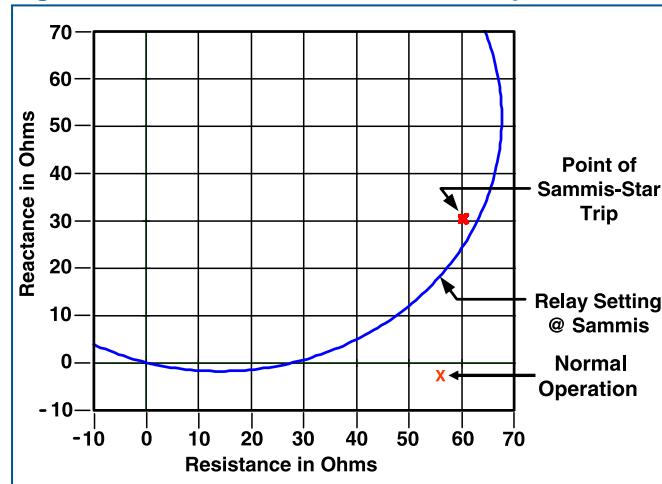
Figure 6.4. Sammis-Star 345-kV Line Trip

The Sammis-Star line tripped at 16:05:57 EDT on a zone 3 impedance relay although there were no faults occurring at the time, because increased real and reactive power flow caused the apparent impedance to be within the impedance circle (reach) of the relay. Between 16:06:01 and 16:10:38.6 EDT, thirteen more important 345 and 138-kV lines tripped on zone 3 operations that afternoon at the start of the cascade, including Galion-Ohio Central-Muskingum, East Lima-Fostoria Central, Argenta-Battle Creek, Argenta-Tompkins, Battle Creek-Oneida, and Perry-Ashtabula (Figure 6.9). These included several zone 2 relays in Michigan that had been set to operate like zone 3s, overreaching the line by more than 200% with no intentional time delay for remote breaker failure protection.³ All of these relays operated according to their settings. However, the zone 3 relays (and zone 2 relays acting like zone 3s) acted so quickly that they impeded the natural ability of the electric system to hold together, and did not allow for any operator intervention to attempt to stop the spread of the cascade. The investigation team concluded that because these zone 2 and 3 relays tripped after each line overloaded, these relays were the common mode of failure that accelerated the geographic spread of the cascade. Given grid conditions and loads and the limited operator tools available, the speed of the zone 2 and 3 operations across Ohio and Michigan eliminated any possibility after 16:05:57 EDT that either operator action or automatic intervention could have limited or mitigated the growing cascade.

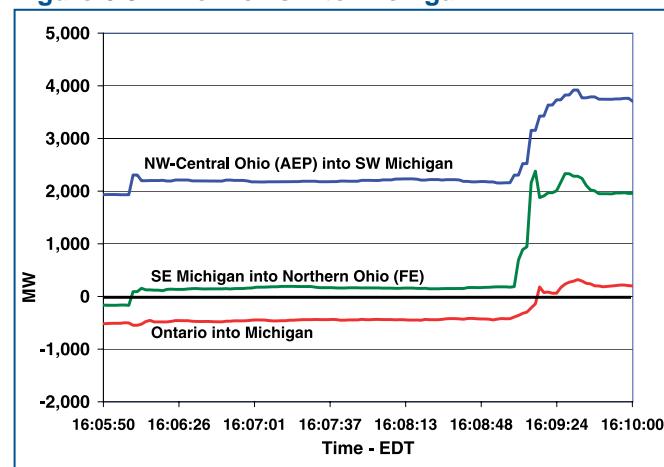
Figure 6.5. Line Flows Into Michigan

overloading and tripping within Ohio, this was happening slowly enough under relatively stable conditions that the system could readjust—after each line loss, power flows would redistribute across the remaining lines. This is illustrated in Figure 6.5, which shows the MW flows on the Michigan Electrical Coordinated Systems (MECS) interfaces with AEP (Ohio), FirstEnergy (Ohio) and Ontario. The graph shows a shift from 150 MW imports to 200 MW exports from the MECS system into FirstEnergy at 16:05:57 EDT after the loss of Sammis-Star, after which this held steady until 16:08:59, when the loss of East Lima-Fostoria Central cut the main energy path from the south and west into Cleveland and Toledo. Loss of this path was significant, causing flow from MECS into FE to jump from 200 MW up to 2,300 MW, where it bounced somewhat before stabilizing, roughly, until the path across Michigan was cut at 16:10:38 EDT.

Note: These curves use data collected from the MECS Energy Management System, which records flow quantities every 2 seconds. As a result, the fast power swings that occurred between 16:10:36 to 16:13 were not captured by the recorders and are not reflected in these curves.

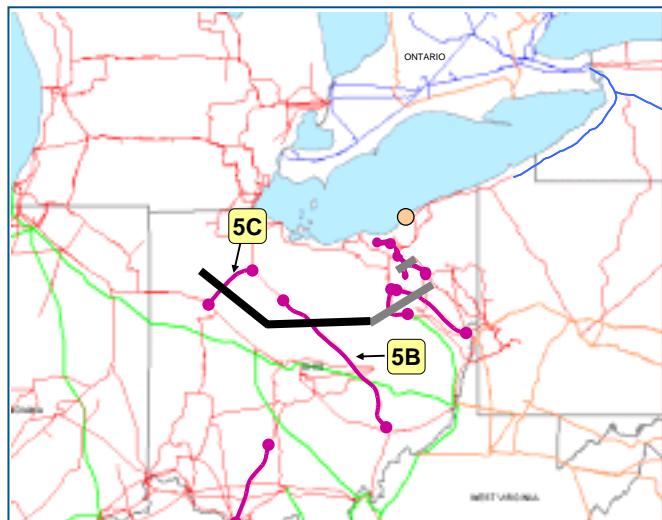
Figure 6.6. Ohio 345-kV Lines Trip, 16:08:59 to 16:09:07 EDT

345-kV transmission lines removed the transmission paths from southern and western Ohio into northern Ohio and eastern Michigan. Northern Ohio was connected to eastern Michigan by only three 345-kV transmission lines near the southwestern bend of Lake Erie. Thus, the combined northern Ohio and eastern Michigan load centers were left connected to the rest of the grid only by: (1) transmission lines eastward from northeast Ohio to northwest Pennsylvania along the southern shore of Lake Erie, and (2) westward by lines west and northwest of Detroit, Michigan and from Michigan into Ontario (Figure 6.6).

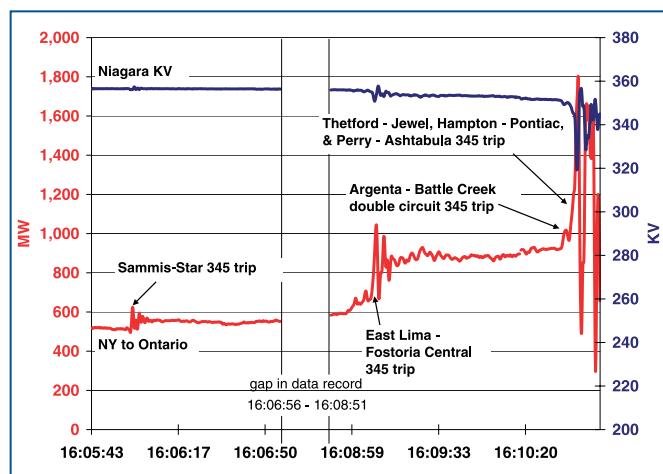
Figure 6.7. New York-Ontario Line Flows at Niagara

shows the impact of the East Lima-Fostoria Central and the New York to Ontario power swing, which continued to oscillate for over 10 seconds. Looking at the MW flow line, it is clear that when Sammis-Star tripped, the system experienced oscillations that quickly damped out and rebalanced. But East Lima-Fostoria triggered significantly greater oscillations that worsened in magnitude for several cycles, and returned to stability but continued to flutter until the Argenta-Battle Creek trip 90 seconds later. Voltages also began declining at this time.

Figure 6.7 also shows the magnitude of subsequent flows and voltages at the New York-Ontario Niagara border, triggered by the trips of the Argenta-Battle Creek, Argenta-Tompkins, Hampton-Pontiac and Thetford-Jewell 345-kV lines in Michigan, and the Erie West-Ashtabula-Perry

As the cascade progressed beyond Ohio, it spread due not to insufficient reactive power and a voltage collapse, but because of dynamic power swings and the resulting system instability. Figure 6.7 shows voltage levels recorded at the Niagara area. It shows clearly that voltage levels remained stable until 16:10:30 EDT, despite significant power fluctuations. In the cascade that followed, the voltage instability was a companion to, not a driver of, the angle instability that tripped generators and lines.

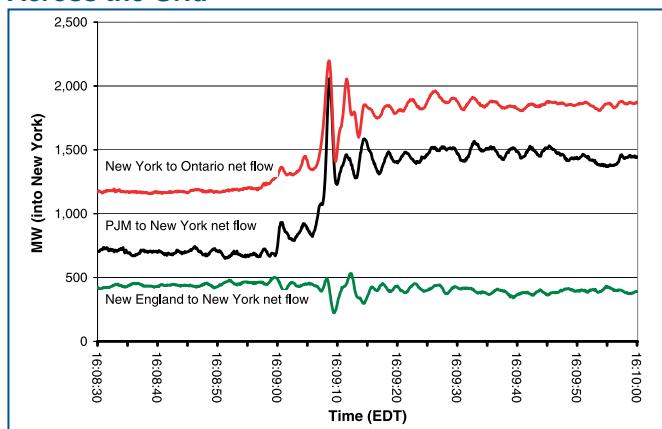
Figure 6.8. First Power Swing Has Varying Impacts Across the Grid

Figure 6.8, of metered power flows along the New York interfaces, documents how the flows heading north and west toward Detroit and Cleveland varied at different points on the grid. Beginning at 16:09:05 EDT, power flows jumped simultaneously across all three interfaces—but when the first power surge peaked at 16:09:09, the change in flow was highest on the PJM interface and lowest on the New England interface. Power flows increased significantly on the PJM-NY and NY-Ontario interfaces because of the redistribution of flow around Lake Erie. The New England and Maritime systems maintained the same generation to load balance and did not carry the redistributed flows because they were not in the direct path of the flows, so that interface with New York showed little response.

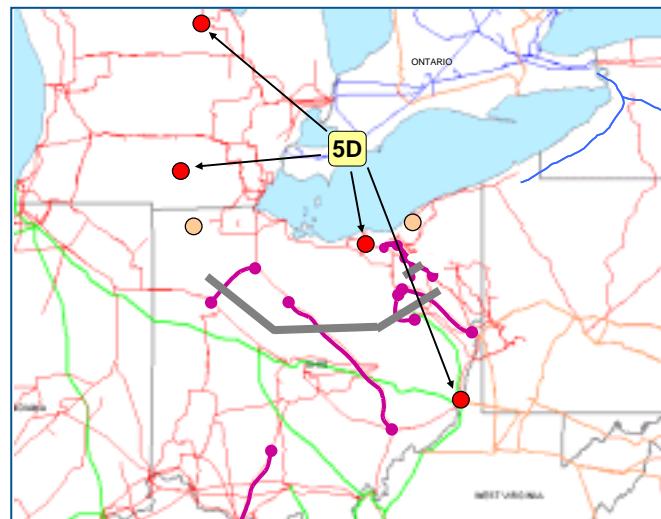
Figure 6.10. Michigan and Ohio Power Plants Trip

The Burger units tripped after the 138-kV lines into the Burger 138-kV substation (Ohio) tripped from the low voltages in the Cleveland area (Figure 6.10). The MCV plant is in central Michigan. Kinder Morgan is in south-central Michigan. The Kinder-Morgan units tripped due to a transformer fault and one due to over-excitation.

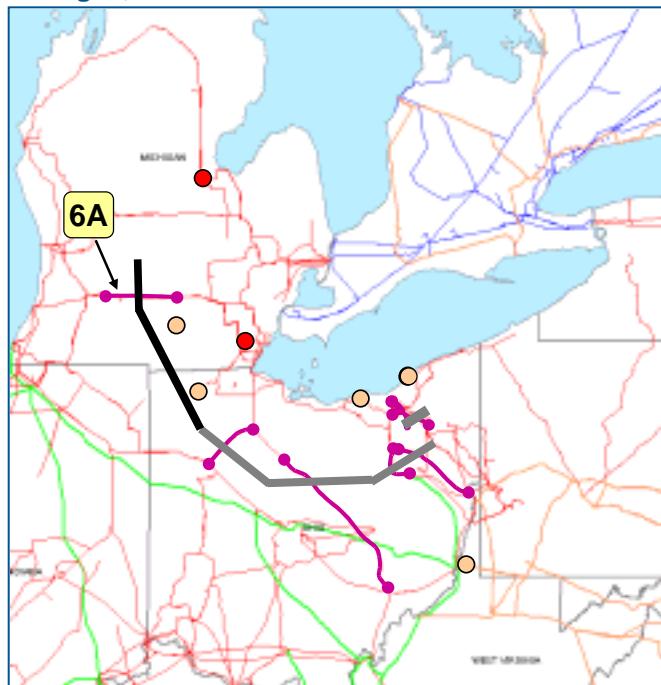
Figure 6.11. Transmission and Generation Trips in Michigan, 16:10:36 to 16:10:37 EDT

under-voltage on the system. Michigan lines west of Detroit then began to trip, as shown in Figure 6.11.

The Argenta-Battle Creek relay first opened the line at 16:10:36.230 EDT, reclosed it at 16:10:37, then tripped again. This line connects major generators—including the Cook and Palisades nuclear plants and the Campbell fossil plant—to the MECS system. This line is designed with auto-reclose breakers at each end of the line, which do an automatic high-speed reclose as soon as they open to restore the line to service with no interruptions. Since the majority of faults on the North American grid are temporary, automatic reclosing can enhance stability and system reliability. However, situations can occur when the power systems behind the two ends of the line could go out of phase during the high-speed reclose period (typically less than 30 cycles, or one half second, to allow the air to de-ionize after the trip to prevent arc re-ignition). To address this and protect generators from the harm that an out-of-synchronism reconnect could cause, it is worth studying whether a synchro-check relay is needed, to reclose the second breaker only when the two ends are within a certain voltage and phase angle tolerance. No such protection was installed at Argenta-Battle Creek; when the line reclosed, there was a 70° difference in phase across the circuit breaker reclosing the line. There

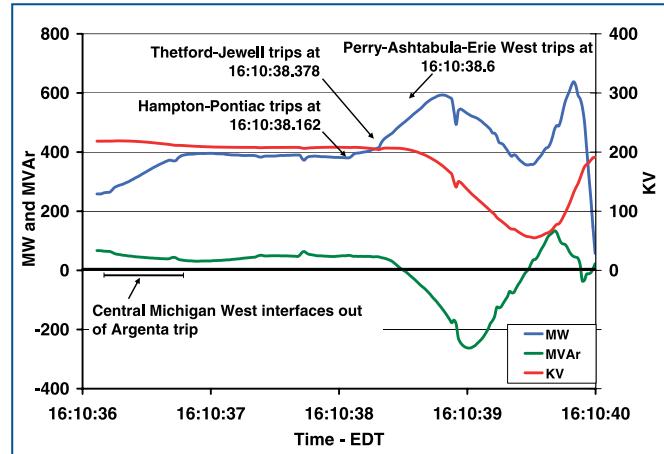
Figure 6.12. Flows on Keith-Waterman 230-kV Ontario-Michigan Tie Line

The Power System Disturbance Recorders at Keith and Lambton, Ontario, captured these events in the flows across the Ontario-Michigan interface, as shown in Figure 6.12 and Figure 6.16. It shows clearly that the west to east Michigan separation (the Thetford-Jewell trip) was the start and Erie West-Ashtabula-Perry was the trigger for the 3,700 MW surge from Ontario into Michigan. When Thetford-Jewell tripped, power that had been flowing into Michigan and Ohio from western Michigan, western Ohio and Indiana was cut off. The nearby Ontario recorders saw a pronounced impact as flows into Detroit readjusted to draw power from the northeast instead. To the south,

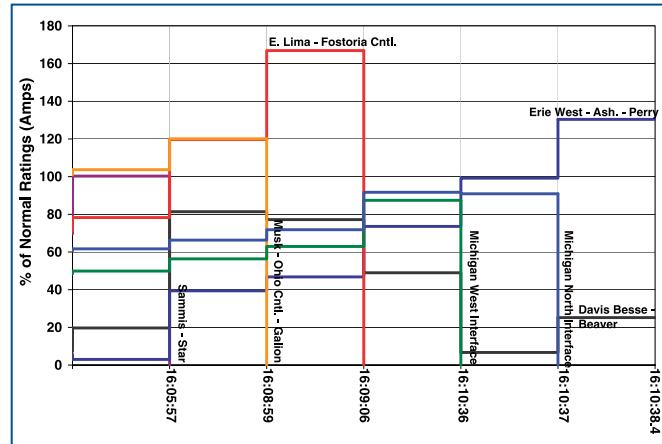
Figure 6.13. Simulated 345-kV Line Loadings from 16:05:57 through 16:10:38.4 EDT

Figures 6.13 and 6.14 show the results of investigation team modeling of the line loadings on the Ohio, Michigan, and other regional interfaces for the period between 16:05:57 until the Thetford-Jewell trip, to understand how power flows shifted during this period. The team simulated evolving system conditions on August 14, 2003, based on the 16:05:50 power flow case developed by the MAAC-ECAR-NPCC Operations Studies Working Group. Each horizontal line in the graph indicates a single or set of 345-kV lines and its loading as a function of normal ratings over time as first one, then another, set of circuits tripped out of service. In general, each subsequent line trip causes the remaining line loadings to rise; where a line drops (as Erie West-Ashtabula-Perry in Figure 6.13 after the Hanna-Juniper trip), that indicates that line loading lightened, most likely due to customers dropped from service. Note that Muskingum and East Lima-Fostoria Central were overloaded before they tripped, but the Michigan west and north interfaces were not overloaded before they tripped. Erie West-Ashtabula-Perry was loaded to 130% after the Hampton-Pontiac and Thetford-Jewell trips.

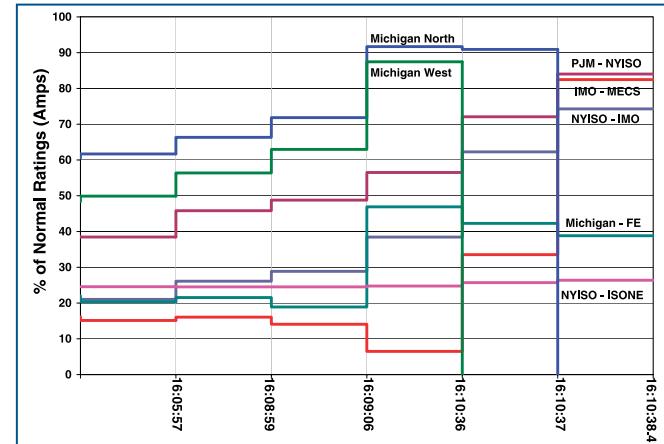
Figure 6.14. Simulated Regional Interface Loadings from 16:05:57 through 16:10:38.4 EDT

The Regional Interface Loadings graph (Figure 6.14) shows that loadings at the interfaces between PJM-NY, NY-Ontario and NY-New England were well within normal ratings before the east-west Michigan separation.

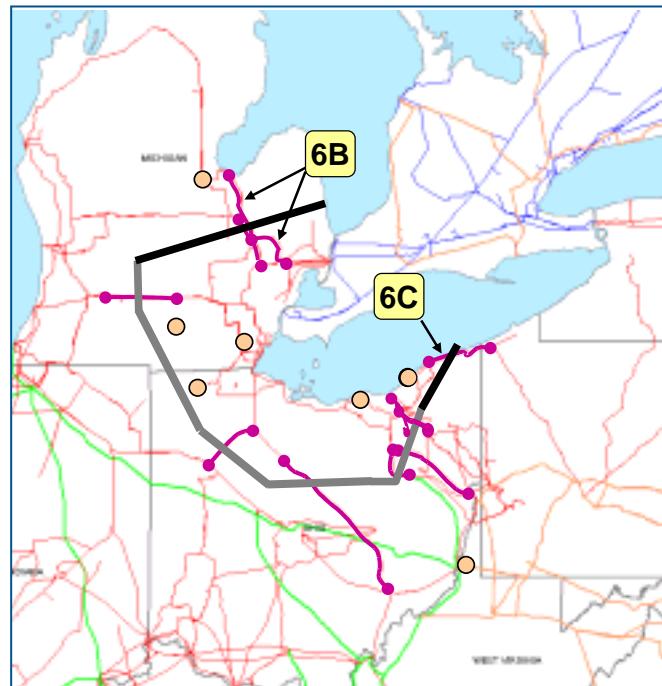
Figure 6.15. Michigan Lines Trip and Ohio Separates from Pennsylvania, 16:10:36 to 16:10:38.6 EDT

- 6C) Cleveland separated from Pennsylvania, flows reversed and a huge power surge flowed counter-clockwise around Lake Erie: 16:10:38.6 EDT
- 16:10:38.6 EDT: Erie West-Ashtabula-Perry 345-kV line tripped at Perry
- 16:10:38.6 EDT: Large power surge to serve loads in eastern Michigan and northern Ohio swept across Pennsylvania, New Jersey, and New York through Ontario into Michigan.

Perry-Ashtabula was the last 345-kV line connecting northern Ohio to the east south of Lake Erie. This line's trip at the Perry substation on a zone 3 relay operation separated the northern Ohio 345-kV transmission system from Pennsylvania and all eastern 345-kV connections. After this trip, the load centers in eastern Michigan and northern Ohio (Detroit, Cleveland, and Akron) remained connected to the rest of the Eastern Interconnection only to the north at the interface between the Michigan and Ontario systems (Figure 6.15). Eastern Michigan and northern Ohio now had little internal generation left and voltage was declining. The frequency in the Cleveland area dropped rapidly, and between 16:10:39 and 16:10:50 EDT under-frequency load shedding in the Cleveland area interrupted about 1,750 MW of load. However, the load shedding did not drop enough load relative to local generation to rebalance and arrest the frequency decline. Since the electrical system always seeks to balance load and generation, the high loads in Detroit and Cleveland drew power over the only major transmission path remaining—the lines from eastern Michigan into Ontario. Mismatches between generation and load are reflected in changes in frequency, so with more generation than load frequency rises and with less generation than load, frequency falls.

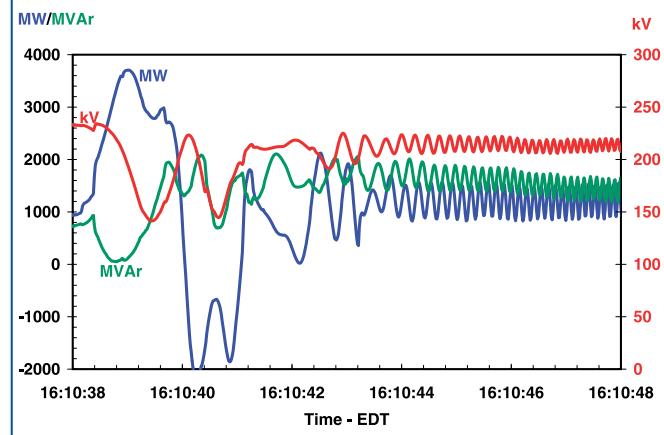
Figure 6.16. Active and Reactive Power and Voltage from Ontario into Detroit

This was a power surge of large magnitude, so frequency was not the same across the Eastern Interconnection. As Figure 6.16 shows, the power swing resulted in a rapid rate of voltage decay. Flows into Detroit exceeded 3,700 MW and 1,500 MVar—the power surge was draining real power out of the northeast, causing voltages in Ontario and New York to drop. At the same time, local voltages in the Detroit area were plummeting because Detroit had already lost 500 MW of local generation. Detroit would soon lose synchronism

and black out (as evidenced by the rapid power oscillations decaying after 16:10:43 EDT).

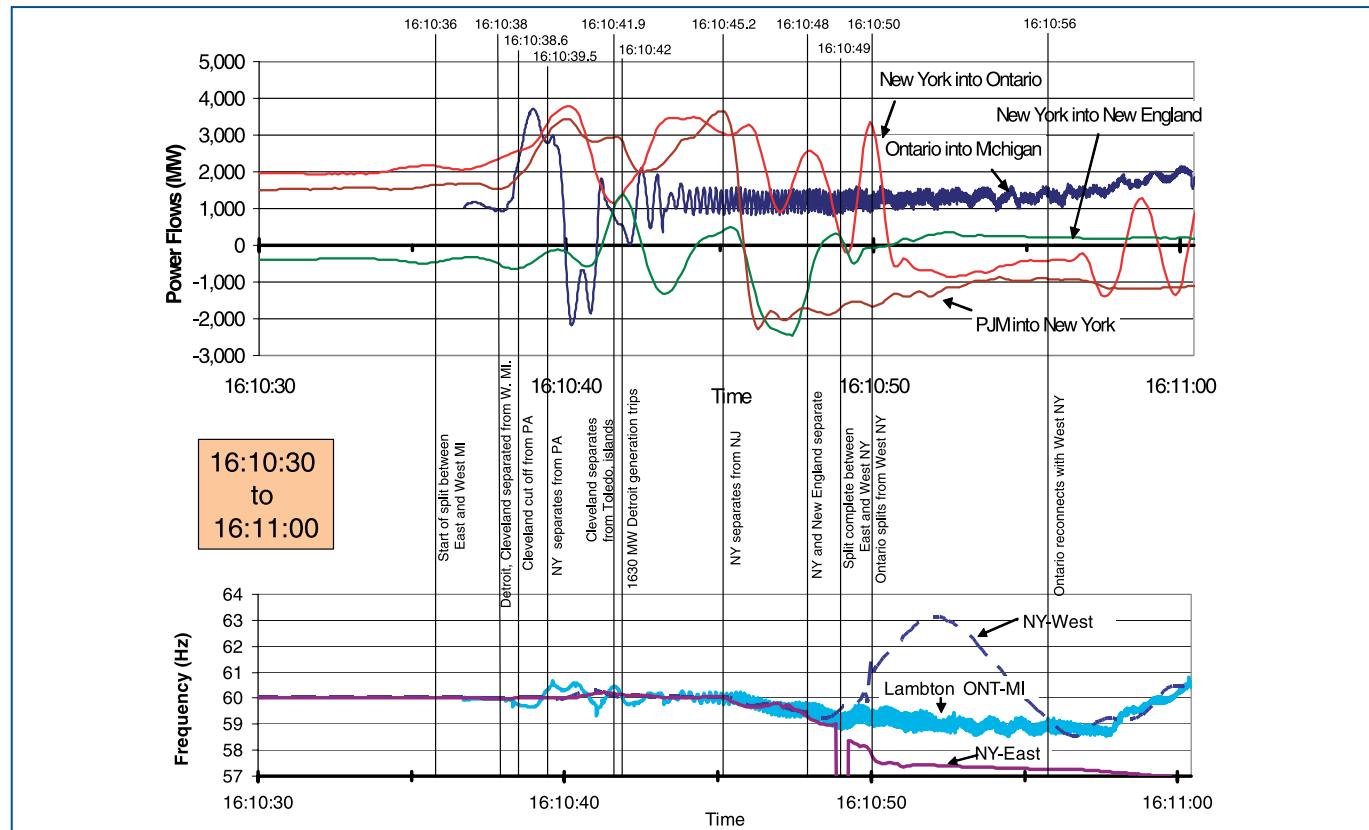
Figure 6.17. Measured Power Flows and Frequency Across Regional Interfaces, 16:10:30 to 16:11:00 EDT, with Key Events in the Cascade

Just before the Argenta-Battle Creek trip, when Michigan separated west to east at 16:10:37 EDT, almost all of the generators in the eastern interconnection were moving in synchronism with the overall grid frequency of 60 Hertz (shown at the bottom of Figure 6.17), but when the swing started, those machines absorbed some of its energy as they attempted to adjust and resynchronize with the rapidly changing frequency. In many

Because the demand for power in Michigan, Ohio, and Ontario was drawing on lines through New York and Pennsylvania, heavy power flows were moving northward from New Jersey over the New York tie lines to meet those power demands, exacerbating the power swing. Figure 6.17 shows actual net line flows summed across the interfaces between the main regions affected by these swings—Ontario into Michigan, New York into Ontario, New York into New England, and PJM into New York. This shows clearly that the power swings did not move in unison across every interface at every moment, but varied in magnitude and direction. This occurred for two reasons. First, the availability of lines to complete the path across

After Cleveland was cut off from Pennsylvania and eastern power sources, Figure 6.17 shows the start of the dynamic power swing at 16:10:38.6. Because the loads of Cleveland, Toledo and Detroit (less the load already blacked out) were now hanging off Michigan and Ontario, this forced a gigantic shift in power flows to meet that demand. As noted above, flows from Ontario into Michigan increased from 1,000 MW to 3,700 MW shortly after the start of the swing, while flows from PJM into New York were close behind. But within two seconds from the start of the swing, at 16:10:40 EDT flows reversed and coursed back from Michigan into Ontario at the same time that frequency at the interface dropped, indicating that significant generation had been lost. Flows that had been westbound across the Ontario-Michigan interface by over 3,700 MW at 16:10:38.8 dropped down to 2,100 MW eastbound by 16:10:40, and then returned westbound starting at 16:10:40.5.

Re-examination of Figure 6.17 shows the power swing from the northeast through Ontario into Michigan and northern Ohio that began at 16:10:37, and how it reverses and swings back around Lake Erie at 16:10:39 EDT. That return was caused by the combination of natural oscillations, accelerated by major load losses, as the northern Ohio system disconnected from Michigan. It caused a power flow change of 5,800 MW, from 3,700 MW westbound to 2,100 eastbound across the Ontario to Michigan border between 16:10:39.5 and 16:10:40 EDT. Since the system was now fully dynamic, this large oscillation eastbound would lead naturally to a rebound, which began at 16:10:40 EDT with an inflection point reflecting generation shifts between Michigan and Ontario and additional line losses in Ohio.

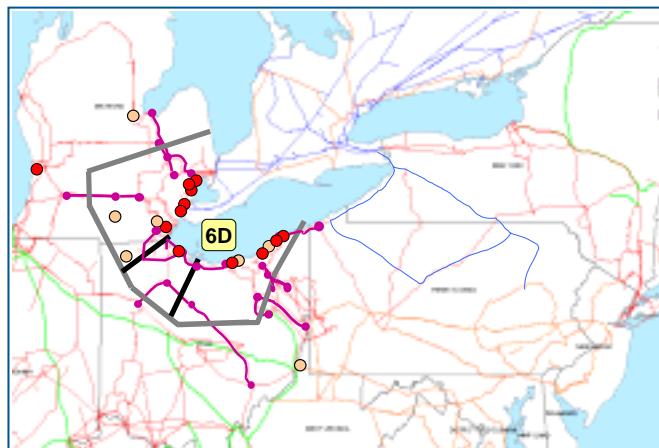
Figure 6.18. Cleveland and Toledo Islanded, 16:10:39 to 16:10:46 EDT

Back in northern Ohio, the trips of the Bay Shore-Monroe, Majestic-Lemoyne, Allen Junction-Majestic-Monroe 345-kV lines, and the Ashtabula 345/138-kV transformer cut off Toledo and Cleveland from the north, turning that area into an electrical island (Figure 6.18). Frequency in this large island began to fall rapidly. This caused a series of power plants in the area to trip

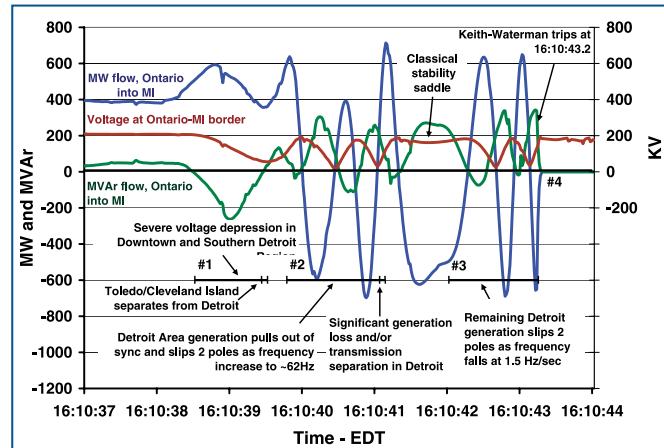
Figure 6.19. Generators Under Stress in Detroit, as Seen from Keith PSDR

running at maximum mechanical output, they began to pull out of synchronous operation with the rest of the grid. When voltage in Detroit returned to near-normal, the generators could not fully pull back its rate of revolutions, and ended up producing excessive temporary output levels, still out of step with the system. This is evident in Figure 6.19, which shows at least two sets of generator “pole slips” by plants in the Detroit area between 16:10:40 EDT and 16:10:42 EDT. Several large units around Detroit—Belle River, St. Clair, Greenwood, Monroe, and Fermi—all tripped in response. After formation of the Cleveland-Toledo island at 16:10:40 EDT, Detroit frequency spiked to almost 61.7 Hz before dropping, momentarily equalized between the Detroit and Ontario systems, but Detroit frequency began to decay at 2 Hz/sec and the generators then experienced under-speed conditions.

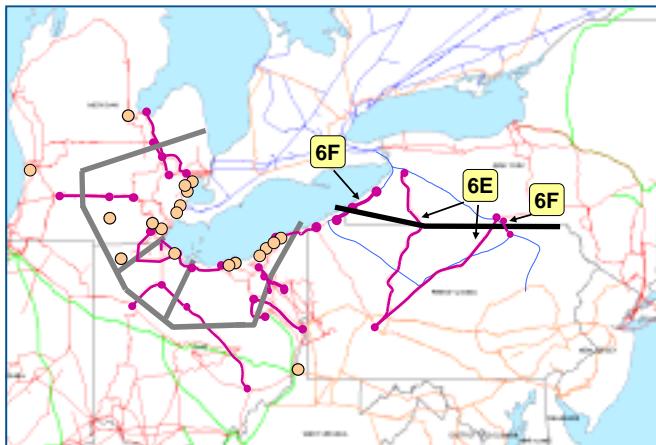
Figure 6.20. Western Pennsylvania Separates from New York, 16:10:39 EDT to 16:10:44 EDT

Responding to the swing of power out of Michigan toward Ontario and into New York and PJM, zone 1 relays on the 345-kV lines separated Pennsylvania from New York (Figure 6.20). Homer City-Watercure (177 miles or 285 km) and Homer City-Stolle Road (207 miles or 333 km) are very long lines and so have high impedance. Zone 1 relays do not have timers, and operate instantly when a power swing enters the relay target circle. For normal length lines, zone 1 relays have small target circles because the relay is measuring a less than the full length of the line—but for a long line the large line impedance enlarges the relay's target circle and makes it more likely to be hit by the power swing. The Homer City-Watercure and Homer City-Stolle Road lines do not have zone 3 relays.

Given the length and impedance of these lines, it was highly likely that they would trip and separate early in the face of such large power swings. Most of the other interfaces between regions are on short ties—for instance, the ties between New York and Ontario and Ontario to Michigan are only about 2 miles (3.2 km) long, so they are electrically very short and thus have much lower impedance and trip less easily than these long lines. A zone 1 relay target for a short line covers a

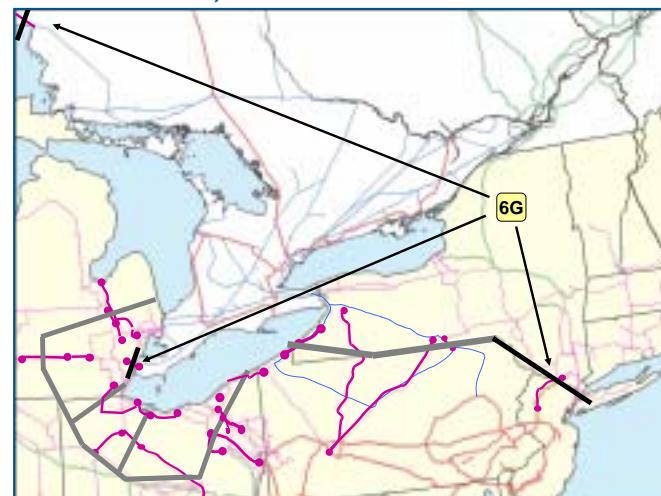
Figure 6.21. Northeast Separates from Eastern Interconnection, 16:10:45 EDT

At 16:10:43 EDT, eastern Michigan was still connected to Ontario, but the Keith-Waterman 230-kV line that forms part of that interface disconnected due to apparent impedance (Figure 6.21). This put more power onto the remaining interface between Ontario and Michigan, but

triggered sustained oscillations in both power flow and frequency along the remaining 230-kV line.

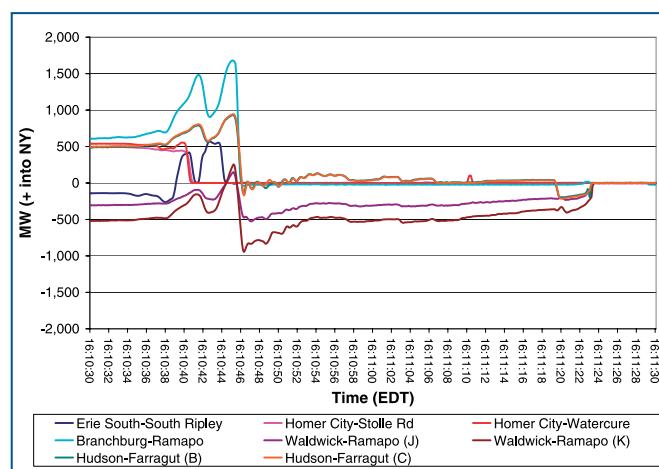
Figure 6.22. PJM to New York Interties Disconnect

The 69-mile (111 km) long Branchburg-Ramapo 500-kV line and Ramapo transformer between New Jersey and New York was the last major transmission path remaining between the Eastern Interconnection and the area ultimately affected by the blackout. Figure 6.22 shows how that line disconnected at 16:10:45 EDT, along with other underlying 230 and 138-kV lines in northeast New Jersey. Branchburg-Ramapo was carrying over 3,000 MVA and 4,500 amps with voltage at 79% before it tripped, either on a high-speed swing into zone 1 or on a direct transfer trip. The investigation team is still examining why the higher impedance 230-kV overhead lines tripped while the underground Hudson-Farragut 230-kV cables did not; the available data suggest that the notably lower impedance of underground cables made these less vulnerable to the electrical strain placed on the system.

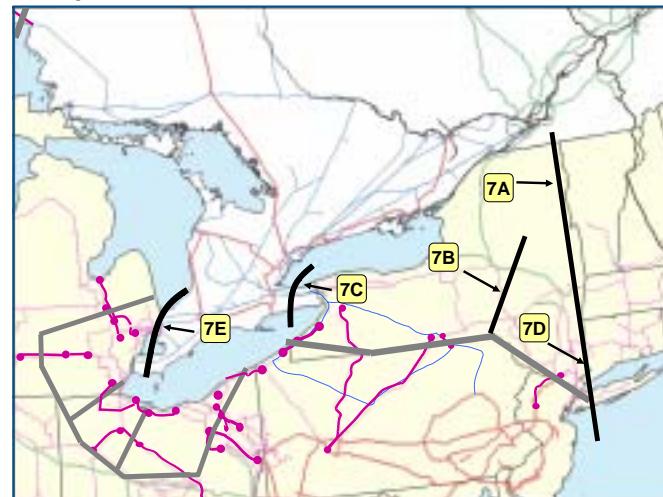
Figure 6.23. New York and New England Separate, Multiple Islands Form

During the next 3 seconds, the islanded northern section of the Eastern Interconnection broke apart internally. Figure 6.23 illustrates the events of this phase.
