U.S.-Canada Power System Outage Task Force

Final Report on the August 14, 2003 Blackout in the United States and Canada: Causes and Recommendations

April 2004

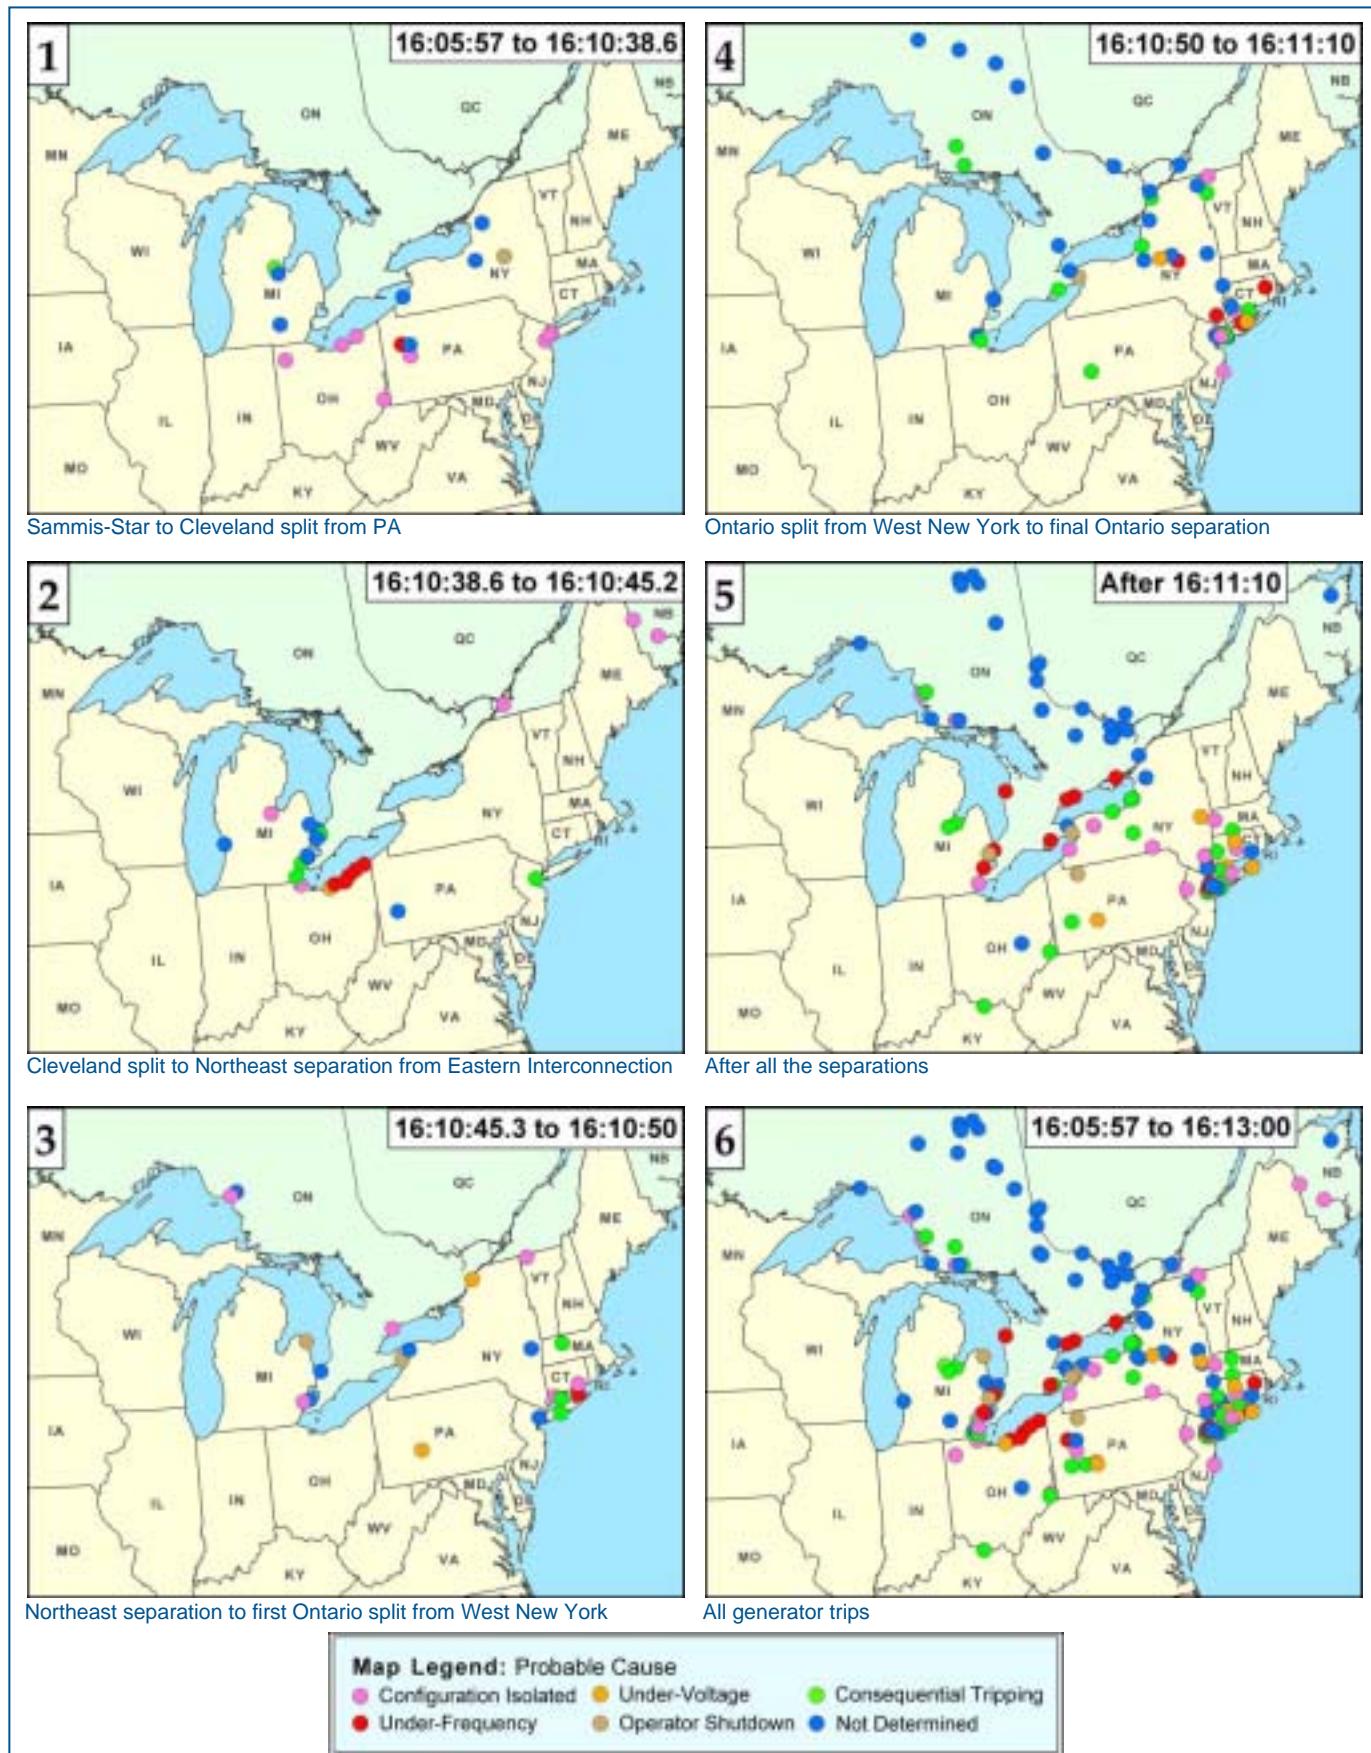
Figure 6.24. Generator Trips by Time and Cause

Within the overall cascade sequence, 29 (6%) generators tripped between the start of the cascade at 16:05:57 (the Sammis-Star trip) and the split between Ohio and Pennsylvania at 16:10:38.6 EDT (Erie West-Ashtabula-Perry), which triggered the first big power swing. These trips were caused by the generators' protective relays responding to overloaded transmission lines, so many of these trips were reported as under-voltage or overcurrent. The next interval in the cascade was as the portions of the grid lost synchronism, from 16:10:38.6 until 16:10:45.2 EDT, when Michigan-New York-Ontario-New England separated from the rest of the Eastern Interconnection. Fifty more generators (10%) tripped as the islands formed, particularly due to changes in configuration, loss of synchronism, excitation system failures, with some under-frequency and under-voltage. In the third phase of generator losses, 431 generators (84%) tripped after the islands formed,

many at the same time that under-frequency load-shedding was occurring. This is illustrated in Figure 6.24. It is worth noting, however, that many generators did not trip instantly after the trigger condition that led to the trip—rather, many relay protective devices operate on time delays of milliseconds to seconds in duration, so that a generator that reported tripping at 16:10:43 on under-voltage or “generator protection” might have experienced the trigger for that condition several seconds earlier.

In particular, it appears that some generators tripped to protect the units from conditions that did not justify their protection, and many others were set to trip in ways that were not coordinated with the region’s under-frequency load-shedding, rendering that UFLS scheme less effective. Both factors compromised successful islanding and precipitated the blackouts in Ontario and New York.

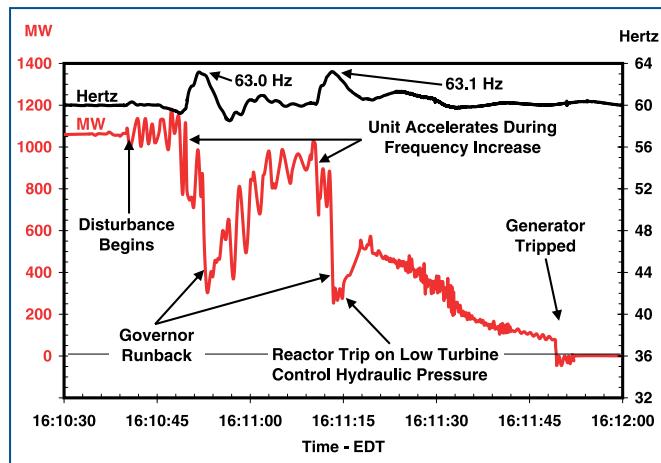
Figure 6.25. Events at One Large Generator During the Cascade

it back again as some frequencies changed several times by as much as 3 Hz (about 100 times normal deviations). Figure 6.25 is a plot of the MW output and frequency for one large unit that nearly survived the disruption but tripped when in-plant hydraulic control pressure limits were eventually violated. After the plant control system called for shutdown, the turbine control valves closed and the generator electrical output ramped down to a preset value before the field excitation tripped and the generator breakers opened to disconnect the unit from the system. This also illustrates the time lag between system events and the generator reaction—this generator was first disturbed by system conditions at 16:10:37, but did not trip until 16:11:47, over a minute later.

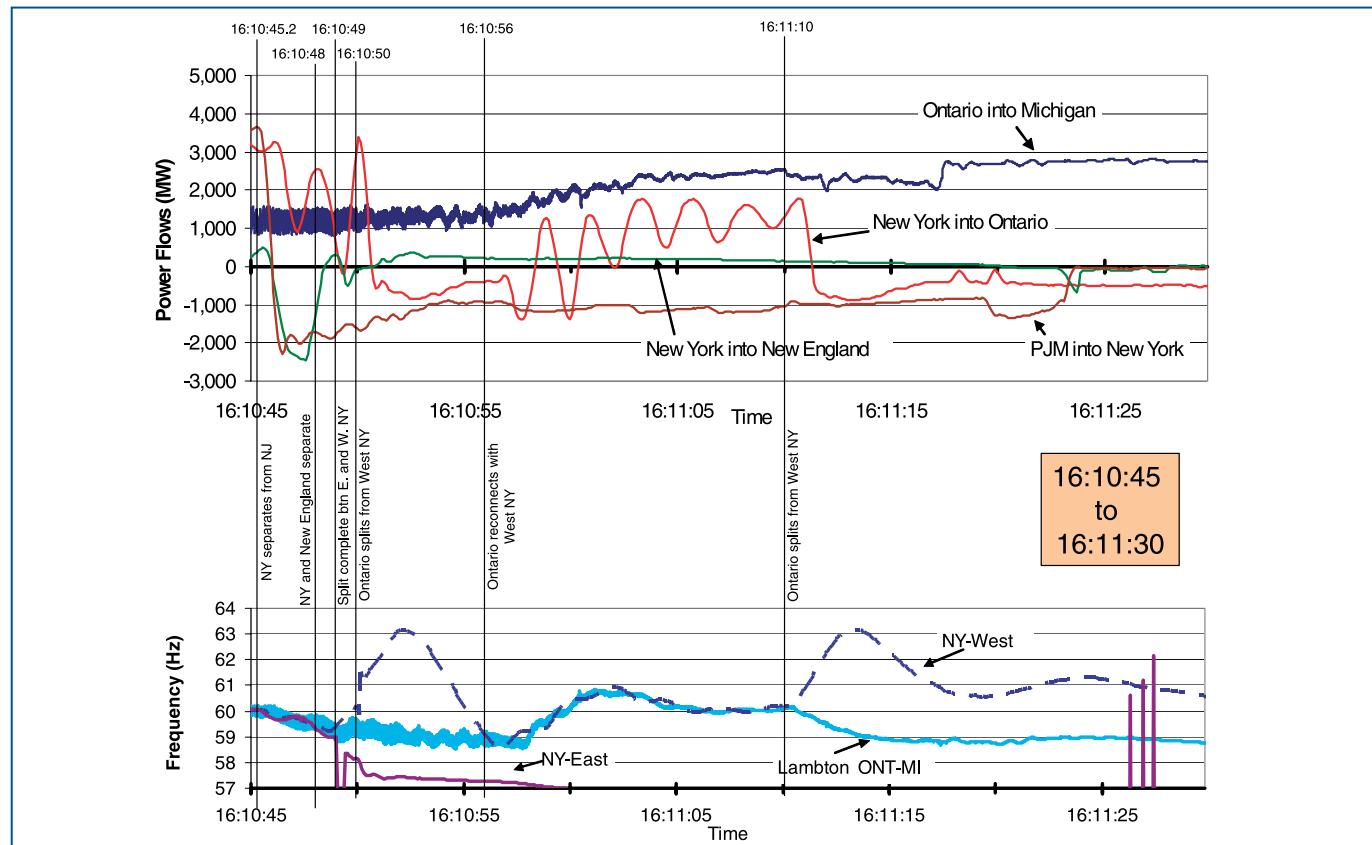
Figure 6.26. Measured Power Flows and Frequency Across Regional Interfaces, 16:10:45 to 16:11:30 EDT, with Key Events in the Cascade

Figure 6.26 gives an overview of the power flows and frequencies in the period 16:10:45 EDT through 16:11:00 EDT, capturing most of the key events in Phase 7.

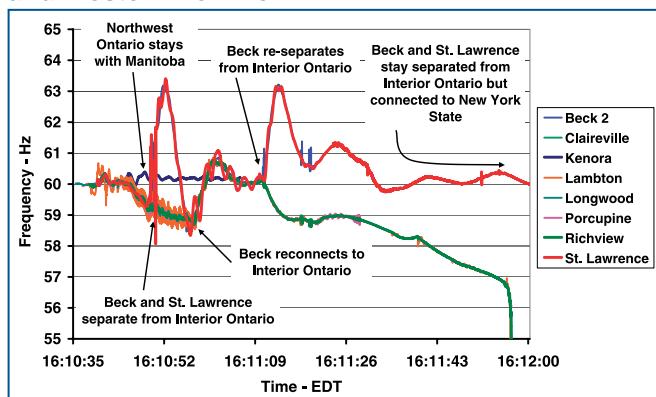
Figure 6.27. Frequency Separation Between Ontario and Western New York

From 16:10:49 to 16:10:50 EDT, frequency in Ontario declined below 59.3 Hz, initiating automatic under-frequency load-shedding (3,000 MW). This load-shedding dropped about 12% of Ontario's remaining load. Between 16:10:50 EDT and 16:10:56 EDT, the isolation of Ontario's 2,300 MW Beck and Saunders hydro units onto the western New York island, coupled with under-frequency load-shedding in the western New York island, caused the frequency in this island to rise to 63.4 Hz due to excess generation relative to the load within the island (Figure 6.27). The high frequency caused trips of five of the U.S. nuclear units within the island, and the last one tripped on the second frequency rise.

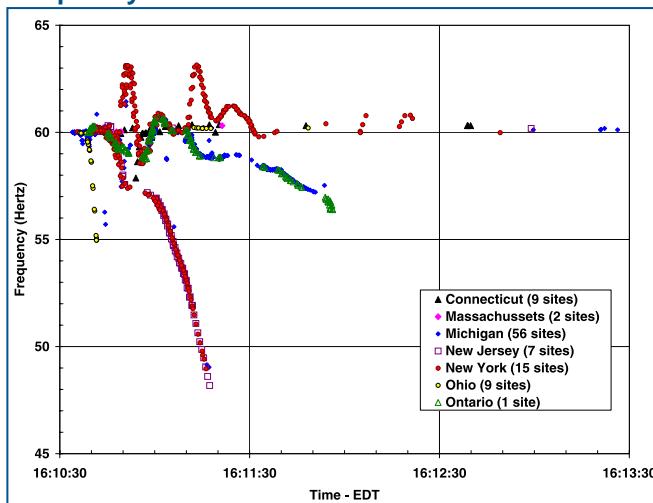
Figure 6.28. Electric Islands Reflected in Frequency Plot

Figure 6.28 shows frequency data collected by the distribution-level monitors of Softswitching Technologies, Inc. (a commercial power quality company serving industrial customers) for the area affected by the blackout. The data reveal at least five separate electrical islands in the Northeast as the cascade progressed. The two paths of red diamonds on the frequency scale reflect the Albany area island (upper path) versus the New York City island, which declined and blacked out much earlier.

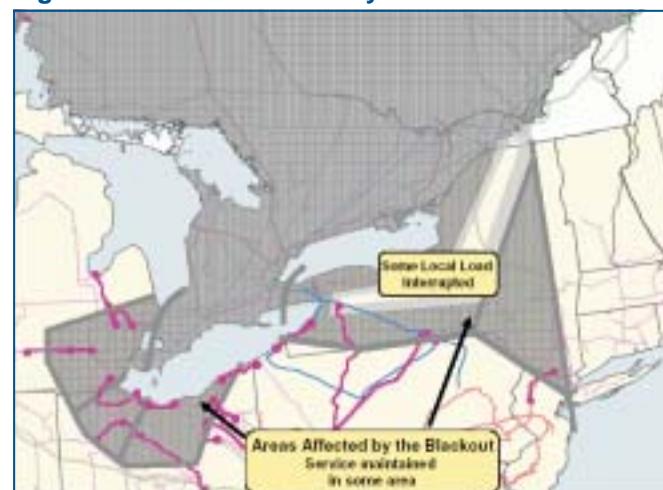
Figure 6.29. Area Affected by the Blackout

Most of the Northeast (the area shown in gray in Figure 6.29) was now blacked out. Some isolated areas of generation and load remained on-line for several minutes. Some of those areas in which a close generation-demand balance could be maintained remained operational.

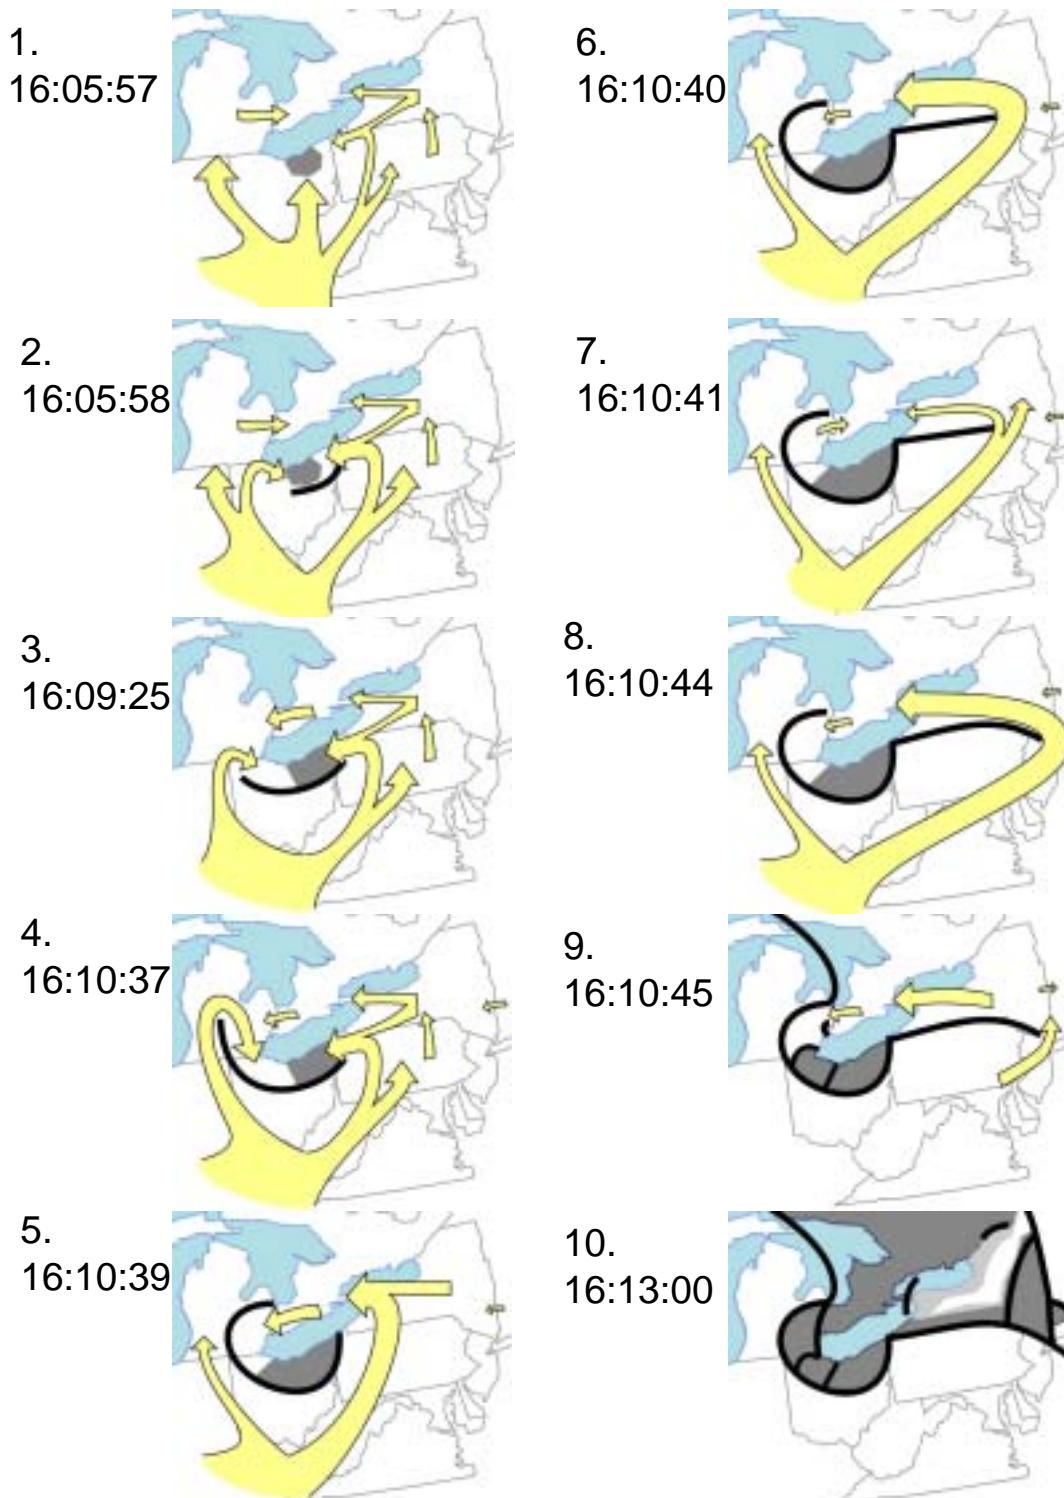
Figure 6.30. Cascade Sequence

The entire cascade sequence is depicted graphically in Figure 6.30.

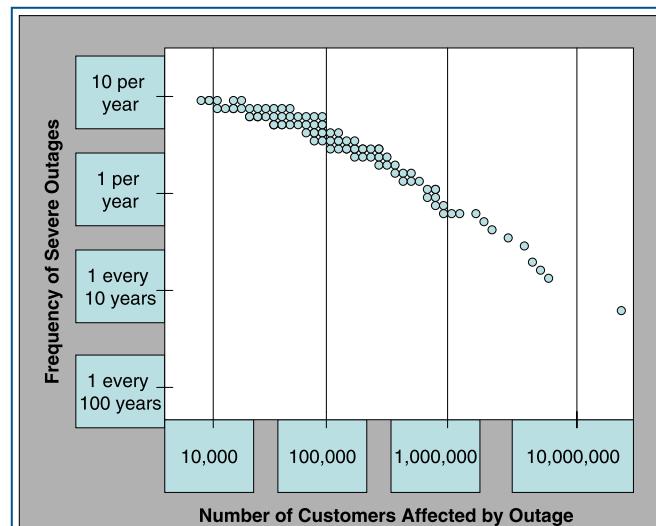
Figure 7.1. North American Power System Outages, 1984-1997

Short, localized outages occur on power systems fairly frequently. System-wide disturbances that affect many customers across a broad geographic area are rare, but they occur more frequently than a normal distribution of probabilities would predict. North American power system outages between 1984 and 1997 are shown in Figure 7.1 by the number of customers affected and the rate of occurrence. While some of these were widespread weather-related events, some were cascading events that, in retrospect, were preventable. Electric power systems are fairly robust and are capable of withstanding one or two contingency events, but they are fragile with respect to multiple contingency events unless the systems are readjusted between contingencies. With the shrinking margin in the current transmission system, it is likely to be more vulnerable to cascading outages than it was in the past, unless effective countermeasures are taken.
