UNITED STATES ENVIRONMENTAL PROTECTION AGENCY
REGION IX
75 Hawthorne Street
San Francisco, CA 94105

WASTE MANAGEMENT DIVISION
RCRA ENFORCEMENT OFFICE

Purpose: RCRA Investigation

Facility: Chemical Waste Management, Inc.

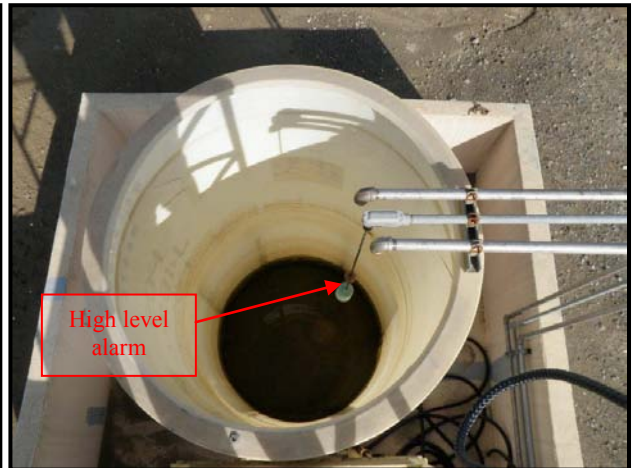
The leachate collection tank at P-9 is an open-top tank. Three pipes are located on top of the tank. One pipe is from the P-9 riser assembly, one pipe is from the P-9 tank sump, and the middle pipe is the high level alarm which ensures that the two-foot freeboard is maintained. The inspectors observed several inches of rainwater on the bottom of the tank, as described on the label.

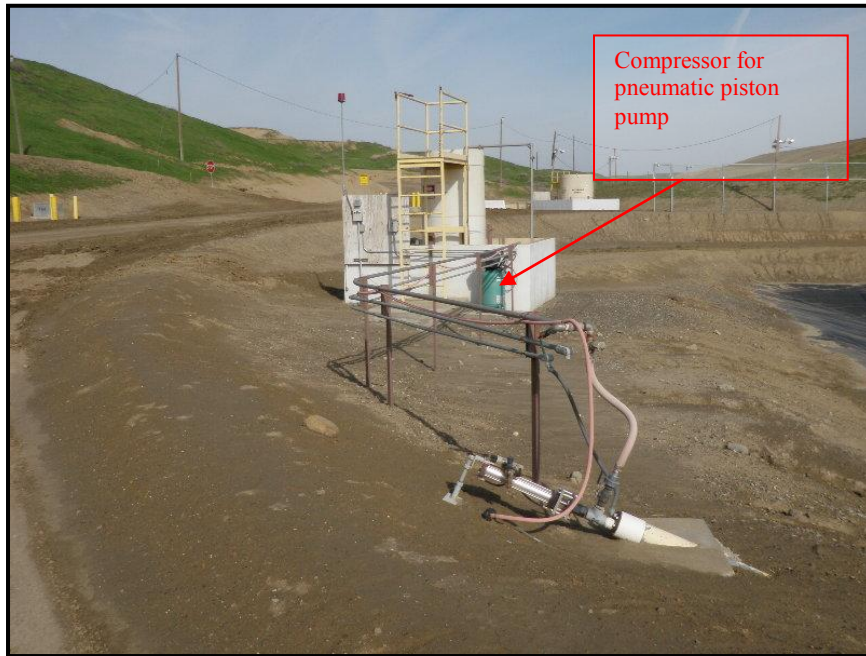
The inspectors noted cracks on the outside wall of the secondary containment system (see cropped and enlarged inset). The inspectors also noted that the cracks on the inside walls and floor of the secondary containment system were repaired.

P-9: Riser assembly in the foreground leading to the leachate collection tank (facing north). A pneumatic piston pump is used to pump out the leachate sump.

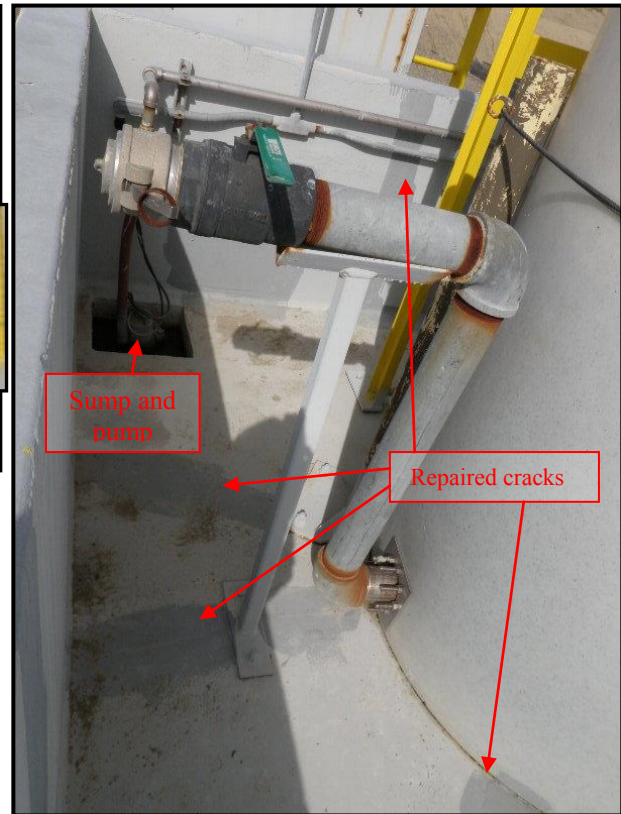
P-14: Pump-out connection used to remove the contents from the 90-day hazardous waste storage tank (facing north). Note: The sump has a pump which is used to transfer any fluid which may accumulate from rainfall events into the P-14 leachate collection tank. The inspectors noted several areas where the secondary containment system was repaired.

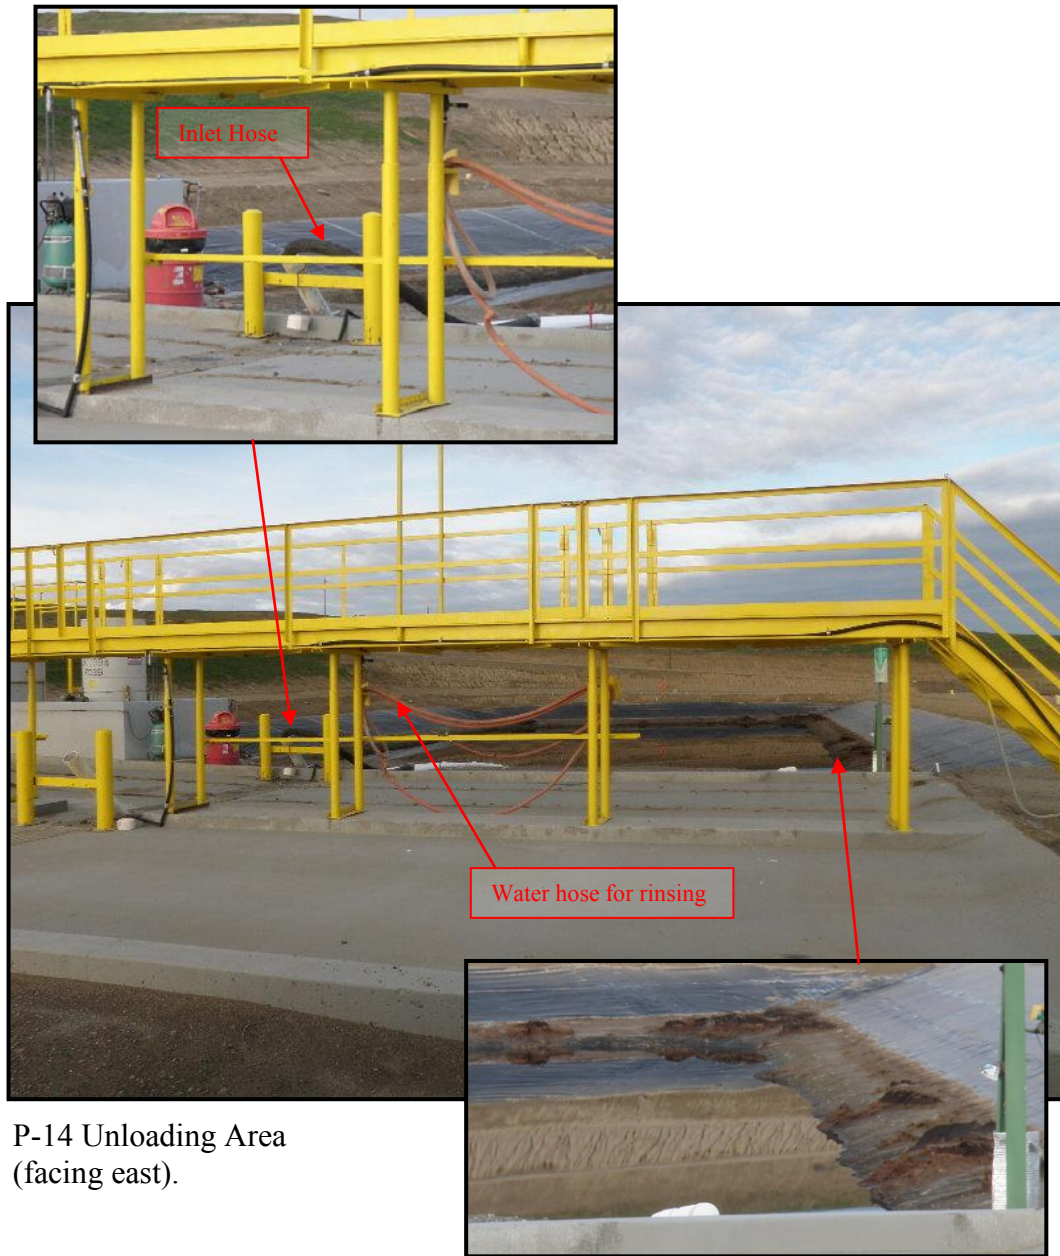
P-14 Unloading Area
(facing east).

The top inset photograph shows the hose which is connected to the vehicles for off-loading. The bottom inset photograph (cropped and enlarged) shows areas where unknown material is accumulating along the waterline of P-14.

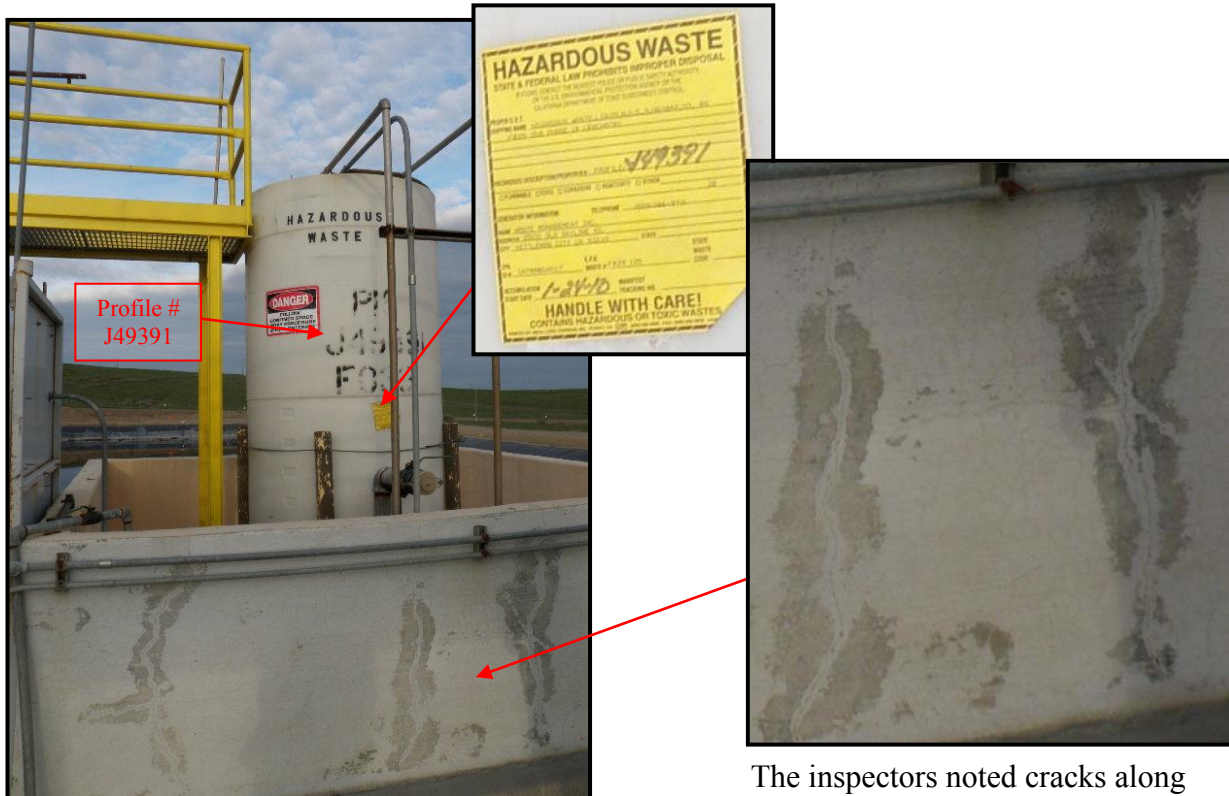
P-16: Leachate Collection Tank (facing east).
Note: The panel on the left side contains the high level alarm and the magnehelic device used for determining the sump liquid level. The inset HW label is cropped and enlarged.

The inspectors noted cracks along the outside portion of the secondary containment system for the P-16 leachate collection tank (facing east; cropped and enlarged).

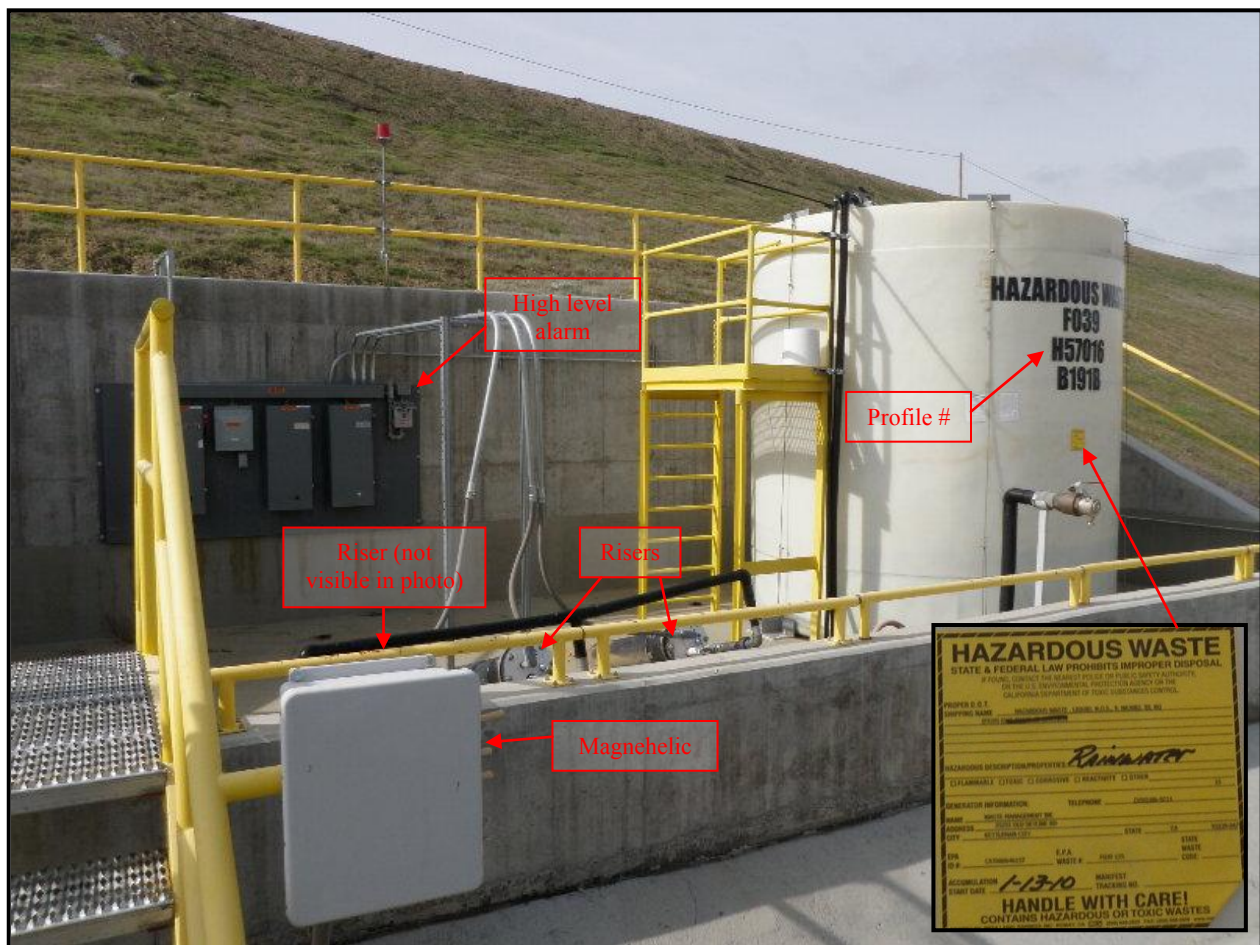
Landfill B-19 Leachate Collection Tank 1B

As stated above, landfill B-19 has three landfill leachate collection tanks which collect the leachate from the three hazardous waste phases of the landfill (Phases 1B, 2, and 3). Phase 1B is located on the northeast section of B-19. The layout of the leachate collection tank system (i.e., risers, above-ground hazardous waste storage tank, secondary containment system, pad sump, etc.) is similar to the layout of the systems for the landfill B-18 leachate collection tanks. Photographs and details of the Phase 1B leachate collection Tank 1B area are provided below. The inset photograph of the hazardous waste label is cropped and enlarged.

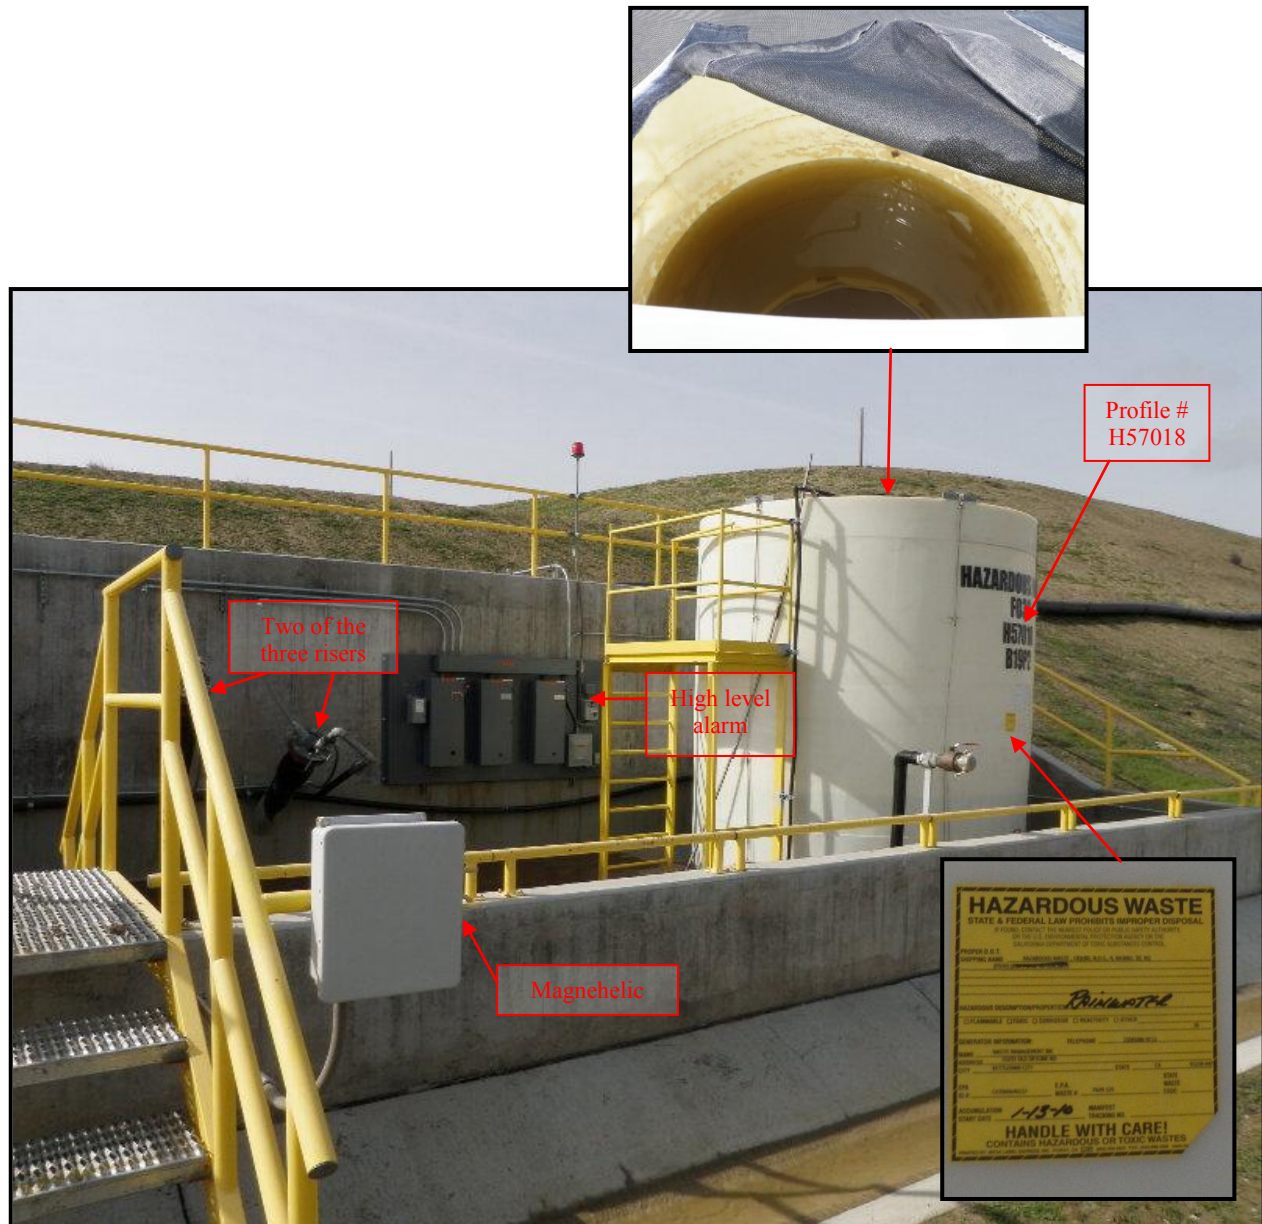
Landfill B-19 Leachate Collection Tank Phase 2

Phase 2 is located on the southeast section of B-19. The layout of the leachate collection tank system (i.e., risers, above-ground hazardous waste storage tank, secondary containment system, pad sump, etc.) is similar to the layout of the system for leachate collection Tank 1B. Photographs and details of the Phase 2 leachate collection Tank P2 area are provided below. The inset photograph of the hazardous waste label is cropped and enlarged.

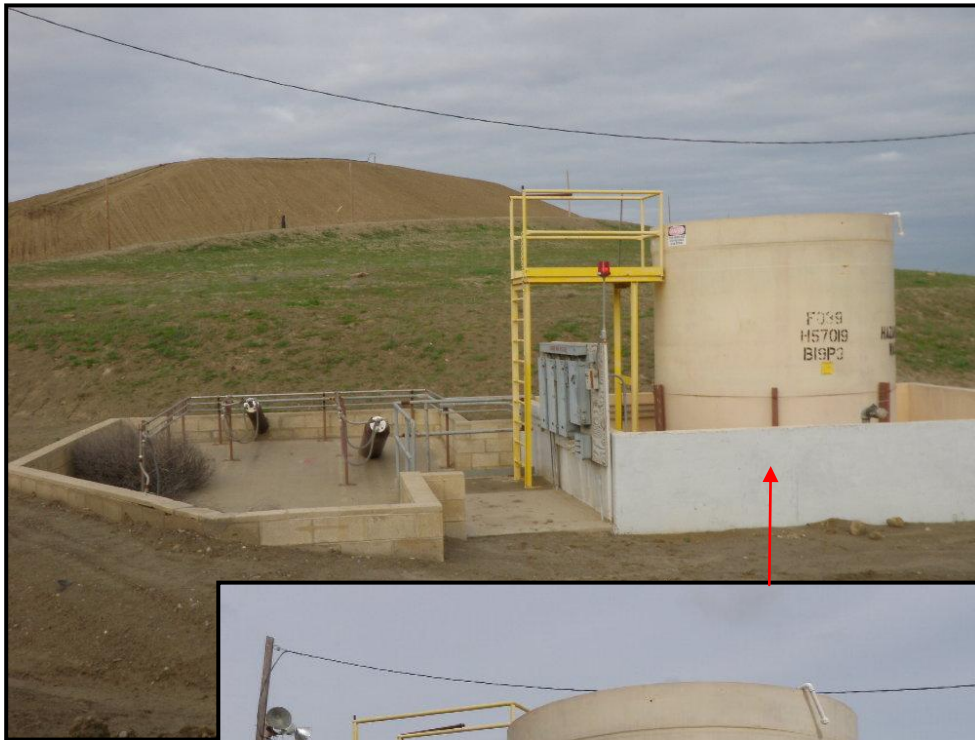
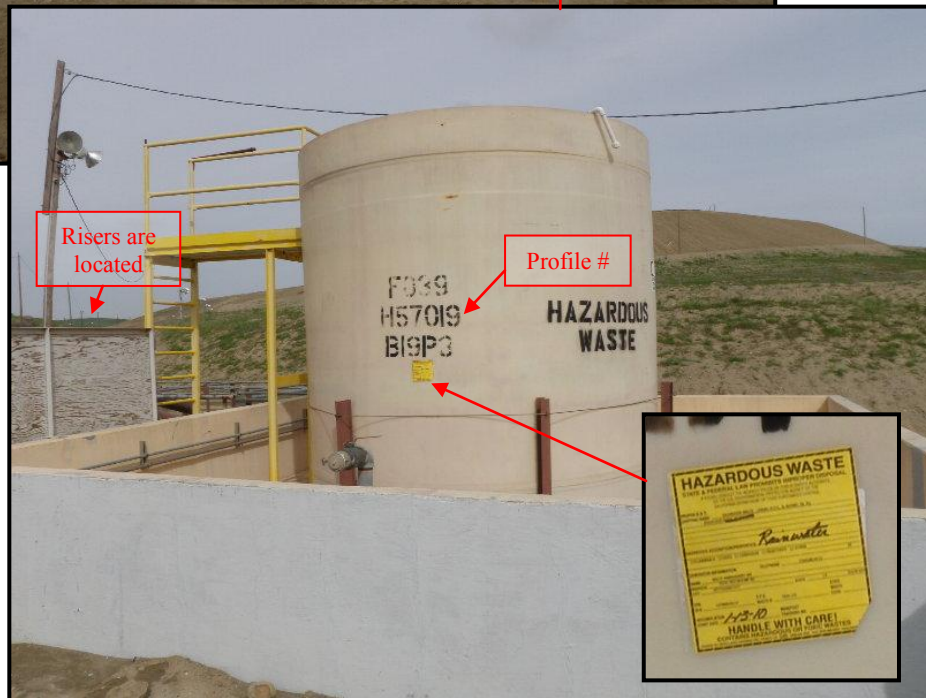
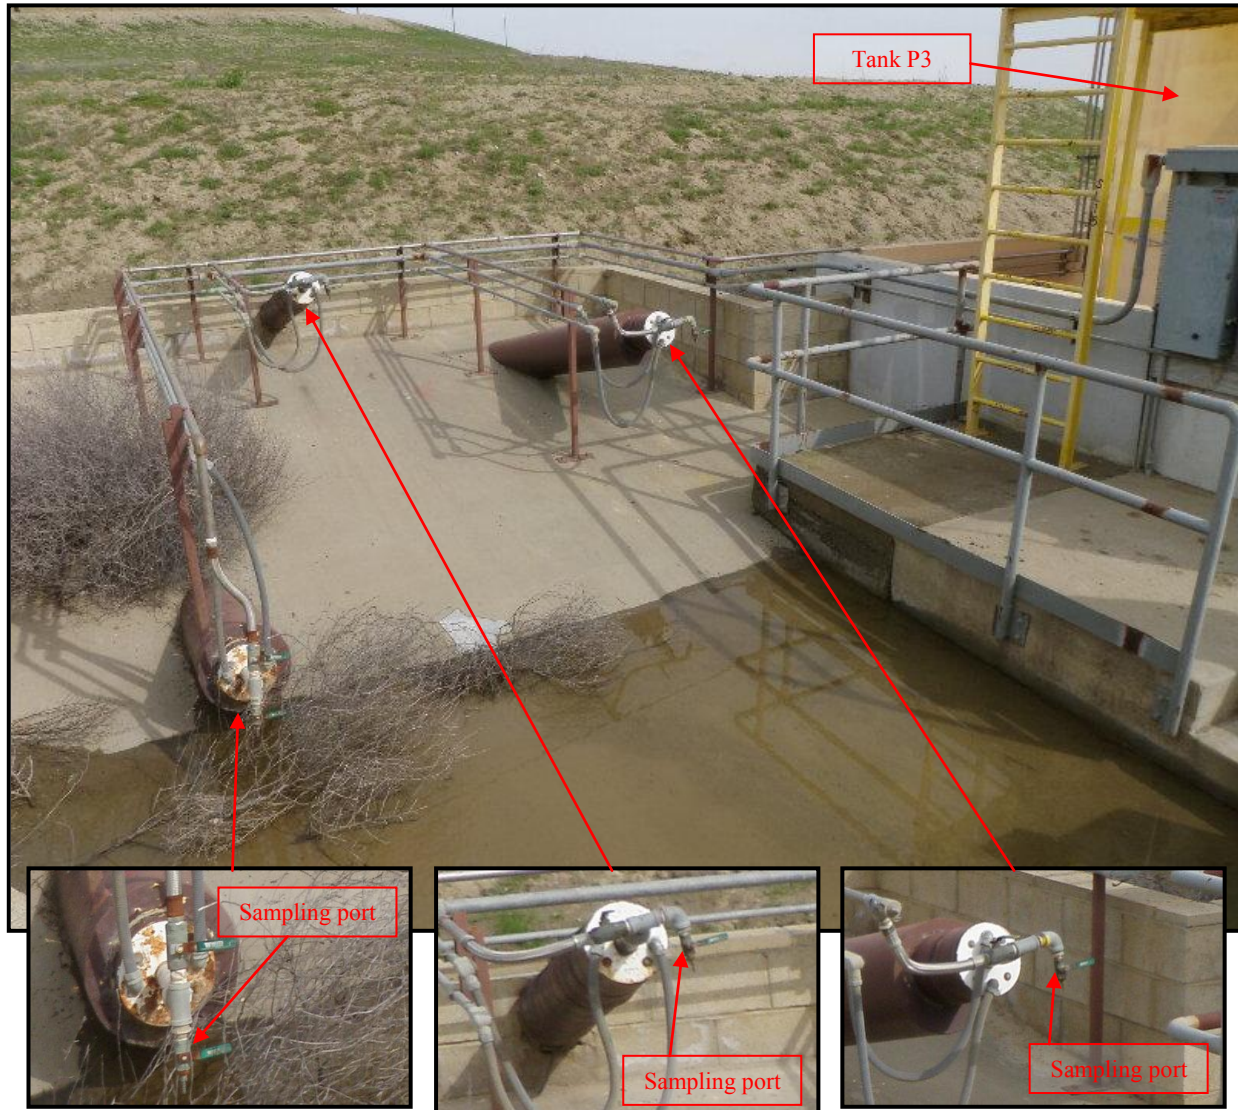
Landfill B-19 Leachate Collection Tank Phase 3

Phase 3 is located on the southwest section of B-19. The layout of the leachate collection tank system (i.e., risers, above-ground hazardous waste storage tank, secondary containment system, pad sump, etc.) is similar to the layout of the systems for leachate collection Tanks 1B and P2 (see photograph below – facing north). However, unlike the other leachate collection tanks for landfill B-19, the risers are located outside of the secondary containment pad for the tank. The risers are located on a separate containment area located on the west side of the tank. Photographs and details of the Phase 3 leachate collection Tank P3 area are provided below. The inset photograph of the hazardous waste label is cropped and enlarged.

The inspectors noted that this area contained rainwater from the previous night's rain. This rainwater will be pumped into the adjacent tank.

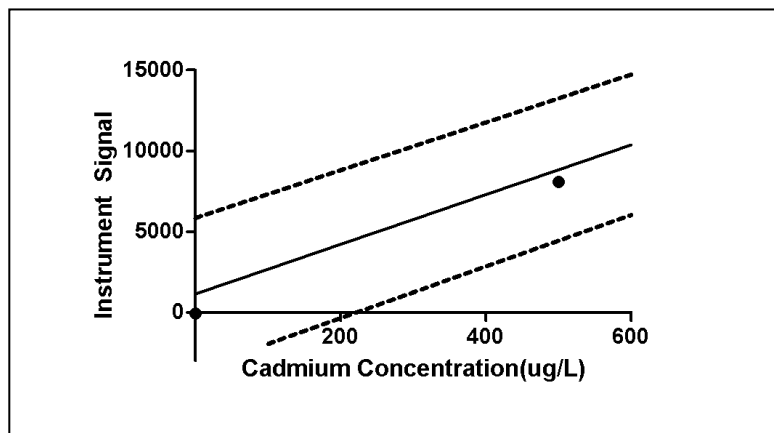
95% Confidence Interval for Cadmium Calibration With Expanded Scale Around the Decision Point of 110 ug/L

The figure below, based on the calibration used to report sample 6061-16, illustrates how this discrepancy results in waste being determined to meet UTS when it actually exceeds UTS. Specifically, it depicts a significant negative bias at the UTS concentration. A clean water sample (no cadmium instrument signal) would be reported as a negative concentration, unless the water was spiked to have a concentration of 70 ppb cadmium. This is analogous to weighing something on a scale that has been dialed back.

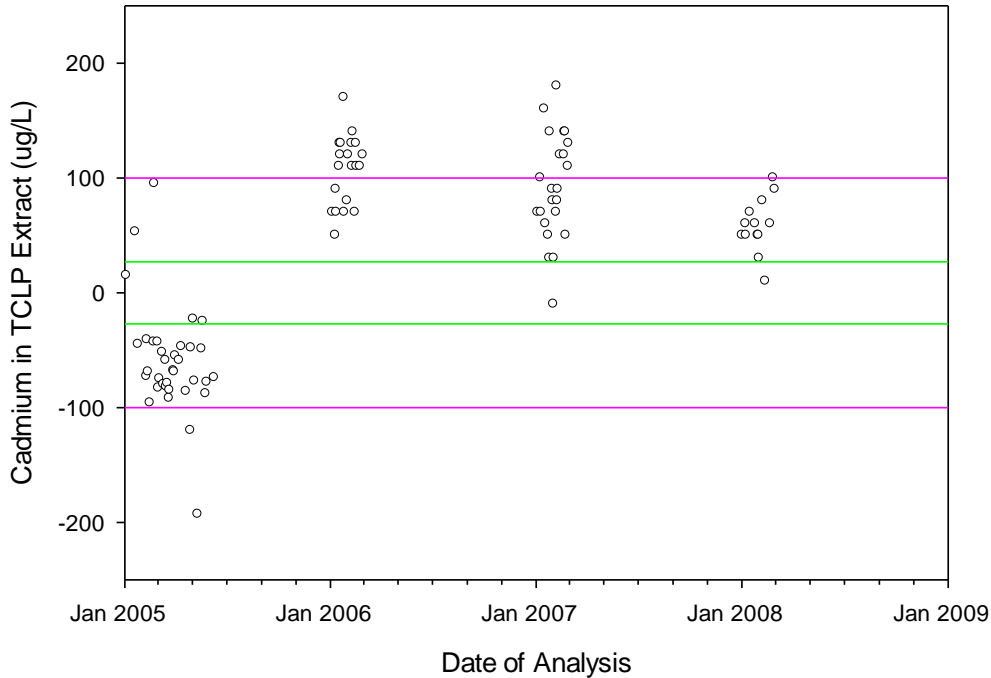
Results for Zero Concentration Cadmium in Quality Control Sample ICS 1

The graph on the following page “Results for Zero Concentration Cadmium in Quality Control Sample ICS 1” illustrates the correction accuracy applied by the CWM laboratory to a zero concentration cadmium in, a quality control standard (ICS 1) that verifies the accuracy of the correction factors. The green lines represent the upper and lower bounds for acceptable performance determined by EPA. The pink lines represent the upper and lower control limits used by the CWM-KHF Laboratory to determine acceptable performance. Notwithstanding this control limit disagreement, the graph depicts many results which exceed both EPA and CWM criteria. As shown in the graph, the ICS 1 quality control results confirm that the failure to accurately calibrate and maintain calibration of the interference corrections is adversely affecting the accuracy of cadmium sample results.
