**UNITED STATES ENVIRONMENTAL PROTECTION AGENCY
REGION IX
75 Hawthorne Street
San Francisco, CA 94105**

Purpose: RCRA Compliance Evaluation Inspection

Facility: **Consolidated Tire Recyclers, Inc.**

Date of Investigation: August 17, 2011

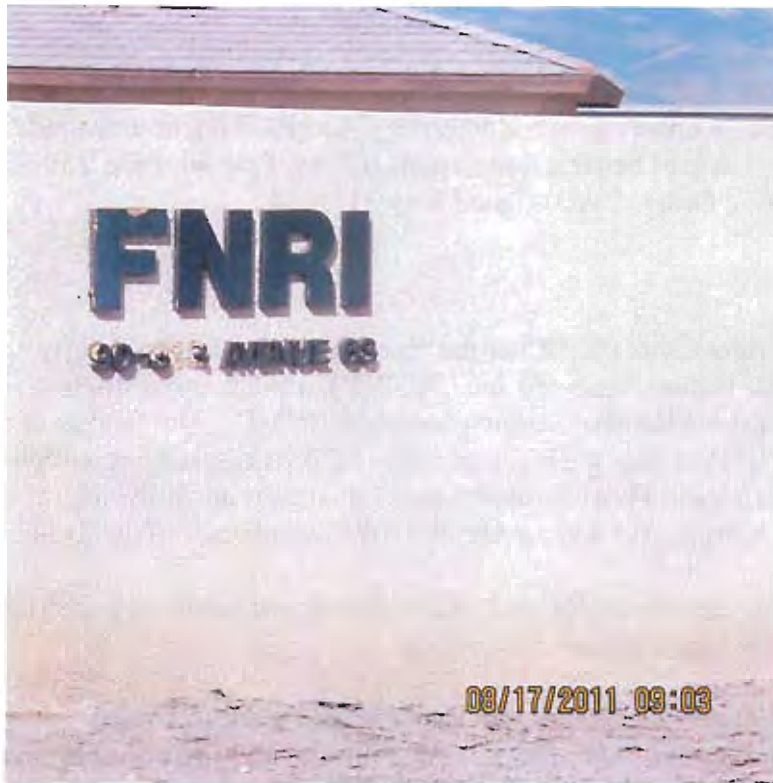
Since large truck and heavy equipment tires are larger and contain more rubber, tires are counted as “passenger tire equivalents.” Facility representatives estimated there were 90,000 passenger tire equivalents on site at the time of the May 2011 fire, and they were down to 70,000 equivalents at the time of this inspection.
