> Subject: Findings of Violations and Order for Compliance EPA Docket No. CWA-309(a)-11-006

Electrochem Solutions, LLC 32500 Central Avenue Union City, CA 94587 Docket No. CWA 309(a)-11-006

FINDINGS OF VIOLATION AND ORDER FOR COMPLIANCE

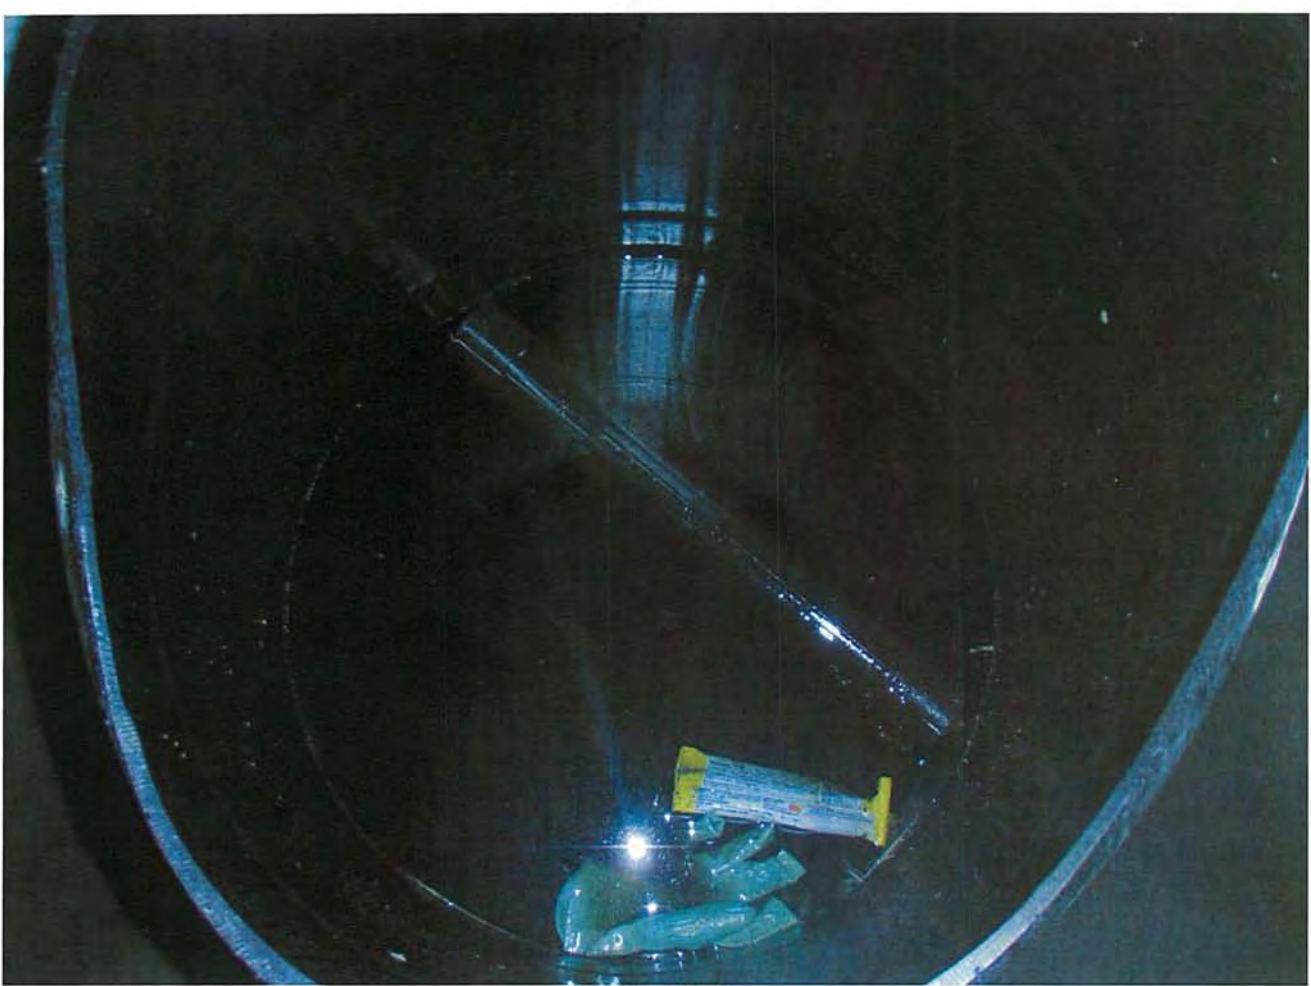
PC030023

- 022. Anodizing Area: An open 5-gallon container of unknown substance.
- 023. Anodizing Area: Open cut top 55-gallon container labeled "waste water." Facility representative stated it was placed in the location to collect rain water from a leak in the roof.

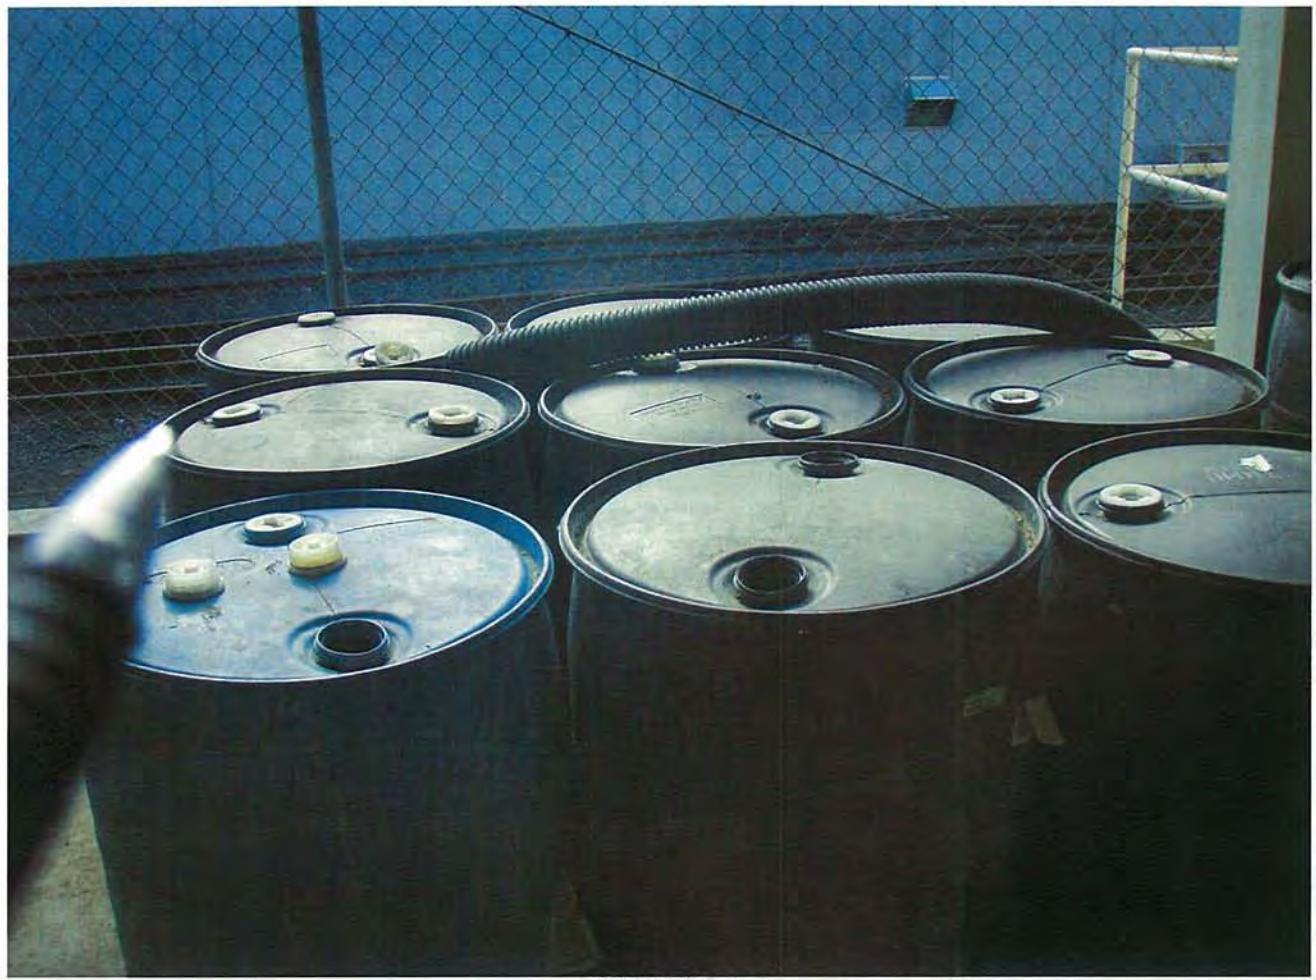
PC030024

- 024. Utility Room: Nine 55-gallon containers of glycol product. Note: the bungs on two of the containers were open.
- 025. Utility Room: Leaking pipes.
