Appendix E

Maintenance Program Site Visit Reports

Site Visit No. 16

**Willow Creek Highway Maintenance Facility
Site Visit Date: 10/22/2009**

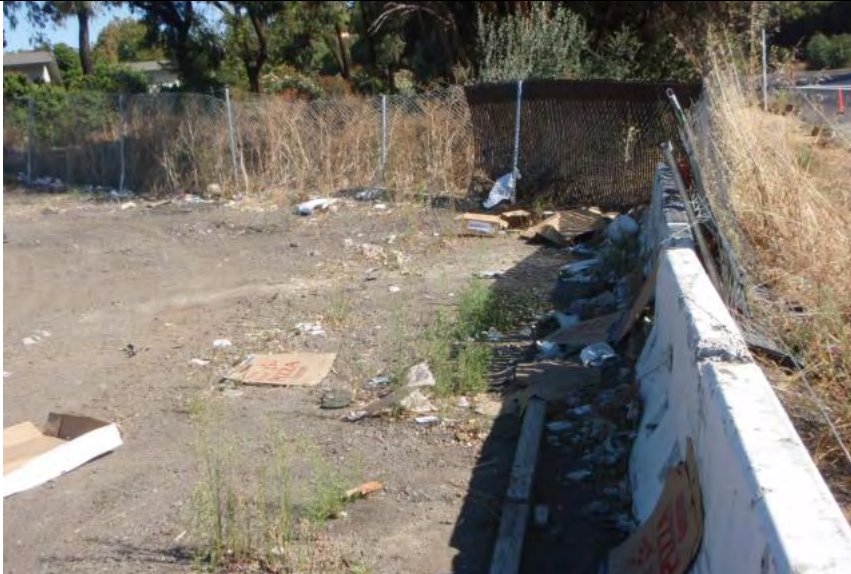
Photograph 5 – Example of fugitive trash and debris

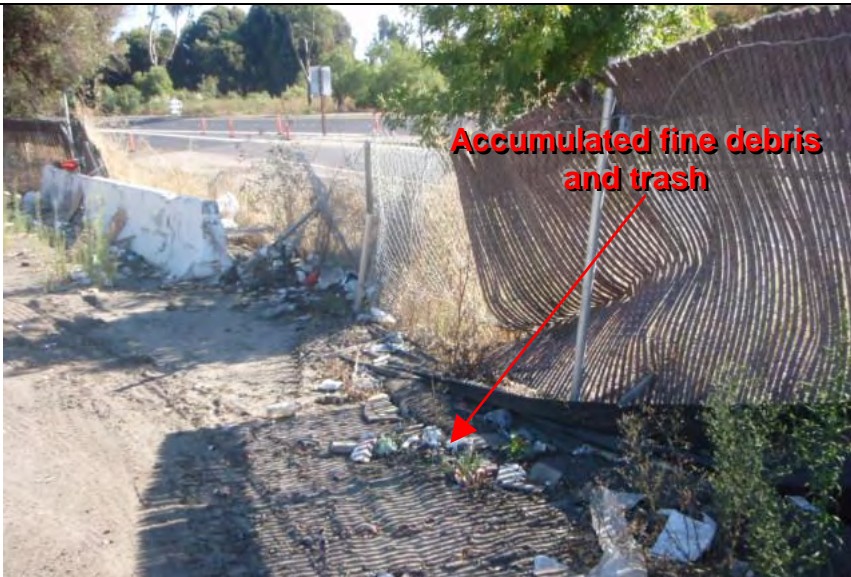
Photograph 7 – View of site boundary down-gradient of road sweeper pre-washing area

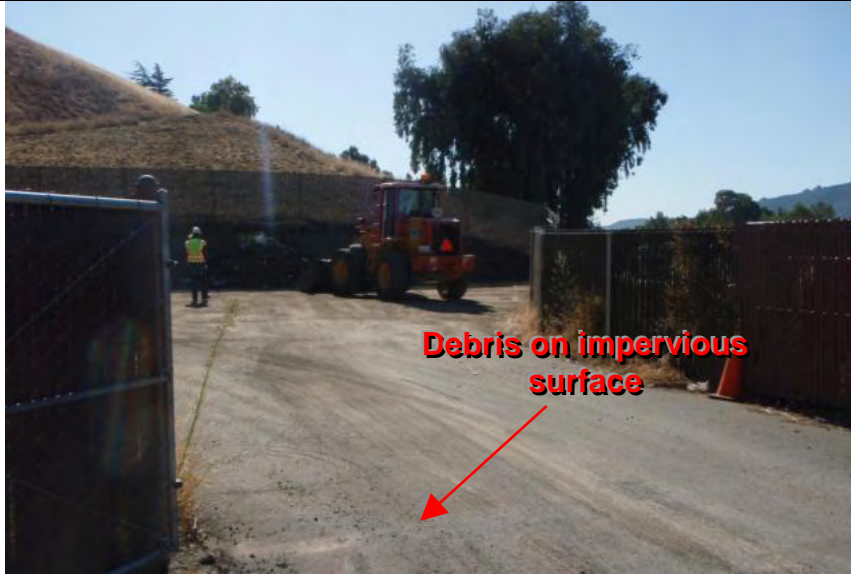
Photograph 1 – Entrance to temporary storage site. (Note: Impervious roadway entrance and tracking of debris)

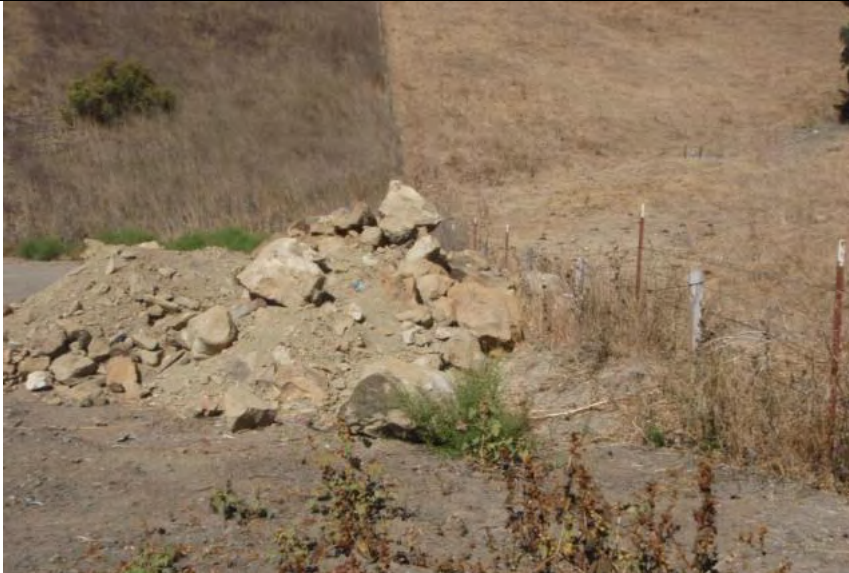
Photograph 5 – Note lack of BMPs for containment around stockpile and the stockpile's proximity to the fenceline

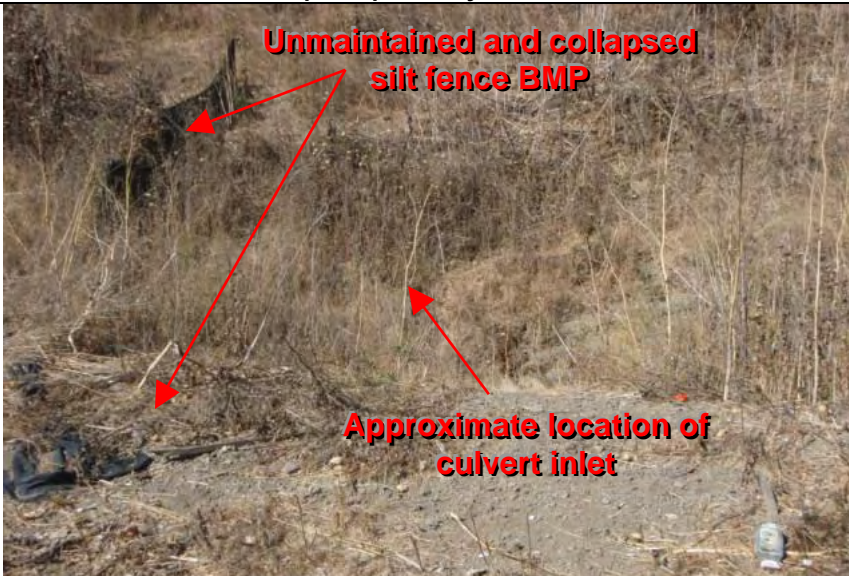
Photograph 7 – Location of culvert inlet and unmaintained and collapsed silt fence BMP up-gradient of inlet

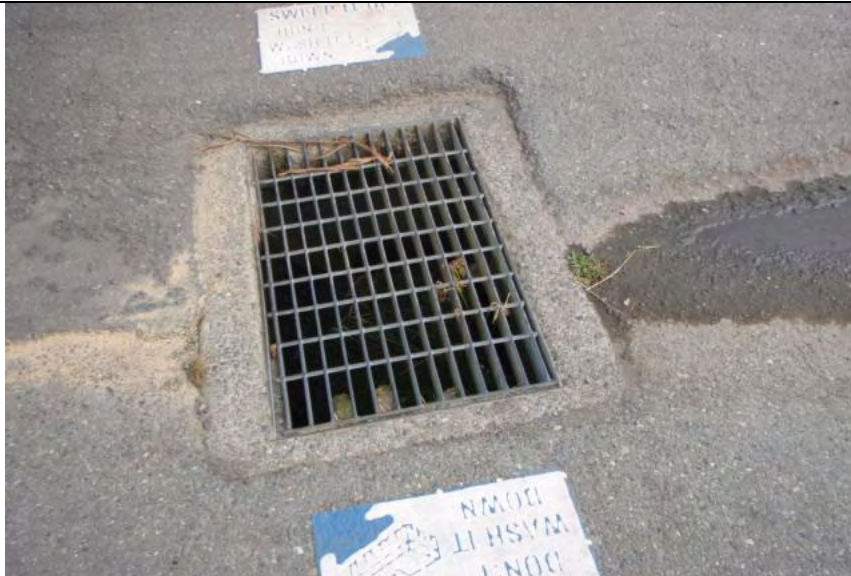
Provision I.3.b of the Permit requires Caltrans to provide appropriate site-specific BMPs for all maintenance facilities. A significant amount of sediment accumulation was observed within a storm drain inlet at the facility that did not appear to have been recently cleaned (see [Photographs 1 and 2](#)). As explained by the Highway Maintenance Supervisor, storm drain inlets at the facility flow to the drainage ditch in the southeast corner of the facility (see [Photograph 3](#)). He added that storm water runoff does not generally discharge off-site from this location but rather ponds and remains as standing water until it infiltrates into the ground. Nonetheless, evidence of sediment discharged to the drainage ditch as well as sediment accumulation within the culvert pipe that discharges to the southeast corner of the facility was observed (see [Photograph 5](#)). Furthermore, a silt fence BMP had been installed in the flow pathway of the culvert outlet and was not entrenched into the ground to retain sediment and prevent failure (see [Photograph 3](#)).

Photograph 1 – Storm drain inlet at facility

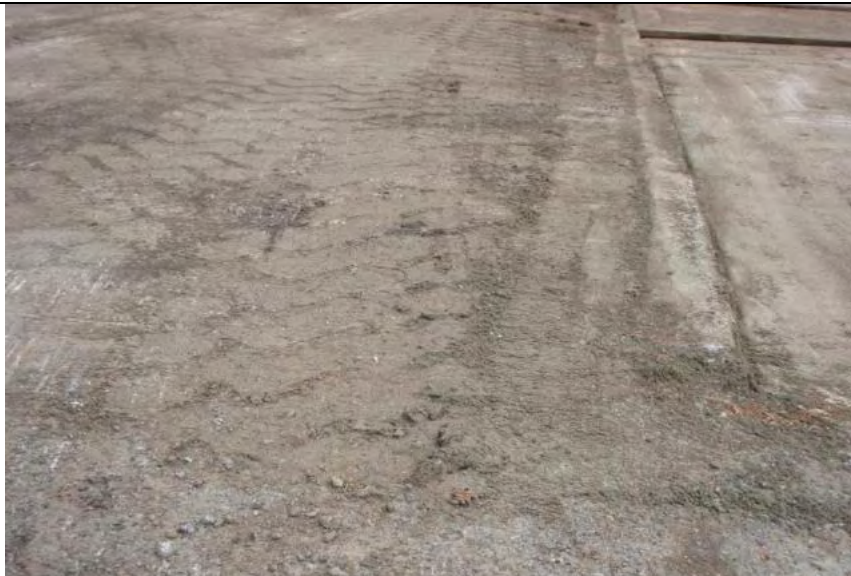
In addition, a significant amount of sediment accumulation was observed on the impervious ground surface near the southeast corner of the facility (see [Photographs 6 and 7](#)). As explained by the Highway Maintenance Supervisor, the area was used as a temporary stockpile location for washout material from front loaders and dump trucks. Whether the equipment washout operation was conducted with dry or wet processes was unclear. Appendix D of the Caltrans SWMP, Section 2.15.1, Vehicle and Equipment Cleaning, states “when possible, truck beds should be cleaned using dry cleanup technique (sweep up or shovel out).” It should also be noted that the stockpile area was located directly in the flow pathway of the surface drainage system at the facility (see [Photograph 8](#)). As a result, there was a potential for the discharge of sediment and other pollutants to the drainage ditch along the southern edge of the facility (see [Photograph 9](#)).

Photograph 7— Closer view of sediment accumulation on imperious
ground surface

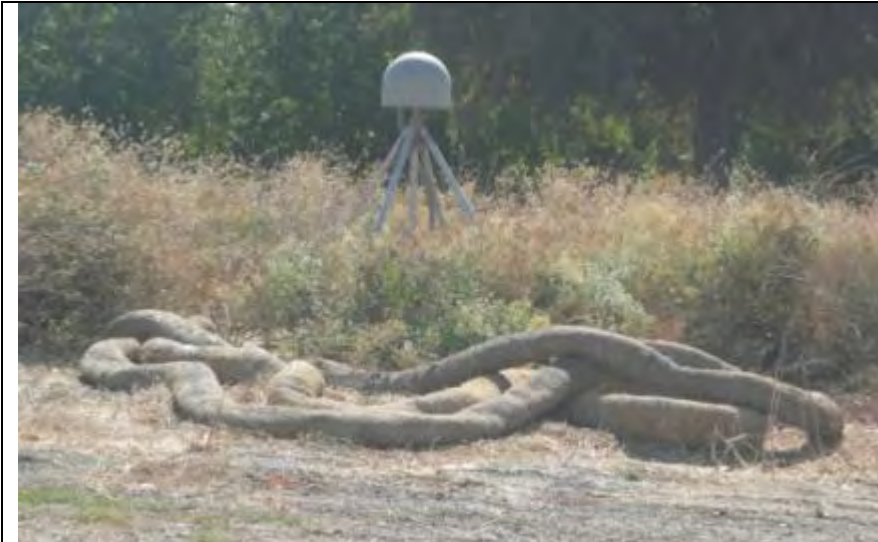
Photograph 1 – View of BMP stockpile
