NPDES Storm Water Inspection Report

Facility Location Information			
Name/Location/ Mailing Address	Sims Metal Management (Sims) 699 Seaport Blvd. Redwood City, CA		
GPS Coordinates	Latitude	37° 30' 40.6"	Longitude 122° 12' 29.6"
Receiving Water(s)	Redwood Creek – Navigable estuary to San Francisco Bay		
	Name	Telephone	
Owner	Steven Shinn – Regional General Manager	510-412-5300	
Operator	Joe Barco – Operations General Manager	510-412-5300	
Environmental Coordinator	Matt Zeiter – On-site Rep	510-715-7569

<u>General</u>	
Inspection Objective, Attendees, and Opening Conference Summary.	<p>The inspection's objective was to determine compliance with the California Industrial General Permit No. CAS000001.</p> <p>In addition to EPA inspectors previously identified, the inspection was attended by Estuardo Montufar (650.372.6240) and Sabrina Mih (650.372.6235) with San Mateo County Environmental Health Services Division (Certified Unified Program Agencies – CUPA), and Matt Zierter (510.412.5300), Mariya Semeit (650.369.4161), Dale Leuer (650.369.4161), and Vistasp Patel (650.369.4161) with Sims Metals Management (Sims or Facility Representatives)</p> <p>Prior to commencing the inspection

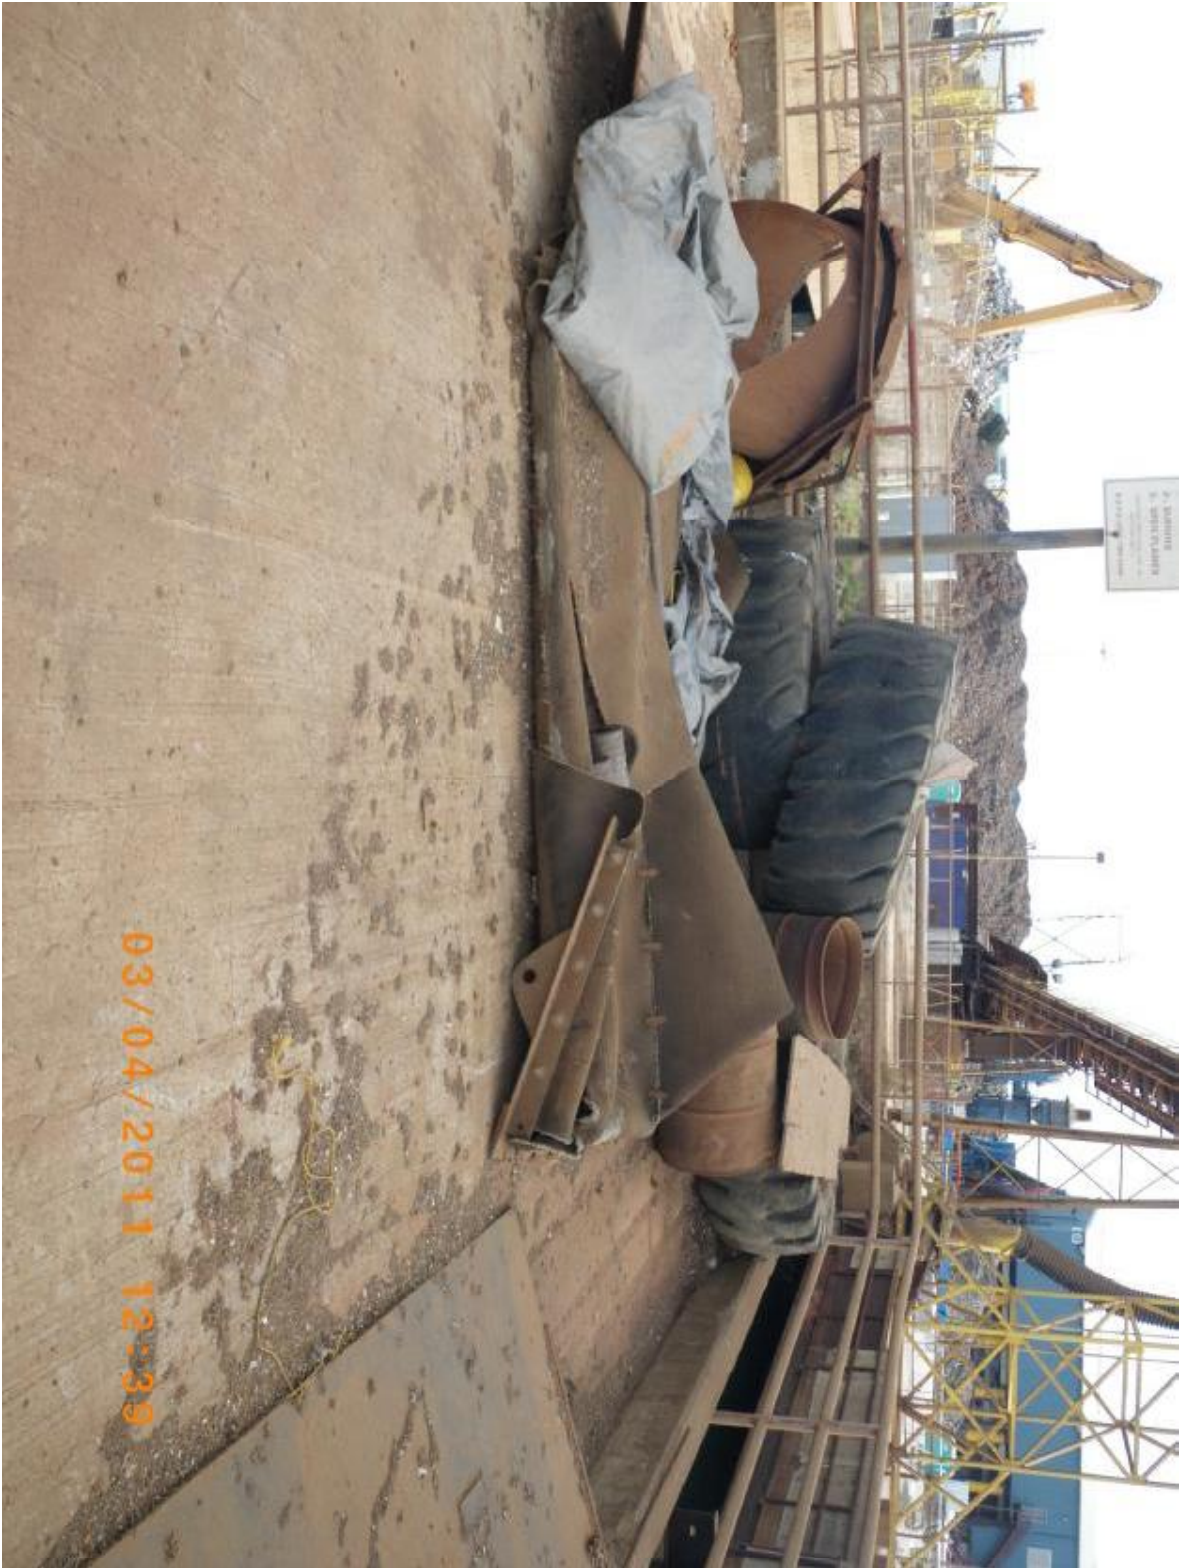
IMGP0259.JPG

IMGP0259 – This photo depicts the shared dock directly underneath the ship loading conveyor (facing south). Equipment tracks were observed from activities depicted in IMGP0242.

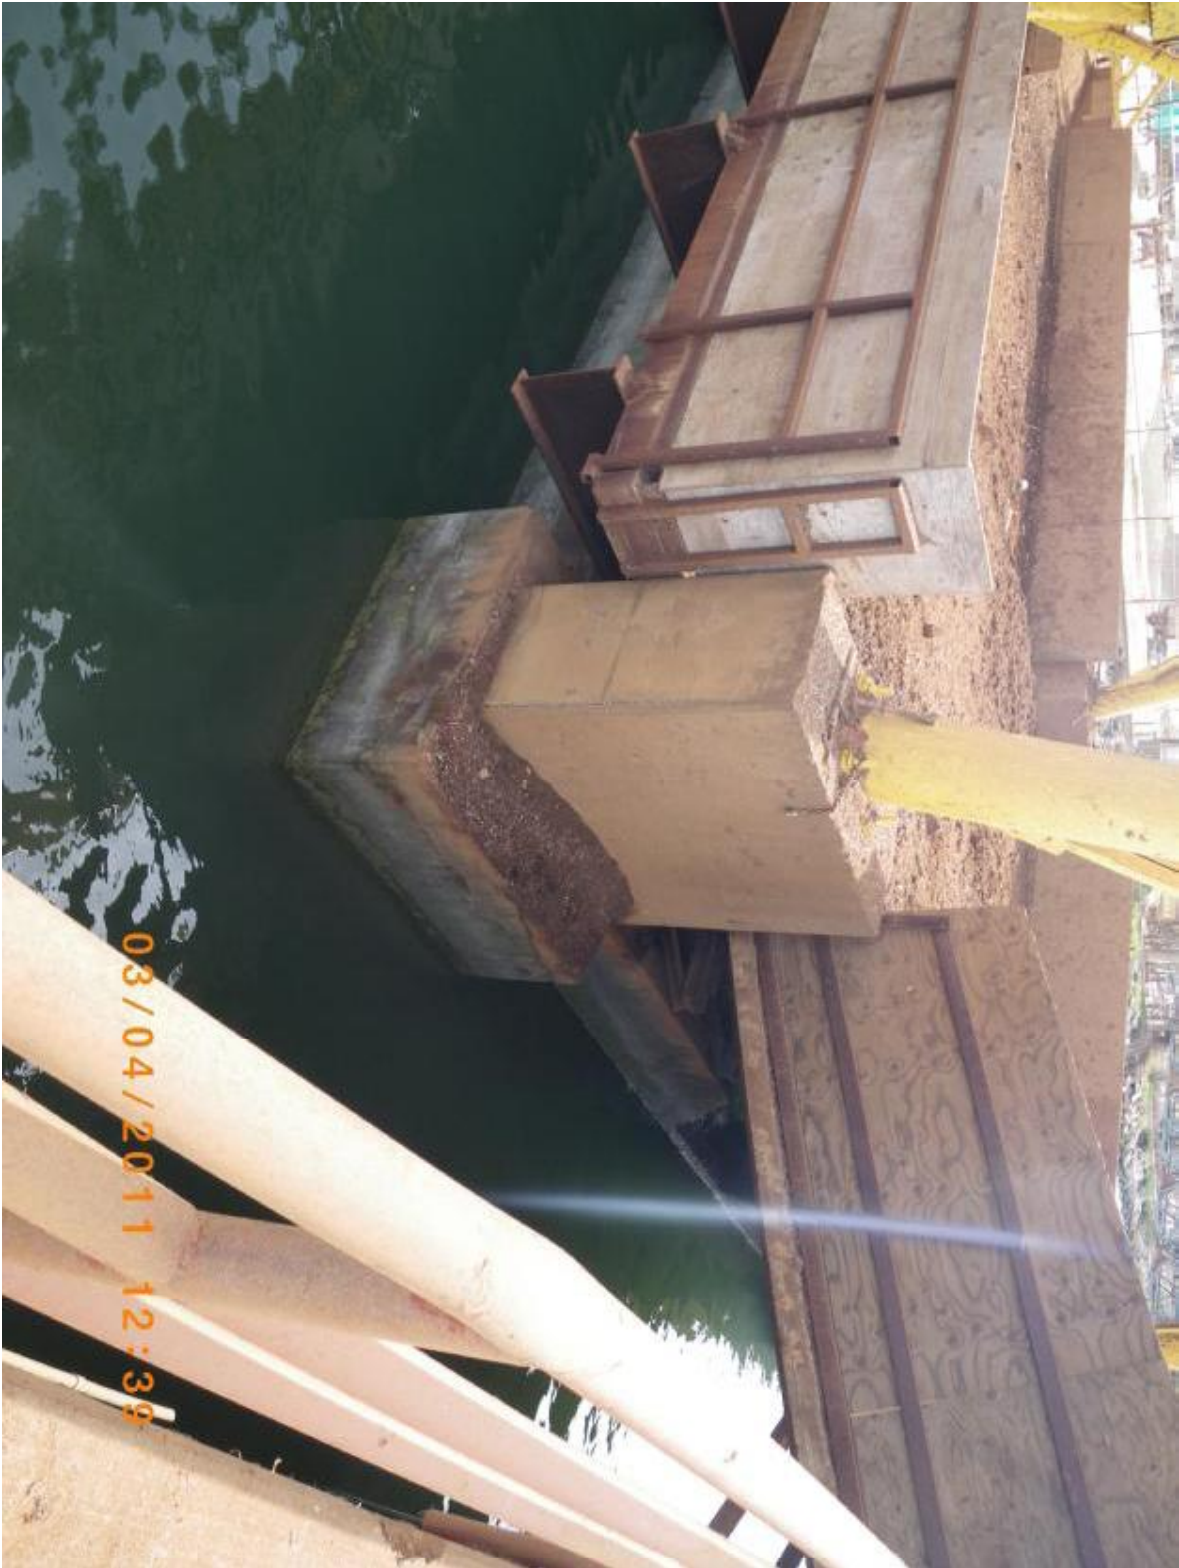
IMGP0260.JPG

IMGP0260 – Obsolete equipment was observed on the shared dock.

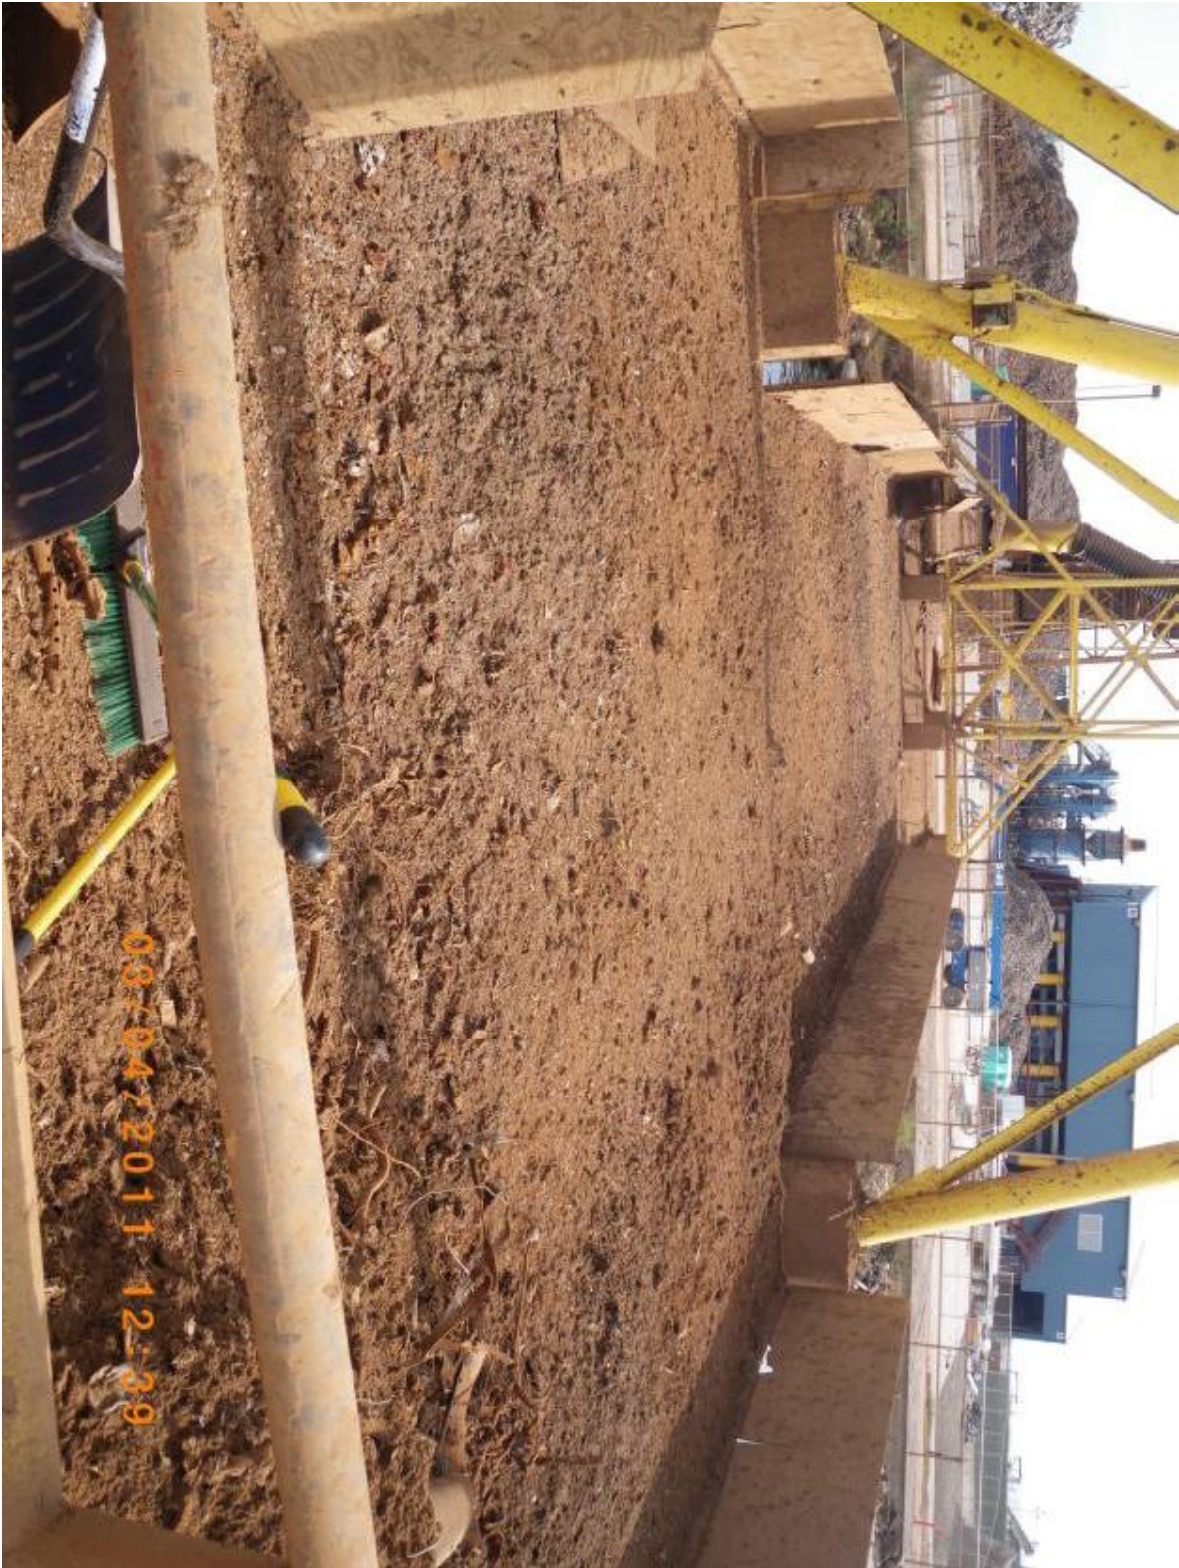
IMGP0261.JPG

IMGP0261 – Accumulated debris and gaps in containment walls on the catchment platform were observed. (North west footing of ship loading conveyor depicted.)

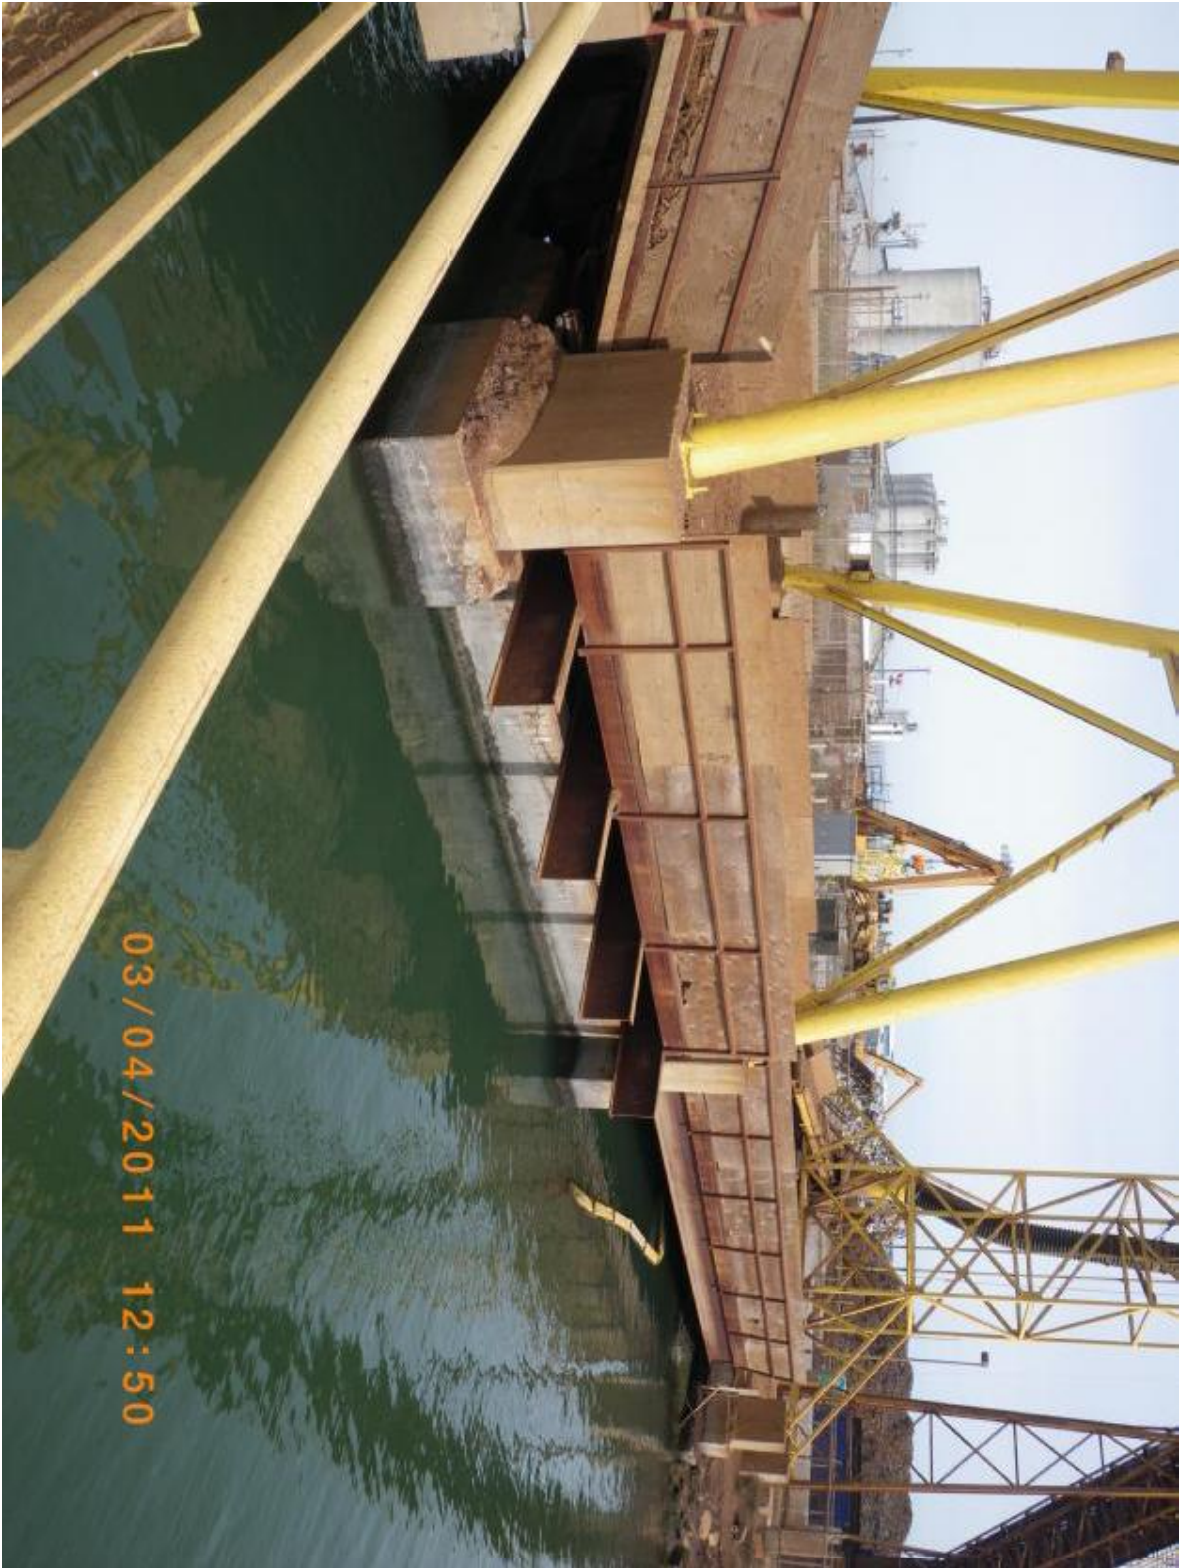
IMGP0262.JPG

IMGP0262 – Surface of the catchment platform with accumulated debris and gaps in the containment walls were observed. (Standing on the dock looking east towards the facility)

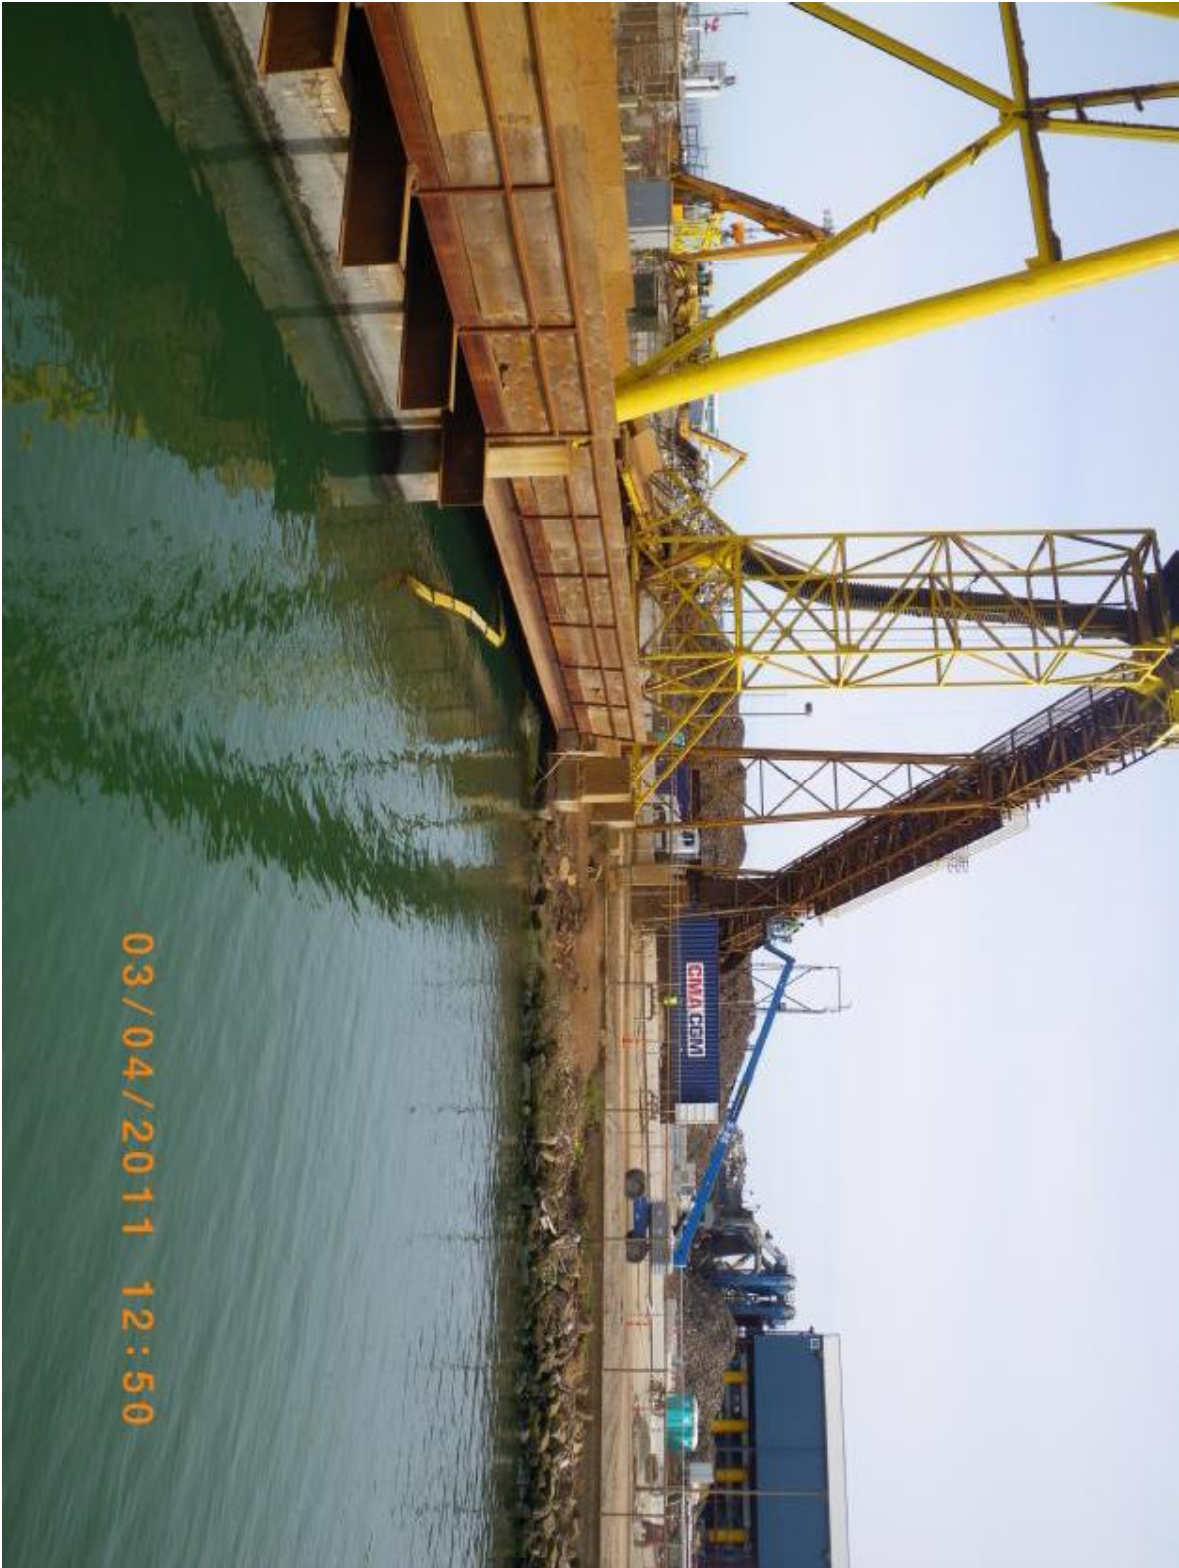
IMGP0263.JPG

IMGP0263 – South side of the catchment platform, looking north east, accumulated debris on footings and I-beams, and gaps in containment walls of the catchment platform were observed.

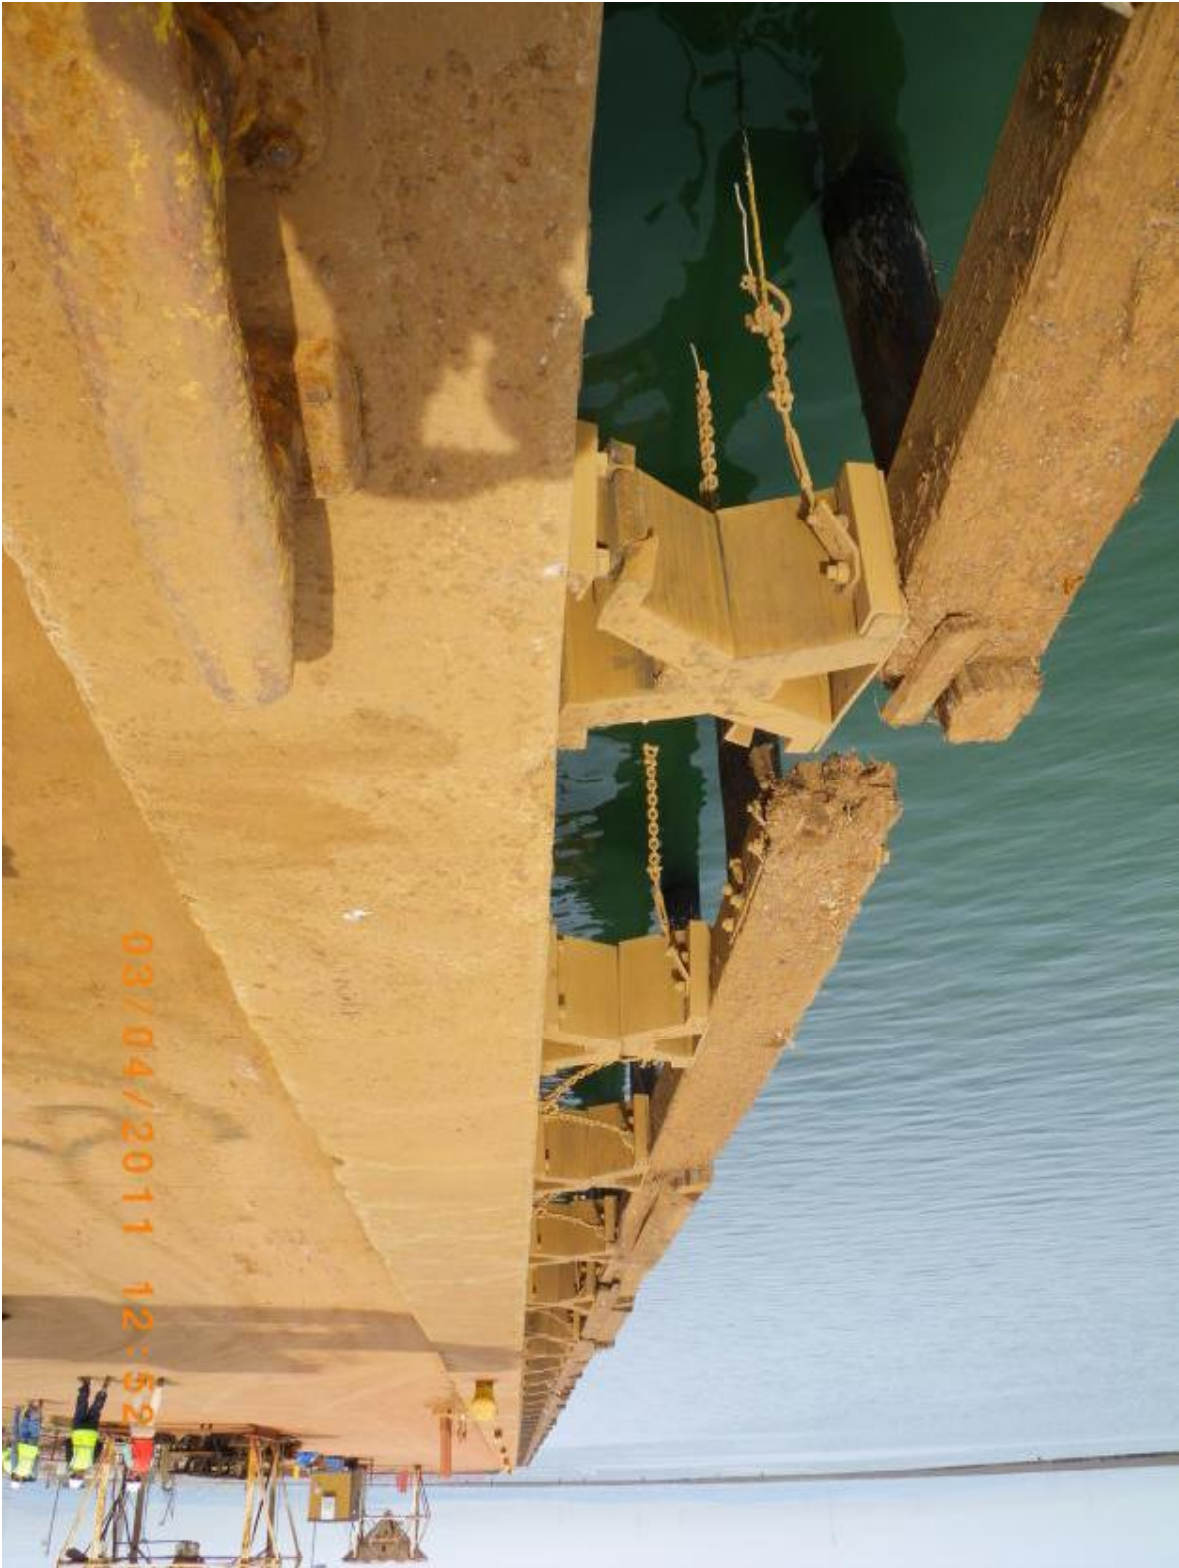
IMGP0266.JPG

IMGP0266 – Accumulated debris was observed on the east side of the catwalk structure to the south of the ship loading conveyor area, as well as on the electrical conduit and conduit box.

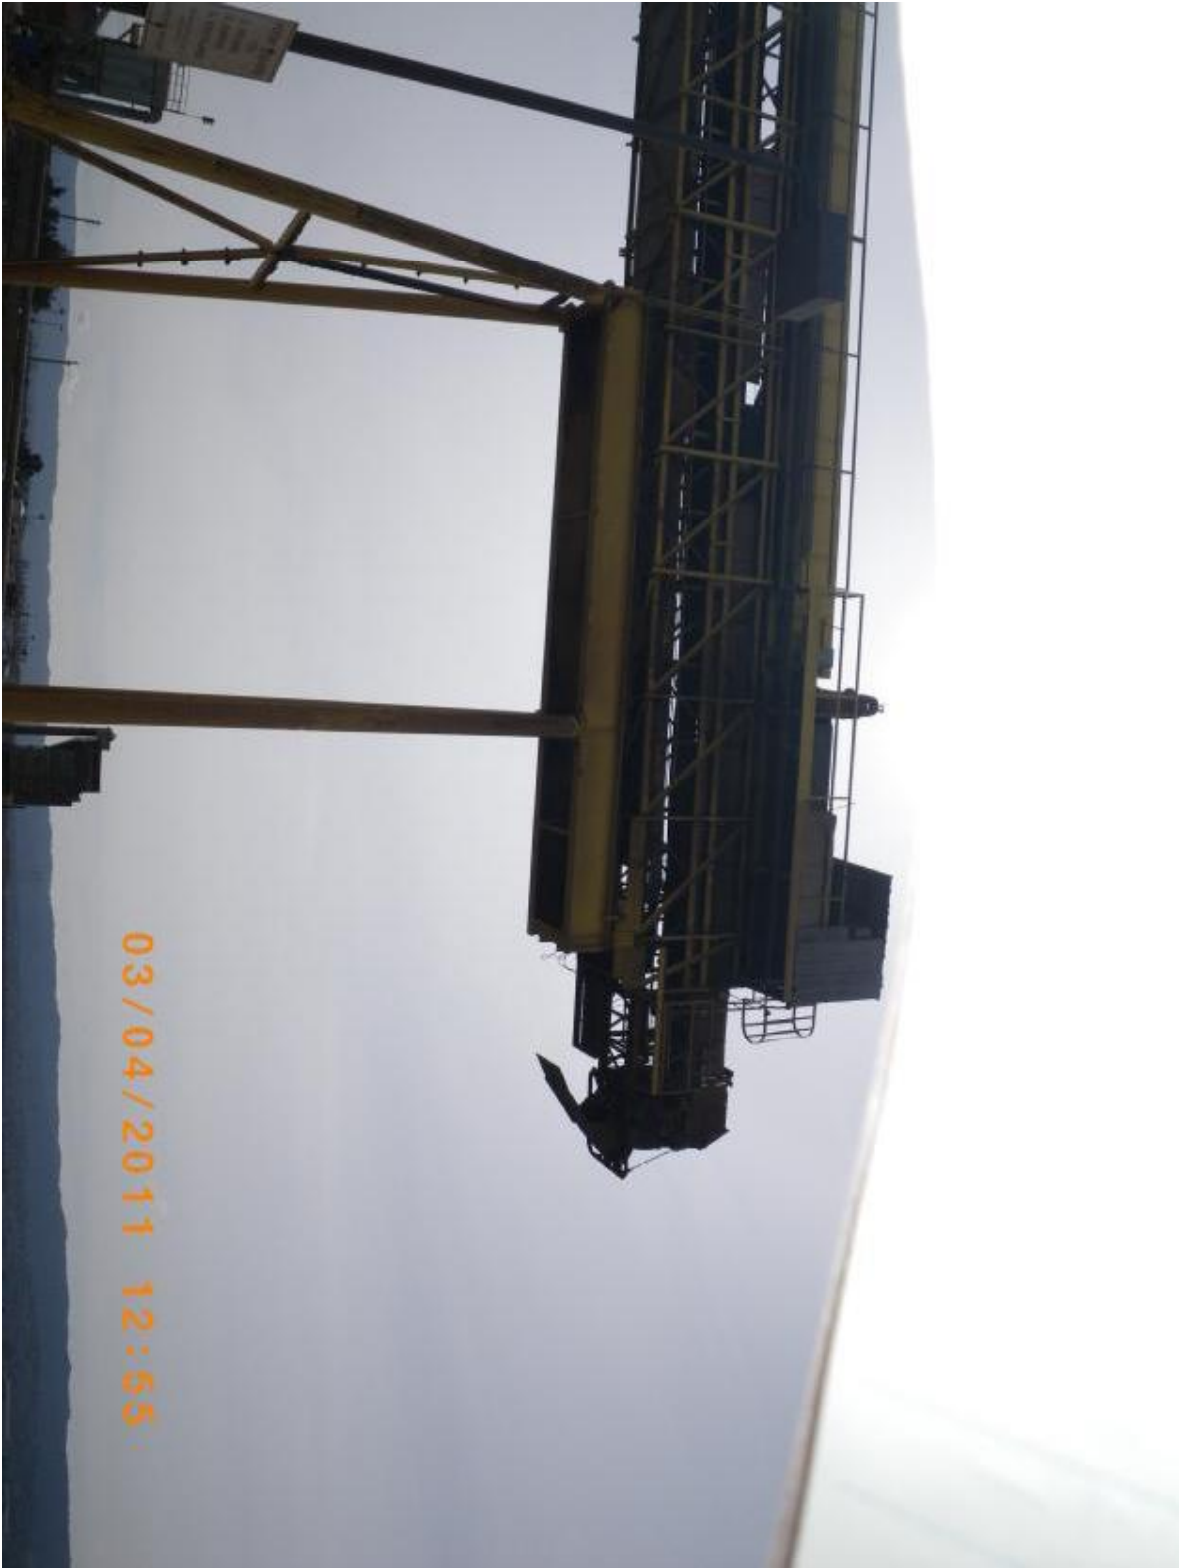
IMGP0267.JPG

IMGP0267 – Accumulated debris was observed along the dock bumper. (Photo taken of the area underneath the ship loading conveyor looking north.)

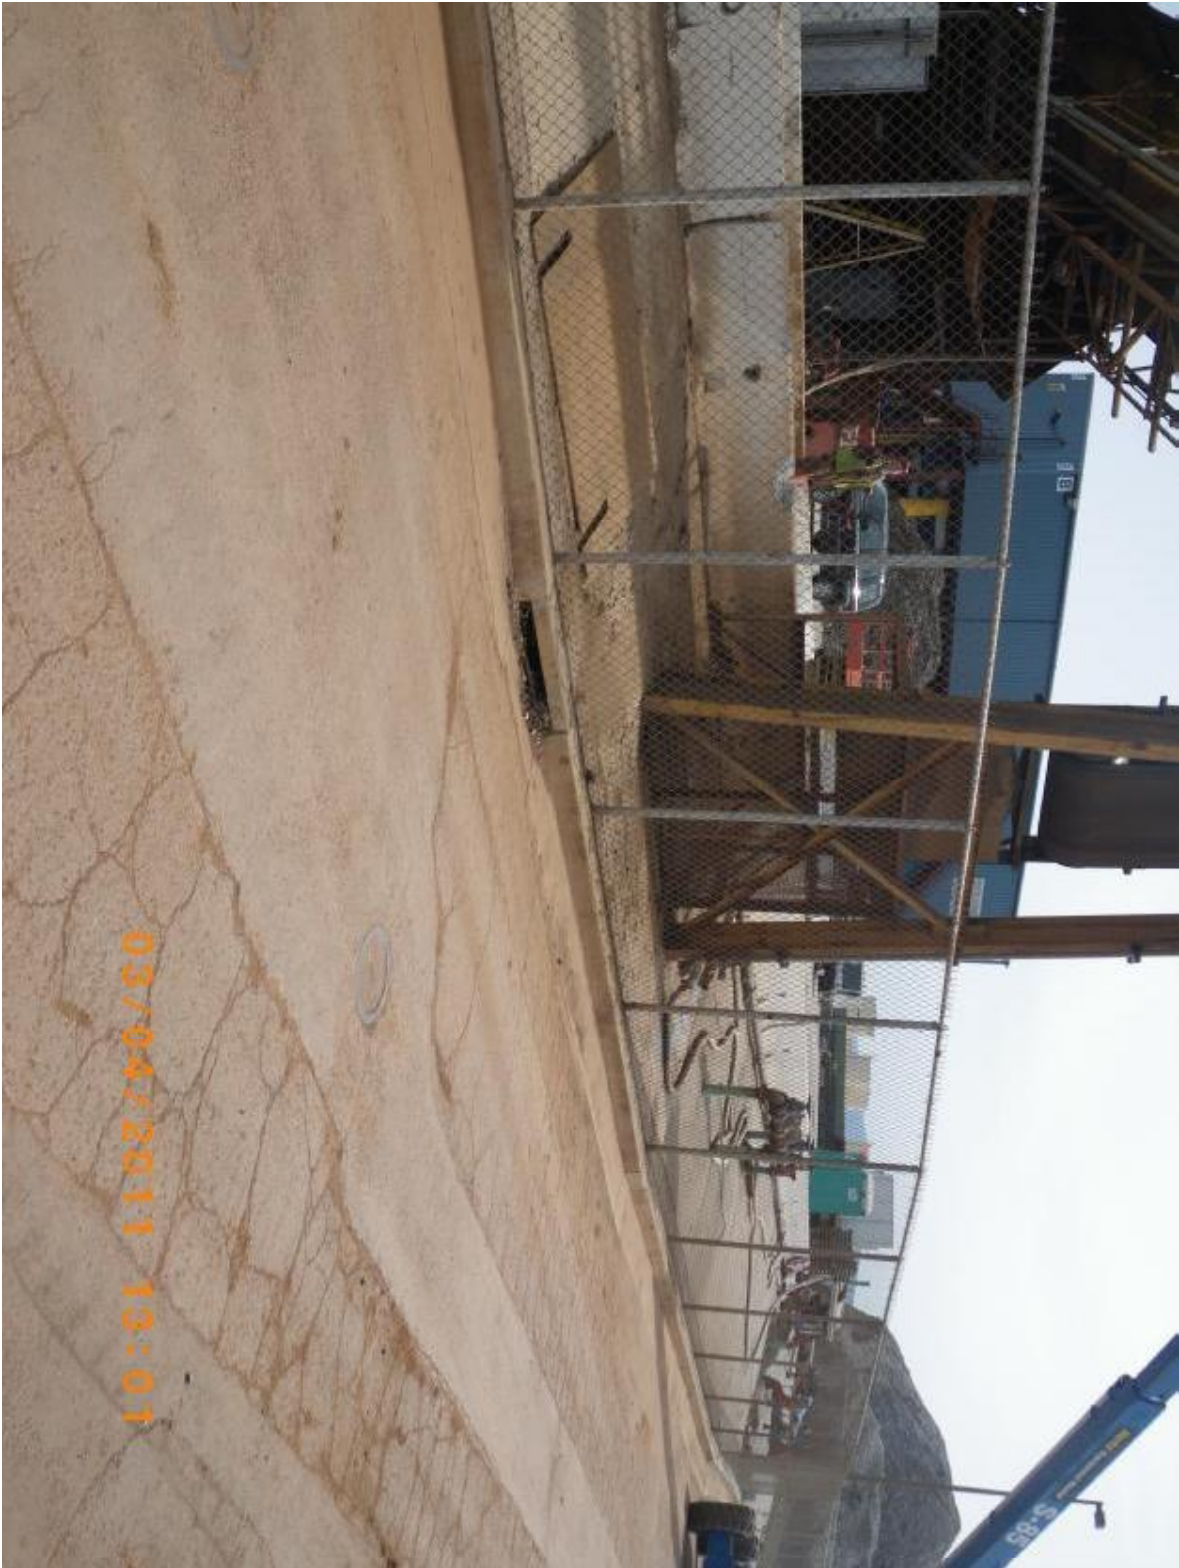
IMGP0269.JPG

IMGP0269 – Accumulated debris was observed on the north, land-side footings of the ship loading conveyor, looking south east.

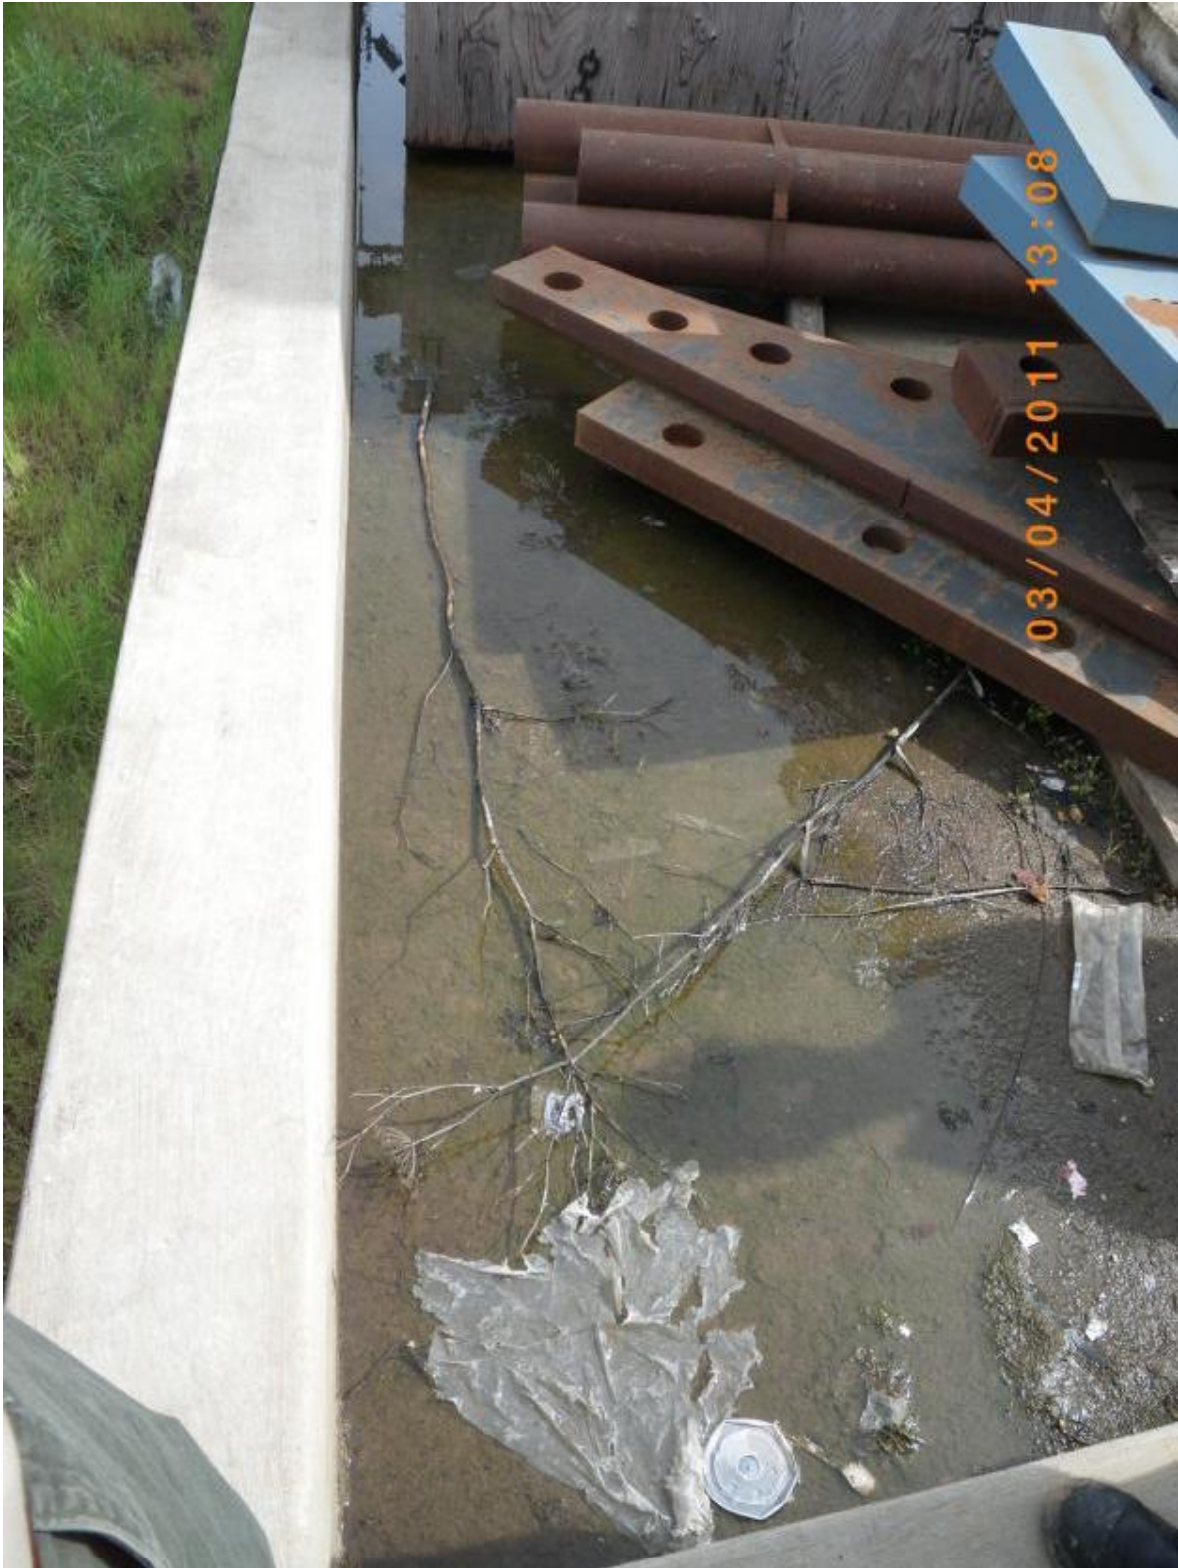
IMGP0273.JPG

IMGP0273 – Standing in the north west gate, looking north. New equipment for facility upgrades were staged in this location, berms were observed around this area, with the only gap in the berm in the center of this photo.

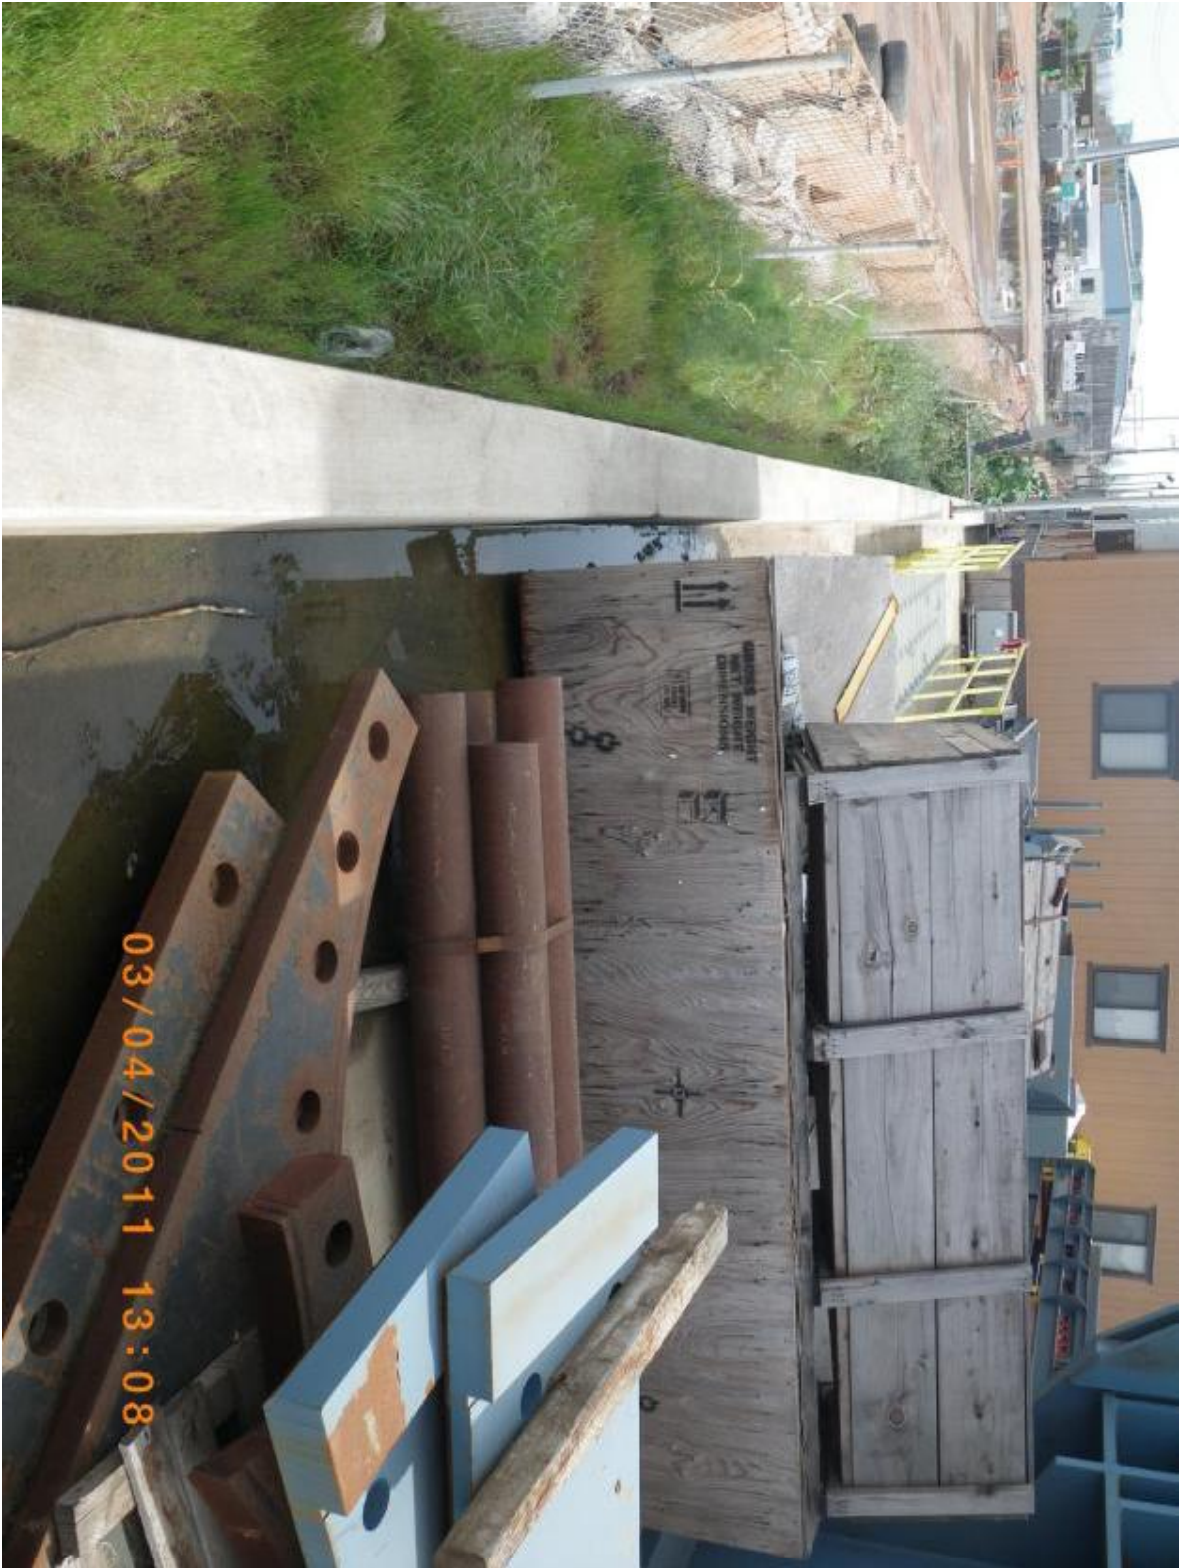
IMG0274.JPG

IMGP0274 and 0275 – North west corner of the facility, berms, staged equipment and scattered debris were observed.

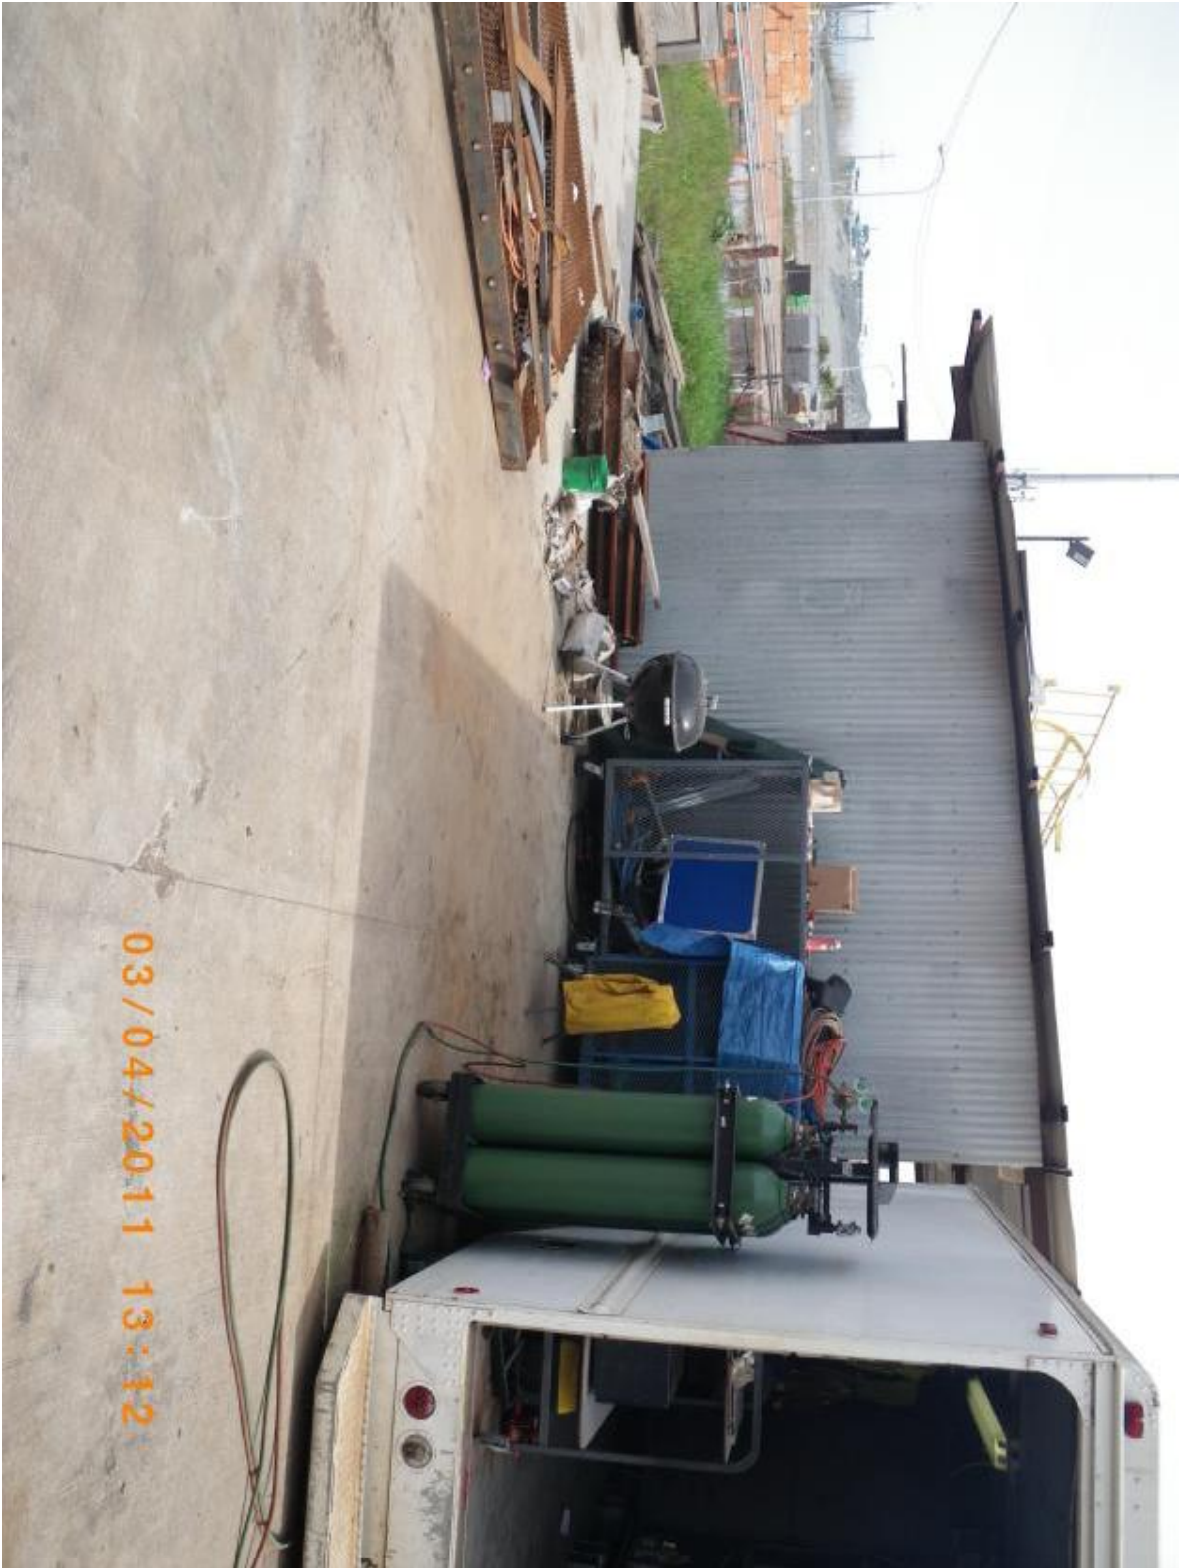
IMGP0277.JPG

IMGP0277 – Covered fueling and oiling depot. Oil staining was observed on the driving surface.

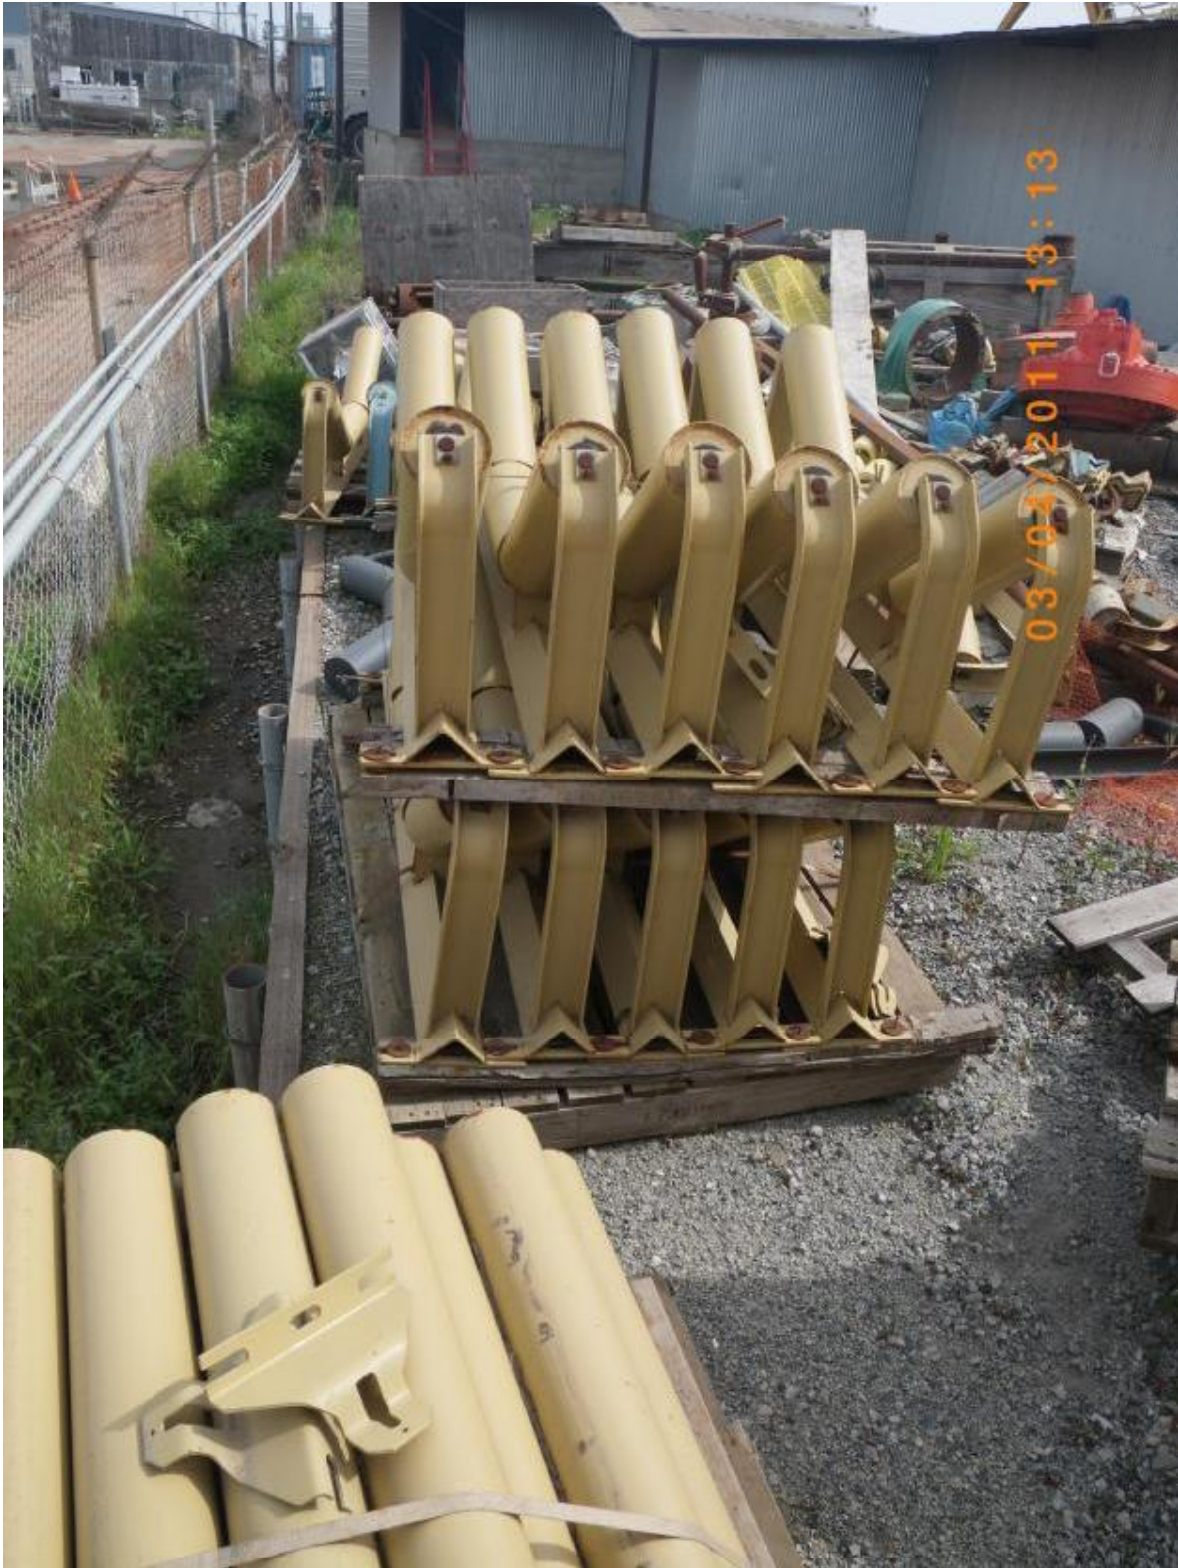
IMGP0279.JPG

IMGP0279 thru 0281 – Staged equipment in the storage yard to the west of the fueling and oiling depot. Some staged equipment was observed over-hanging the berms and had potential to discharge storm water to areas where runoff could occur.
