NPDES Storm Water Inspection Report

Facility Location Information			
Name/Location/ Mailing Address	Sims Metal Management (Sims) 699 Seaport Blvd. Redwood City, CA		
GPS Coordinates	Latitude	37° 30' 40.6"	Longitude 122° 12' 29.6"
Receiving Water(s)	Redwood Creek – Navigable estuary to San Francisco Bay		
	Name	Telephone	
Owner	Steven Shinn – Regional General Manager	510-412-5300	
Operator	Joe Barco – Operations General Manager	510-412-5300	
Environmental Coordinator	Matt Zeiter – On-site Rep	510-715-7569

<u>General</u>	
Inspection Objective, Attendees, and Opening Conference Summary.	<p>The inspection's objective was to determine compliance with the California Industrial General Permit No. CAS000001.</p> <p>In addition to EPA inspectors previously identified, the inspection was attended by Estuardo Montufar (650.372.6240) and Sabrina Mih (650.372.6235) with San Mateo County Environmental Health Services Division (Certified Unified Program Agencies – CUPA), and Matt Zierter (510.412.5300), Mariya Semeit (650.369.4161), Dale Leuer (650.369.4161), and Vistasp Patel (650.369.4161) with Sims Metals Management (Sims or Facility Representatives)</p> <p>Prior to commencing the inspection

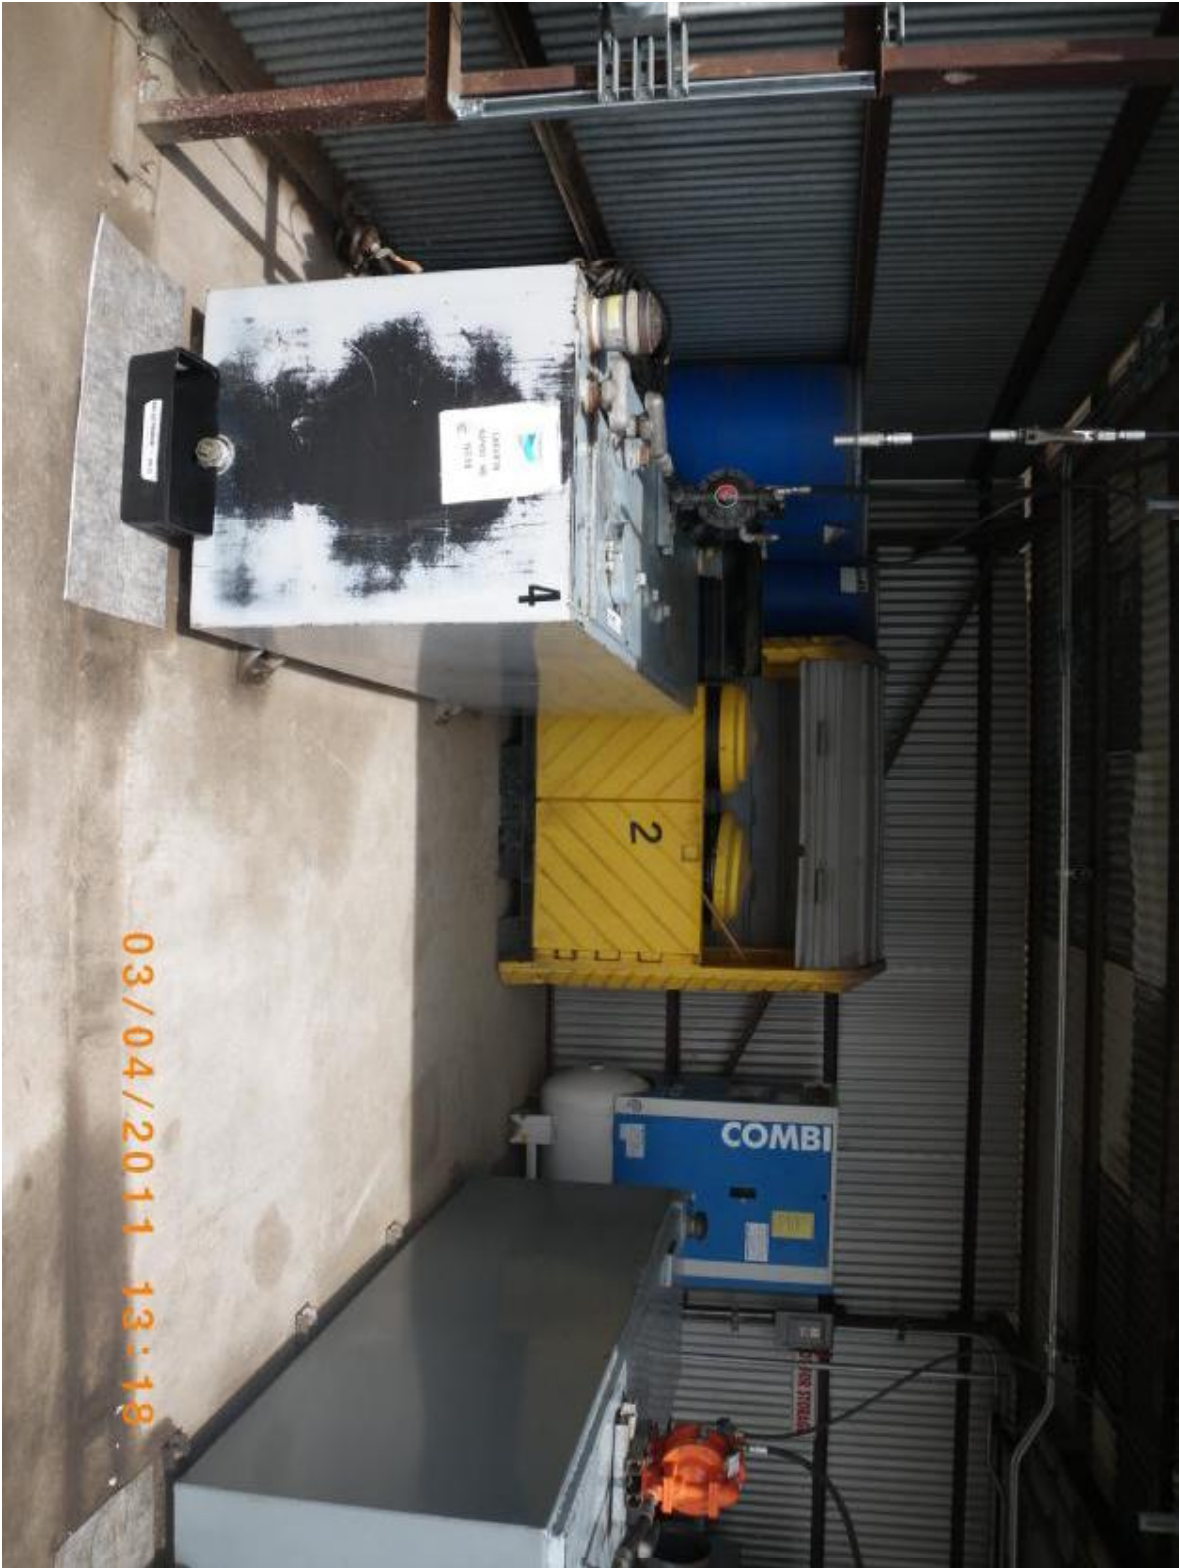
IMGP0282.JPG

IMGP0282 – Oil staining was observed on the exterior wall and earthen ground on the north side of the fueling and oiling depot. IMGP0285 and 0286 demonstrate that this area is exterior to the air compressor.

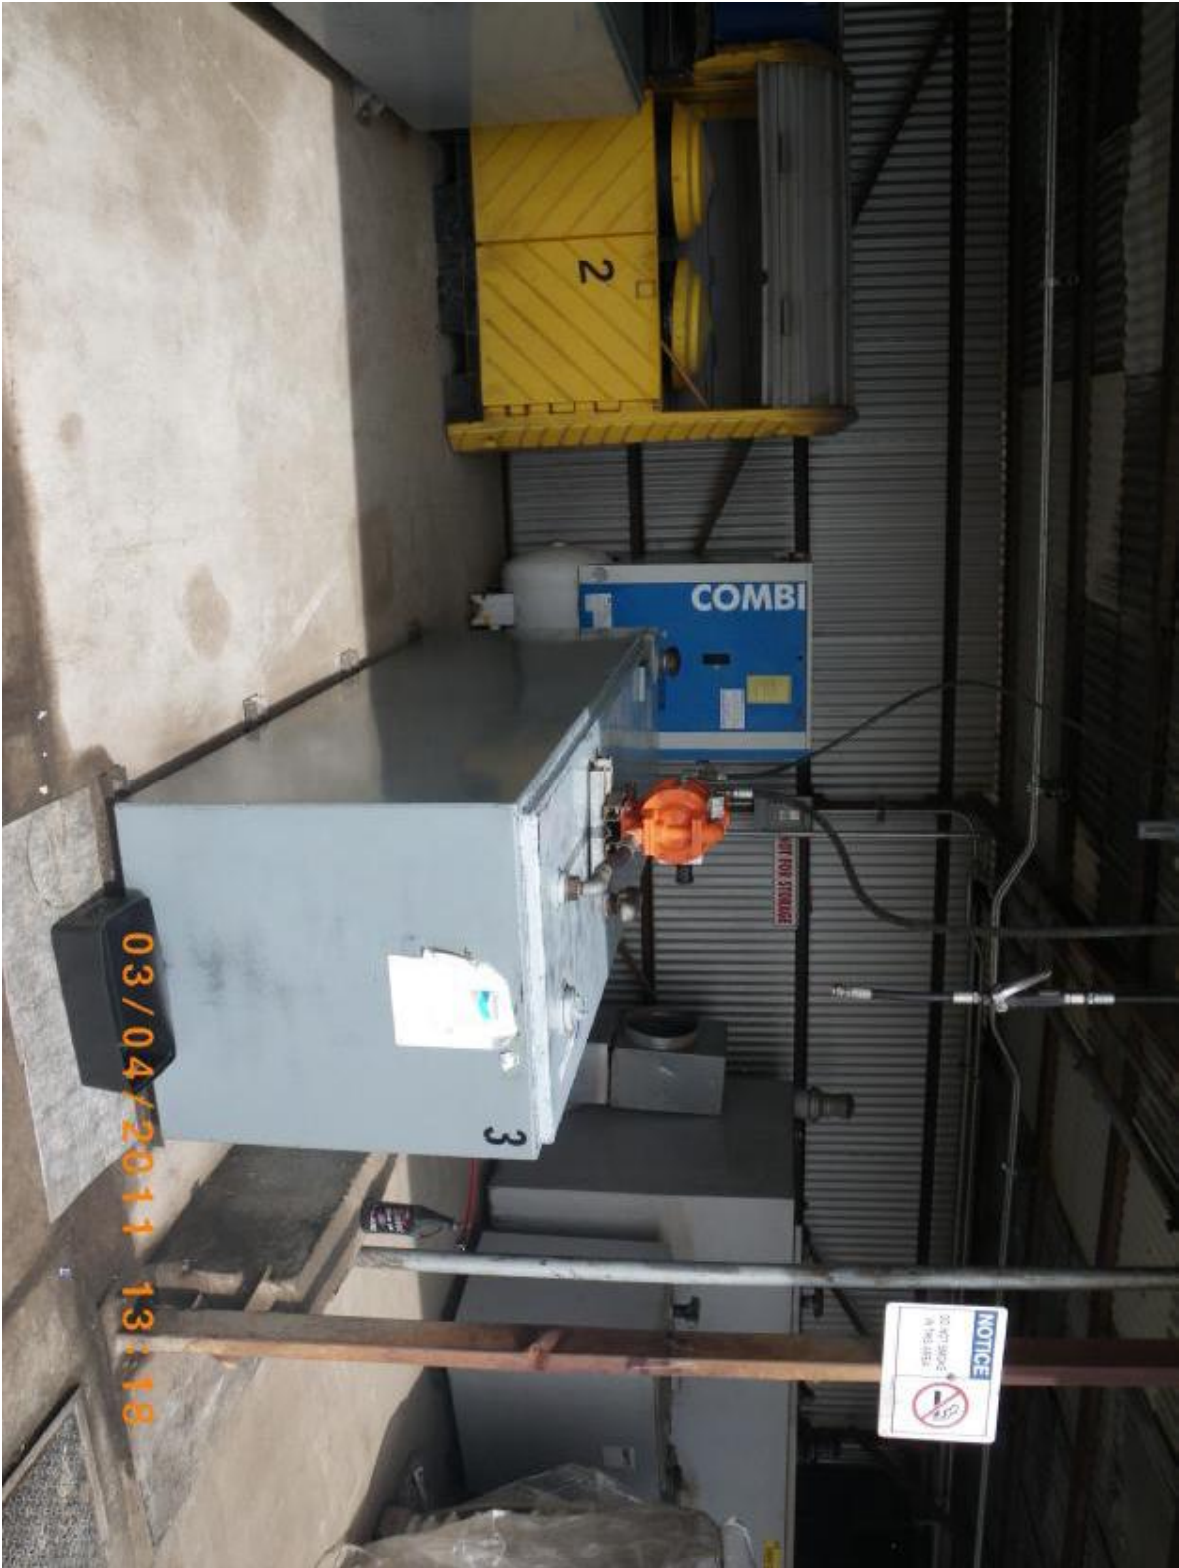
IMGP0283.JPG

IMGP0283 and 0284 – Bulk oil ASTs, spill kit, and air compressor were observed under cover. Oil staining was observed around the grey oil tank.

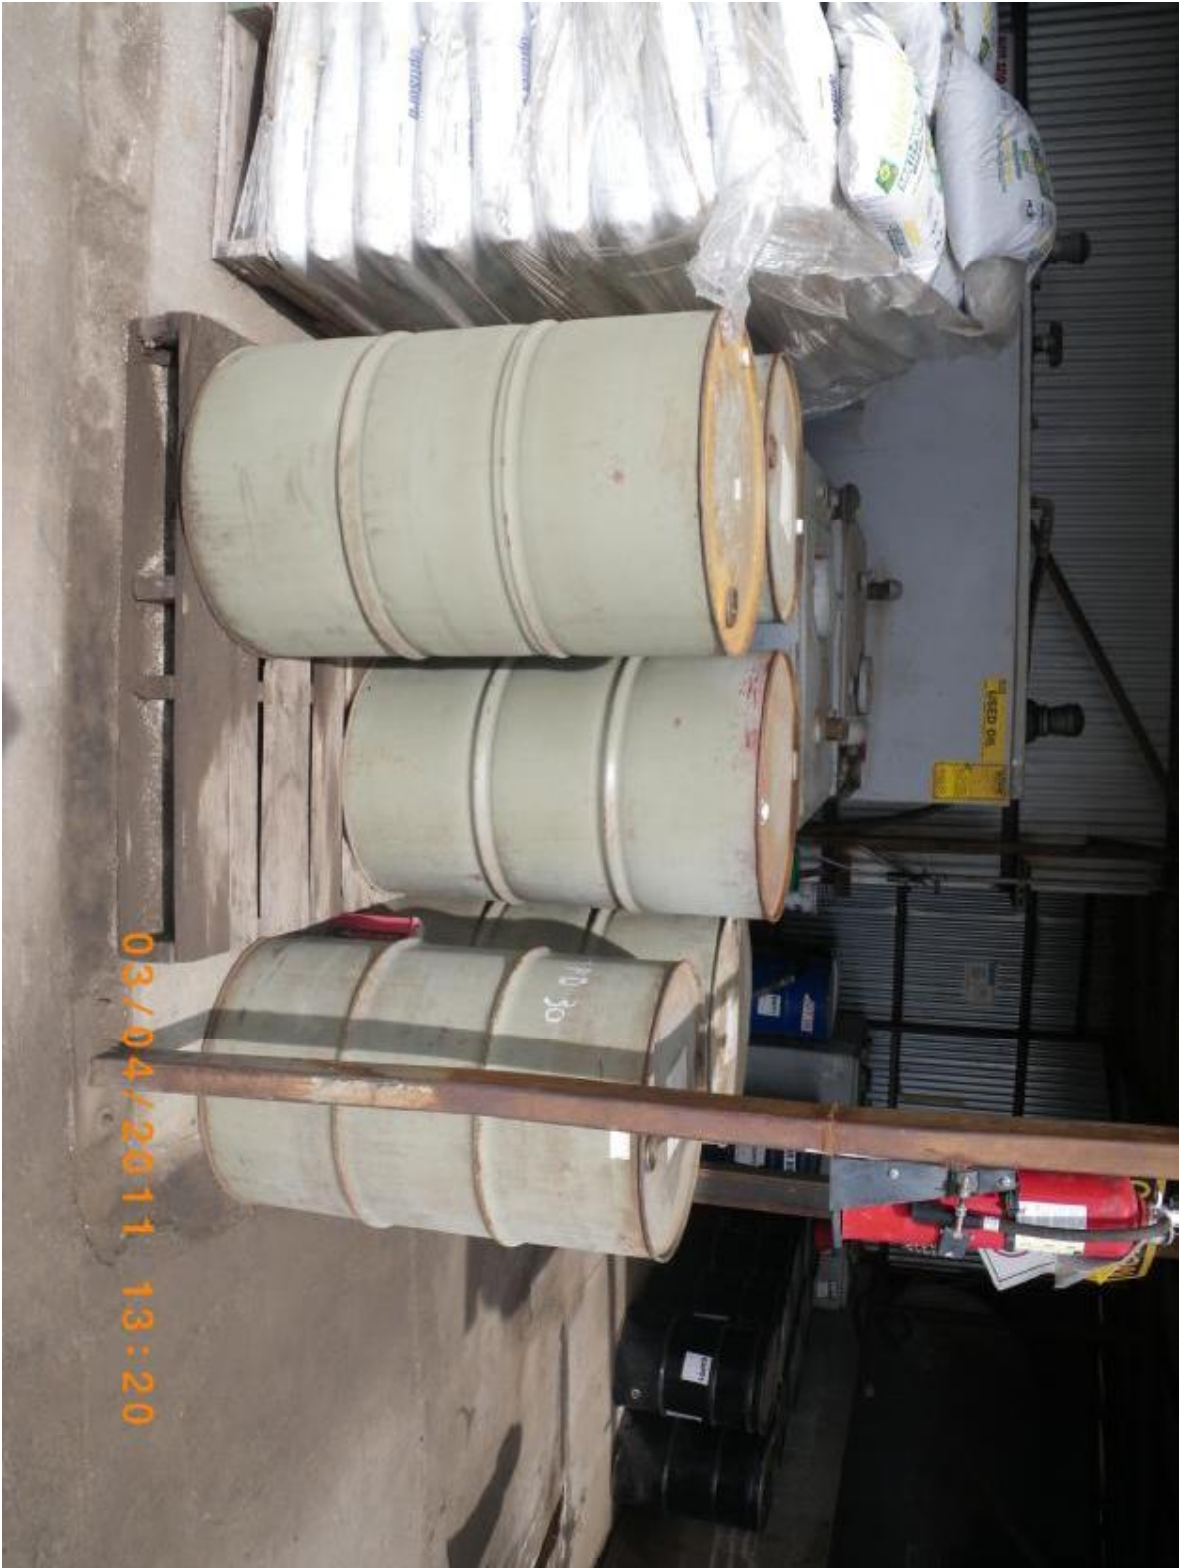
IMGP0286.JPG

IMGP0285 and 0286 – Area behind the air compressor where oil staining was observed as mentioned regarding IMGP0282.

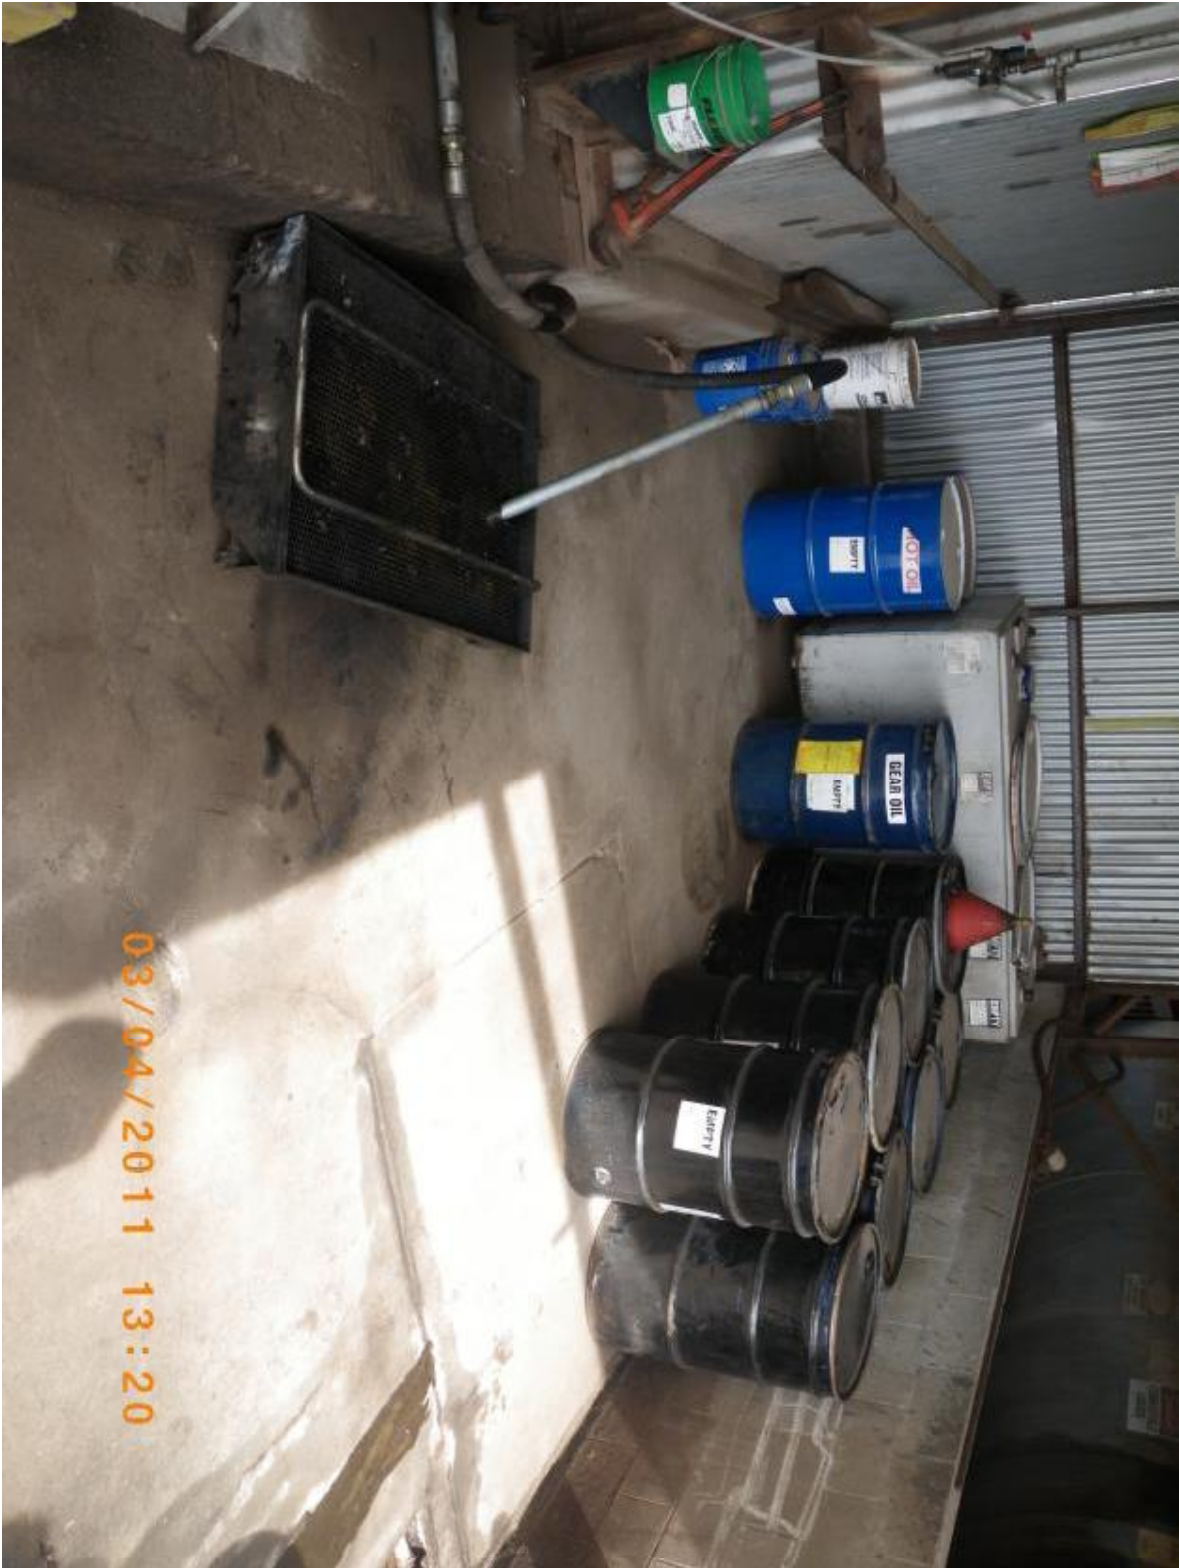
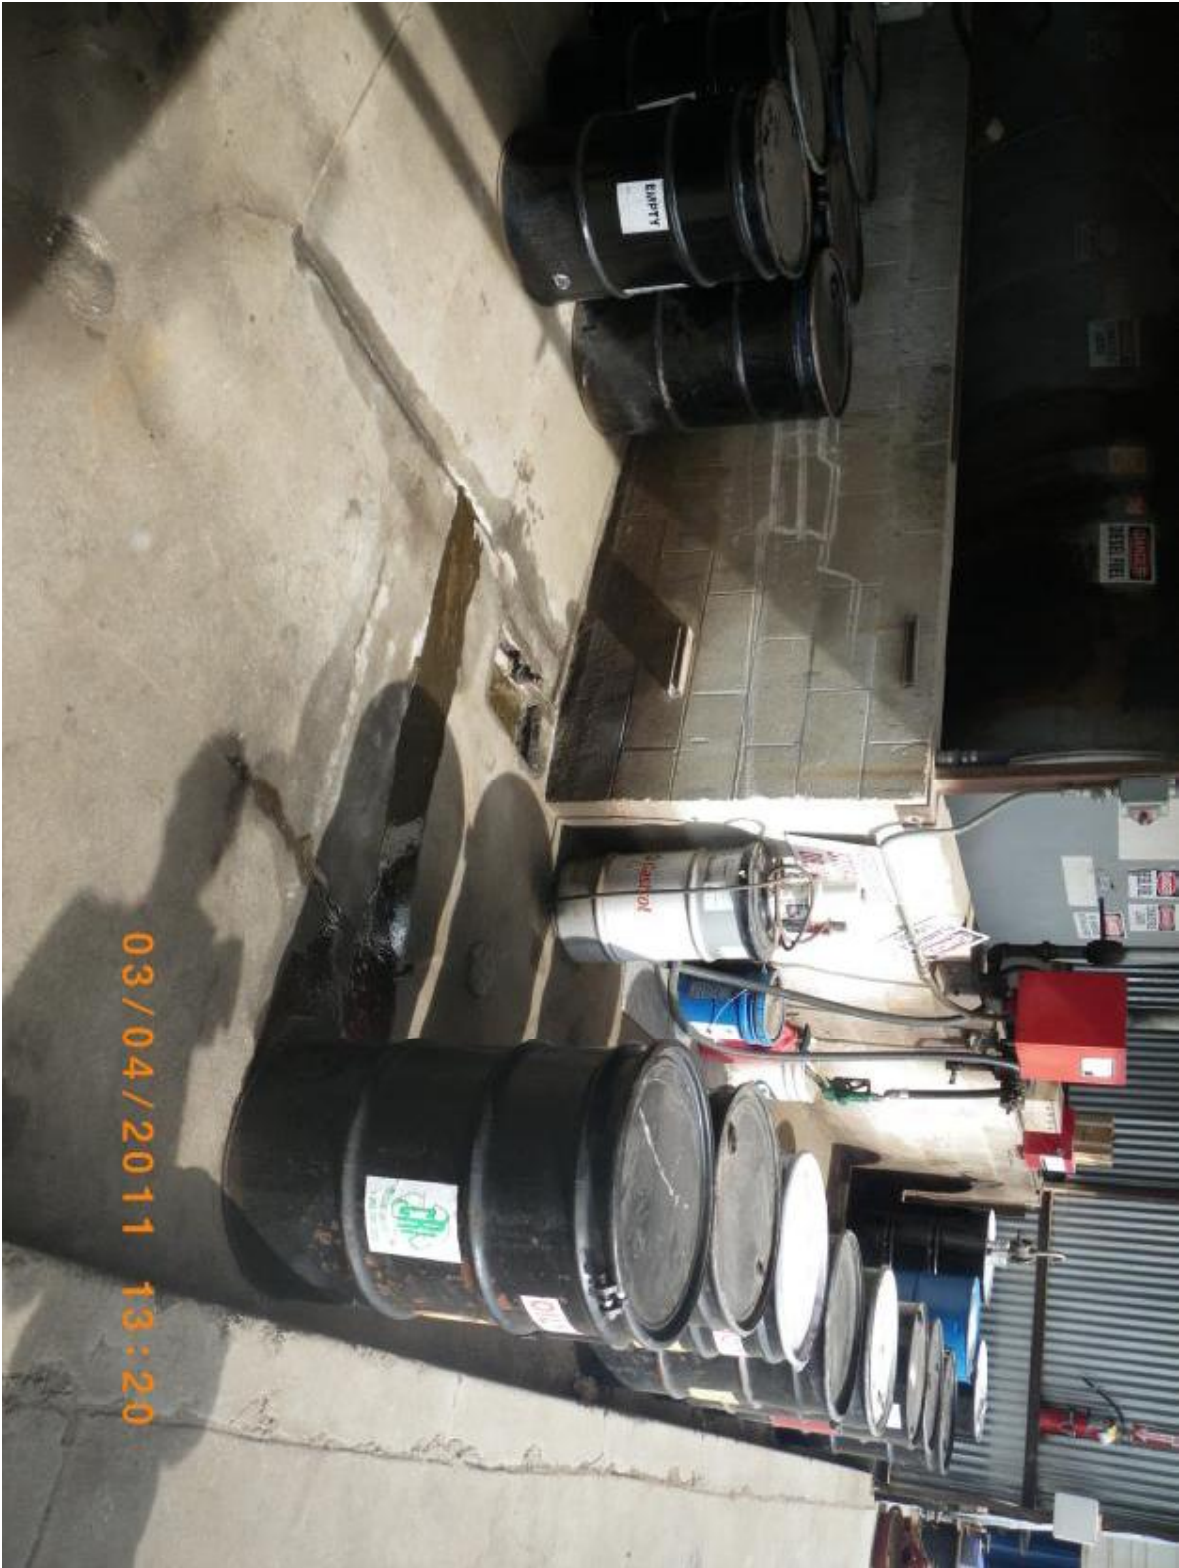
IMGP0288 thru 0293 – Oil lines, drums, and oil leaks observed within the covered fueling and oiling depot. The spigot in IMGP0293 is a drain line for the secondary containment basin for the diesel tank depicted in IMGP0294 thru 0298 – Diesel AST and secondary containment basin. Diesel dispensing nozzle is stored over a bucket to catch incidental drips.

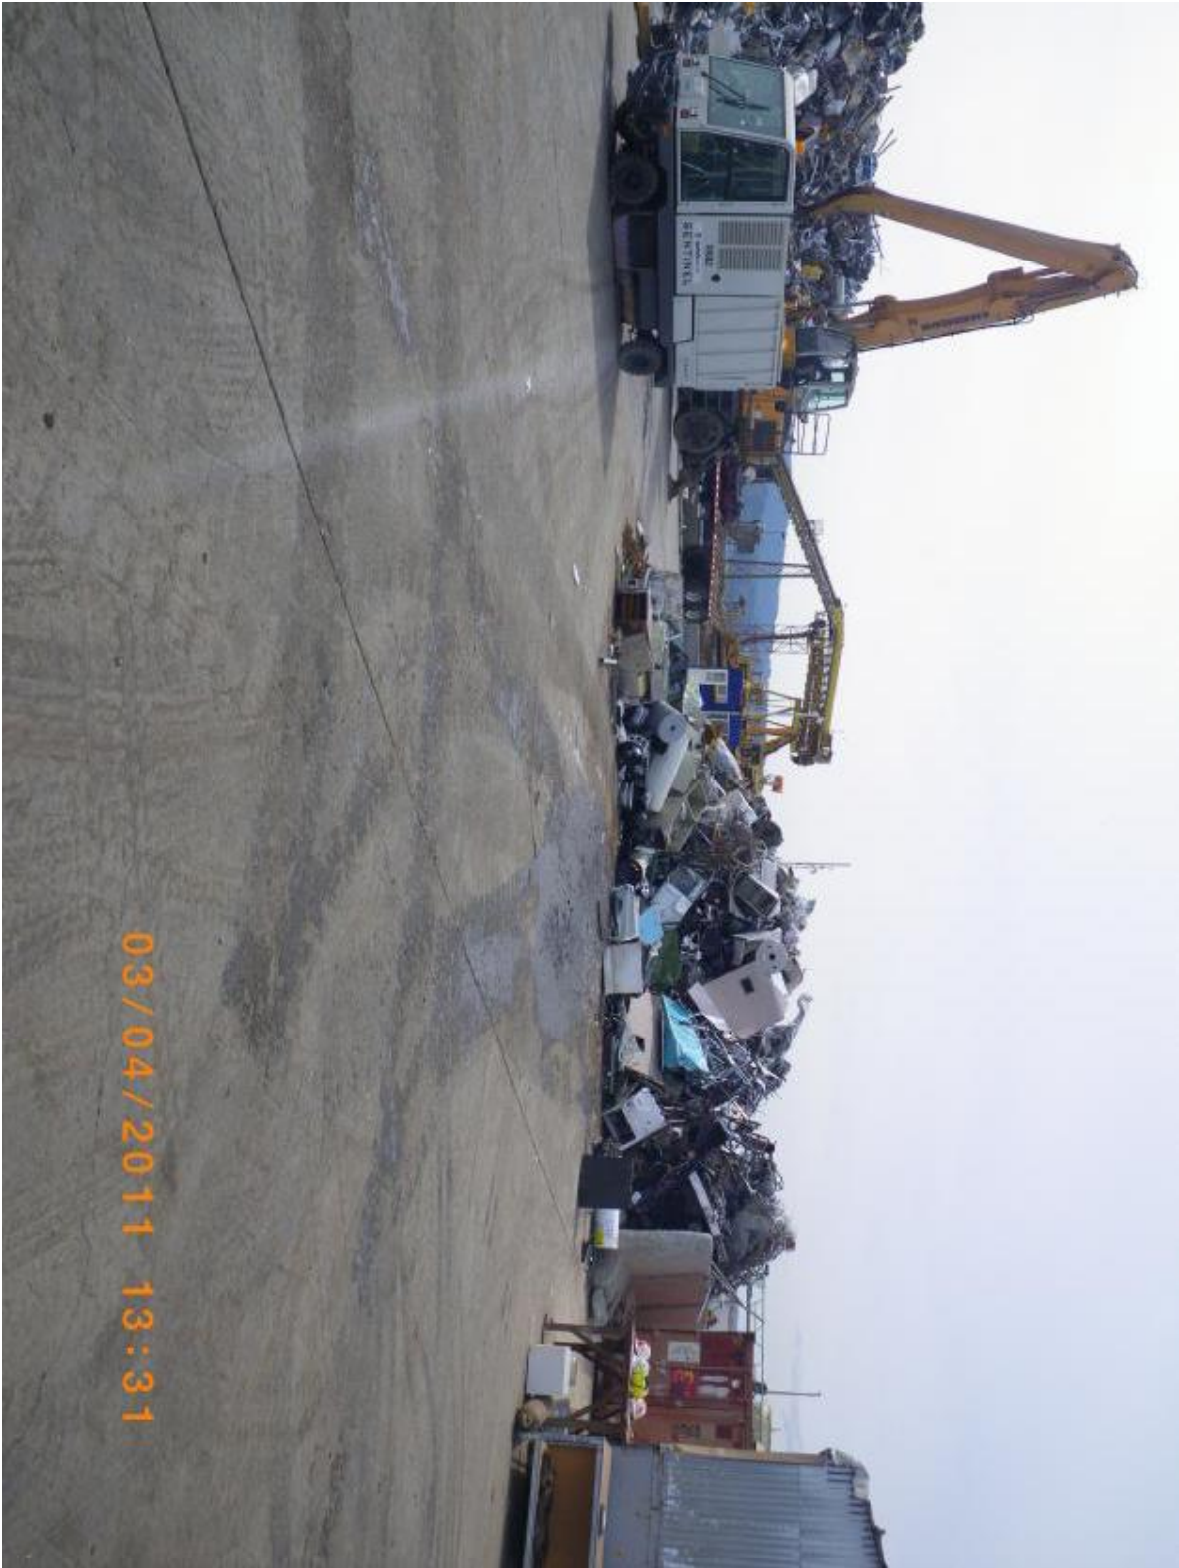
IMGP0301.JPG

IMGP0301 – Dump truck depositing transferred metal from another Sims facility. Vehicle tracks were observed on the driving surface.
